RE: Arboricultural Assessment of Supporting Removal of Tree 5 Camphor Laurel: MP10_0016 - "The Terraces" 2 Cooper Street, Paddington
Ref: 246MonTree5[AR-RE-P-1007]

1. Background

2. Current Status of Tree 5 and the Surrounding Trees

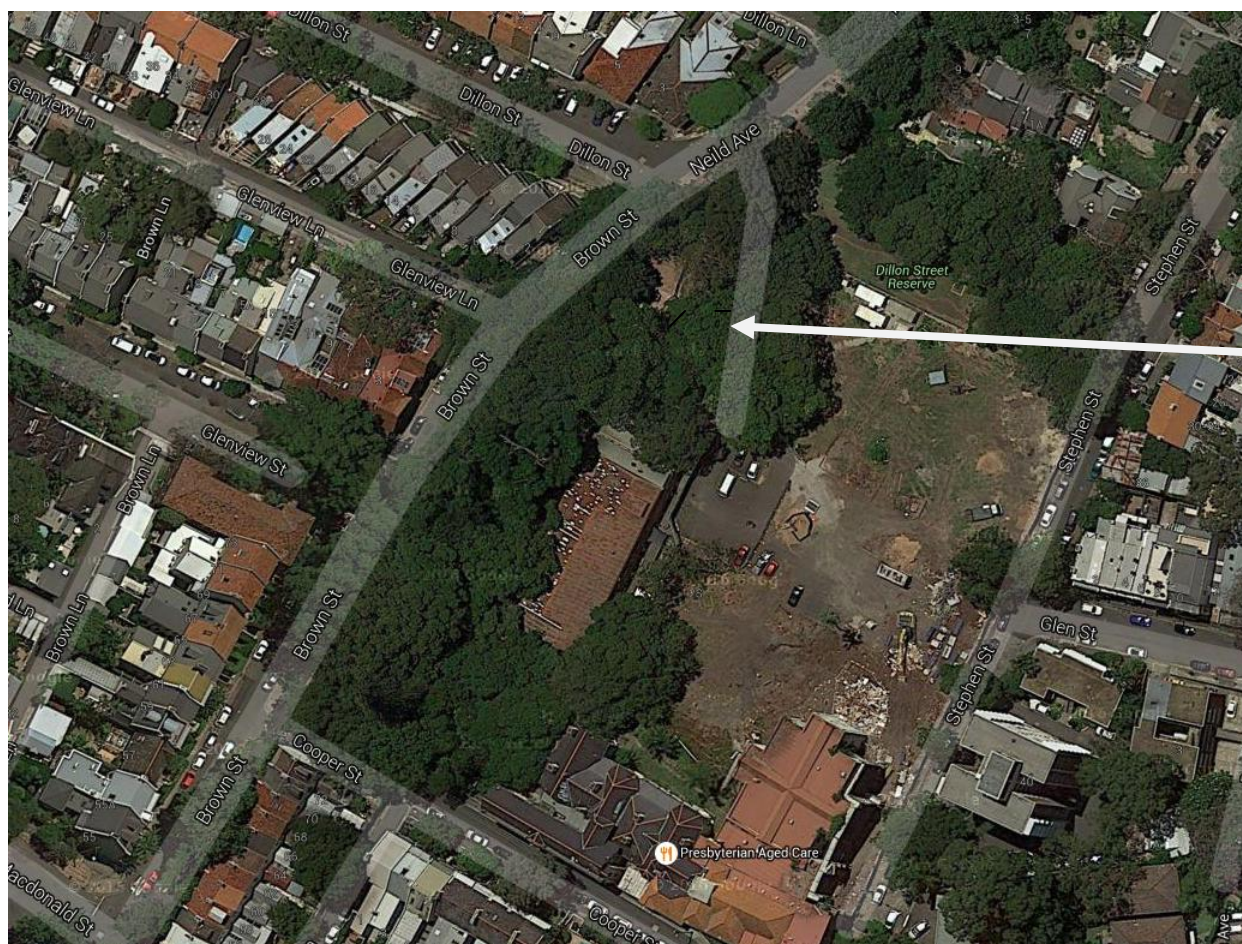
Google Maps image 26.11.15 showing Tree 5 following Stage 1 tree removals.

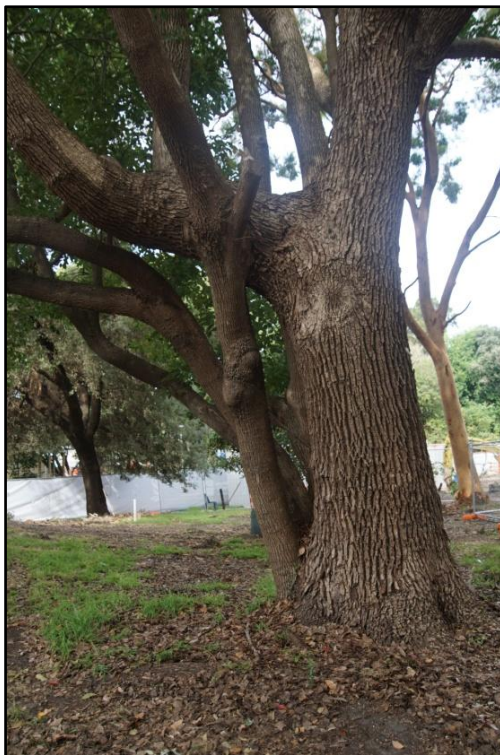
Tree 5 is a ©Retention Value *B* tree by virtue of its ©Significance Rating of 3 and Useful Life Expectancy (ULE) of *Long*. The ©Significance Rating of 3 is due to this tree species being Exempt under the Woollahra TPO when less than 10m tall and not located on a Heritage Item. The *Fair* Condition is a reflection of the crossing branches and previous pruning of the tree (Photo A).

Photo A: Tree 5 Camphor Laurel showing basal suckers and previous pruning wounds resulting in ©Significance Rating of 3. Trees 4 and 8 to be retained are visible in the background.

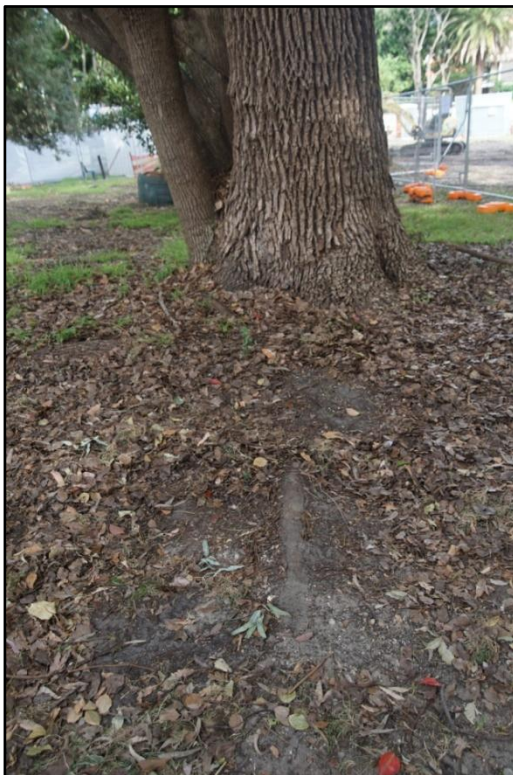
On the subject site Tree 5 dominates the surrounding trees including Tree 6 and this will continue as Tree 5 still has *Long* life expectancy with further capacity for growth above and below ground. There are surface roots growing towards the existing kerb and gutter (Photo B) which may need to be removed with the proposed Driveway realignment (towards the tree) and boardwalk construction.

Photo B: Tree 5 showing surface roots within SRZ which need to be retained as part of proposed construction.

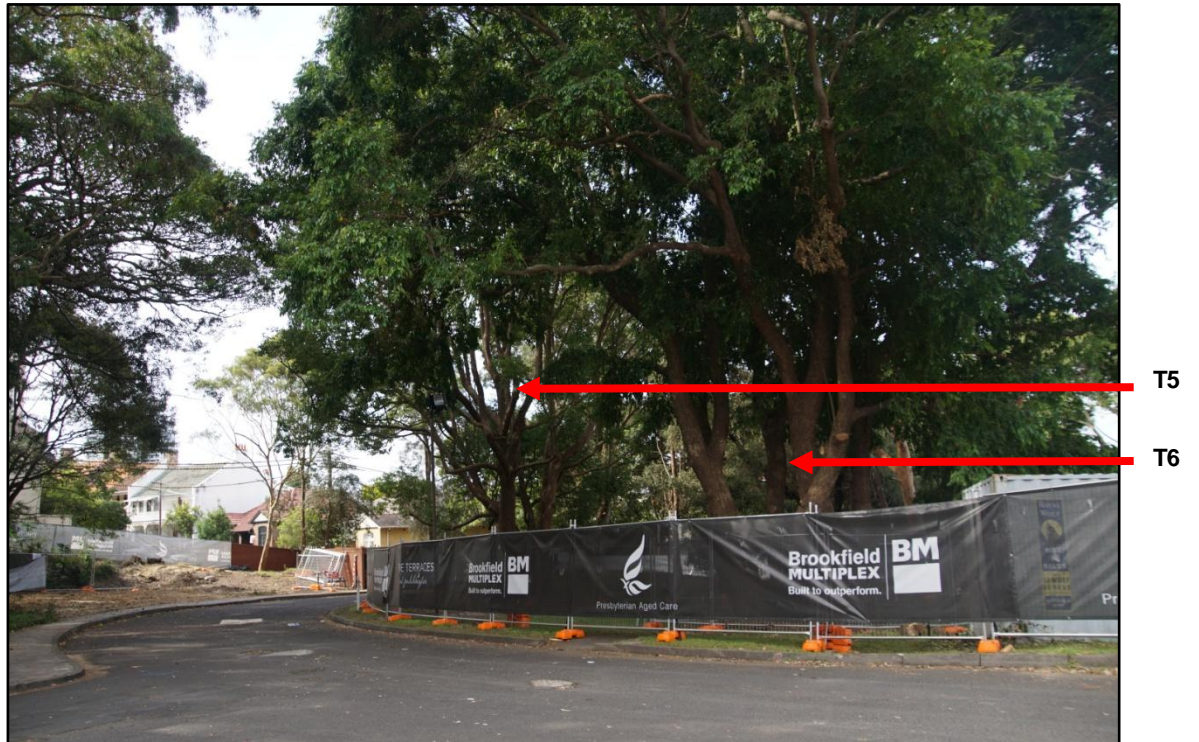
The crown of Tree 5 merges with (competes with) the crown of other surrounding trees to be retained including Tree 6 the Heritage Listed Weeping Lilly Pilly, *Waterhousea floribunda* (Photo C). The Weeping Lilly Pilly, *Waterhousea floribunda* is a ©Retention Value A by virtue of the ©Significance Rating of 1 and ULE of *Long*.

Photo C: Crown of Tree 5 (background) merging with surrounding trees to be retained.

- It will provide a feasible construction zone for Stage 2 works.
- It will benefit the more significant Heritage Listed, Tree 6 Weeping Lilly Pilly, *Waterhousea floribunda* by reducing competition for soil nutrients and water and allowing space for the crown to growth in a northwesterly direction.

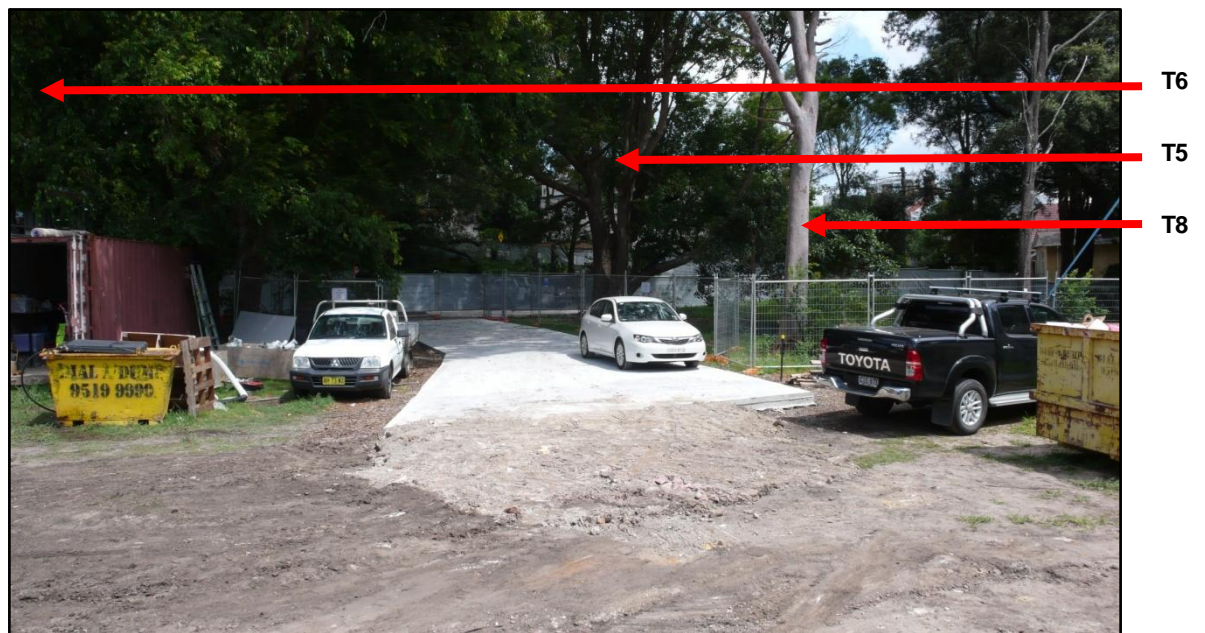
A temporary construction Driveway has recently been built to the Project Arborist's (TWM) specifications for the purposes of Stage 1 construction (Photo D). This temporary Driveway passes between Tree 5 and Tree 6. The alignment of the Driveway is as indicated on *Site Establishment Plan – Stage 1, PM-P-2002 Rev. 3* prepared by BMC (Attachment C).

Crown pruning has recently been undertaken on the southern side over the temporary Driveway to provide a 4.5 metres clearance for vehicles and machines.

Photo D: Recently installed temporary construction Driveway between Tree 5 and Tree 6. More similar pavement is required adjacent Trees 5 and 6 for the Stage 1 and Stage 2 construction.

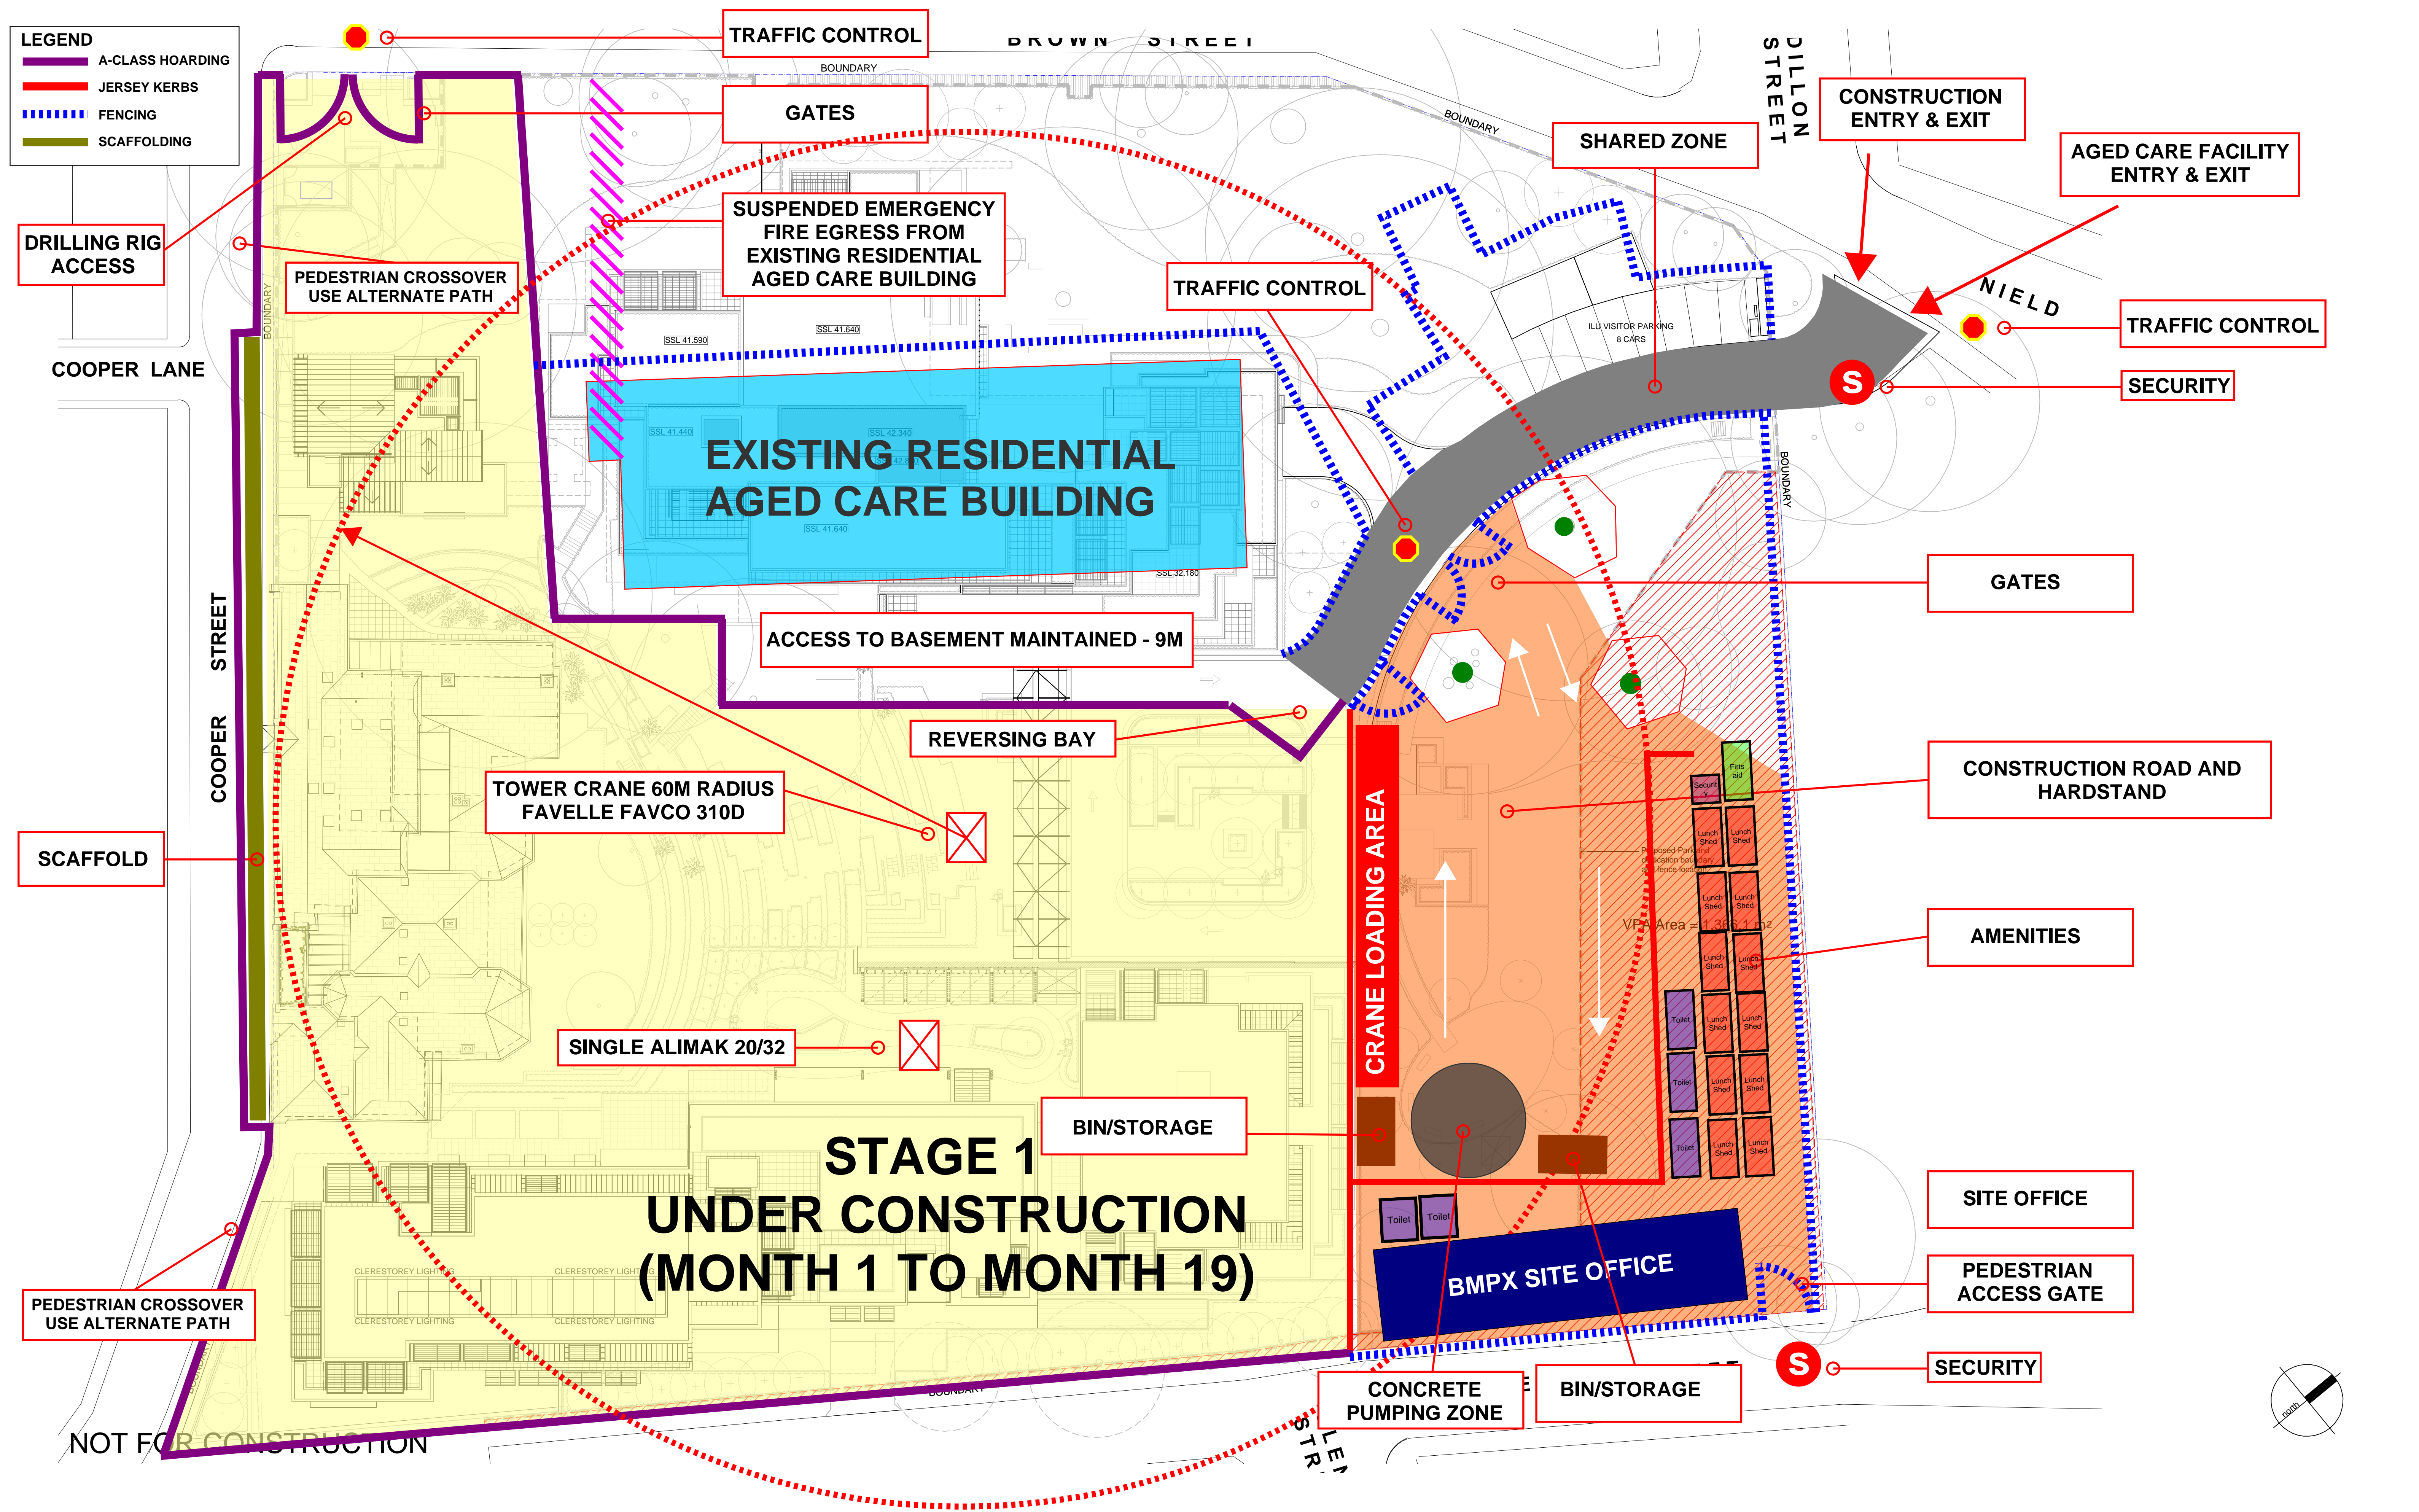
Drawing No. PM-P-2002
Rev. 3
Scale 1:250
Date 17/09/15

- It will provide a better Stage 1 hardstand layout benefiting Heritage Listed Tree 6. Trucks and vehicles will not need to exist the gate south of Tree 6 indicated on *PM-P-2002, Rev 3*. This temporary Driveway south of Tree 6 has not yet been constructed.

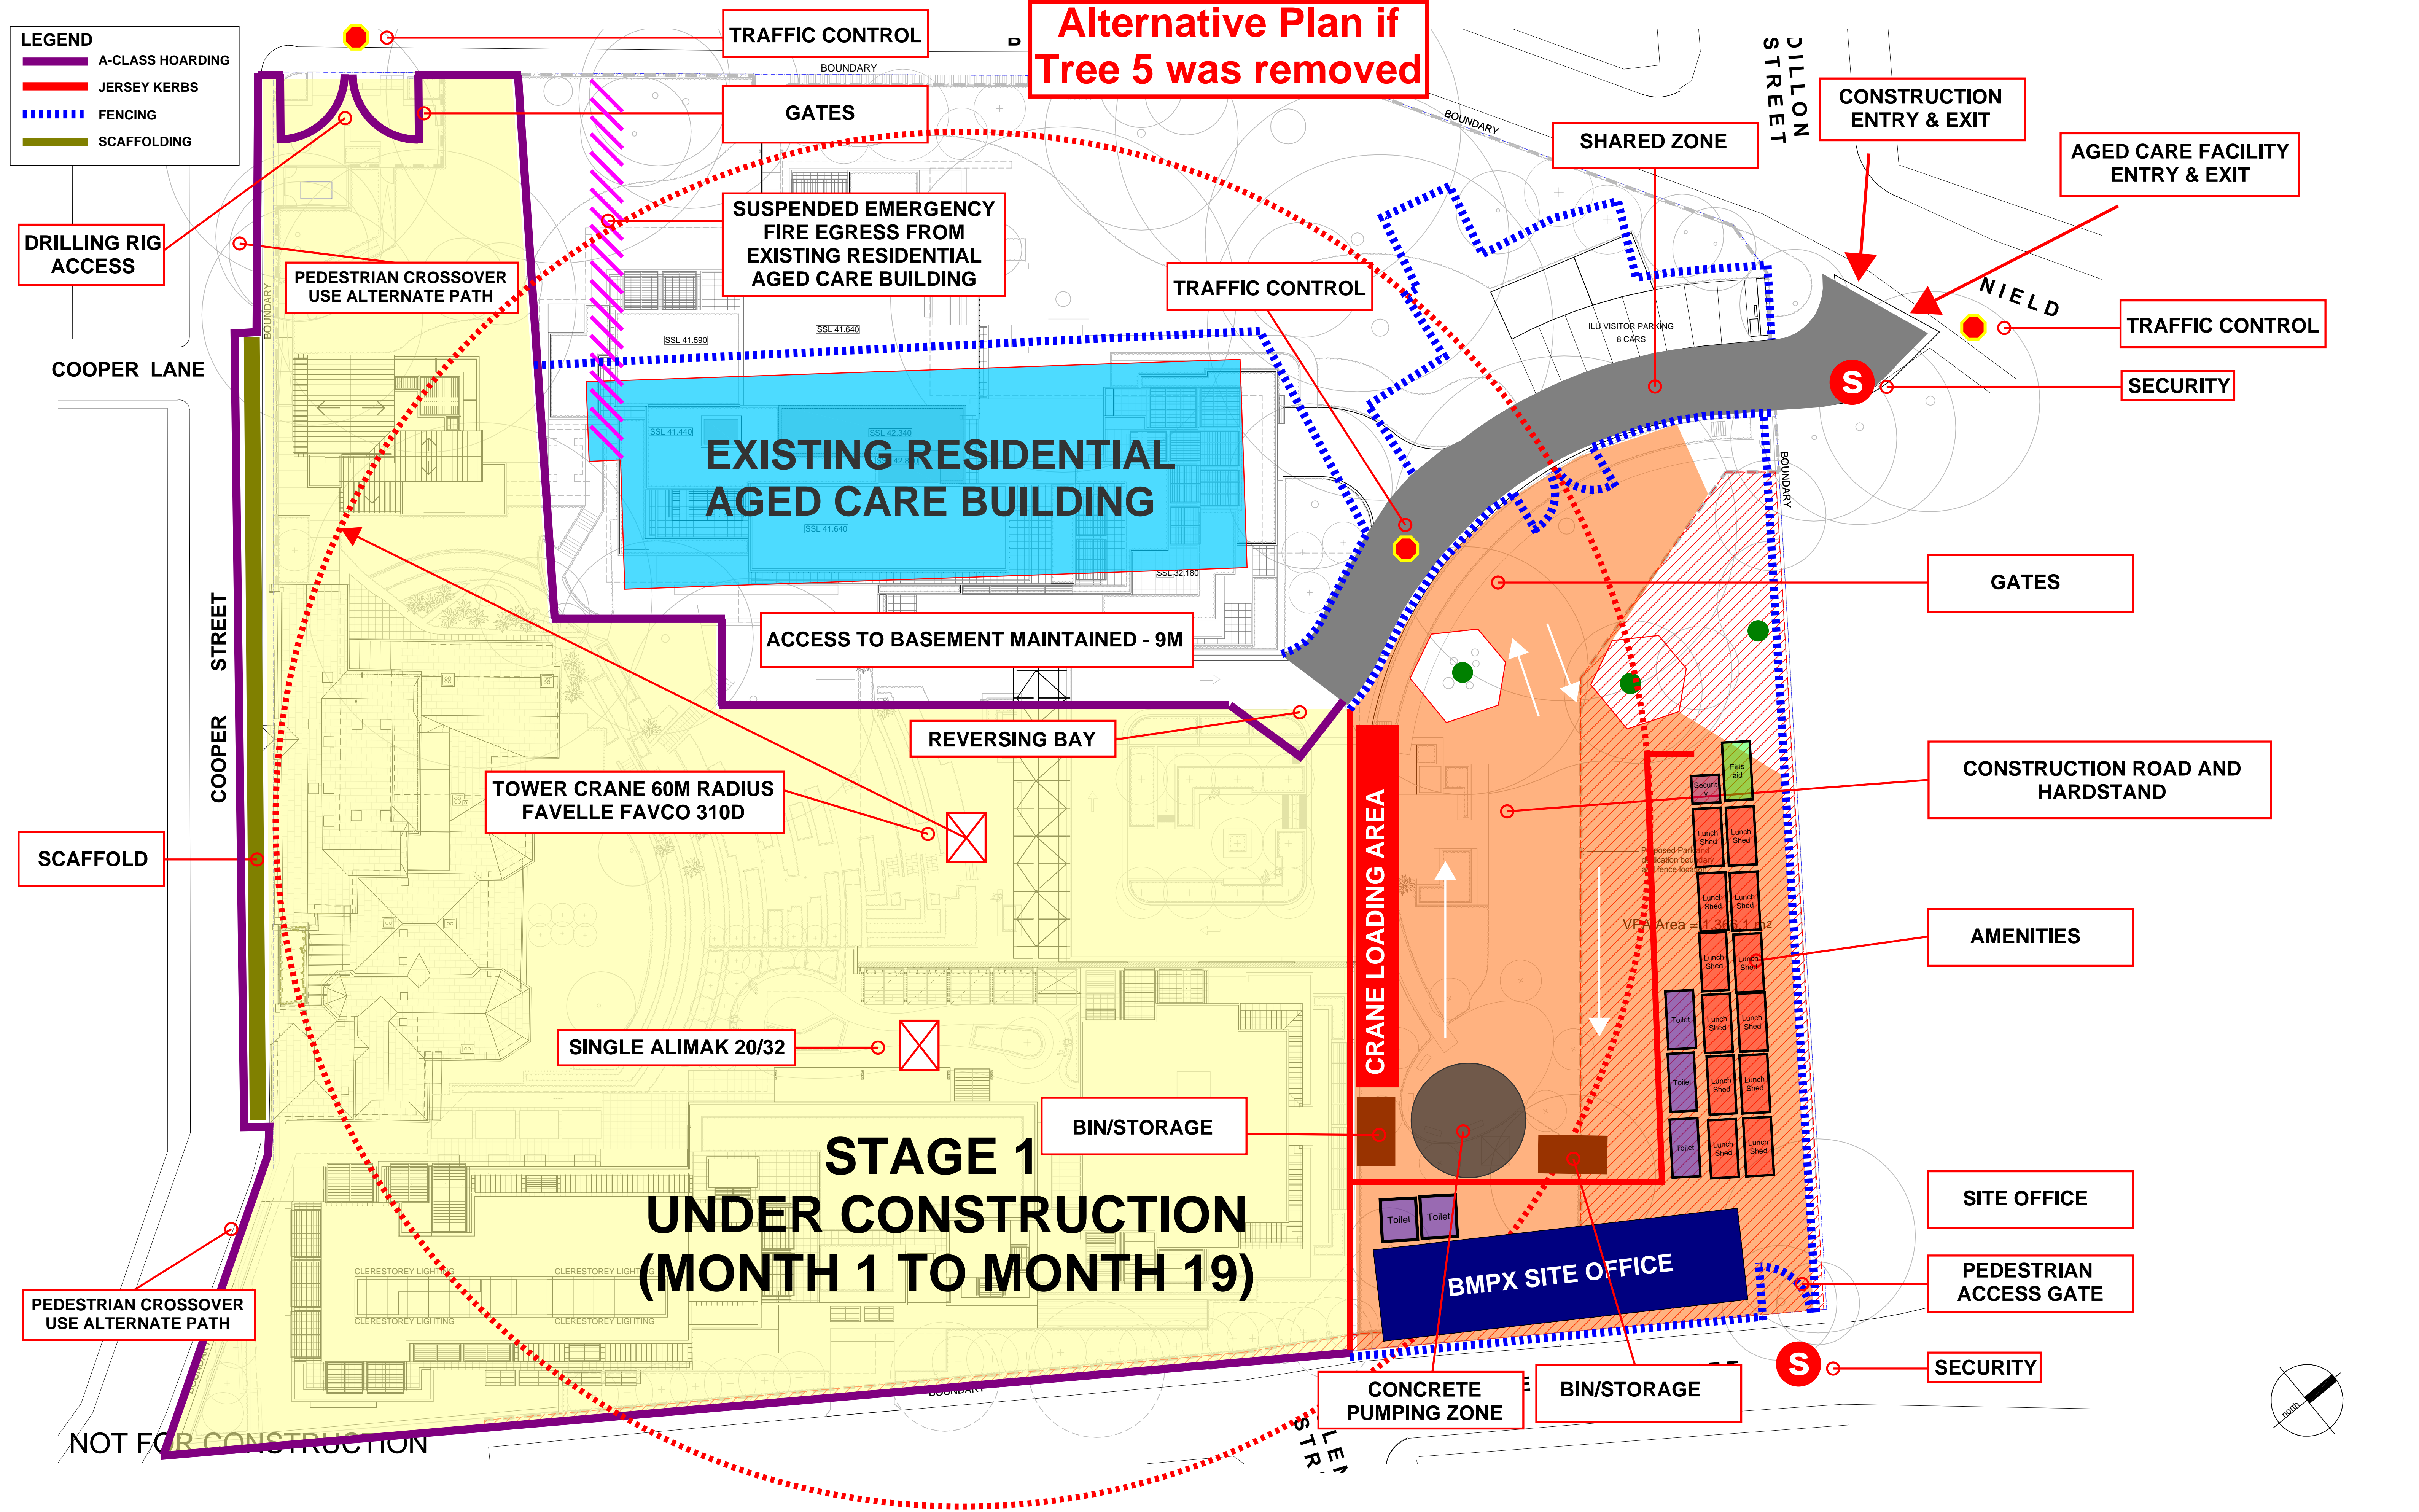
Drawing No. PM-P-2002
Rev. 4
Scale 1:250
Date 04/02/16

The Stage 1 works have commenced and temporary Driveway is in place for works between Trees 5 and Tree 6. The *Site Establishment – Stage 1 PM-P-2002, Rev 4* (Attachment E) shows the revised hardstand Driveway and gate layout with Tree 5 removed.

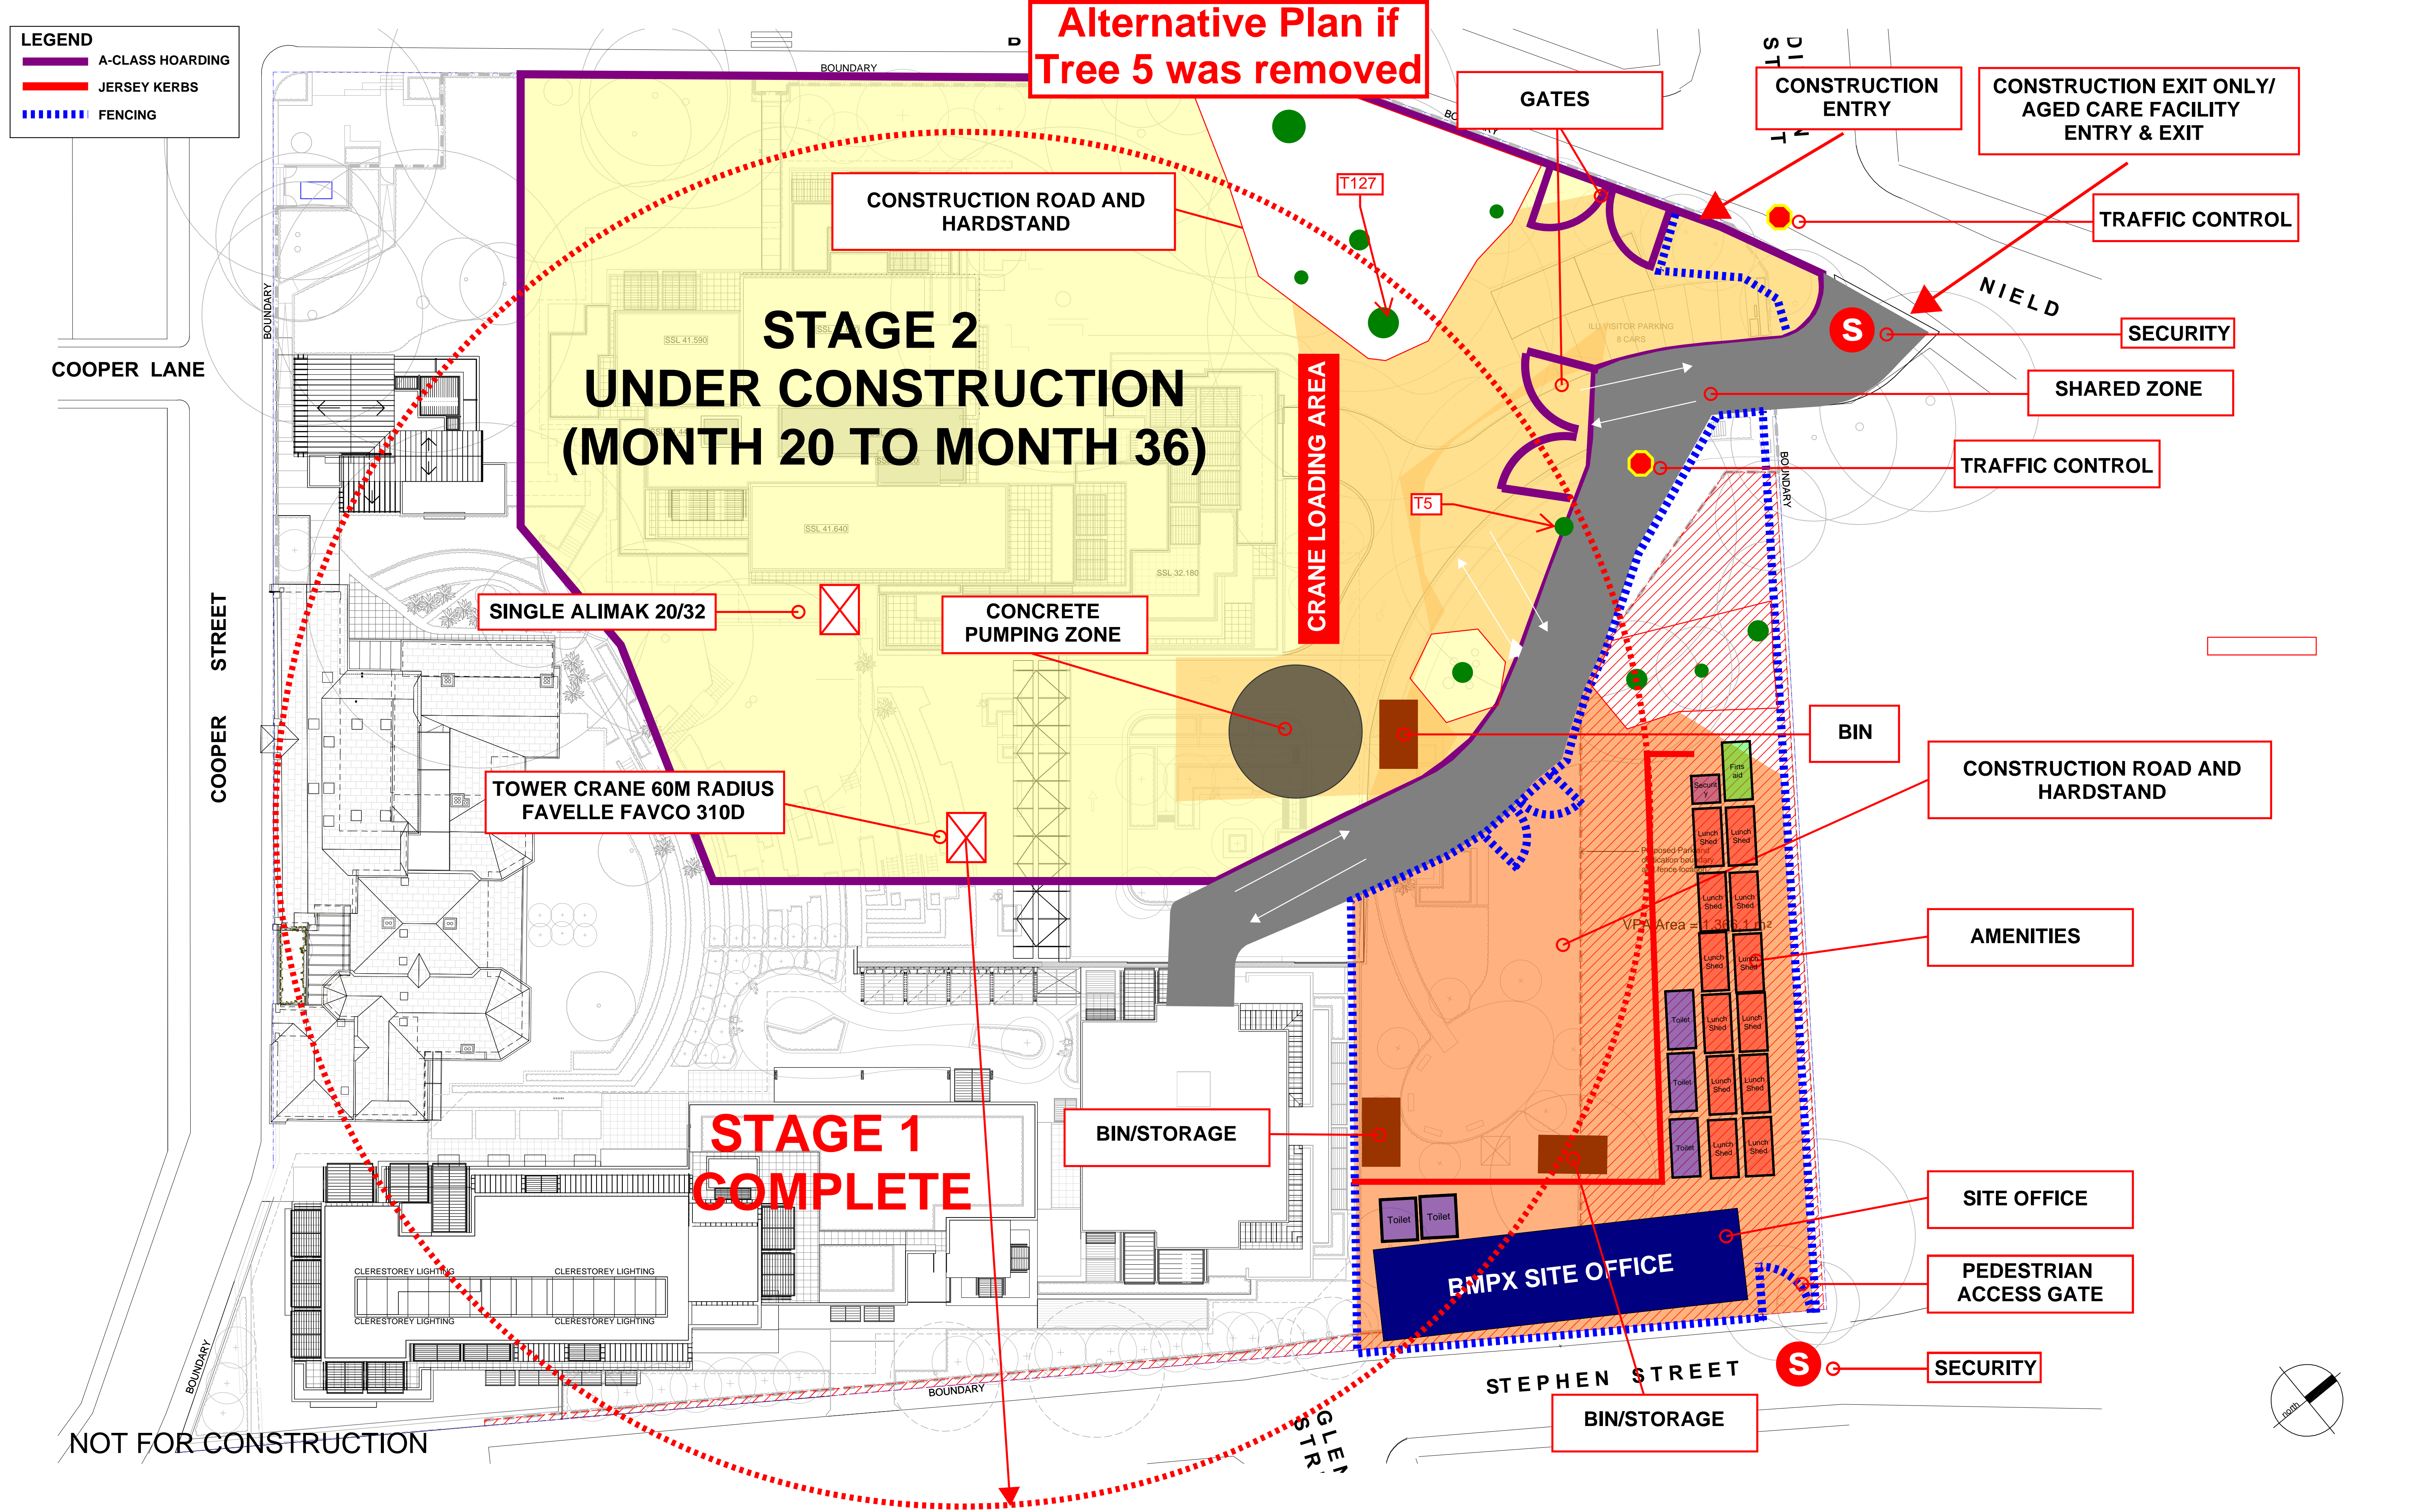
Drawing No. PM-P-2003
Rev. 4
Scale 1:250
Date 04/02/16

A revised *Site Establishment – Stage 2, Rev 4* (Attachment G) has been prepared with Tree 5 removed. This changes the alignment of the vehicular access road and it shifts the construction zone away from Trees 6, 122, 126, 127 and 133.
