Reference: 14.289r03v03

**Re: The Terraces - Seniors Living and Residential Aged Care Facility
74 Brown Street, Paddington
Removal of Significant Trees 5 and 130**

**RE: Arboricultural Assessment of Supporting Removal of Tree 130 Sydney Red Gum:
MP10_0016 - "The Terraces" 2 Cooper Street, Paddington**

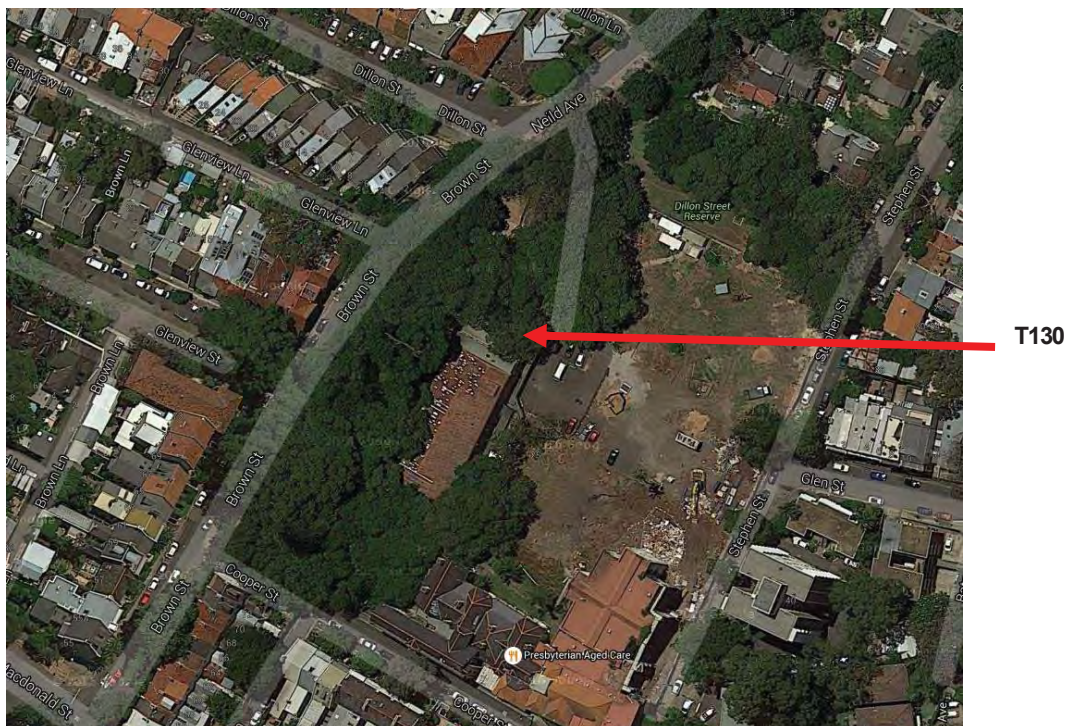
Google Maps image 26.11.15 showing Tree 130 following Stage 1 tree removals.

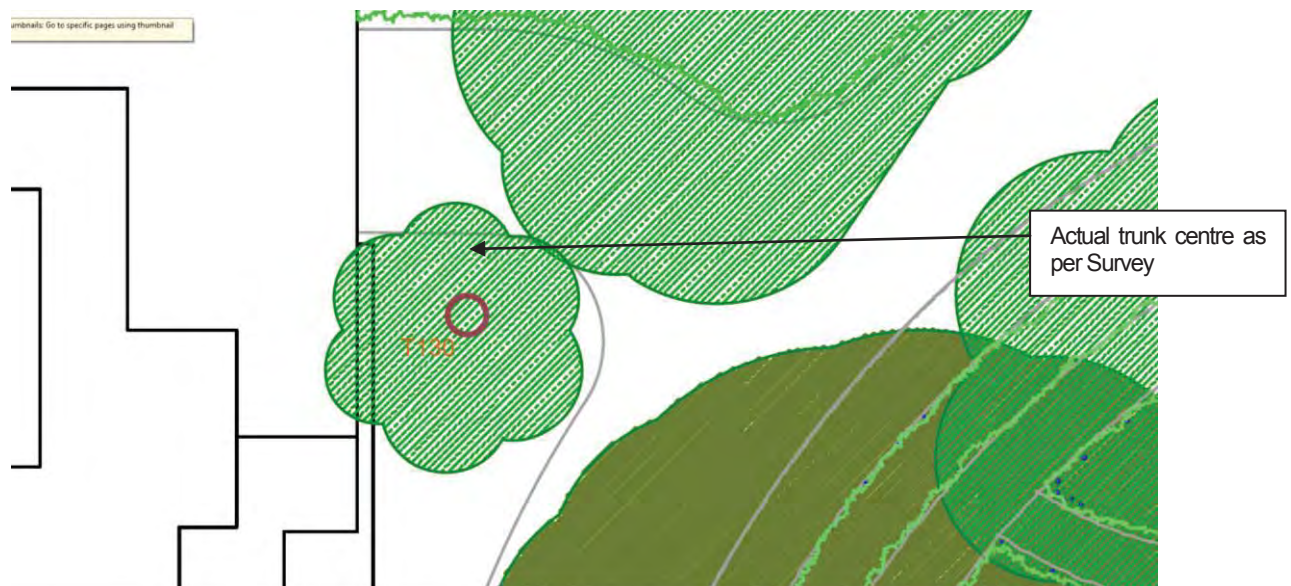
Excerpt from *Site Plan, DA101 Rev. P11* by JPRA.

The JPRA Architectural set, Rev. P11, 7.09.10 reviewed for the AIA, September, 2010 had the trunk shown as the tree number rather than the trunk centre, marginally further from the proposed ramp than shown on the current Drawings.

The assessment of the impact of the proposed building works on the tree in the Arboricultural Impact Assessment report for the DA (Ref: 246DAIA, September 2010) was in error. The close proximity of the trunk of the tree to the proposed Driveway ramp to the basement was not accurately assessed. The earlier tree number (#16) on the Survey was misinterpreted by some as the trunk of the tree. The actual trunk centre is at ERL 16.14 as indicated.

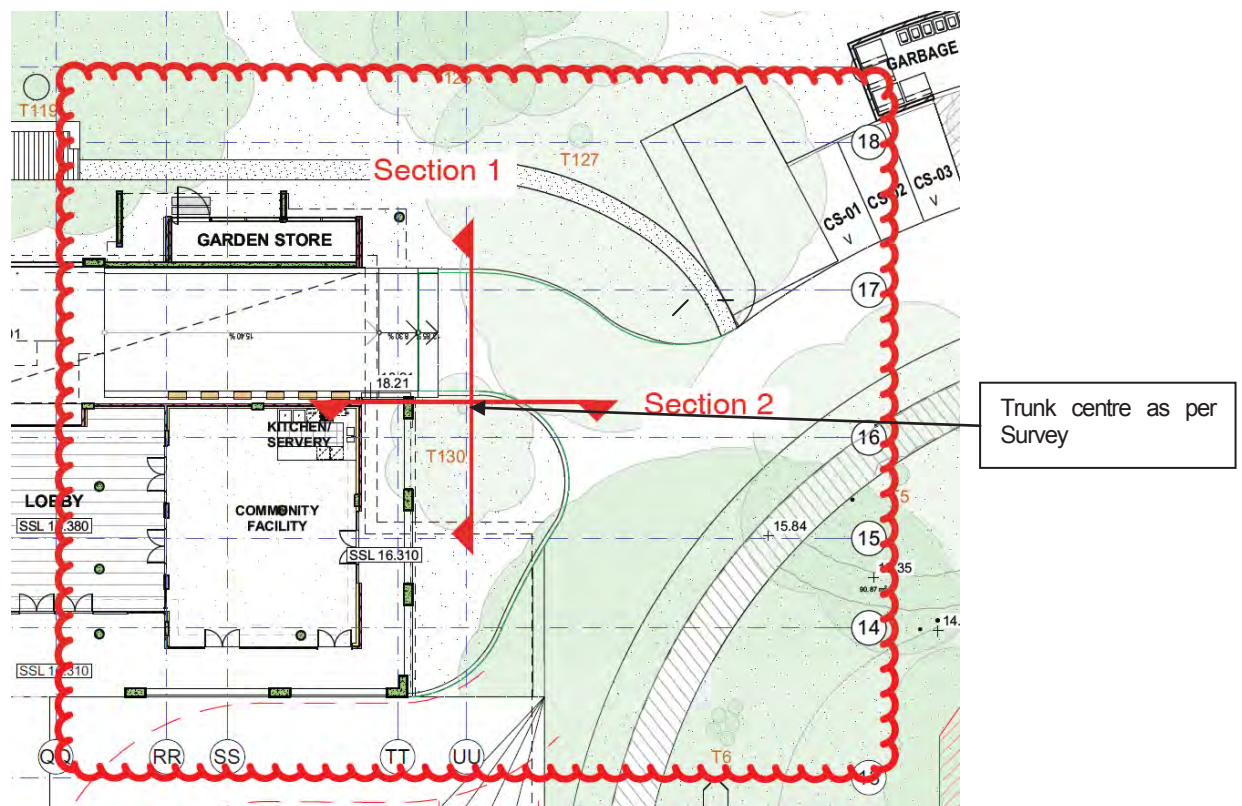
Excerpt from *Level 01 Plan A-P-1103, Rev 10* by JPRA. Refer to Attachment C of detail of Sections 1 and 2.

The current construction drawings show the actual trunk location well within the Structural Root Zone (SRZ) (2.8m) of the tree. In fact the excavation needed for the Driveway ramp down to the Basement is within 1m of the base of the tree and will result in root cutting on the tension side of the tree.

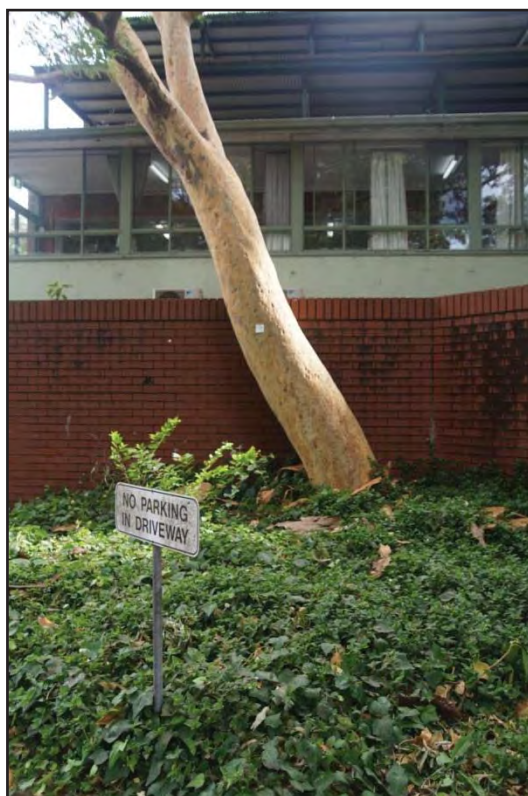
Photo A: Tree 130 looking southwest showing significant trunk lean to the south and close proximity to existing walling.

Tree 130 is a ©Retention Value A tree by virtue of its ©Significance Rating of 2 and Useful Life Expectancy (ULE) of *Long*. The ©Significance Rating of 2 is due to its size, this tree species being protected under the Woollahra TPO and being an Australian native species. The *Fair* Condition is a reflection of the trunk lean, crown skew and possible root confinement by existing walling (Photos A and B). The tree is growing within 1m of brick walling with likely root restriction or confinement resulting from the wall footings.

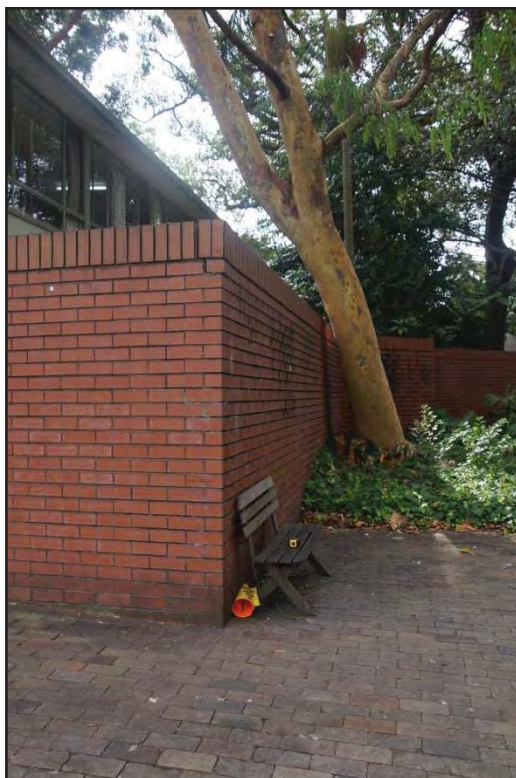
Photo B: Tree 130 looking west showing proximity to existing walling and overhang of existing building.

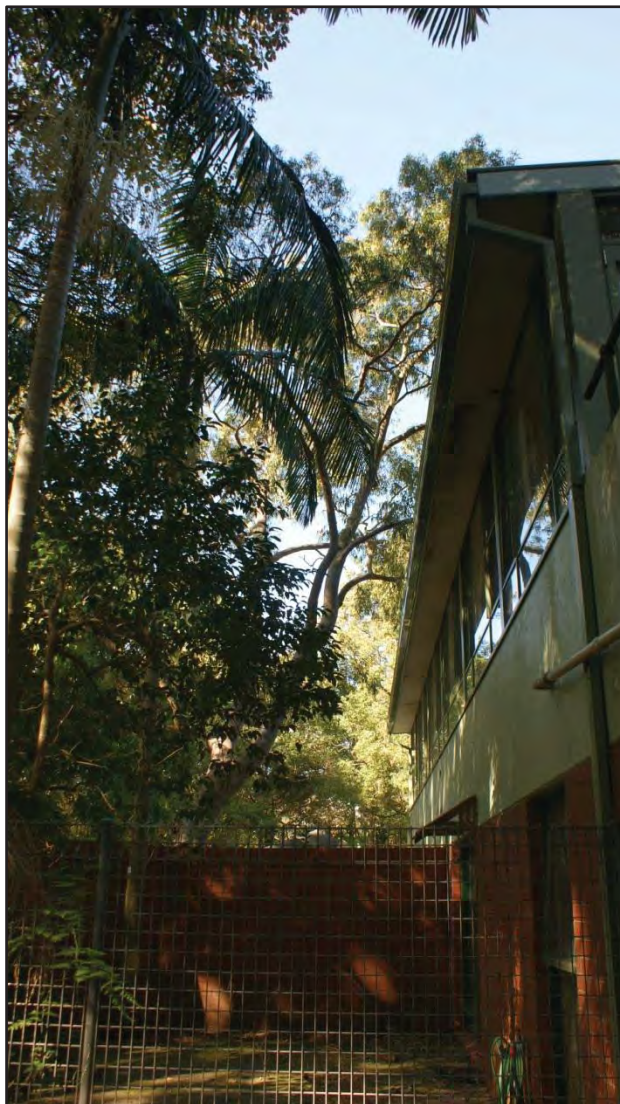
Photo C: Tree 130 looking east showing crown skew to south over existing and proposed building.

The crown symmetry of Tree 130 has been influenced by the older and larger adjacent trees predominantly Tree 127 (Port Jackson Fig, *Ficus rubiginosa* Photo C).

The crown of the tree is skewed to the south as indicated in Photo C, in the Survey excerpt above and as indicated in the External Works Sections markup (Attachment C). Substantial crown pruning would be required to allow for the proposed building facade and the scaffold required for the construction. As indicated in Section 2 (looking west) scaffolding is required in line with the base of the trunk. Even if the building were to be constructed without external scaffolding, the southern-most leader would need to be pruned to the main junction at approximately 3m above ground level and all the southern branches would need to be pruned to provide reasonable building clearance. This extent of crown pruning would render the tree significantly disfigured such that its ULE would be reduced and the landscape amenity provided by the tree would be lost.

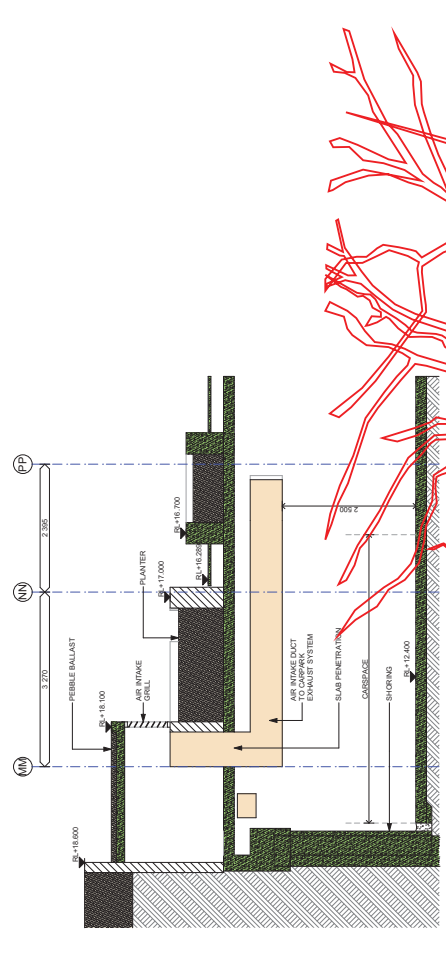
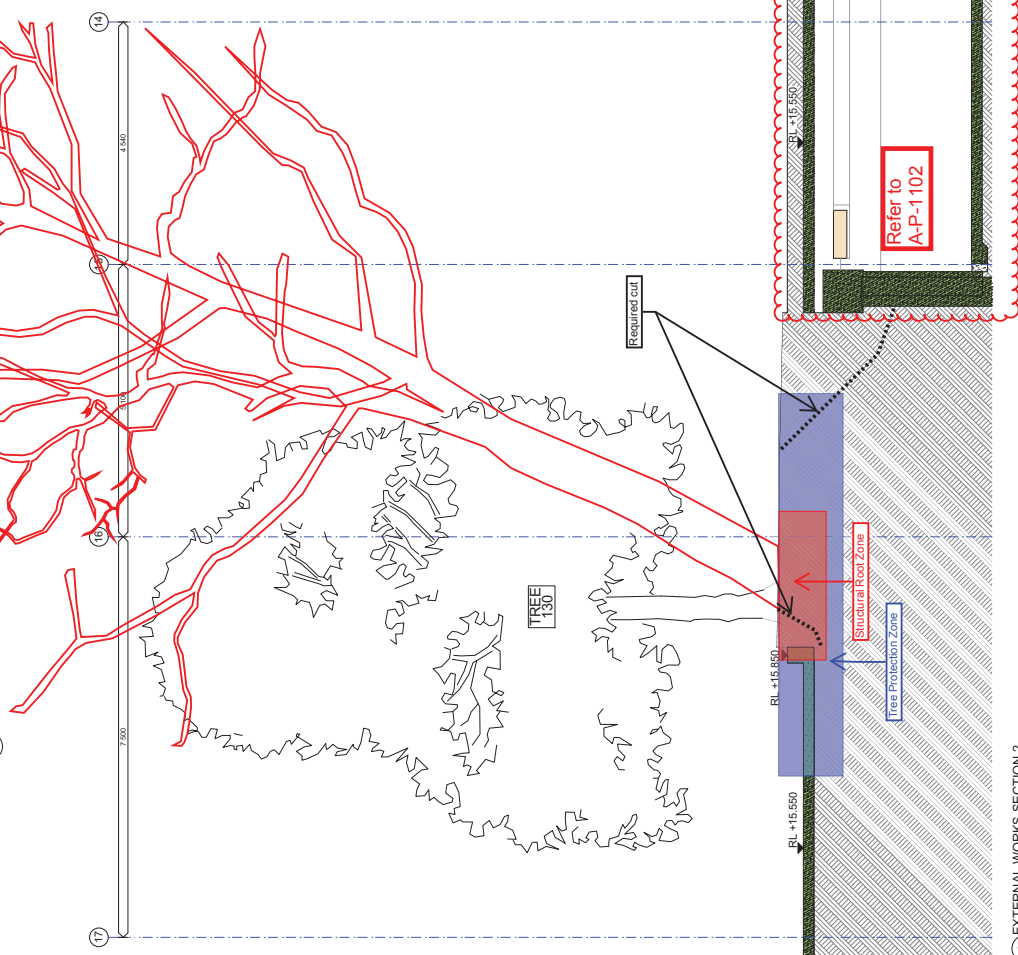
1 EXTERNAL WORKS SECTION 2 1:50

Section 1 shows the existing ground lines and proposed cut required for the Driveway ramp. Substantial cut for the proposed Driveway ramp is required at the base of the trunk to the west well inside the SRZ. Section 2 shows the cut required for the Basement (Grid line 15) within the Tree Protection Zone (TPZ) (7.2m) and excavation for the Basement (Grid line TT) within the SRZ. The tree will be destabilised by these combined excavation works within the SRZ, particularly given the lean of the tree away from Driveway ramp line of cut.

The External Works Sections Drawing A-P-1116, Rev 2 by JPRA has been marked up by Brookfield Multiplex Site Manager 3.12.06 (Attachment C) to accurately show the proposed excavation and the actual lean of the tree.

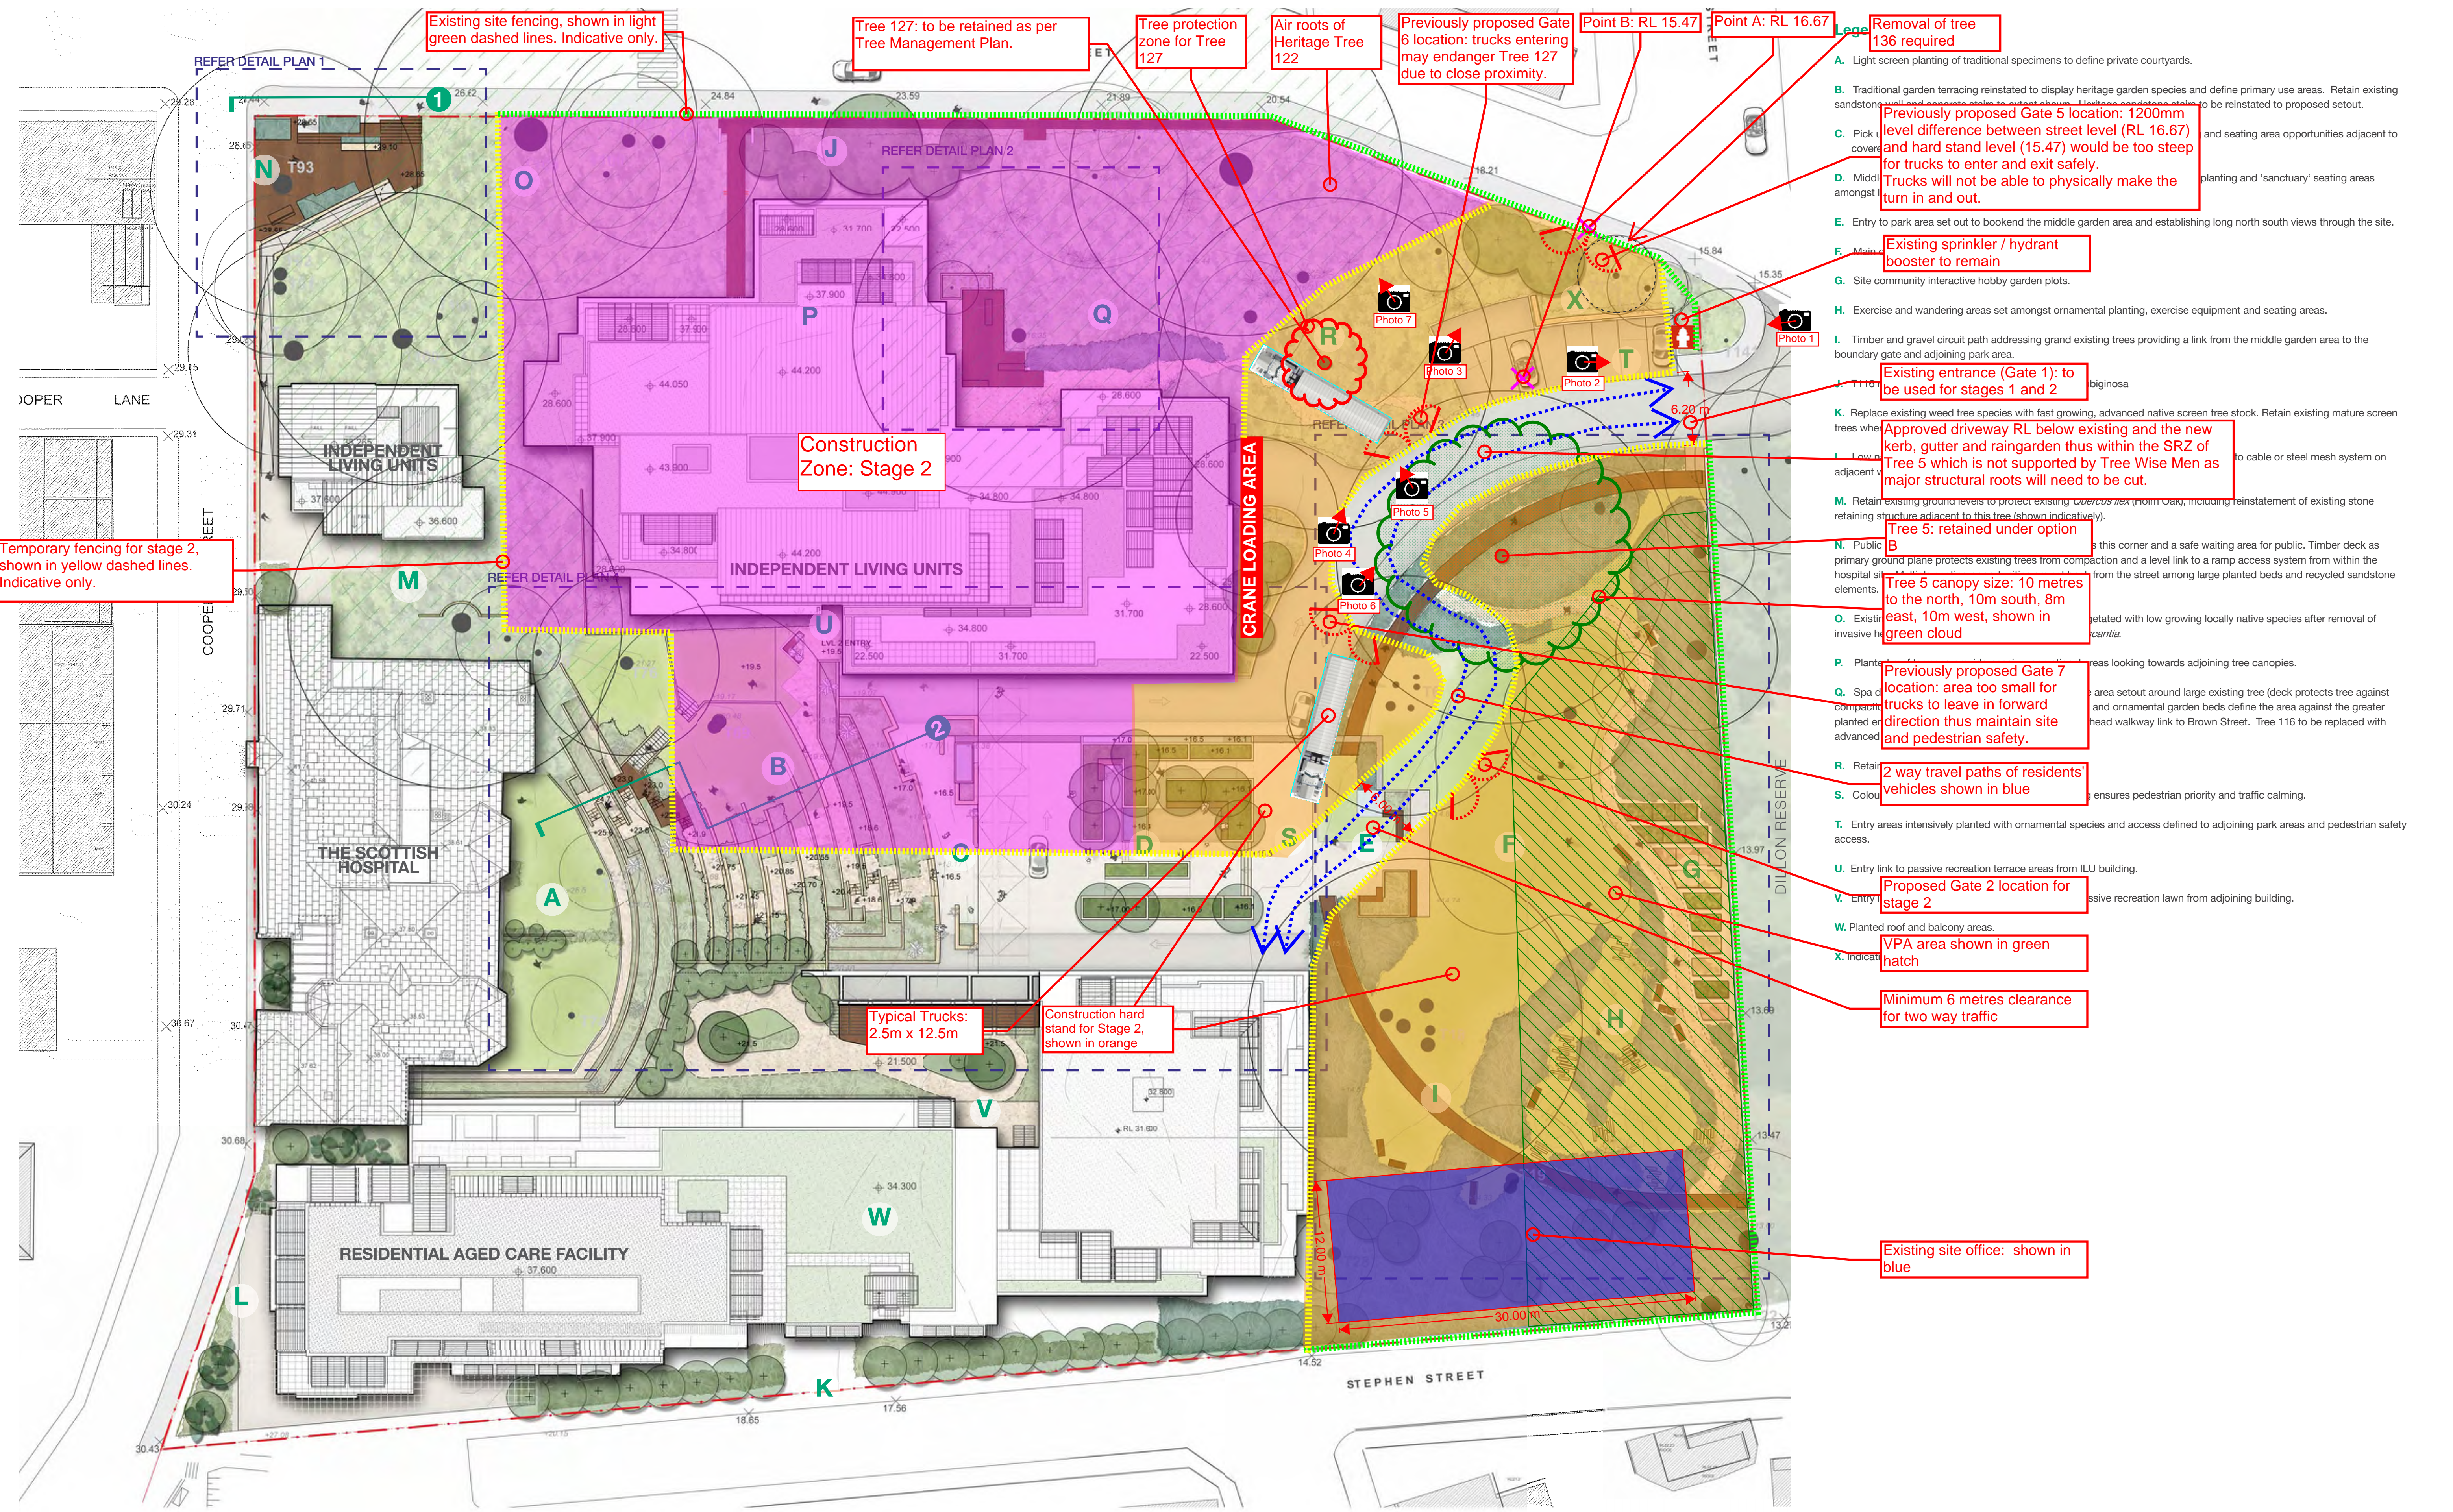
OPTION B - TREE 5 MAINTAINED

- The internal arrangements would not permit trucks to satisfactorily turn around within the site, ensuring that they could exit the site in a forward direction. Forward entry and exit manoeuvres to the site are essential for both safety and efficiency reasons, as well as being a requirement under Condition B7 of the development approval (MP10_0016). Specifically, reverse manoeuvres would most likely be required from previously proposed Gates 5, 6 and 7.

- The change in levels between the street and hardstand at the previously proposed Gate 5 is approximately 1.2m. This is considered a significant grade that trucks would need to reverse up in order to exit the site, which is considered unsafe. This would also result in efficiency concerns along Brown Street as through traffic would need to be held by traffic controllers each time a truck exits the site.

- The construction access driveway at the previously proposed Gate 5 would be situated in a prohibited location having regard for Figure 3.1 of AS 2890.1 (2004), rendering it unsafe.

Whilst Option B would ensure that Tree 5 is able to be retained, this arrangement is considered unsatisfactory for the following reasons:
