REPORT
TO
SIR MOSES MONTEFIORE JEWISH HOME
ON
GEOTECHNICAL INVESTIGATION
FOR
PROPOSED ALTERATIONS AND ADDITIONS
AT
36 DANGAR STREET, RANDWICK, NSW

29 June 2016
Ref: 17167ZRpt5

JK Geotechnics
GEOTECHNICAL & ENVIRONMENTAL ENGINEERS

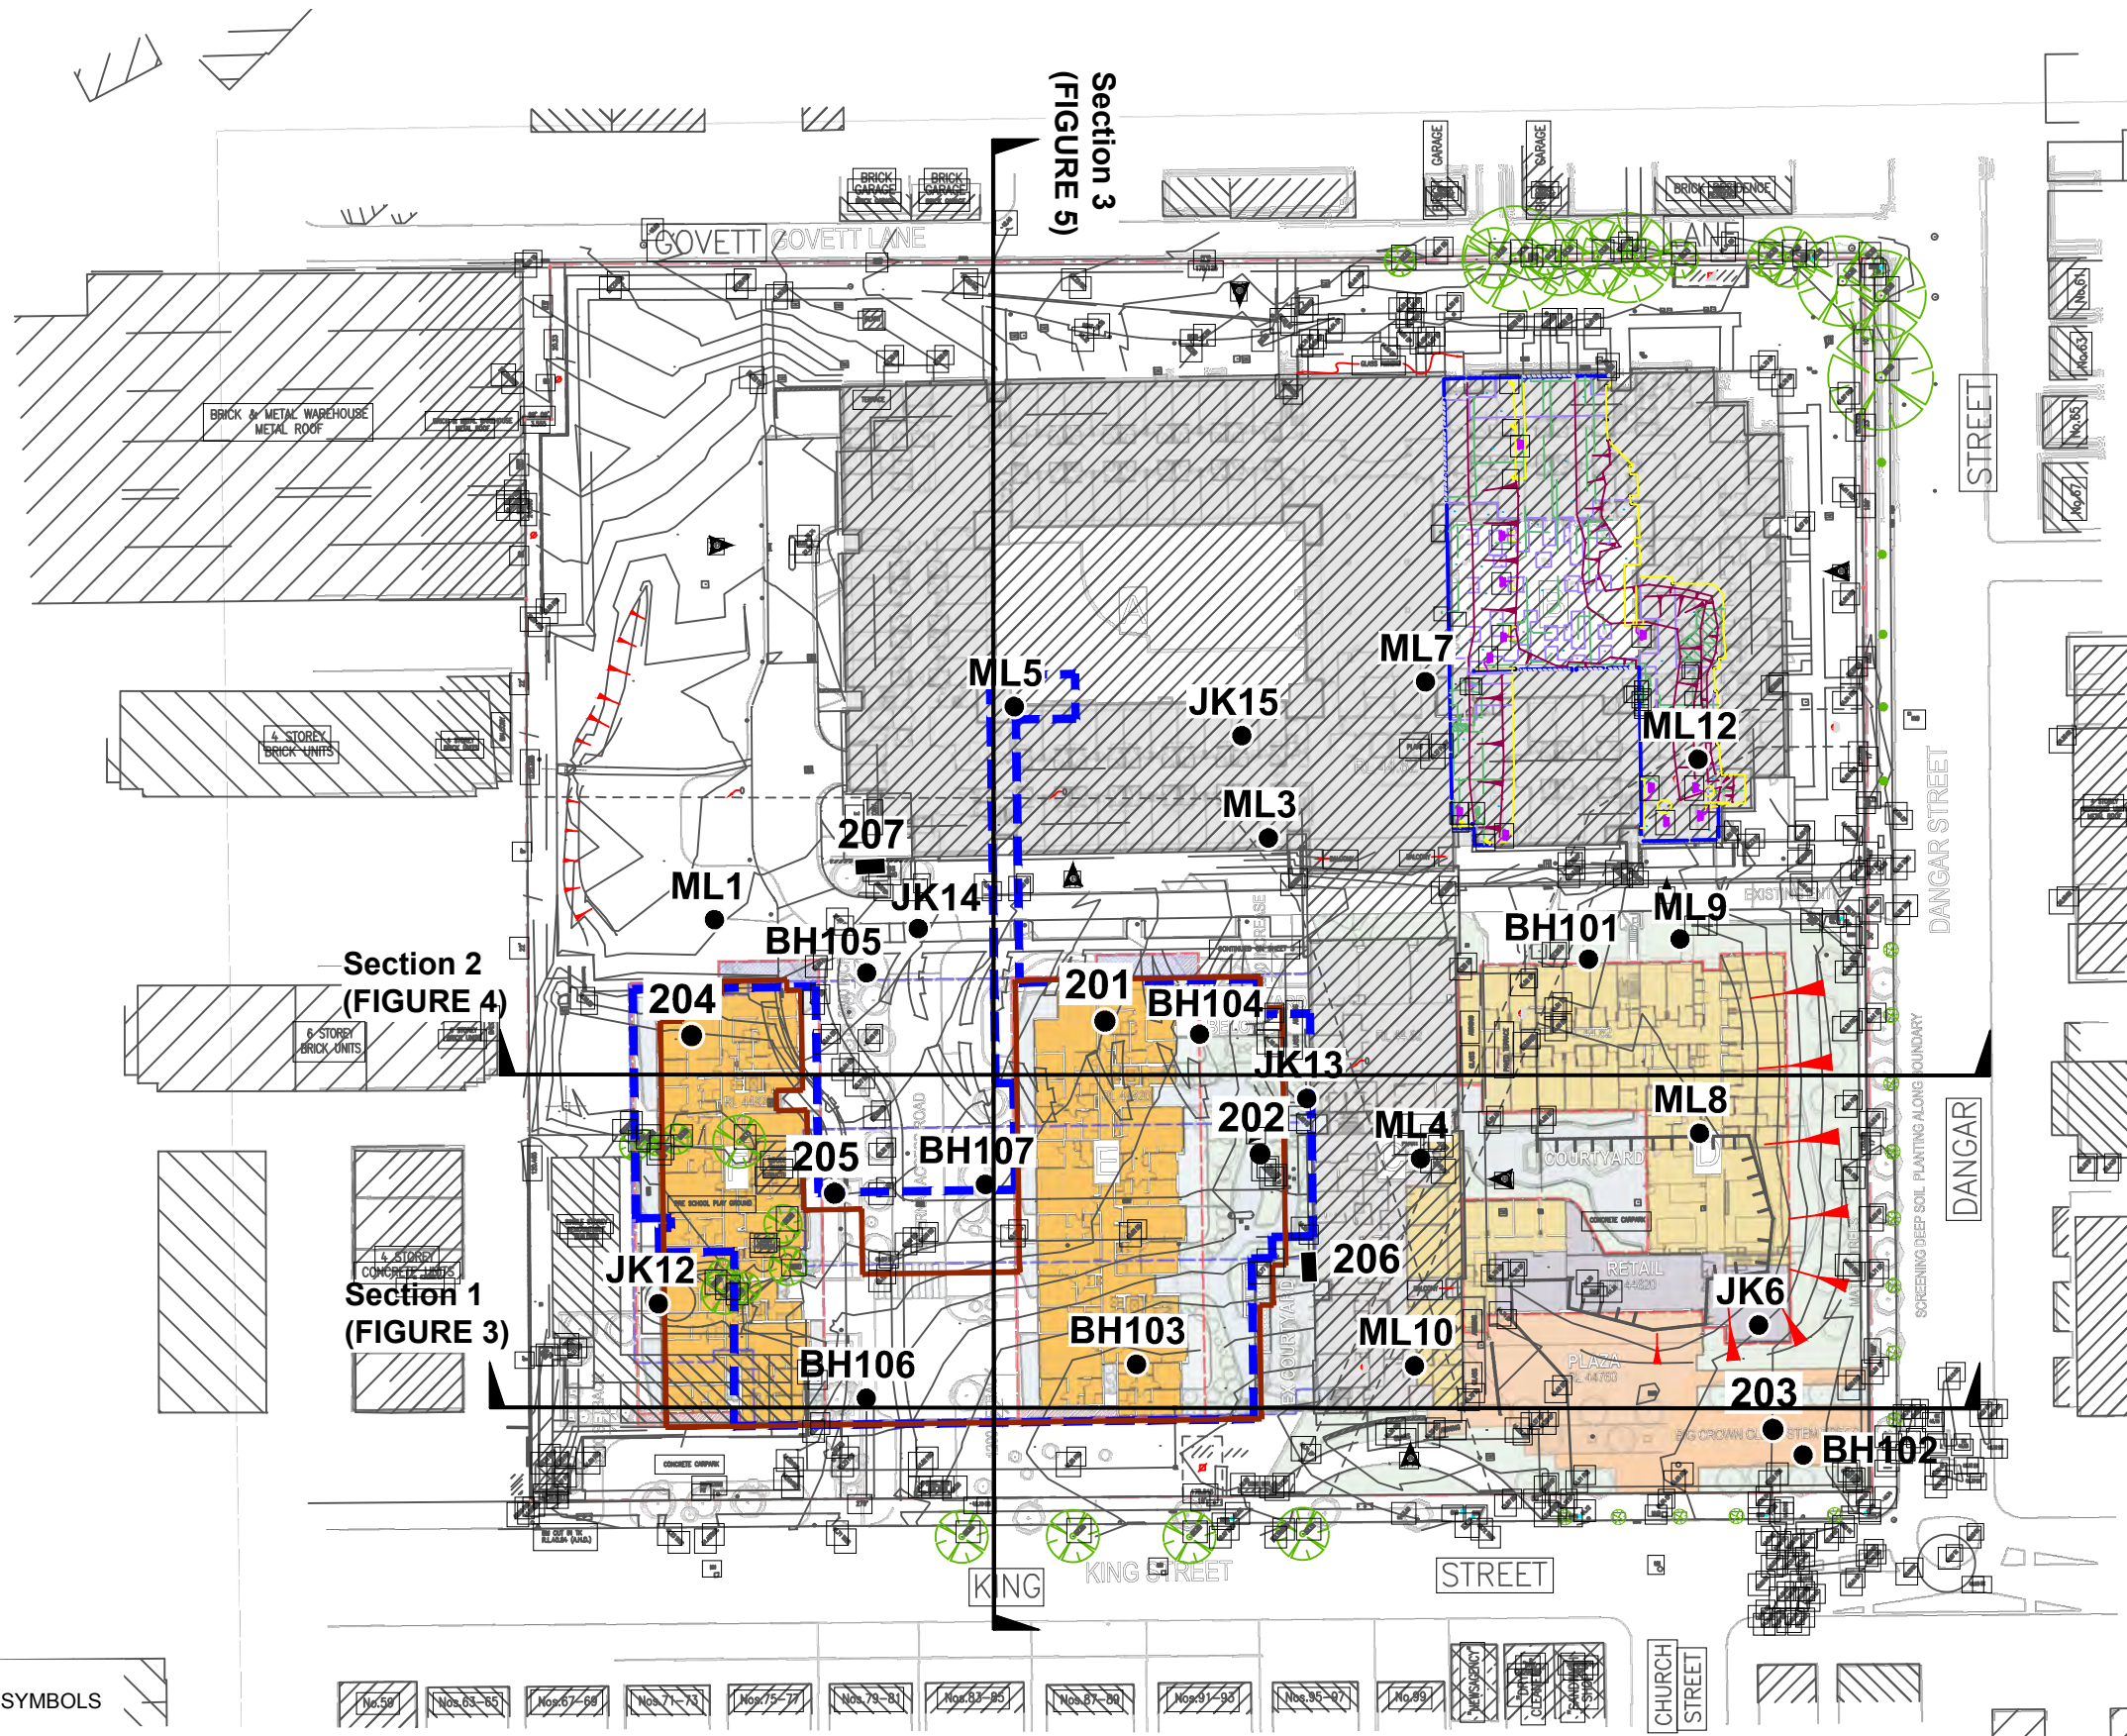
Our current subsurface investigations have revealed a similar subsurface profile as described above. A summary of the pertinent subsurface conditions encountered during our current subsurface investigation and, where relevant, details from our previous subsurface investigation are presented below. The attached Figures 3, 4 and 5 present sections providing graphical borehole summaries; their locations are indicated on the attached Figure 2.

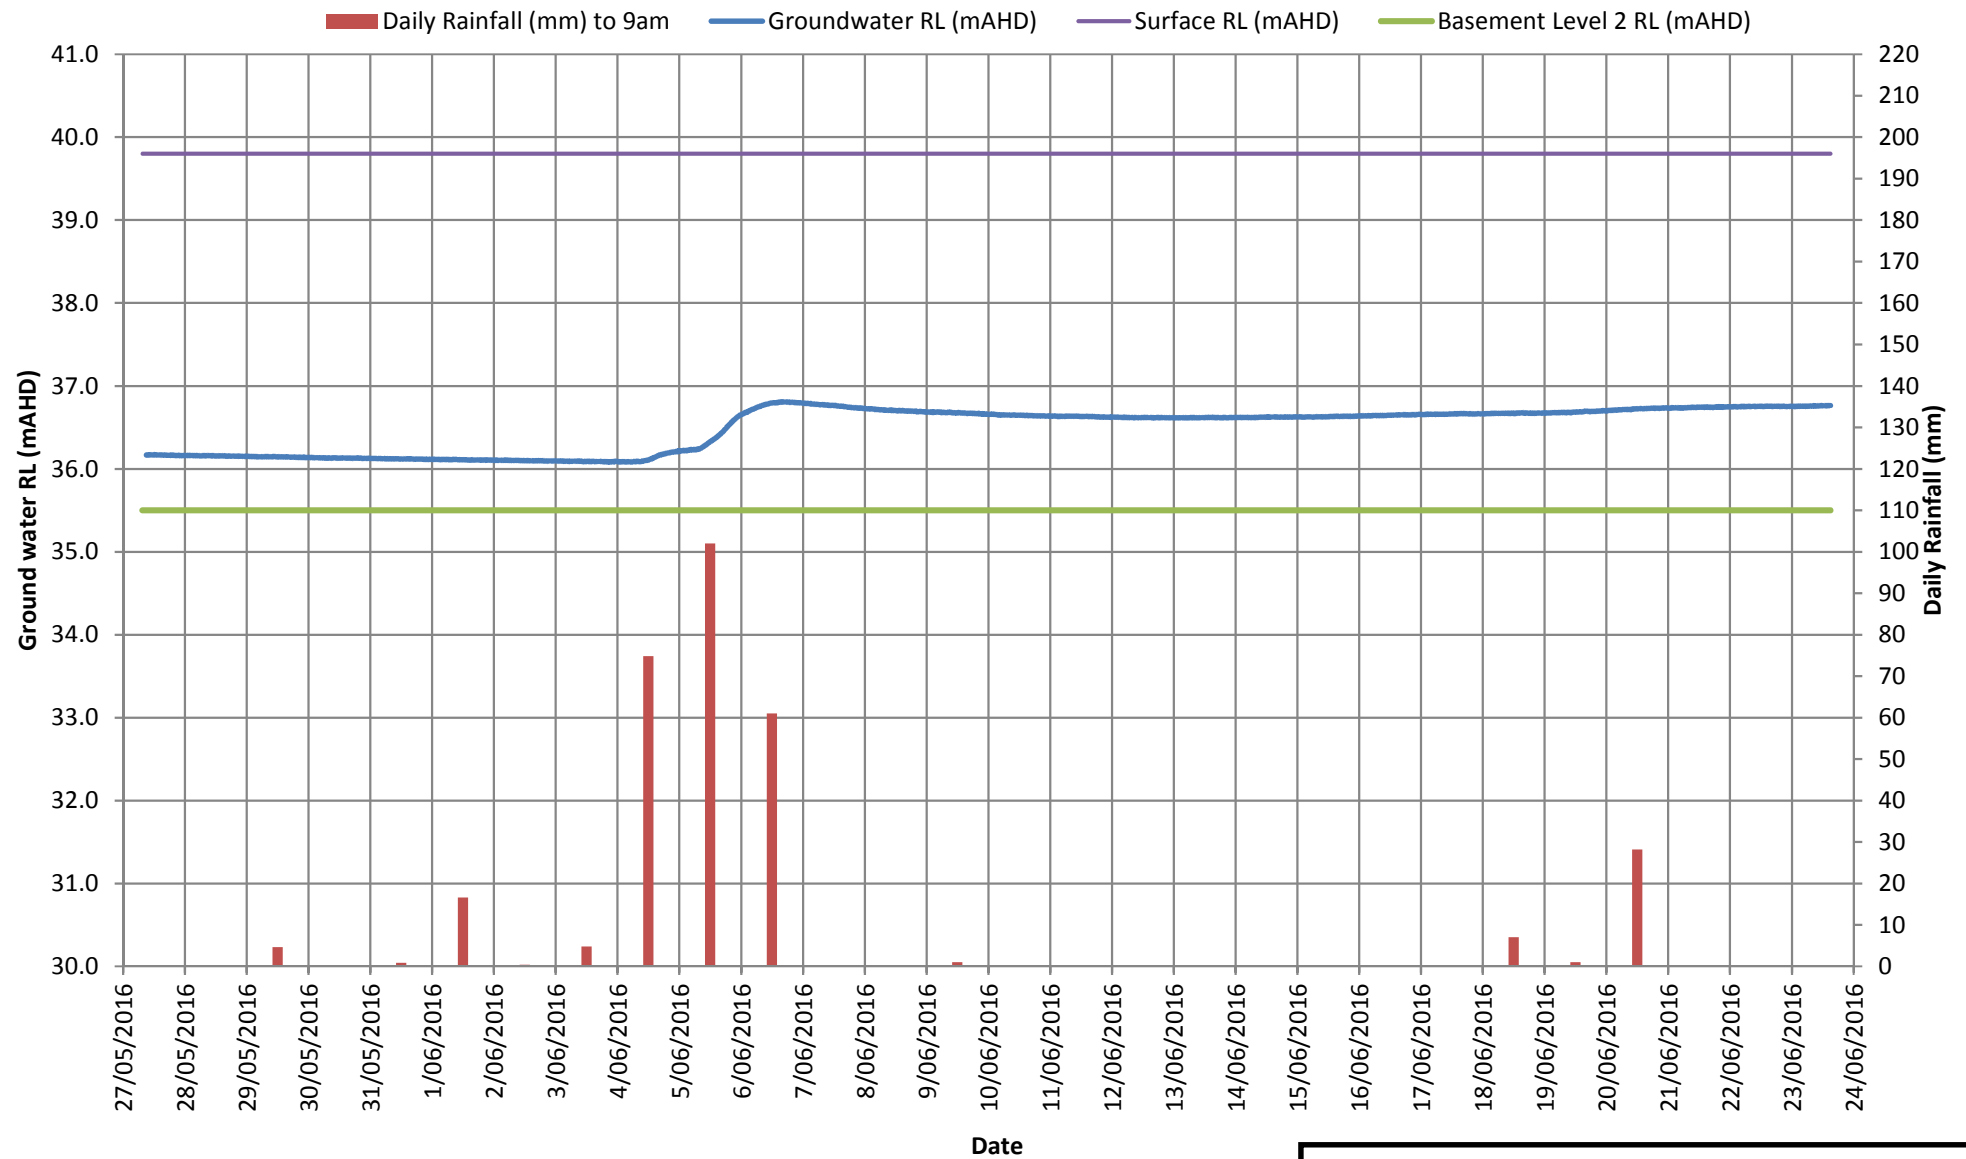
Ground Water Level and Daily Rainfall -v- Time Plot BH201

The current data loggers have indicated that following the heavy and prolonged rainfall between 4 and 6 June 2016 groundwater levels rose to maximum levels of between RL36.2m and RL37.8m in the sandy soil profile and between RL36.8m and RL40.5m in the bedrock. We note that the standing water levels recorded in BH201, BH202 and BH205 are above the proposed Basement Level 2 design subgrade level. However, the standing water level recorded in BH201 may indicate the piezometric head of groundwater within water carrying defects within the rock mass which may not be encountered in the excavation. The elevated groundwater in the bedrock over the south-eastern corner of the site (RL40.5m in the bedrock) is below the proposed Lower Ground Level of Block D (RL41.5m). Again, the standing water level recorded in BH203 may indicate the piezometric head of groundwater within water carrying defects within the rock mass.

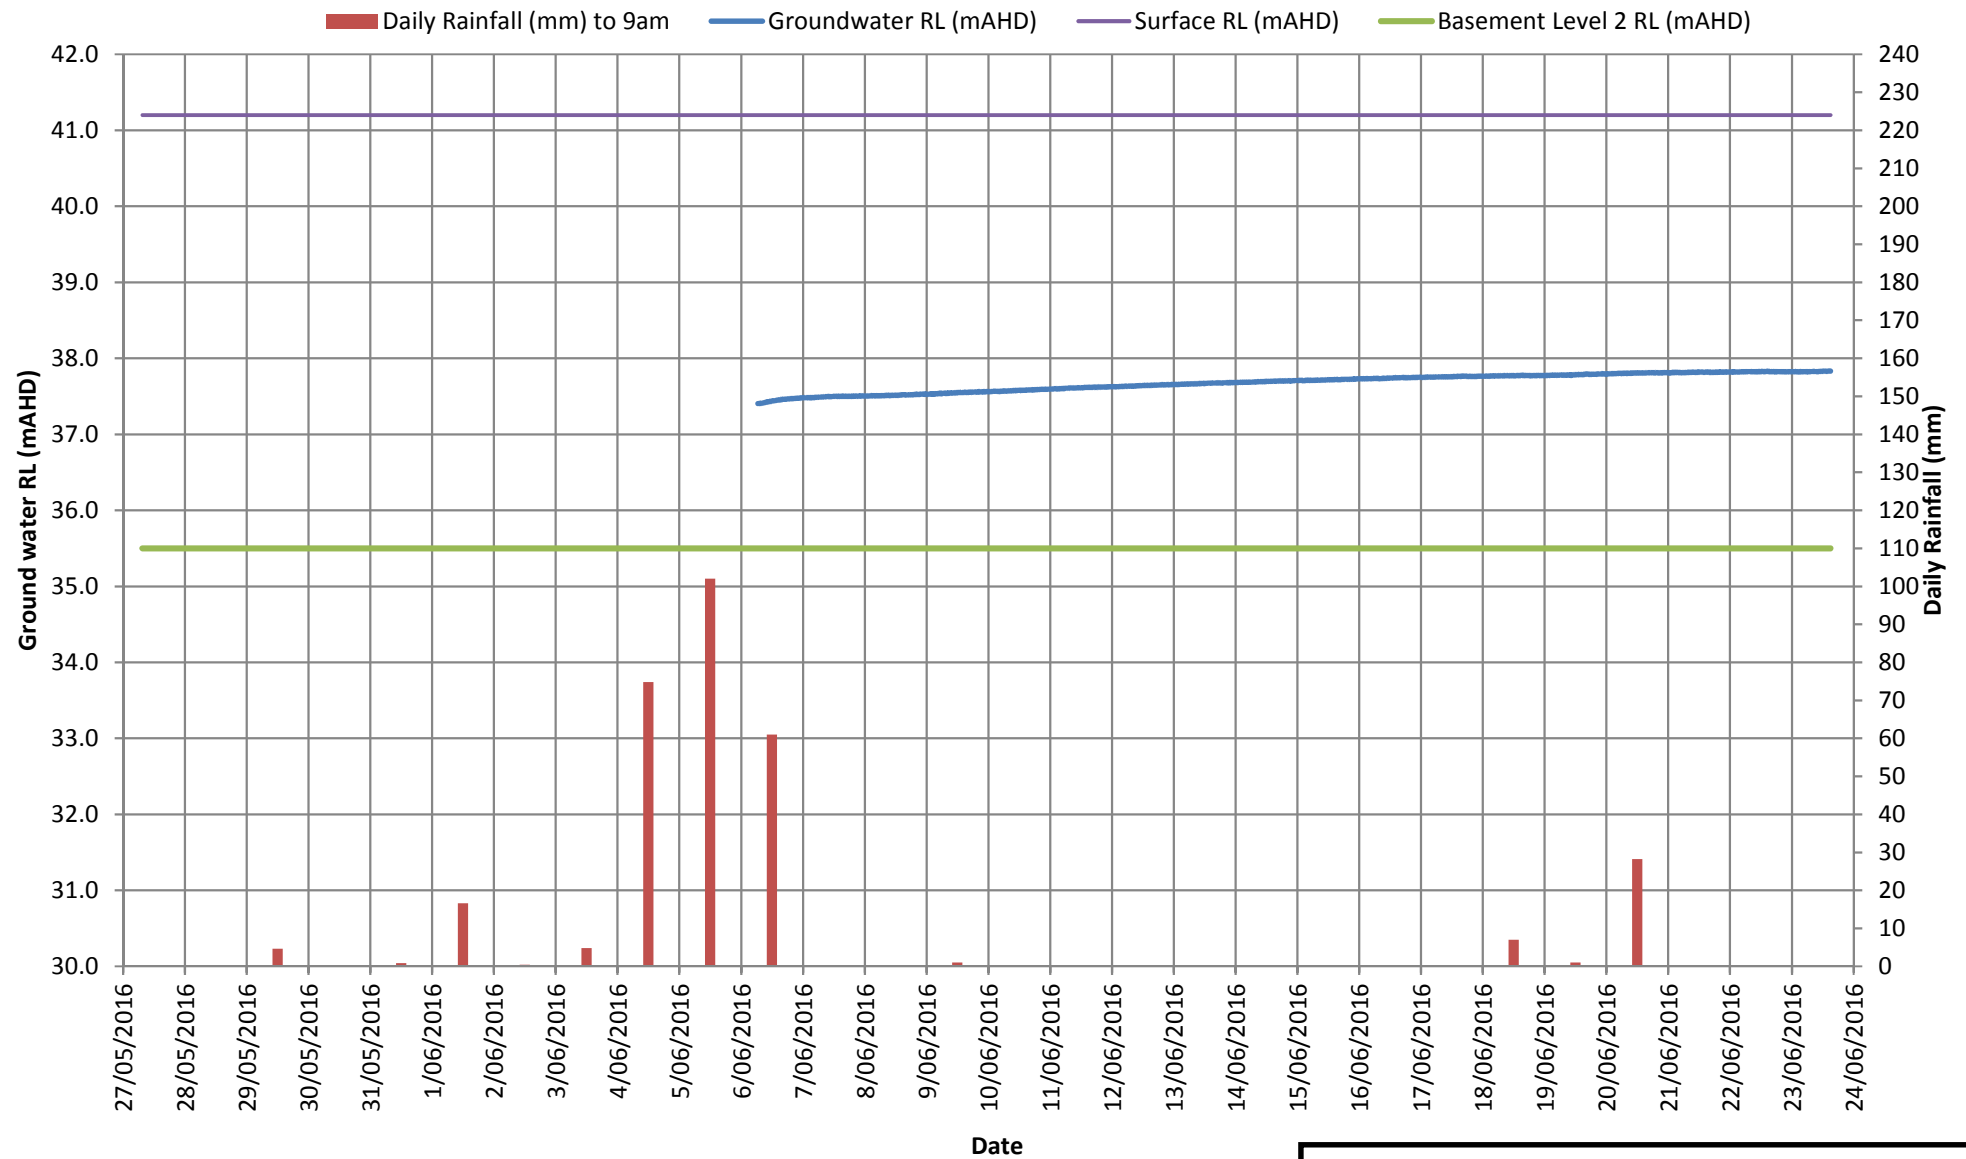
Ground Water Level and Daily Rainfall -v- Time Plot BH202

Rainfall data from Randwick Street, Station No. 66052

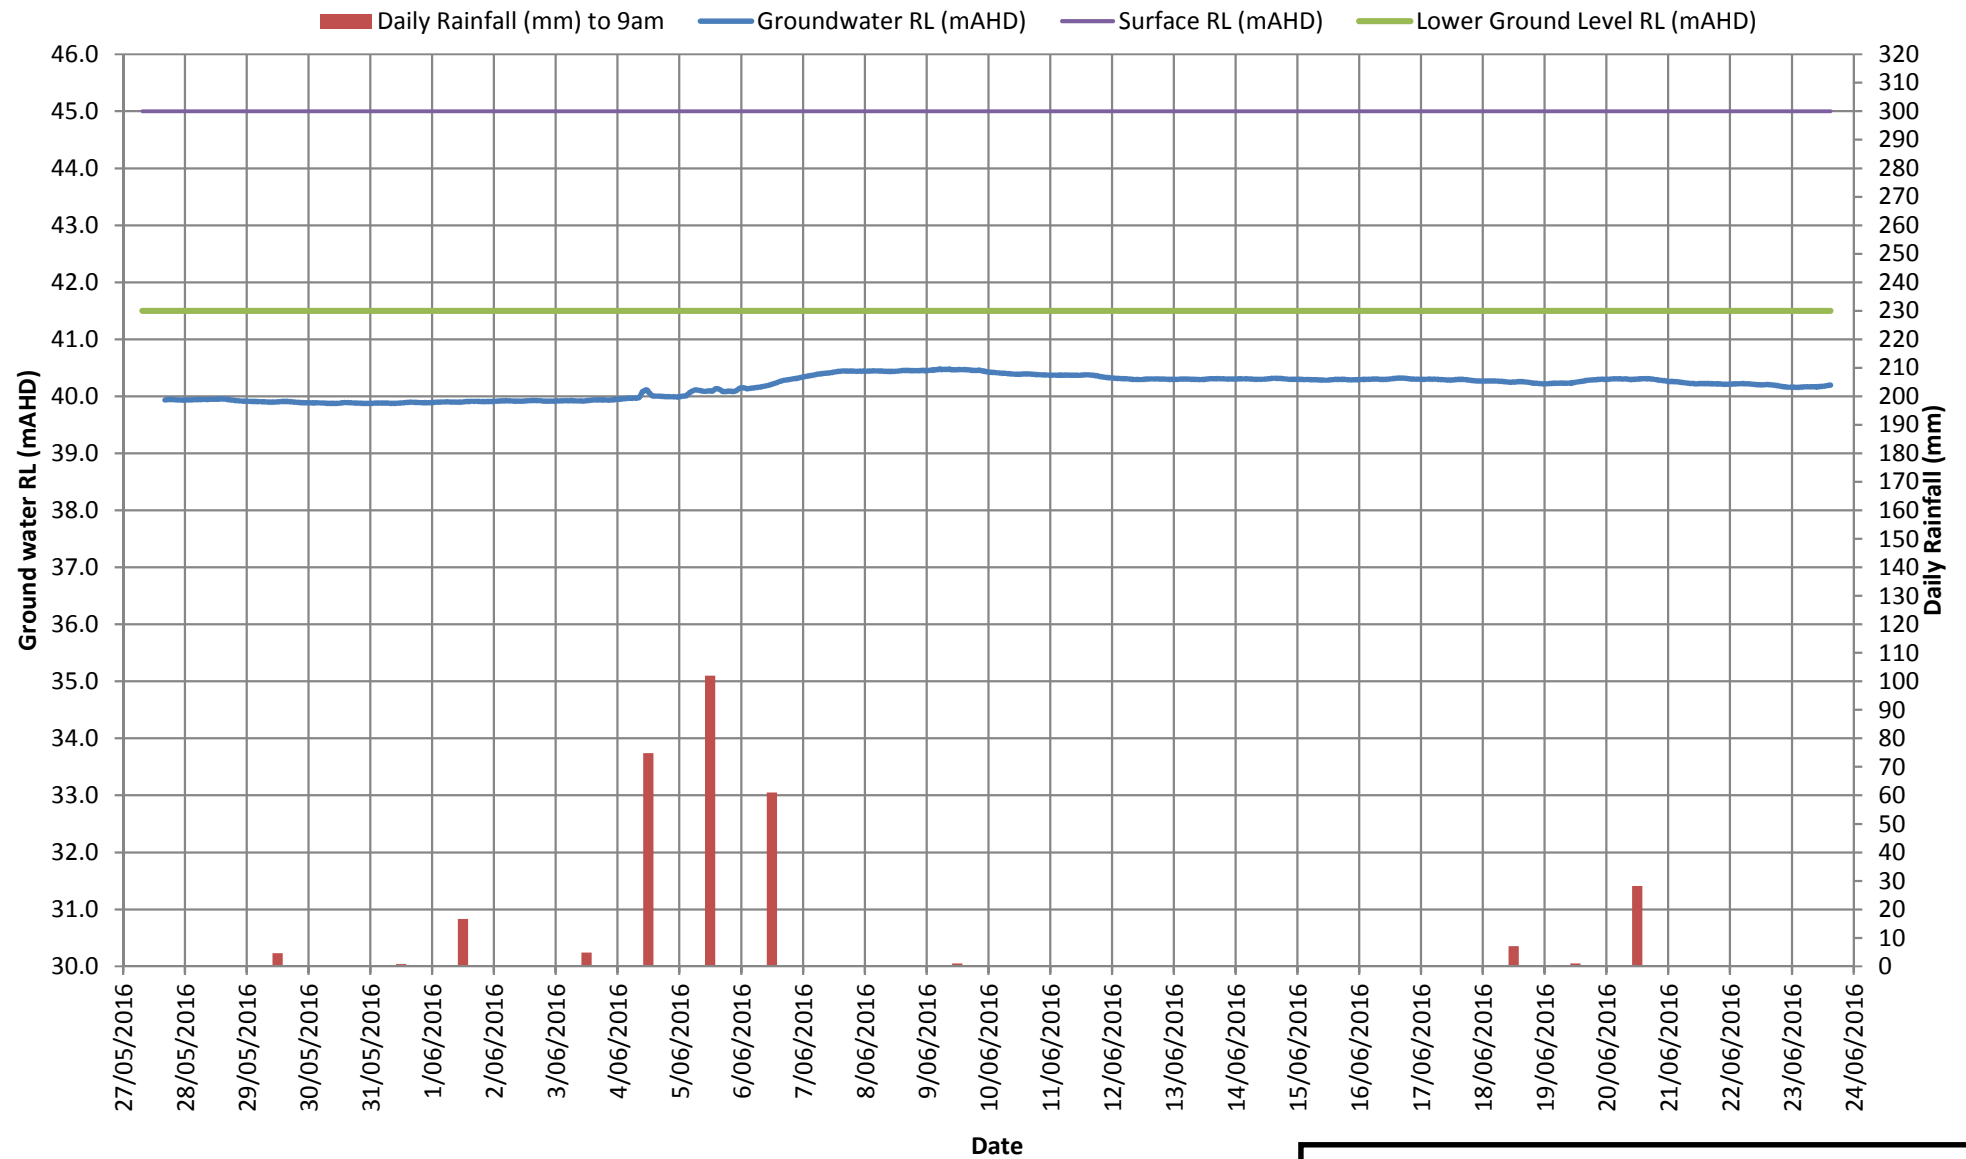
Ground Water Level and Daily Rainfall -v- Time Plot BH203

Rainfall data from Randwick Street, Station No. 66052

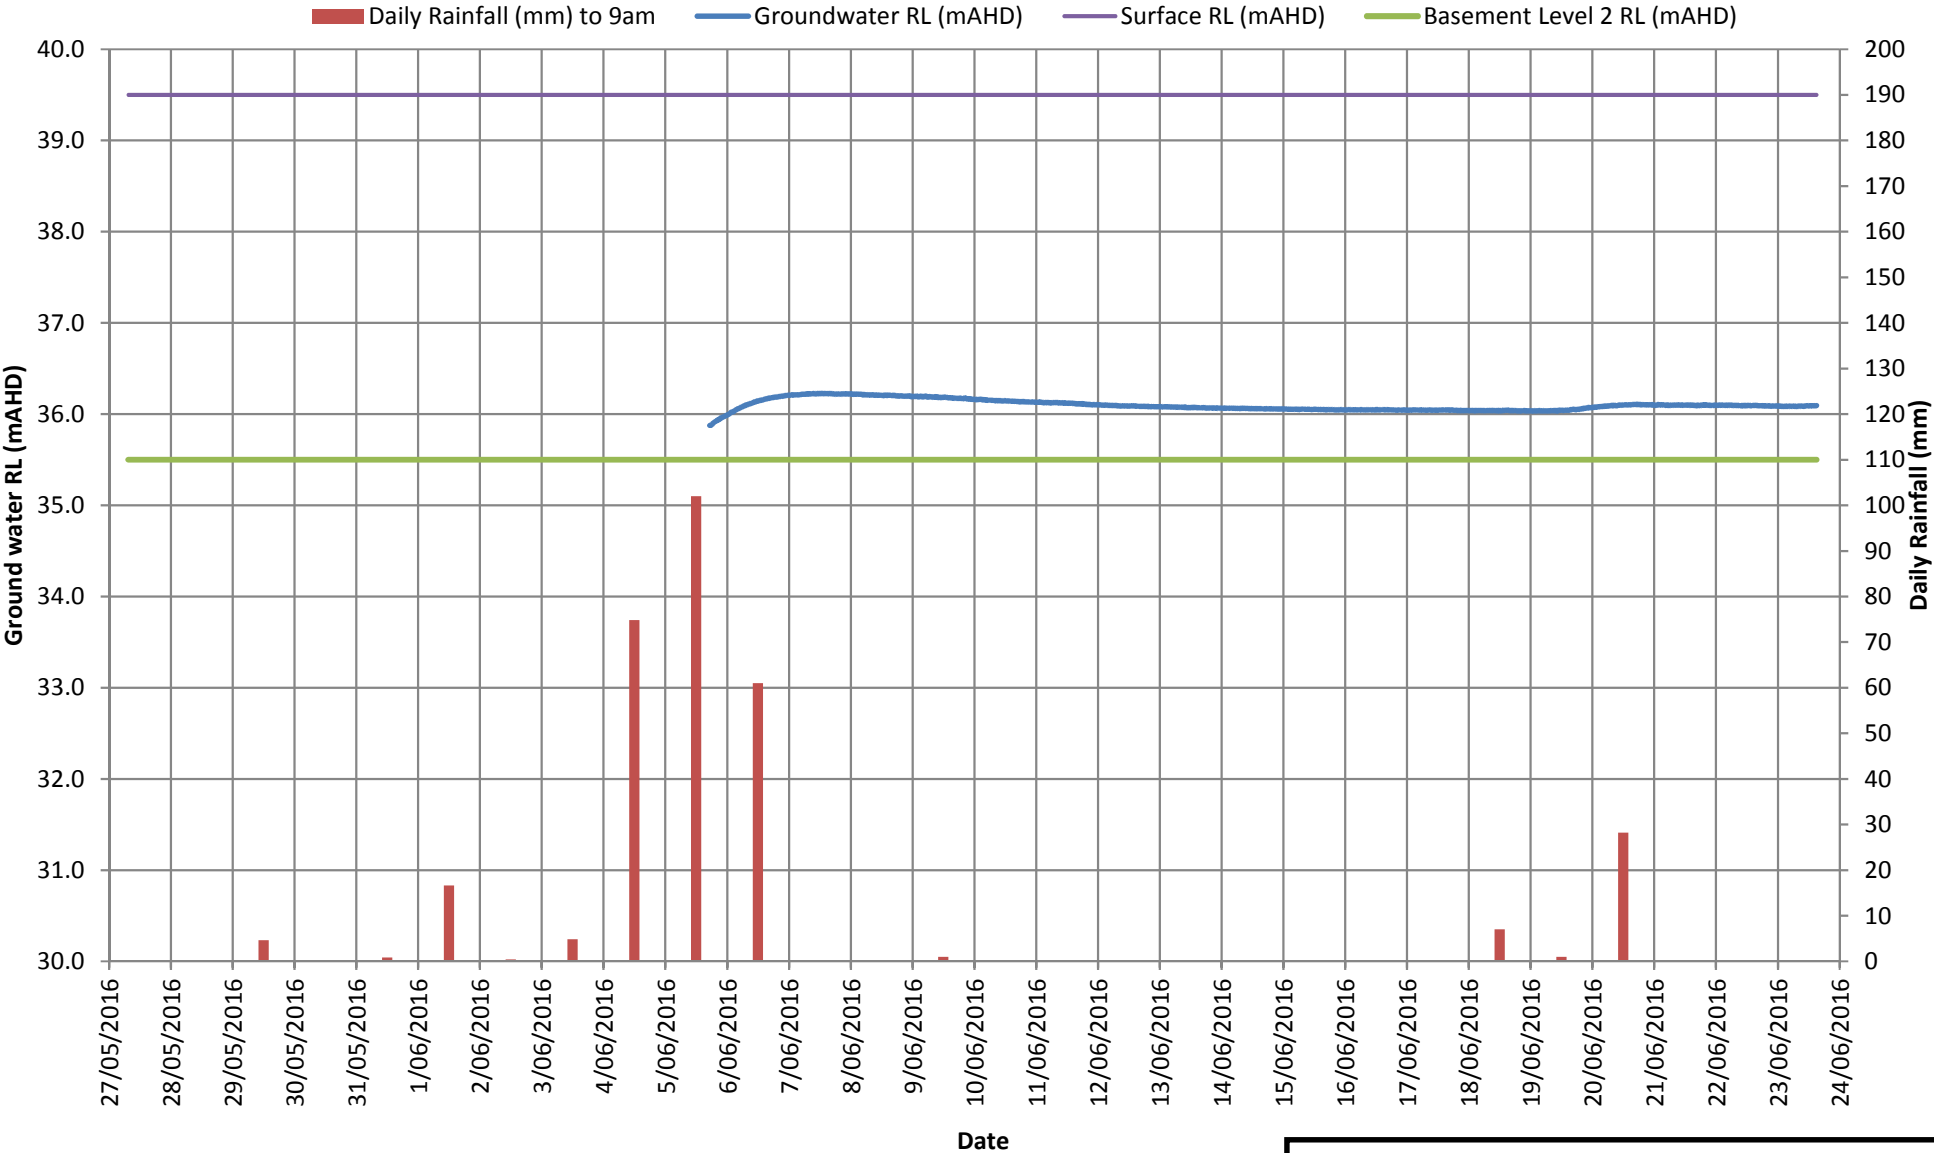
Ground Water Level and Daily Rainfall -v- Time Plot

Rainfall data from Randwick Street, Station No. 66052
