Aboriginal Heritage Assessment  
Addendum

# Additional Areas, South West Rail Link – Glenfield to Leppington Rail Line: Aboriginal Heritage Assessment

Prepared by Australian Museum Business Services  
for Parsons Brinckerhoff

July 2010

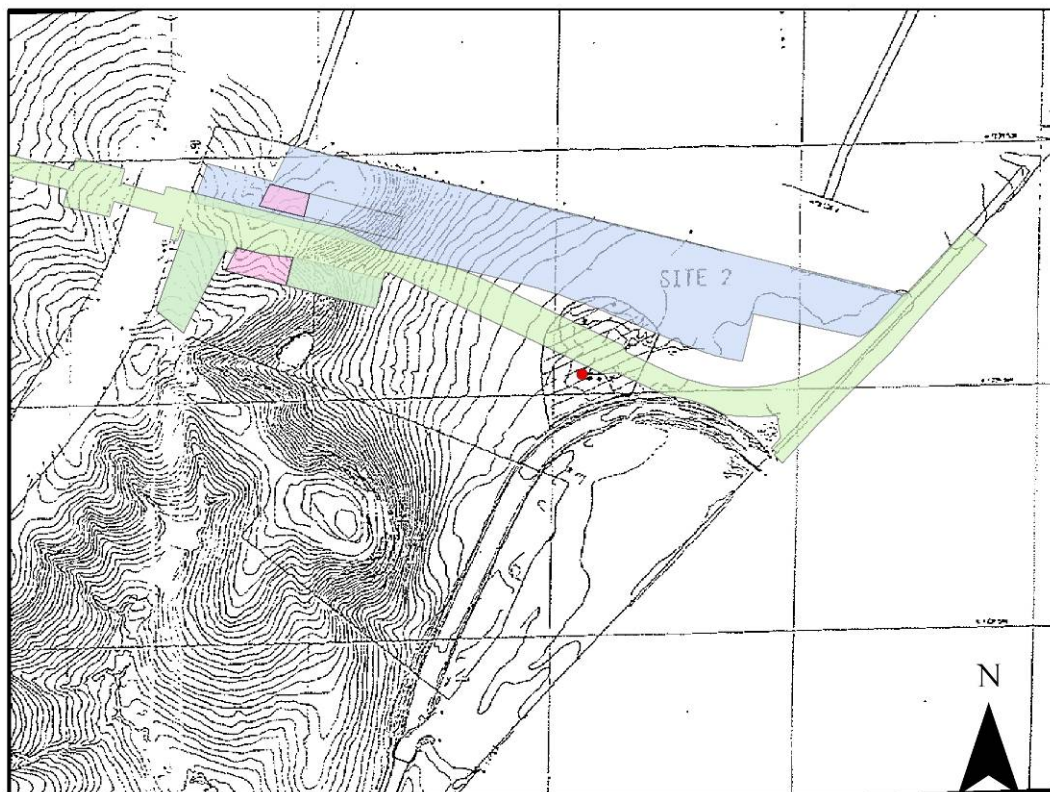
Figure 2 Location of MFH#2 and adjacent area of PAD (cross-hatching) in relation to the additional area 1.1 (Dallas 1989: Map 3).

An area to the west of previously recorded site MFH#2, extending upslope to a ridge between Quarter Sessions Road and the Hume Highway (including additional area 1.1), was identified as having **moderate** archaeological sensitivity. This is a relatively undisturbed, elevated area between Bunbury Curran Creek and Maxwells Creek, which represent reliable water sources. There are also sites in the surrounding area (MFH#2 and MLE1). Site MFH#2 (#45-6-2495) was excavated by Dallas in 2000 and found to comprise a low density background scatter of stone artefacts, of types common in the region, and hence is considered to have low archaeological significance. However, the excavated area was situated on the low-lying area surrounding the creek. More recent work by ENSR (2009) suggests that sites are more extensive on elevated areas above reliable water sources, and as such, the ridge is considered to have moderate potential for *in situ* subsurface archaeological deposit.

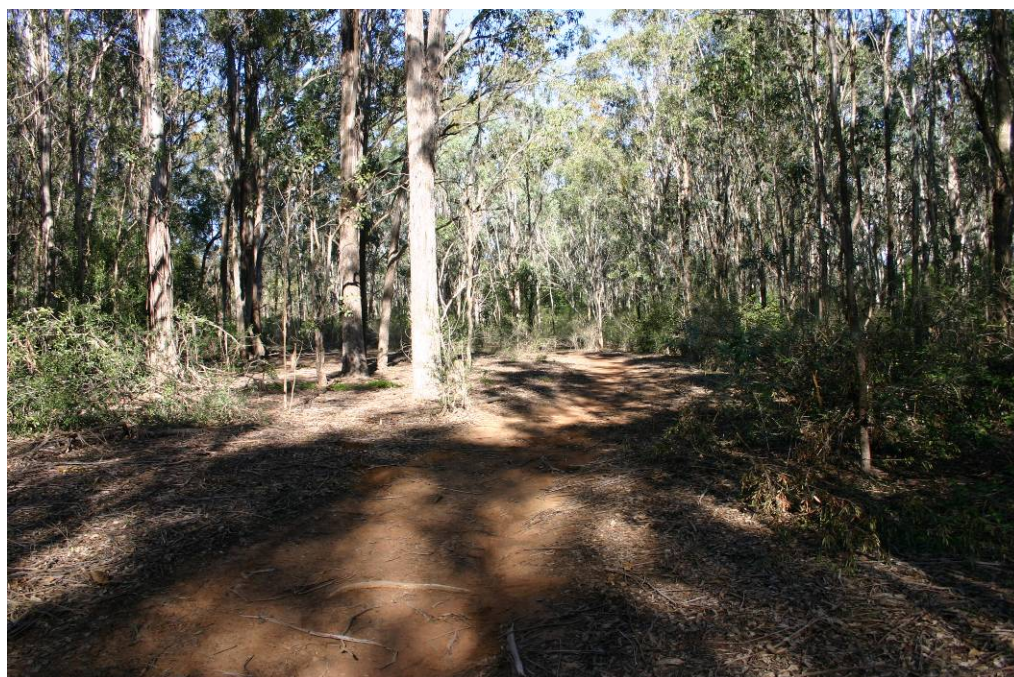
**Figure 5** Track, on which additional artefact was recorded, leading upslope to original recorded location of SWRL Site 10 (view to south west).

**Site Description:** SWRL Site 10 was originally located in March 2010, in a powerline easement directly adjacent to the end of Cassidy Street, within Lot 7 D205472. An additional artefact was located during the current survey, on a track approximately 100m downslope from the transmission easement (Figure 7). A small second order tributary of Cabramatta Creek is located approximately 15m downslope from this additional artefact. The track is currently being impacted by water erosion.

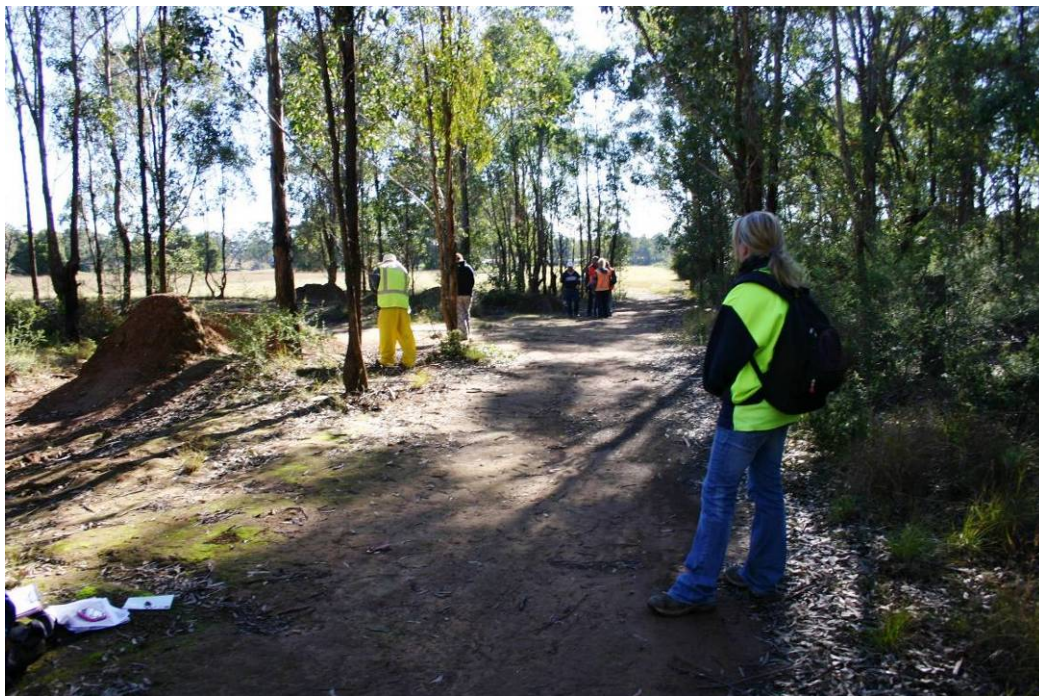
Figure 8 Track on which SWRL Site 11 artefact was recorded (view to north). Note BMX bike jumps next to track.

**Site Description:** This isolated artefact is located on a dirt track adjacent to an old property boundary fenceline, c.70m north west of a small second order tributary of Cabramatta Creek, within Lot 7 D205472 (Figure 7). The site comprises a single flaked silcrete artefact. There are no indications of subsurface deposit. A number of BMX bike jumps have been formed on the western side of the track.

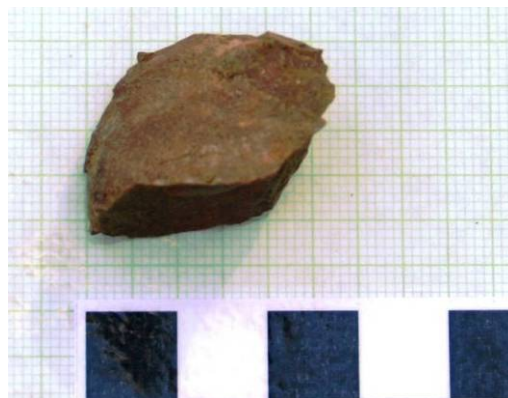
Figure 9 Silcrete artefact at SWRL Site 11.

Material	Colour	Maximum Size (cm)	Artefact Type
Silcrete	Red	3	Flake

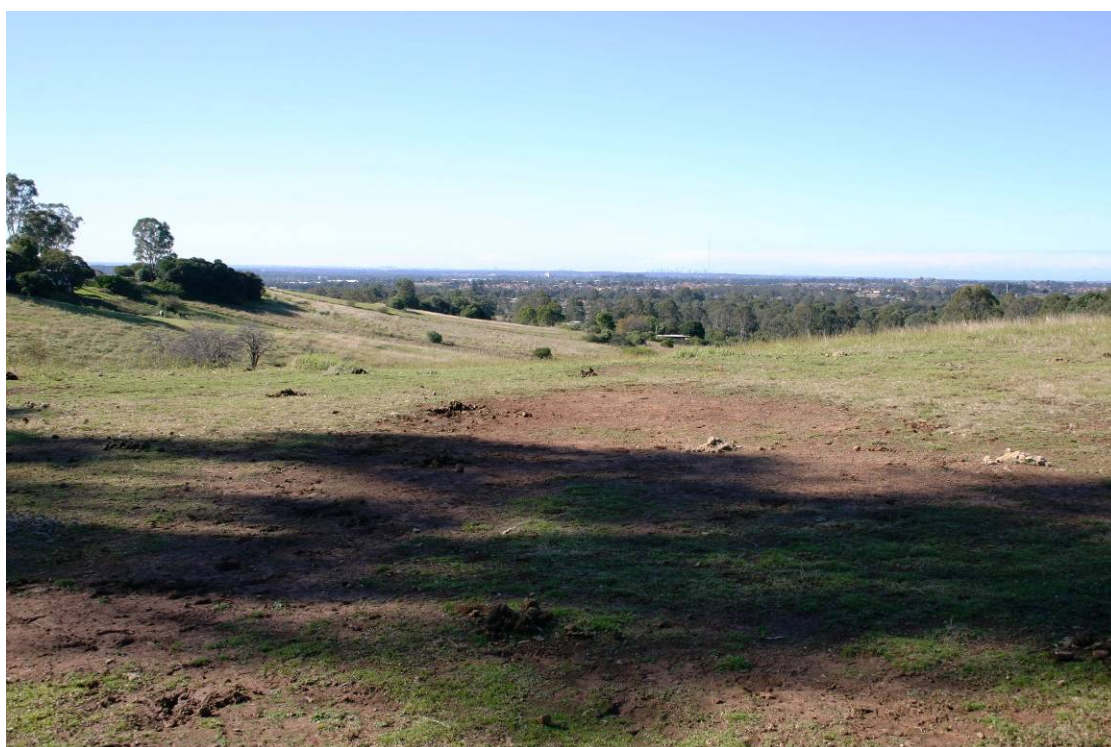
Figure 10 Exposure on which SWRL Site 12 artefact was recorded (view to south east).

**Site Description:** This isolated artefact is located on an area of exposure adjacent to a stand of trees, in a horse paddock c.70m south west of a small first order tributary of Cabramatta Creek, within Lot 1 D513403 (Figure 12). There is a small hill crest approximately 50m to the south of the exposure. The artefact is a distal flake made of quartz.

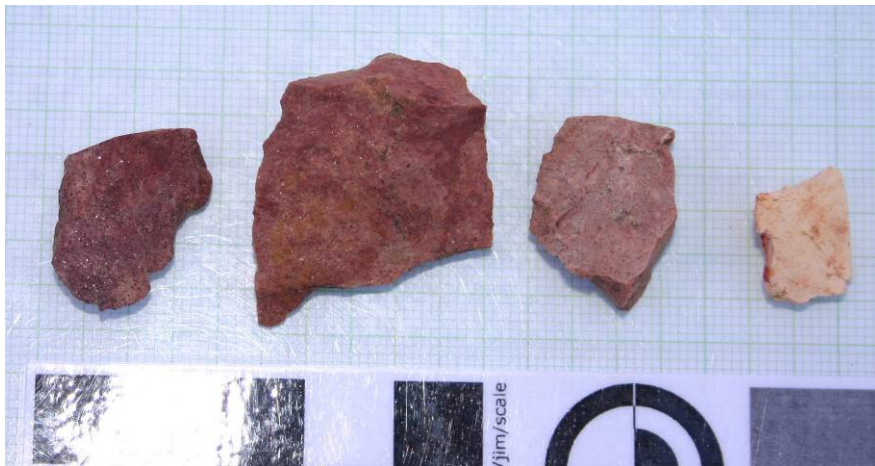
Figure 11 Silcrete and mudstone artefacts located at SWRL Site 13 (01).

Material	Colour	Maximum Size (cm)	Artefact Type	Location
Silcrete	Red	2.5	Flake	SWRL Site 13 (01)
Silcrete	Red	3	Proximal flake	SWRL Site 13 (01)
Silcrete	Pink	2	Proximal flake	SWRL Site 13 (01)
Mudstone	Cream	1.5	Distal flake	SWRL Site 13 (01)
Silcrete	Red	2	Medial flake	SWRL Site 13 (02)
Silcrete	Red/grey	2	Flake	SWRL Site 13 (02)
Silcrete	Purple	2.5	Distal flake	SWRL Site 13 (02)

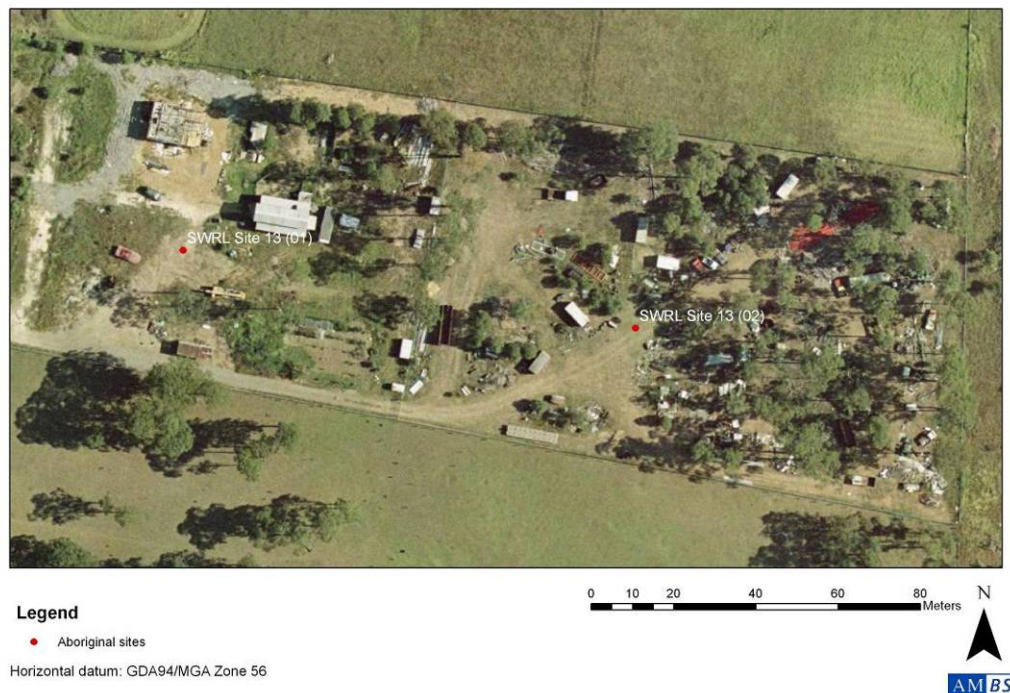
Figure 16 Location of SWRL Site 13 on 2007 aerial, showing recent occupation of the land.

An area west of and adjacent to Rickard Road, including additional area 4.3, was identified as having **low** archaeological sensitivity because it is in a vegetated area that is relatively undisturbed and isolated find site SW1 is located in the vicinity. Although the area is relatively undisturbed, there is evidence that market gardens were previously grown adjacent to the creek. SWRL Site 13 is also located in this area, but is on land which has been disturbed by recent occupation.
