Research Design and Archaeological Excavation Methodology

MAIN WORKS APPLICATION HEADLAND PARK, BARANGAROO

Research Design & Archaeological Excavation Methodology

FINAL REPORT

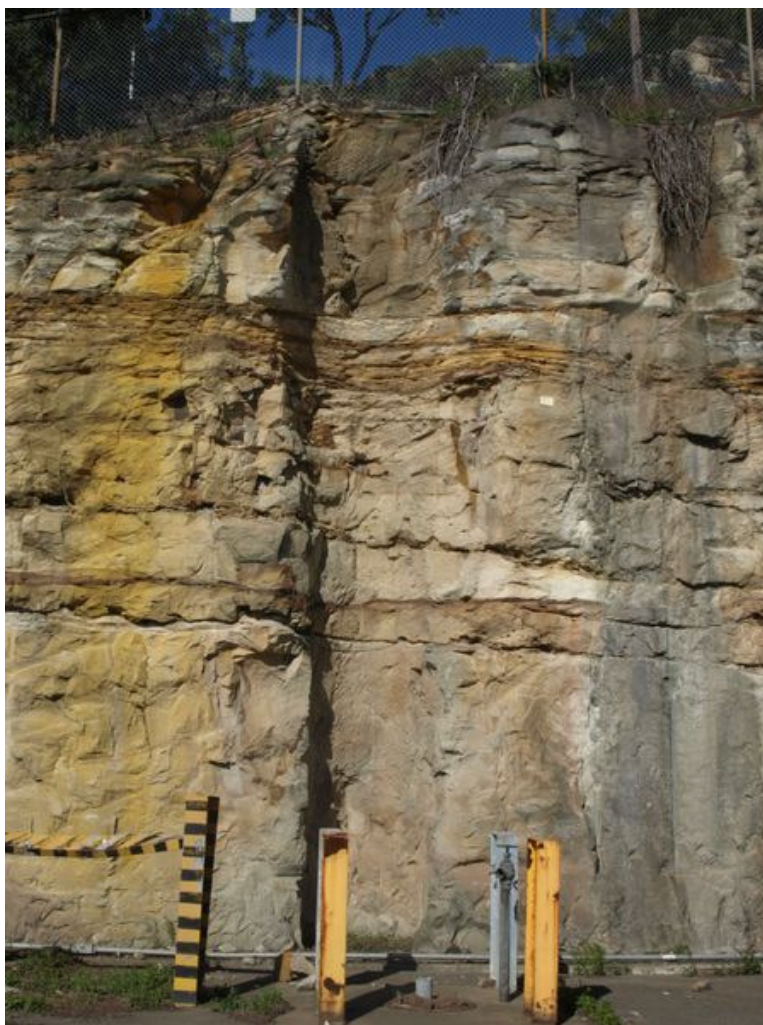
Section of hand cut well exposed in the Barangaroo headland.

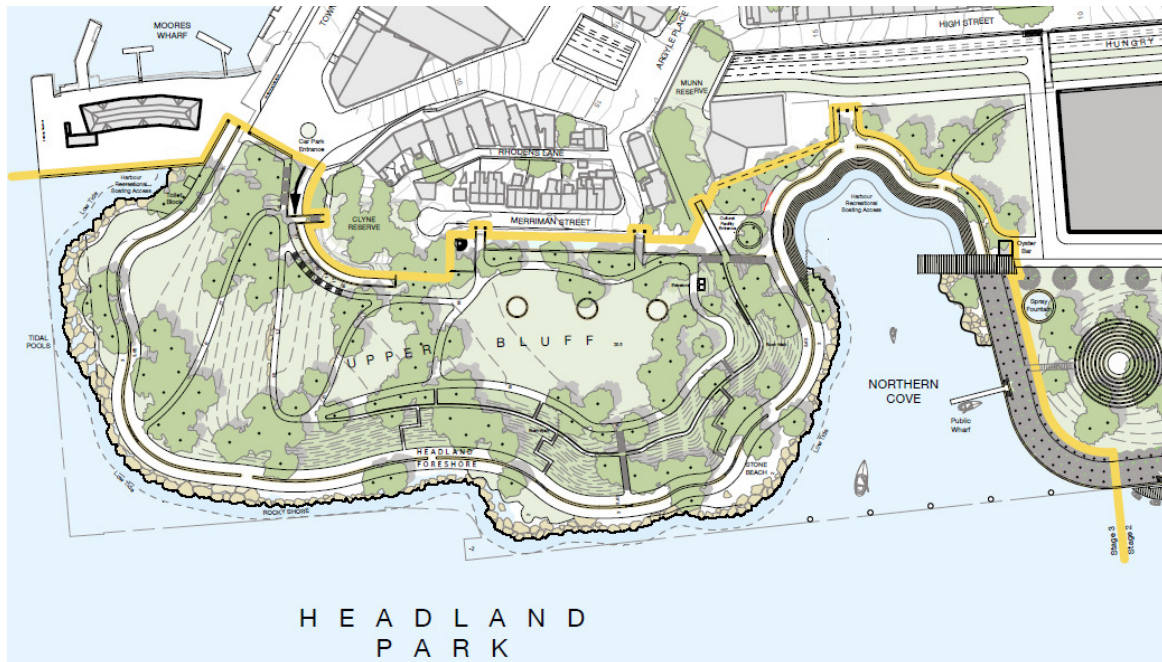
Figure 1.2 Proposed Barangaroo Headland Park and Northern Cove (Source BDA).

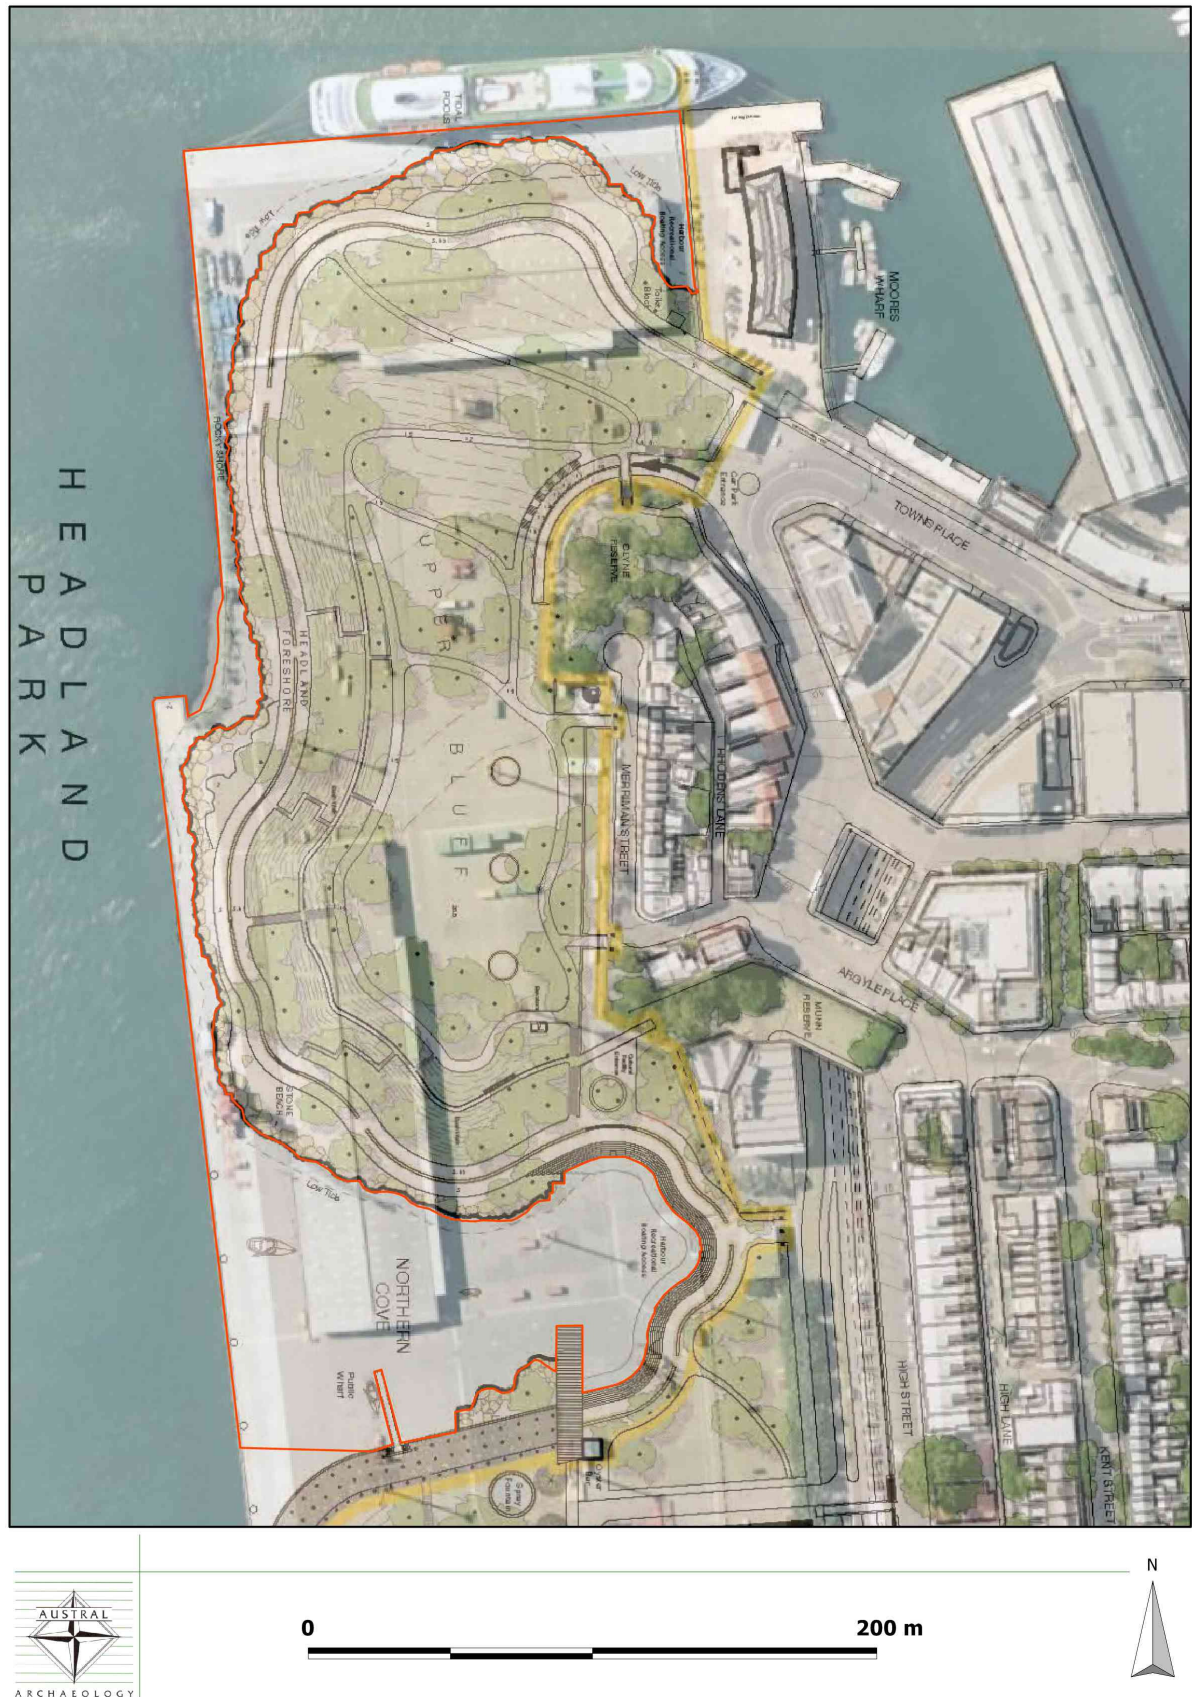
Figure 1.3 Aerial photograph of the northern part of the Barangaroo site with the proposed landscape plan overlay. There may be slight changes to the proposed above ground contours in the future, however they will have no effect on the outcome of the archaeological potential or the testing program (Source: Google and BDA)

The proposed new headland has a form that will require penetration and reduction of the size of the current deck. The caisson wall that forms the northern edge of the deck will be cut and a water insertion will be created adjacent to the western edge of Moore's Wharf. The caisson wall on the western edge of the deck will be modified to form a naturalised shape and the sandstone sea wall will be removed. The creation of the northern cove at the south west of Munn Reserve and Dalgety Stores will be a large water insertion to mimic the shape of the 1830s headland and allow for boats to dock (Figure 1.3).

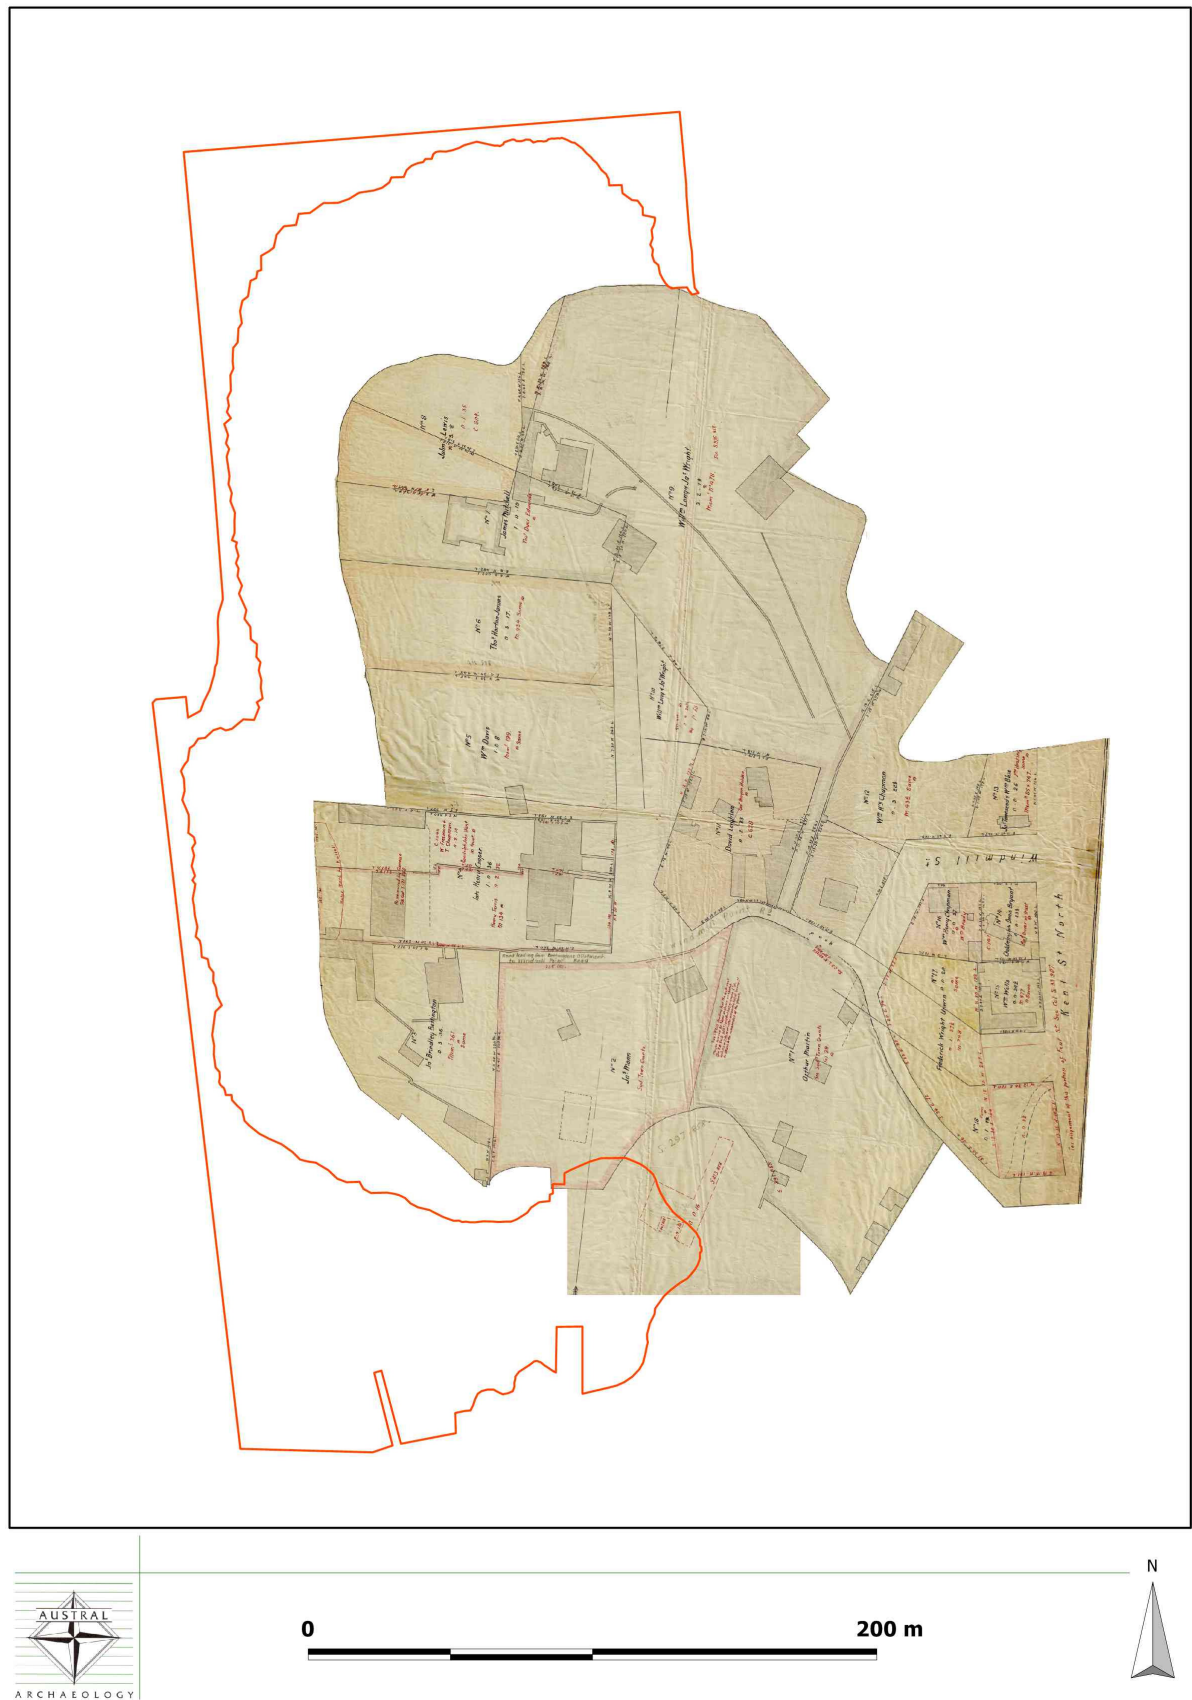
Figure 2.2. 1833 headland and allotments with proposed new headland overlaid (red). (Source <http://www3.photosau.com/CoSMaps/scripts/home.asp>)

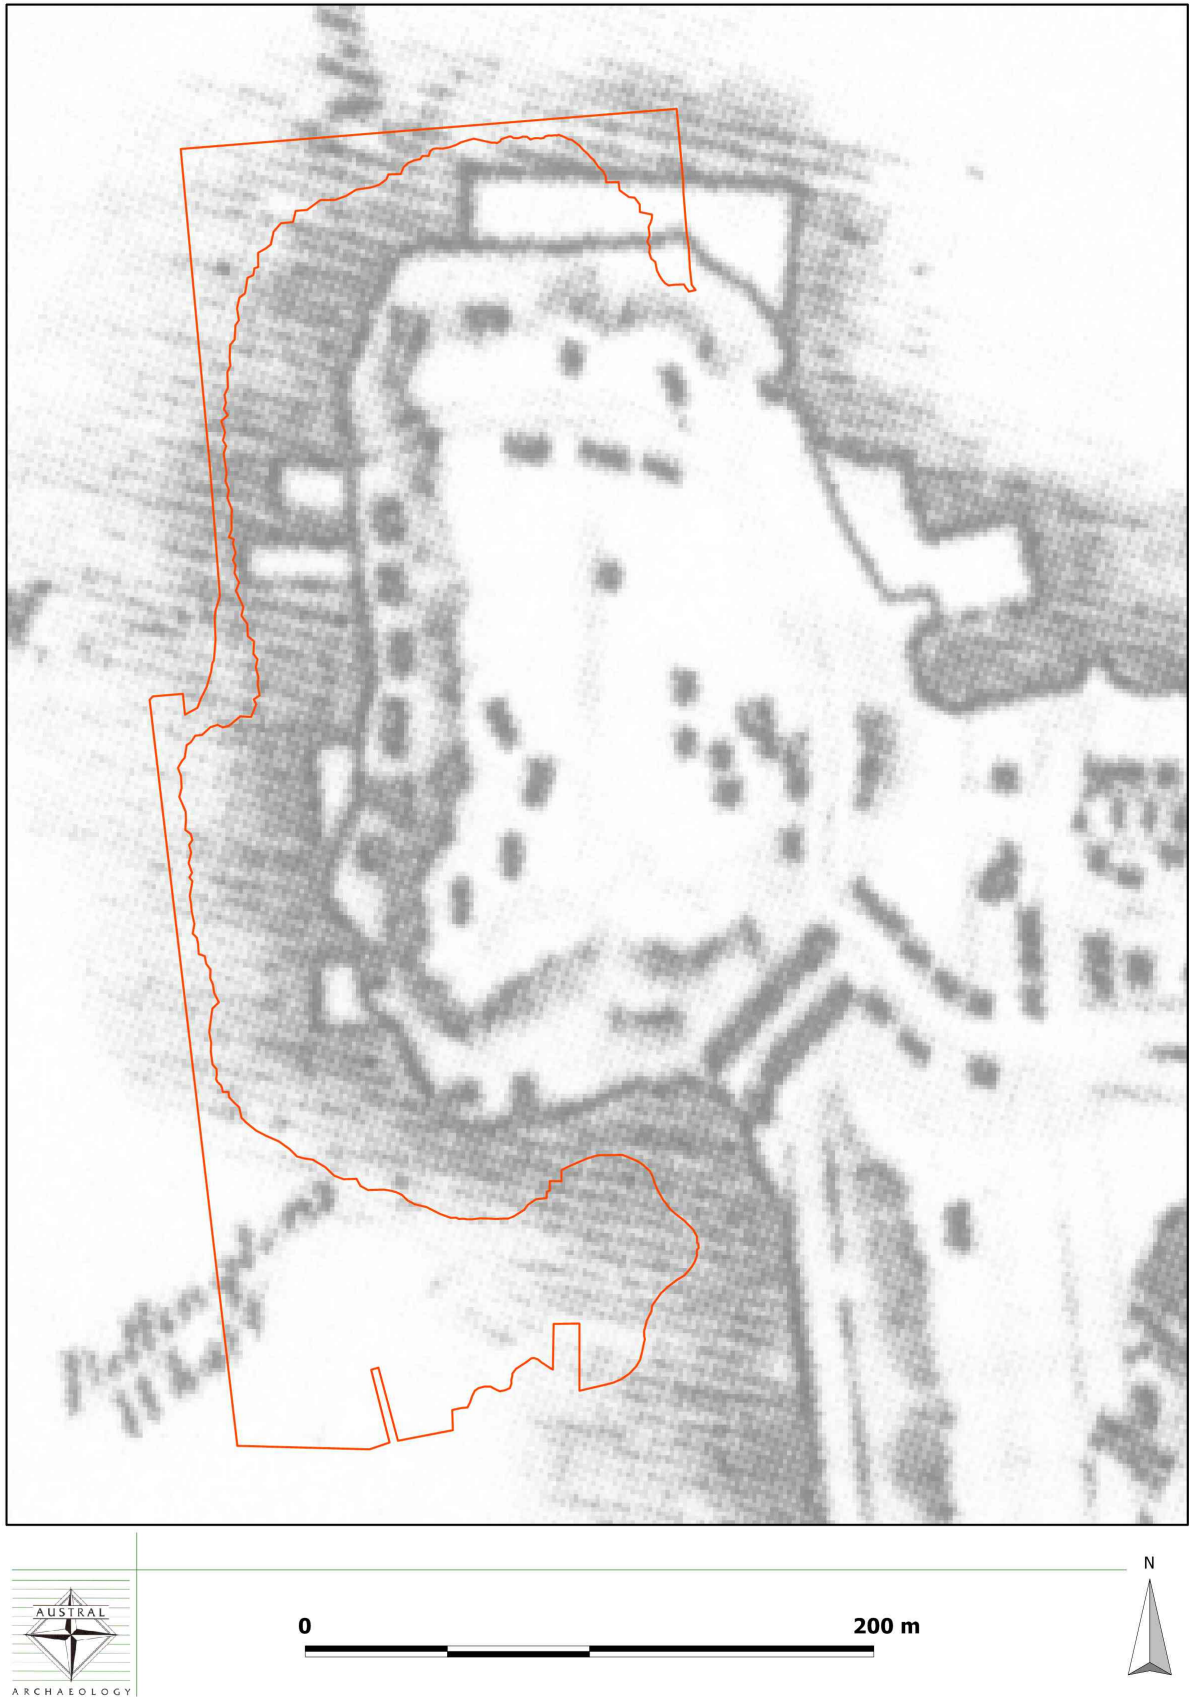
Figure 2.3. Detail *Map of the City of Sydney, 1843* by William Henry Wells, Land Surveyor showing wharves and location of buildings with proposed new headland overlaid (red) (Source: Ashton and Waterson 2000:25)

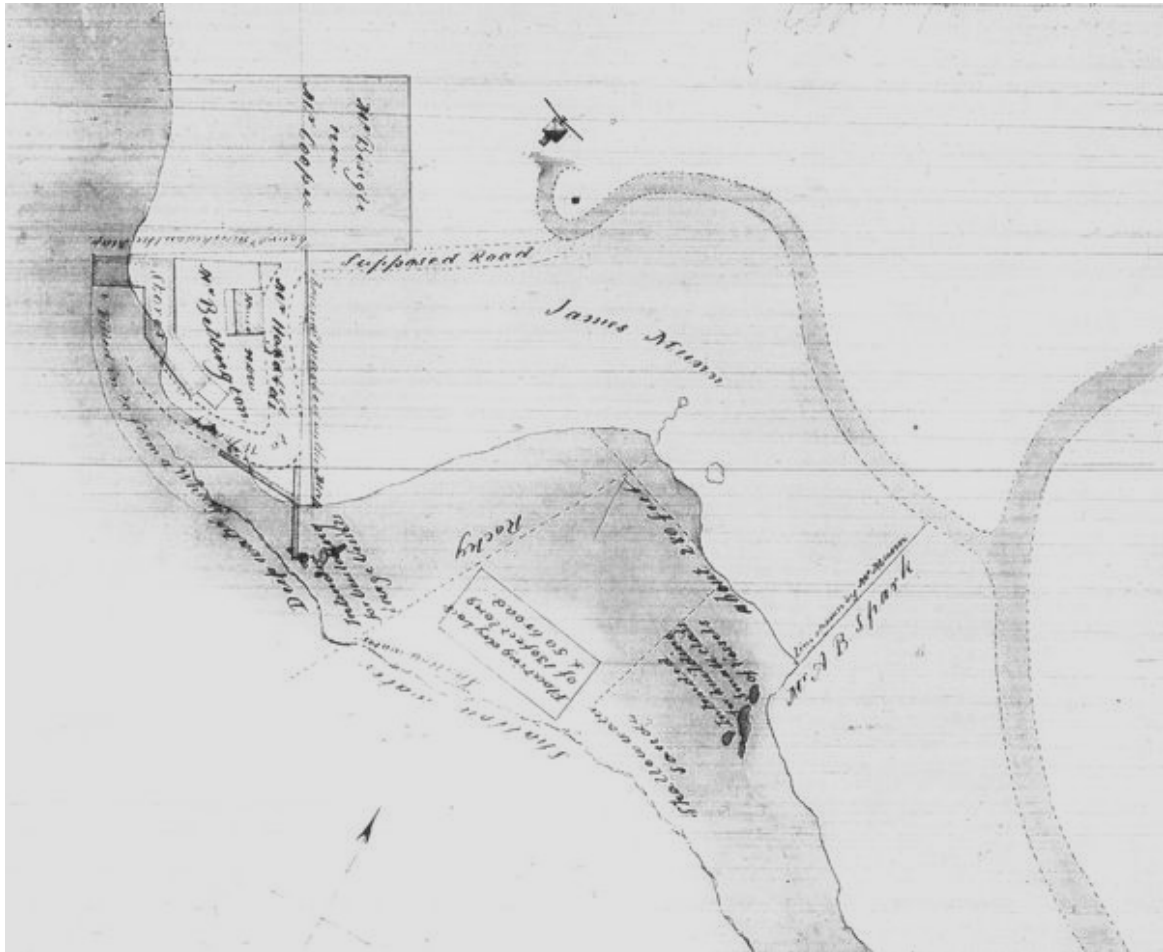
Figure 2.4. Drawing of Munn and Bettington's properties from October 1831. The majority of the waterfront of Munn's property is 'shallow and rocky'. The western side of Munn's property is annotated 'Intended for the building of large vessels'. In the bay is a 'floating dry dock 130 ft long and 50 ft broad'. The eastern side of the property is 'intended for building small class of vessels'. Munn also had a slipway and shed adjacent to the boundary with Bettington, (not indicated on this plan) as well as a house and garden just south of the windmill and the remains of lime kilns close to the water's edge marked by the circle. Bettington has constructed stores and a wharf at the north western edge of his property and reclaimed land beyond the shoreline; it has been 'filled in to create a wharf'. Bettington has constructed a boundary wall and wharf on the most southern part of the point and extending out into the harbour, obscuring Munn's access to deep water (Source: State Records maps and plans Parish of St Philip vo1 folios 1-50 reel 2746).

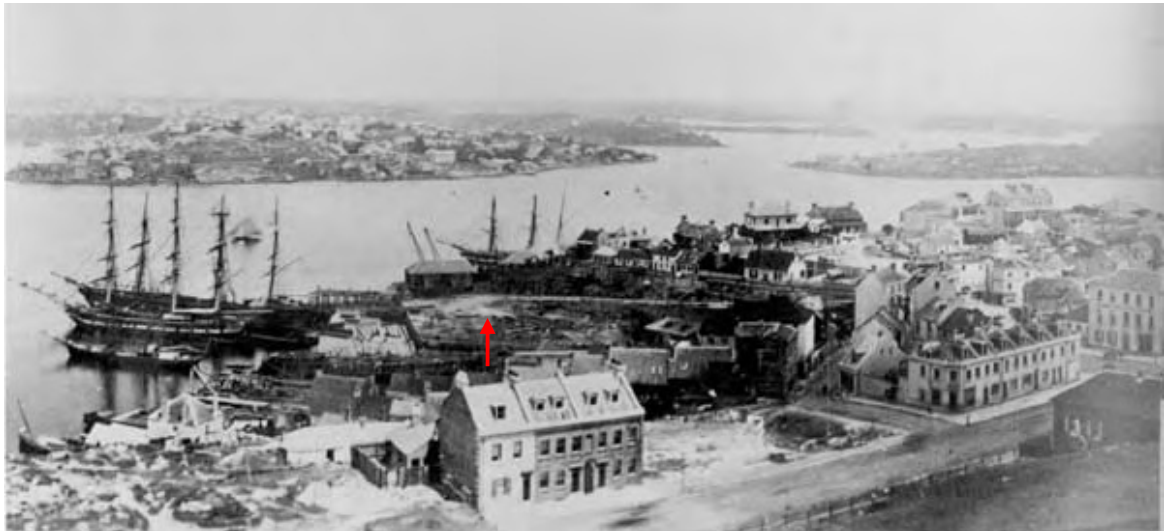
Figure 2.6 View of Darling Harbour over Kent Street from the Observatory, c1873. This image shows the sea wall and extensive reclamation (red arrow) at Cuthbert's shipyard a few years prior to redevelopment by Dibbs. The edge of the escarpment can also be seen as well as the wharf road that ran below Munn Street. Kent Street is in the foreground with Millers Road veering off to the left and Hart Street running steeply down to the harbour behind the houses in the foreground. The area has clearly been modified and levelled for the construction of houses and roads (Source: ML, Holtermann Collection Box 55).

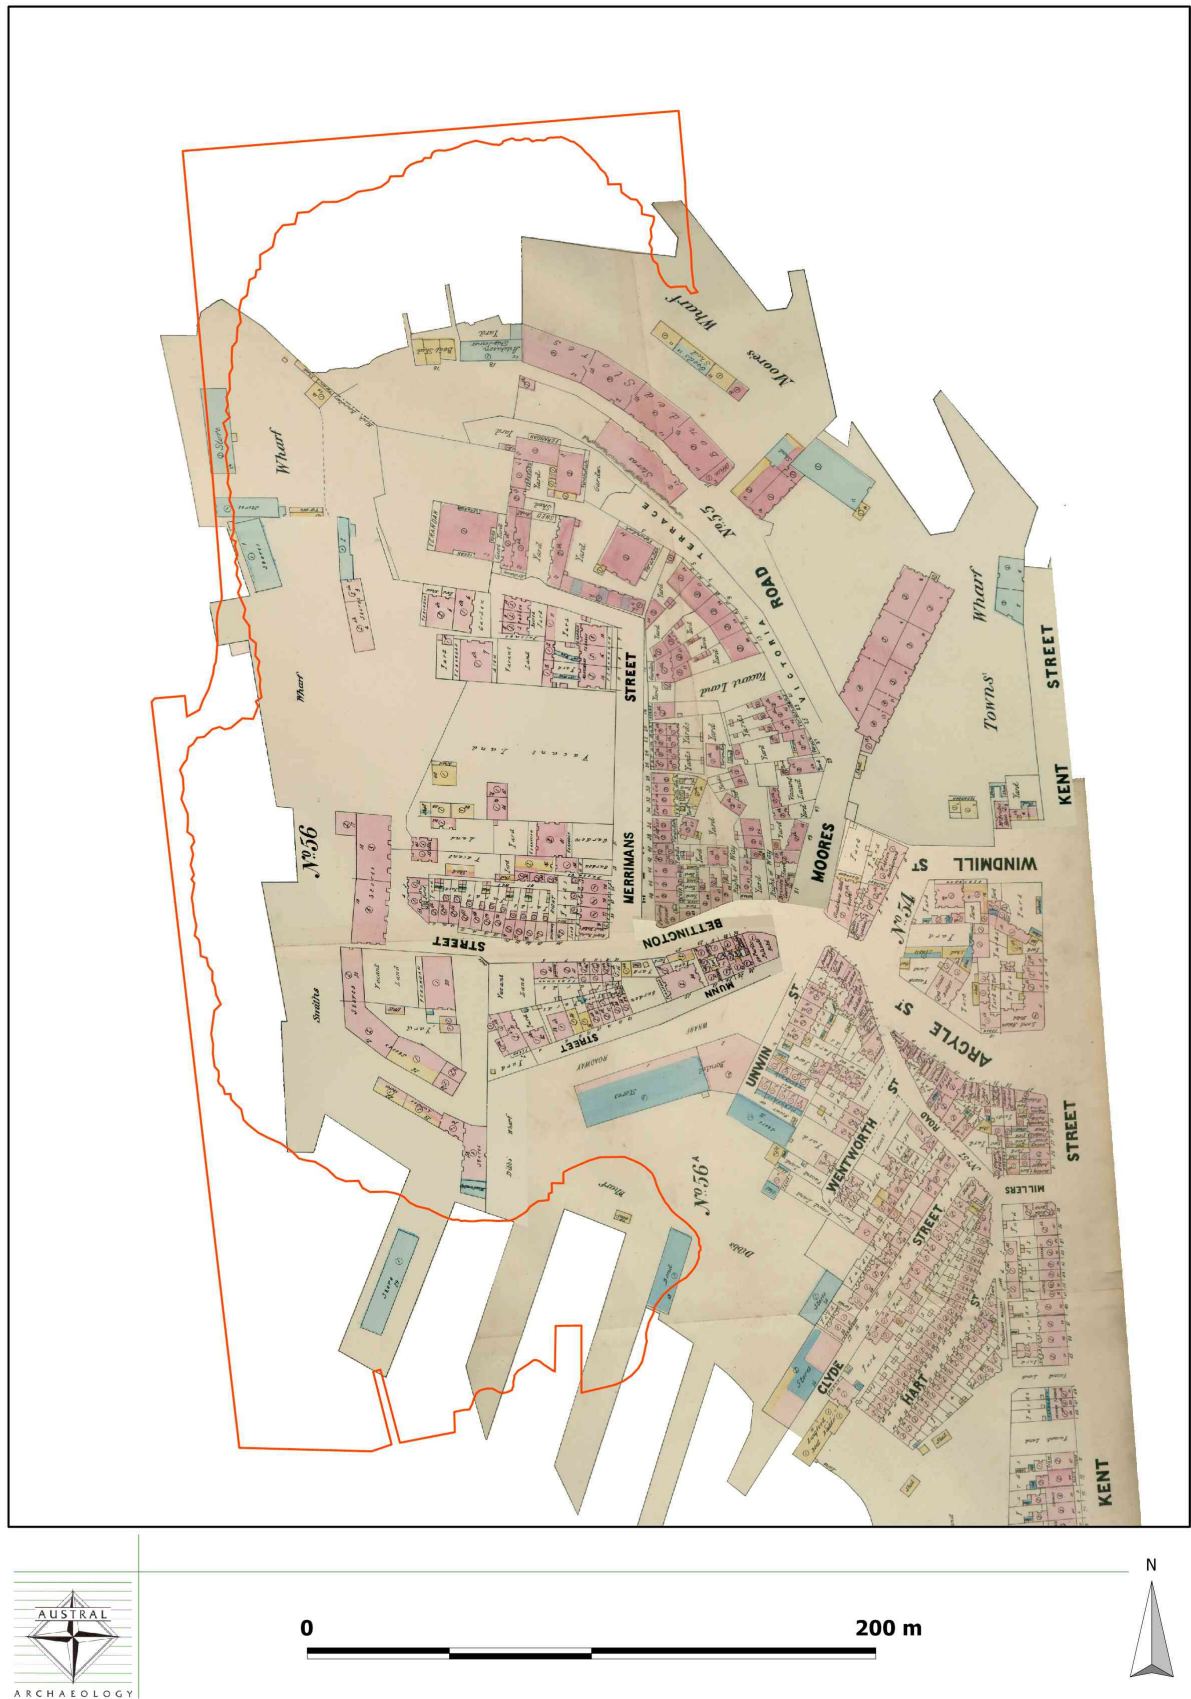
Figure 2.7. 1880 Dove Plan showing the configuration of the shoreline and the location of buildings with the proposed new headland overlaid (Source <http://www3.photosau.com/CoSMaps/scripts/home.asp>).

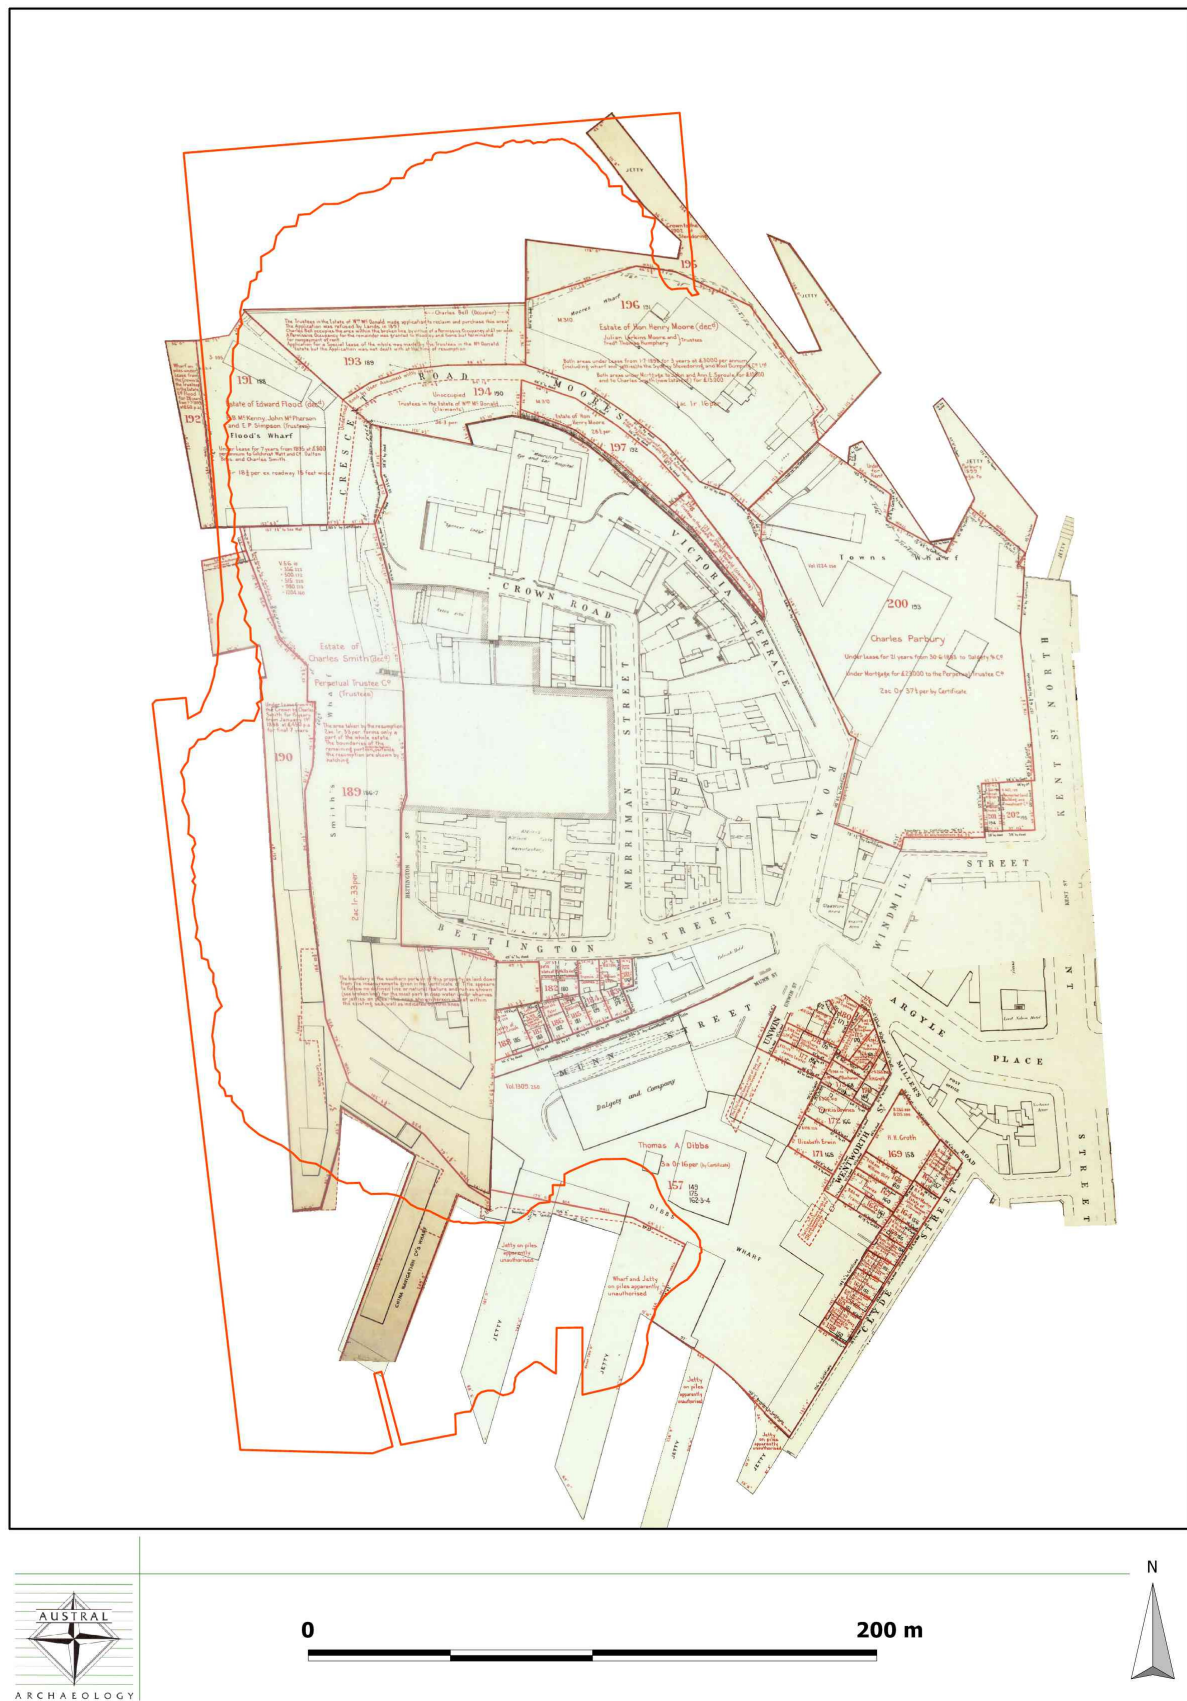
Figure 2.8 1900 Darling Harbour Resumption Plans showing the configuration of the shoreline and the location of buildings with the proposed new headland overlaid (Source: SHFA Historic Maps collection).

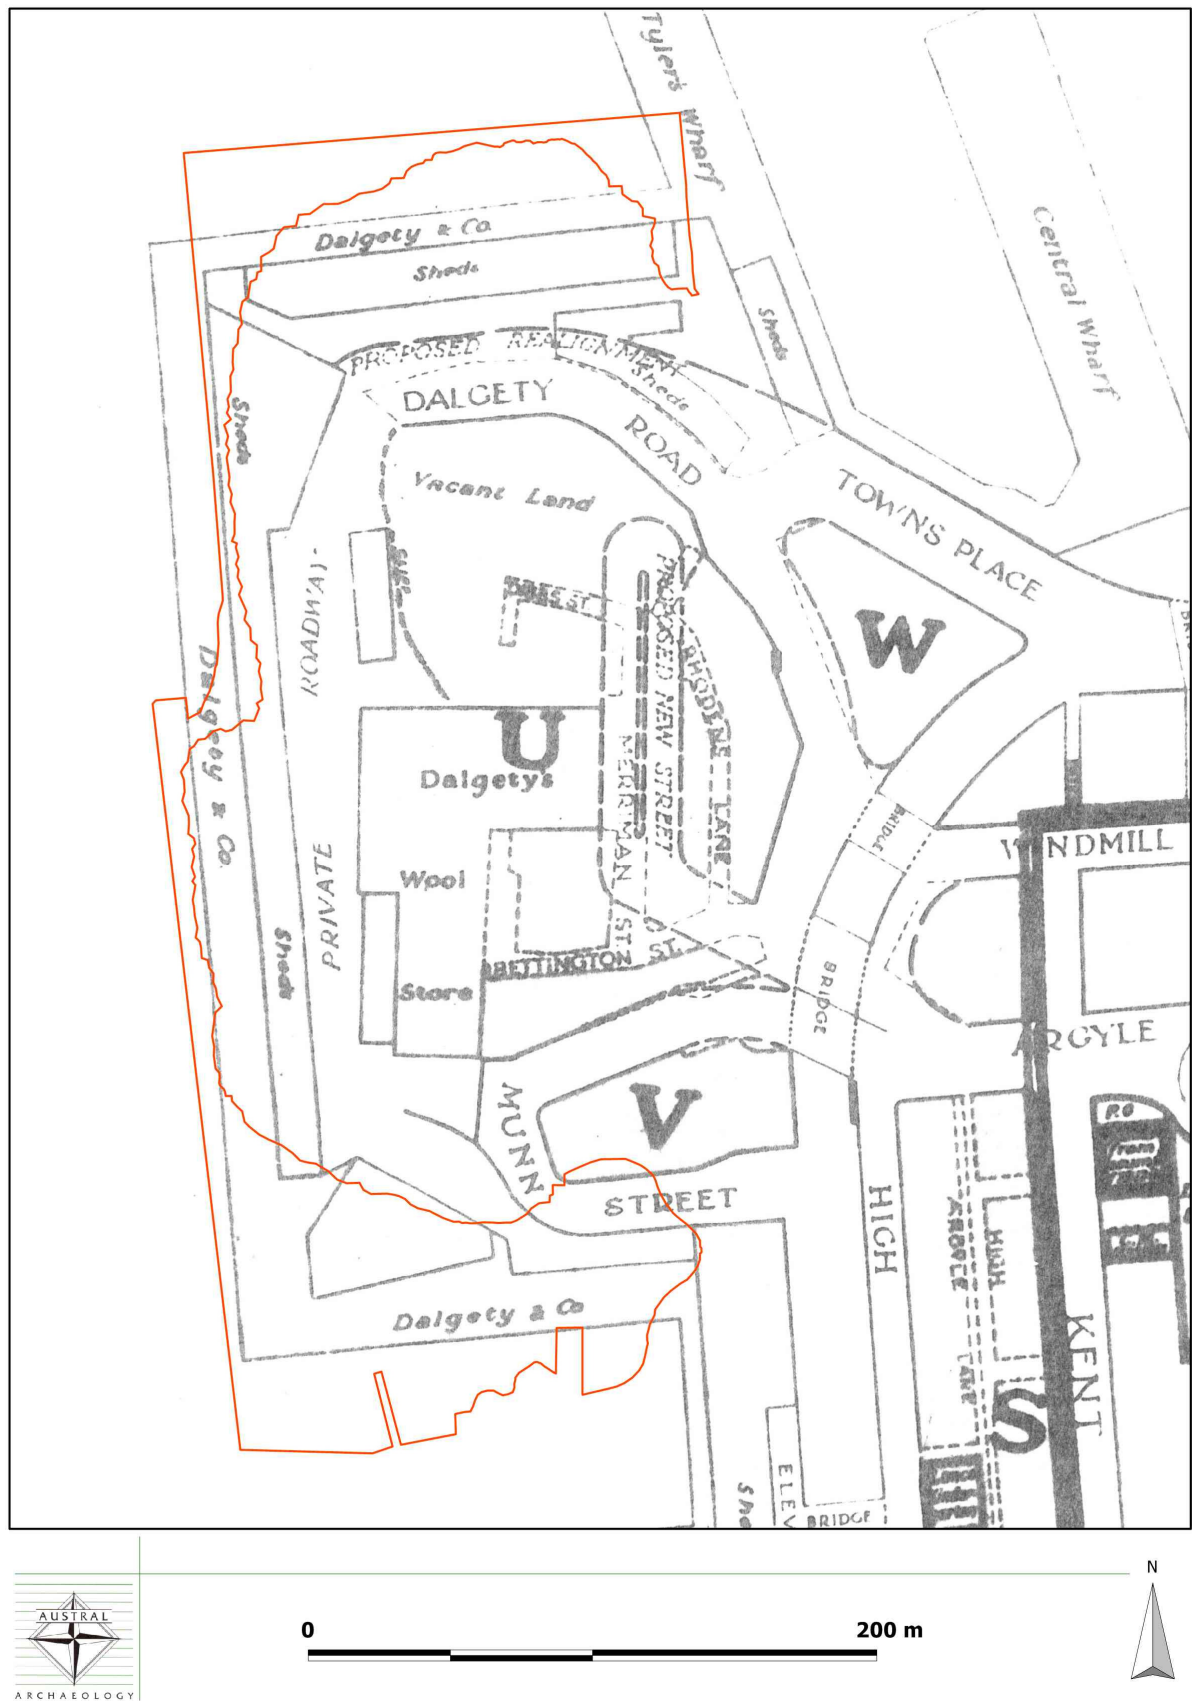
Figure 2.9 1913 plan showing the redevelopment of the headland, streets and wharfage with proposed new headland overlaid. The existing Dalgety Stores buildings adjacent to the headland are located in section V on this plan (Source: SHFA Historic Maps collection).

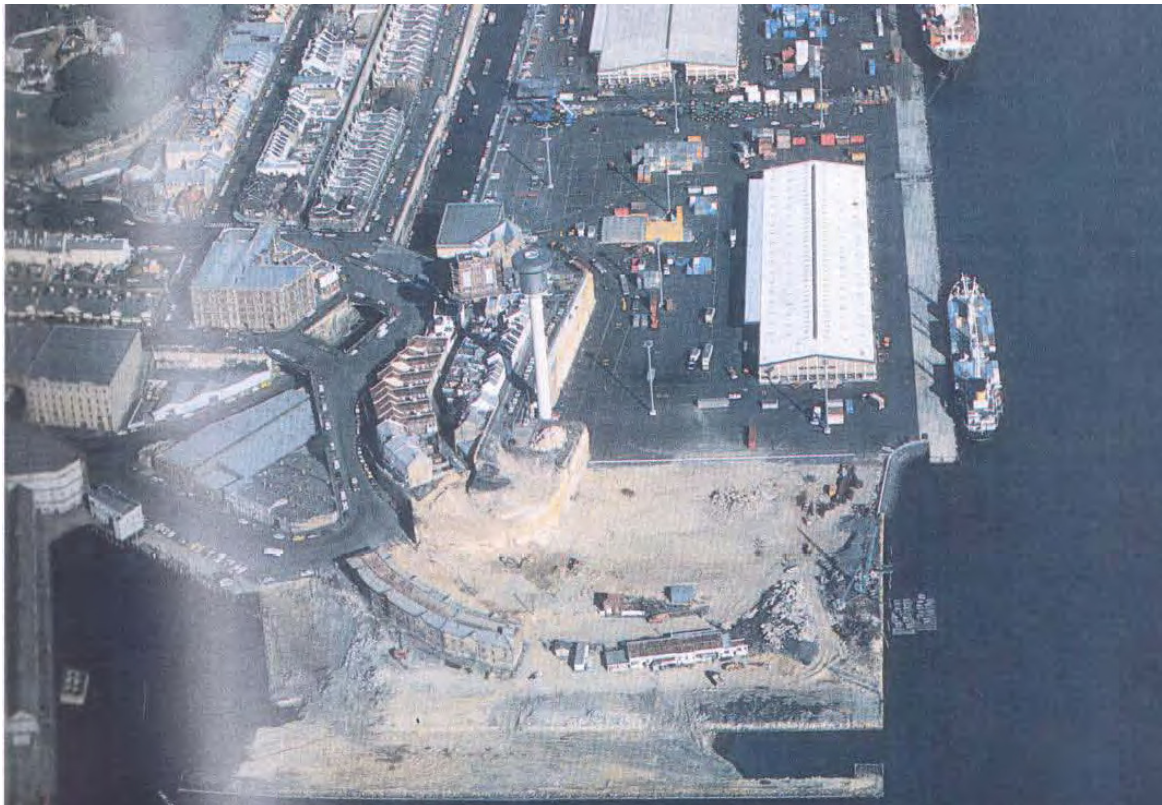
Figure 2.10 Reconstruction of the headland 1970s. Moore's Wharf is in its original position and the shape of the headland can be discerned by the location of the buildings. (Source: Maritime Services Board Annual Report 1977-78, p 8)

Moore's Wharf was originally located on the northern edge of the headland and was relocated in the 1980s. The landform was considerably cut back in the 1970s (Figure 2.10) and it is expected that any evidence of Aboriginal occupation will have been disturbed or destroyed.

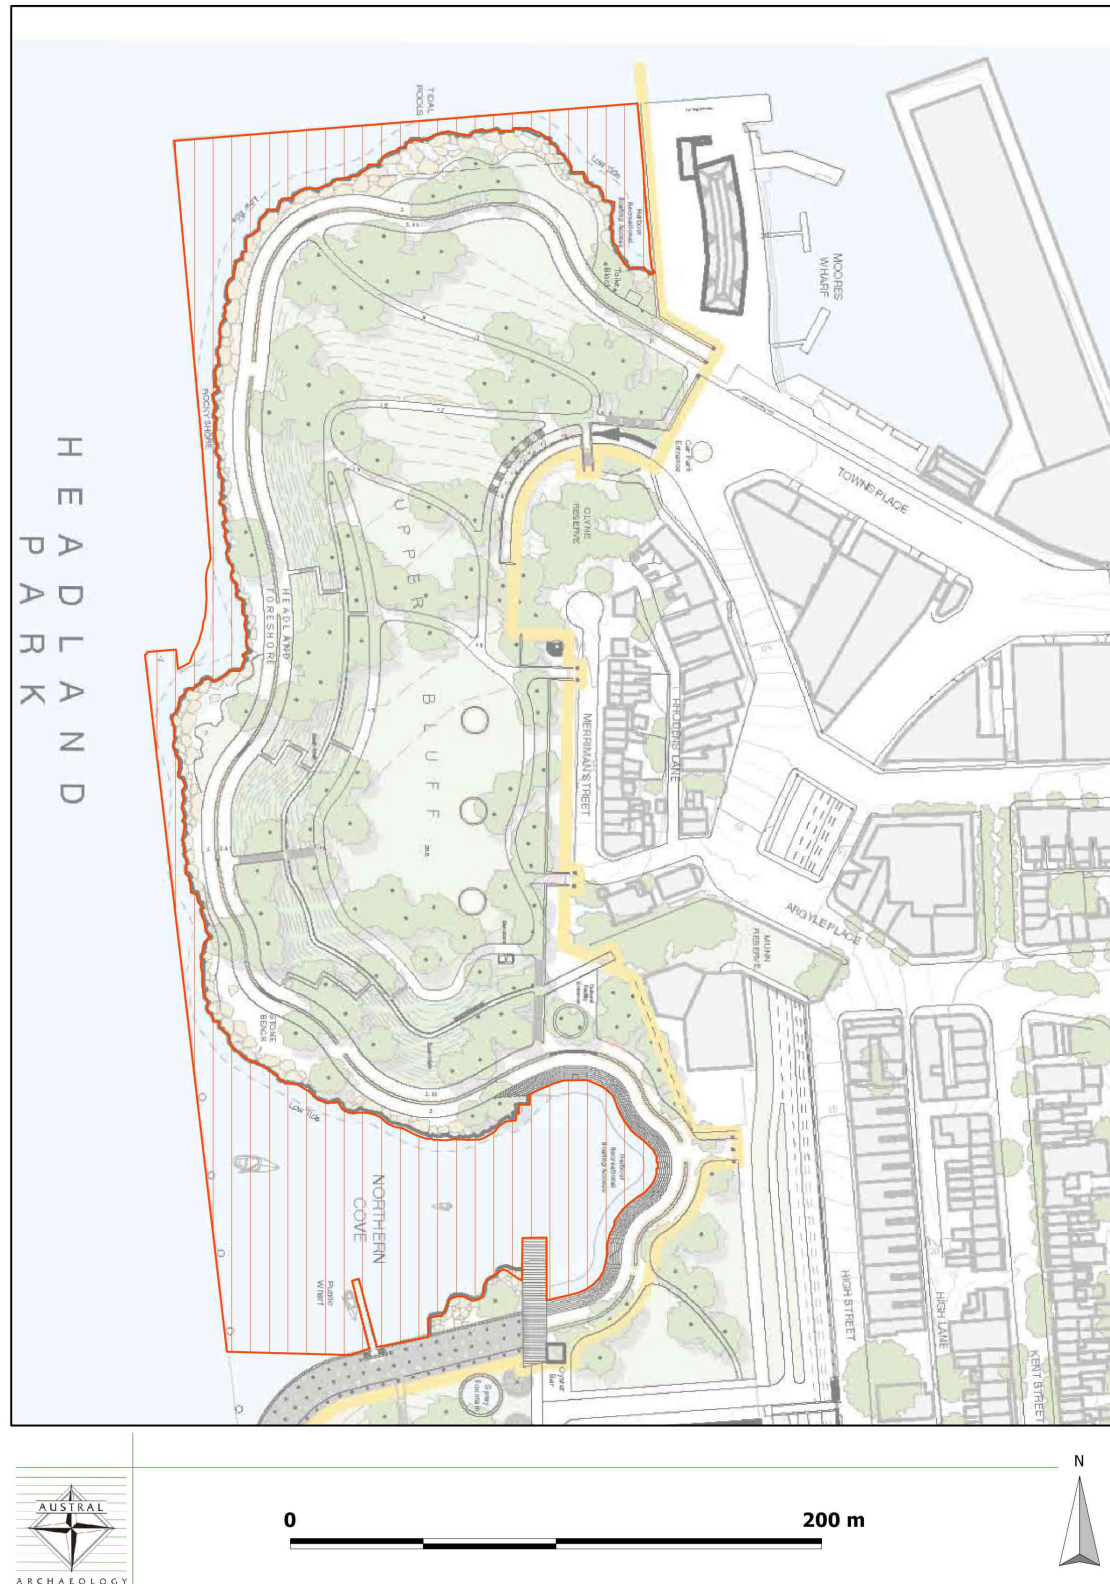
Figure 4.1. Proposed Headland Park and Northern Cove overlaid onto the current wharf configuration. The area striped red is the area to be removed/impacted.

The creation of a naturalised shape and form for the headland will require the penetration of the caisson wall at the north and west of the deck, as well as removal of the current sandstone sea wall. The main impacts on the identified potential archaeological resource of the Northern Headland is from the bulk excavation to create the water insertions of the Northern Cove and the Moore's Wharf inlet.

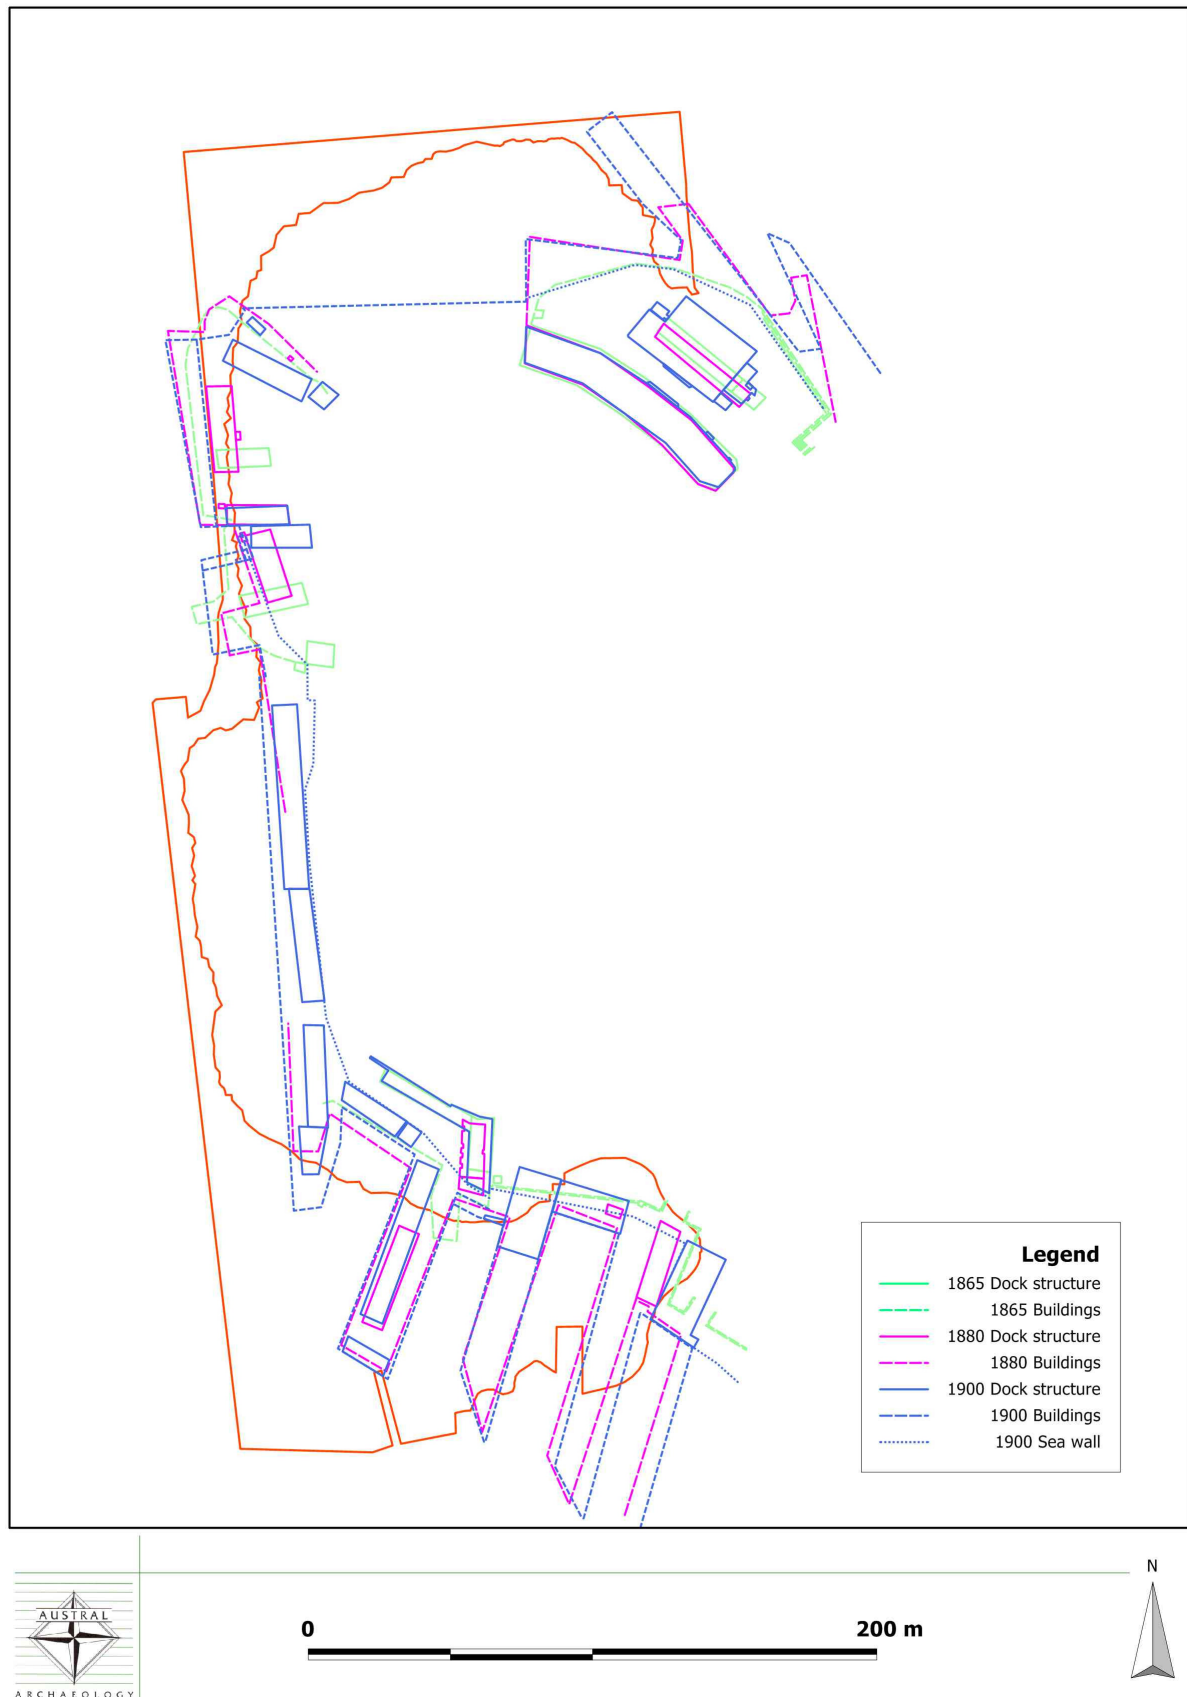
Figure 4.2. Overlay of the 1865, 1880 and 1900 plans showing the location of buildings that were extant during this period. A number of these buildings are known to have been constructed well before the 1860s, some as early as the 1830s, and were still present in 1900.
