Research Design and Archaeological Excavation Methodology

MAIN WORKS APPLICATION HEADLAND PARK, BARANGAROO

Research Design & Archaeological Excavation Methodology

FINAL REPORT

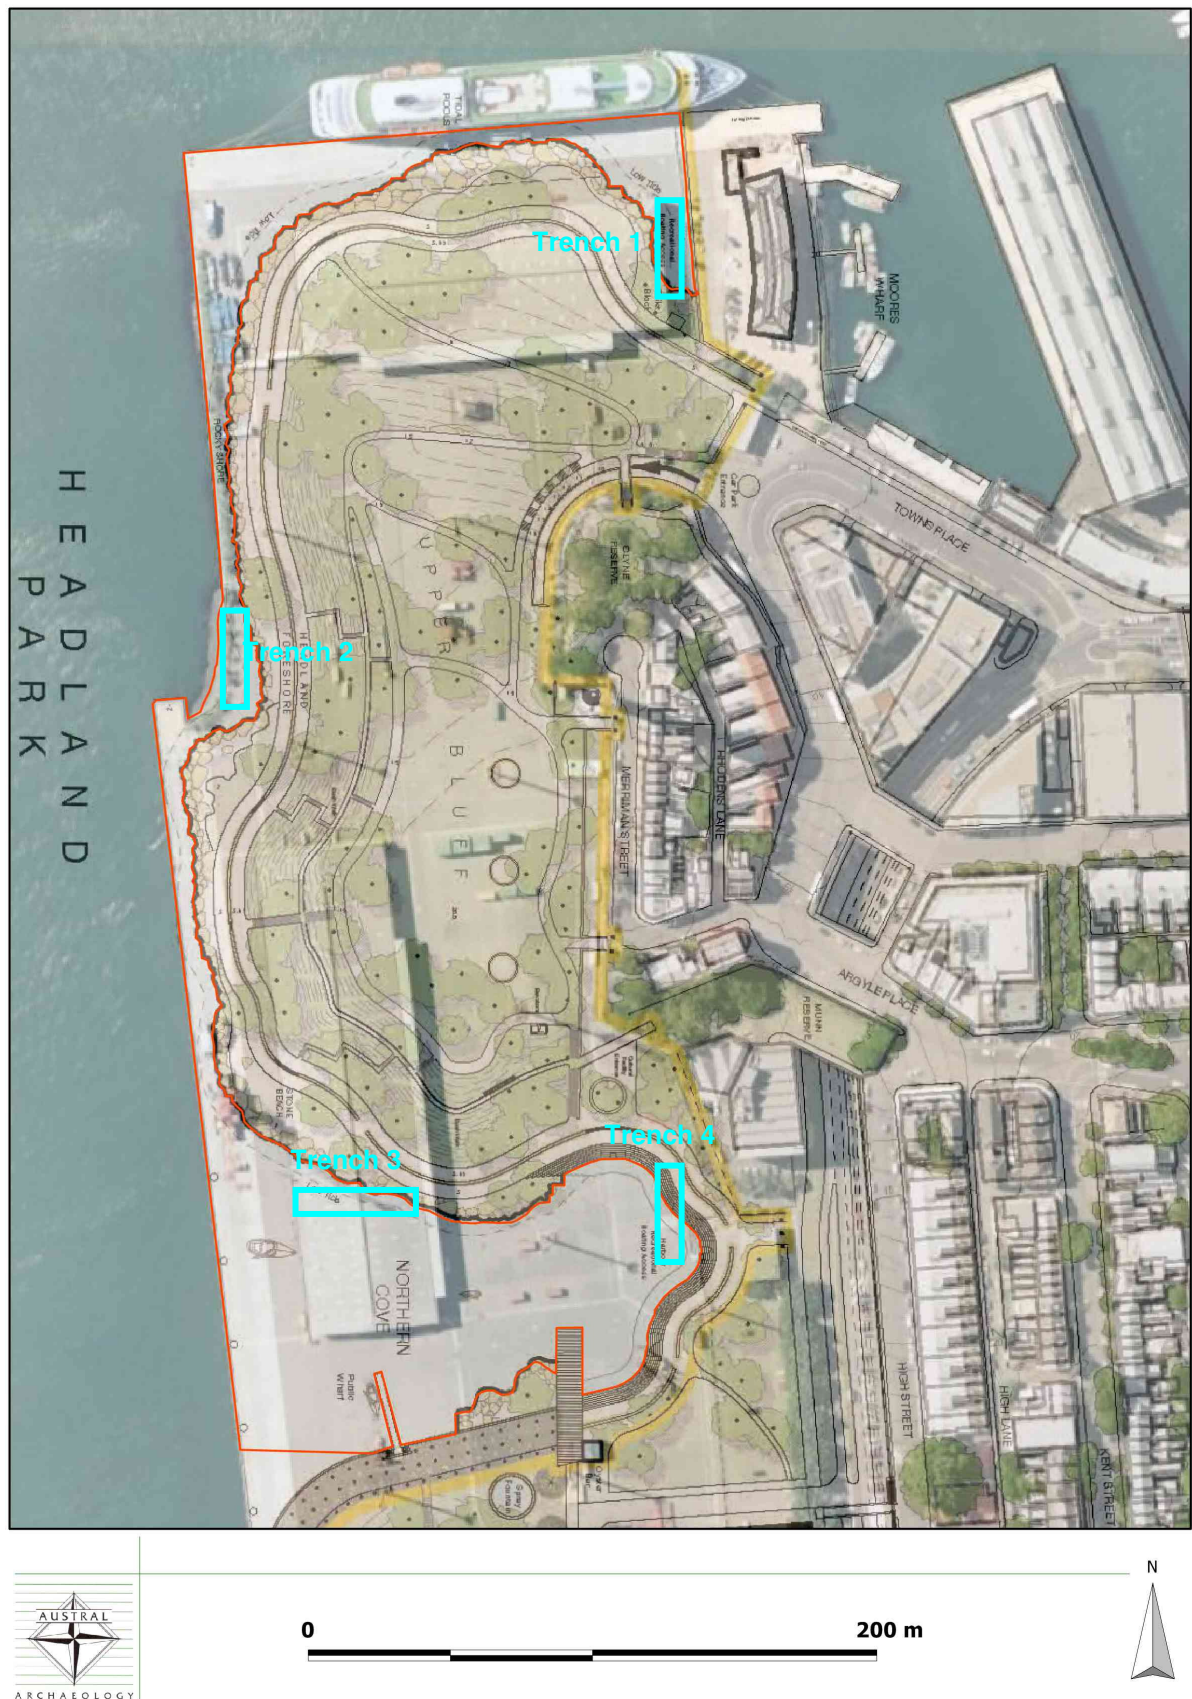
Figure 5.1 Location of four proposed archaeological test trenches.

Four archaeological test trenches are proposed to be located within areas to be impacted by the development of the Headland Park, specifically in the Northern Cove, Moore's Wharf inlet and behind the sandstone sea wall. All these areas are assessed to be of moderate to high archaeological potential and are likely to contain features and deposits of both local and State

significance. The test trenches will be located as closely as possible (given the accuracy of the available historic mapping) to intersect with historic structures or landforms present on the plans from 1833, 1865, 1880 and 1900. It is understood that existing services will have been decommissioned as part of the early works program and prior to the archaeological testing works.

Due to the size of the site and the large scale of features such as jetties, store houses and sea walls, the test trenches will necessarily be large in order to expose the nature of the resource. The following trenches are proposed:
