Environmental Site Assessment
Report
NSW Health Infrastructure
12 March 2010

Environmental Site Assessment Report

Westmead Hospital, Westmead, NSW

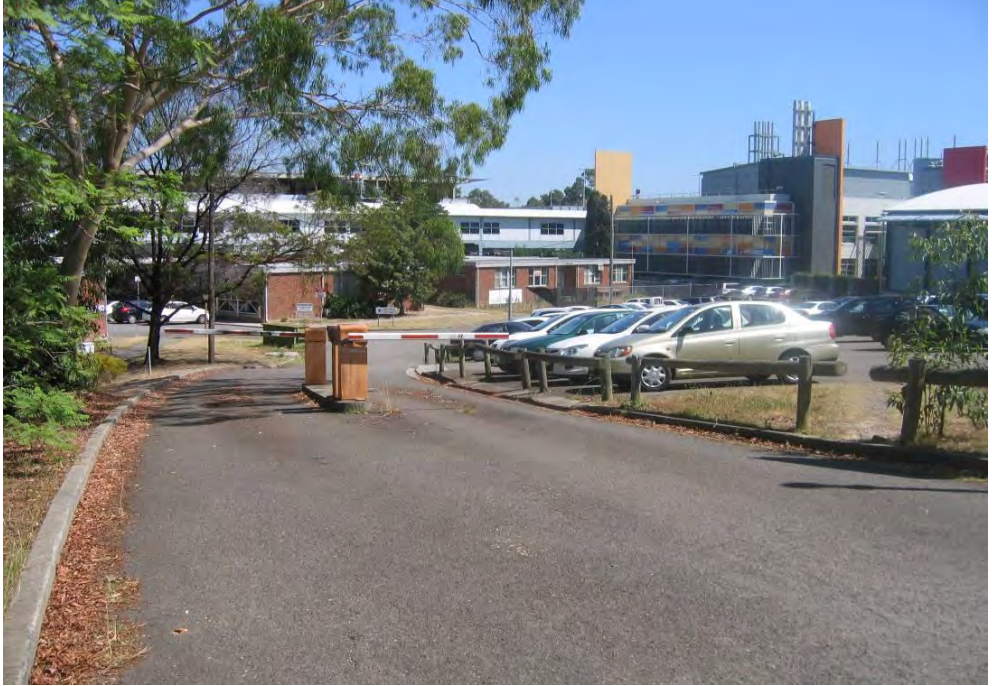
Client Name: Capital Insight Pty Ltd		Site Location: Westmead Hospital , Hawkesbury Road, NSW	Project No. S777101
Photo No. 1	Date: 23.12.09

Direction Photo Taken: Facing north			
Description: Photograph showing boom gate for the site entrance, surrounding topography and adjacent bitumen sealed carpark area. Note the S.T.I Research Centre (Marian Villa) building is to the left of boom gate.

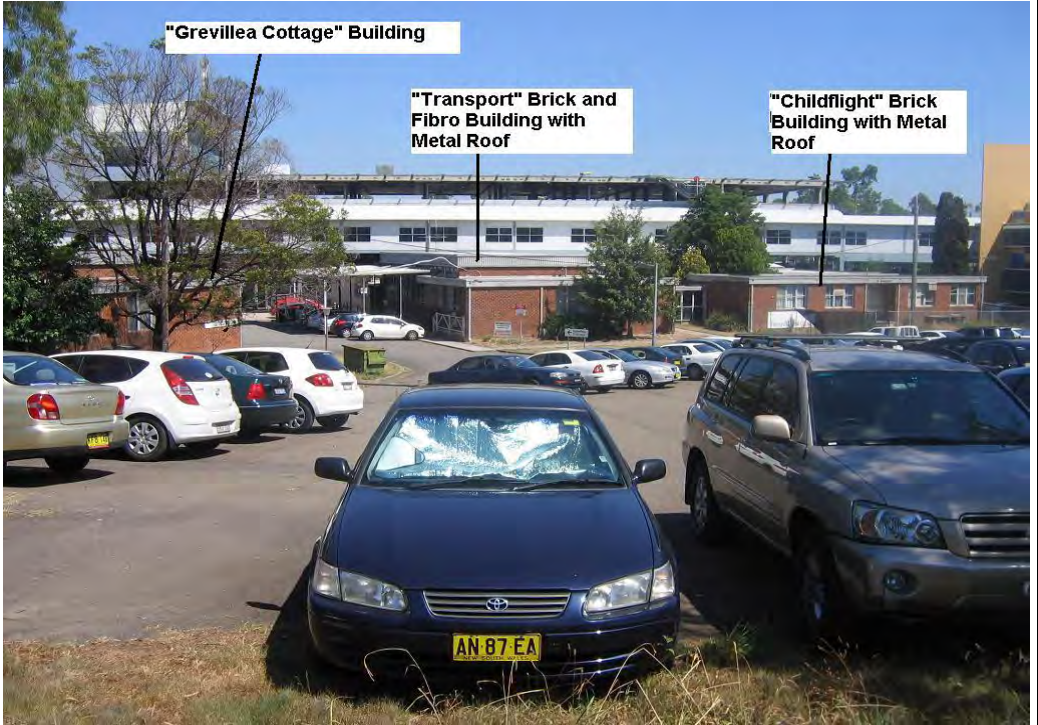
Photo No. 2	Date: 23.12.09

Direction Photo Taken: Facing north		
Description: The carpark area and other surrounding buildings are visible in the photograph.

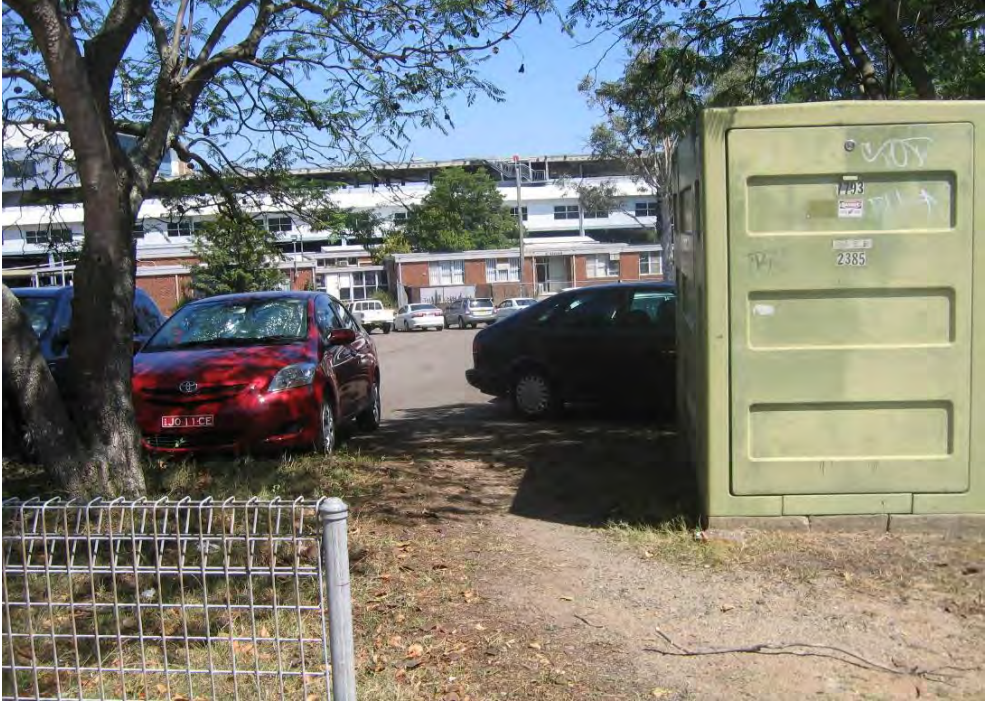
Client Name: Capital Insight Pty Ltd		Site Location: Westmead Hospital , Hawkesbury Road, NSW	Project No. S777101
Photo No. 5	Date: 23.12.09

Direction Photo Taken: Facing North			
Description: Photograph showing substation of Integral Energy (right of the photograph) located in the south east corner of the Site. Note that only substation area lease to Integral Energy.

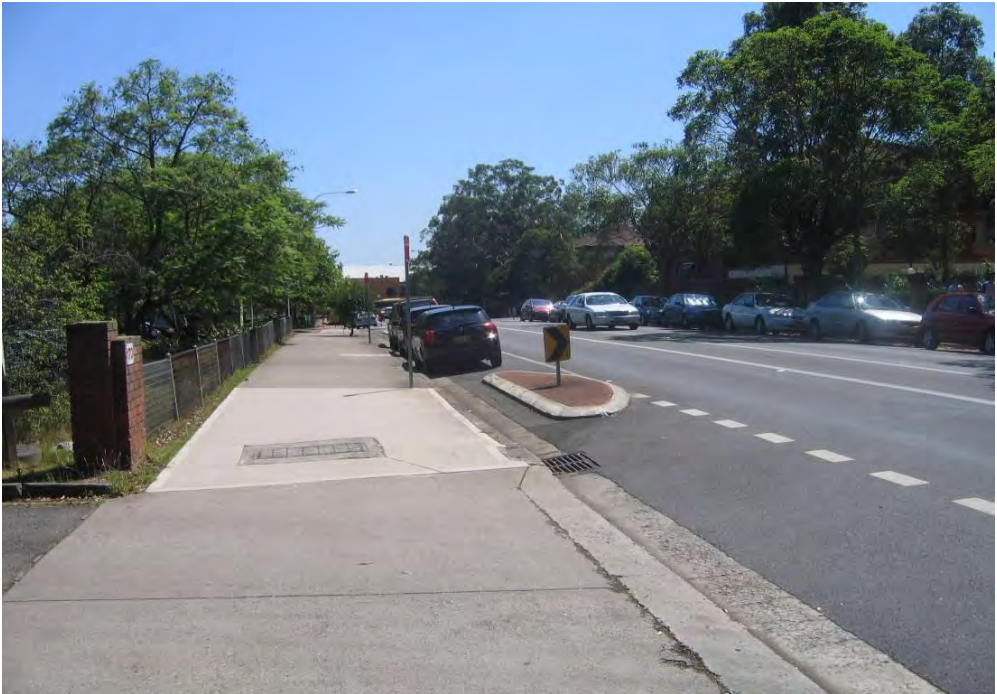
Photo No. 6	Date: 23.12.09

Direction Photo Taken: Facing east		
Description: Photograph showing Hawkesbury Road which running east to west along southern portion of the Site. Note predominantly fenced off southern portion of the Site is visible.

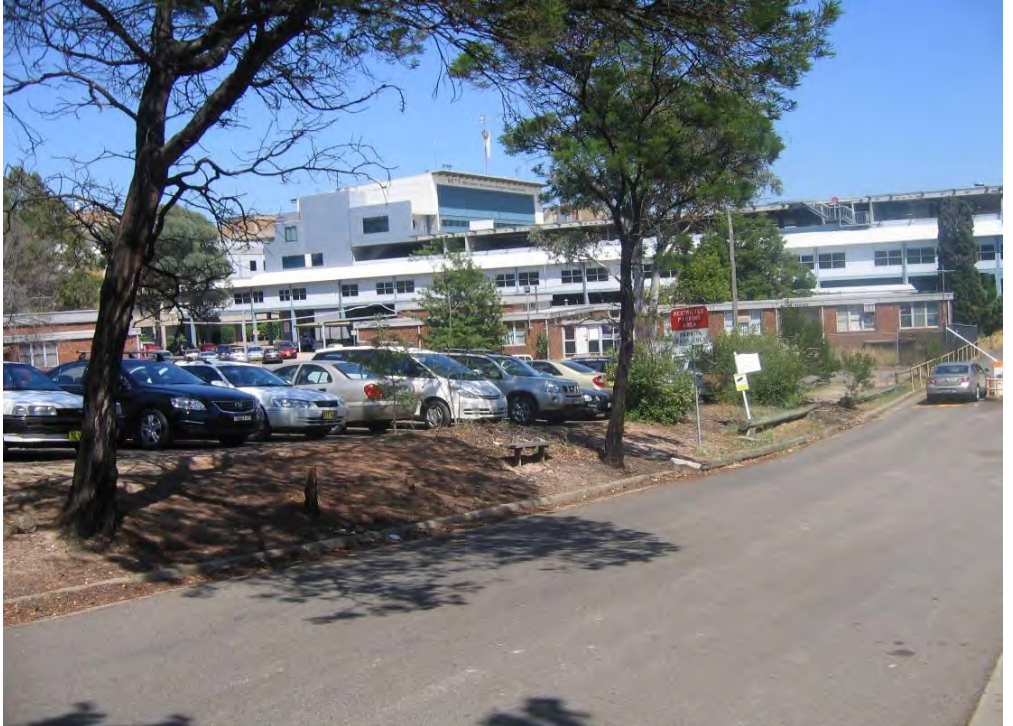
Client Name: Capital Insight Pty Ltd		Site Location: Westmead Hospital , Hawkesbury Road, NSW	Project No. S777101
Photo No. 7	Date: 23.12.09

Direction Photo Taken: Facing west			
Description: Bitumen sealed running north- south to the southern portion of the Site. Note the Children Hospital building is to the right of the photograph.

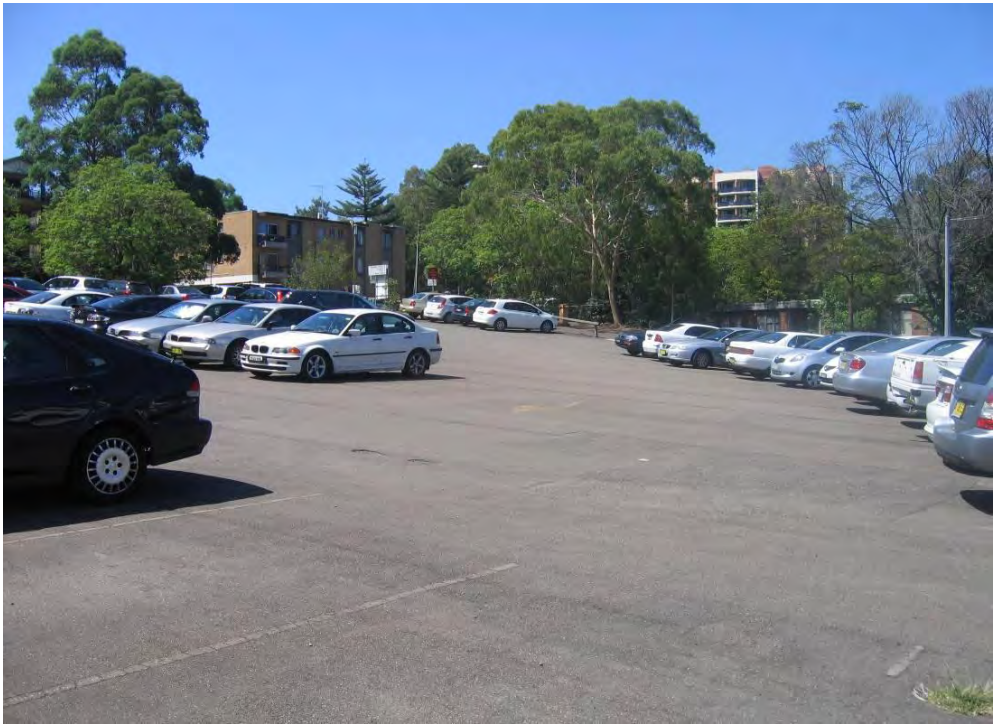
Client Name: Capital Insight Pty Ltd		Site Location: Westmead Hospital , Hawkesbury Road, NSW	Project No. S777101
Photo No. 9	Date: 23.12.09

Direction Photo Taken: Facing south west			
Description: Photograph showing bitumen sealed carpark area and moderate slope to the north to north-west. Note the high rise residential building located across Hawkesbury Road is visible.
