Westmead Hospital

Geotechnical Interpretive Report

NSW Health Infrastructure

AECOM Australia Pty Ltd

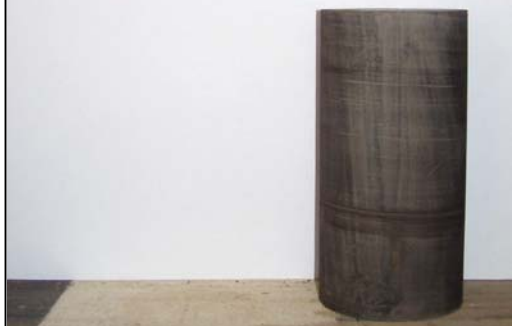
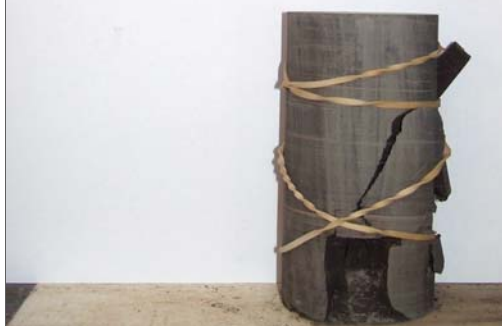
BH 1
6.53-6.65m

AECOM
Westmead Hospital
Unconfined Compressive Strength
Test Sample

AECOM
Westmead Hospital
Unconfined Compressive Strength
After Test Sample

U.C.S. (MPa) = 11.3

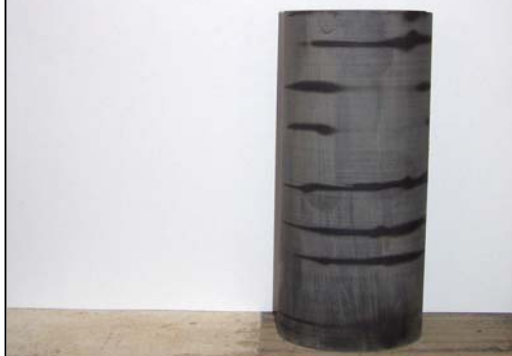
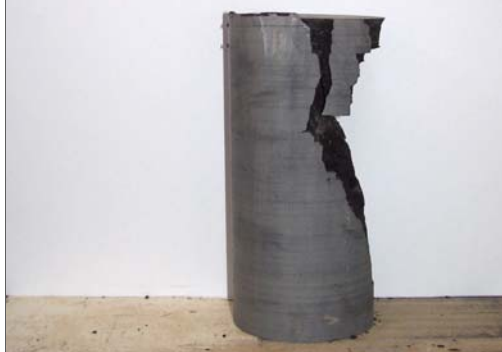
BH 2
8.32-8.47m

AECOM
Westmead Hospital, Westmead
Unconfined Compressive Strength
Test Sample

AECOM
Westmead Hospital, Westmead
Unconfined Compressive Strength
After Test Sample

U.C.S. (MPa) = 18.5

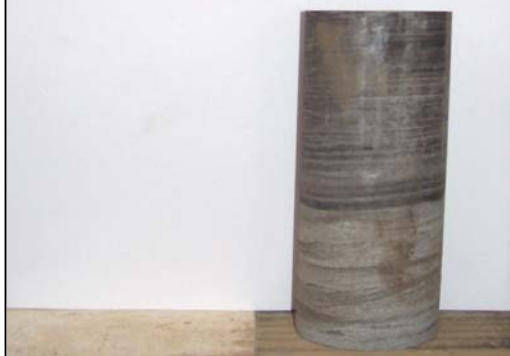
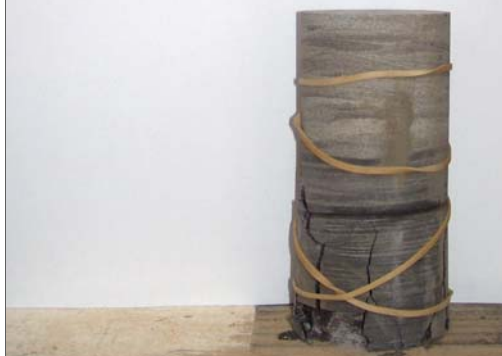
BH 2
9.90-10.0m

AECOM
Westmead Hospital, Westmead
Unconfined Compressive Strength
Test Sample

AECOM
Westmead Hospital, Westmead
Unconfined Compressive Strength
After Test Sample

U.C.S. (MPa) = 20.5

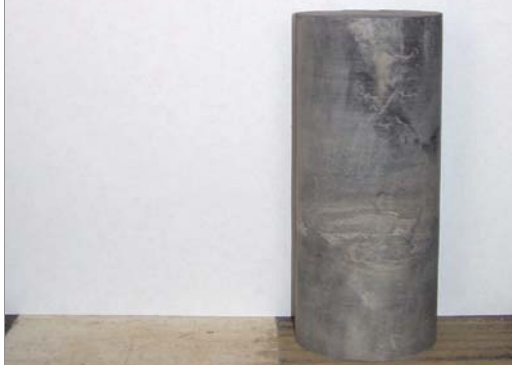
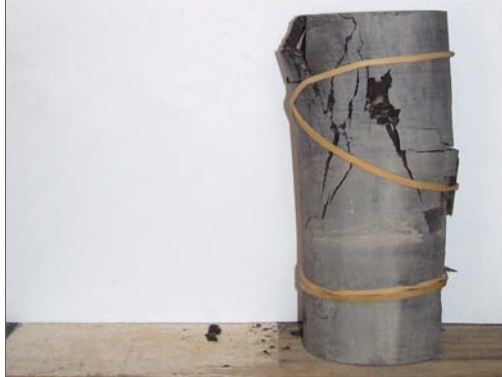
BH 3
7.84-7.98m

AECOM
Westmead Hospital, Westmead
Unconfined Compressive Strength
Test Sample

AECOM
Westmead Hospital, Westmead
Unconfined Compressive Strength
After Test Sample

U.C.S. (MPa) = 20.4

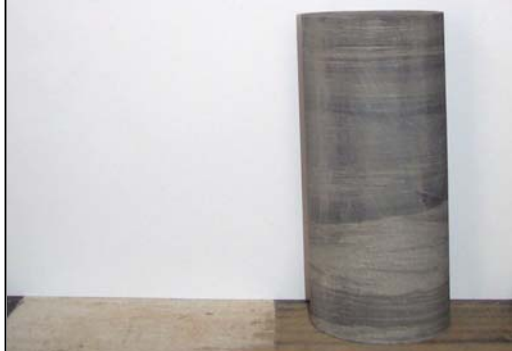
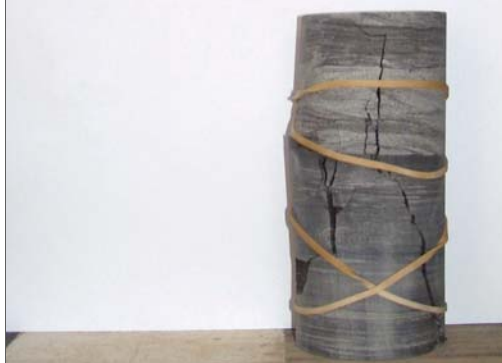
BH 3
9.50-9.65m

AECOM
Westmead Hospital, Westmead
Unconfined Compressive Strength
Test Sample

AECOM
Westmead Hospital, Westmead
Unconfined Compressive Strength
After Test Sample

U.C.S. (MPa) = 29.8

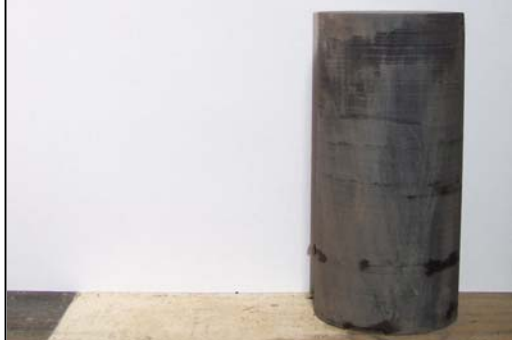
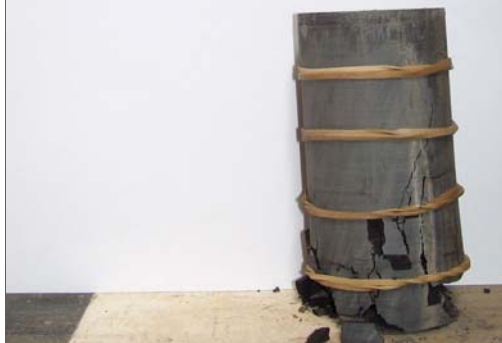
BH 4
7.28-7.43m

AECOM
Westmead Hospital
Unconfined Compressive Strength
Test Sample

AECOM
Westmead Hospital
Unconfined Compressive Strength
After Test Sample

U.C.S. (MPa) = 19.3

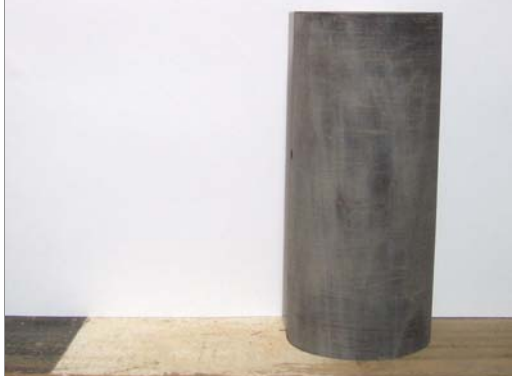
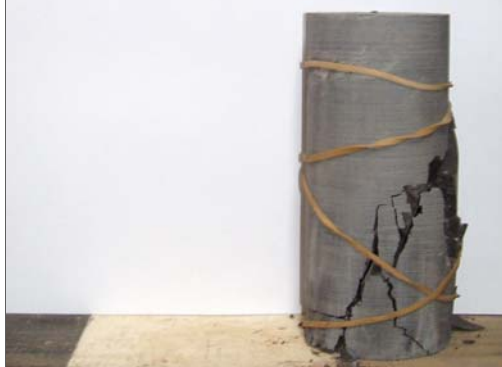
BH 4
9.02-9.16m

AECOM
Westmead Hospital
Unconfined Compressive Strength
Test Sample

AECOM
Westmead Hospital
Unconfined Compressive Strength
After Test Sample

U.C.S. (MPa) = 18.9

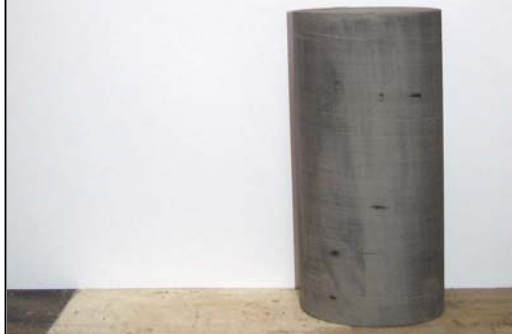
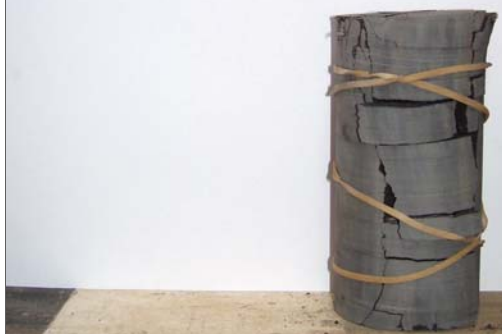
BH 5
4.30-4.46m

AECOM
Westmead Hospital
Unconfined Compressive Strength
Test Sample

AECOM
Westmead Hospital
Unconfined Compressive Strength
After Test Sample

U.C.S. (MPa) = 18.6

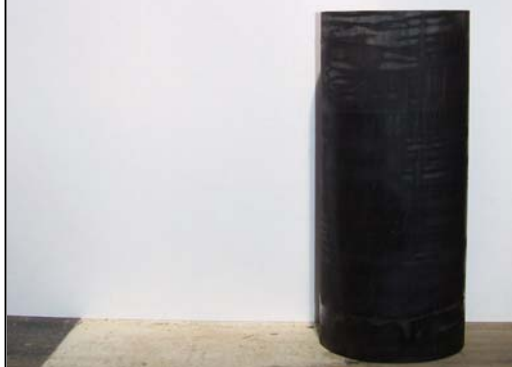
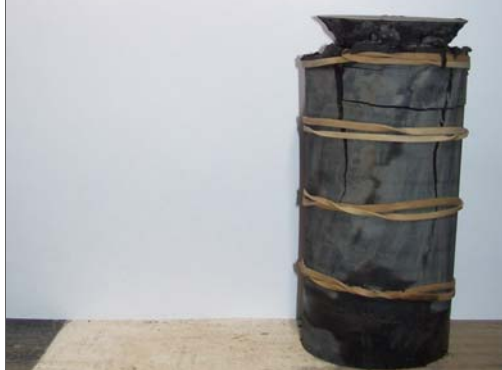
BH 5
8.50-8.64m

AECOM
Westmead Hospital
Unconfined Compressive Strength
Test Sample

AECOM
Westmead Hospital
Unconfined Compressive Strength
After Test Sample

U.C.S. (MPa) = 18.6
