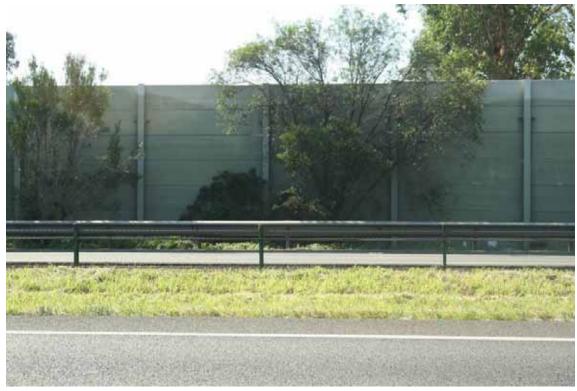
Plate 1: Mown Grass Median

The central median of the M5 West Motorway is comprised of four basic elements: concrete, exotic grass, planted shrubs and planted trees. The median between King Georges Road and Fairford Road is currently paved as is the median between the Hume Highway and Moorebank Road. The remaining areas of median consist predominantly of mown exotic grasses with occasional plantings and concentrated landscape plantings around bridge abutments (Plate 1, Plate 2 and Plate 3). The species recorded along the central median have been planted (or hydro-mulched) as part of landscaping of the M5 West Motorway, and no remnant vegetation is present within the median. The soil profile has been highly modified, consisting predominantly of cut and fill batters. Whilst the species planted are native, they do not entirely represent species that would have naturally occurred in the area. Such species include *Melaleuca armillaris* (Bracelet Honey-myrtle), *Westringea fruiticosa* (Coastal Rosemary), *Acacia saligna* (Cooba), *Doryanthes palmeri* (Giant Spear Lily) and various Grevillea cultivars. The ground cover in all areas of the median consists predominately of introduced grasses including *Eragrostis curvula* (African Lovegrass), *Pennisetum clandestinum* (Kikuyu) and *Chloris gayana* (Rhodes Grass).

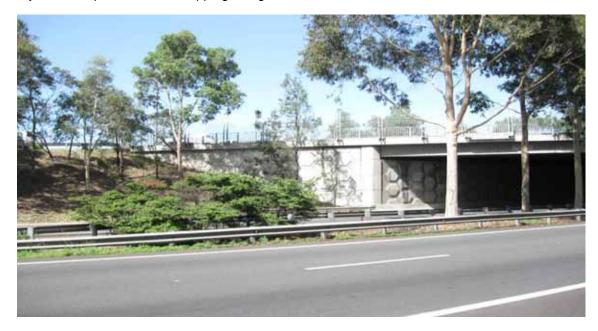
Plate 4: Downy Wattle (Acacia pubescens) in central median

One locally native threatened species, *Acacia pubescens* (Downy Acacia), was observed to have been included within landscaped areas of the Subject Site (Plate 4). Approximately 33 plants were observed within the median close to the overpasses for River Road, Fairford Road and Heathcote Road. Downy Acacia is listed as vulnerable under both state and federal legislation (TSC Act 1995 and EPBC Act

1999). The individuals found within the median exist due to hydro-mulching and landscaping activities associated with the original construction of the M5 West Motorway, with seed stock sourced from plants that are thought to have naturally occurred within the M5 corridor area (NPWS 2003). The location of Downy Wattle is presented via mapping in Figure 7.

While the Downy Wattle is native to the Study Area, it was planted as part of the original landscaping of the M5 West Motorway and is generally located in the central median around bridge abutments east of Moorebank Road. Several other populations of Downy Wattle have been identified both within and adjoining the M5 Motorway corridor, however these populations occur behind the noise walls and are unlikely to be directly affected by the proposal.

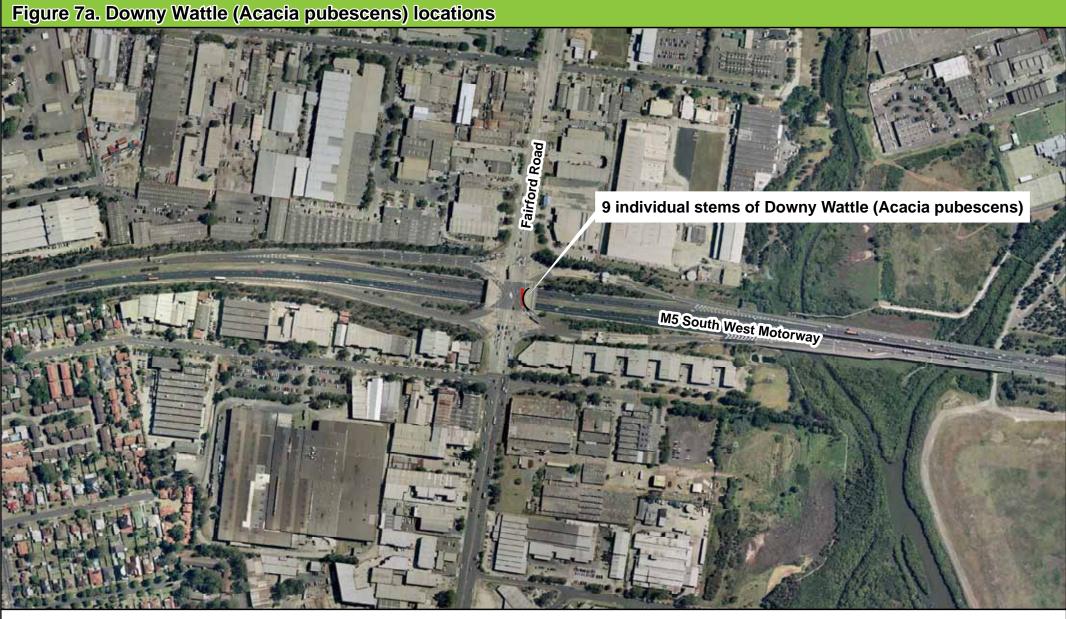
Acacia pubescens locations
