# FARM SHED & MONASTERY INTERPRETIVE STRATEGY & CONSERVATION WORKS

132-138 KILLEATON STREET ST IVES  
Former Site of 'Macquarie Farm' and the  
Pope Pius X Memorial College  
of the Passionist Fathers

OCTOBER 2011

**STATEMENT OF HERITAGE IMPACT  
FOR 132-138 KILLEATON STREET ST IVES  
FARM SHED & MONASTERY INTERPRETIVE STRATEGY &  
CONSERVATION WORKS**

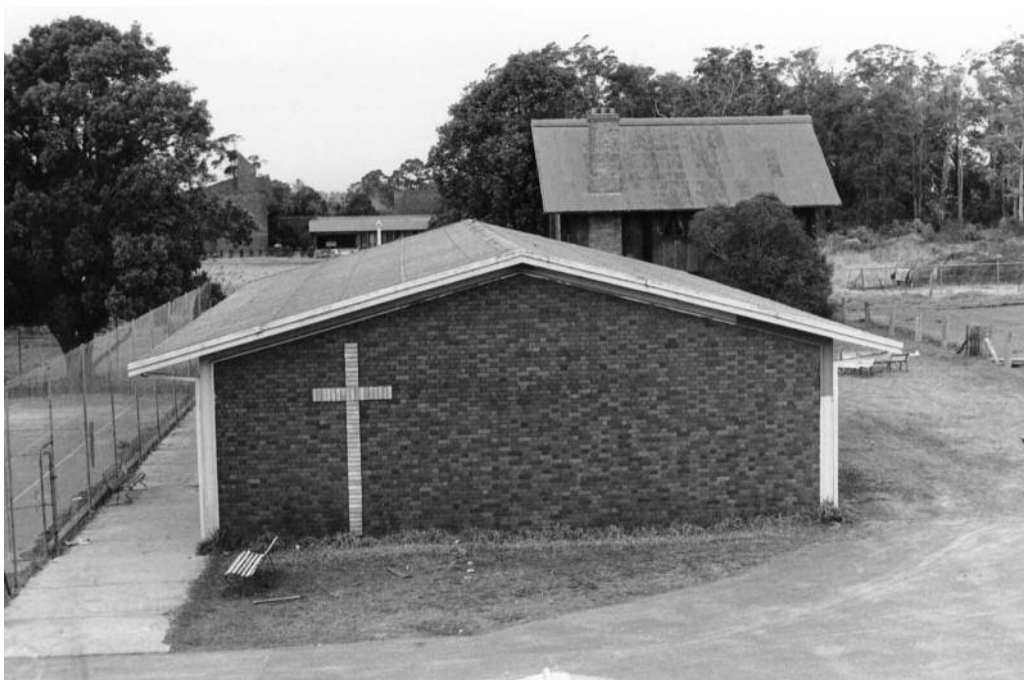
*Figure 2 Photograph pre 1982 showing the original (c.1880) farmhouse standing behind the former gymnasium (demolished). Note the split post timber fencing to the right of the photo. The farmhouse was destroyed by fire in 1982. The site has previously been excavated as an archaeological site. Source: Archives of the Passionist Fathers Community*

The farmhouse had various uses after the construction of the college, they include an early chapel, later a gymnasium and after the construction of a purpose built gymnasium in the mid 1960's a storehouse. The house was destroyed in a fire in 1982.
