PENRITH NEPEAN HEALTH CAMPUS REDEVELOPMENT STAGE 3A

Geotechnical Investigation Report

Report Number. 107622059_002_R_Rev1

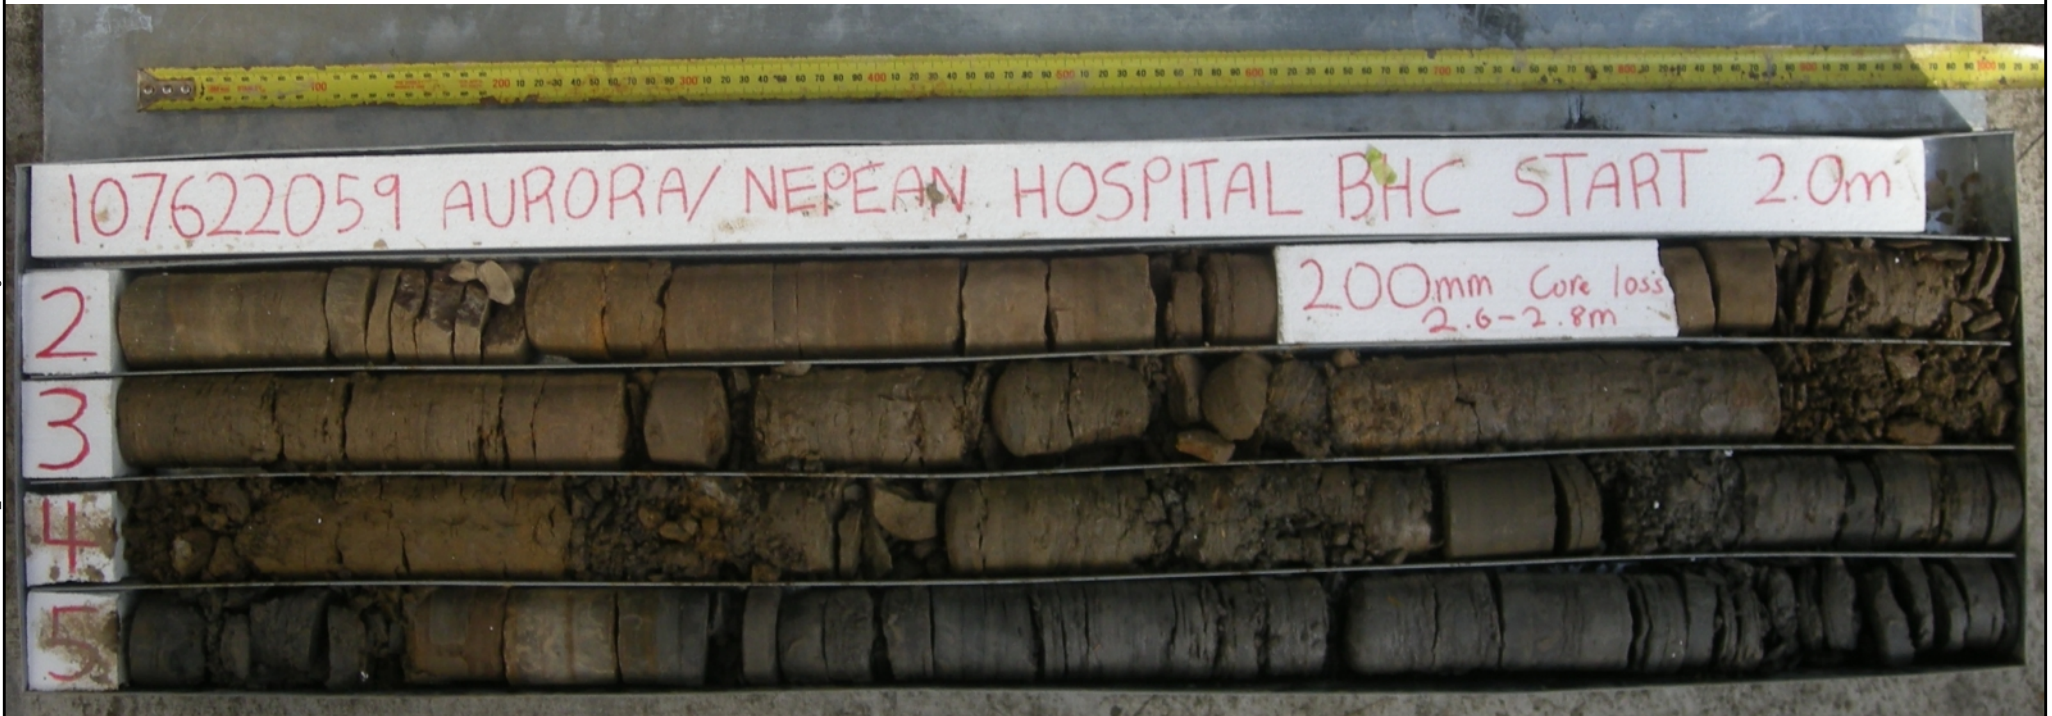
SHEET: 2 OF 2
DRILL RIG: Geoprobe 66200DT
CONTRACTOR: Terratest
LOGGED: TGC DATE: 3/5/10
CHECKED: CSC DATE: 26/5/10

COORDS: 288284.0 m E 6262080.0 m N MGA94 56
INCLINATION: -90°
HOLE DEPTH: 10.00 m

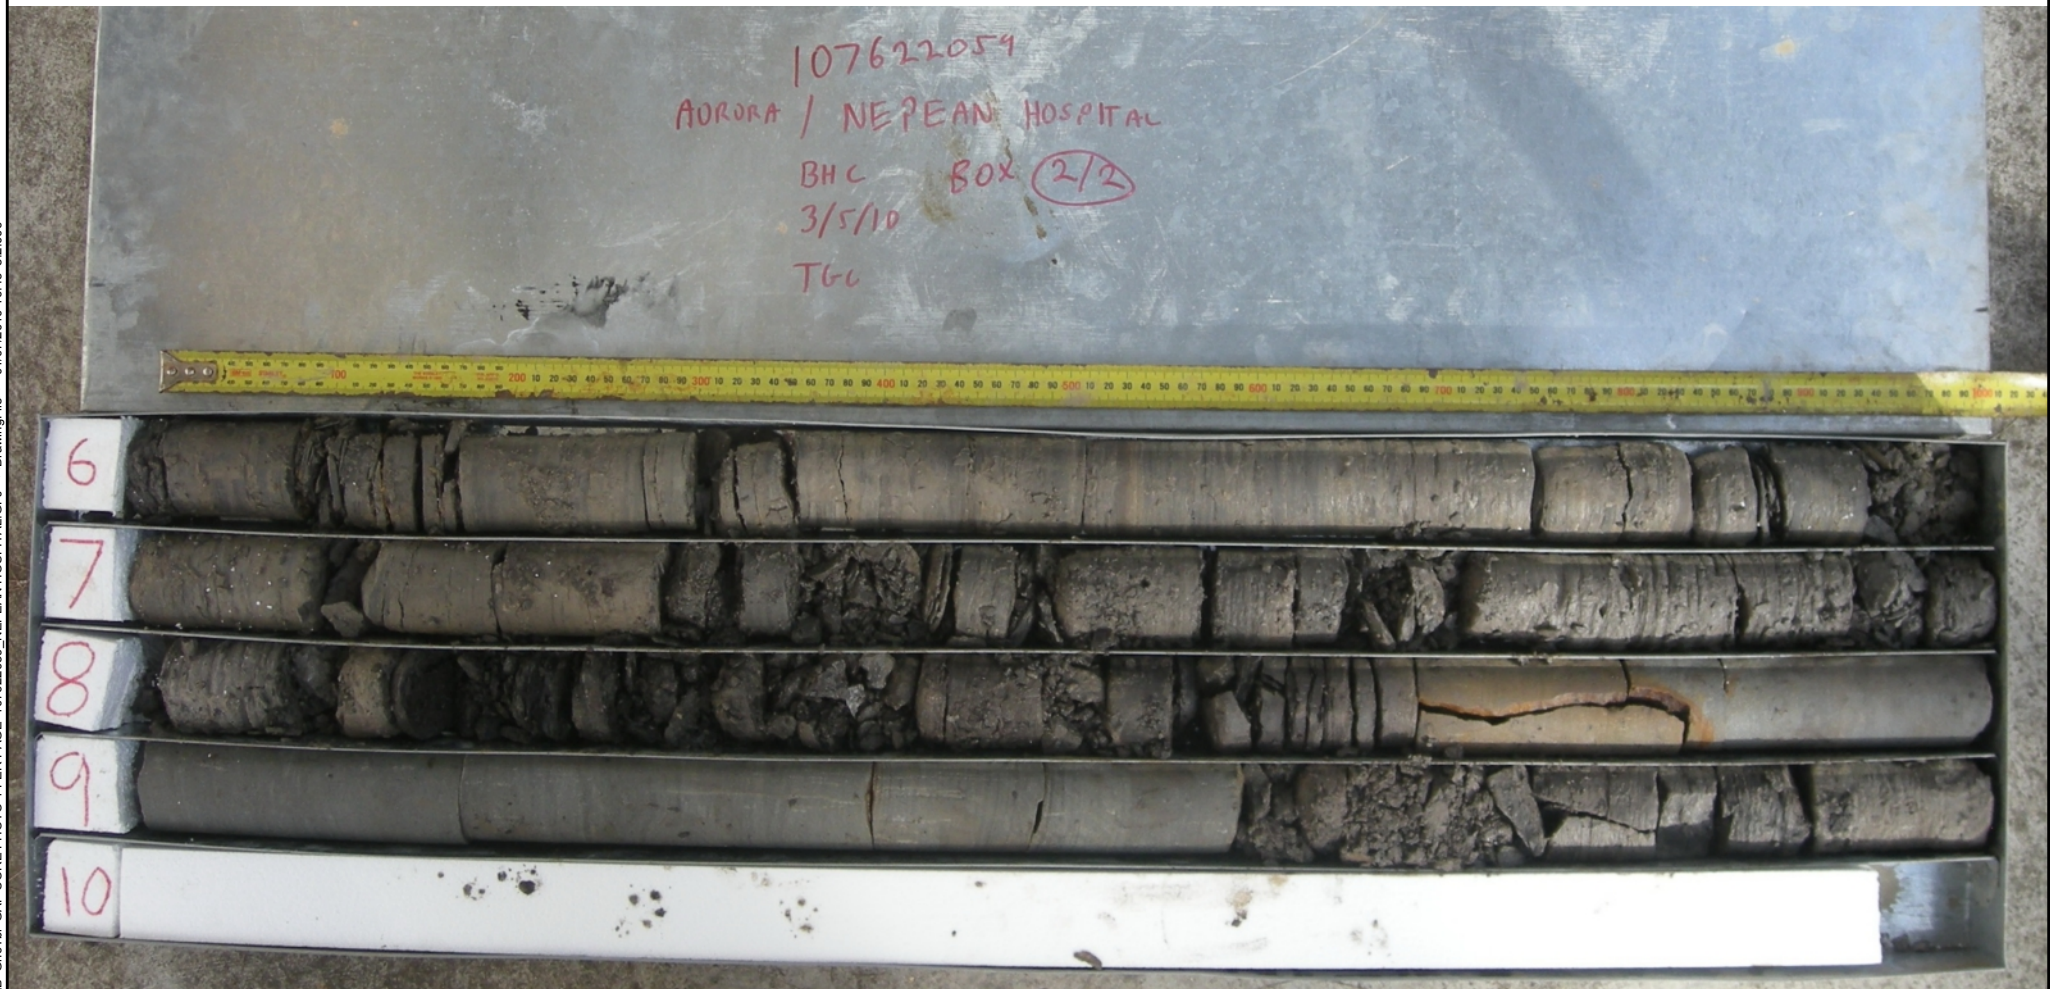
This report of core photographs must be read in conjunction with accompanying notes and abbreviations. It has been prepared for environmental purposes only, without attempt to consider geotechnical properties or the geotechnical significance of the materials encountered. As such it should not be relied upon for geotechnical purposes.

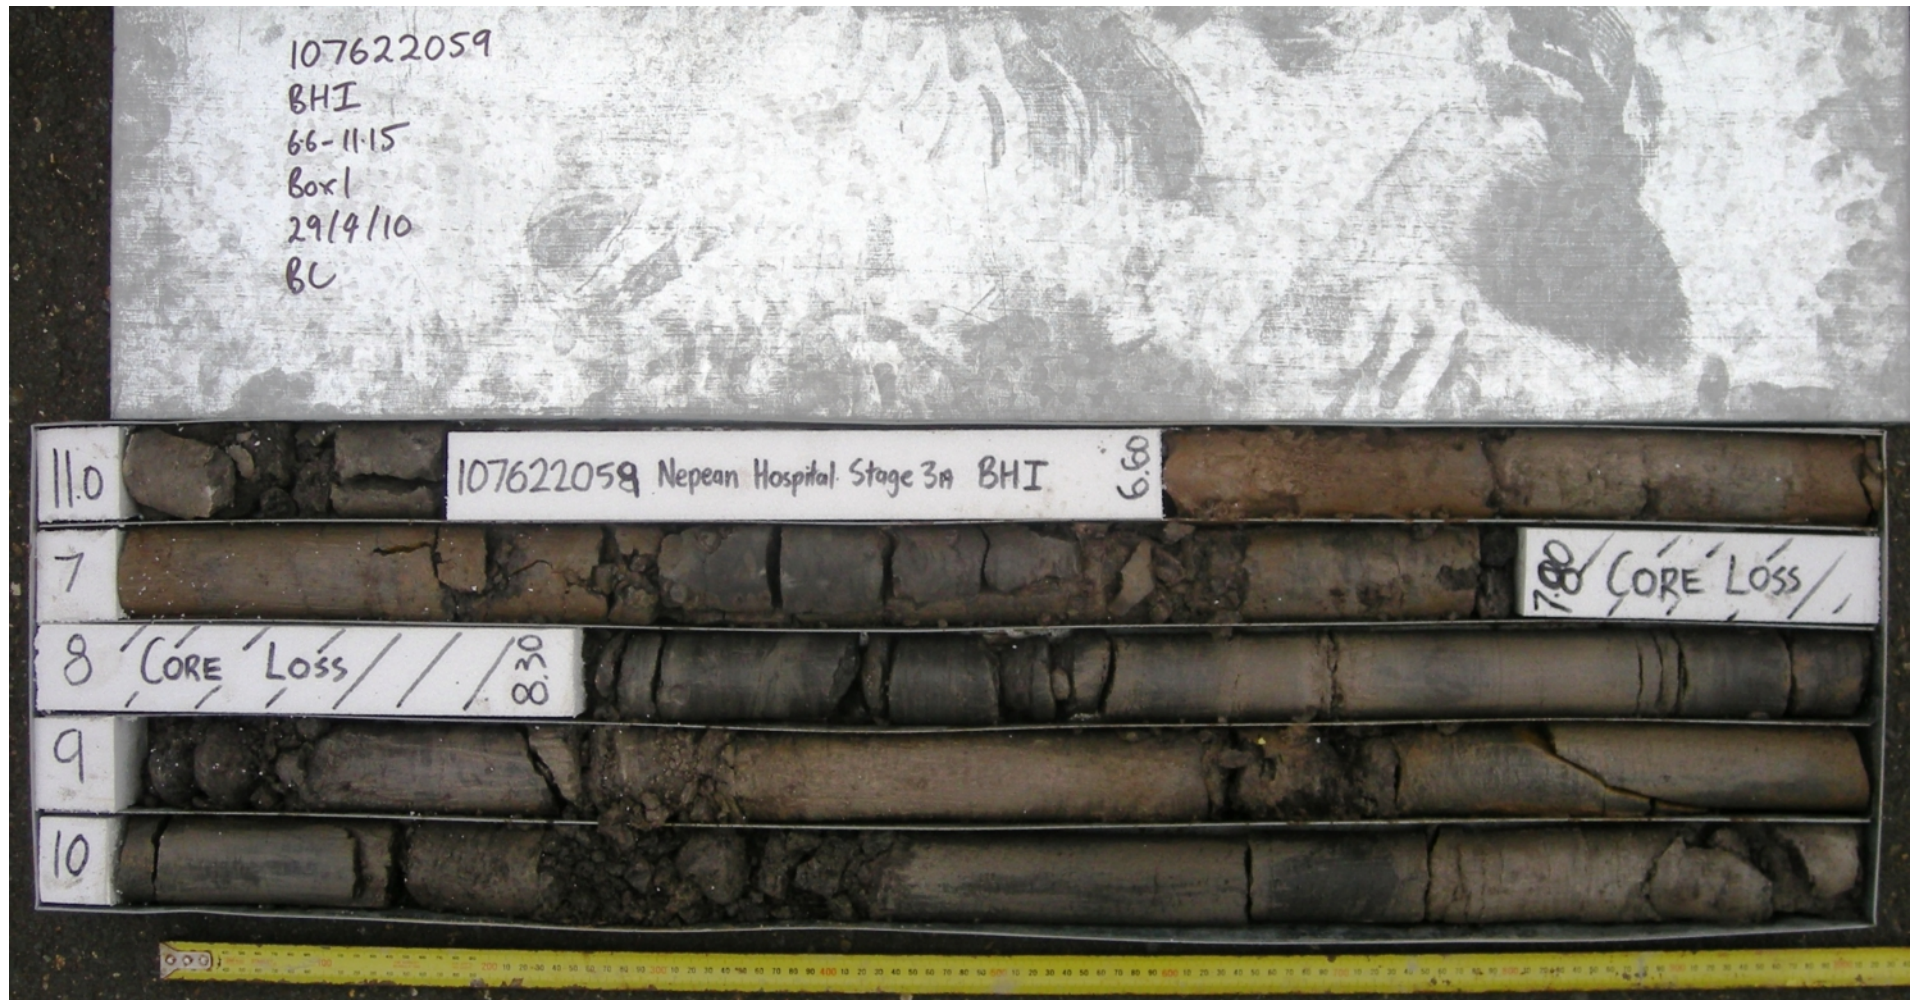
SHEET: 1 OF 1
DRILL RIG: EXplorer
CONTRACTOR: Terratest
LOGGED: BC DATE: 29/4/10
CHECKED: CSC DATE: 26/5/10

COORDS: 288235.0 m E 6262268.0 m N MGA94 56
INCLINATION: -90°
HOLE DEPTH: 11.15 m
