Report on
Preliminary Contamination, Salinity and Acid Sulphate
Soil Assessment

Proposed Spectator Precinct
Royal Randwick Racecourse, Randwick

Prepared for
Australian Jockey Club

Project 71976.01-1
September 2010

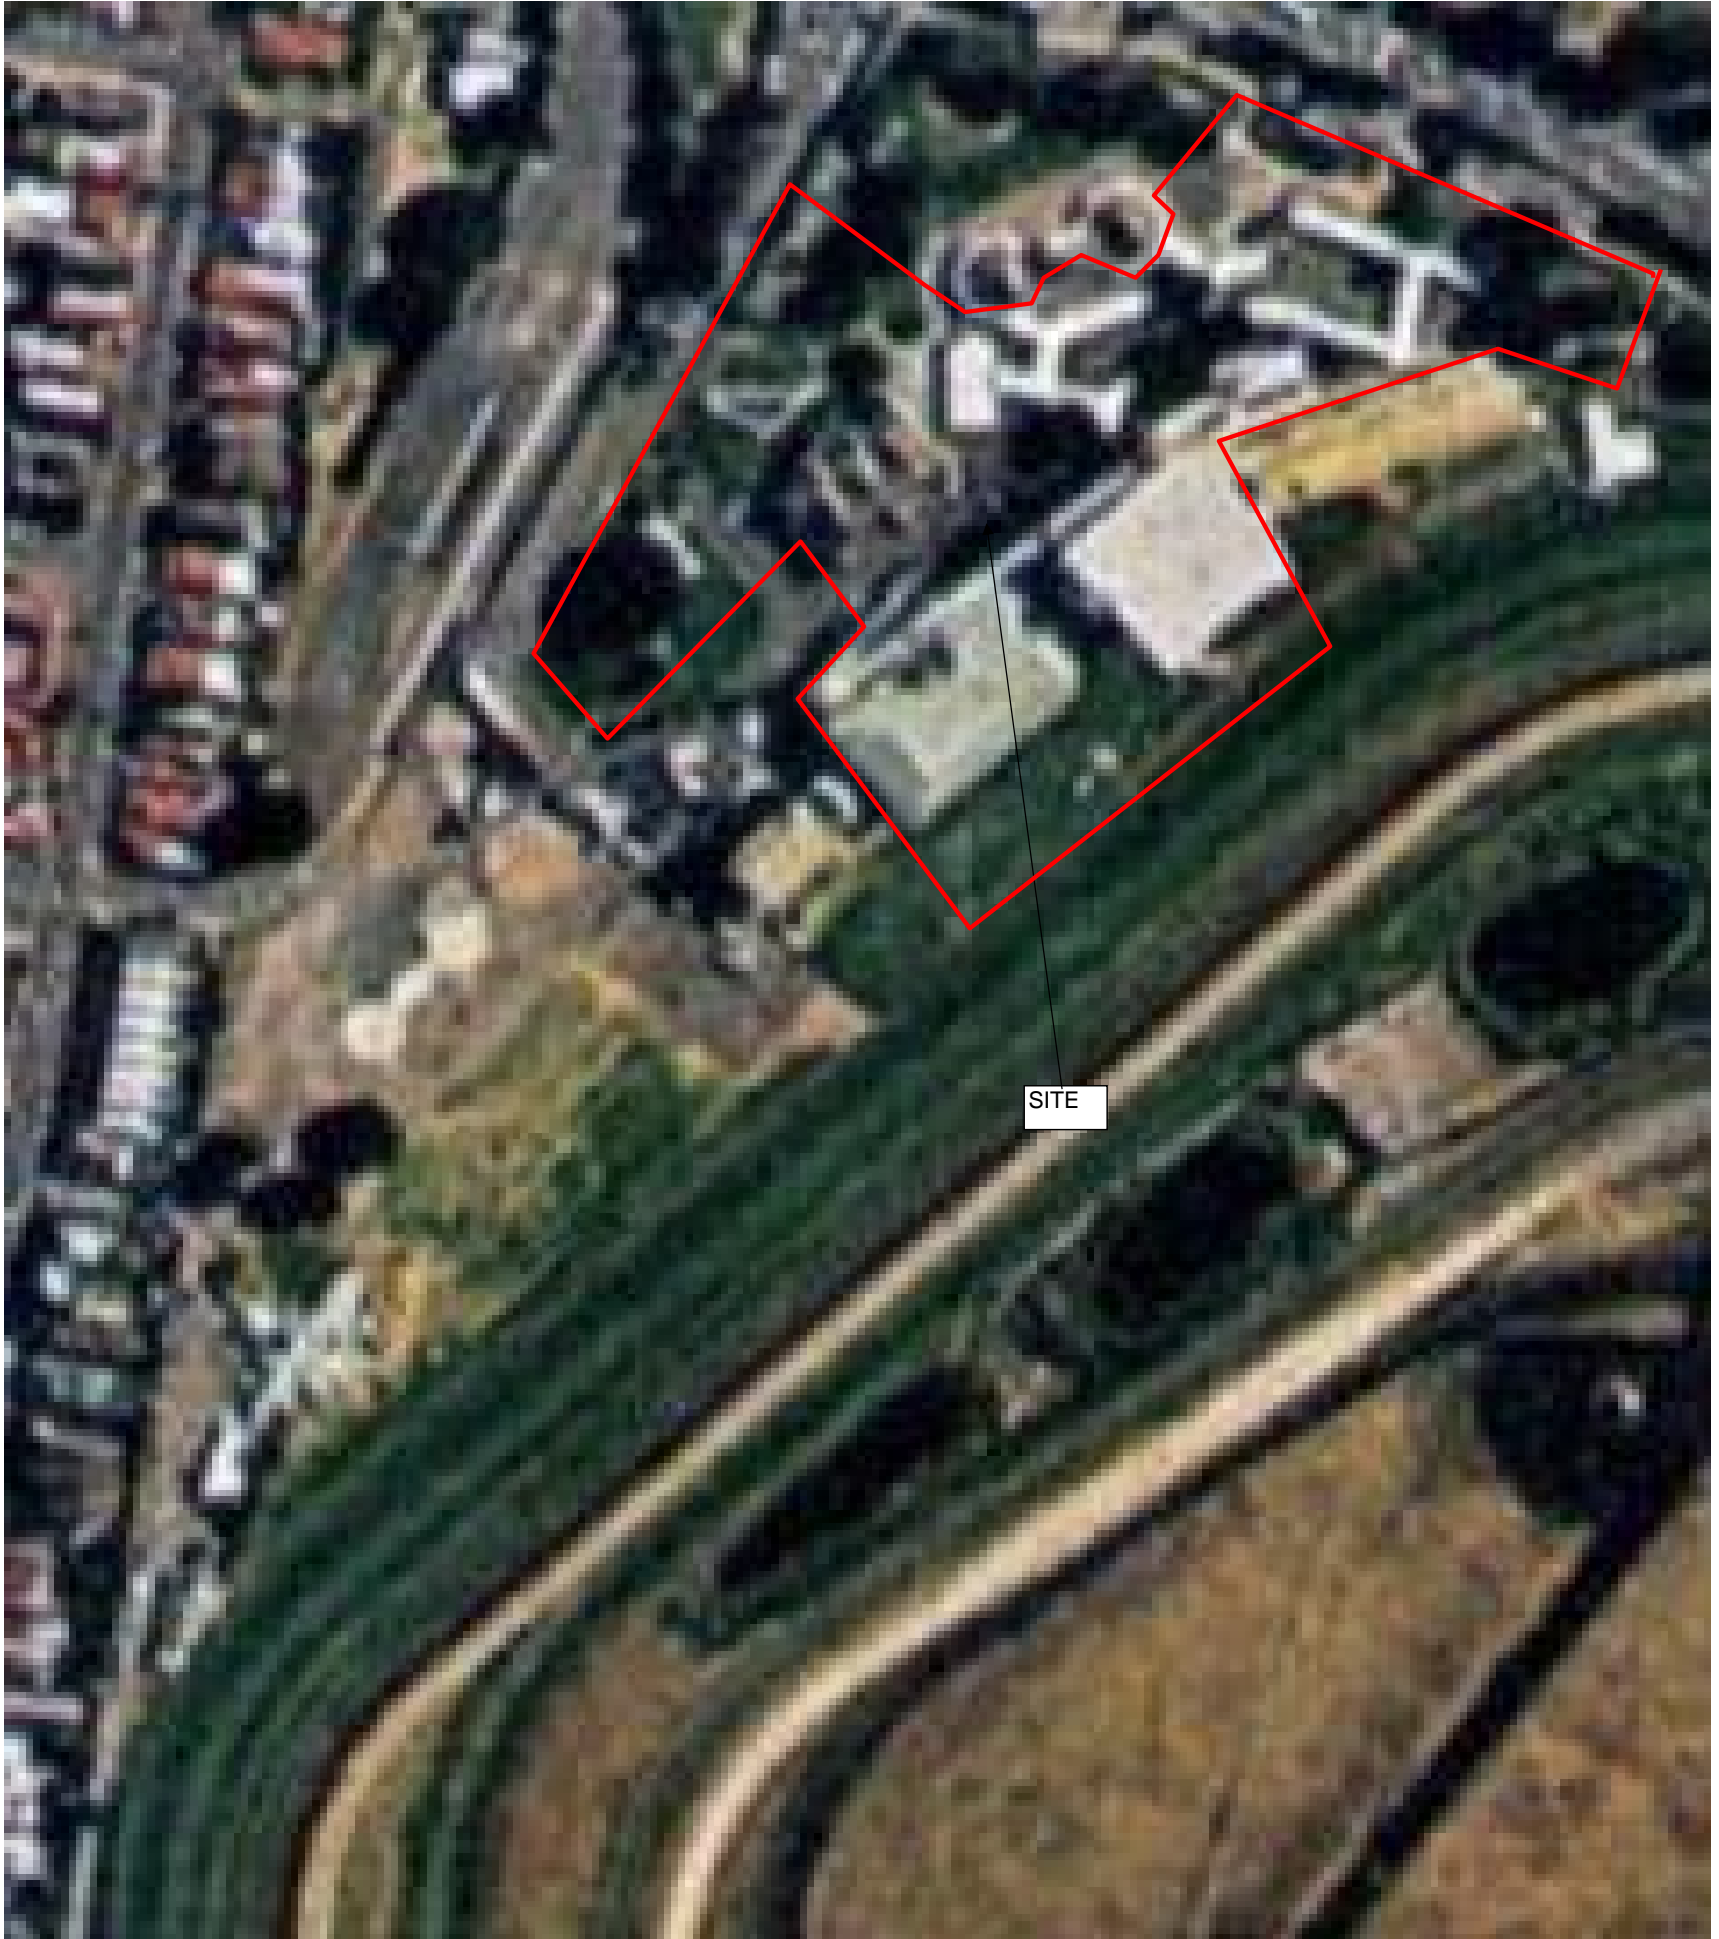
Plate
6
1994 Image

The image is not very clear, however, the site appears to have undergone significant changes when compared to the 1970 image. The stand that was seen in the 1930 image has been replaced by two buildings that resemble the present day Grand Stand and QEII Stand. Further there appears to be rectangular shaped building and a number of paved surfaces in the central and eastern portions of the site.
