VISUAL Impact Assessment

MANILDRA Solar Farm

MANILDRA, NSW

Project No: 0635 Issue: B Date: 13/10/2010

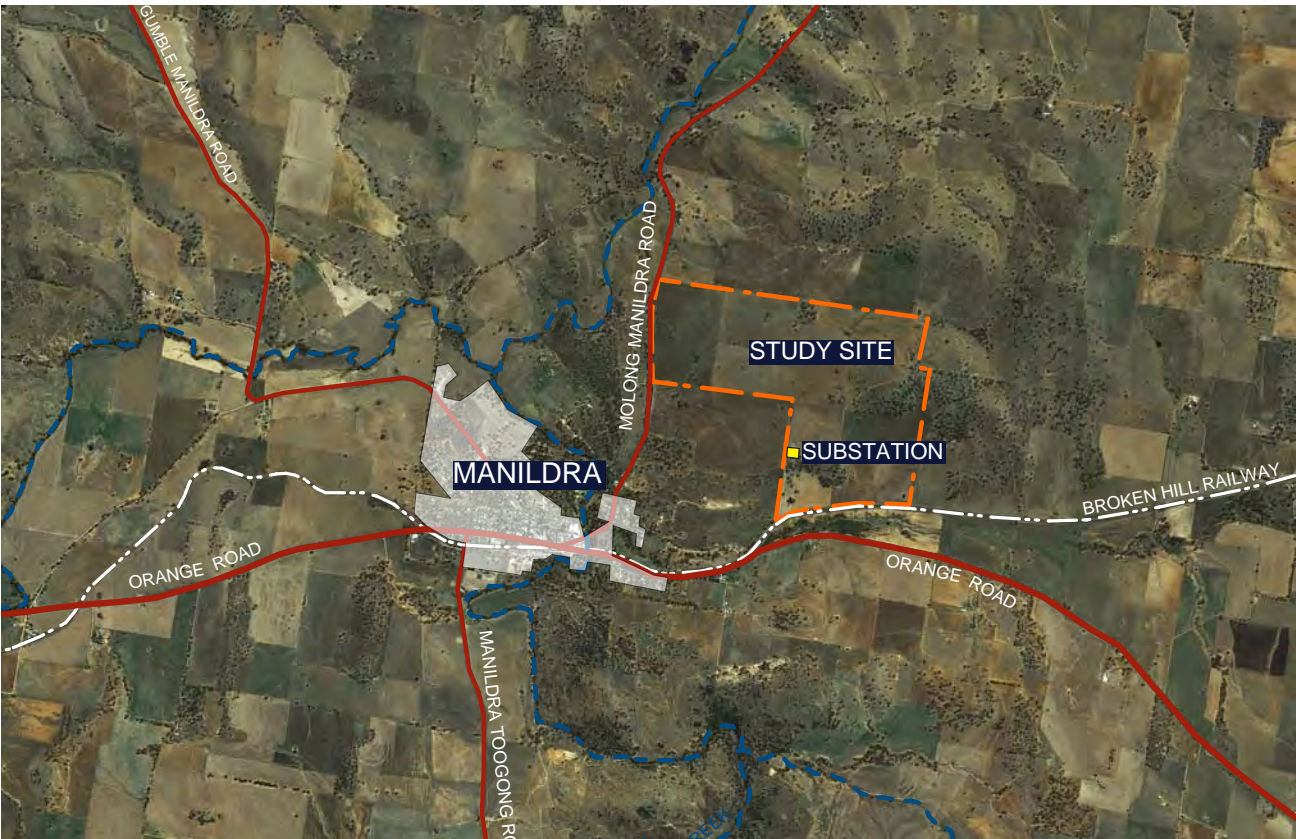
Figure 2: Study Site Location

The Study Site is located on a 180 hectare site adjacent to the Molong Manildra Road, in Manildra within the Cabbone Shire. The subject site is located approximately 1.2km in a north easterly direction from Manildra at its nearest point. The southern edge of the Study Site is defined by the Broken Hill Railway, and the western edge is bordered by the Molong Manildra Road.

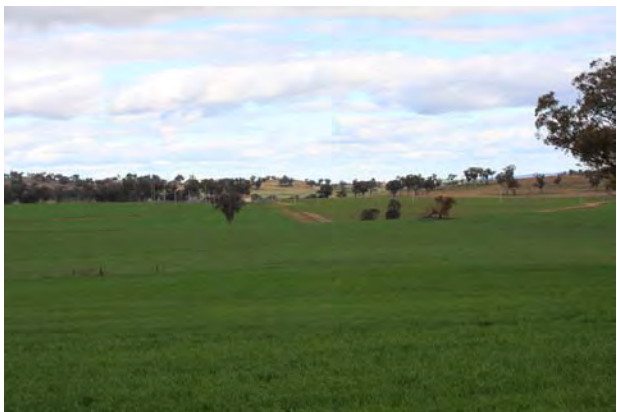
Existing Substation within the landscape.

The Manildra Solar Farm is proposed to connect to the existing Manildra 132kV substation which is immediately adjacent the Study Site.
