STAGE 1 PRELIMINARY SITE INVESTIGATION:
LOT 5 DP 262213, ROPES CREEK EMPLOYMENT PRECINCT, NSW

PREPARED FOR JACFIN PTY LTD

REPORT ID: CES100604-JBA-01-F

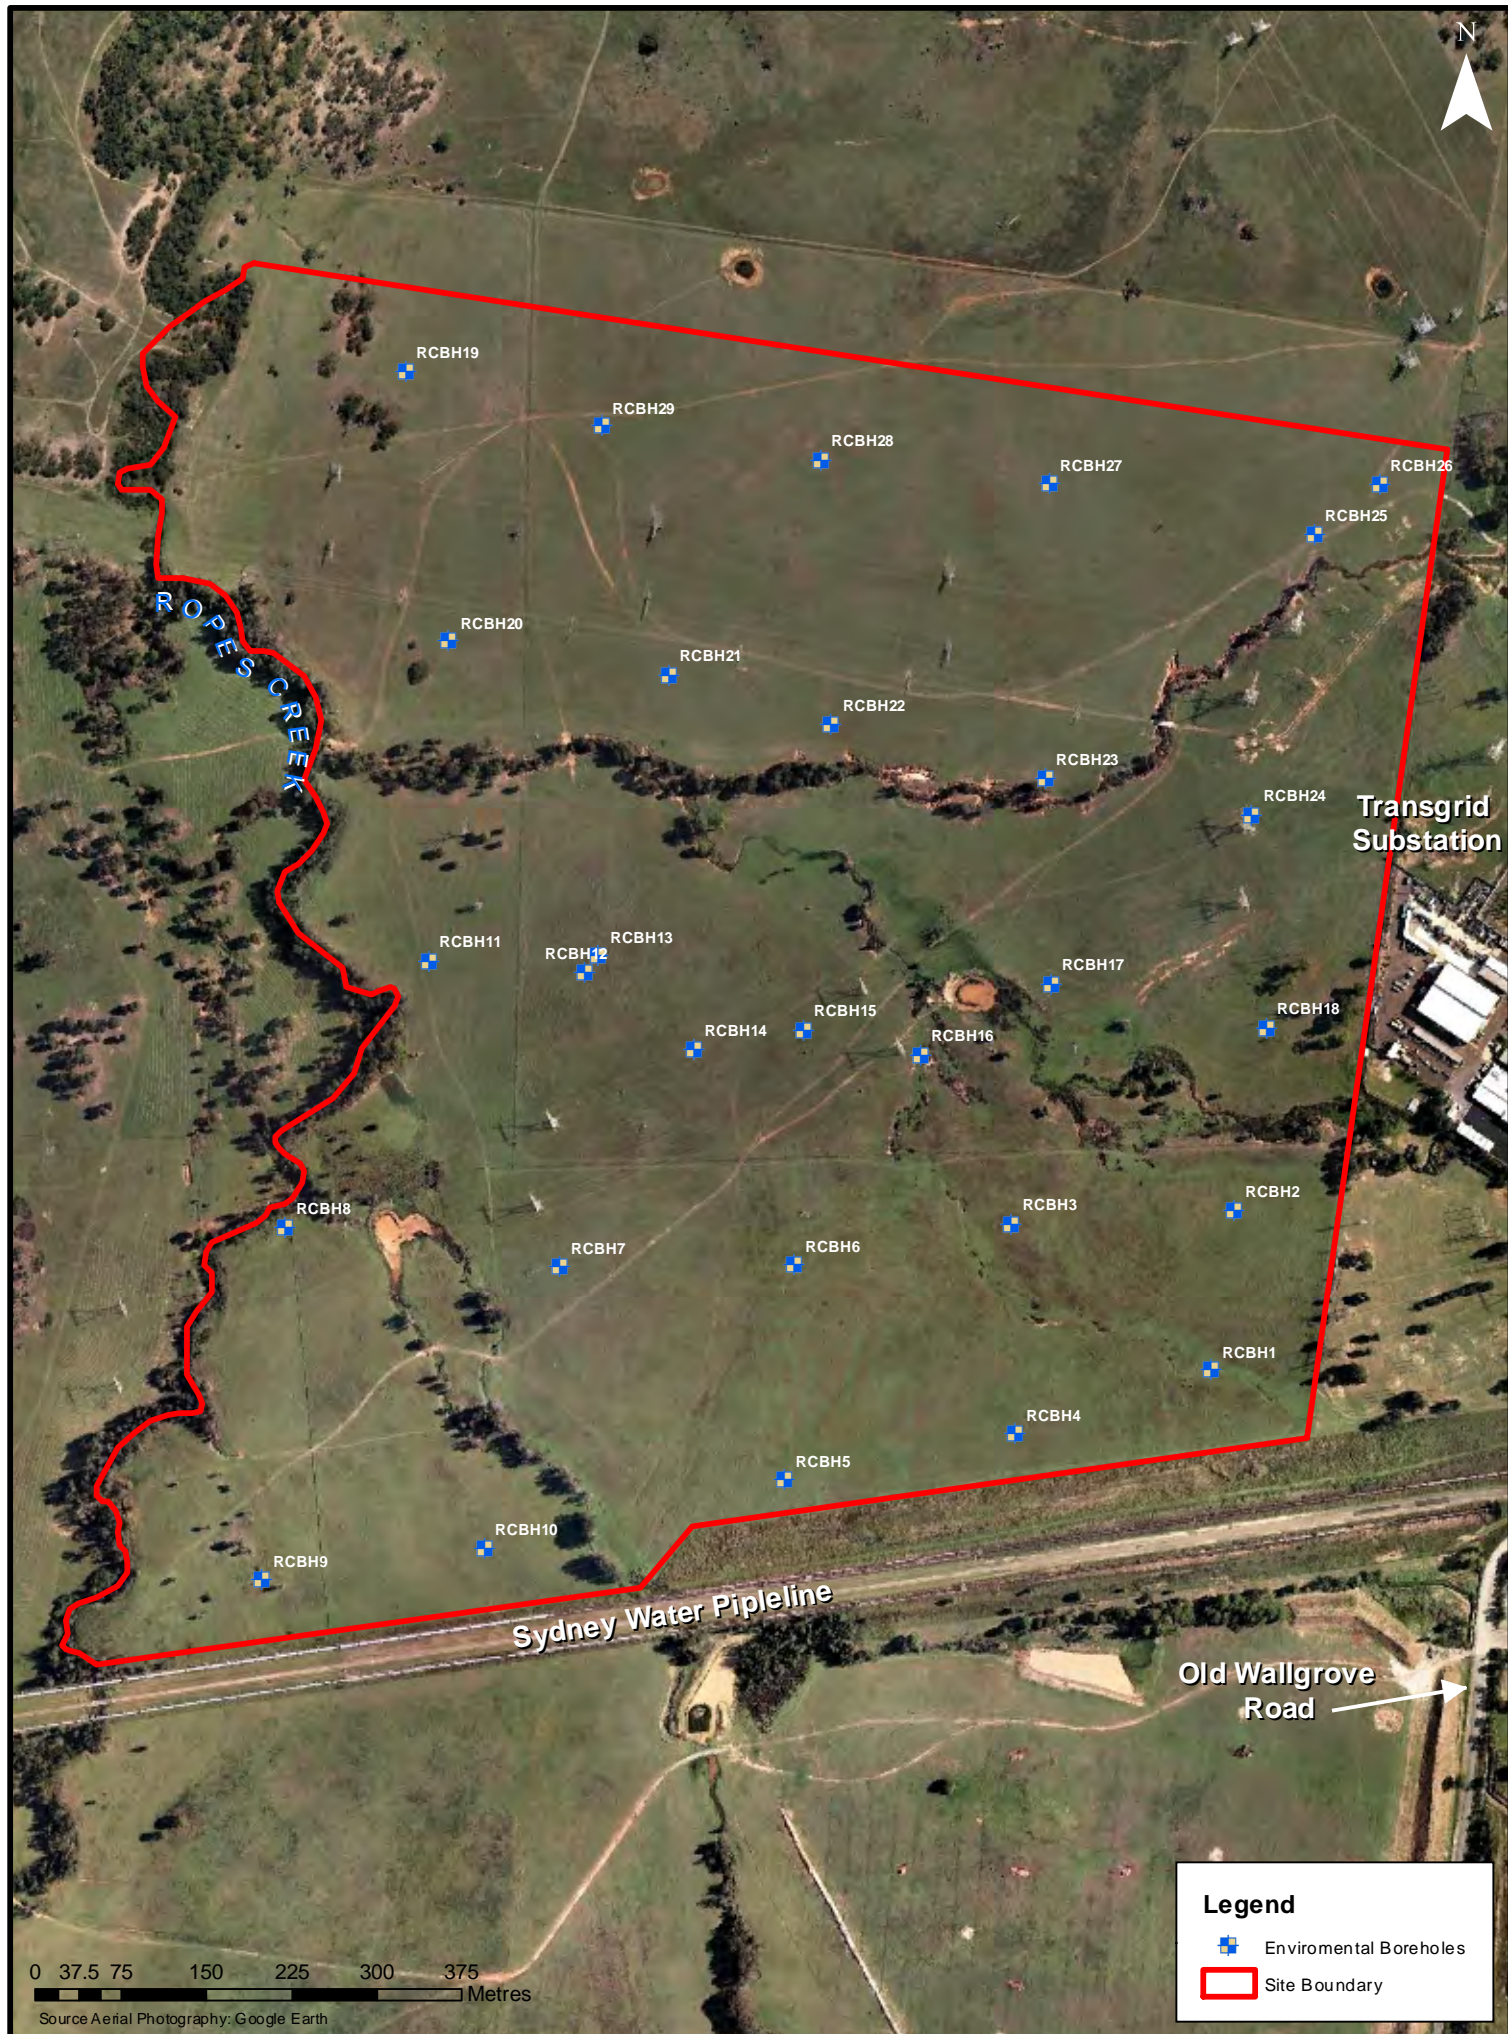
Figure 2: Site Boundary and Sample Locations Ropes Creek Employment Precinct

Although disturbed terrain was noted during the field investigation, there was no sign of significant quantities of imported fill being brought onto the site or any considerable filling activities having taken place on the site. Disturbed terrain was observed at the following locations. Sample locations are presented on Figure 2.
