# **VEGETATION ASSESSMENT**

## **MODIFICATION 3 (OVERHEAD TRANSMISSION LINE) – CAPITAL II CAPITAL WIND FARM SOUTHERN TABLELANDS, NSW**

### **KEVIN MILLS & ASSOCIATES**

**September 2014**

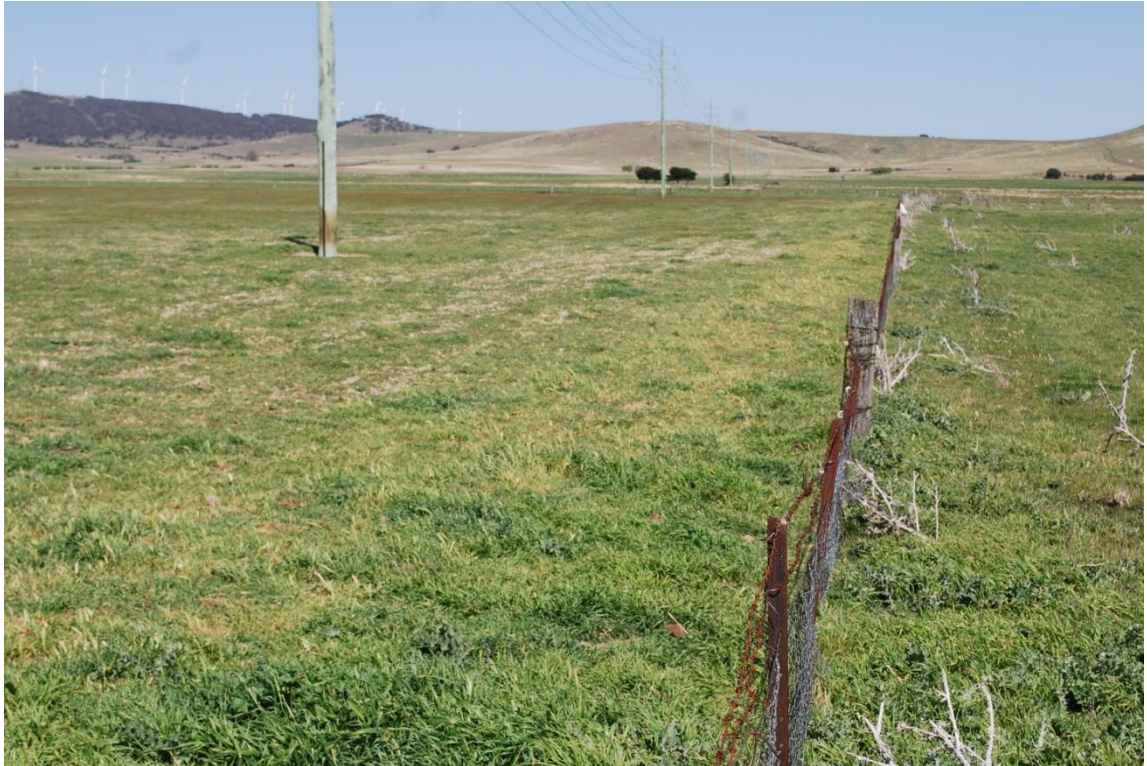
**Photograph 1. View looking south along Survey Section 1.**

0 - 1000 m                      Heavily pasture improved, sown exotic grasses, no natives present, several paddocks crossed. Obvious exotics: Barley Grass *Hordeum* sp., Scotch Thistle *Onopordium acanthium*, Clovers *Trifolium* spp., Rye Grass *Lolium* sp., Sheep Sorell *Acetosella vulgaris*. Photographs in Appendix 2 - 1 and 4.

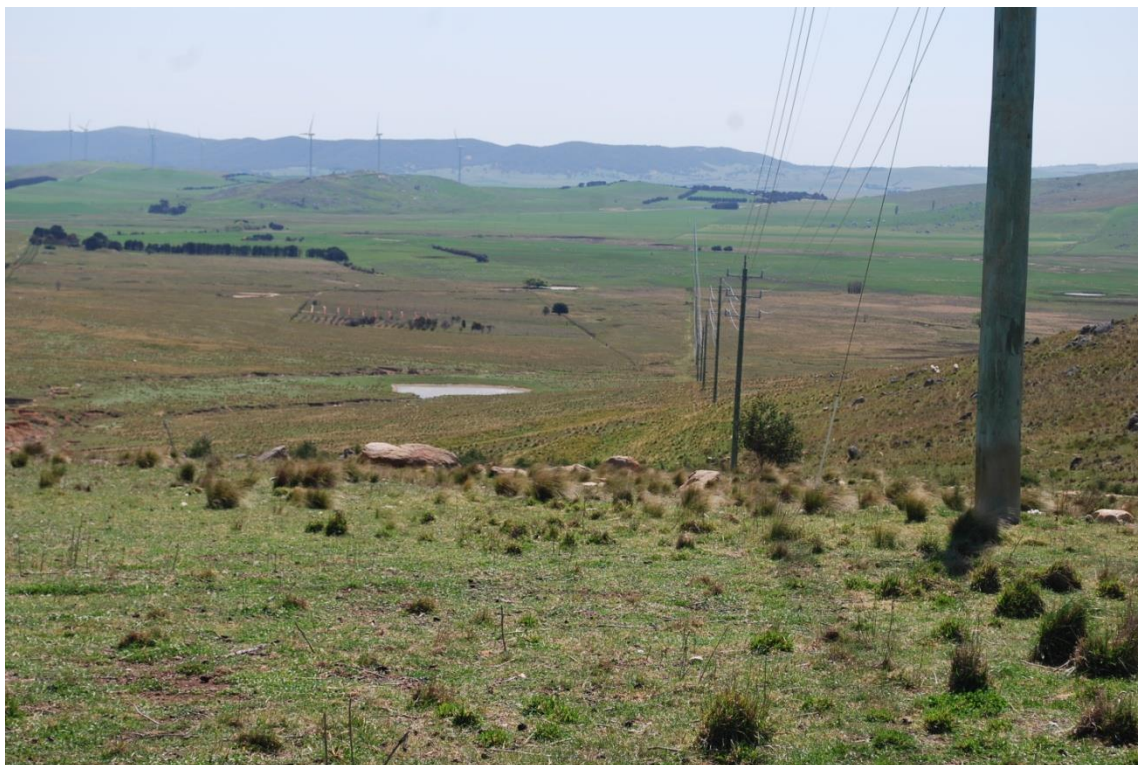
**Photograph 2. View looking north along Survey Section 5**

3350 - 4300 m                      Moderate to steep slopes, mostly exotic grassland, scattered natives and patches of natives in rocky areas (not on line route). Serrated tussock *Nassella trichotoma* common. Natives noted: Spear-grasses *Austrostipa*, Common Everlasting *Chrysocephalum apiculatum*, Austral Sunray *Triptilodiscus pygmaeus*. Some pasture improvement, e.g. Subterranean Clover *Trifolium subterranean*. Photographs in Appendix 2 - 2 and 3.

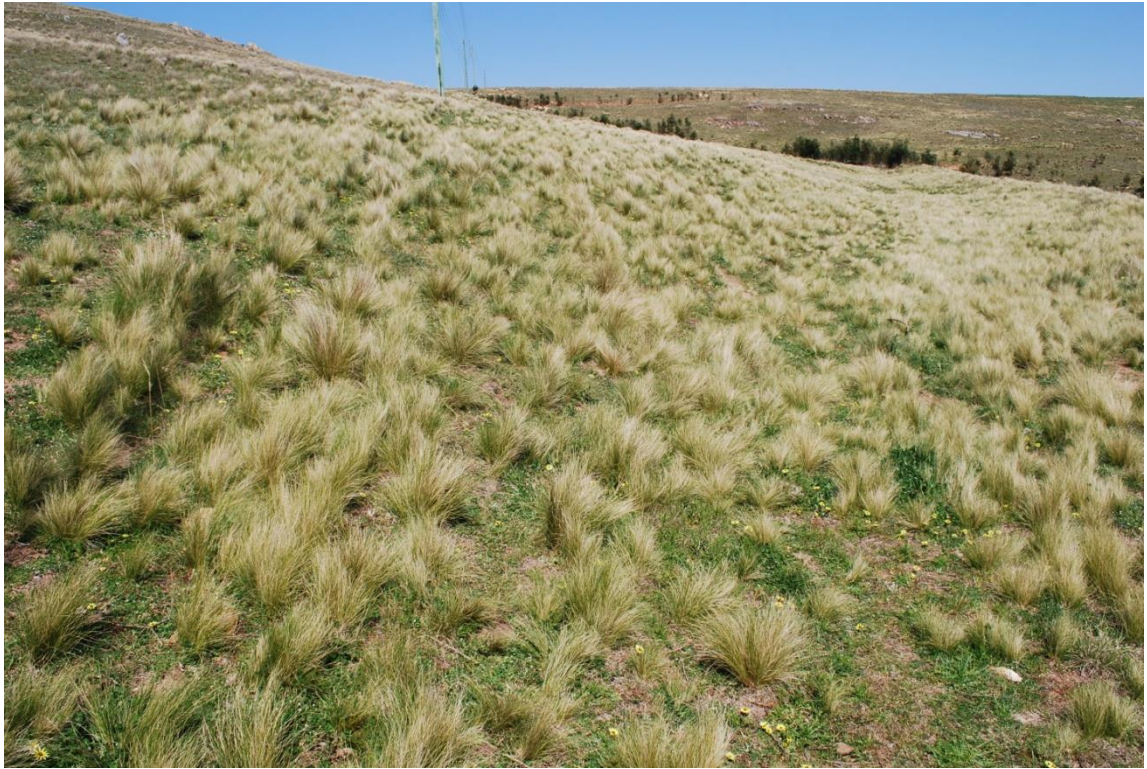
**Photograph 3. Much of Survey Section 5 is invested with Serrated Tussock.**

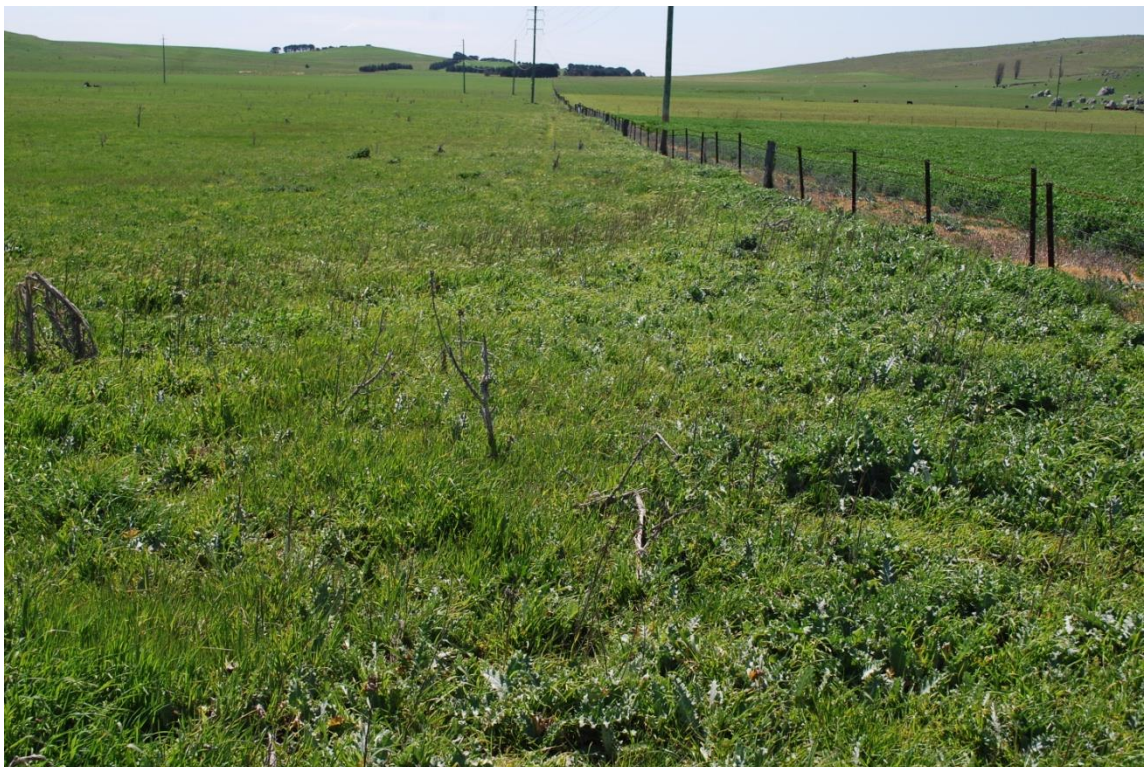
**Photograph 4. Improved pasture, Survey Section 1; this exotic grassland is similar to Survey Section 3.**

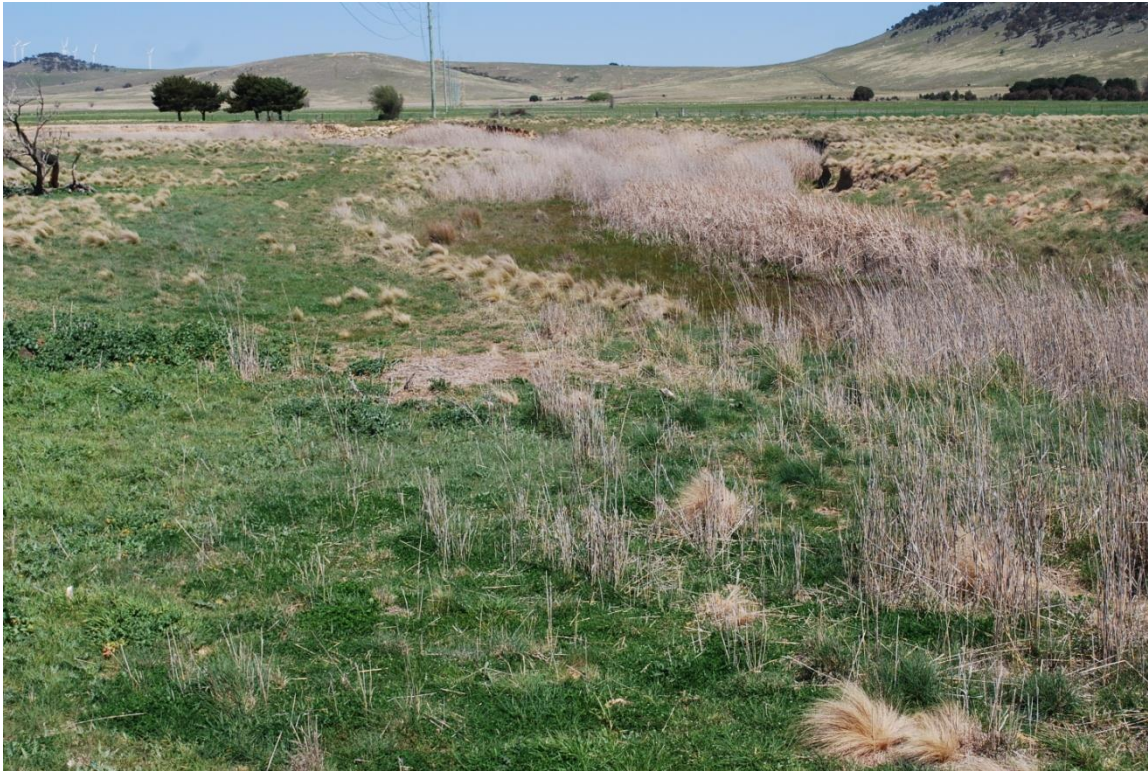
**Photograph 5. Survey Section 2 is across Taylors Creek; the tall grass is the native Common Reed, which is beginning to resprout after winter die-back.**

- the line can be constructed across Taylors Creek without interfering with the creek channel, as was previously done with the existing line.

- works should not be undertaken in very wet weather, as the soils in the local area are highly erosion prone and vehicle movements can easily initiate erosion;
- care is required in constructing the line across Taylors Creek; construction activities should be excluded from the channel area.

1000 - 1300 m                      Taylors Creek crossing, wetland habitat in channel, exotic grassland on banks. Stands of Common Reed *Phragmites australis* and a few other wetland plants in channel. Photograph in Appendix 2 - 5.

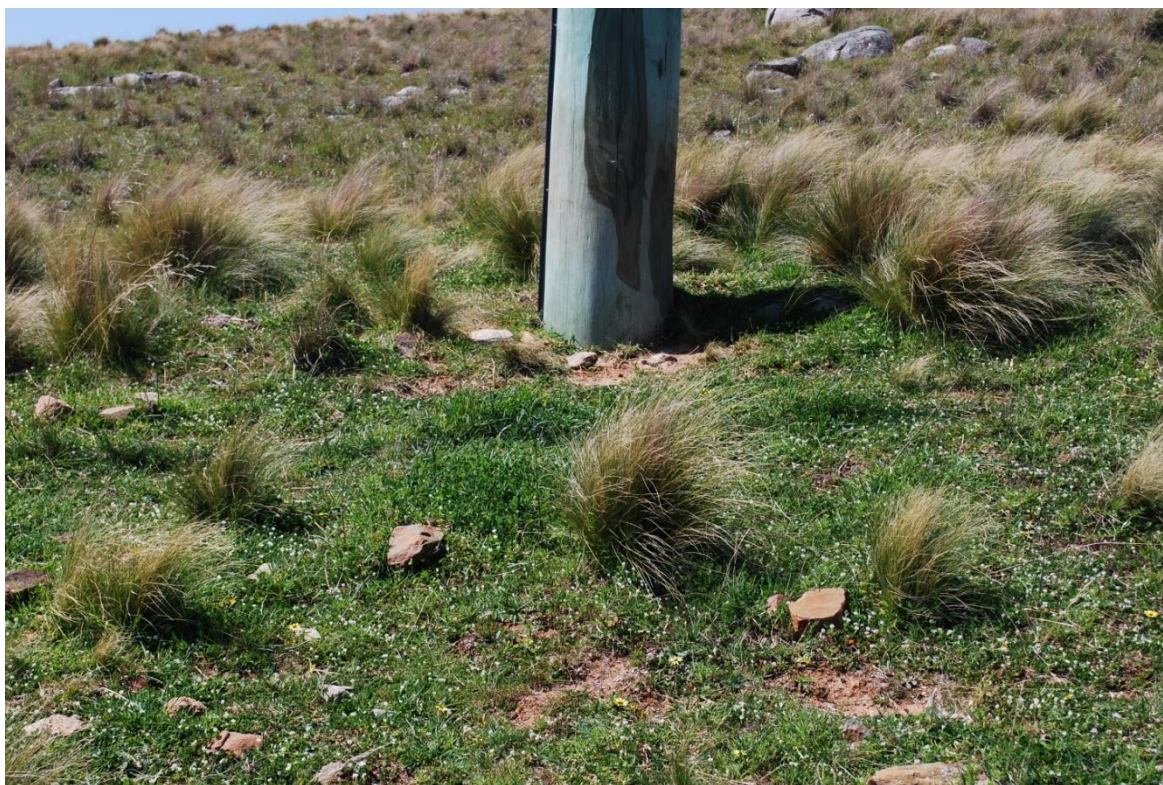
**Photograph 6. A pole on the existing parallel OHL, showing minimal disturbance during pole installation.**

- the route is almost totally exotic grassland and is treeless;
- installation of the poles results in very minor soil disturbance (see Photograph 6 in Appendix 2;
- there is no need to construct a vehicle track to construct the line;
