GEO TECHNIQUE PTY LTD

Job No: 12382/1
Our Ref: 12382/1-AA
15 December 2010

re: **Proposed Development
2 Australia Avenue, Sydney Olympic Park
Geotechnical Investigation**

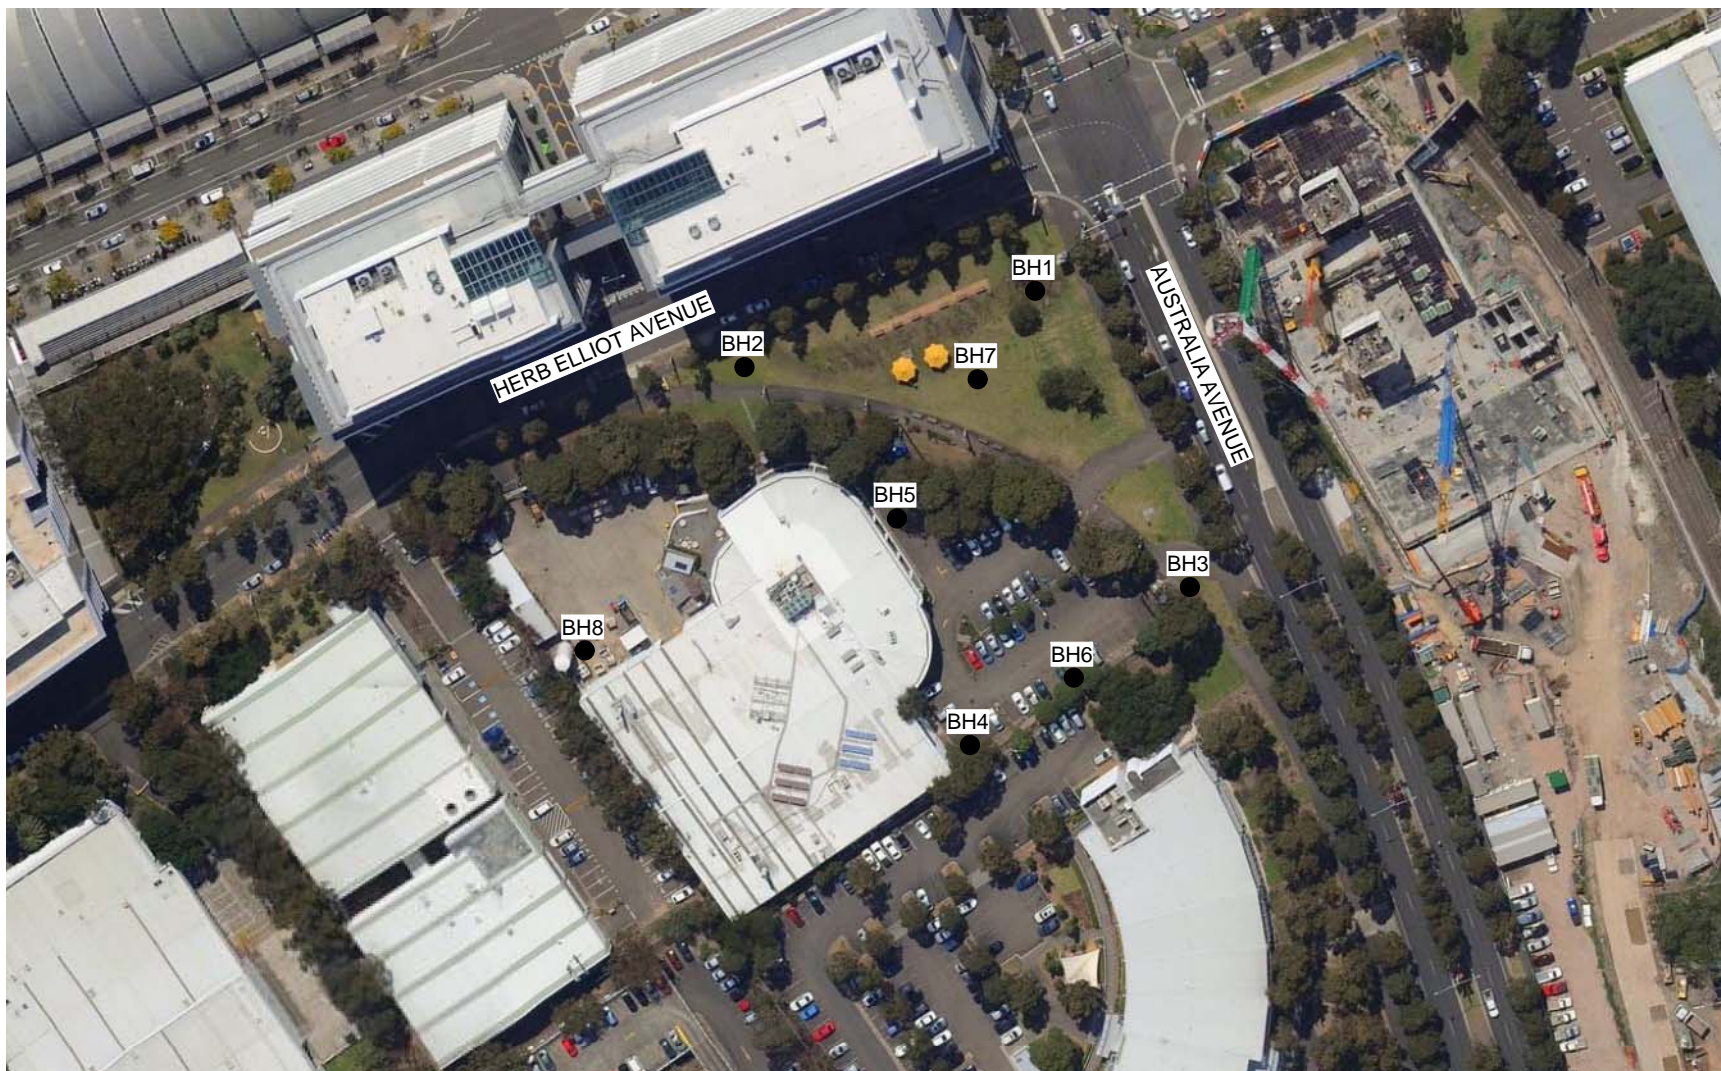
LEGEND

● Borehole

- Drilling eight boreholes (BH1 to BH8) using a truck mounted drilling rig fully equipped for geotechnical investigation. The boreholes were drilled to depths ranging from 5.4m to 12m. The boreholes were initially drilled using V and TC bits to refusal on bedrock and then cored to obtain rock cores (BH1 to BH5 and BH8). Approximate borehole locations are indicated on the attached Drawing No 12382/1-AA1. Engineering borehole logs and cores photographs are also attached.

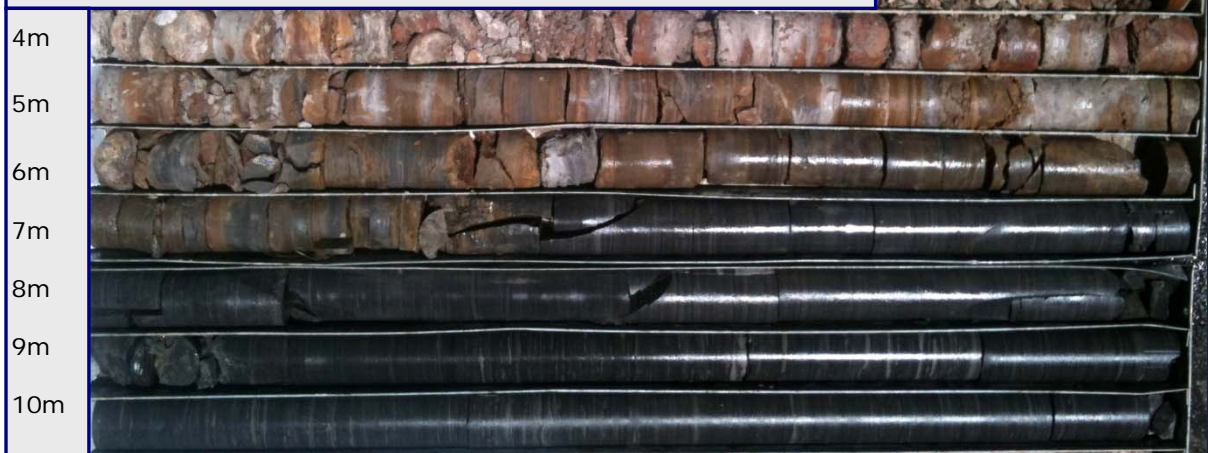
BH2 terminated at 11.0m

Job No 12382/1 BH2 Started Coring at 3.7m

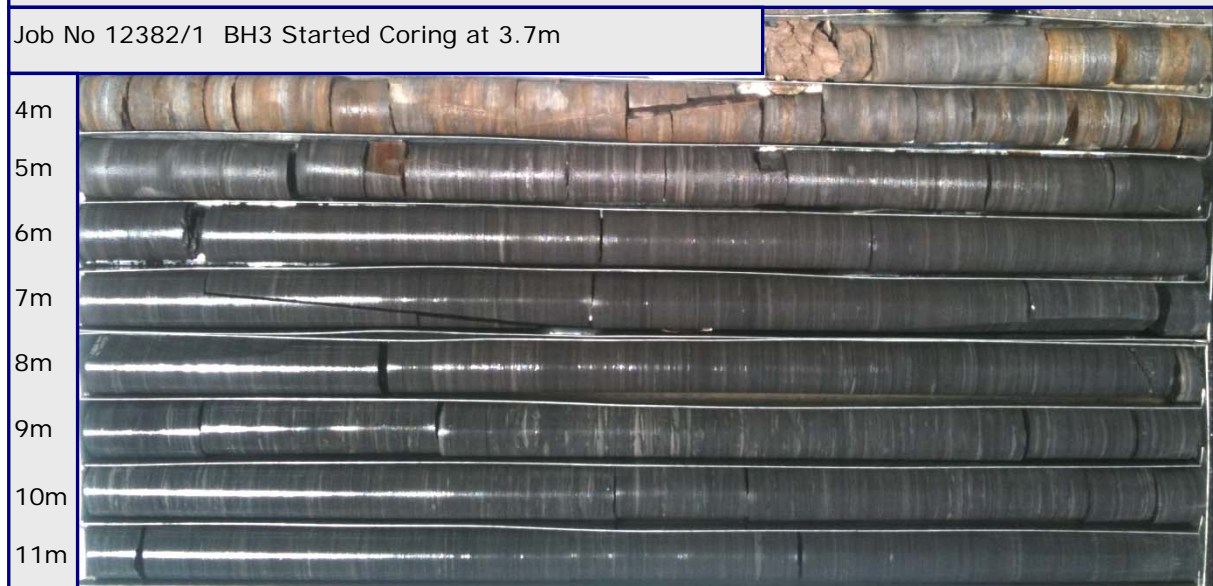
BH3 terminated at 12.0m

Job No 12382/1 BH3 Started Coring at 3.7m

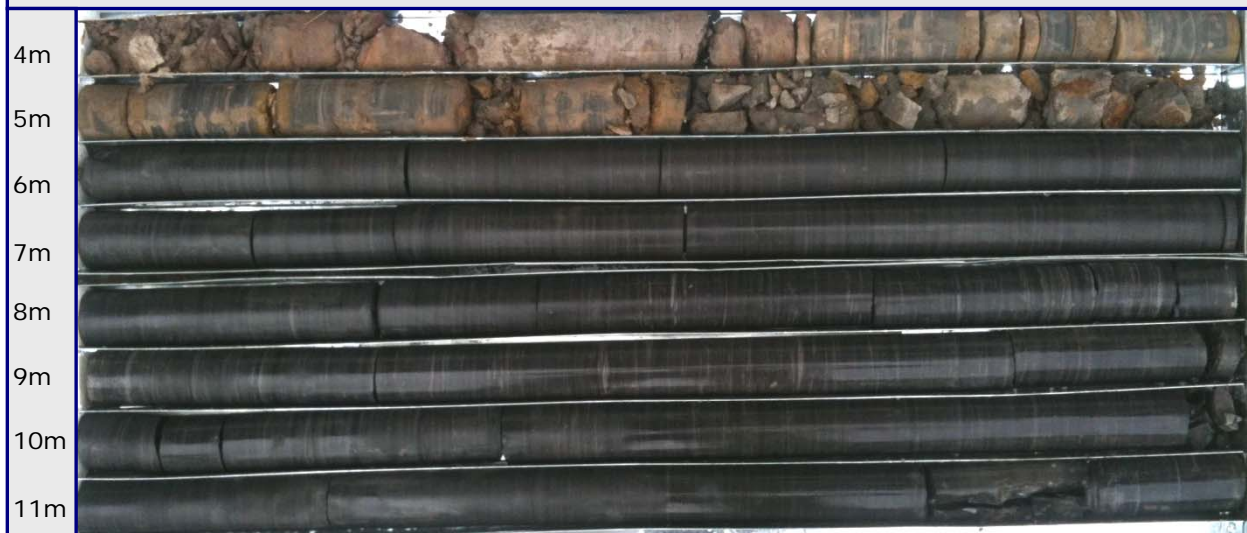
BH8 terminated at 12.0m

Job No 12382/1 BH8 Started Coring at 4.0m
