**Re: Summer Hill Stage 1 – Groundwater Management**

### **PROPOSED MIXED USE DEVELOPMENT**

#### **ALLIED FLOUR MILLS SITE**

### **GEOTECHNICAL INVESTIGATION REPORT**

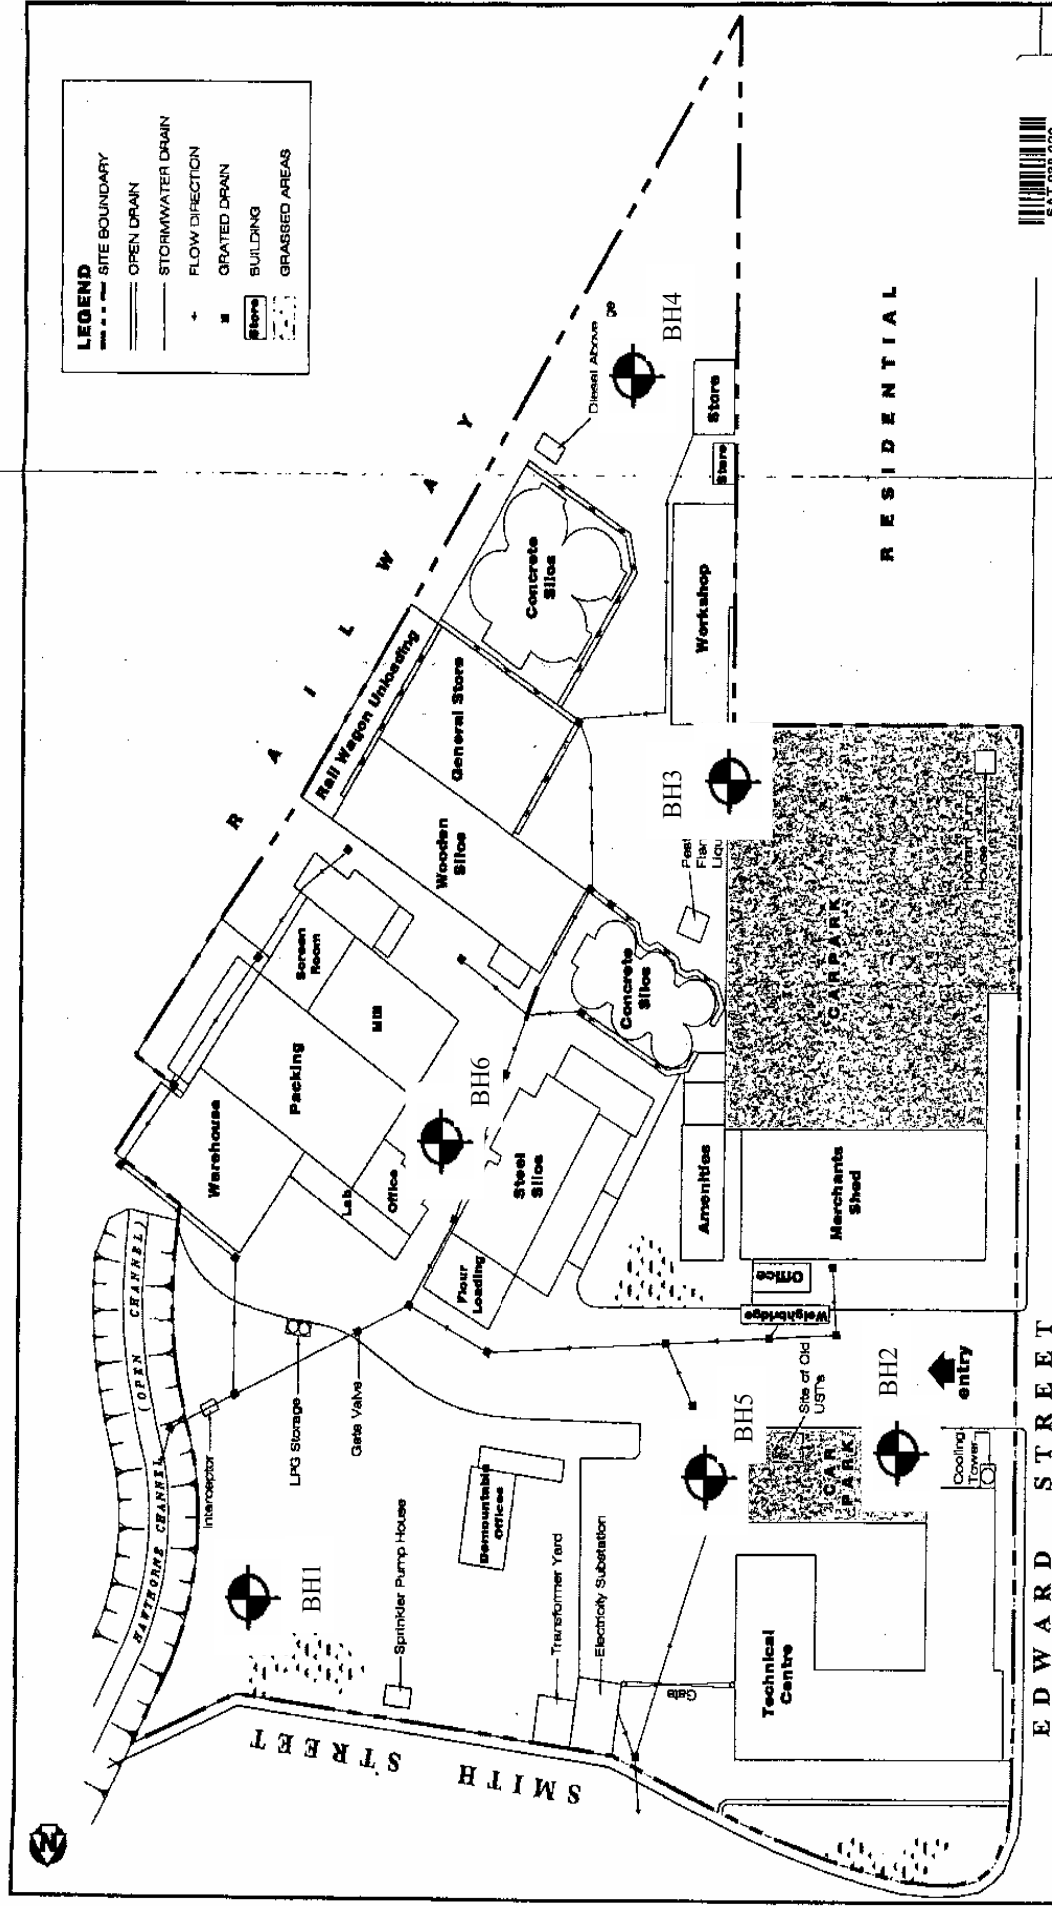
## **APPENDIX D**

The approximate test locations have been shown on the site sketch referenced Drawing No. S07146-1.in Appendix D.

A borehole plan and site plan indicates that the only location where groundwater was found was at Borehole location 6. The site plans indicate that the Stage 1 area where BH1, BH2 and BH5 are located has a proposed single level basement. This basement level is founded at a depth of at most 3m below ground surface with an average of 2.5m (plans attached). As the basement excavation does not intersect any groundwater and in the absence of groundwater shown from the logs taken, a detailed groundwater assessment would not be warranted as the groundwater would not be disturbed during site works or foundation works. It should be noted that the closest location where groundwater was found is at location BH6. The depth of groundwater was found at 3.9m and it is considered that this is rather water seepage as a perched water layer on top of the sandstone bedrock formation.
