Site Audit Report

0503-1410

Bank Street
Pyrmont, NSW

28 April 2015
50429-100373
JBS&G Australia Pty Ltd

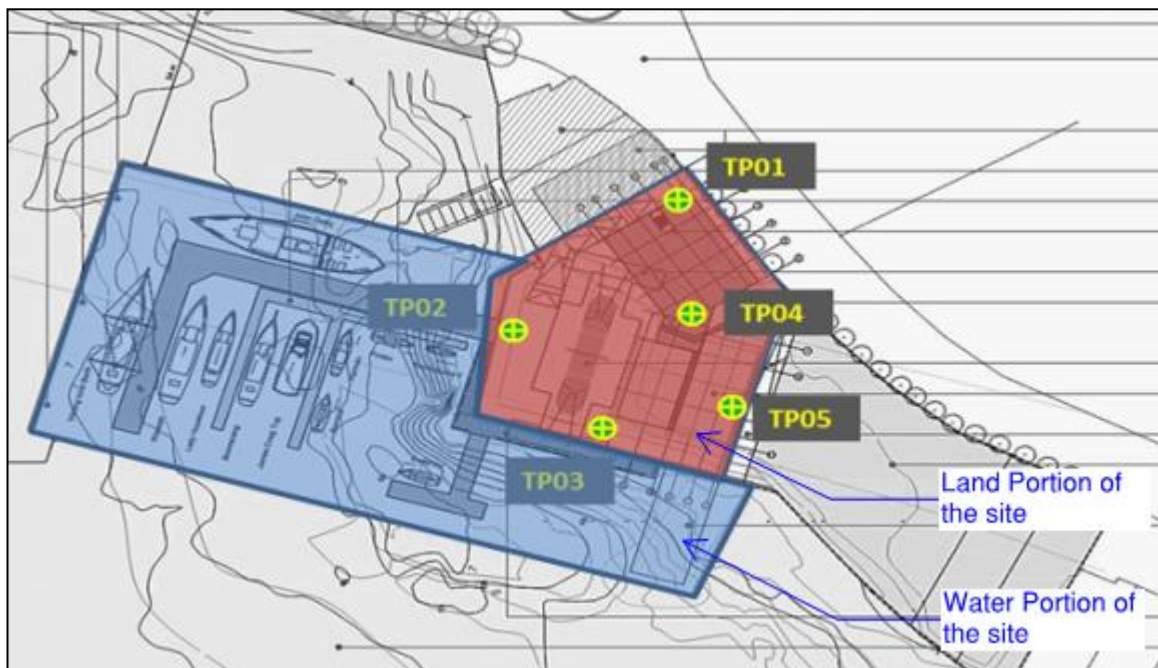
Figure 2 Site Layout and Test Pit Locations

Modified from Crawford Architects Drawing SK10-F Master plan

The locality of the site is presented in **Figure 1**. A site layout plan is presented in **Figure 2**.
