**Barangaroo South - C3
Commercial Building**

**Geotechnical Report - Project
Application**

Rev C | 26 October 2011

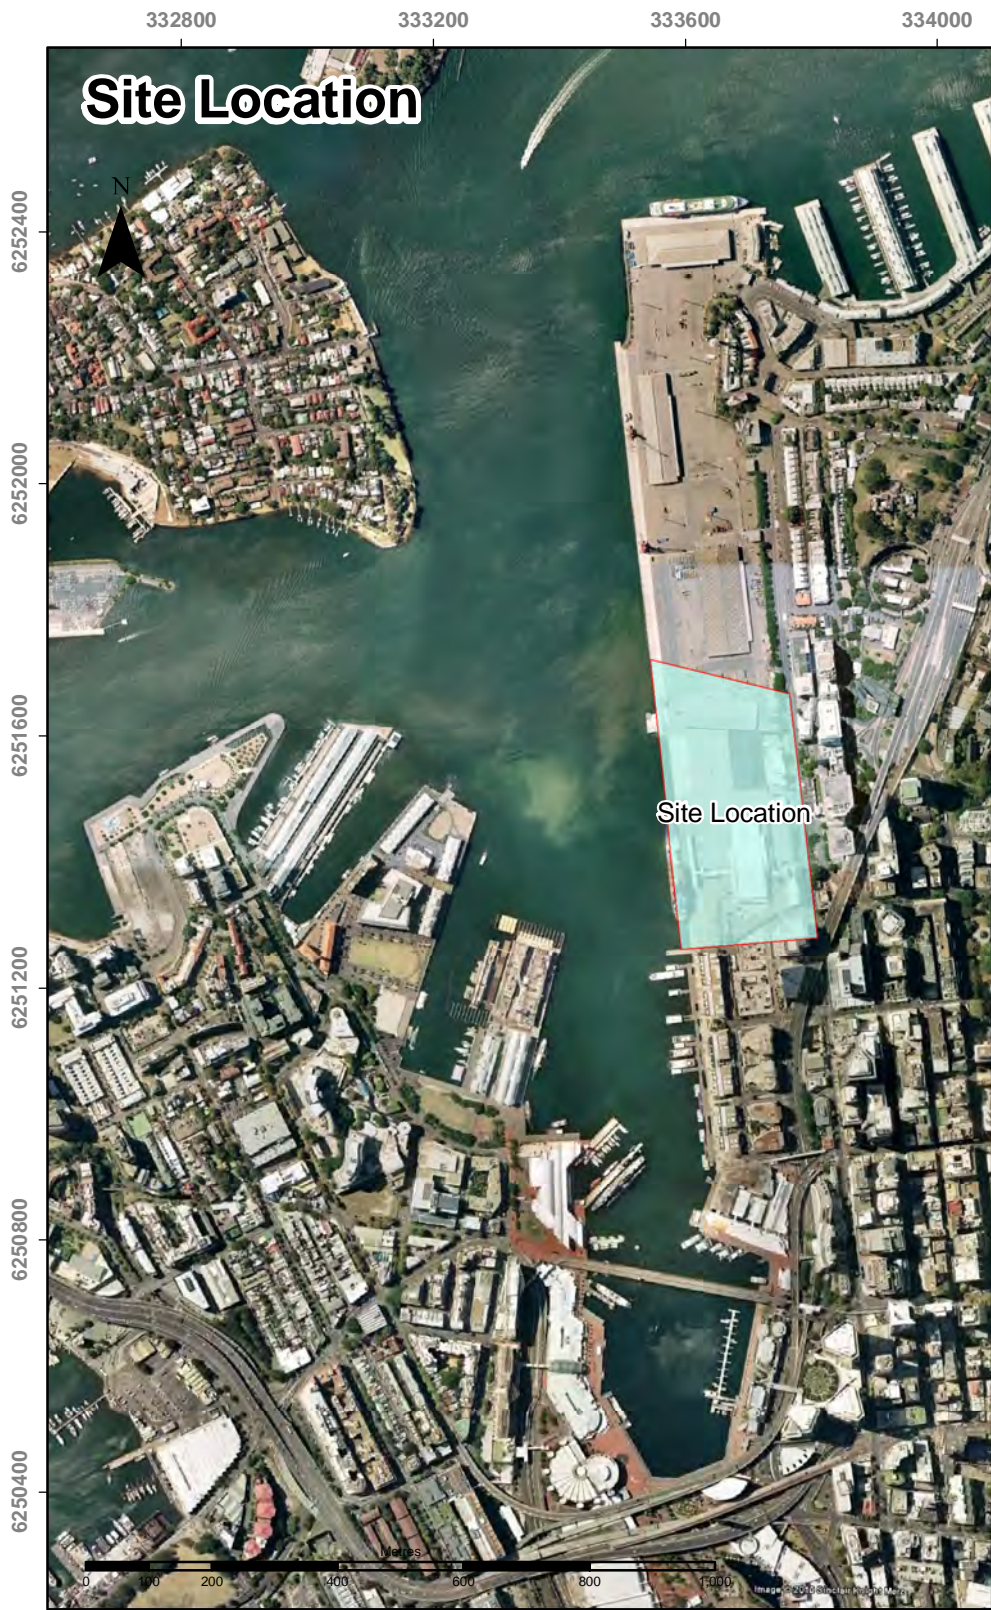
Drawing No
Figure 2

The area of land within which development is proposed under this Project Application is shown in Figure 2. The Project Application Site extends over land generally known and identified in the approved Concept Plan as Block 3 which comprises Lot 5 in DP 876514.

For the purpose of reference, a general arrangement of the proposed building is illustrated in Figure 2.

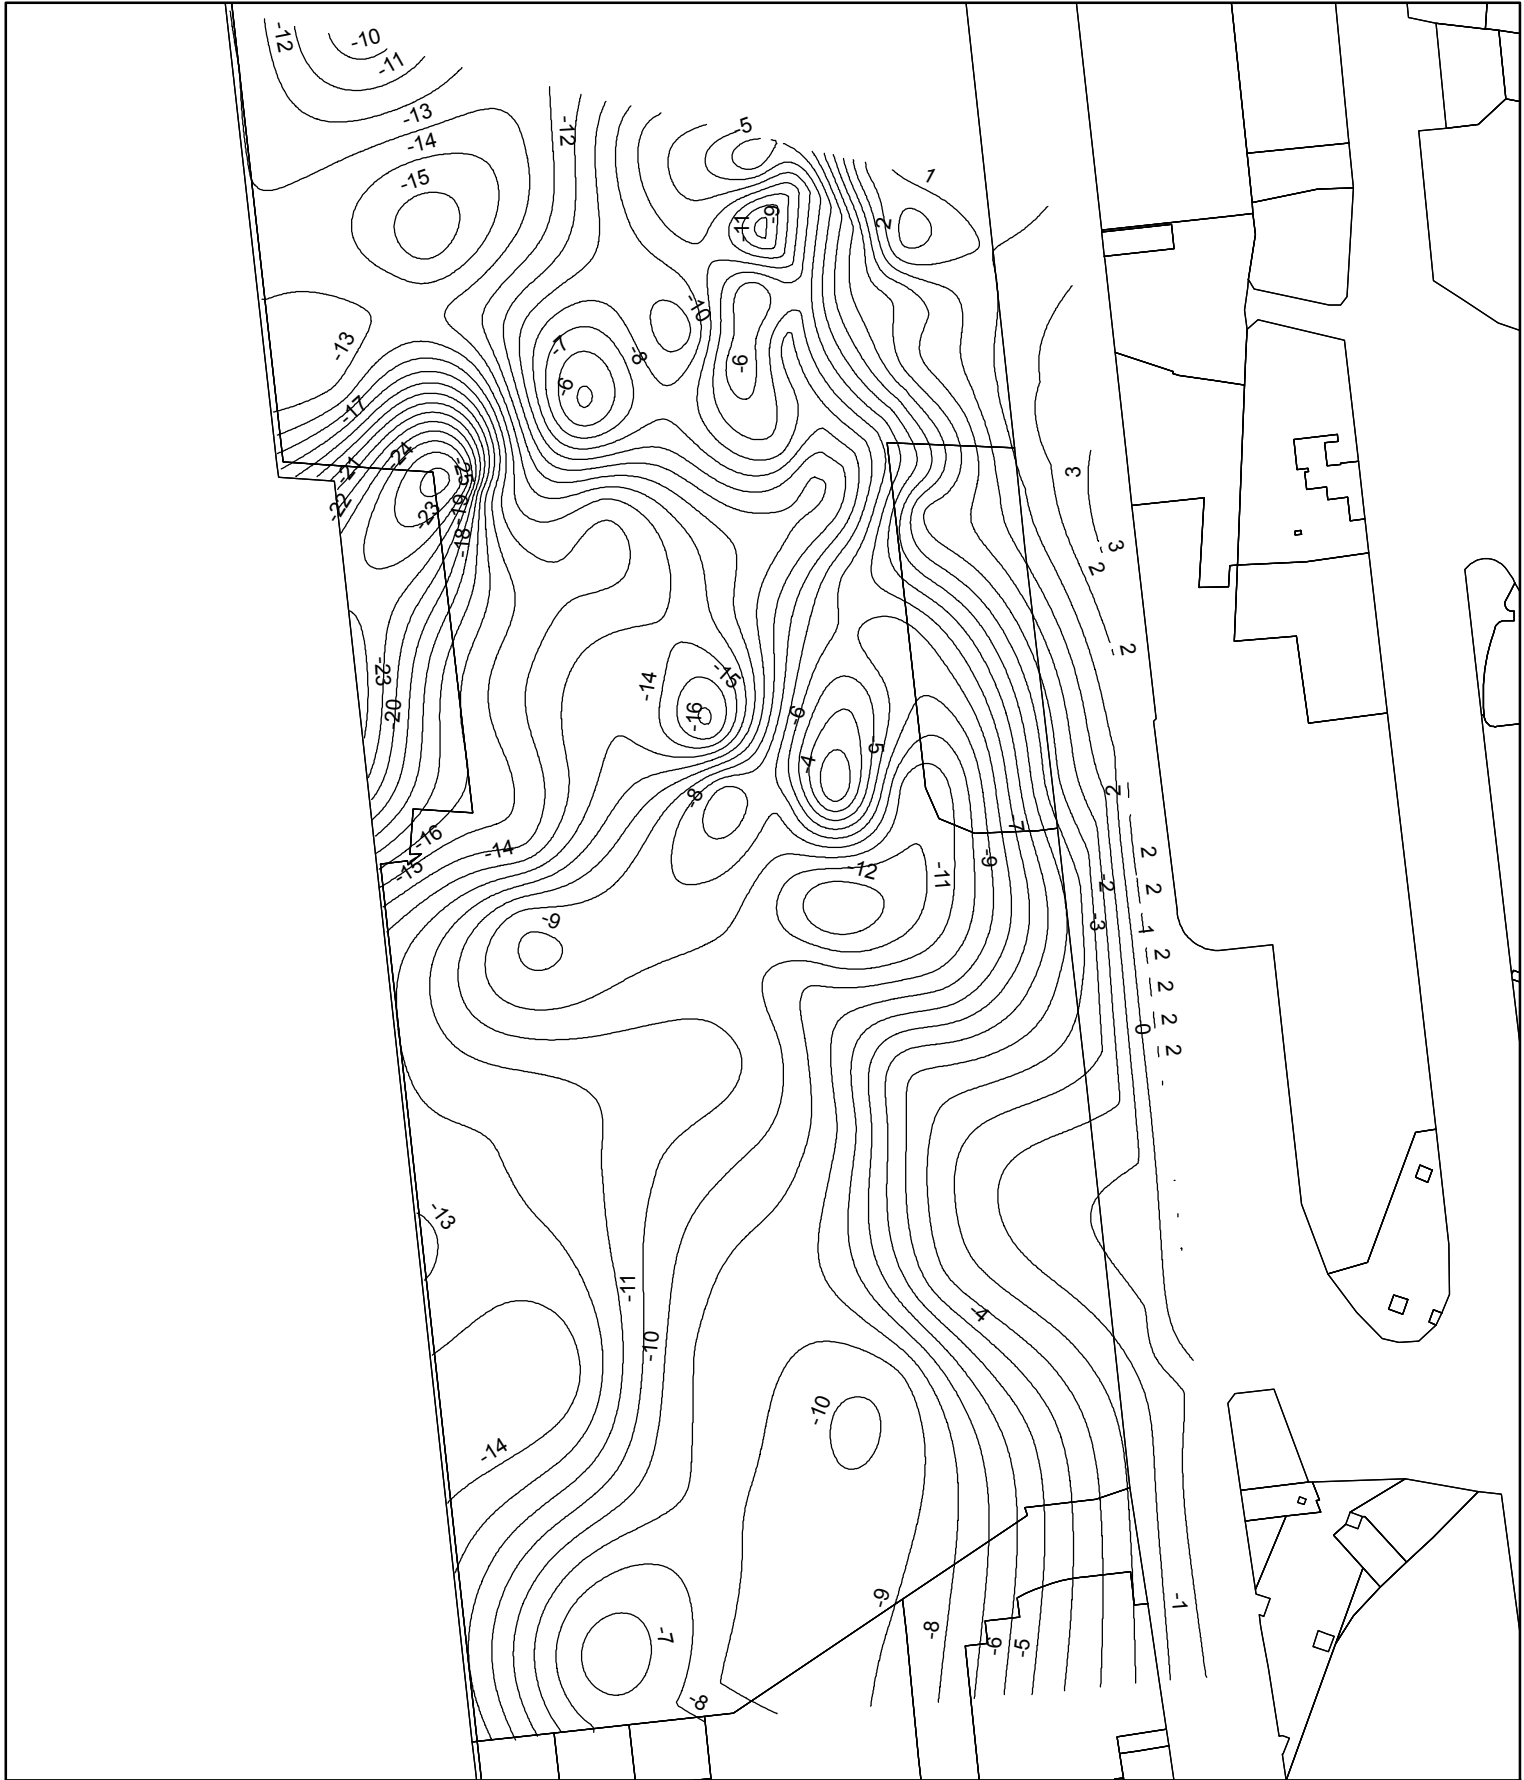
FIGURE 12

- Base of Fill
- Barangaroo Cadaster

- The base of the fill / top of the marine / estuarine sediments – refer Figure 12
- The base of the marine / estuarine sediments / top of the sandstone – refer Figure 13.

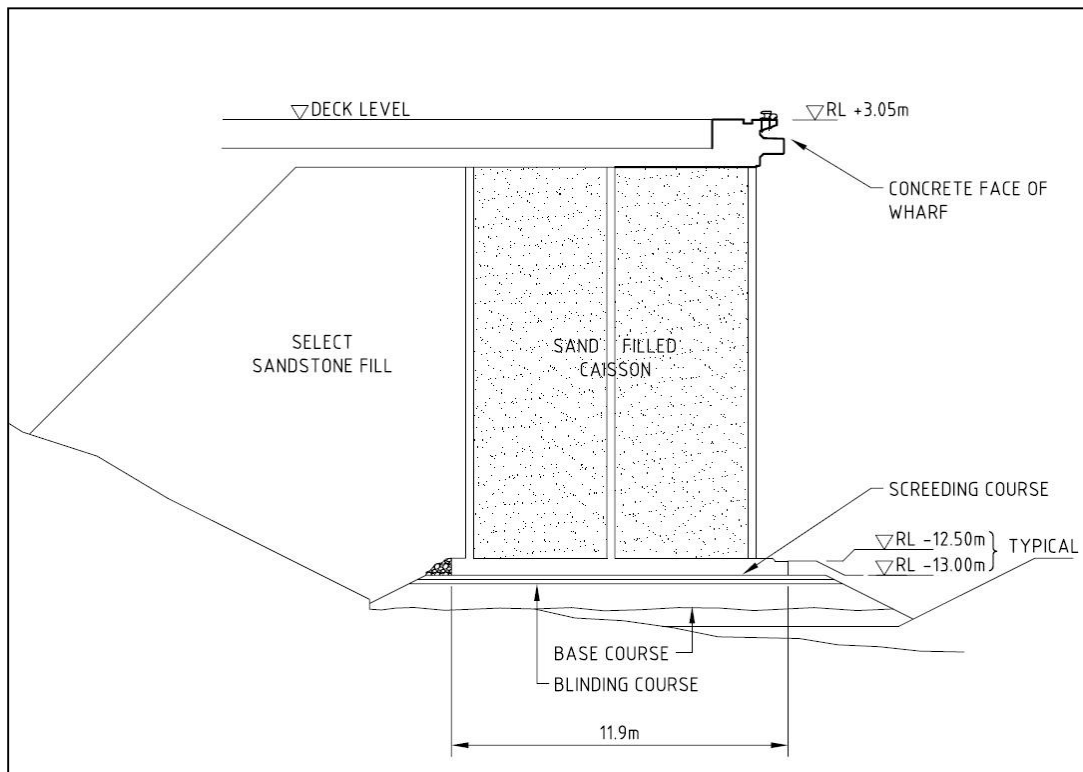
Plate 1: Typical Section of Wharves 3, 4, 5 & 8 (SKM August 2005)

A typical section through Wharves 3, 4, 5 & 8 is provided in Plate 1 below. The coping detail of Wharf 8 is slightly different to the others sections but the general cross section is similar. A typical cross section through Wharf 7 is provided in Plate 2 below.

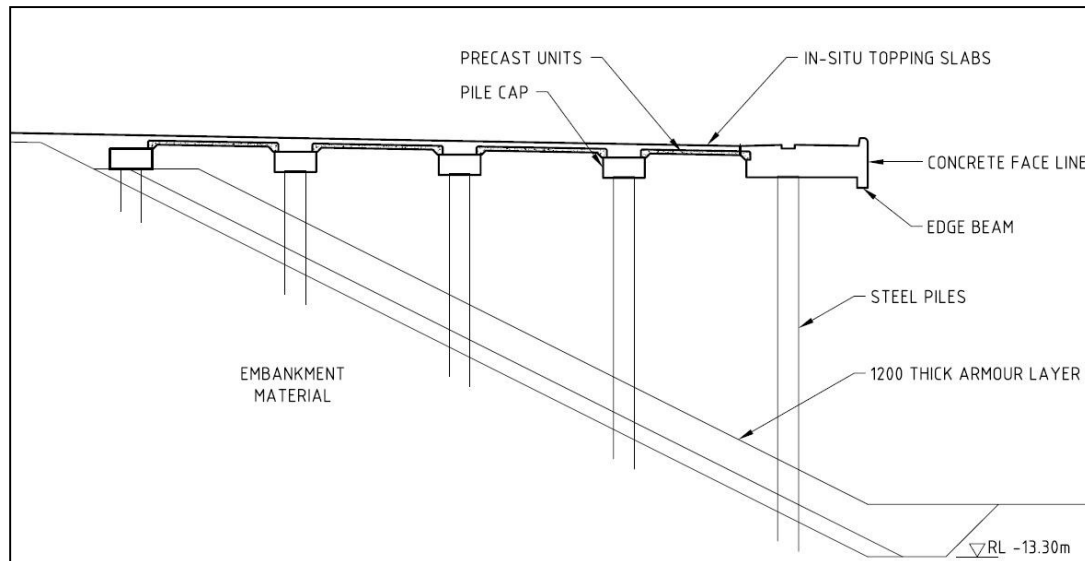
Plate 2: Typical Section of Wharf 7 (SKM August 2005)
