# **Non-Indigenous Archaeological Assessment**

## **Barangaroo Stage 1**

### **Lend Lease (Millers Point) Pty Ltd**

**June 2010**

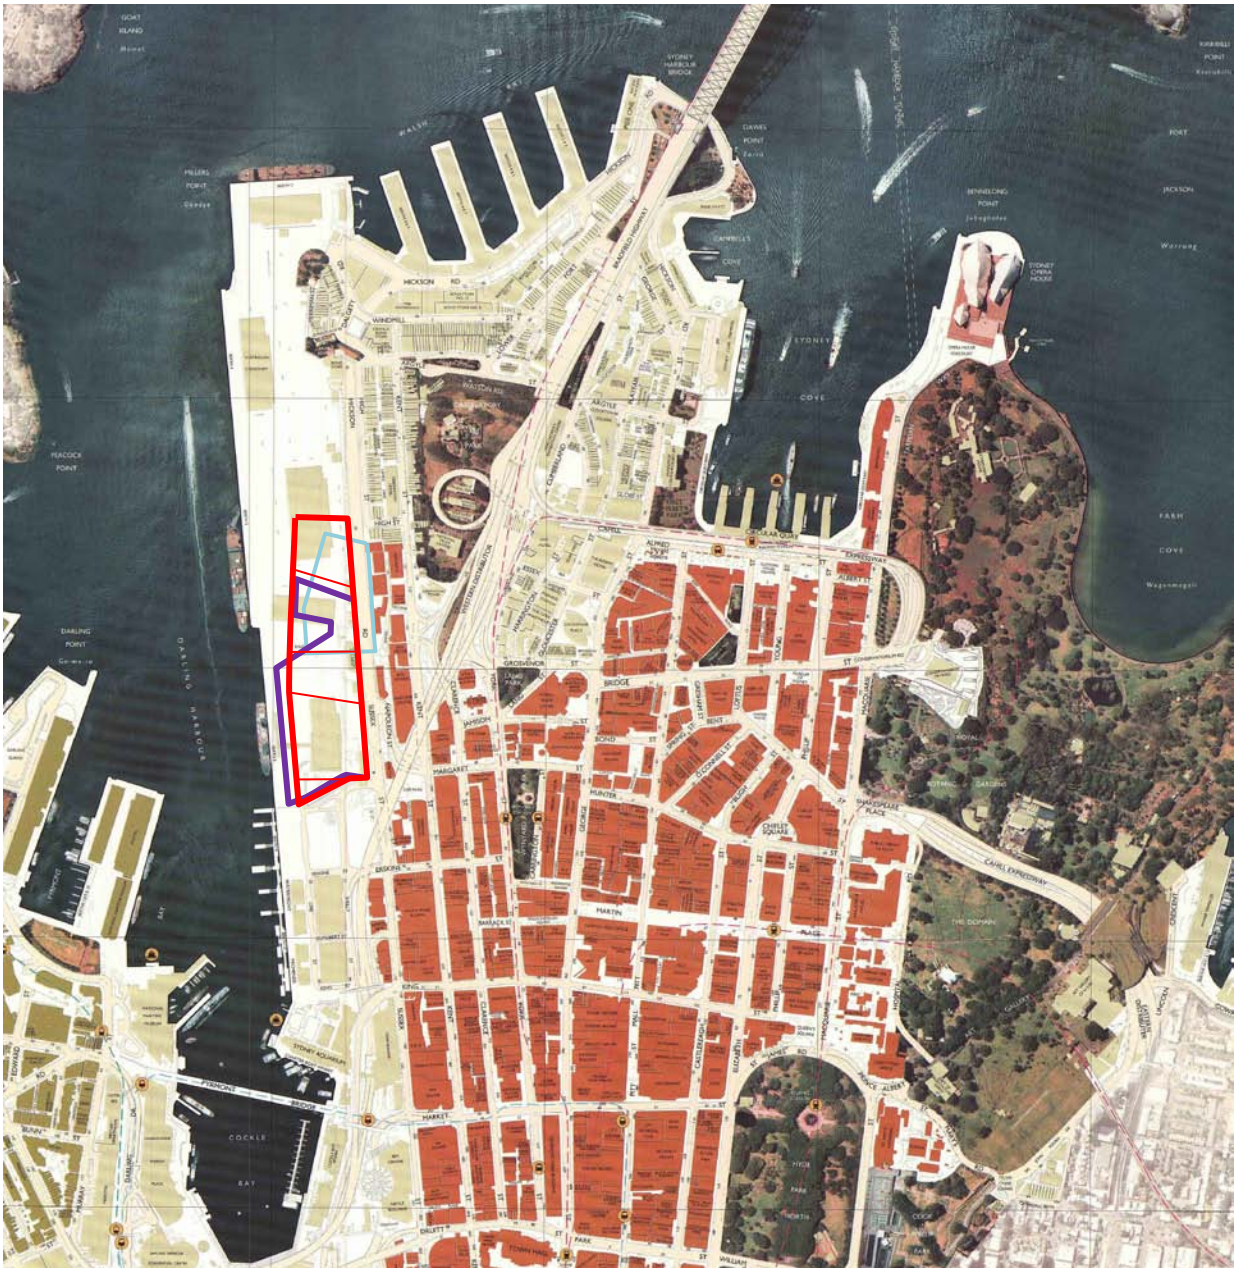
Figure 1.1: Barangaroo Stage 1 (red outline) showing the basement (purple outline) and the DECCW declared area (blue outline). Historical Atlas of Sydney, City of Sydney Archives

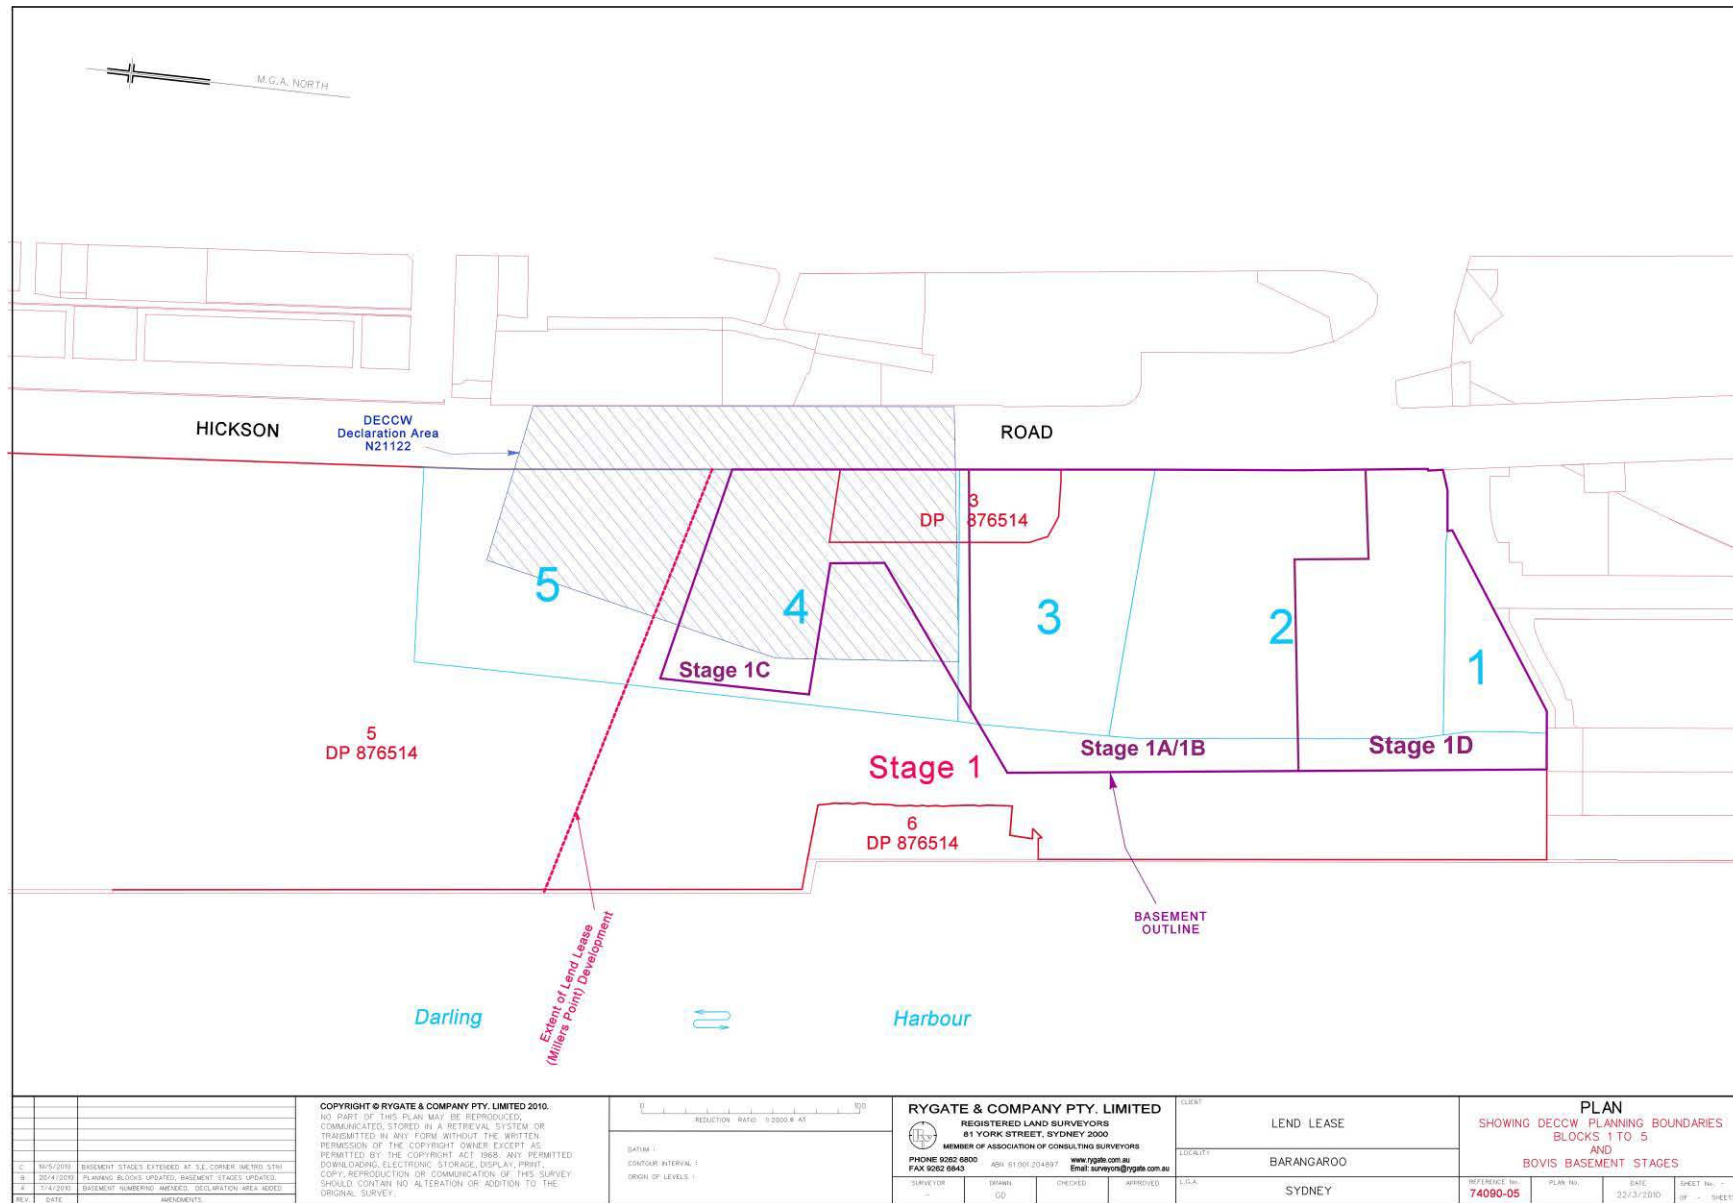
Figure 1.2: Plan showing the five development blocks, basement excavations (purple lines), and the main areas of contamination (hatched). Rygate & Co for Lend Lease.

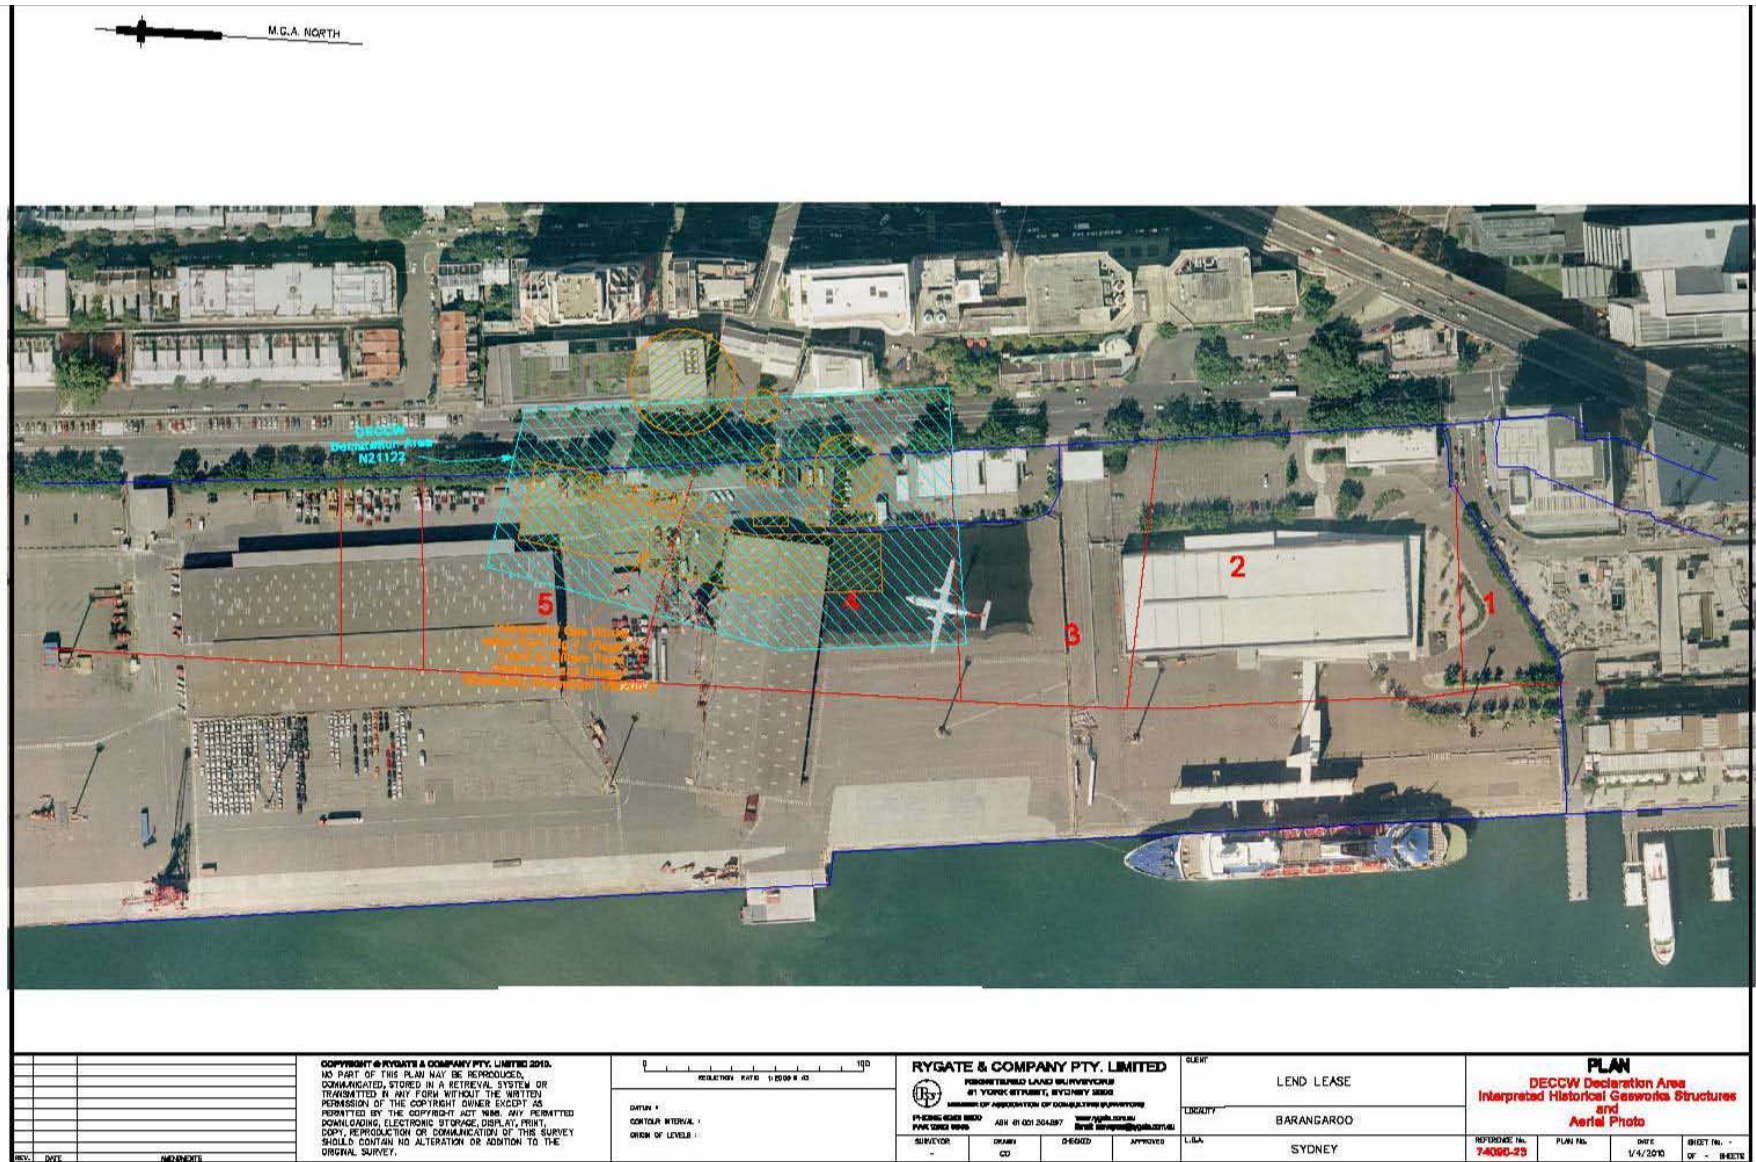
Figure 1.3: Aerial photo showing the location of Blocks 1 to 5 and the identified contaminated areas (blue hatched lines). Rygate & Co for Lend Lease

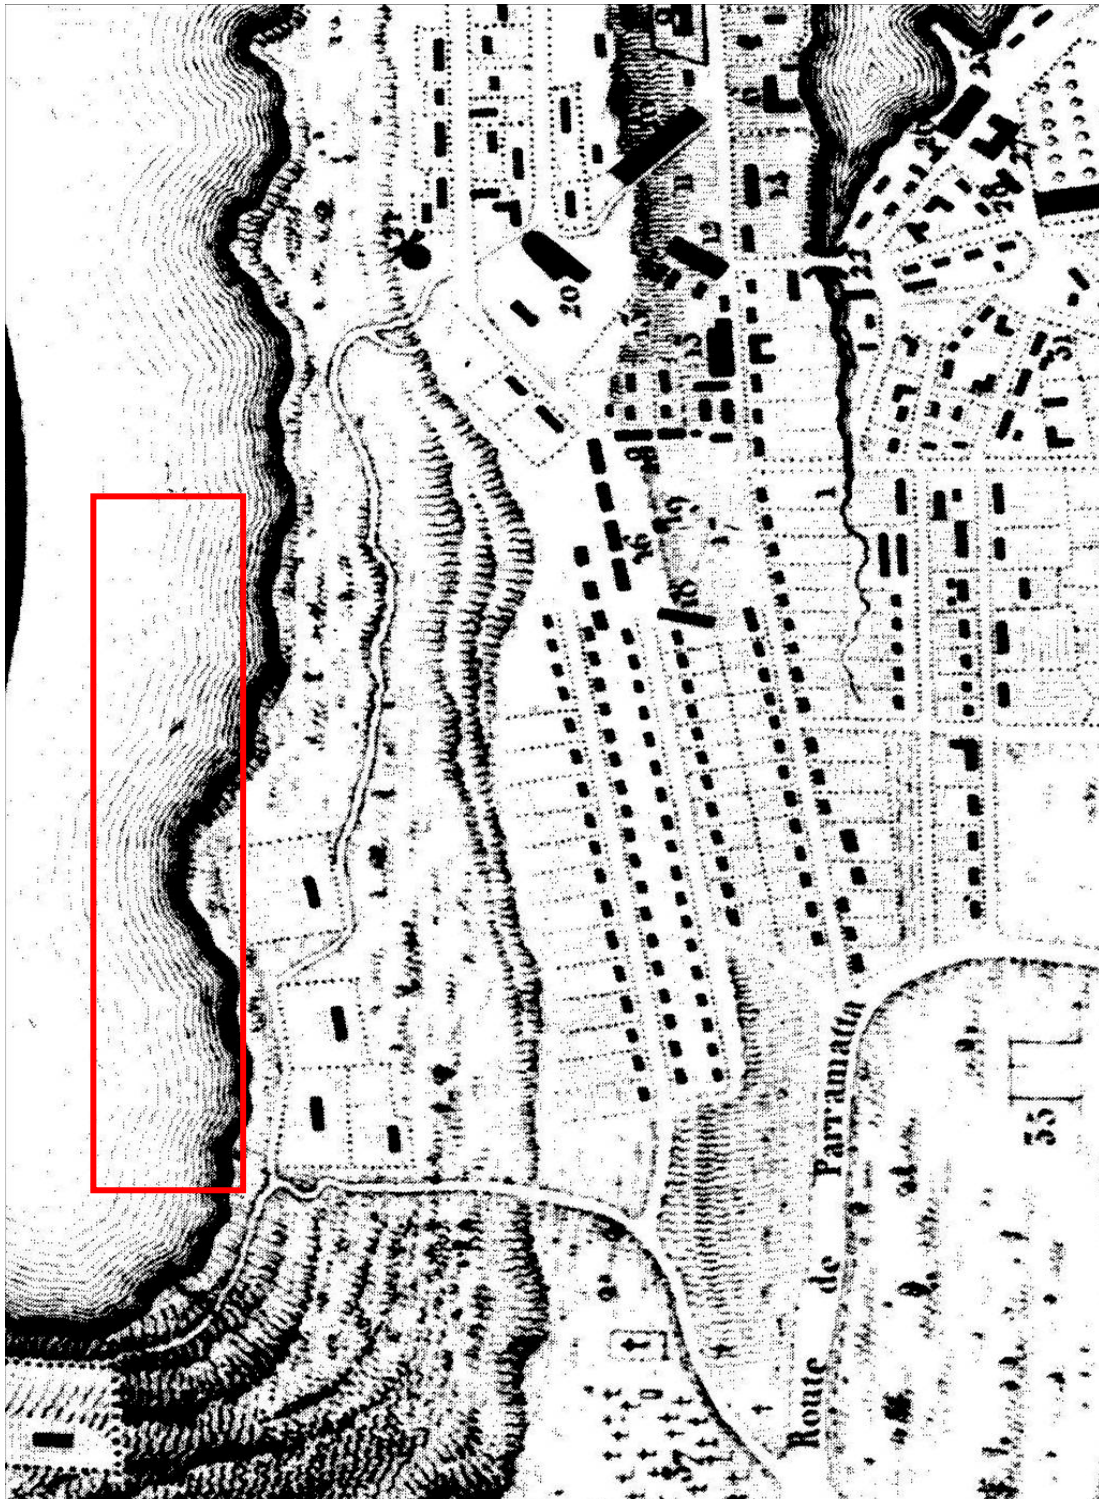
Figure 2.3: Lesueur's 'Plan of the Town of Sydney', 1802. By this time there were some early grants for small farms, mostly for soldiers in the vicinity of the study area. There are access road somewhere near the modern alignment of Margaret Street and Sussex Street. Max Kelly & Ruth Croker: *Sydney Takes Shape. A collection of contemporary maps from Foundation to Federation*, p10.

Lesueur and Meehan's plans of Sydney drawn in 1802 and 1807 respectively show little occupation along the east side of Cockle Bay, and there are, similarly, few references to the place in the earliest editions of the *Sydney Gazette*. Amongst brief mentions of a cottage or two with well stocked gardens, the concealment of stolen goods, other felonious dealings and a shark attack, perhaps the most important was the announcement in January 1809 of the construction in Cockle Bay of a vessel of 60 tons for James and William Jenkins, the aptly named *Brothers*, an indication of the potential importance of the area in Sydney's maritime trade.<sup>7</sup>

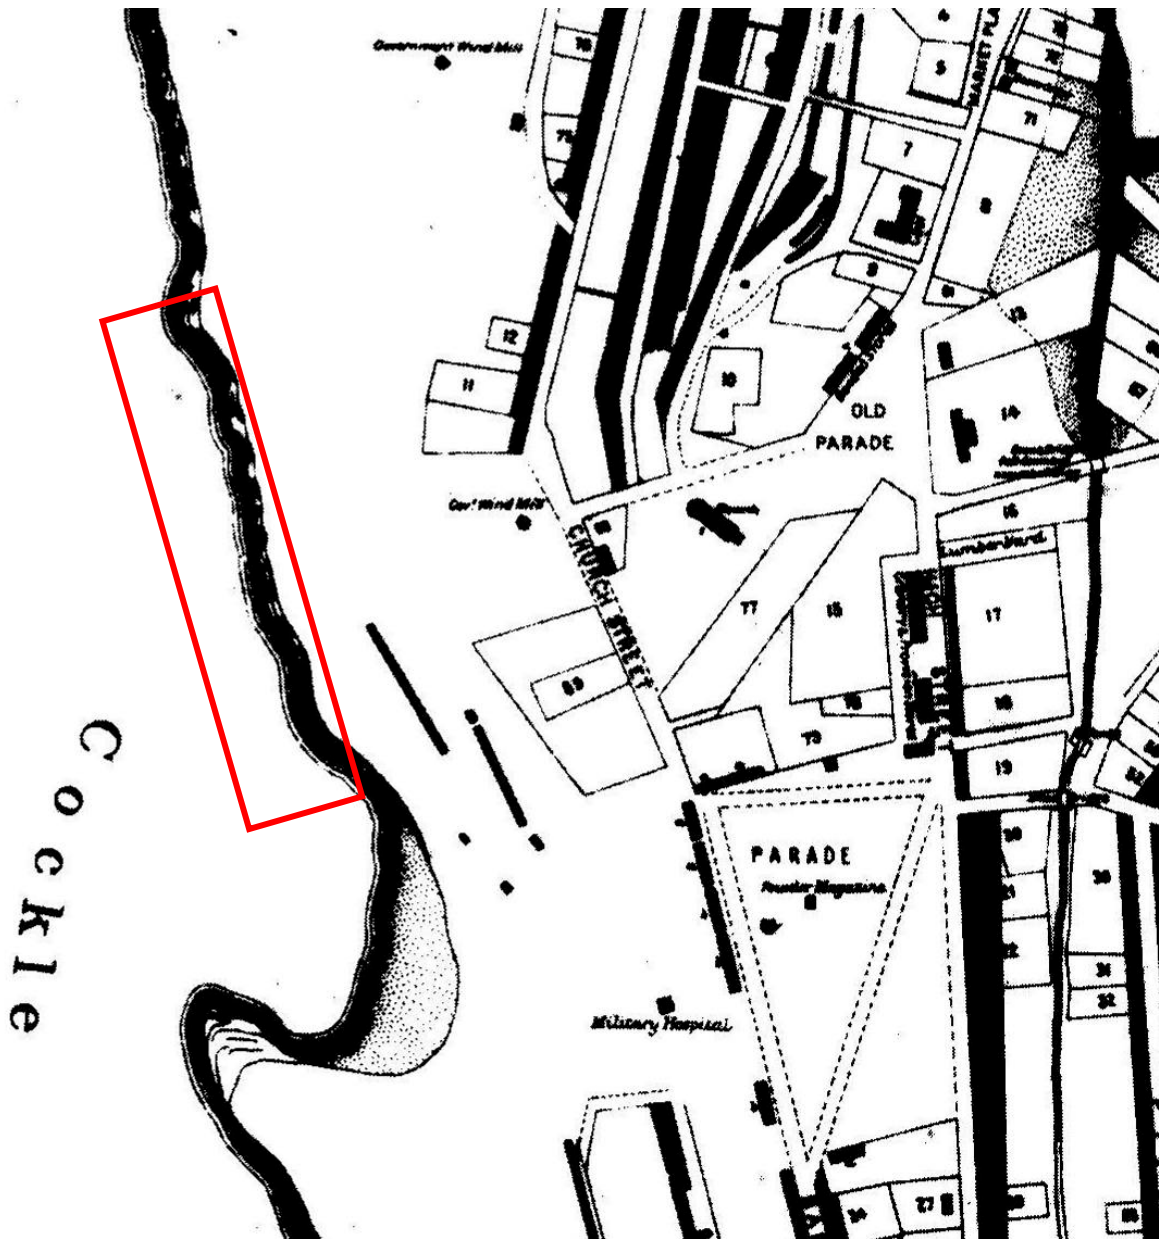
Figure 2.4: James Meehan's 1807 'Plan of the Town of Sydney in NSW'. Max Kelly & Ruth Croker: *Sydney Takes Shape. A collection of contemporary maps from Foundation to Federation*, p10.

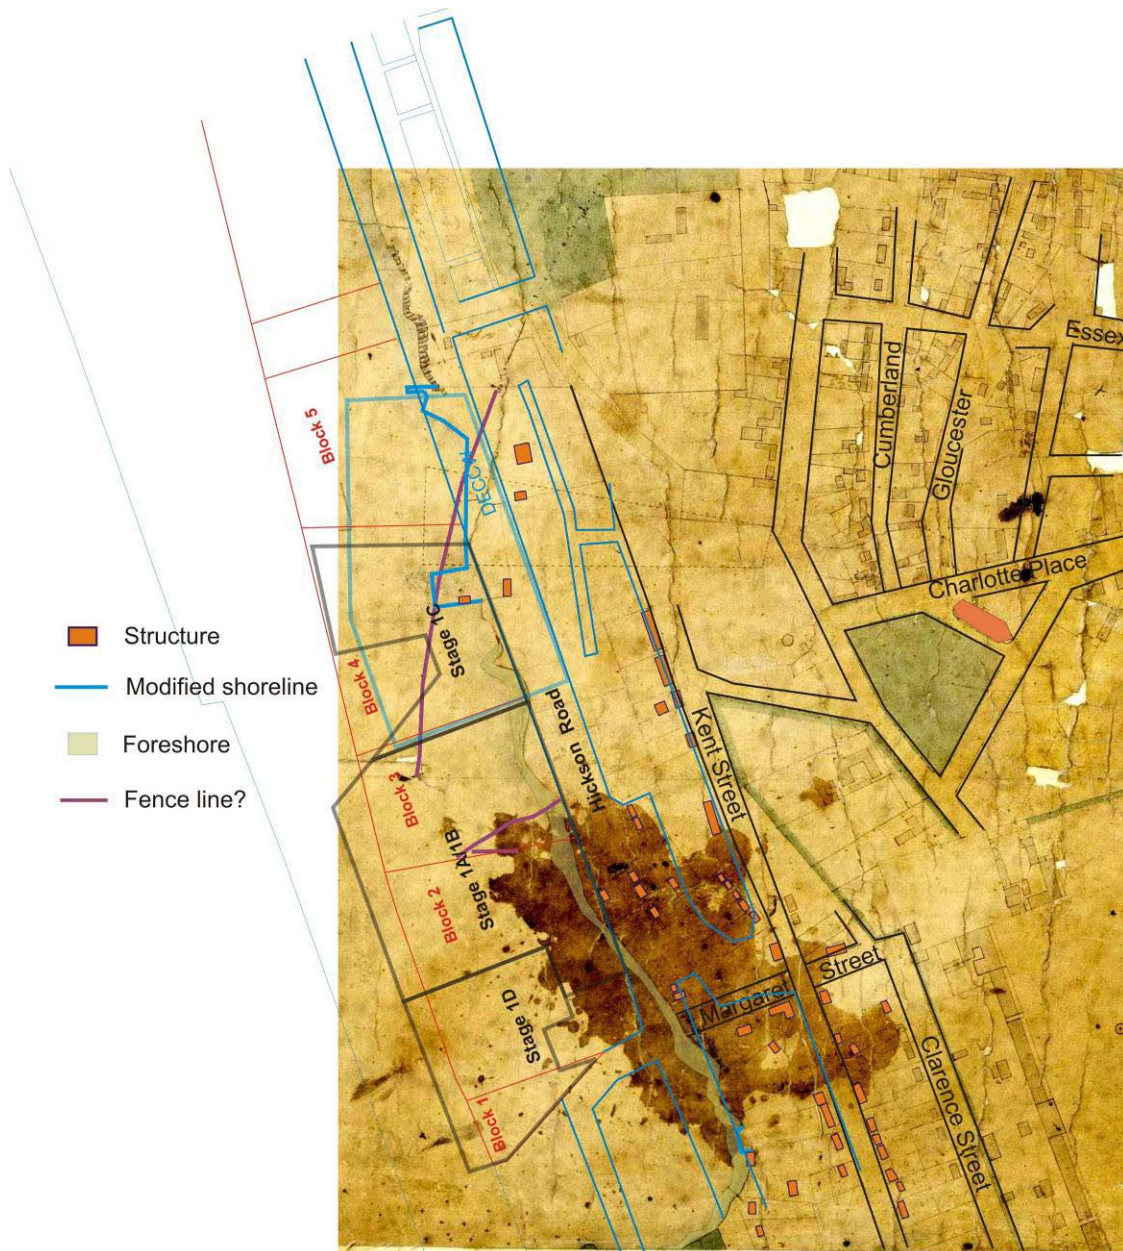
**Figure 2.5: Harper's 1823 plan showing the approximate position of Barangaroo Stage 1 and the development blocks. The foreshore has been highlighted in green, this would be above the high tide line. There is thought to be evidence of fence lines indicating that these were probably part of early leases or grants. The squarish modified section of shoreline, highlighted, is part of Portions 16 and 15 which became the site of the gasworks. State Records. Abi Cryerhall, Casey & Lowe. Development blocks (red) basement (grey) DECCW declared area (aqua).**

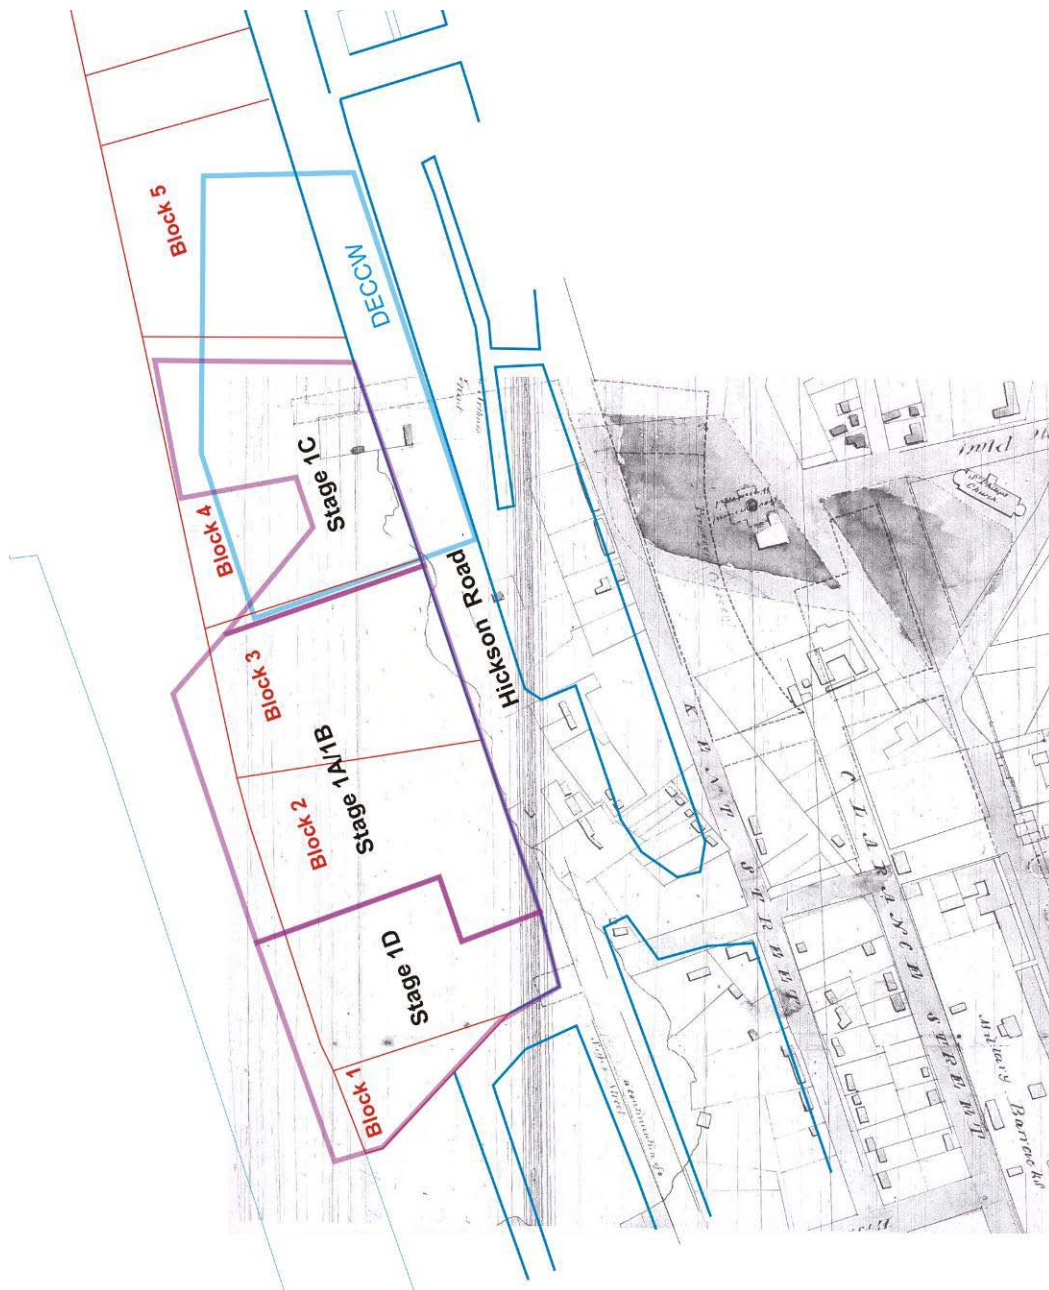
**Figure 2.6: Approximate location of the study area development blocks and basement stages and the DECCW declared area. This sketch shows the same buildings and portions as on the 1823 plan (Fig. 2.5). Overlay is indicative use only. Surveyor General's Sketch Books Vol. 1 Fol. 82, Reel 2778 [nd but early 1820s], SRNSW. Development blocks (red) basement (purple) DECCW declared area (aqua).**

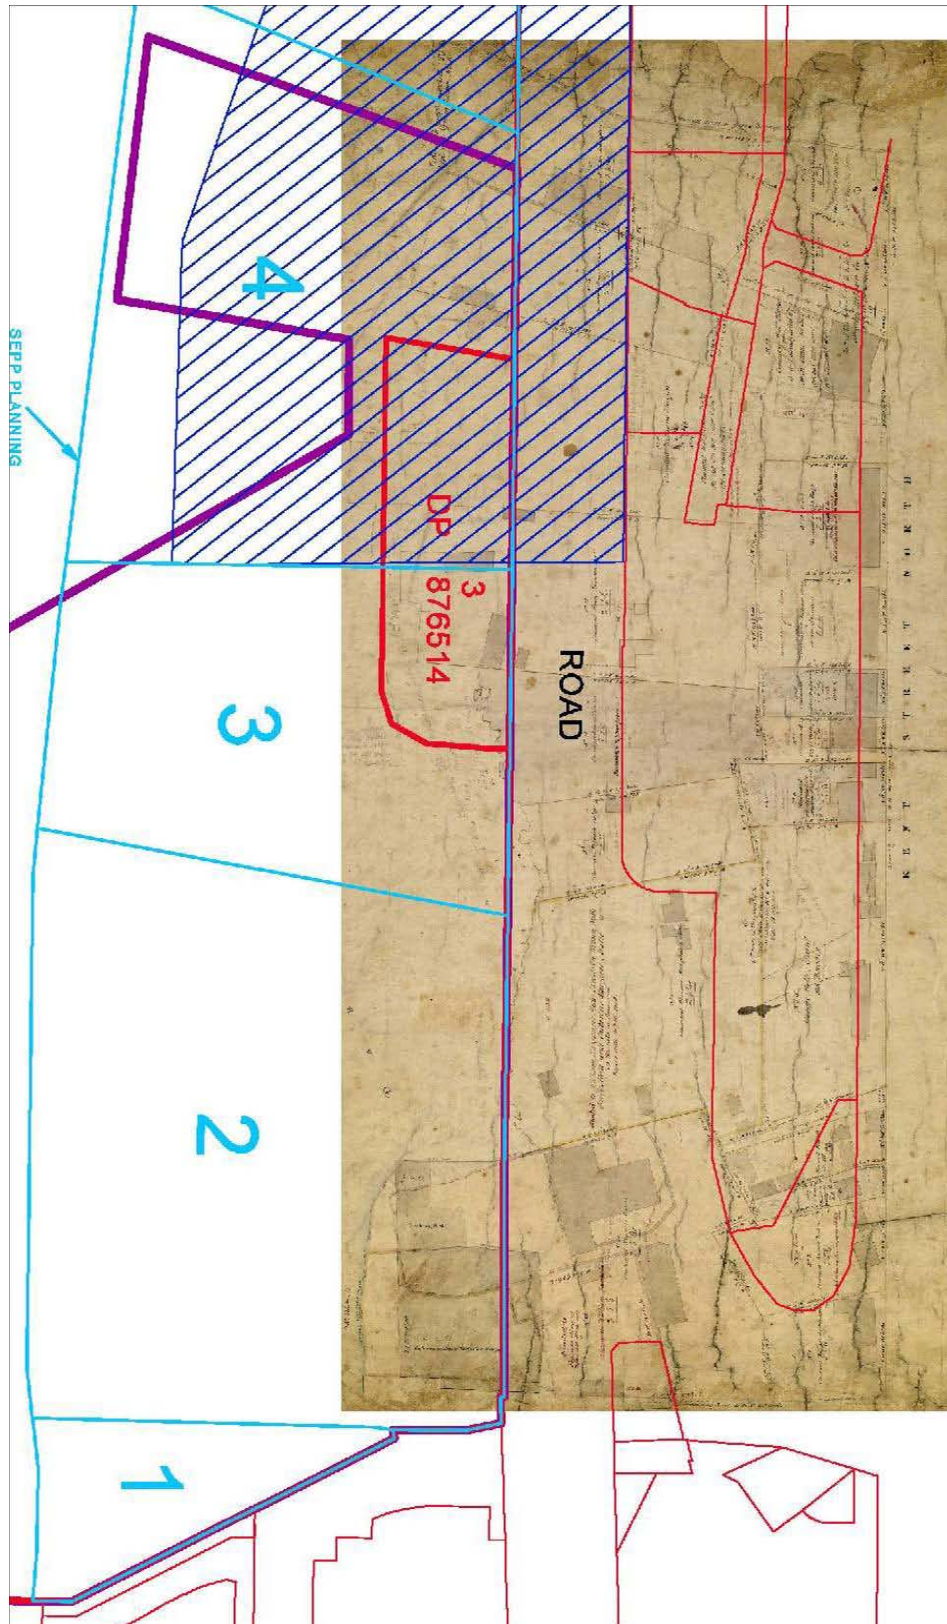
Figure 2.7: This map shows the reclamation of the foreshore is limited to the northern and southern sections while the middle area remains unchanged. Sydney Section 67 (Crown Plan S.45.684) by Robert Russell dated 18 November 1834, AO Map 5421, SRNSW. Rygate & Co surveyors Development blocks (aqua) basement (purple) DECCW declared area (blue hatched).

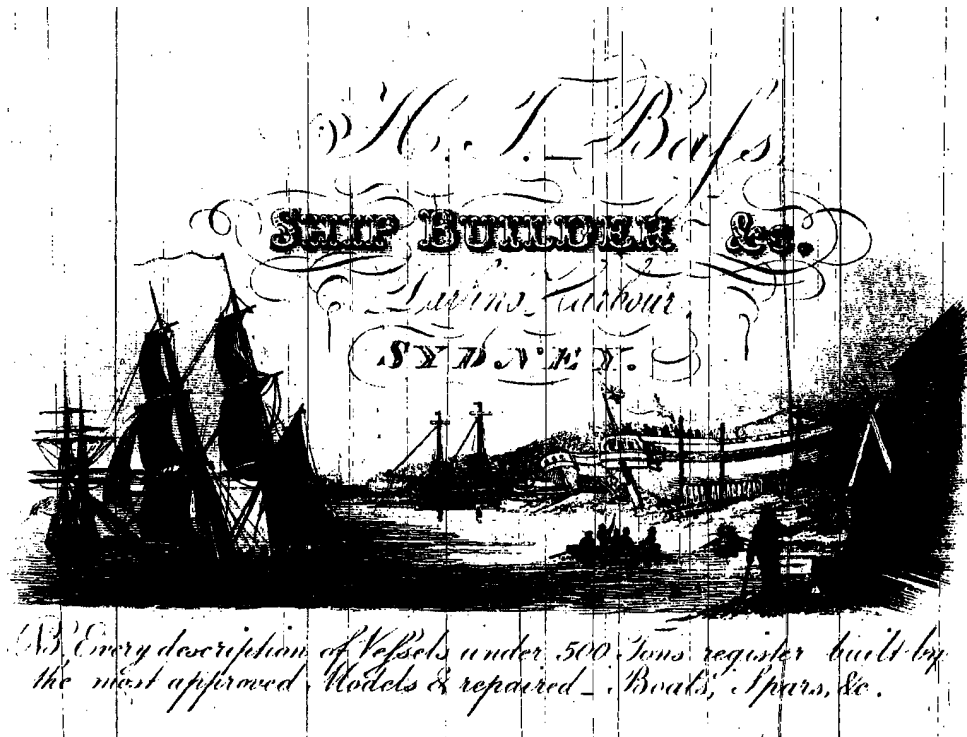
Figure 2.8: Sketch of Mr Bass' ship yard in 1835. *NSW Calendar & Post Office Directory* 1835, opp. Page 8.

Evidence for the history of the two lots purchased by Henry Bass in 1832 for £350 dated from 1819. A building (Lot 17) is shown towards the southern boundary of the area in an 1830 sketch and a rapid increase in value between 1831 and 1832 suggests that some of the other improvements shown on the 1834 plan could have been made at this date.<sup>19</sup> This coincided with Bass' appearance as a 'shipbuilder Darling Harbour' in the *NSW Calendar and Post Office Directory for 1833* a publication in which he had a full page advertisement, complete with illustration, two years later (Fig. 2.8). The wharfage on the shoreline of his grant and the large buildings were presumably his ship building enterprise where 'Every description of Vessels under 500 Tons register built by the most approved Models & repaired – Boats, Spars &c'.<sup>20</sup>

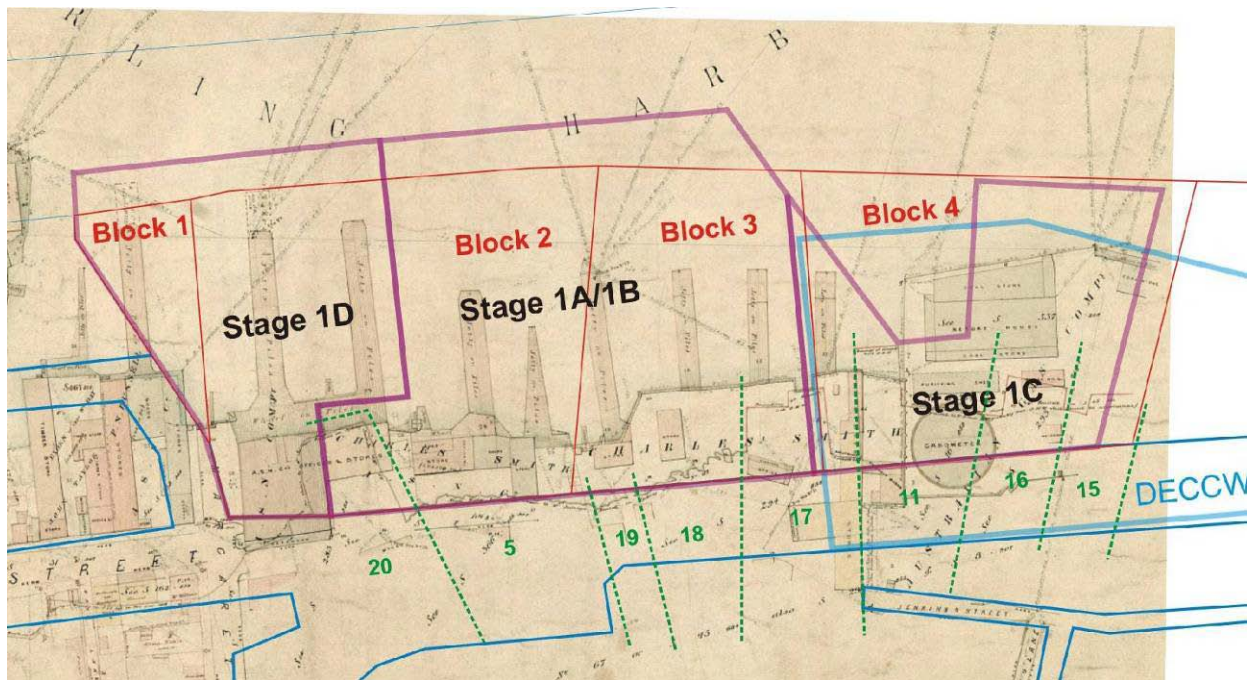
Overlay of the study area onto the 1875 plan with early portions indicated in green

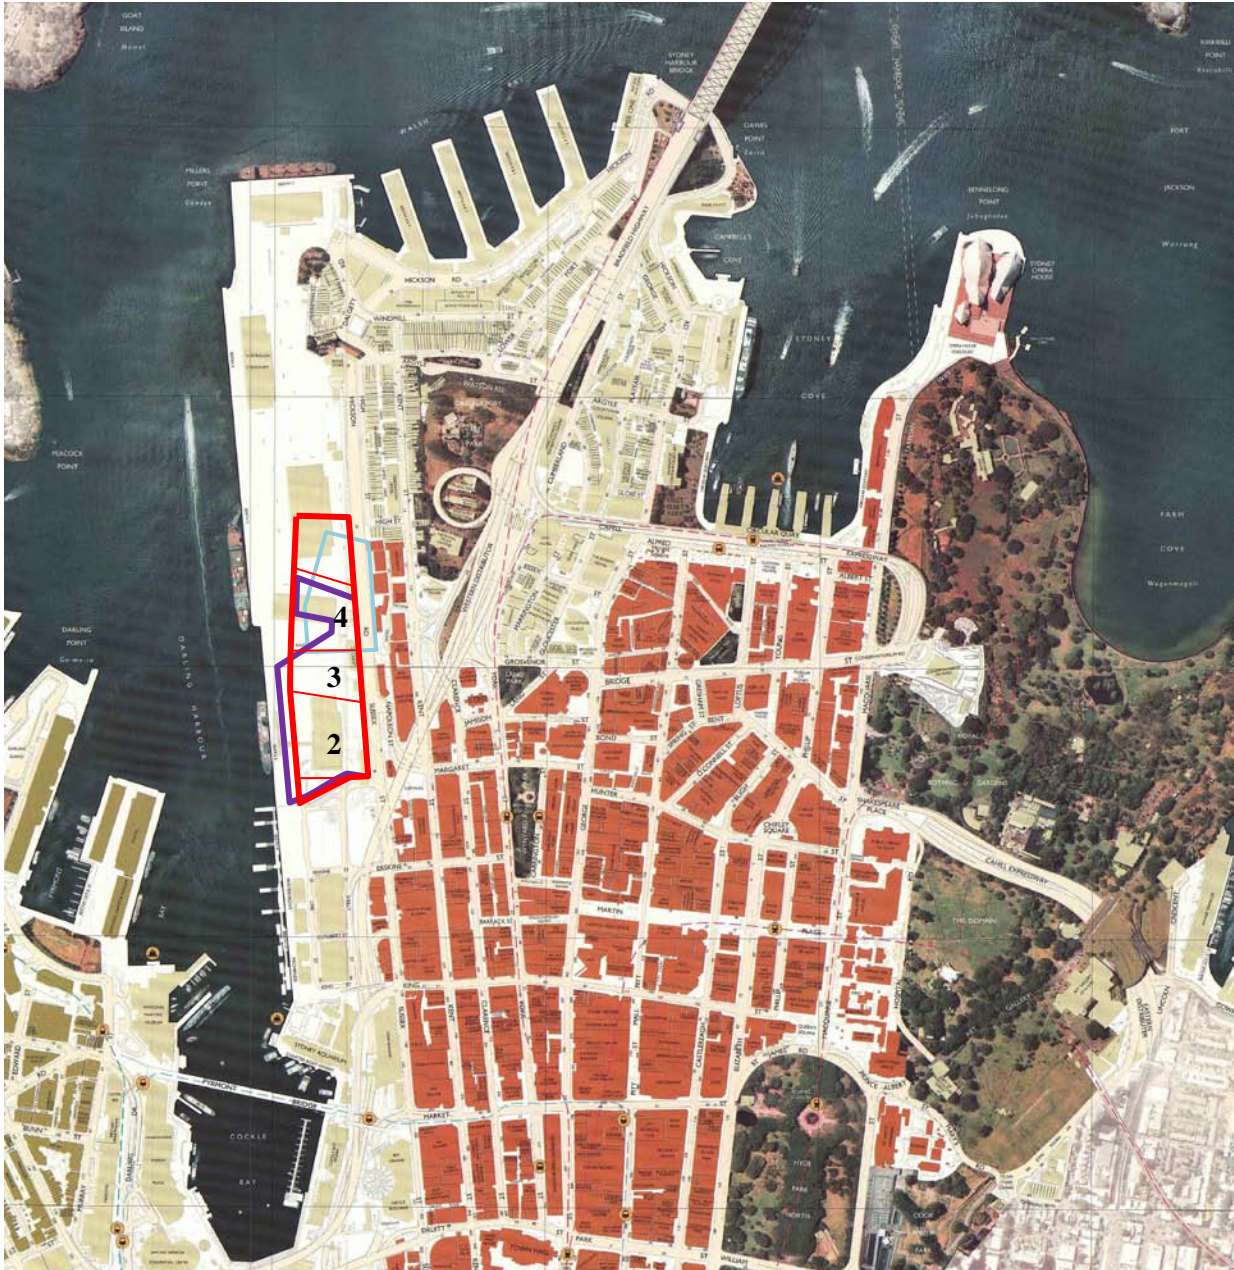
Figure 1.1: Barangaroo Stage 1 within the current wharfage.

Barangaroo Stage 1 is located along the eastern side of the Darling Harbour precinct with Hickson Road forming the eastern side of the study area and Shelly Street the southern end. The western side is within the existing concrete wharfage and the northern end is also within the wharfage. Blocks 1 to 4 form the basis of the Stage 1 development (Figs 1.1, 1.2, 1.3). There is an area of contamination associated with the operation of the historic gasworks (c1840-1910s) that was located within the northern part of the site (Blocks 4 and 5). The Stage 1 redevelopment will provide for commercial, residential, tourist, retail and

The existing site consists of the 1960s concrete wharfage along Hickson Road. This has recently been used for container wharfage, the World Youth Day and for docking of cruise ships.

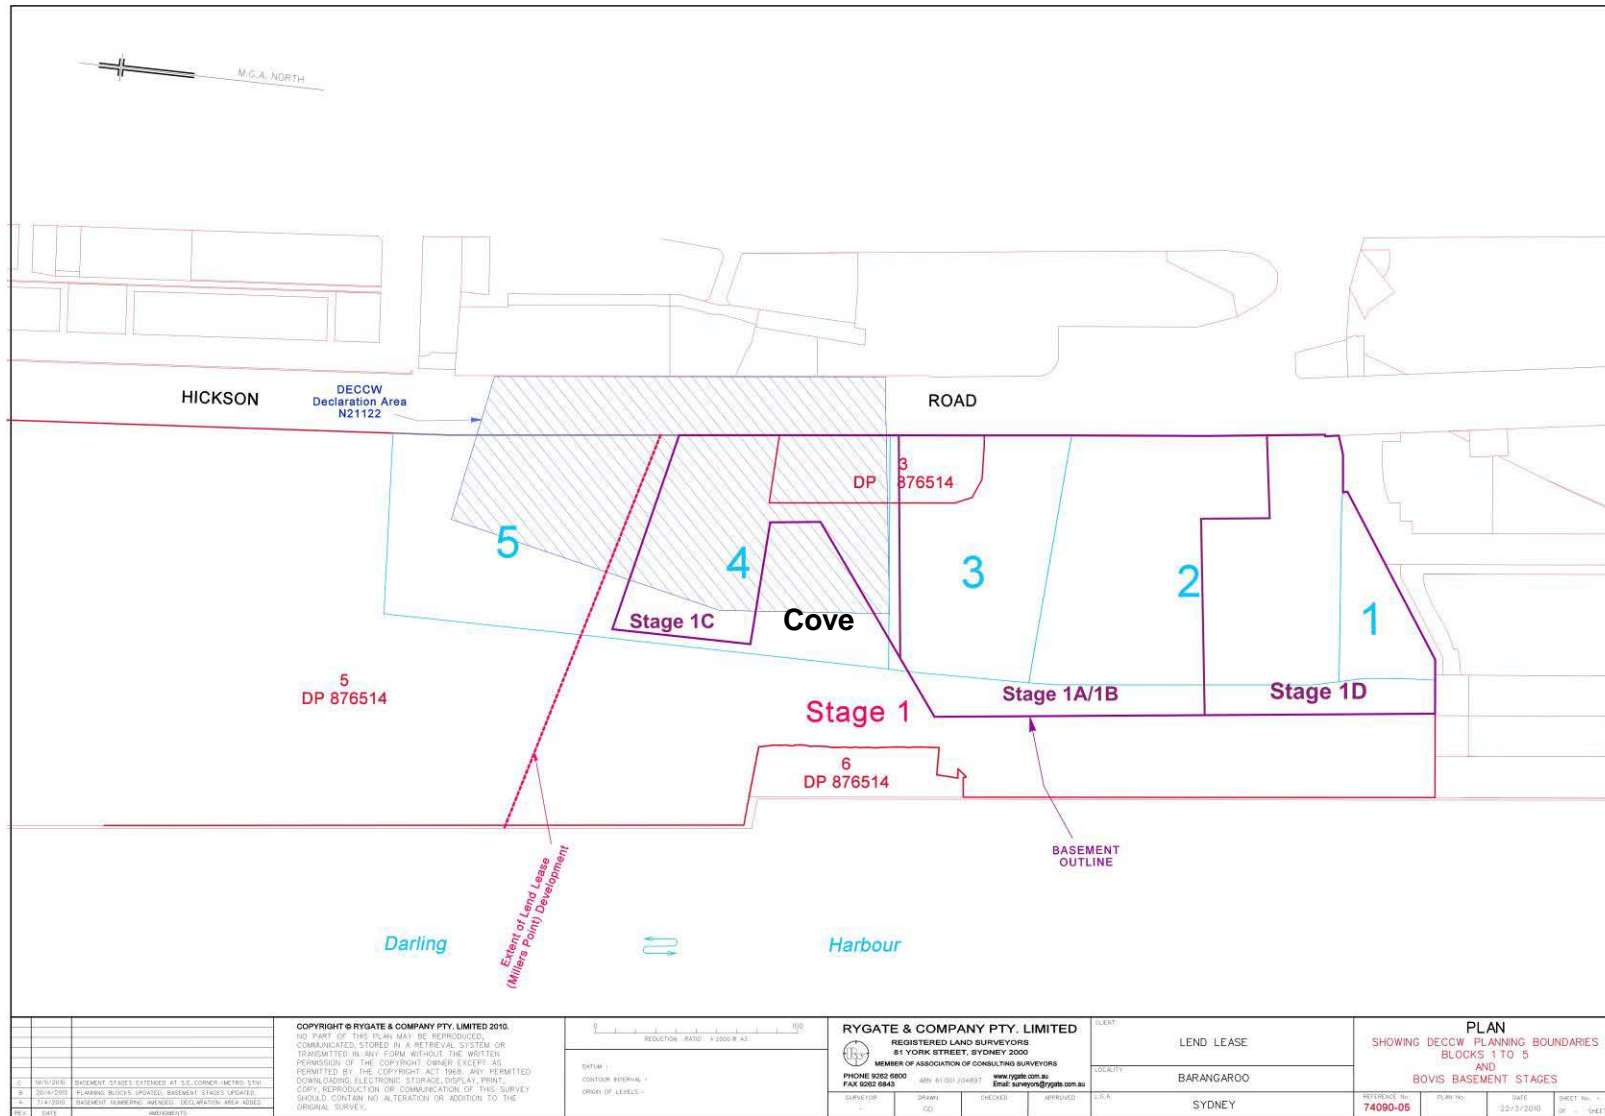
**Figure 2.1: Plan showing the five development blocks, basement excavations, location of the cove which is mostly within Block 4, and the main areas of contamination (blue hatched lines). Purple line indicates the basement footprint with various stages labelled. The blue lines indicated the development blocks and the DECCW area is hatched. Rygate & Co for Lend Lease Millers Point.**

The excavation for the cove is exterior to the basement and perimeter retention system in Block 4. This will involve the bulk excavation of this part of the existing wharf to allow for boats to dock within the cove. Most of this area was excavated in the 1920s for the new jetties installed within the footprint for the gasworks site (Fig. \*). This work removed the archaeological resource in the northern area while to the south there is some potential for remains of jetties.

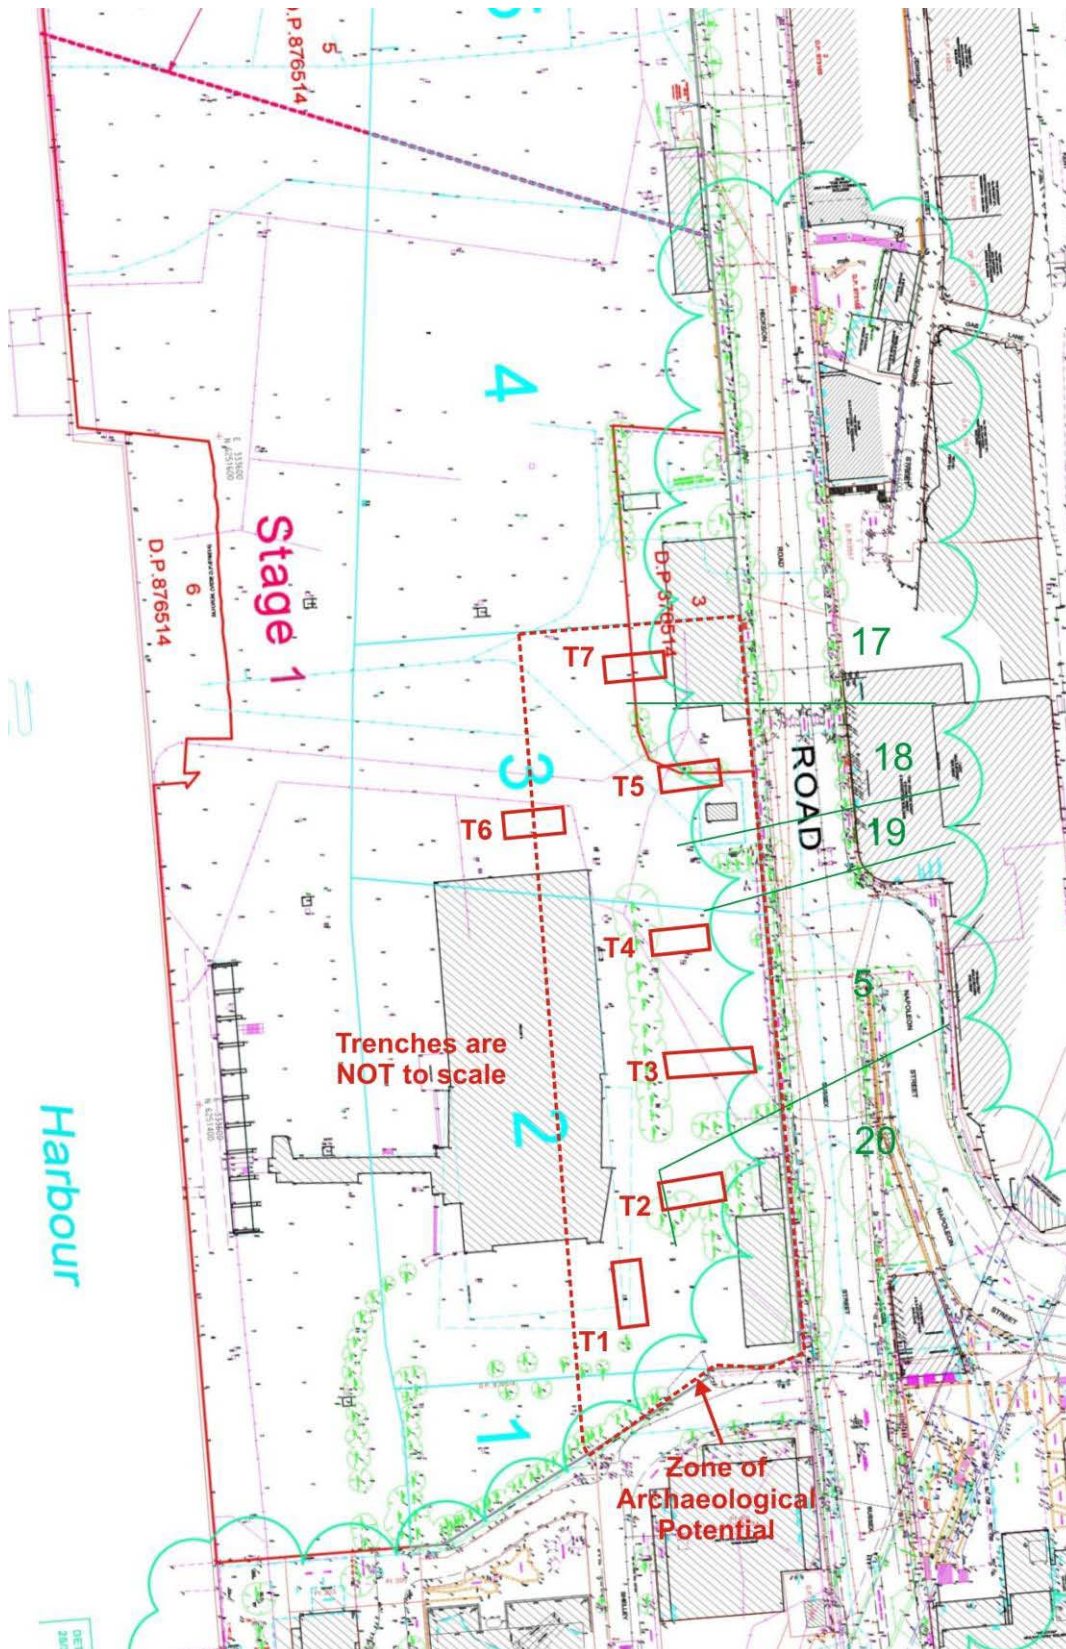
Figure 5.1: Plan showing the proposed location of test trenches in the eastern area of the site. Please note these trenches are not to scale.

- Test trenches will be excavated to a maximum depth of 2.5m below modern ground level. Current ground level is between RL 2.4 to 2.8m.
- Excavation will stop once the water table is reached. This is expected to be at RL 0.3 to 0.6m.
- In order to safely facilitate hand excavation and recording the trenches will be benched at a ratio of 1:1m.
- Trenches will be up to 10m in length and 6m in width. This will allow for a base working area of 8m by 4m and 2m in depth.
- In order to facilitate excavation the existing concrete hardstand will be cut to the designed dimensions.
