Aboriginal Archaeological and Cultural Heritage Assessment

Barangaroo: Stage 1

Report to Casey & Lowe Pty Ltd
on behalf of Lend Lease

May 2010

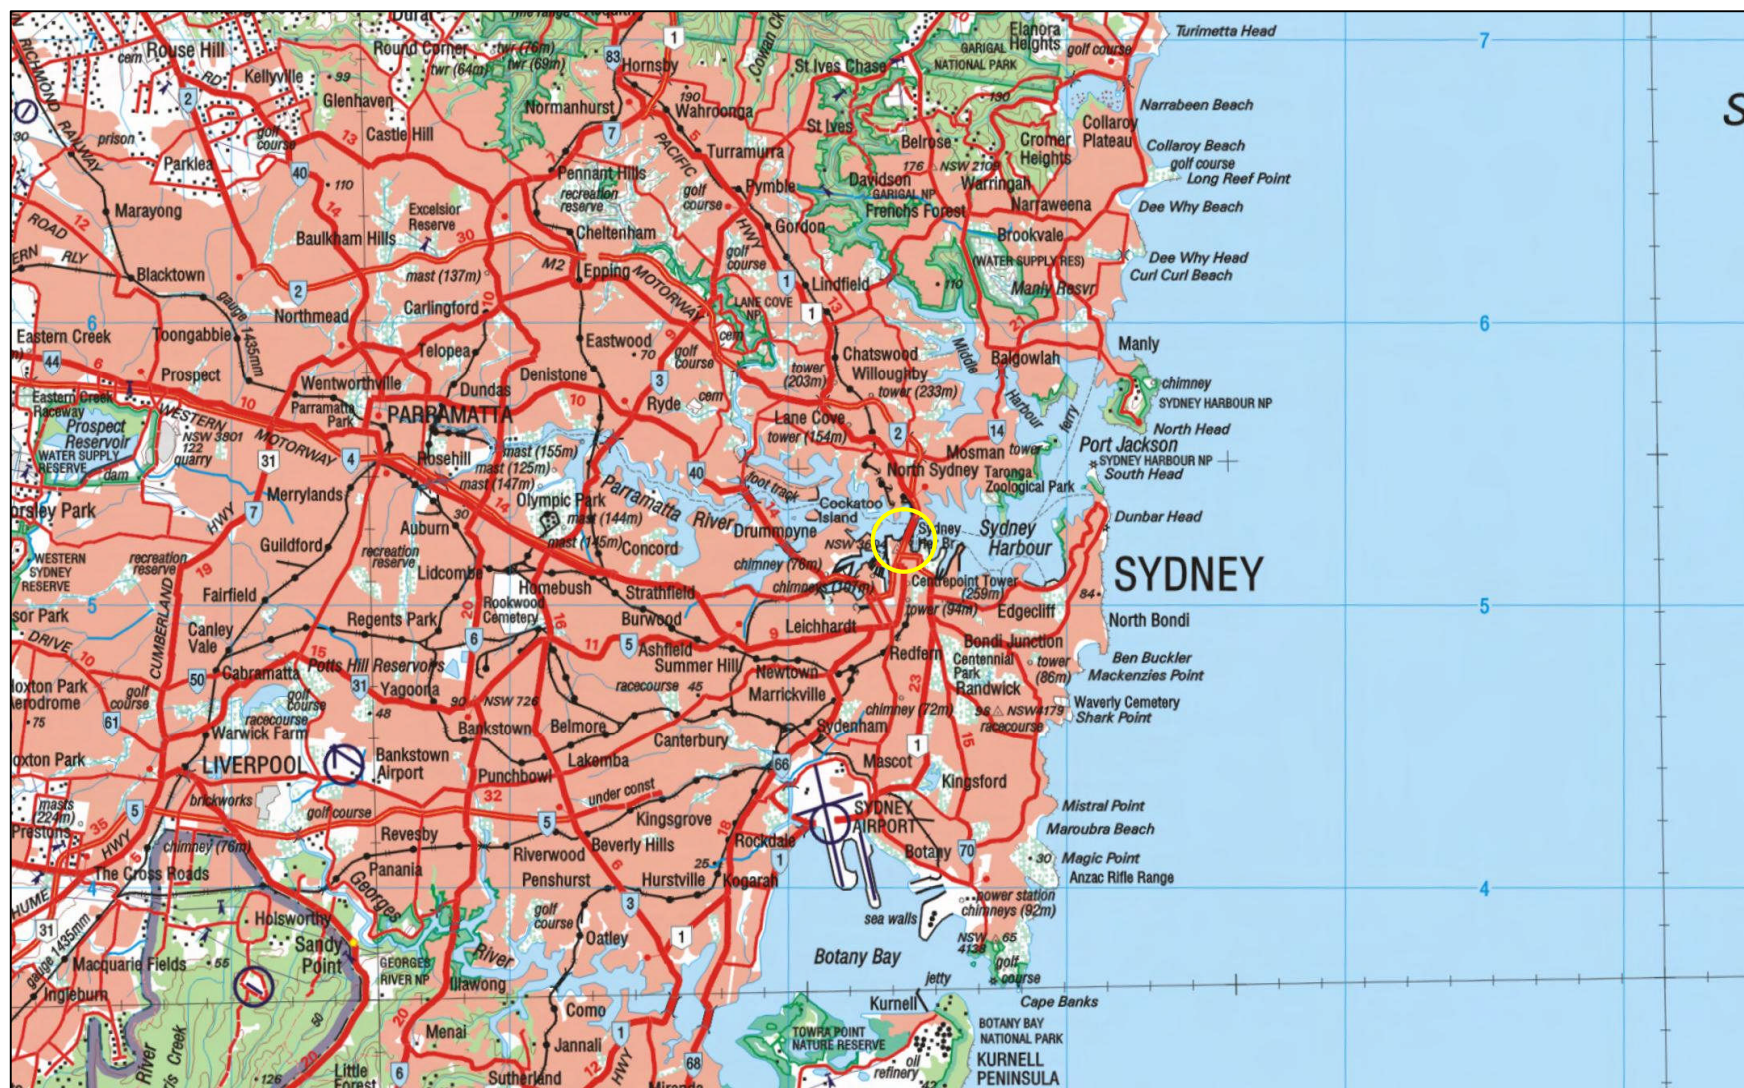
Figure 1: Location of Barangaroo circled in yellow.
(1:250,000 Sydney Special ED2 – 1998 topographic map)

Figure 1 shows the location of Barangaroo on the 1:250,000 topographic map. Figure 2 shows the location of Barangaroo on the 1:25,000 topographic map.

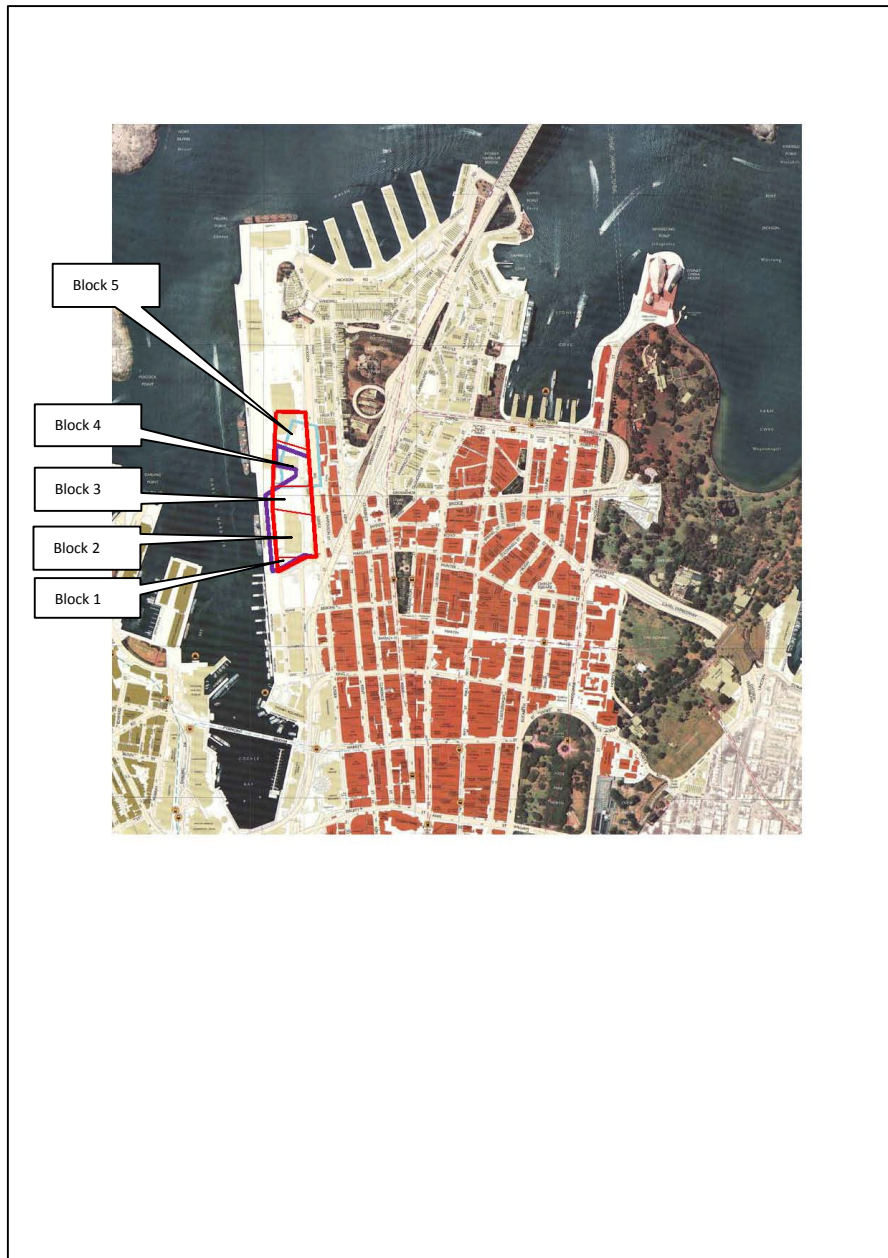
Figure 3: Aerial photo showing the extent of Stage 1 development which comprises Blocks 1 - 4. The proposed footprint of individual Blocks 1 – 5 are outlined in red. Block 5 is a later development stage. The purple line indicates the location of the basement/carpark.
(courtesy Casey & Lowe)

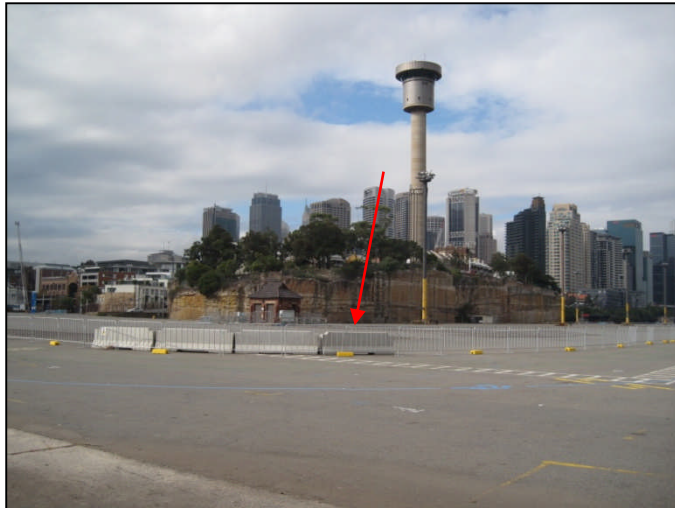
Photograph 1:

Looking east within the northern portion of Barangaroo at the area within the original shoreline, indicated by the red arrow.

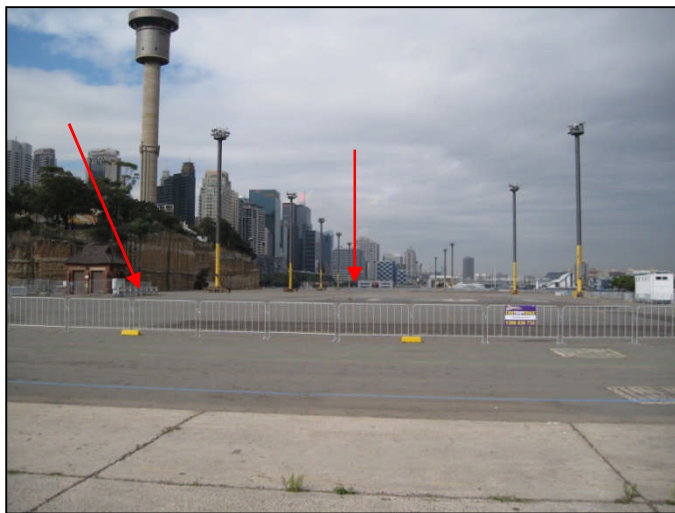
Photograph 2:

Looking south within the northern portion of Barangaroo. The area is the foreground and surrounding the sandstone outcrop is within the original shoreline. The area in the background is the location of Stage 1. The locations of areas within the original shoreline are approximately indicated by the red arrows.

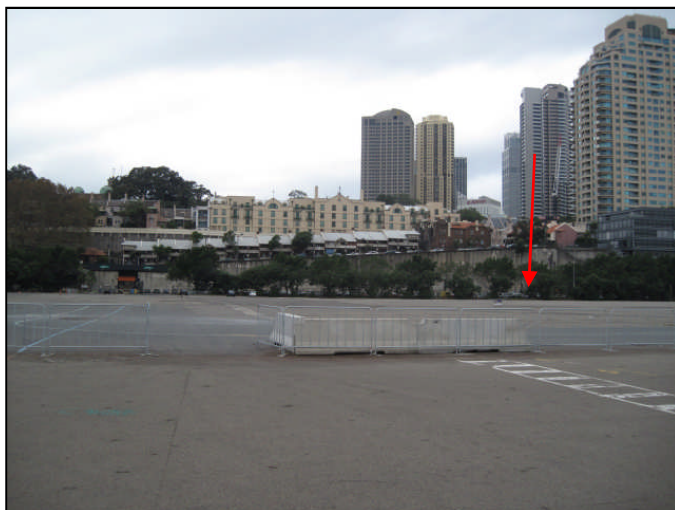
Photograph 3:

Facing east looking across Barangaroo towards Hickson Road. The location of the original shoreline is approximately indicated by the red arrow.

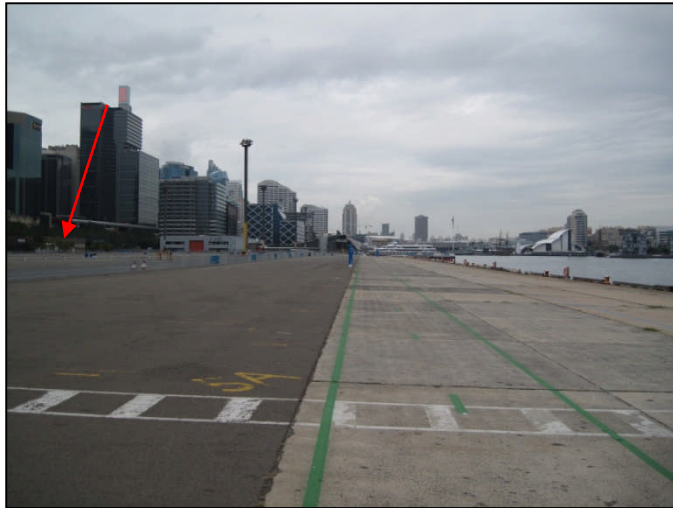
Photograph 4:

Facing south looking across the area designated for Stage 1 of development. The approximate area of the original shoreline is indicated by the red arrow.

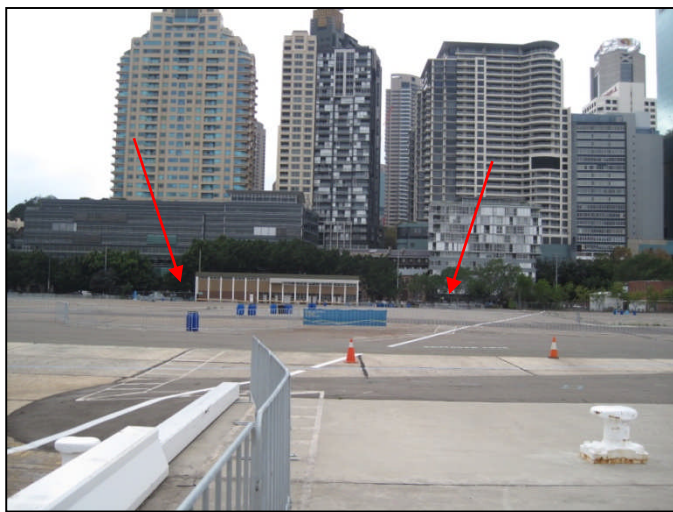
Photograph 5:

Facing east looking across Barangaroo towards Hickson Road. The approximate area of the original shoreline is indicated by the red arrows.

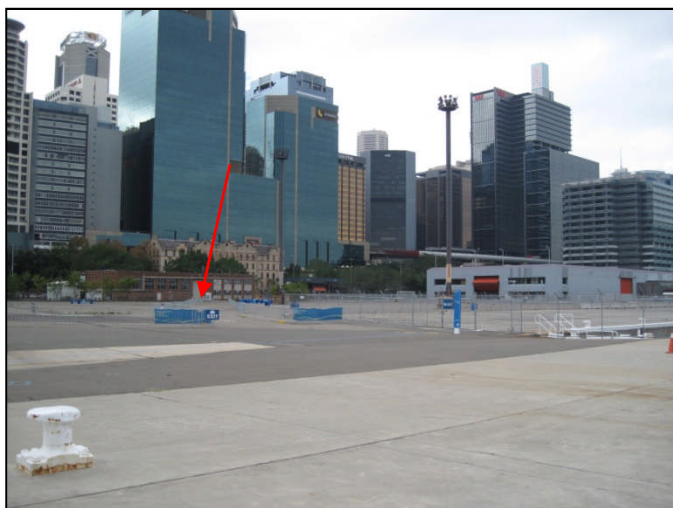
Photograph 6:

Looking south east across Barangaroo towards Hickson Road and the CBD. The area where the original shoreline was is indicated by the arrow.

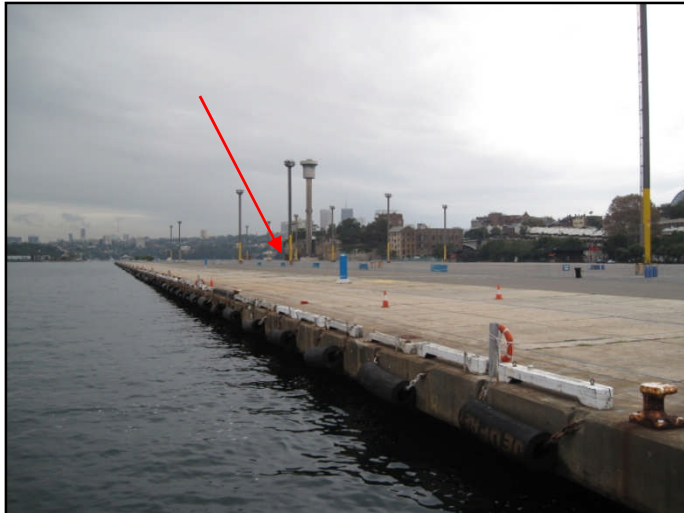
Photograph 7:

Looking north east across Barangaroo. The location of the area within the original shoreline is indicated by the red arrow.

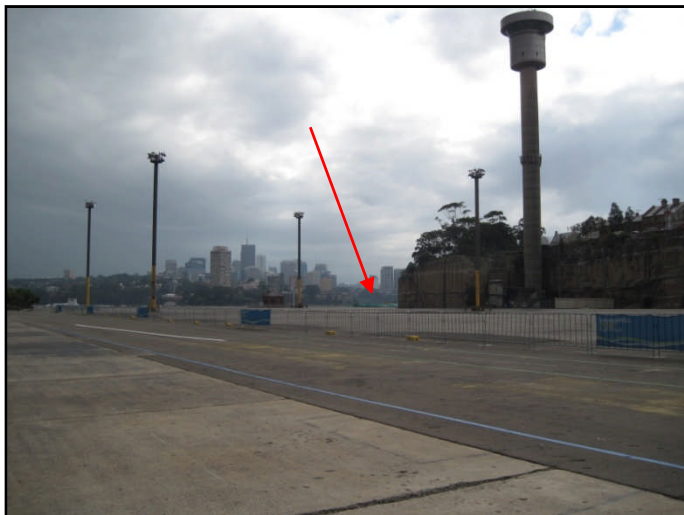
Photograph 9:

Looking north east at the northern section of Barangaroo. The sandstone outcrop seen in the middle left of the photo is in the region where the original shoreline is located, indicated by the red arrow. This is the area where the public domain and parkland will be created.
