Soil and Groundwater

Phase III: Risk Assessment

61 Mobbs Lane, Epping, NSW

Project No: CN081101

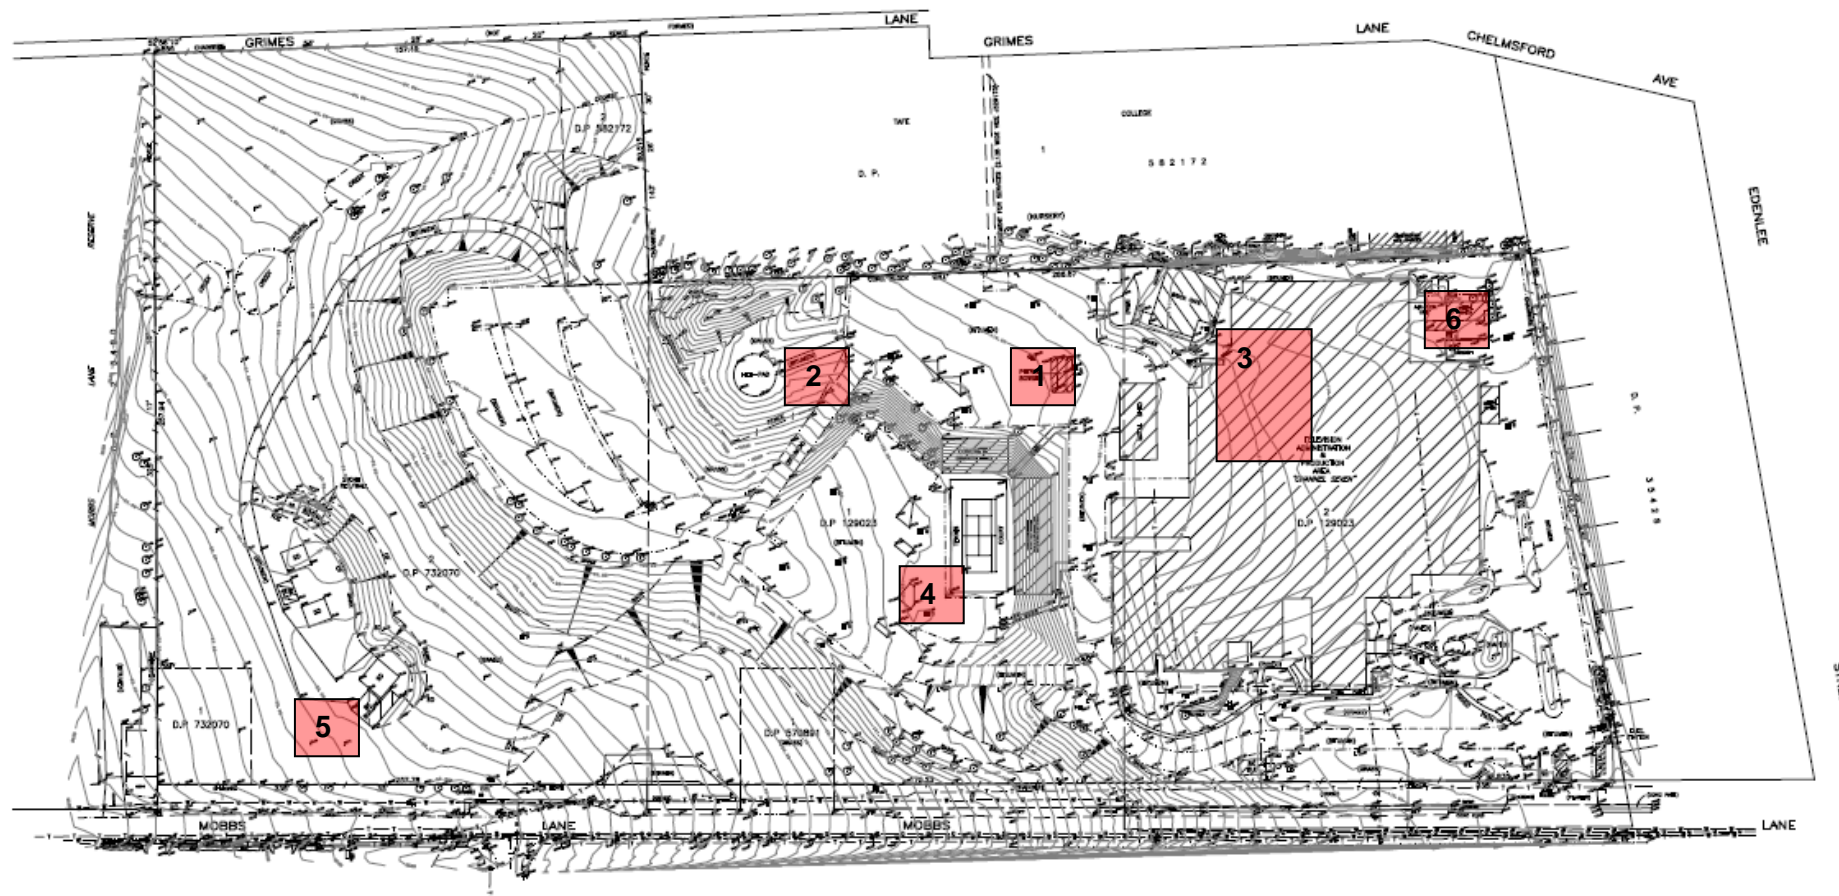
Figure 1: Location of contaminated soil at 61 Mobbs Lane

Hydrocarbon contaminated soil that remains in situ to the east of the excavation at a depth greater than 3m is likely to be below the NEPM health investigation levels for the proposed land uses (see Appendix F). This remaining contaminated soil is not likely to pose an unacceptable risk of exposure since contamination hasn't been detected in surface soil (depth 0-3m). Further to this site plans provided to CETEC show that this area is likely to be covered by hard landscaping (i.e. a driveway) (see Figure 2). If any further excavation of soil is required in this area it is recommended that the soil is tested further for waste classification purposes.
