Report on  
Geotechnical Investigation

Proposed Commercial Development  
3 Murray Rose Avenue, Sydney Olympic Park

Prepared for  
Lend Lease Project Management & Construction  
(Australia)

Project 45153.02  
August 2012

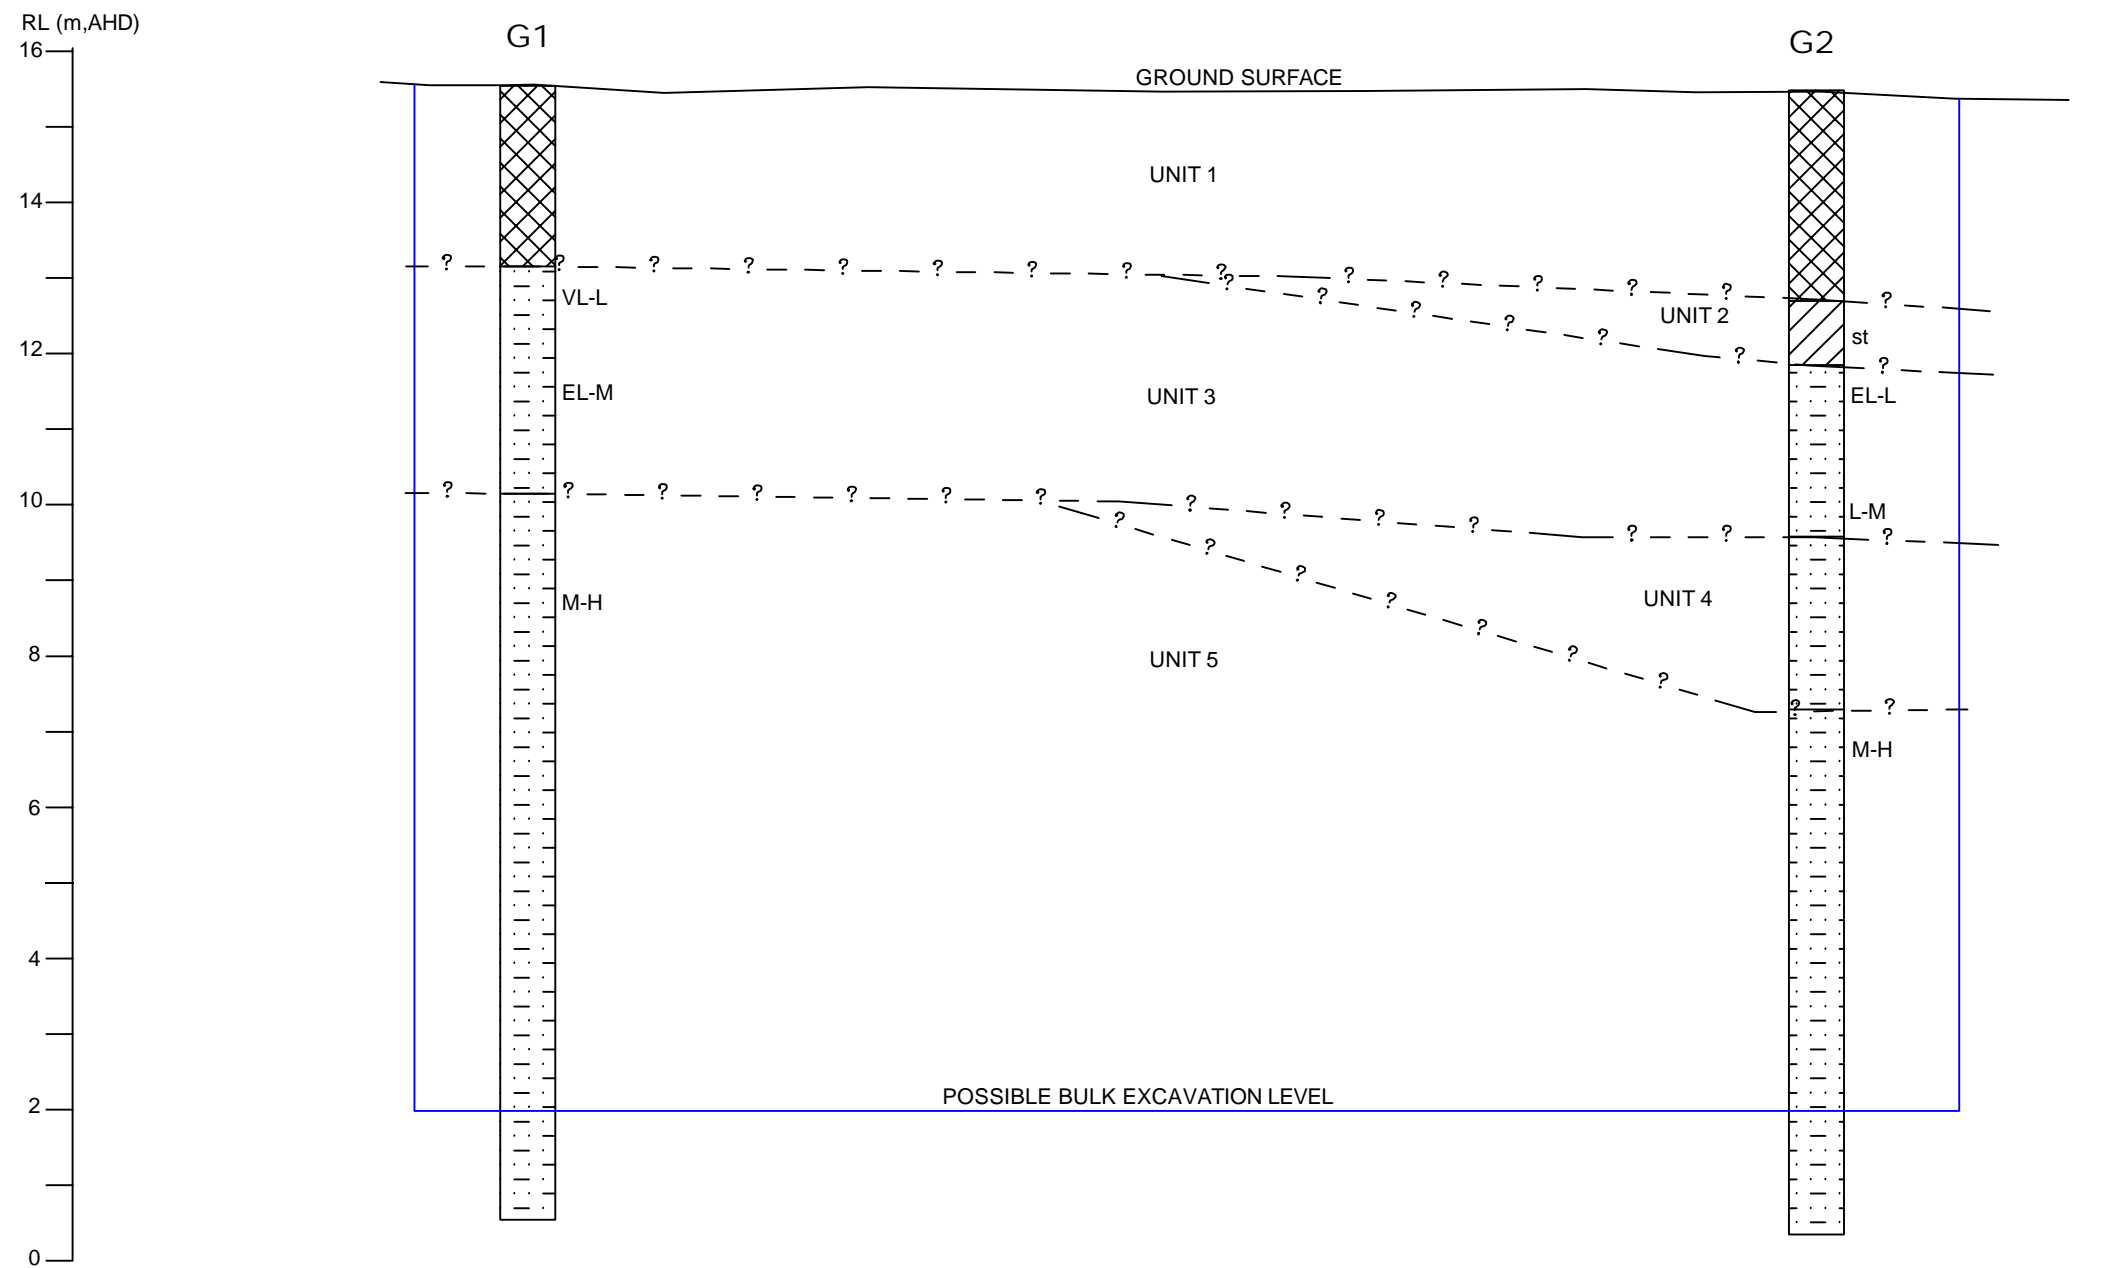
Note: Strata boundaries are inferred.  
Depths accurate only at test locations.

The subsurface conditions encountered in the boreholes are presented in the borehole logs in Appendix C. Notes defining descriptive terms and classification methods are included in Appendix A.

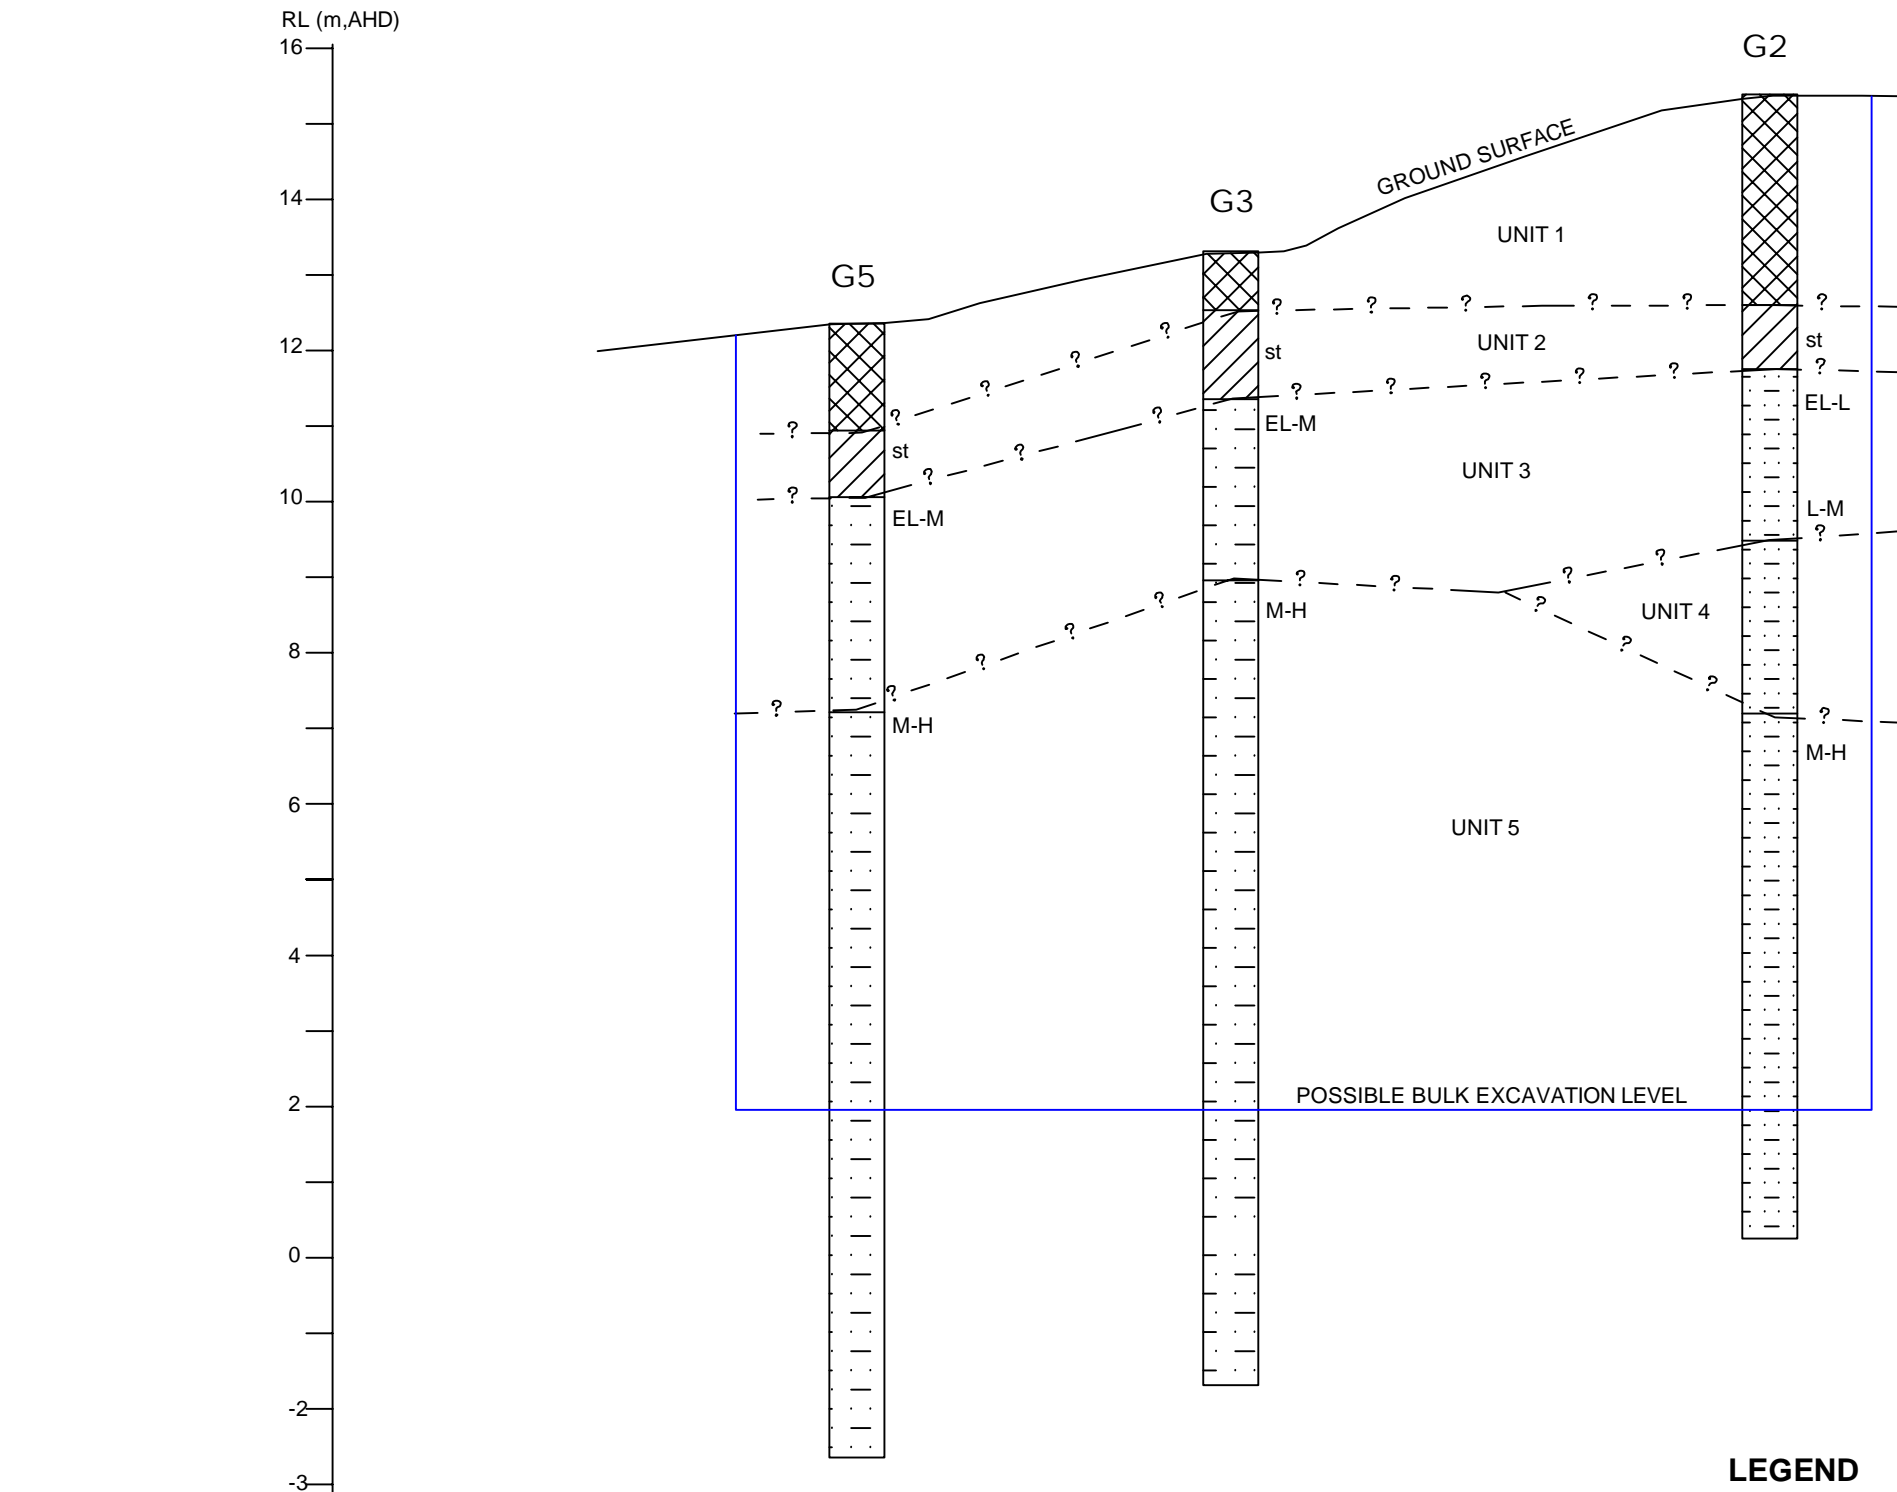
Note: Strata boundaries are inferred.  
Depths accurate only at test locations.
