WAGGA WAGGA BASE HOSPITAL

BASELINE ARCHAEOLOGICAL ASSESSMENT

FOR WEIR PHILLIPS

January 2011

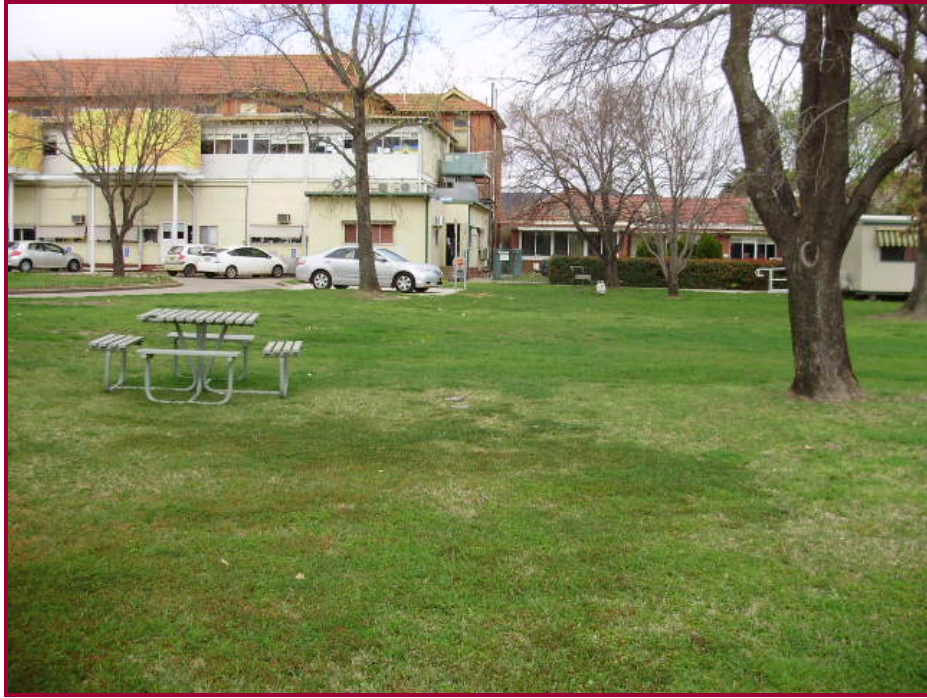
Figure 3. View facing South across the Edward Street lawn, showing lack of original vegetation and homogenized nature of the landscape.

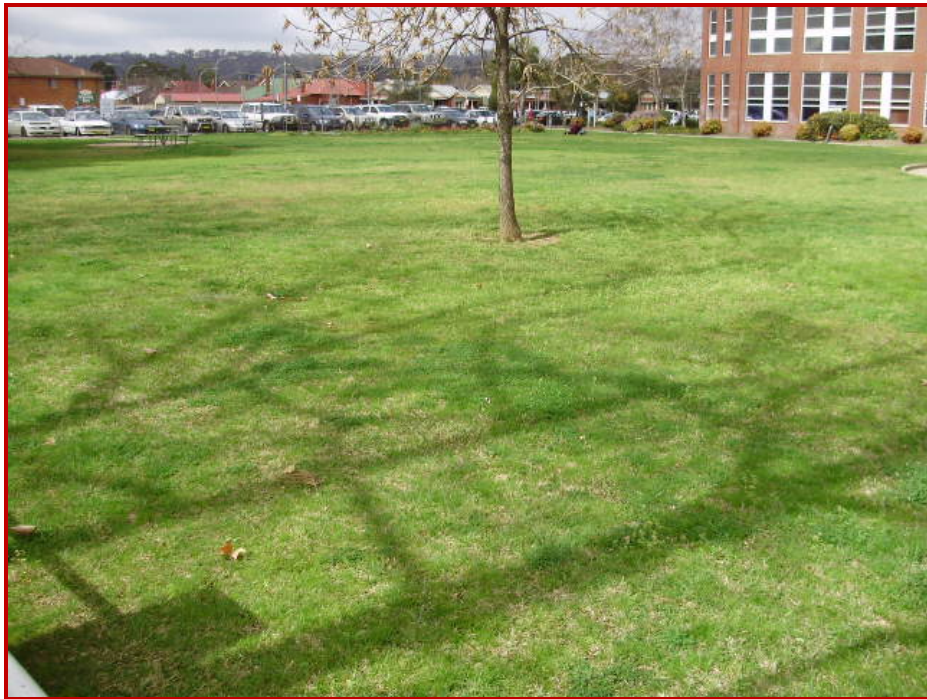
Figure 4: Approximate location of the former Rawson House facing Edward Street.

The one area of exception is Rawson House, the archaeological remains of which may have been retained largely intact (Figure 4). This structure appears not to have been recorded in any detail and information about it and its use do not seem to have been retained in public records. This information may be retained in the archaeological record.

- There are some grounds, however, to photographically record any remains associated with Rawson House (shown in **Figure 14** of this report) during site works should they indicate the internal configuration of the building.

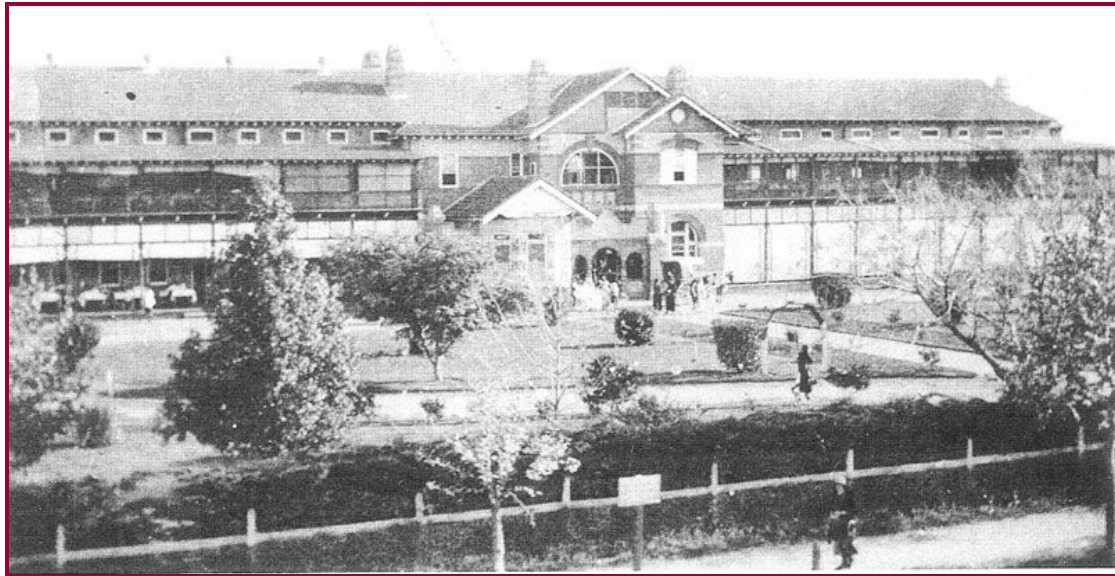
Figure 7: The Hospital after the addition of the second wing (Morris, 1988)

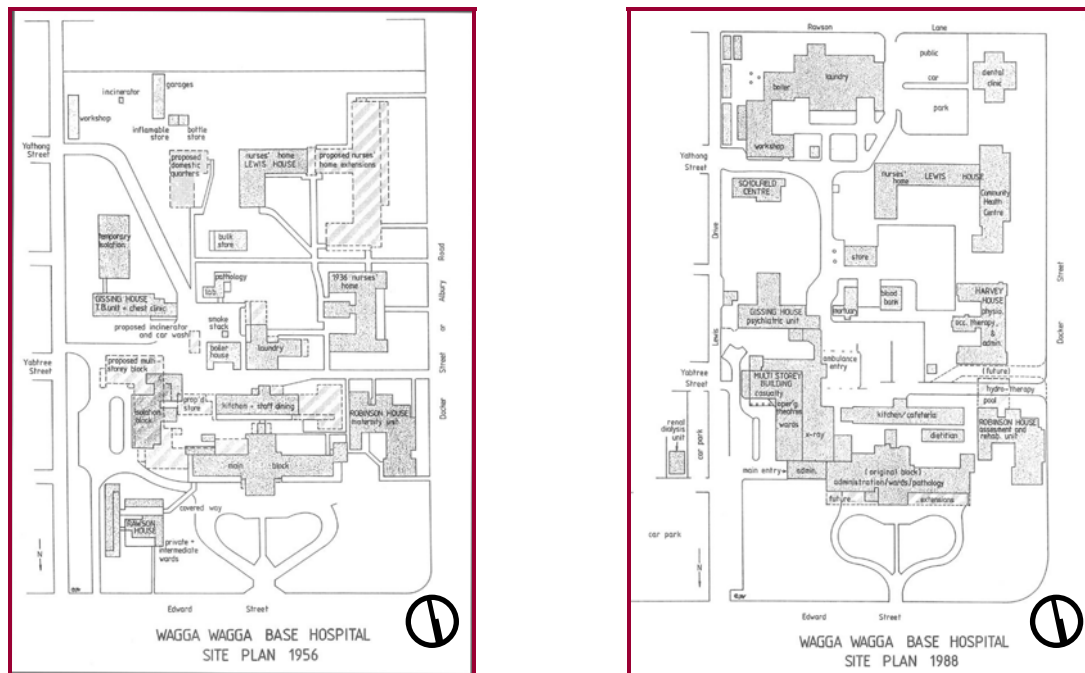
Site Plans 1956 and 1988 below (Figure 9) indicate the extent of post war change, demolition of older buildings and improvement.

Figure 9: Hospital Site Plans dating from 1956 (left) and 1988 (right) (Morris, 1988).

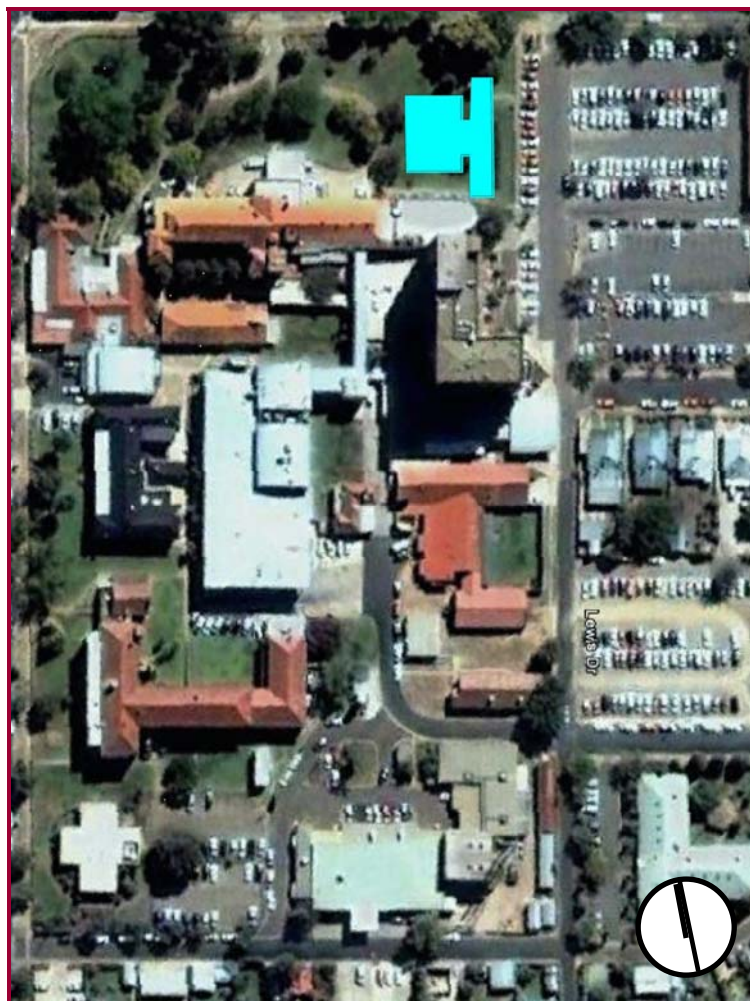
Figure 10 below indicates the location of the Rawson House archaeological remains (light blue) relative to current structures and features at the site.

Figure 10: Image in Blue indicates the location of the former Rawson House (light blue) within the Wagga Wagga Base Hospital site.

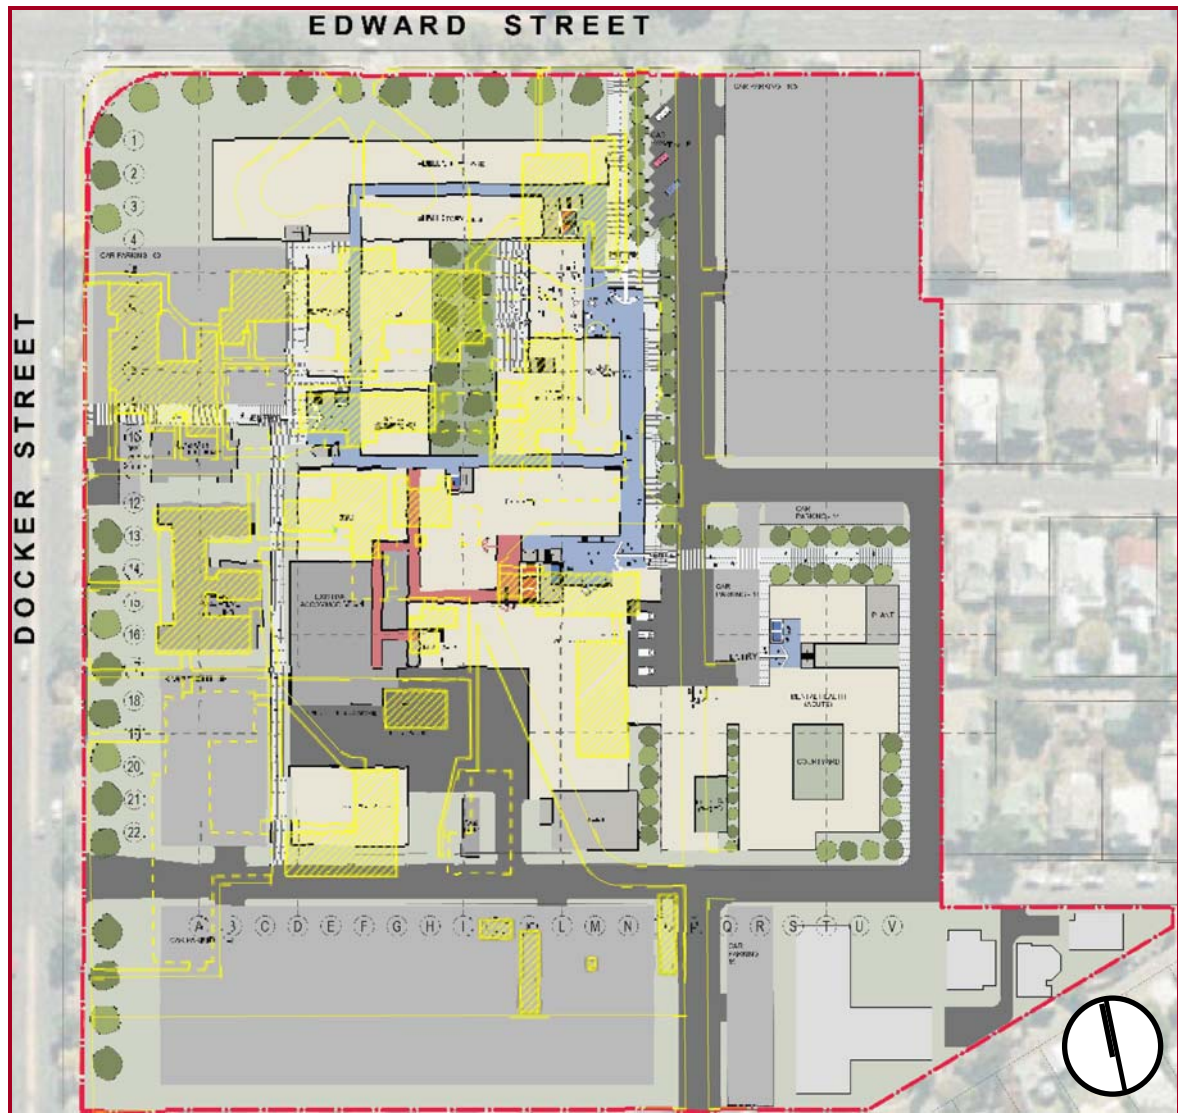
Overlays of the 1956 plan of the Wagga Wagga Base Hospital with the footprint of the proposed new works (Figures 11 and 12), indicate that nearly all current buildings and historical archaeological resources will be impacted by the proposed new works. This includes the remains of Rawson House which would be disturbed to make way for the proposed new Ambulatory Care and Health Information buildings.

Figure 11: Overlay of the 1956 Wagga Wagga Base Hospital (yellow) over proposed development plan.
