Report on
Preliminary Contamination Assessment

Proposed Redevelopment
Wagga Wagga Base Hospital
Edward Street, Wagga Wagga NSW

Prepared for
Health Infrastructure

Project 72320.01
May 2011

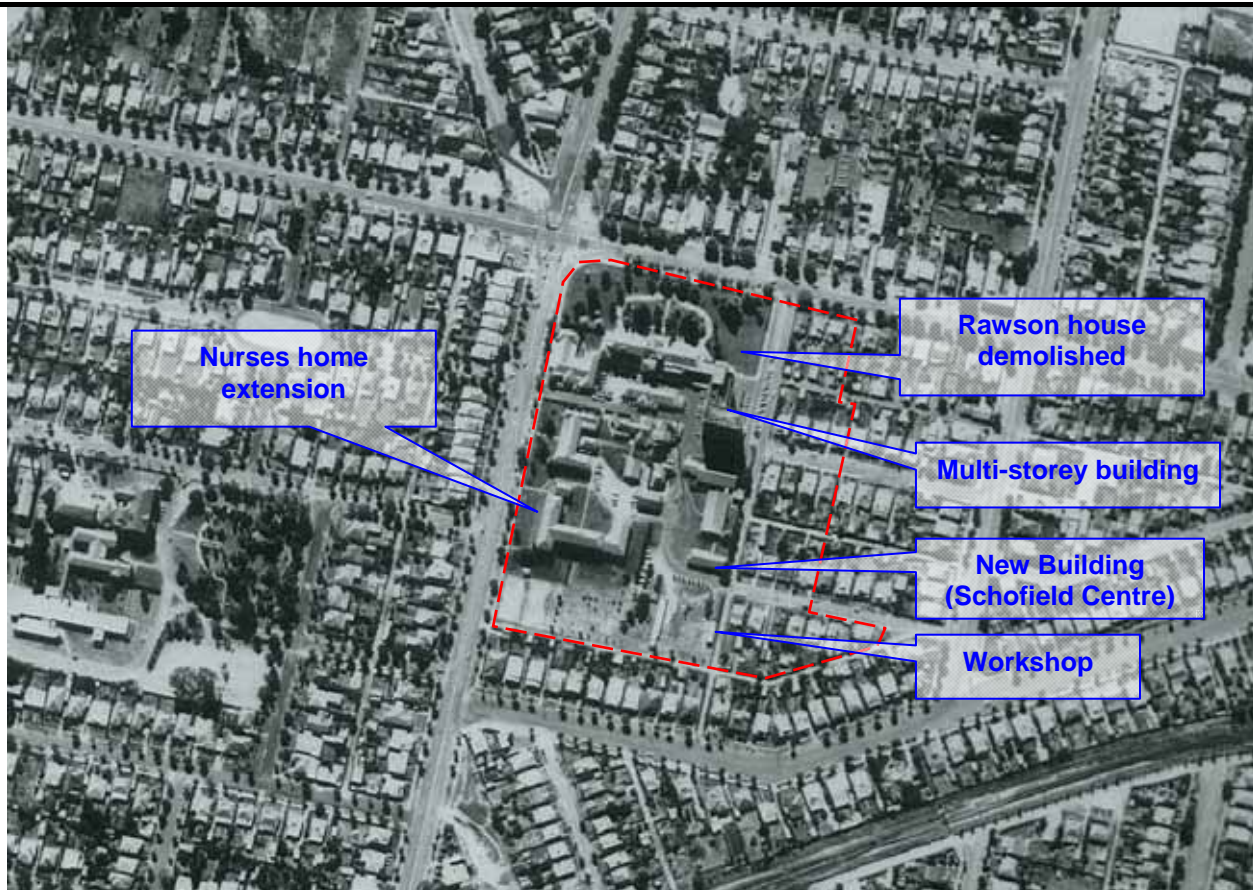
Plate 3: 1971

No significant changes to the surrounding land use is observed since the 1953 aerial photograph. The current location of the Caltex service station along the corner of Edward and Docker Street to the west of the Site appears to have a similar building orientation. However, this location appears to have been redeveloped in the 1971 aerial photograph.

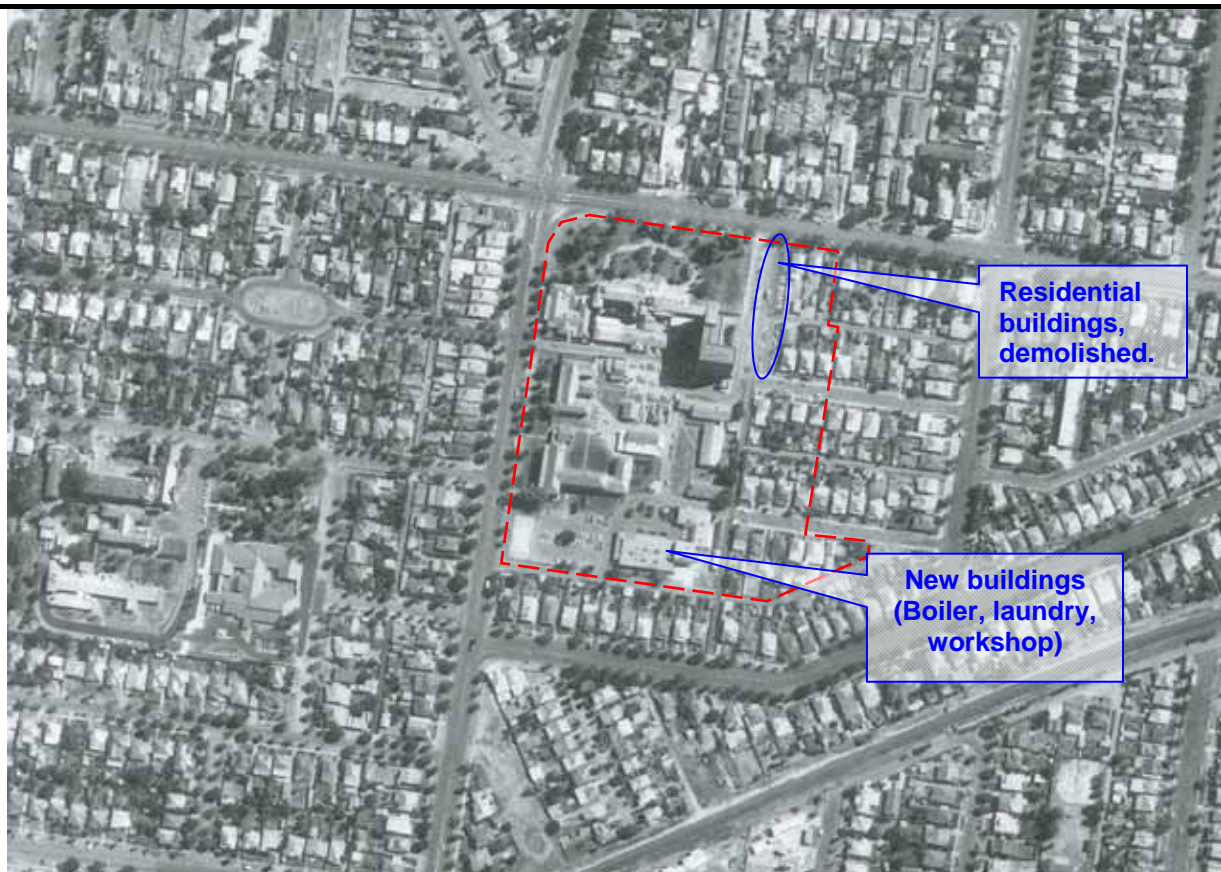
Plate 5: 1985

Some residential areas adjacent to Lewis Drive appear to have been demolished. Several buildings can now be seen south of the site. These buildings are noted to have been used as workshop, laundry and boiler house. No significant changes to the surrounding land use is observed since the 1980 aerial photograph.

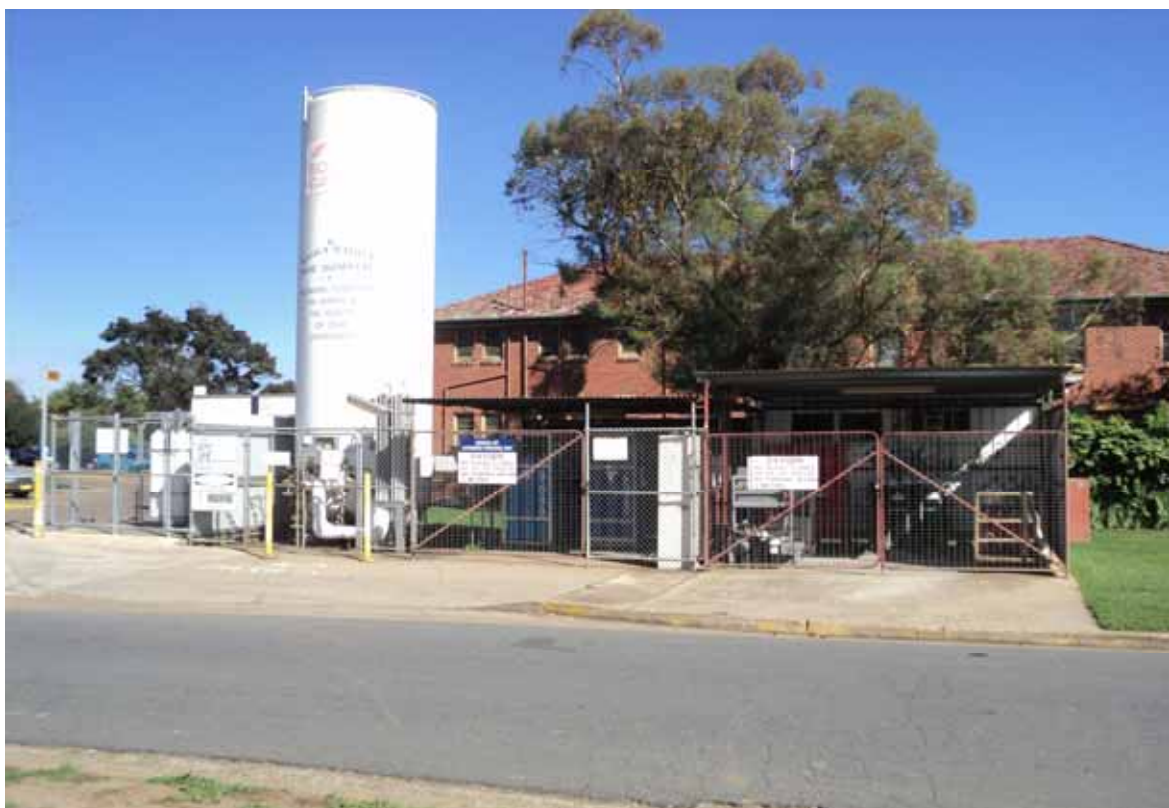
Photo 4 - Liquid Oxygen Depot

- An old boiler house was noted to have been built near Borehole 108 (Photo 1, Appendix F). No stressed vegetation was found in the grassed areas outside the building footprints. A new boiler house is located adjacent to the current laundry building.
- A Caltex service station was observed approximately 30m to the northwest off-site, across Docker Street (Photo 2). Borehole 106 (Photo 3) was placed down-gradient of Caltex service station. No stressed vegetation was observed near borehole 106.
- An oxygen tank was observed to be present on site (Photo 4).

The location of the former and current workshop may have used petroleum-based products (e.g. hydraulic oils, solvents, etc.). Spillage and/or inappropriate disposal of these products may cause contamination of the subsurface soil by TPH, BTEX, and other VOCs. These potential chemical contaminants may also be present within the oxygen depot as a result of maintenance.
