**Yarren Hut Solar Farm (SSD 10415)**

Thank you for your request dated 12 August 2020 to the Biodiversity and Conservation Division (BCD) requesting advice on the Yarren Hut Solar Farm project (SSD 10415).

## BCD's detailed comments

### Yarren Hut Solar Farm – Environmental Impact Statement (EIS)

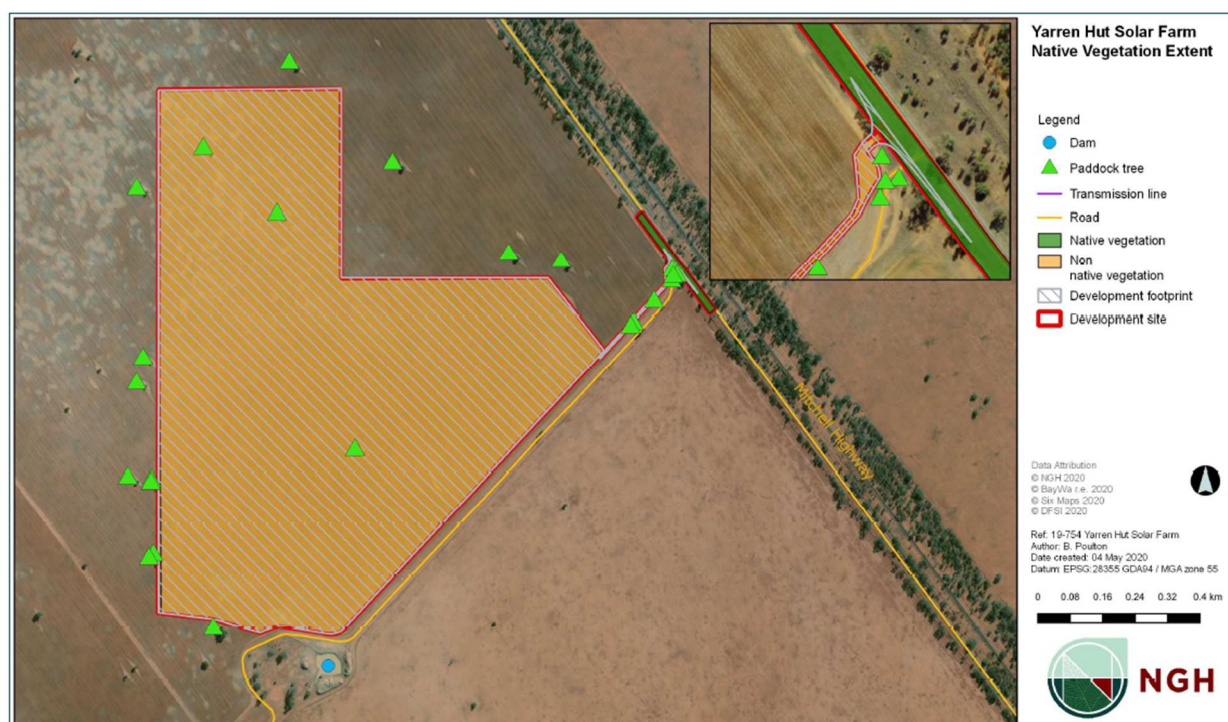
Figure 3-1 Native vegetation extent within the development site

Two example maps (Figure 3-1 and 6-1) from the Biodiversity Development Assessment Report (BDAR) are provided below. They appear to show two different alignments for the access treatment. The alignment shown in Figure 6-1 appears to conflict with that shown in the remainder of the maps in the BDAR.

The scale of the maps presented and some apparent conflict between them has made it difficult to verify the exact location of the 'access treatment' portion of the development footprint and the impact of the access area on native vegetation and habitat elements. Clarification of the footprint via a definitive map at an appropriate scale, habitat assessment results and adequate photos of this area will assist in addressing the comments and recommendations provided in this attachment.

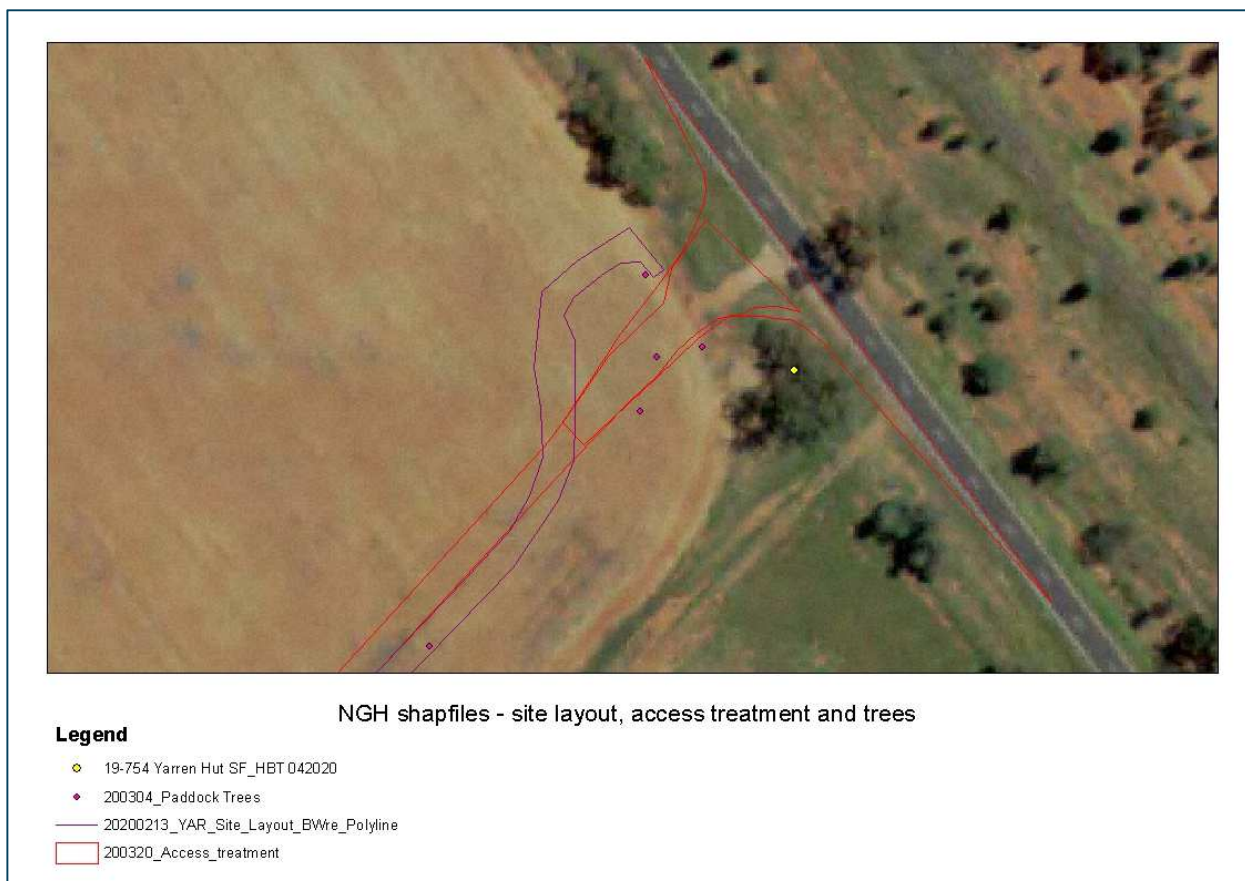
The map below shows the access treatment, site layout and recorded trees shapefiles provided to BCD by NGH. Despite checking the datum and projection of all layers, it appears there may be an issue in alignment of the files and the aerial image. Nevertheless, it appears the footprint shapefiles align with Figure 6-1 above but not the remainder of the maps in the BDAR.

Furthermore, it appears that the BAM plot established was located adjacent to, but outside of the development footprint. No plot data is provided from within the area of impact associated with the access treatment.
