DARLINGTON PUBLIC SCHOOL: CAPITAL INVESTMENT VALUE

Arboricultural Development Assessment Report

Darlington Public School
Chippendale NSW 2008
October 2018
DRAFT 1

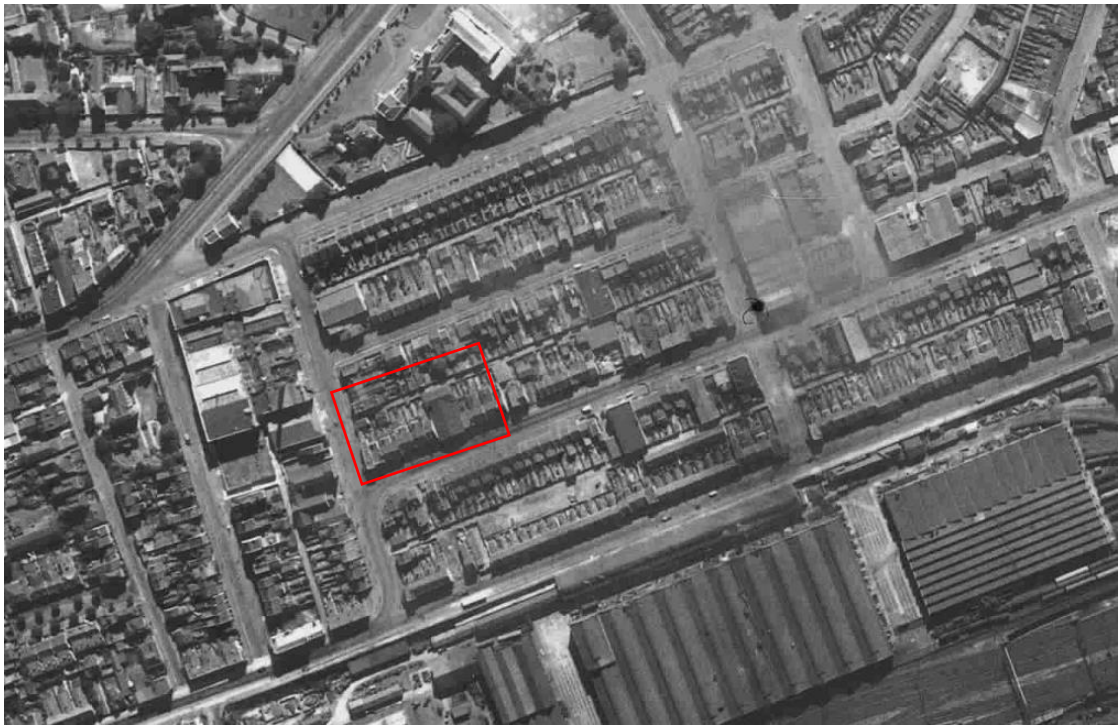
Diagram 2: The site as seen in 1943, devoid of trees (RTA From the skies, 2007).

- 3.11** Although this part of Sydney may be high in sand content that would normally encourage deeper root systems, the site has an uncertain history. Based on Diagram 2, it appears that prior to the school being built there were rows of terrace houses and warehouse structures, so subsoil conditions will be far from natural and would be highly disturbed. This will mean that old footings or foundations that may be subsurface will deflect woody roots keeping them close to the surface such as near Tree 20 (Plate 8).

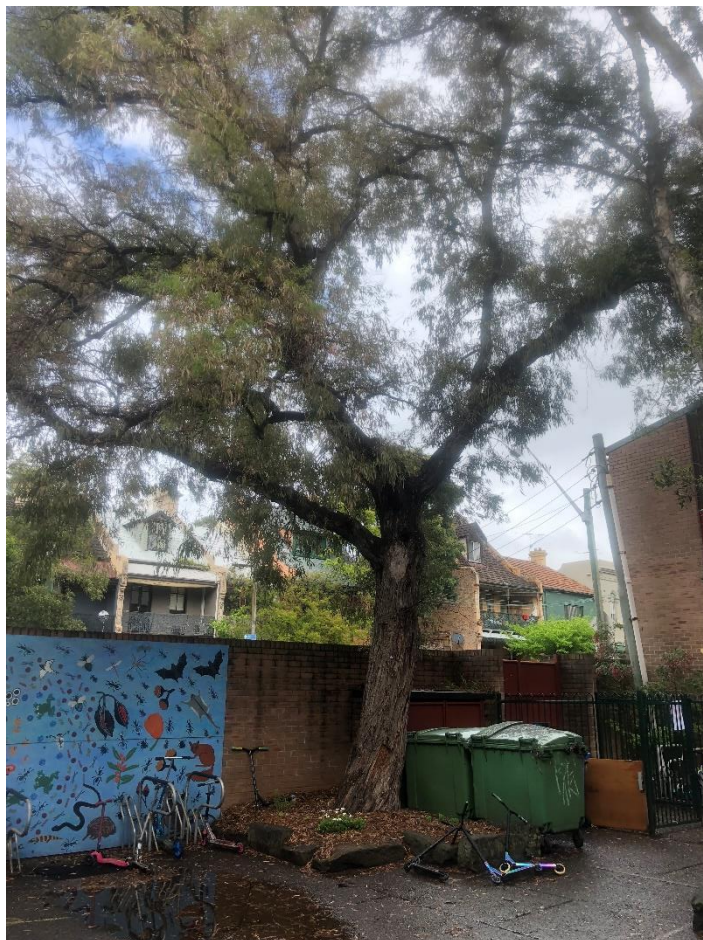
- 3.4 The Site Trees:** The site was inspected on 15th October 2018. Each tree has been given a unique number for this site and can be viewed on the Tree Location Plan (Appendix 1). All site trees have been tagged to correspond with the Tree Location Plan.
- 3.5** The site consists of several buildings connected by covered walkways. Playground areas are located throughout the site with specimen trees located in some protected courtyard areas (Plate 1). Some of these courtyard specimens are large mature specimens and potentially are nearing over-maturity such as Tree 3.

Plate 1: Image showing Tree 3. This tree has signs of drought stress however recent rain fall may extend its life expectancy. Working around a mature tree such as this will be difficult in terms of canopy impacts and root disturbance. P. Vezgoff

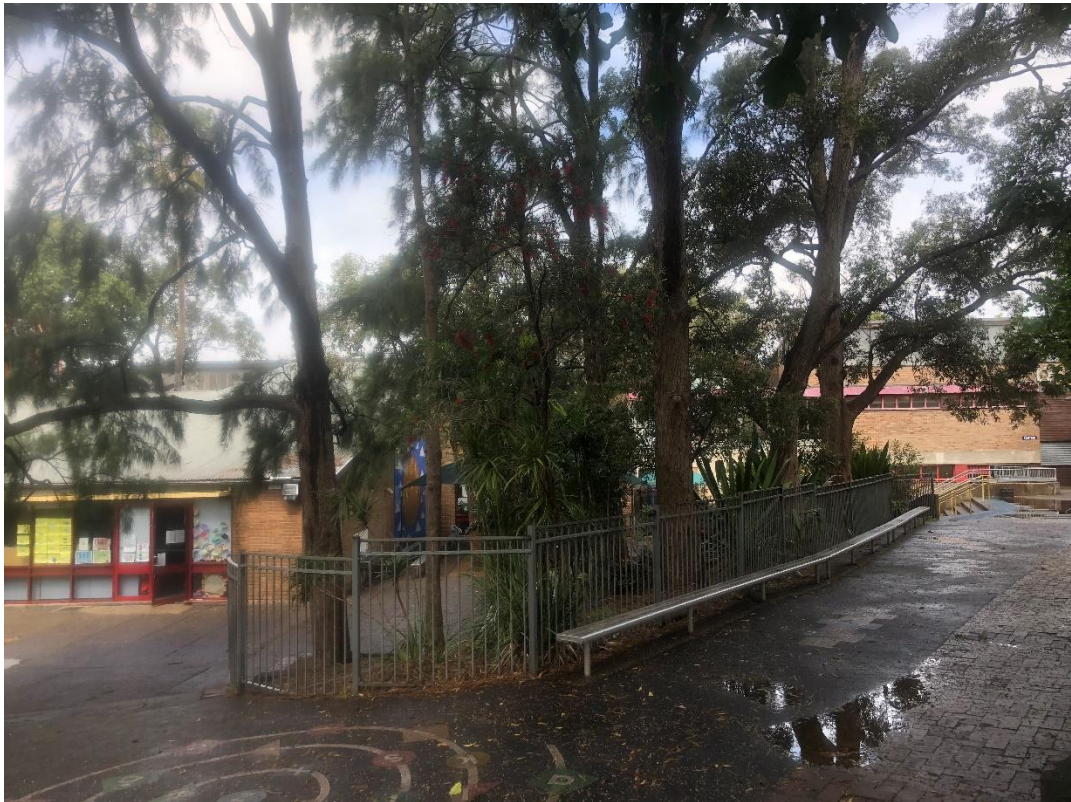
- 3.6** Trees 9-15 are within the central playground area (Plate 2). Although not great specimens individually, they do work well as a group providing canopy cover and good aesthetic value to the rear area.

Plate 2: Image showing Trees 9-15 central to the playground area. P. Vezgoff

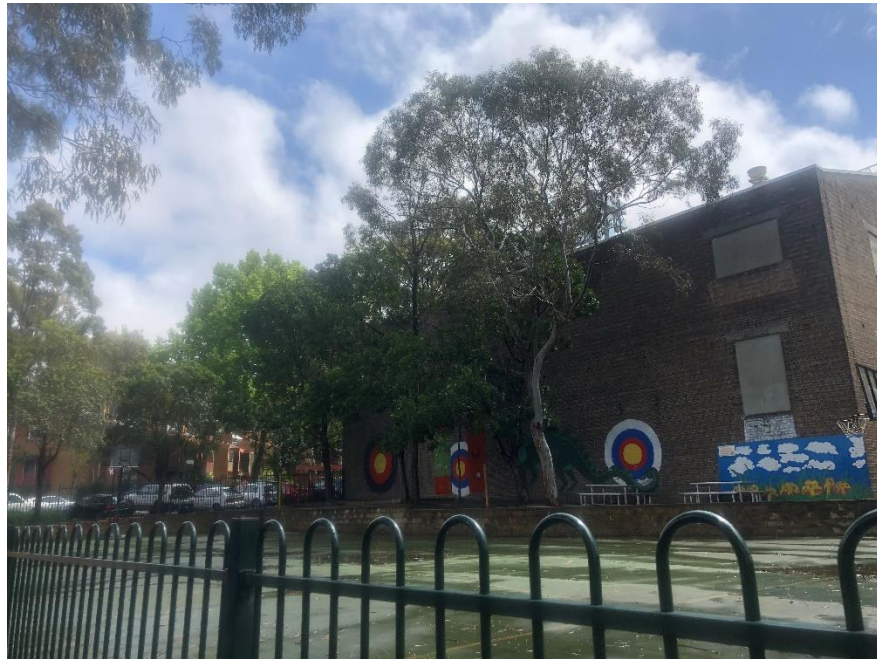
- 3.7** Trees 26-31 (Plate 3) are tightly grouped specimens that have a restricted root space and are covered with asphalt and playground rubberised matting up to the trunks. These trees are in good health but could be replaced with better specimens. They would not be considered long term specimens.

Plate 3: Image showing Trees 26-31. P. Vezgoff

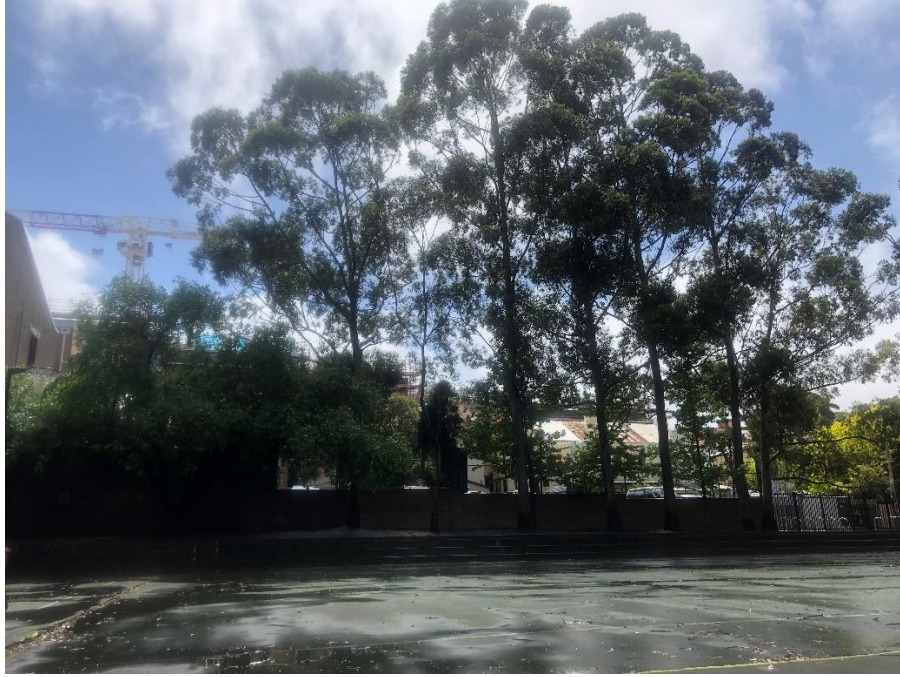
- 3.8** Trees 32-43 (Plate 4) are growing along the northern boundary fence (Plate 4). These are a mixed group of large mature *Eucalyptus* specimens but competing with some exotic specimens that have been planted between and under the large *Eucalyptus* specimens. As with Trees 26-31, these trees are also tightly grouped specimens that have a restricted root space and are covered with asphalt and playground rubberised matting up to the trunks. Varied levels are present as these trees have been planted on a stepped area (Plate 5).

Plate 4: Image showing Trees 32-43. P. Vezgoff

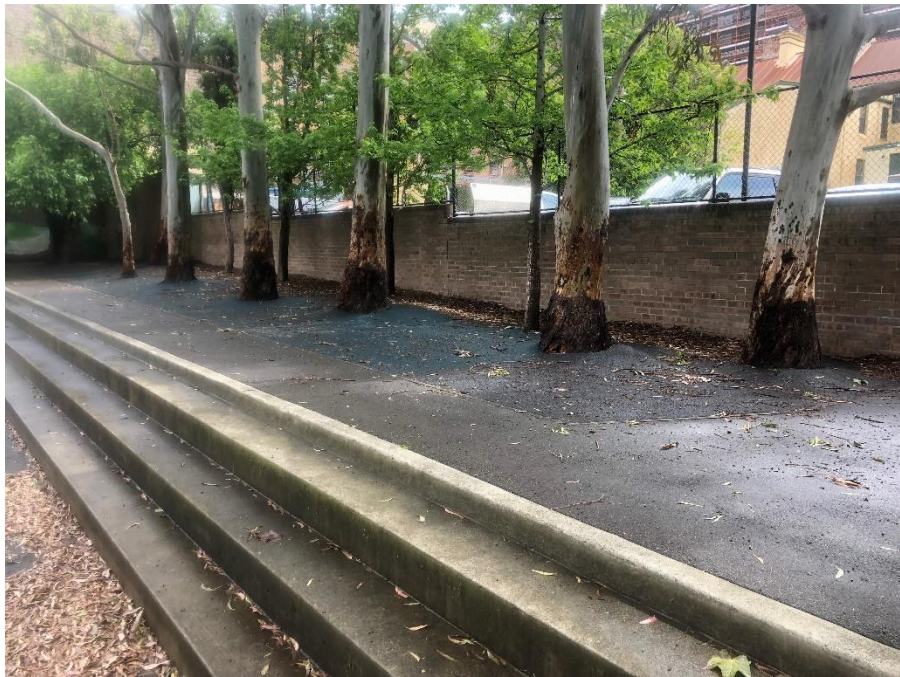
Plate 5: Image showing surface condition of Trees 32-43. P. Vezgoff

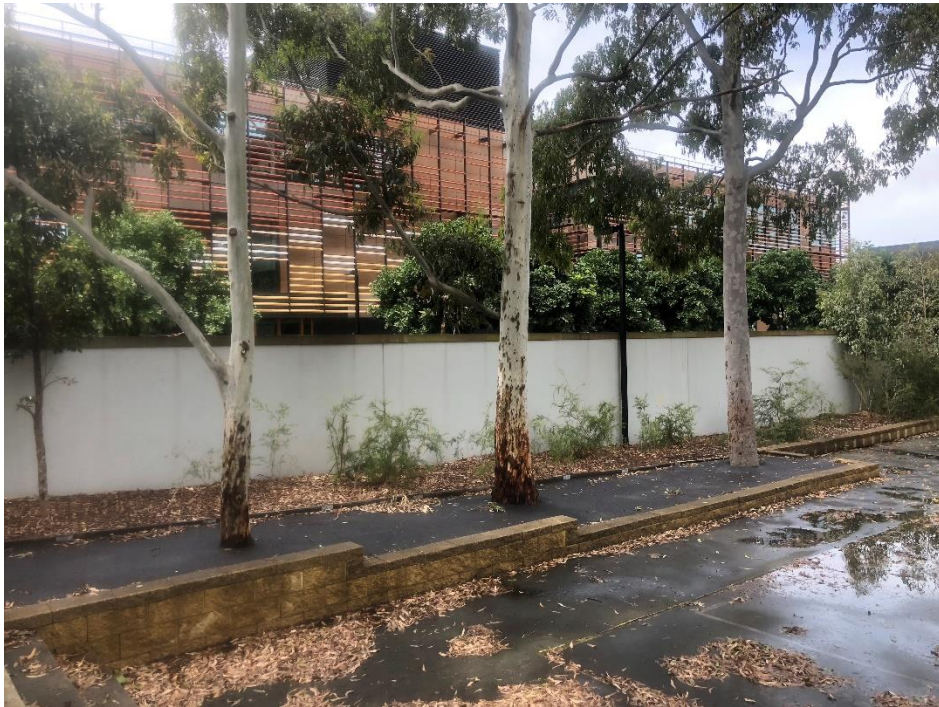
Plate 6: Image showing Trees 44-46. P. Vezgoff

- 3.9** Trees 44-46 (Plate 6) are growing along the eastern boundary fence. These trees are younger specimens in excellent health and condition and provide a good screen between two properties. Majority of the root zone of these trees is covered with hard surface.

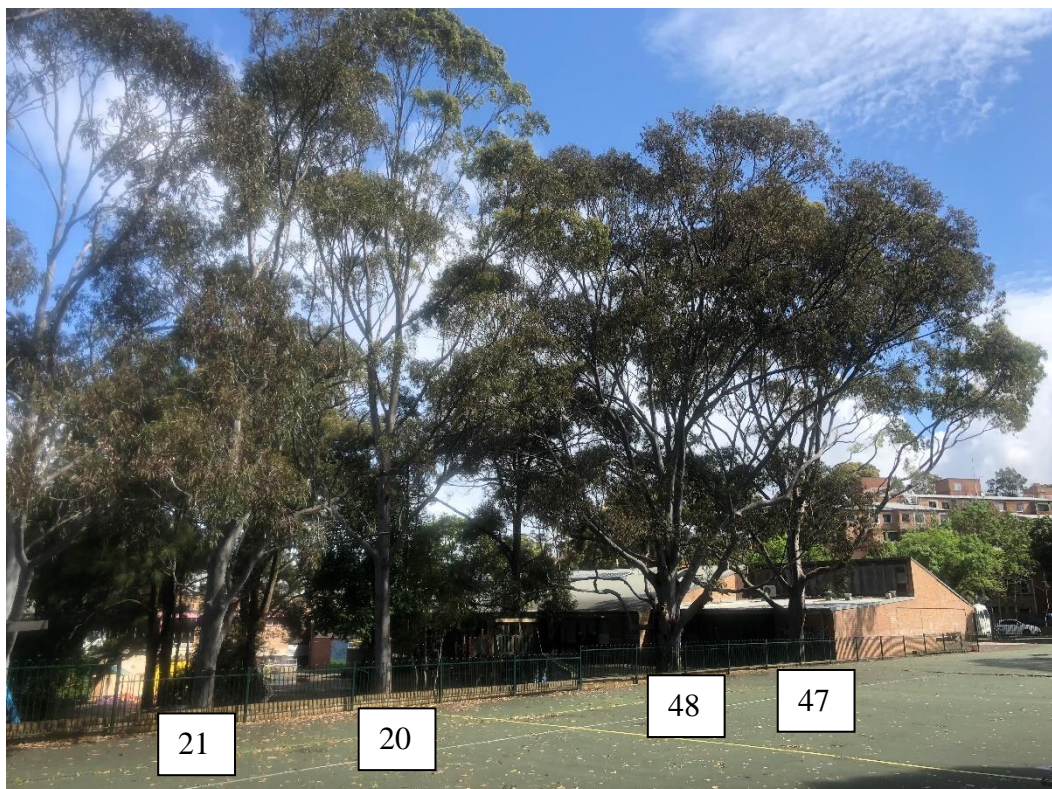
Plate 7: Image showing Trees 21, 20, 48 and 47. P. Vezgoff

- 3.10** Trees 47-48 (Plate 7) along with Trees 20 and 21 are some of the larger trees on site being some twenty (20) meters in height. Again, the majority of the root zone of these trees is covered with hard surface. These trees have some previous failures which is to be expected from trees of this size and age. These trees were assessed as being in good health and condition. The main trunk, first and second order branches are free of any cracks, splits or fruiting bodies. New extension growth was noted. The basal area and woody root zone were free of any ground heaving, or lifting. Ideally an aerial inspection should occur to fully determine the condition of the main branch unions.

- 4.3** Trees 20, 21, 47 and 48 require an aerial inspection due to the size of these trees and the limited ability to inspect from ground level.
- 4.4** Trees are dynamic living organisms that provide a broad, extensive range of benefits. Whilst Moore Trees has used the most recent in industry standards with regards to tree health and risk assessment the advice and recommendations in this report are limited to twelve (12) months after which all reasonability regarding the site trees is that of the School.

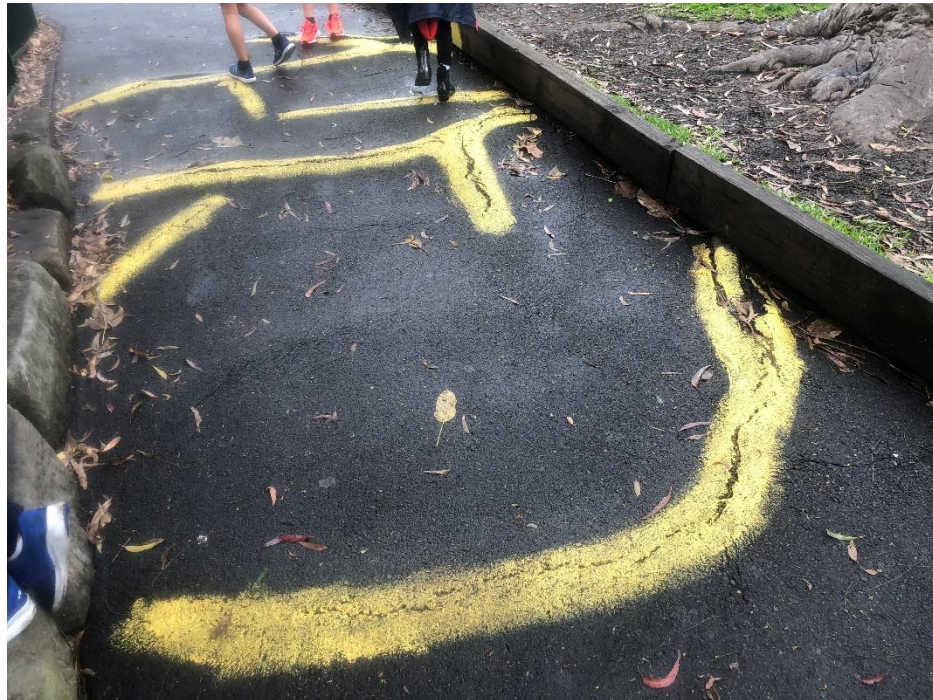
Plate 8: Image showing surface roots from Tree 20. P. Vezgoff

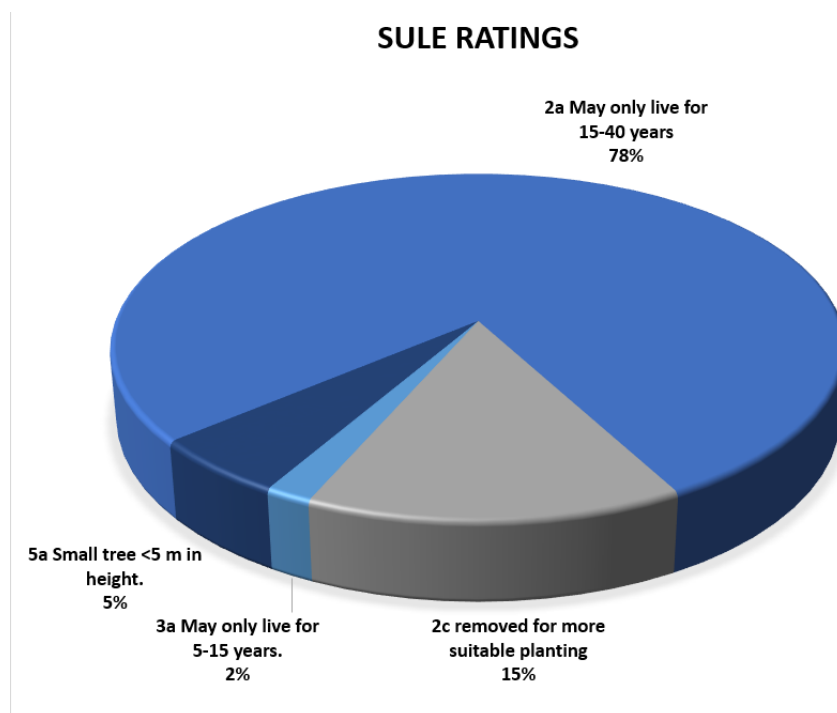
3.12 Safe Useful Life Expectancy (SULE) is a method of evaluating individual trees. The evaluation is a subjective assessment, not an absolute judgement, because the nature of trees and opinions on trees can vary greatly. SULE assessments are made only by those who are experienced and knowledgeable in tree management. SULE is generally accepted and used world-wide as a method of evaluating trees. Each category has a number of sub-categories. These sub-categories should always be recorded to help future users of the information appreciate the reason for each allocation decision. It is normal to have instances where trees will not fit neatly into a single SULE category. The assessment of the site trees can be seen in Graph 1. In general, the trees were mostly assessed as being in good health. SULE results show that 78% of the site's tree population has a life expectancy of between 15-40 years. Trees that have a short life expectancy or could be readily replaced total 22%.

Graph 1: SULE ratings for the site trees.

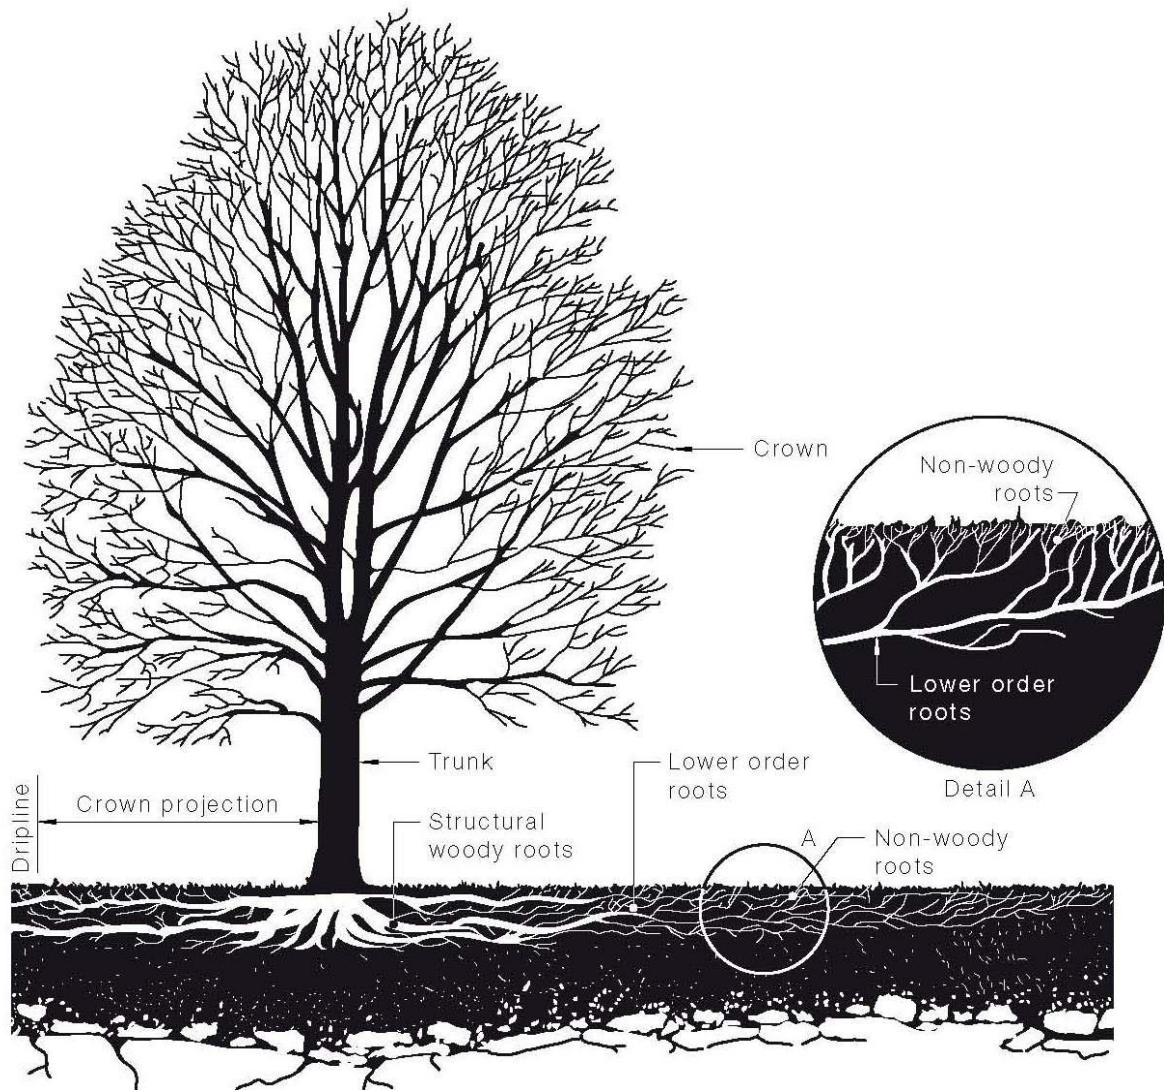
Figure 2: Structure of a tree in a normal growing environment (AS 4970, 2009.).
