Subject: Murwillumbah High School – Aboriginal Heritage Creek Investigation Report

Re: Murwillumbah High School, Murwillumbah, NSW -Aboriginal heritage - creek investigation

1 Rationale and approach

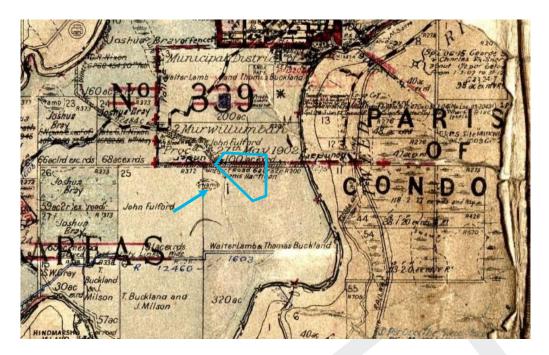
Plate 1 Detail, 1903, Parish of Murwillumbah, County of Rous, Land District of Murwillumbah.

Department of Lands, Sydney. School site marked in blue. Arrow shows swamp

The 1903 parish map (Plate 1) indicates the School is located on the 100 acres (c.40.5 hectares (ha)) granted to John Fulford May (7 May 1902) and the 320 acres (c.129.5 ha) acres granted to Walter Lamb and Thomas Buckland.¹ A roadway, possibly Elizabeth Street, is north of the school site and notes indicate it was established by Dennis Hartigan. The school site was known as Hartigan's Estate, so it is likely the estate was established at this time. There are no waterways marked between the town of Murwillumbah and the small inlet near the bend in the river, which survives today. Murwillumbah Creek to the north of the school site is not marked. A swamp area is included west of the present school site. A photograph from around 1905 shows that the area was lightly wooded farmland.

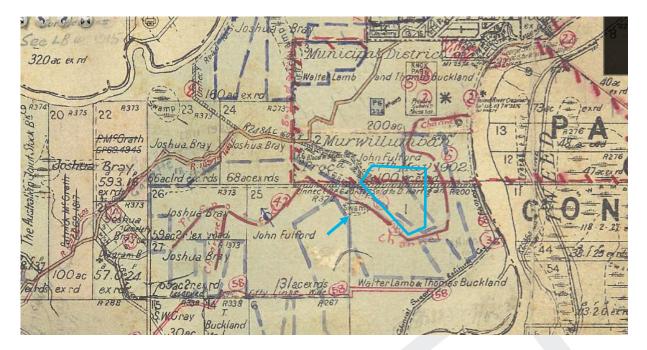
Plate 3 Detail, 1907 (annotated 1907 to c.1913), Parish of Murwillumbah, County of Rous, Land District of Murwillumbah. Department of Lands, Sydney. School site marked in blue. Arrow shows swamp.

An annotated version of the 1907 parish map (Plate 3) is the first plan that indicates the origins of the creek. The annotations on the map date between 1907 and c.1913. A red hand-drawn line marked "channel" maps the route of the Lavender Swamp drainage channel system, completed on the 18 December 1912 (Government Gazette of the State of New South Wales, 24 December 1912, p. 7531). The channel connects inland wetlands, including the swamp west of the current school site, to the Tweed River. The map shows the alignment of the creek differs from the present. It curves north to (unmarked) Murwillumbah Creek, whereas today the creek continues east to the river.

The earliest aerial photograph for the area dates to 1962 (Appendix B). The image shows the creek follows the present alignment. Another waterway is visible running north/south through the sports fields east of the school. This waterway connects to Murwillumbah Creek in the north and the creek system near Commercial Road to the south. The north/south waterway appears to be artificial, but incorporates natural sections of Murwillumbah Creek. It must be noted, however, Murwillumbah Creek has a history of realignment itself. This waterway aligns with the north/south creek illustrated in the annotated 1907 Parish map and army topographic plan (Plate 3, Plate 6).

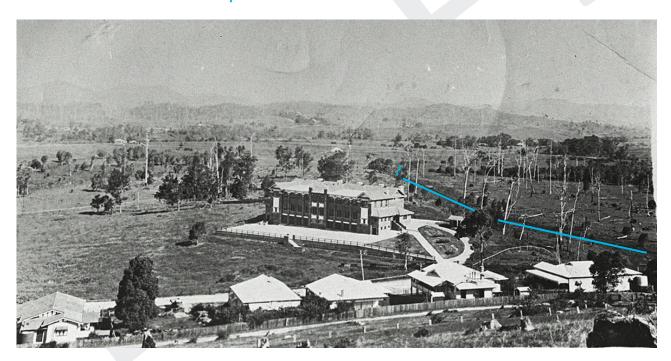
Plate 4 Completed school building in 1929 (Source: Tweed Regional Museum). Blue lines delineate visible sections of the drainage channel (dashed section marks its possible continuation)

The creek channel is visible in the 1929 photograph of the completed Murwillumbah School building (Plate 4). The photograph was taken looking south east and the line of the creek can be seen passing the school on the right -hand side of the image.

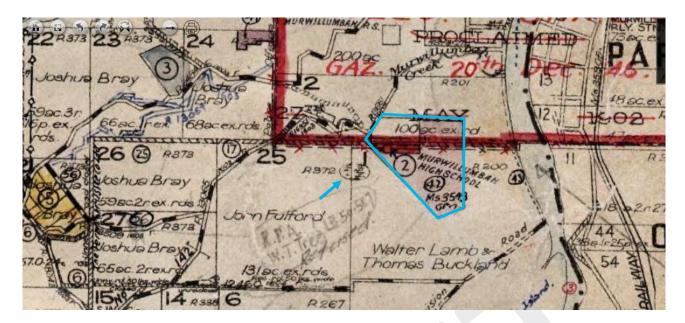
Plate 5 Parish of Murwillumbah, County of Rous, Land District of Murwillumbah, 1838. The school site is delineated in blue; the arrow shows the swamp discussed in text (Source: Department of Lands, Sydney)

Later parish maps include the land resumed for the school but do not depict the creek (for example Plate 5). A military map from 1942 confirms this early route of the creek may still have been present (Plate 6). It shows the creek/channel running along the south west border of the school before turning to the north and disappearing into the gridded streetscape of the growing township.

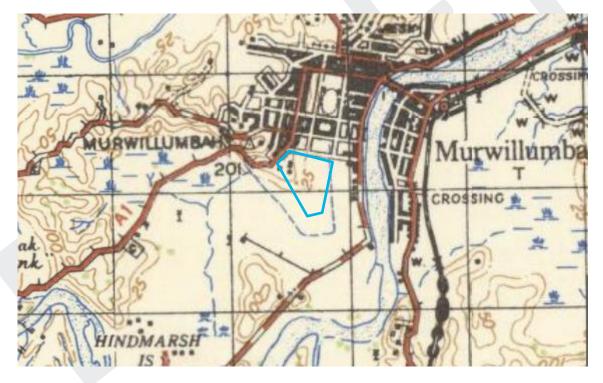
Source: 2/1 Aust. Army Topo. Svy. Coy., Sept. 1942; National Library of Australia

Plate 6 A topographic map of the study area (approximate location shown in blue) showing the different alignment of the drainage channels, which currently runs along the edge of the study area

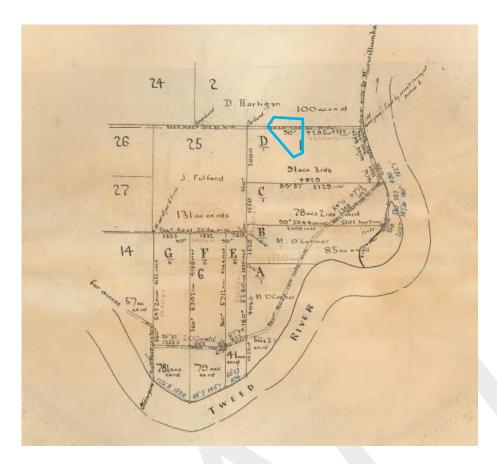
Plate 7 Plan of 5 blocks numbered C D E F G, being subdivisions of portions 1 and 6, County of Rous, Parish of Murwillumbah, Land District of Murwillumbah Land Board District of Grafton, 1903. The school site is delineated in blue

A property and DP search was completed for Lot 2 DP 574278, which encompasses the portion of the creek nearest the present day school site (Appendix A). The 1903 survey plan of the area details the occupants and subdivision of the area (Plate 7). The plan does not show the wetlands or any natural creek around the future school site.

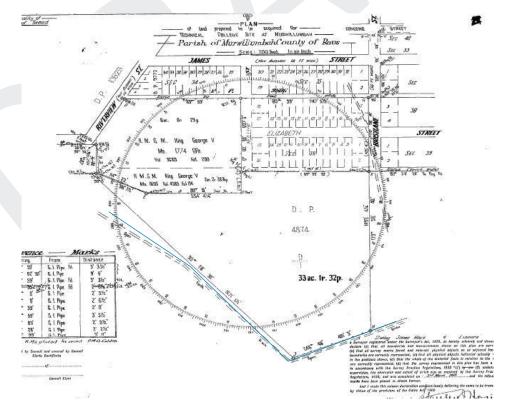
Plate 8 Plan of land proposed to be acquired for Technical College Site At Murwillumbah, Parish of Murwillumbah, County of Rous, 1929. The blue line shows the alignment of the drainage channel

The 1929 plan of the High School Block illustrates an 'open earth drain' in the present alignment of the modern creek (Plate 8) -a terminology more indicative of a human made construction than a natural water feature. In 1969, however, the drain is not mapped (Plate 9). The 1975 plan depicts the modern alignment of the creek, where it is similarly labelled as an "open drain" (Appendix B).

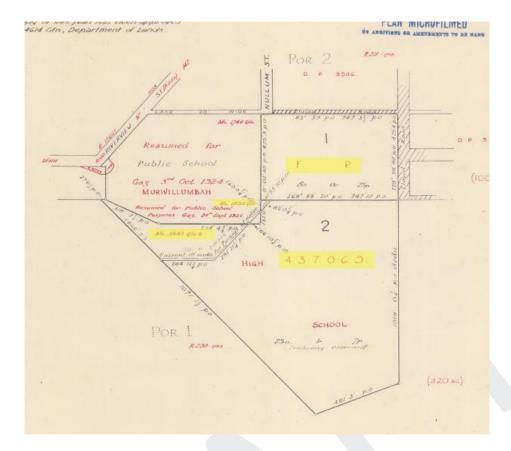
Plate 9 1969 plan of subdivision of Land contained in cert. title. Vol 6698, Fol 170. At Murwillumbah, Parish of Murwillumbah, County of Rous

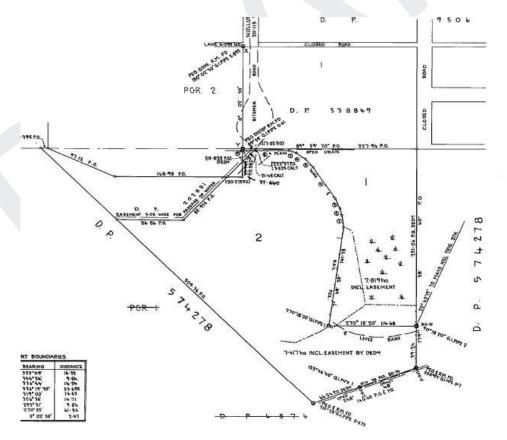
Plate 10 1975 plan of subdivision of Lot 2 DP 5742785 being land in C.T. Vol 11225 Fol. 124, County of Rous, Parish of Murwillumbah
