Project Name	253-267 Aldington Road, Kemps Creek - Riparian Constraints Assessment
Project Number	21SYD - 18730
Project Manager	Roshan Kalugalage
Prepared by	Roshan Kalugalage and Claire Wheeler
Reviewed by	David Bonjer
Approved by	David Bonjer
Status	Final
Version Number	4
Last saved on	26 April 2021

This report should be cited as 'Eco Logical Australia 2021. 253-267 Aldington Road, Kemps Creek - Riparian Constraints Assessment. Prepared for Icon Oceania.'

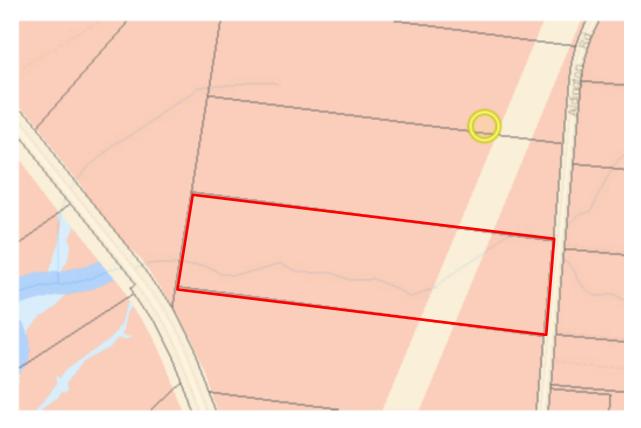
Name	Relevance to the project
Draft Cumberland Plain Conservation Plan (2020)	The draft CPCP classifies the entire site at Urban Capable (see Figure 5 below). The nearest land proposed Non-certified – Western Sydney Aerotropolis or Non-certified – Avoided for Other Purposes is downstream of the site.

Figure 5 Extract from draft Cumberland Plain Conservation Plan - Exhibition Viewer

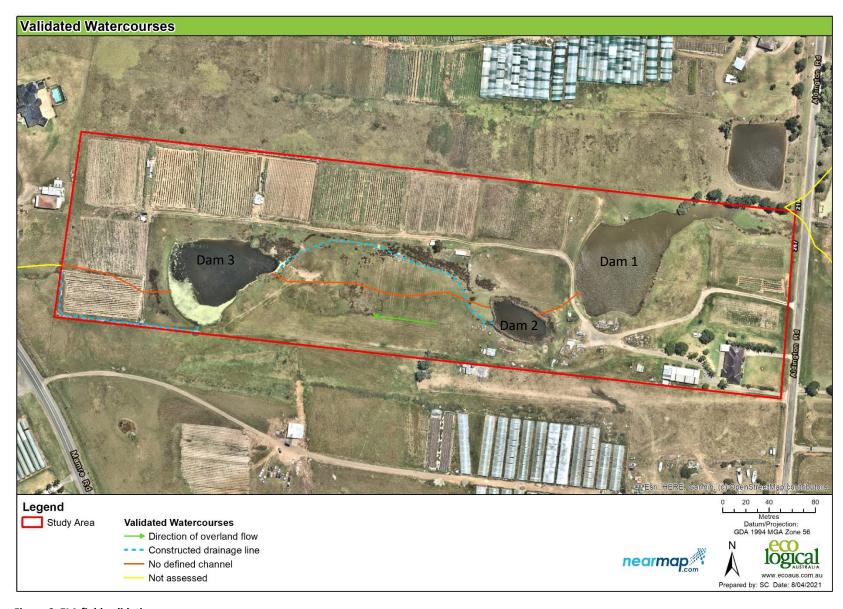
Figure 6: ELA field validation

DPI mapping showed an unnamed second order watercourse within the study area, which travels in a westerly direction and is fed by two first order watercourses that are located to the northeast of the study area (Figure 1). These watercourses are tributaries of Kemps Creek within the Hawkesbury Nepean catchment. A map of the validated watercourse within the study area is located in Figure 6.
