Report on
Geotechnical Investigation

Proposed Sand Mine Expansion
Tarago Road, Lake George

Prepared for
Grantham Park Holdings Pty Ltd

Project 46089.01
September 2017

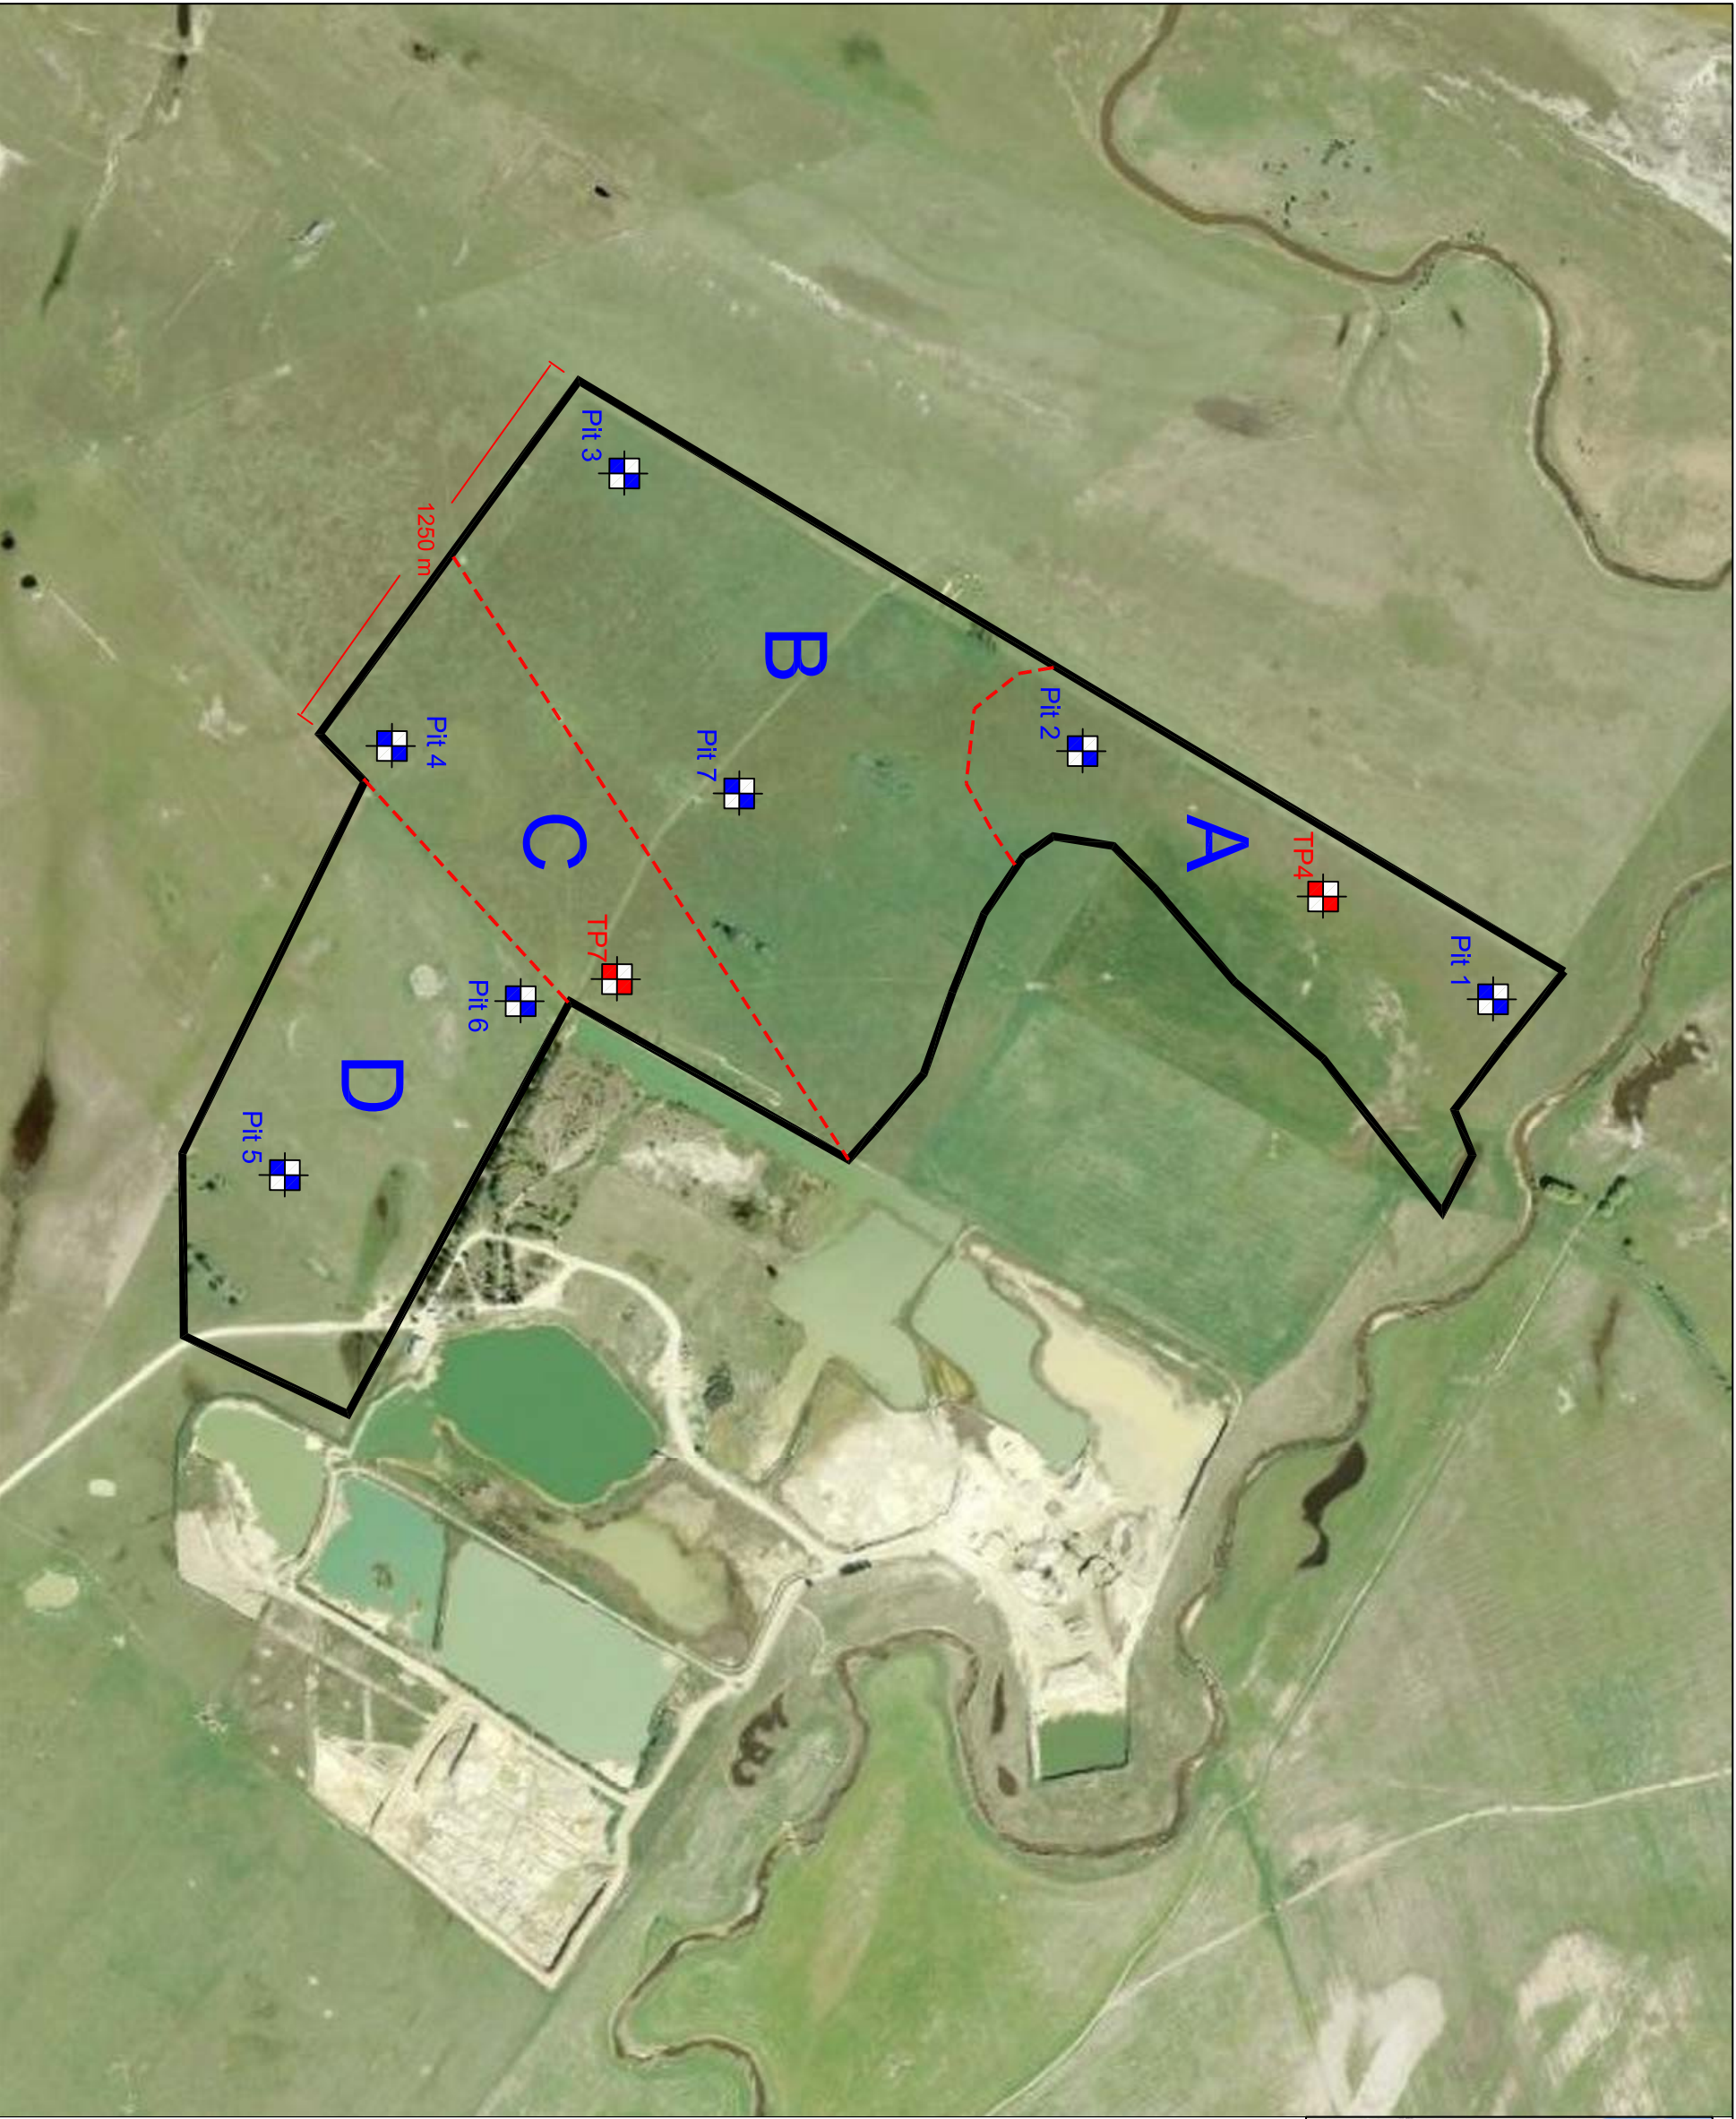
Drawing 1 which is included in Appendix B, details the values/methodology for establishing the mass of the sand resource. The study area was divided into 4 areas corresponding to different interpreted total sand thicknesses from the geological mapping of the area and the test pit information to date. Each area was then multiplied by the average interpreted sand thickness then added together to obtain an approximate volume (3.8 million m³). Adopting a density value of 1.6 tonne per m³, the mass of the sand interpreted within the study area was estimated to be over 6 million tonnes.

A site plan showing the previous test pit locations are presented in Drawing 1 (Appendix B) with the test pit logs included in Appendix C.
