East Guyong Quarry Annual Review – 06_0193

1 January 2020 to 31 December 2020

Document Title	Environmental Management Annual Review – East Guyong Quarry						
Document Number	V1	V1					
Document Owner	Hanson Construction	Hanson Construction Materials Pty Ltd					
Revision	Issue Date Originator Reviewed Approved						
Draft	Belinda Pignone Chris Cooke Chris Cooke						
Final

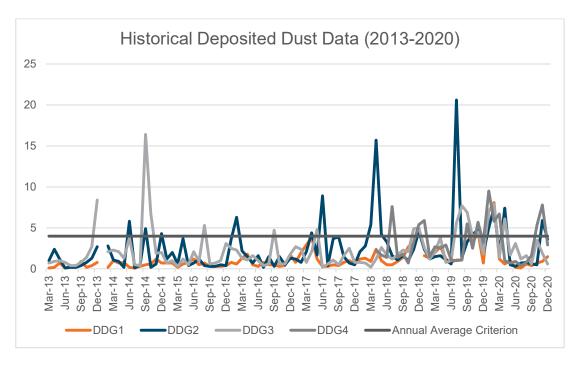
Figure 6: Deposited Dust 2013-2020

Deposited dust monitoring data from March 2013 to December 2020 is presented in **Figure 6**. This chart shows that deposited dust has predominantly remained below the annual average criterion with the following exceptions.

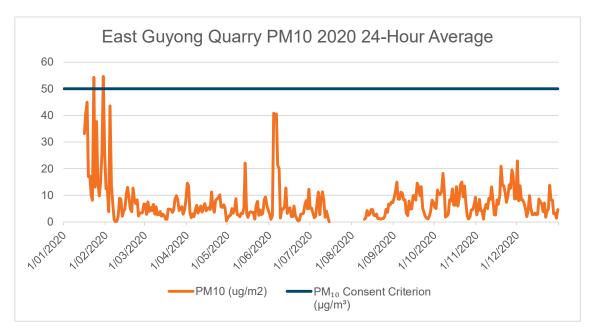
Figure 7: East Guyong Quarry average 24-hour PM₁₀ Dust Concentration 2020

The concentration of PM $_{10}$, namely that component of suspended particulates with an aerodynamic diameter of 10µm or less, commenced at monitoring location PM $_{10}$ on 24 January 2012 using a DustTrak PM $_{10}$ monitor (**Figure 3**). **Figure 7** presents the results of the PM $_{10}$ dust monitoring during the reporting period.

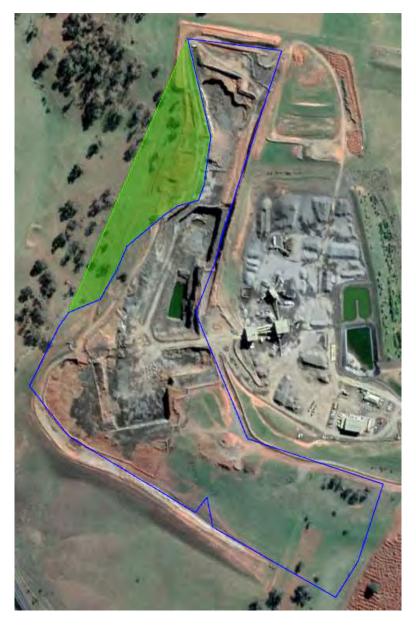
The expansion of the extraction area (2019 Modification 2) has begun with stripping beginning on the west side of the pit (indicated below).

Figure 1: extraction area expansion at East Guyong Quarry. Blue outline is the original extraction area, green shaded area is the expansion of the extraction area (approved 2019).

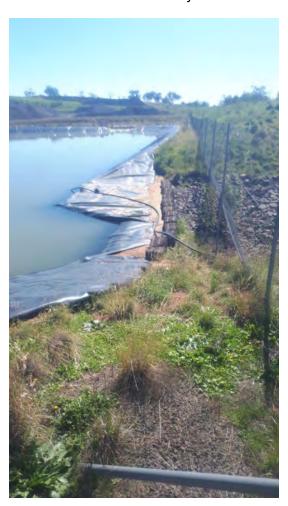
Figure 2: Picture of water storage dam taken 14 April 2020

There has been no water discharge since last CCC meeting. Recent rain has indicated that discharge might be required (see Figure 2). Due to the dam being filled from recent rain, operations have relied on dam water with the groundwater solar bore not in use since March 2020. Total of 57,235 m³ (57.24ML) has been pumped since December 2017. The site's water licence has an entitlement of 40 ML to be used annually.

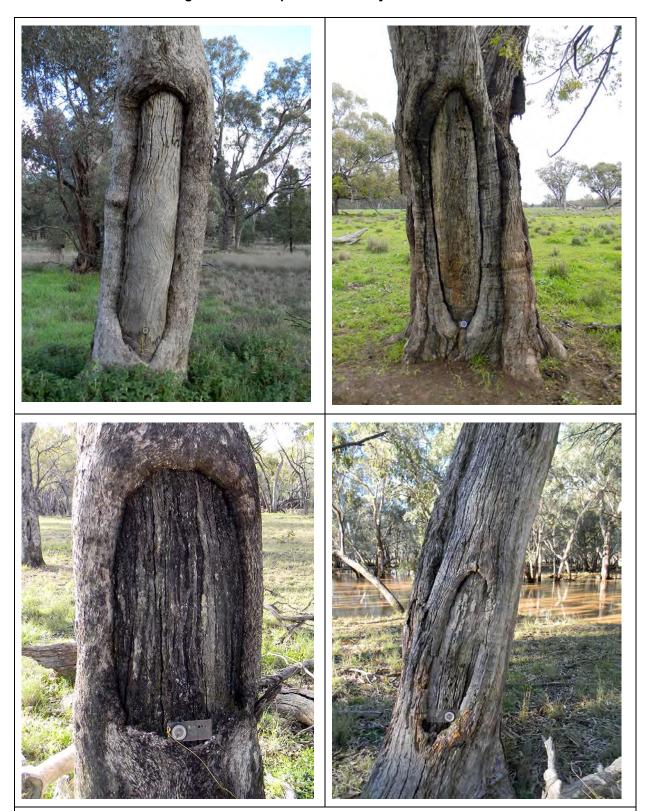
Figure 2-1: Examples of culturally scarred trees.

Examples of culturally scarred trees: Symmetrical shape, rounded proximal and distal ends (except where overgrowth creates the 'impression' of pointed terminations), no signs of tearing, weathered dry wood, substantial overgrowth, likely location (i.e. adjacent to waterways where people would have camped in the past).

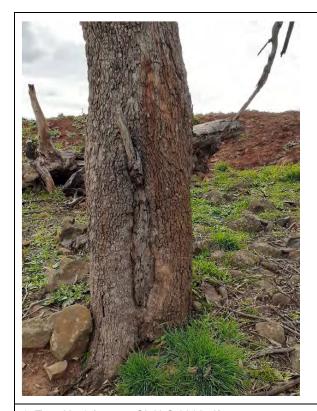
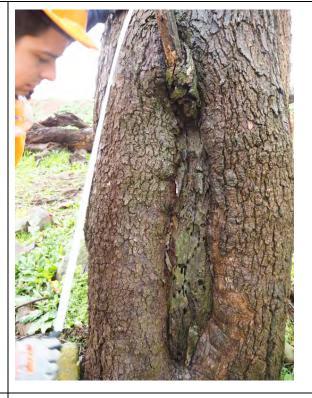
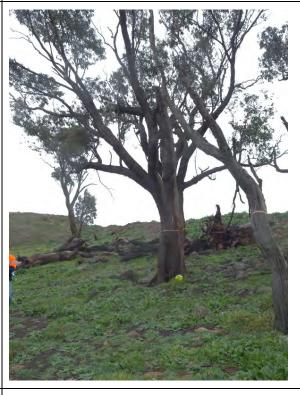
Figure 2-2: Tree no 1.

The results of the criteria analysis outlined in **Table 2-2** indicate that Tree No. 1 is not a culturally modified tree. The shape of the scar, signs of insect infestation, and the presence of a broken branch at the top of the scar all suggest that the scar is likely caused by either impact or trauma. **Figure 2-2** shows recent photographs of Tree No. 1 and the scar.

7. The tree must not be an introduced species	The tree is a native species.	
8. Axe or adze marks	There are no axe or adze marks present.	
9. The presence of epicormic growth	There is no epicormic growth at the bottom the scar. There is broken branch at the top of the scar.	
Conclusion	Not a culturally modified tree.

2. Scar detail of Tree No. 1 (source Hanson Construction Materials).

4. View of Tree No. 1 (source Hanson Construction Materials).

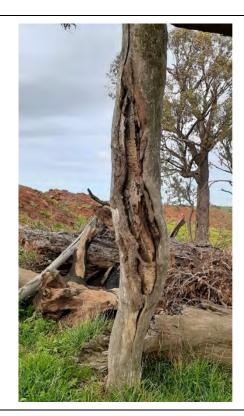
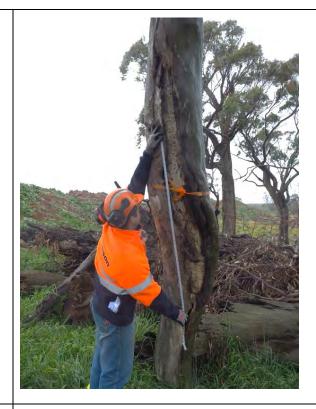
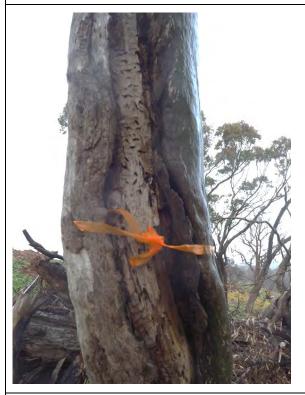
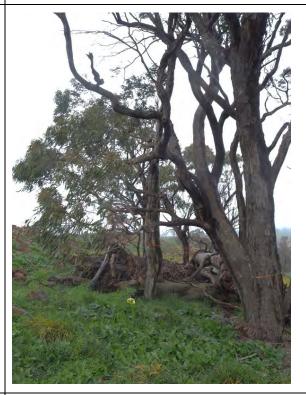
Figure 2-3: Tree no 2.

The results of the criteria analysis outlined in **Table 2-3** indicate that Tree No. 2 is not a culturally modified tree. The shape of the scar, signs of insect infestation, and the presence of a hollow higher along the trunk, the trunk split between the hollow and the scar and the ground surface, all indicative of branch tear. **Figure 2-3** shows recent photographs of Tree No. 2 and the scar.

7. The tree must not be an introduced species	The tree is native.		
8. Axe or adze marks	There are no axe or adze marks on the scar surface.		
9. The presence of epicormic growth	There are no signs of epicormic growth at the base of the scar		
Conclusion	Not a culturally modified tree.

2. Scar of Tree No. 2 (source Hanson Construction Materials).

3. Centre of scar of Tree No. 2 (source Hanson Construction Materials).

4. View of Tree No. 2 (source Hanson Construction Materials).

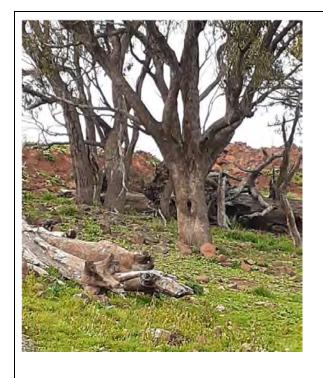
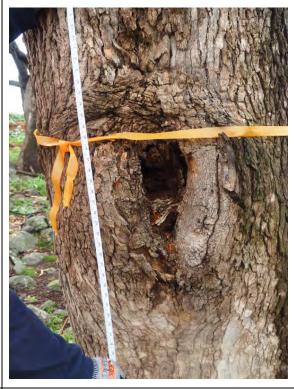
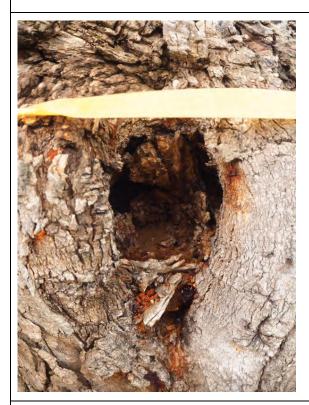
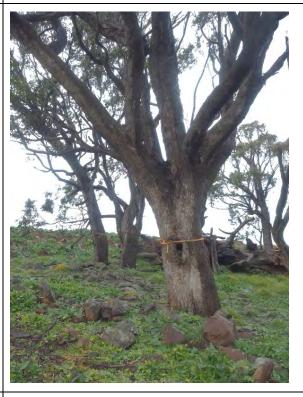
Figure 2-4: Tree No 3.

The results of the criteria analysis outlined in **Table 2-4** indicate that Tree No. 3 is not a culturally modified tree. Based on the size, shape and regrowth surrounding the hollow, it was likely caused by trauma, possibly branch tear. **Figure 2-4** shows recent photographs of Tree No. 3 and the scar.

7. The tree must not be an introduced species	The tree is native.	
8. Axe or adze marks	There are no axe or adze marks present.	
9. The presence of epicormic growth	There is no epicormic growth present.	
Conclusion	Not a culturally modified tree.

1. Tree No 3 (source OLALC 2020: 8).

2. Detail of scar on Tree No. 3 (source Hanson Construction Materials).

3. Detail of scar on Tree No. 3 (source Hanson Construction Materials).

4. View of Tree No. 3 (source Hanson Construction Materials).

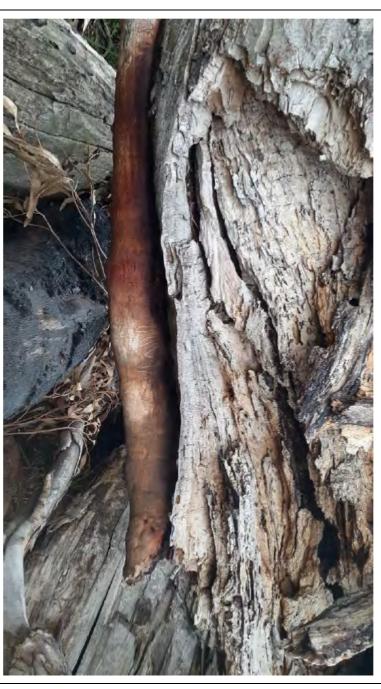
Figure 2-5: Tree No 4.

The only available photograph for Tree No. 4 is provided in **Figure 2-5**. Unfortunately, the tree was unable to be reidentified for further photographs to be taken. Based on **Figure 2-5**, the scar in question appears to be on a dead branch lying on the ground as there is grass in the background. The trunk in the photograph has been affected by insects as galleries and borer holes are present and it is highly deteriorated. Due to the lack of further photographs, a conclusive analysis using the criteria is unable to be conducted for this tree; although it is highly unlikely that it is culturally modified.

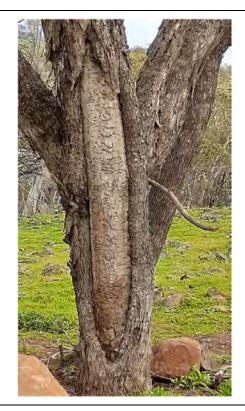
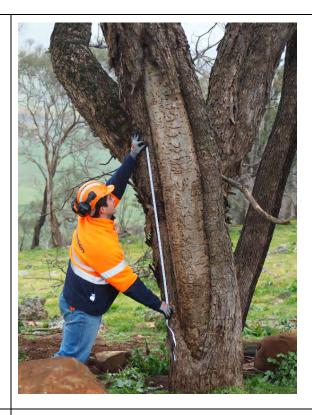
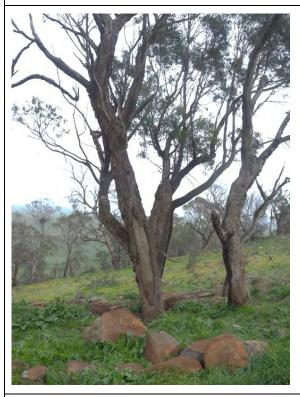
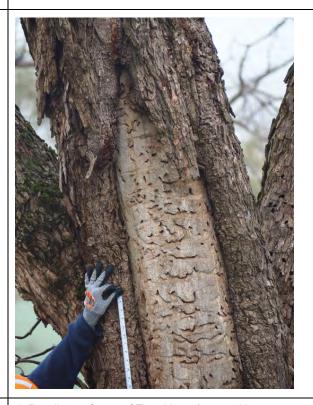
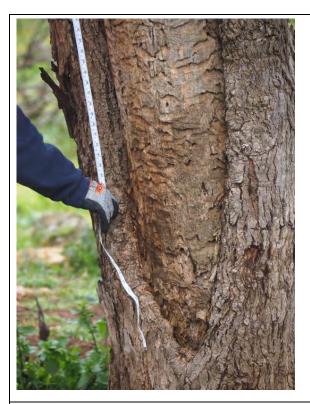
Figure 2-6: Tree No 5.

Of the five trees identified as having possible cultural scars, Tree No. 5 is visually suggestive of being cultural in origin. However, the results of the criteria analysis outlined in **Table 2-5** indicate that Tree No. 5 is not a culturally modified tree. Based on the shape and regrowth surrounding the scar, it was likely caused branch tear. **Figure 2-6** shows recent photographs of Tree No. 5 and the scar.

9. The presence of epicormic growth	There is no presence of epicormic growth.		
Conclusion	Unlikely to be a culturally scarred tree.

2. Scar of Tree No. 5 (source Hanson Construction Materials).

3. View of Tree No. 5 (source Hanson Construction Materials).

4. Detail top of scar of Tree No. 5 (source Hanson Construction Materials).

Detail of base of scar on Tree No. 5. Note the uneven taper at the base of the scar (source Hanson Construction Materials).

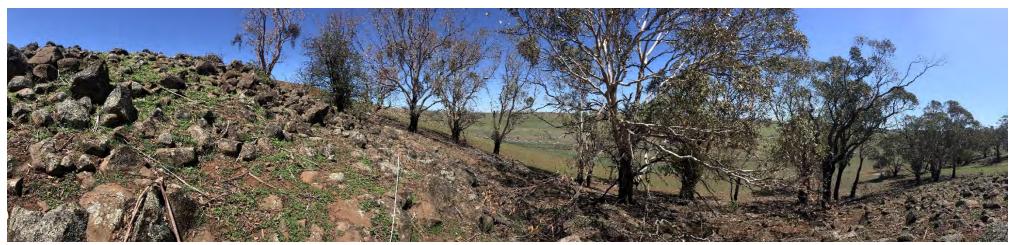
Transect 1 Photo point

Transect	Location description		Point					Cover %	Species present within and surrounding transect:	
			1	2	3	4	5			
1	Regenerating woodland along rocky slope north west of site.	Priority Weeds	0	0	0	0	0	0	Blackberry, Sweet Briar, Bathurst Burr	
	Following recent rain broad leaf weeds are colonising	Other Weeds	70	2	19	1	50	28.4	Hawthorn (Crataegus monogyna), Paddy Melon (Cucumis myriocarpus), Purslane (Portulaca oleracea), Catsear (Hypochaeris radicata), Philaris aquatica, Yarrow (Achillea millefolium), Amaranth (Amaranthus sp), Sorrel (Acetosella vulgaris), Clover (Trifolium sp), Mallow weed (Malva sp), Horehound (Marrubium vulgare)	
	Tree die back and presence of mistletoe	Native	1	0	1	4	10	3.2	Native Geranium (<i>Geranium homeanum</i>), Lomandra sp, Slender Dock Weed (<i>Rumex</i> sp), Climbing Salt bush (<i>Einadia nutans</i>)	
	Evidence of grazing by rabbits and hares.	Bare earth / rock	29	98	80	95	40	68.4

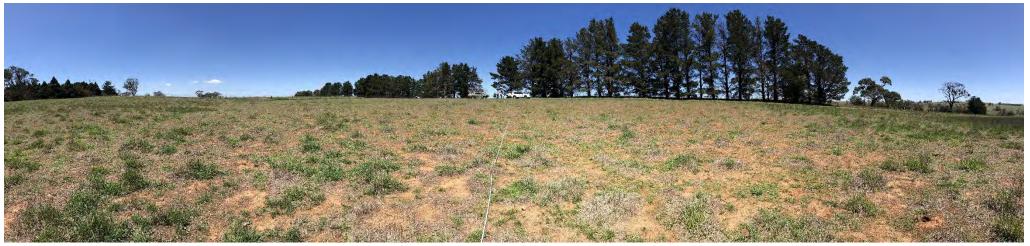
Transect 2 Photo Point

Transect	Location		Point				Cover %	Species present within and surrounding transect:	
			1	2	3	4	5		
2	Grazed Paddock	Priority Weeds	0	0	0	0	0	0	No priority weeds observed
		Other Weeds	50	30	50	50	70	50	Thorn Apple (<i>Datura stramonium</i>), Philaris aquatica, Amaranth, Paddy Melon (<i>Cucumis myriocarpus</i>)
		Native	1	0	0	0	0	0.2	Climbing Salt bush (Einadia nutans)
	Evidence of heavily grazing during drought conditions; rabbits, horses and possibly sheep	Bare earth / rock	49	70	50	50	30	49.8

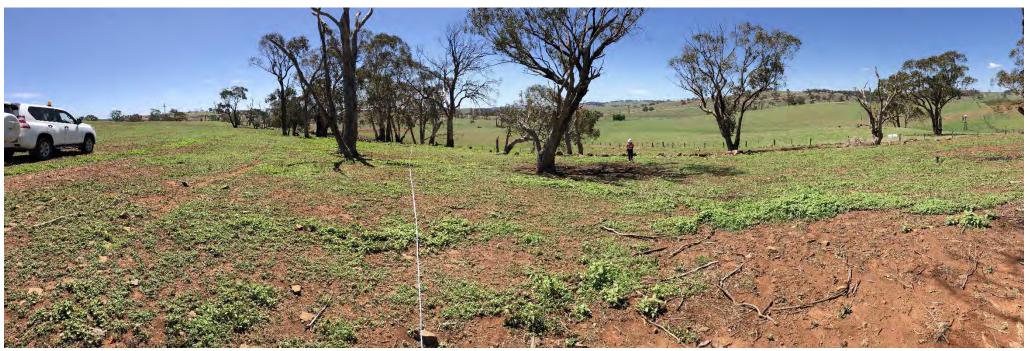
Transect 3 Photo Point

Transect	Location description		Poin	t				Cover %	Species present within and surrounding transect:
			1	2	3	4	5		
3	Grazed Paddock small patch of open woodland canopy eastern extent of site	Priority Weeds	0	0	0	0	0	0	No priority weeds observed
	Erosion along rocky slope	Other Weeds	10	85	50	20	20	37	Amaranth, Purslane, Variegated Milk Thistle (Silybum marianum), Philaris aquatica, Amaranth, Paddy Melon (Cucumis myriocarpus)
	Eucalypts showing signs of stress and dieback	Native	0	1	1	0	0	0.4	Climbing Salt bush (Einadia nutans), Yellow Box (Eucalyptus melliodora), Bundy (Eucalyptus goniocalyx), Dock (Rumex sp)
		Bare earth / rock	90	14	49	80	80	62.6

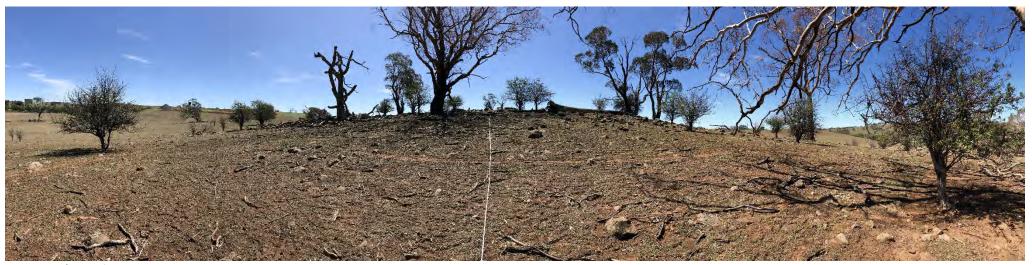
Transect 4 Photo Point

Transect	Location description	escription						Cover %	Species present within and surrounding transect:
			1	2	3	4	5		
4	Grazed Paddock – north eastern extent	Priority Weeds	0	0	0	0	0	0	No priority weeds observed
	Erosion along slope	Other Weeds	15	20	10	10	5	12	Amaranth, Stinging Nettle (<i>Urtica dioica</i>), Mallow weed (<i>Malva</i> sp), Hawthorn (<i>Crataegus monogyna</i>)
	Eucalypts showing signs of stress and dieback	Native	0	0	0	0	0	0	
	Heavily grazed including rabbits, Kangaroos	Bare earth / rock	85	80	90	90	95	88

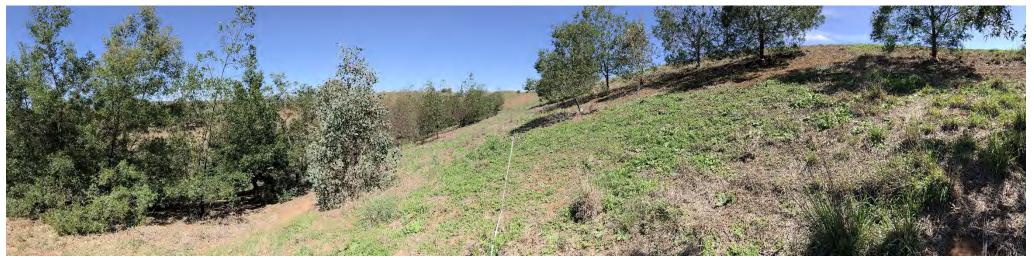
Transect 5 Photo Point

Transect	Location description		Poin	t				Cover %	Species present within and surrounding transect:
			1	2	3	4	5		
5	Revegetated earthern bund / embankment adjacent spillway	Priority Weeds	0	0	0	0	0	0	Blue Heliotrope observed outside the transect
		Other Weeds	15	70	25	80	70	52%	Pigweed (Chenopodium album), Variegated Thistle, Purslane, Amaranth, Horehound, Philaris aquatica, , Patterson's Curse, Flatweed,
		Native	0	0	0	0	0	0	
		Bare earth / rock	85	30	75	20	30	48%

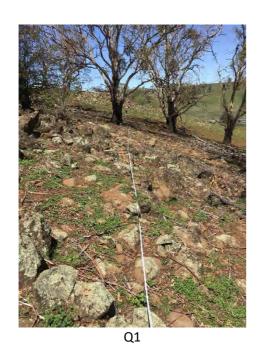
Transect 1 Photo Monitoring Point

Evidence of grazing by rabbits and eastern grey	Native	10	15	1	0	1	5.4	Rytidiosperma sp, Swamp Dock (<i>Rumex brownii</i>), <i>Geranium sp</i> , Redgrass (<i>Bothriochloa macra</i>), Tall Speargrass (<i>Austrostipa bigeniculata</i>)
	kangaroos— scats, diggings and burrows	Bare earth / rock	25	65	25	60	4	35.8

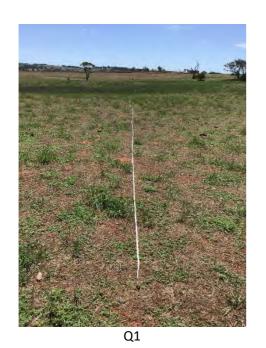
Transect 2 Photo Monitoring Point

Transect	Location		Point		Cover %	Species present within and surrounding transect:			
			1	2	3	4	5		
2	2 Grazed Paddock		0	0	0	0	0	0	No priority weeds observed
			98	95	95	90	95	94.6	Phalaris (<i>Phalaris aquatica</i>) Clover (<i>Trifolium sp</i>), Wild Oats (<i>Avena barbata</i>), Medicago sp, Ryegrass (<i>Lolium</i> sp.), Bulbous Poa (<i>Poa bulbosa</i>), Winter Grass (<i>Poa annua</i>), Mouse-ear Chickweed (<i>Cerastium glomeratum</i>), Spear Thistle (<i>Cirsium vulgare</i>)
		Native	2	5	3	3	1	2.8	Swamp Dock (Rumex brownii), Wallaby Grass (Rytidosperma sp)
		Bare earth / rock	0	0	2	7	4	2.6

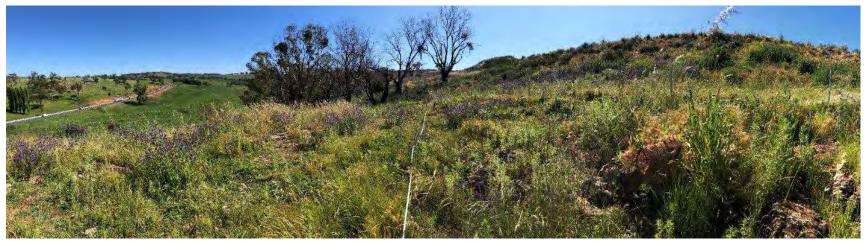
Plate 1 Plot 1 facing north west within vegetation screen area

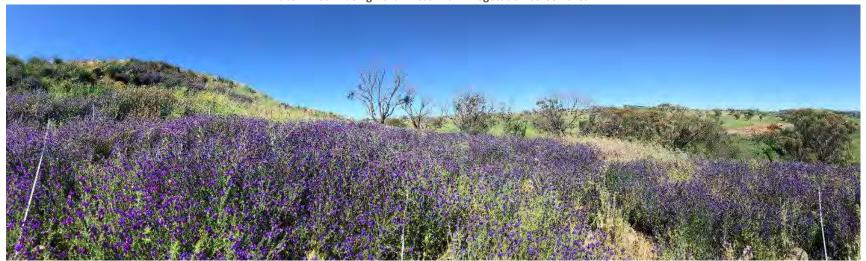
Plate 2 Plot 1 facing south east

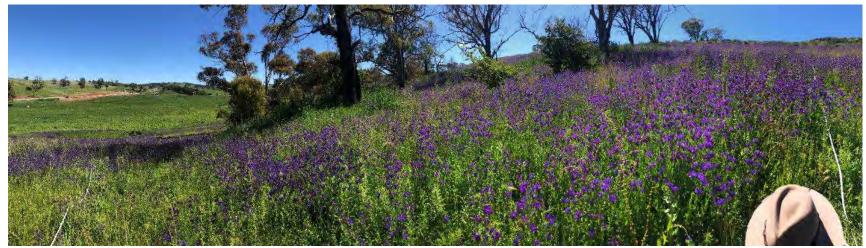
Plate 3 Plot 2 facing north west within rehabilitation area

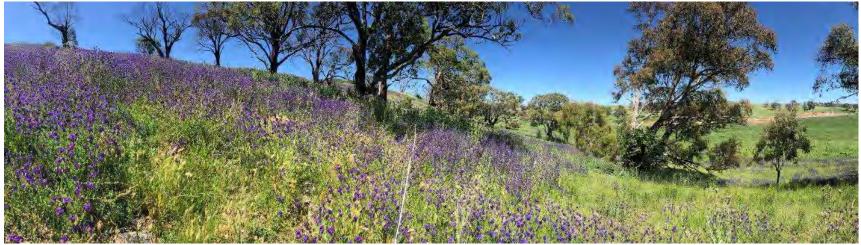
Plate 4 Plot 2 facing south east

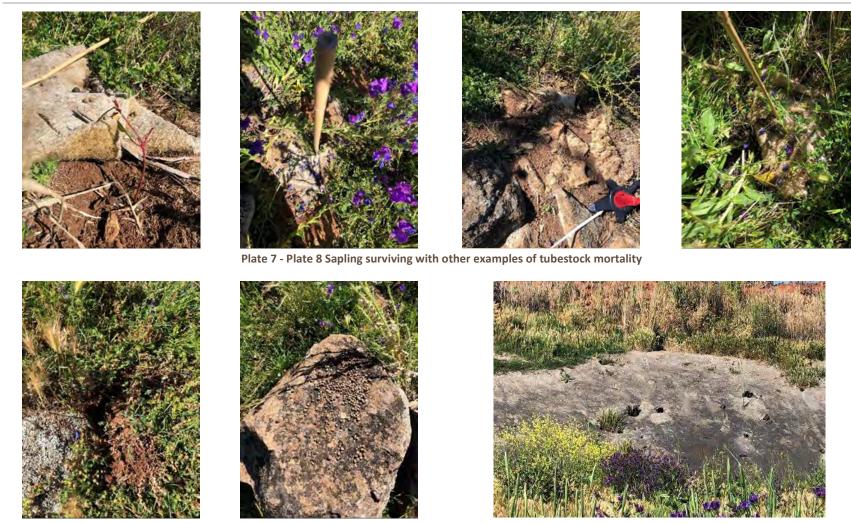
Plate 9 - Plate 10 Evidence of rabbits – diggings, scats and burrows
