4 Archaeological survey

4.3 Archaeological survey results

5 Test excavation

5.3 Test excavation results

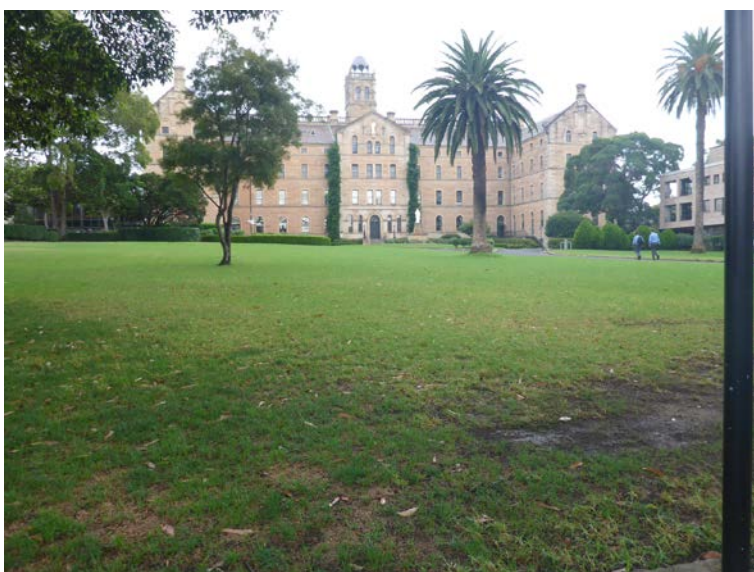
Plate 16 Western view of the crest landform

The study area is located across two landform units; a crest, and an upper slope which falls in a south-easterly direction towards Tarban Creek, Tarban Bay and the Parramatta River (Plate 15, Plate 16). The areas of proposed works are situated on both landforms: the south-eastern corner is situated on the lowest part of the upper slope within the study area (Plate 17); the north-eastern corner is positioned on the upper slope at a slightly higher elevation (Plate 18); and the north-western corner is on the edge of the crest landform (Plate 19).

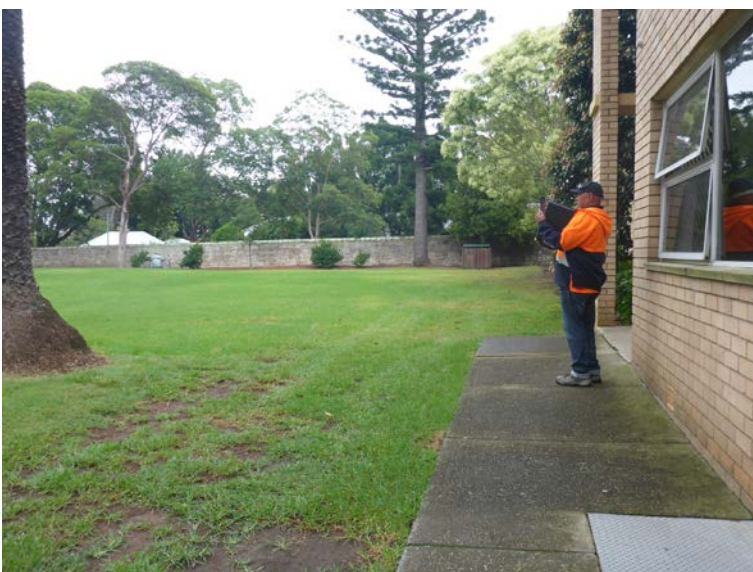
Plate 19 View of area of proposed works in north-western corner of the study area, facing west

There has been a significant amount of disturbance throughout the study area. These disturbances include levelling fills, which in parts of the south-eastern corner extend deeper than 1.7 metres in the basketball court area, construction of multi-storey buildings, roads, footpaths, carparks, landscaping sports facilities such as swimming pools and sports courts, and associated sub-surface infrastructure. The area of proposed works in the south-eastern corner consists of terraced sports courts, an access driveway and parking, facilities buildings and storage/stockpiling areas (Plate 17, Plate 20, Plate 21). The north-eastern corner contains landscaped garden beds, road access and parking facilities, with some existing infrastructure present (Plate 18). The north-western corner largely features landscaped lawns and garden beds, a statue and footpaths (Plate 19, Plate 22, Plate 23).

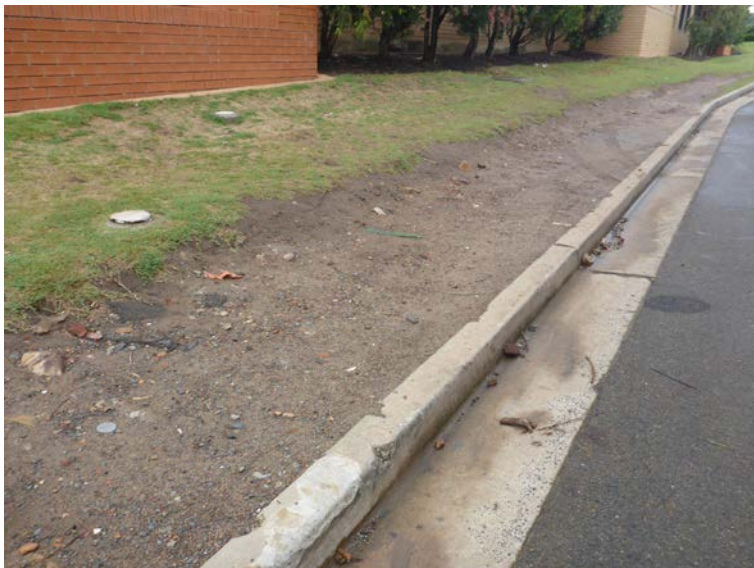
Plate 24 Area of exposure in the south-eastern portion of the study area, facing west

The archaeological survey was conducted in one day with a field team of two members, which consisted of Charlotte Allen (Biosis) and Kevin Telford (Metropolitan LALC). Generally, the survey was hampered by poor ground surface visibility (approximately 10%) throughout the majority of the areas to be impacted by proposed works. This was due to vegetation, grass cover, and disturbance caused by standing structures, and paved areas such as roads, footpaths and carparks. Despite the known presence of introduced fill material within the study area, particularly in the south-eastern portion, locations featuring exposed ground surface were inspected for the presence of any artefacts which may be present within the fill material (Plate 20, Plate 24, Plate 25). Within the north-western portion of the study area, exposures contained shell fragments, but

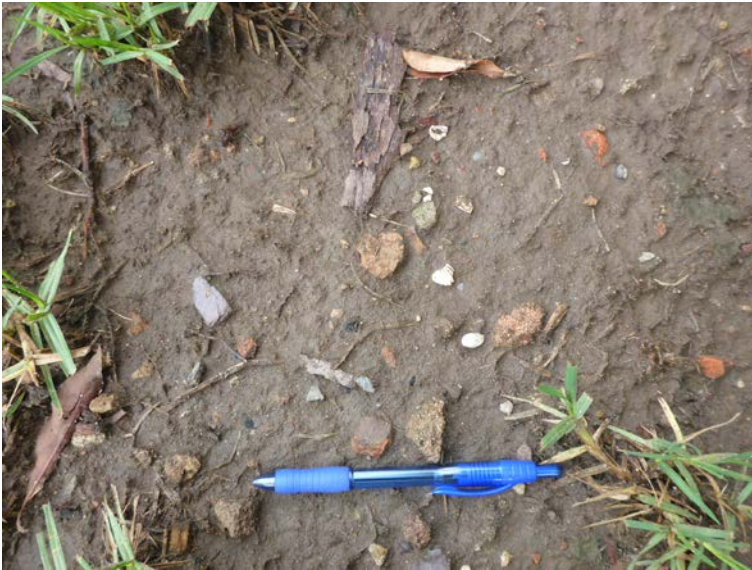
Plate 26 Detail of shell, brick and other inclusions in an exposure in proximity to area of proposed works in the north-western portion of the study area

also European artefactual material such as ceramic, glass and brick fragments, suggesting that the area has also been subject to levelling with introduced fill (Plate 26). No Aboriginal objects were identified during the survey. The study area has been subjected to extensive clearing and no mature trees were identified within the area of proposed works, limiting the potential for scarred trees to be located within the study area. No sandstone rock outcroppings were located within the study area capable of supporting art sites or grinding grooves, and no midden or shell remains consistent with Aboriginal resource exploitation were visible within the study area at the time of survey.

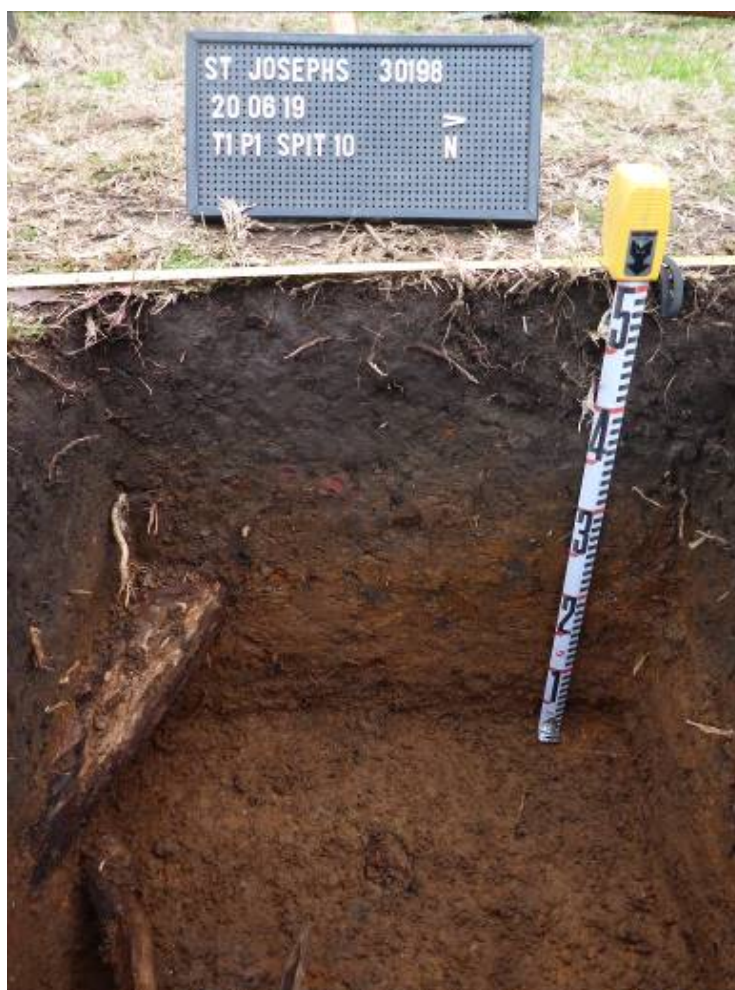
Plate 27 Section of T1 TP1, showing soil profile in the crest landform, facing west

Soil composition varied across the extent of the area. Transect 1 was located on the side of a crest landform, with the area containing high levels of fill deposit above the natural soil profiles. These soil profiles contained three to five stratigraphic contexts, generally consisting of a dark brown to black silty and silty sandy loam of low compaction, overlaying either a low to moderately compacted gravelly deposit with elevated levels of inclusions and increasing clay context with depth, or a very dark brown loamy clay with elevated levels of

inclusions (Plate 27, Plate 28 and Plate 29). These fill deposits were above the natural clay deposits, which comprised of moderate to highly compacted reddish brown clay (gn3) (Plate 27).

TP1 had minimal fill deposits present in comparison to the other two test pits, with 200 millimetres of very dark brown silty clay loam above 100 millimetres of moderately compacted loamy clay. These fill deposits were visible over highly compacted natural reddish brown clay deposits (gn3) (Plate 27). The amount of fill present could be a result of the location of TP1 in relation to its associated landform, with TP1 located on the side of a crest that is closer to the top of the crest.

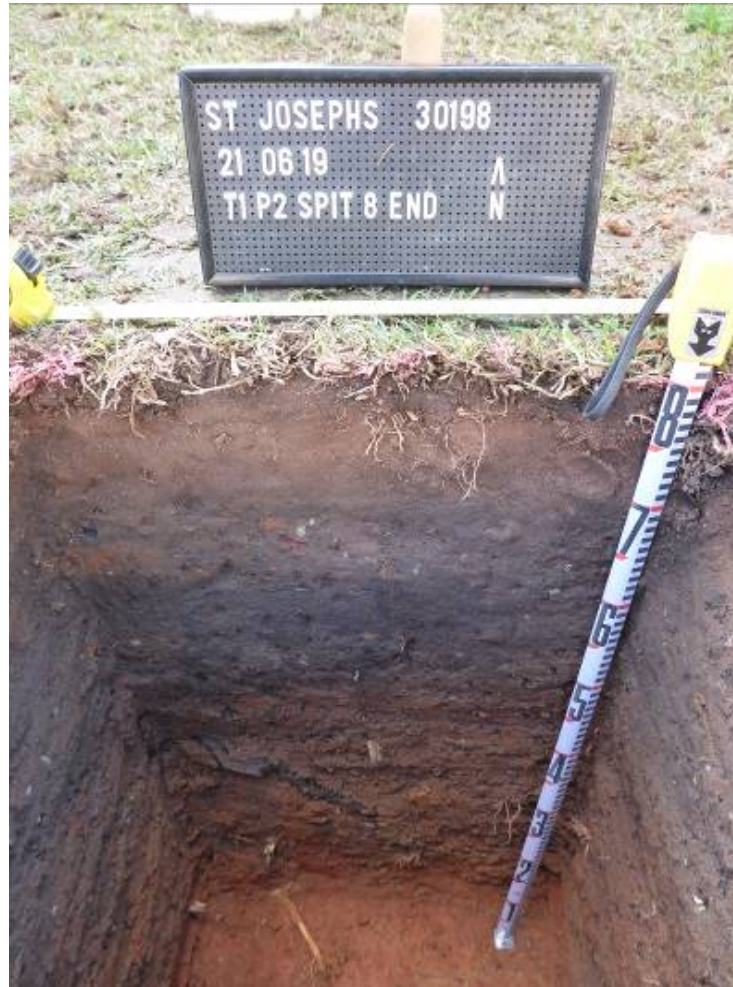
Plate 28 Section of T1 TP2, showing soil profile in the crest landform, facing north

The fill deposits in TP2 extended further down, supporting the previous assumption of test pit location on the crest landform. TP2 had four stratigraphic fill contexts consisting of silty sandy loam to loamy clay soils, visible until 700 millimetres, where natural, B-horizon clay was encountered. B-horizon soils comprised of highly compacted natural reddish brown clay, which extended to the base of the test pit at 800 millimetres, where the soils were confirmed as archaeologically sterile (Plate 28).

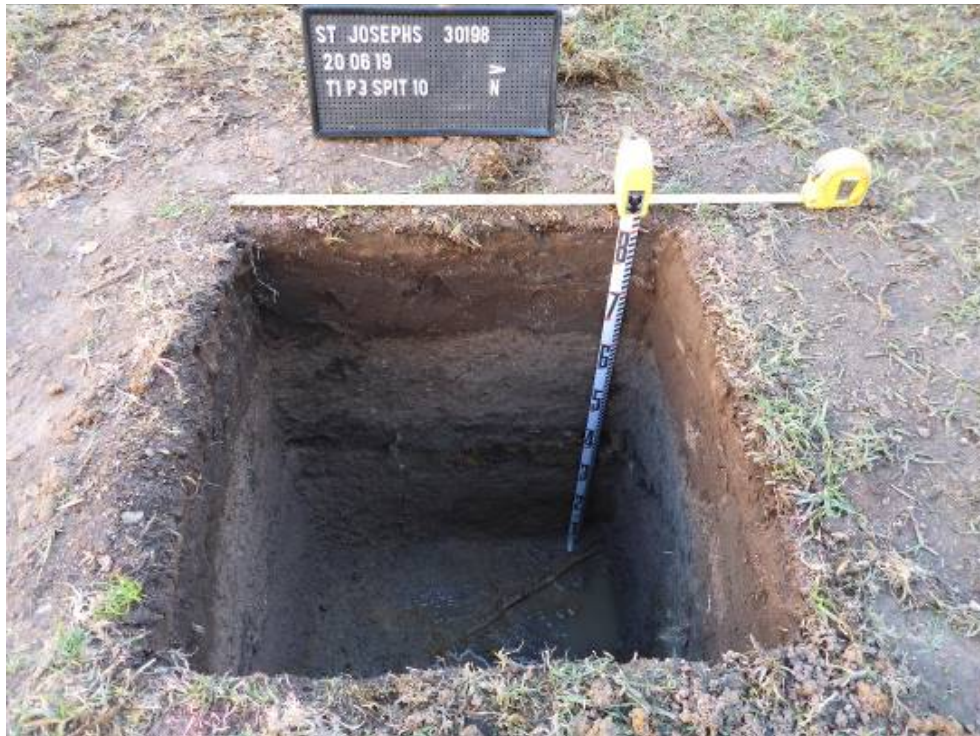
Plate 29 Section of T1 TP3, showing soil profile in the crest landform, facing west

TP3 could not be excavated to B-horizon soils as the fill deposits extended down to the water table at 810 millimetres (Plate 29). The fill deposits found throughout TP3 differed to those found in TP1 and TP2, with lowly compacted, very dark brown, silty sandy loam present in the first 200 millimetres, overlying lowly compacted, brown sand, found throughout the extent of the test pit. This sand context contained high levels of gravel and plastic inclusions, ranging between 30 to 40%. A small root system extended through the north-eastern corner of the test pit, with natural reddish brown clays mixed in under this system to base. The pH levels in TP3 were more alkaline (8) than soils found in TP1 and TP2 (6 to 6.5), which could be due to the type of deposited fill, in addition to the proximity to the water table.

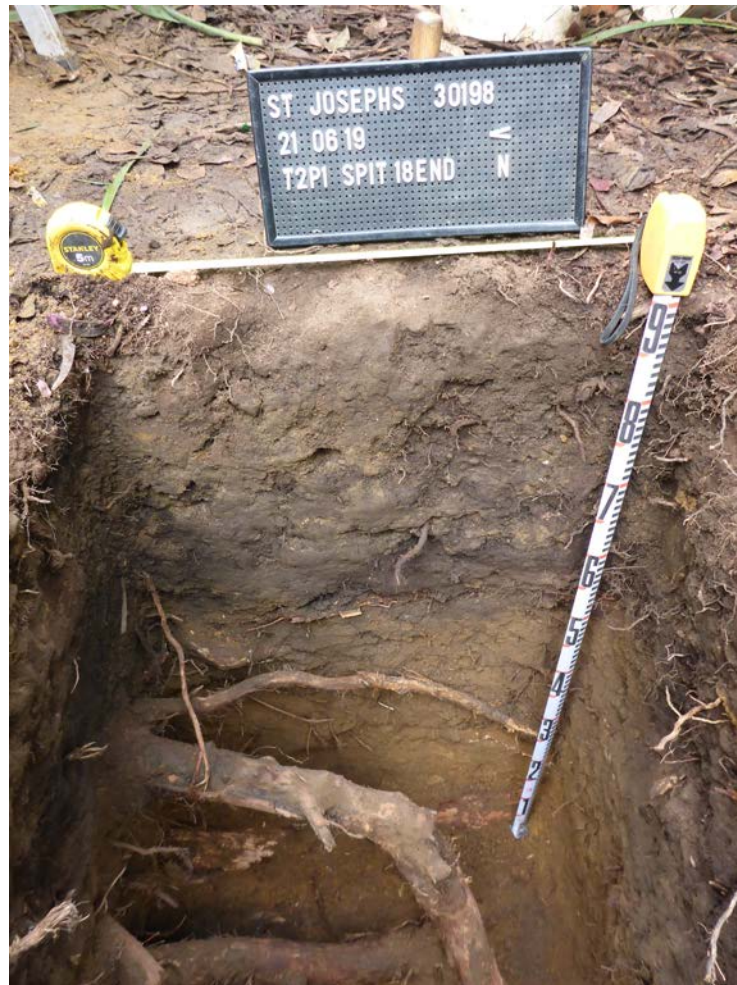
Plate 30 Section of T2 TP1, showing soil profile in the slope landform, facing east

TP1 comprised three stratigraphic levels of fill deposit, with 150 millimetres of lowly compacted, dark brown silty loam, above 350 millimetres of very dark brown silty clay loam. This was followed by a further 400 millimetres of lowly compacted, dark yellowish brown silty clay loam. These layers of fill contained large amounts of plastic, food wrappers, charcoal flecks, ceramic, glass and iron and clay stone throughout. In the north-eastern side of the dark yellowish brown deposit, a largely intact ceramic tea cup and layer of faunal remains (most likely macropod or bovine in origin) was uncovered. No cut was identified, suggesting that these remains were mixed in with the fill context at the time of redeposition. The dark yellowish brown deposit also appears to closely resemble the natural soil profile gn2, however due to the fill inclusions seen throughout the context, it is likely that the natural context was removed from another portion of the study and redeposited in the north-eastern side as fill. A large root system, appearing at 500 millimetres depth, caused difficulties with excavation throughout the test pit. At 900 millimetres it was decided that excavation could not continue due to this root system, with TP1A being placed directly adjacent to TP1.

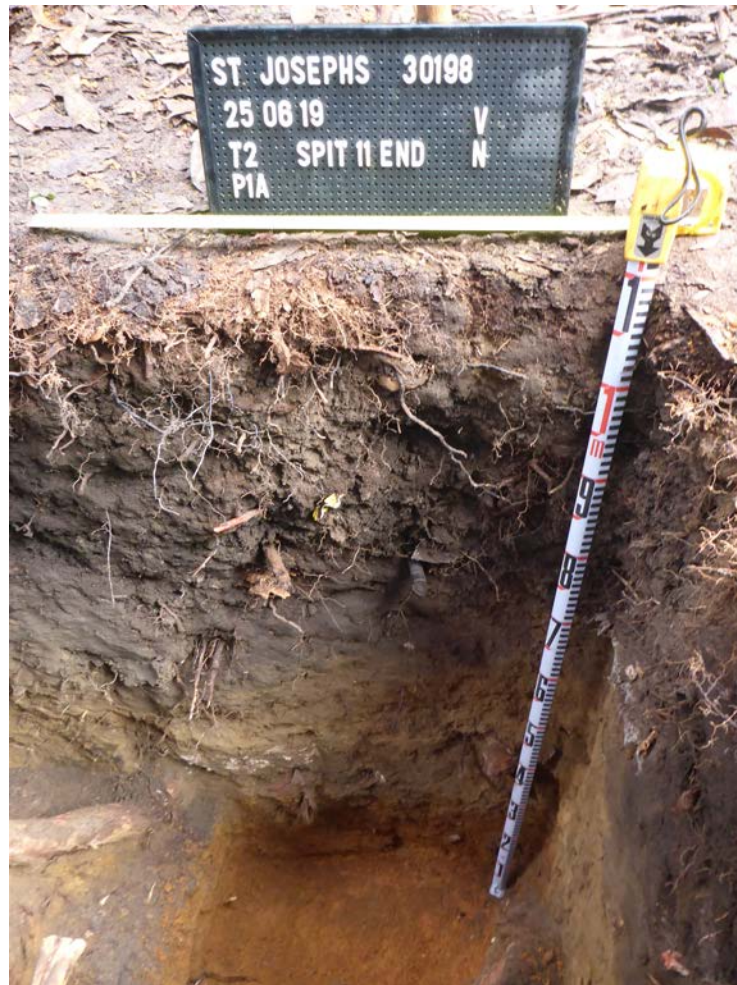
Plate 31 Section of T2 TP1A, showing soil profile in the slope landform, facing south

TP1A contained three stratigraphic layers of fill contexts atop a natural clay deposit, and comprised of identical fill deposits to that of TP1. The inclusions found throughout TP1 were also identified in similar quantities, with the north-west portion of the test pit containing the same, redeposited dark yellowish brown soil visible from 550 millimetres to 900 millimetres, comprising of ceramic, faunal remains (most likely macropod or bovine in origin) and clay stone. This fill layer was laid directly onto natural B-horizon clay, with a moderately compacted, yellowish red clay present until 1100 millimetres, when the soils were confirmed as archaeologically sterile.

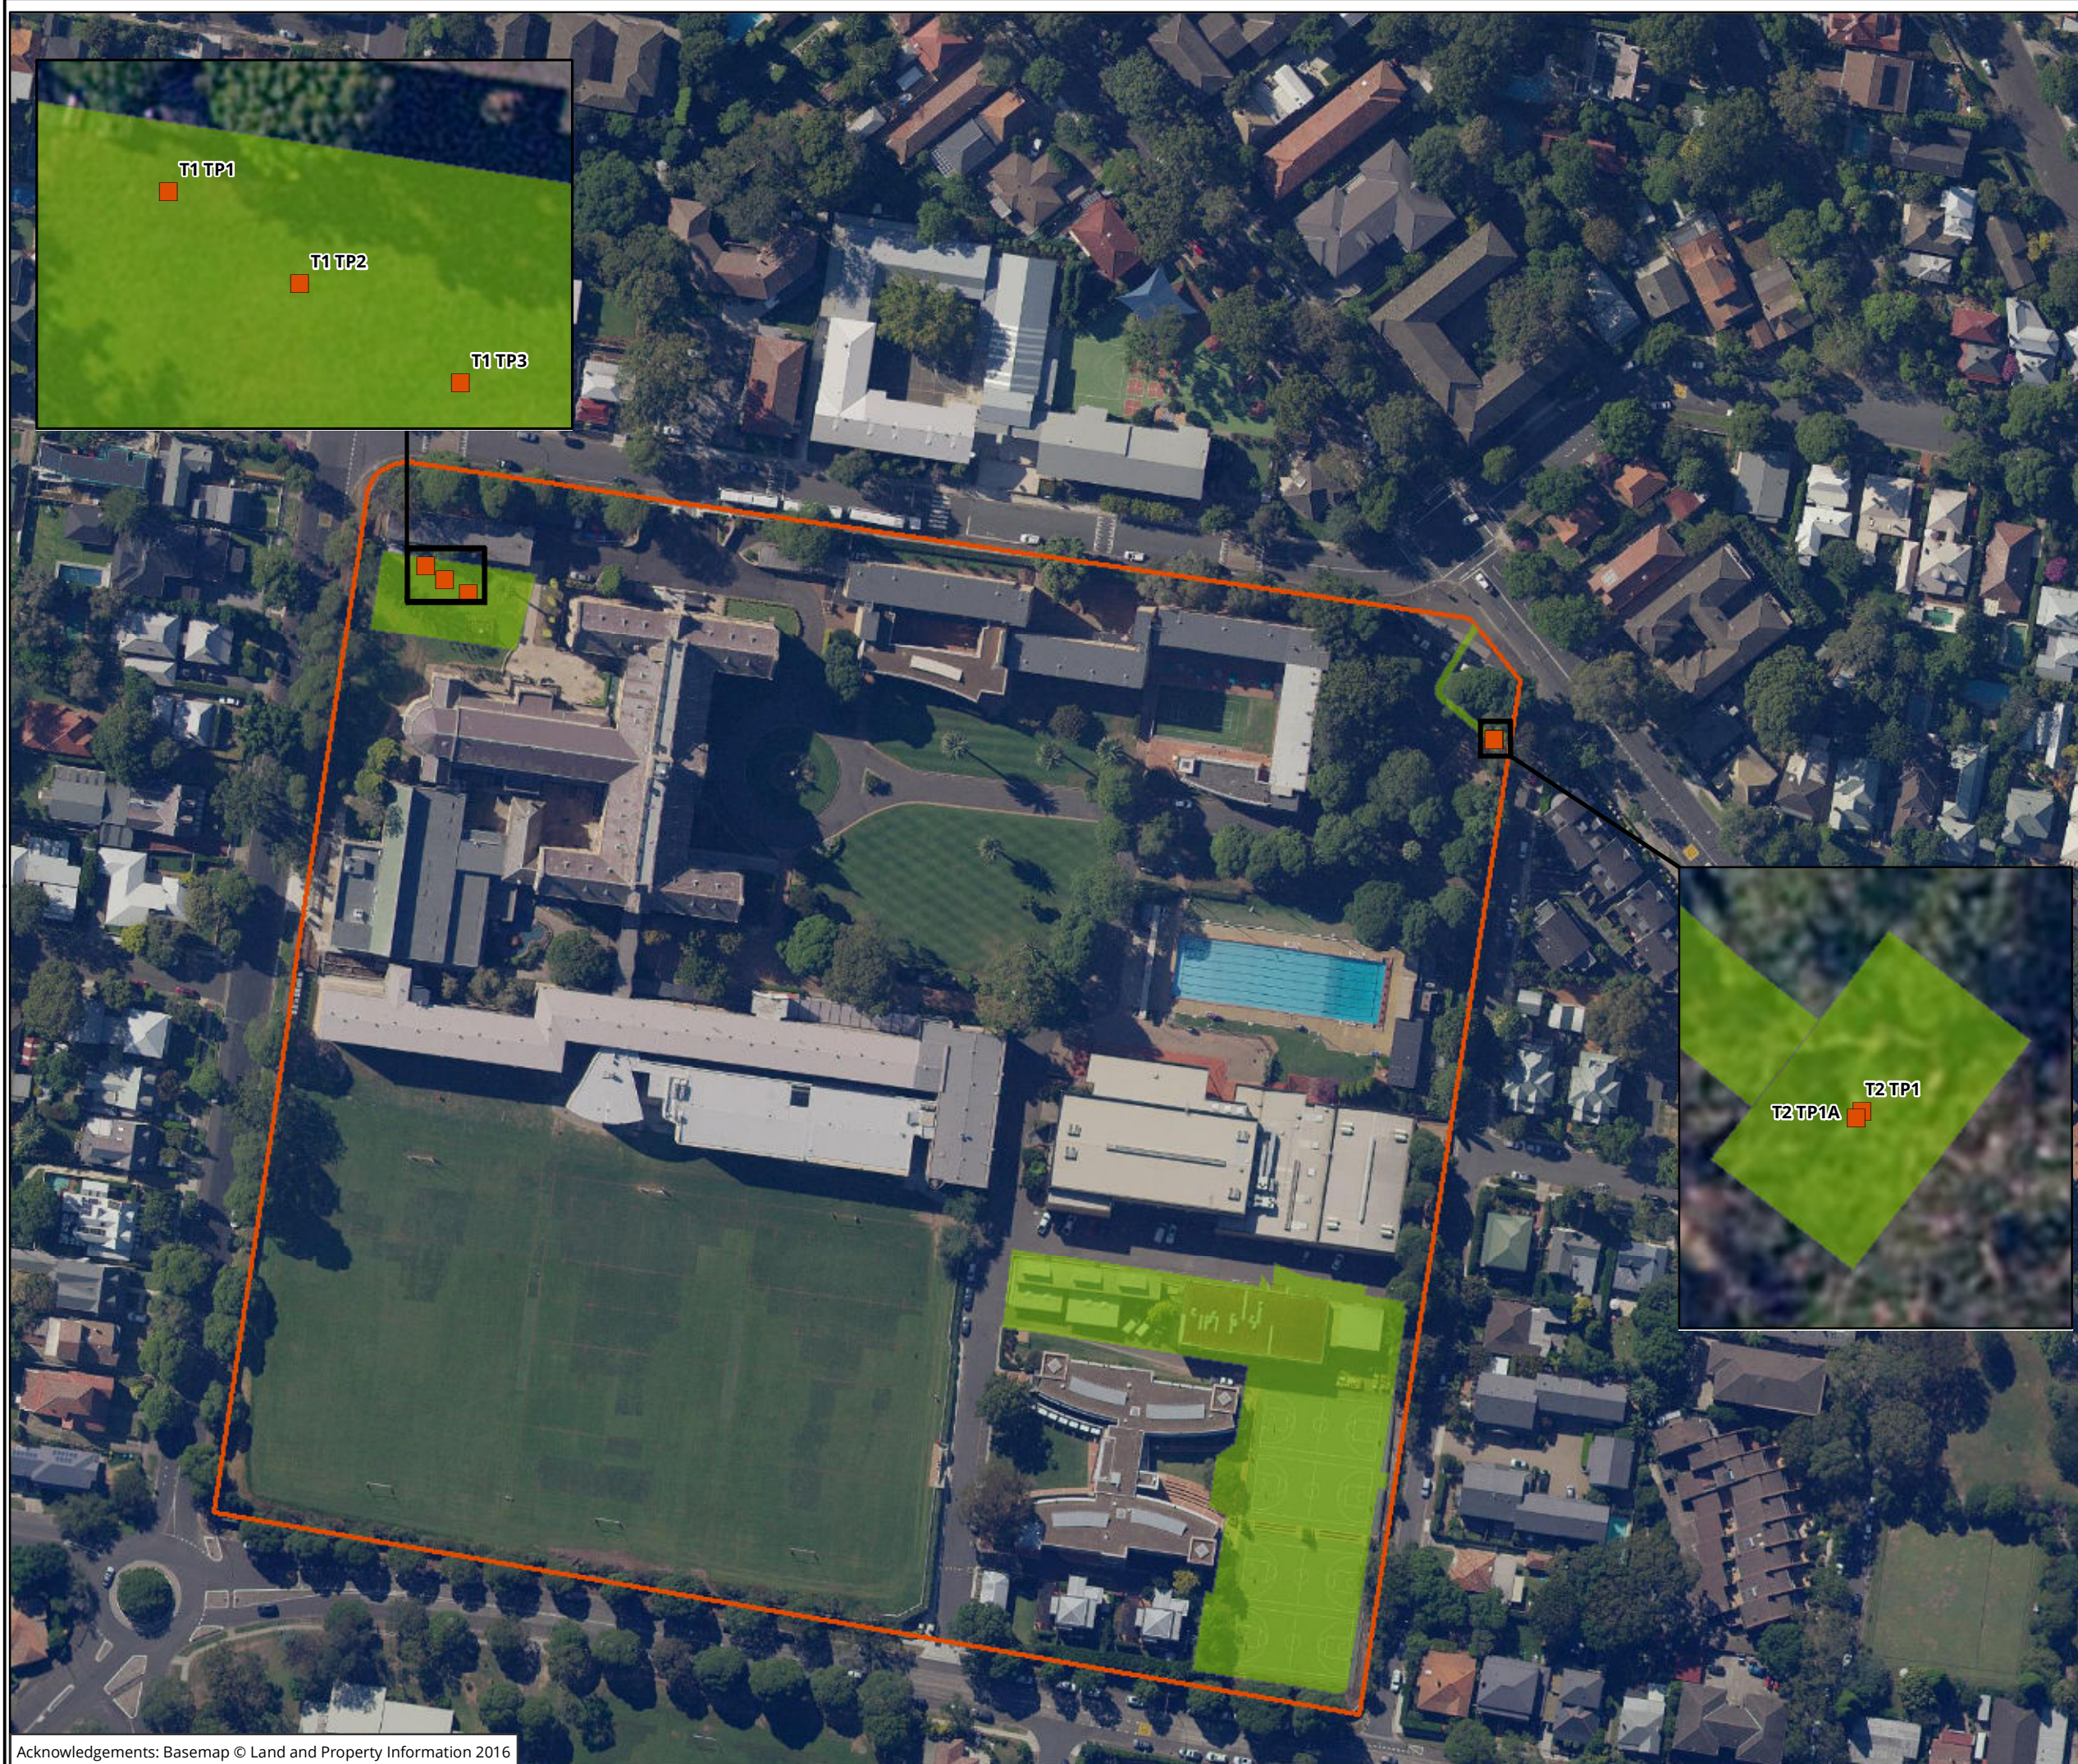
Figure 12 Test pit locations and results

A total of 5 test pits were excavated across the north-western and north-eastern areas of proposed works within the study area. Individual test pit and soil analysis results are provided Appendix 3. Results by area of proposed works are shown in Table 8 and Figure 11, and a detailed discussion of results is provided below.

In conclusion, no Aboriginal objects or sites were identified during the archaeological survey or test excavations. The results of the test excavations in the north-eastern and north-western areas contained highly disturbed, historic fill materials, with no in-situ, natural, non-clay soils present within either of the transects. These results strongly support the argument for an assessment of low archaeological potential in these two areas of the proposed works (Figure 12). Similarly, the combination of an erosional soil landscape, topography and high level of disturbance as shown by the geotechnical investigations (in some areas extending up to 1.7 metres of fill material) also support an assessment of low archaeological potential in the south-eastern area of proposed works.

Recommendation 1: Works may proceed with caution in areas of low archaeological potential

No Aboriginal objects, sites, or areas of sensitivity were identified within the study area. The areas of proposed works have been assessed as holding low archaeological potential. No further archaeological works are required. The proposed works may proceed with caution; refer to Recommendation 2 and 3 below for unexpected finds procedures to be adhered to.
