Response to request for information memo

Tilbuster Solar Farm

February 2022

Project Number: 20-729

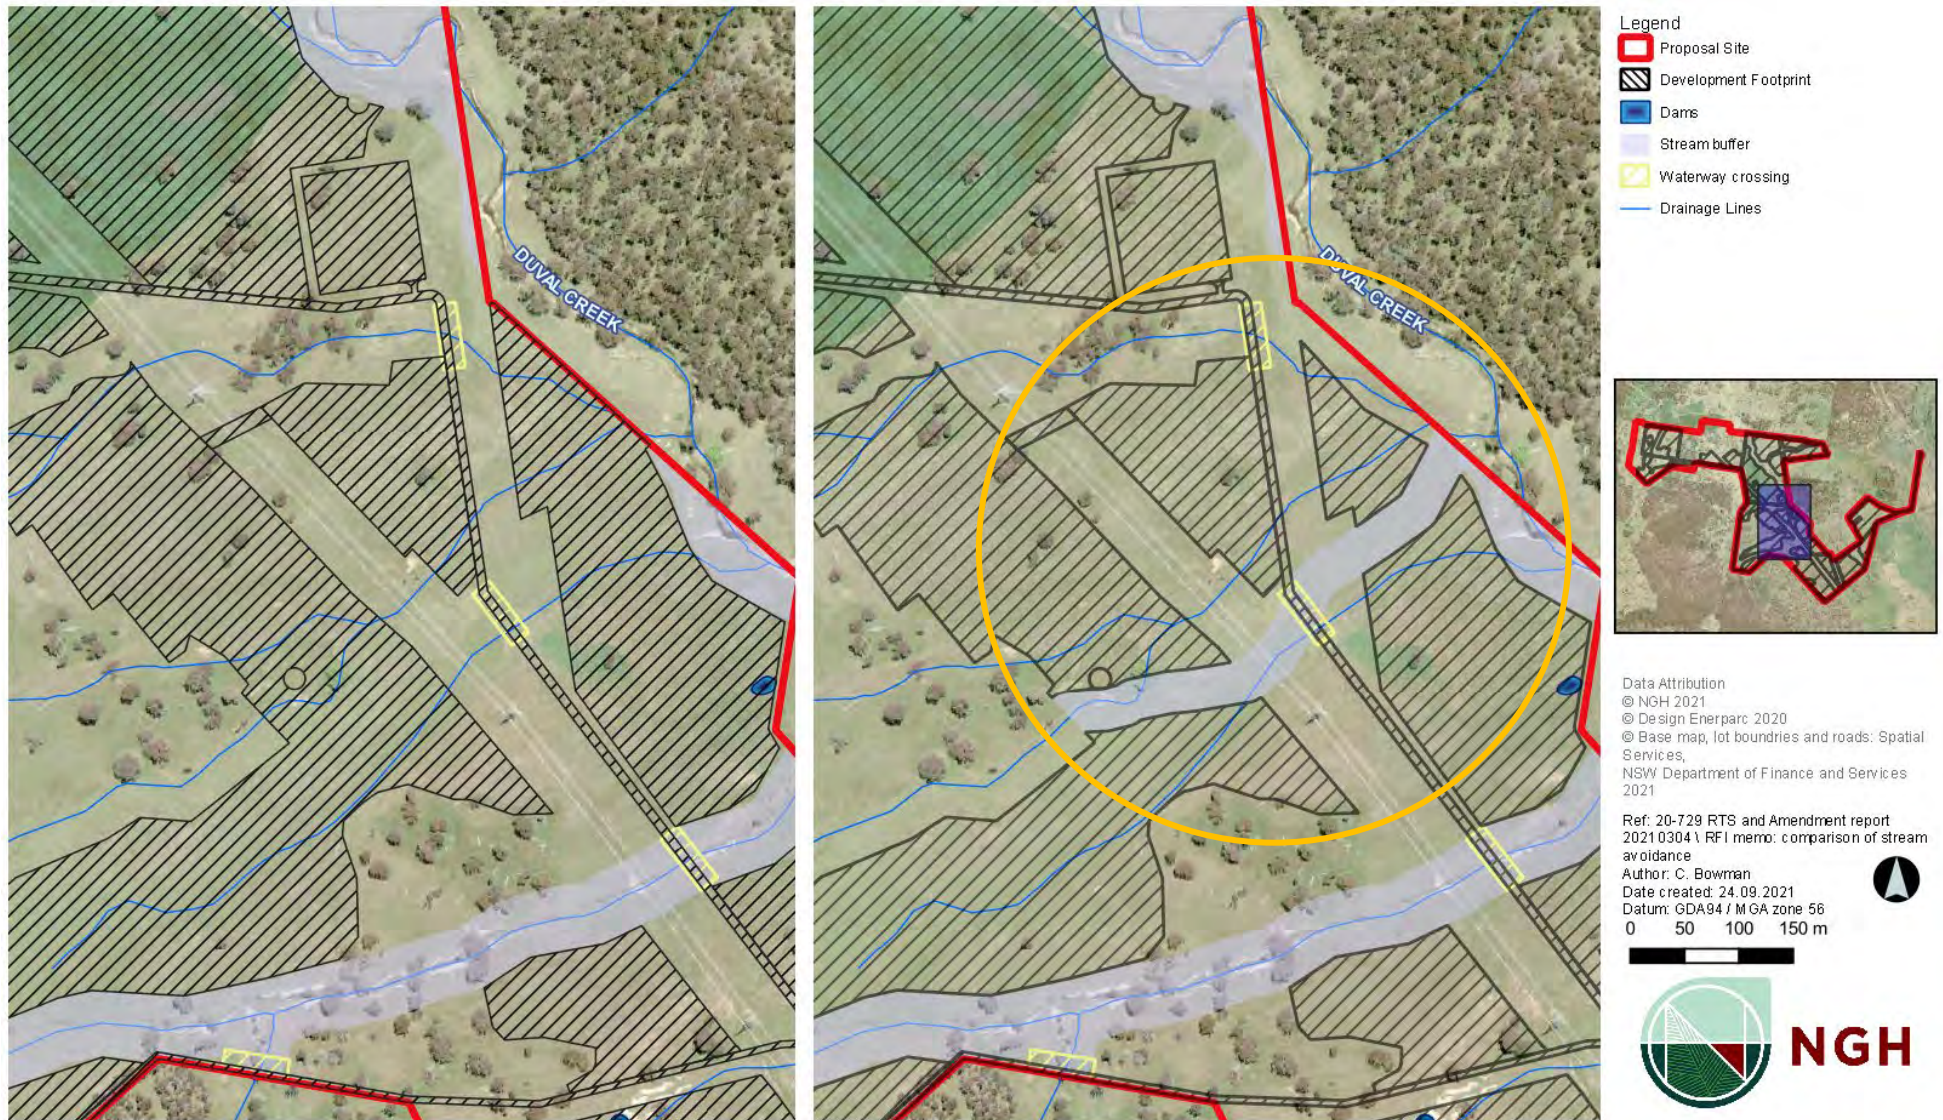
Figure 2-1 Comparison of the Development Footprint presented in the Amendment Report and the updated Development Footprint following additional consultation with NRAR

This advice has now been adopted, and the Development Footprint has been adjusted (resulting in a minor reduction to the Development Footprint in comparison to the Amendment Report) in accordance with NRAR's latest advice. A comparison of the previous and updated Development Footprint in the area in question is presented in Figure 2-1. This figure also shows the alignment of the 20-meter buffer.

During consultation, NRAR requested that a 20-meter stream buffer be adopted, that follows the centreline of the modelled maximum flow area nearest this stream, rather than applying the buffer to the drainage lines presented in the Strahler stream order mapping.

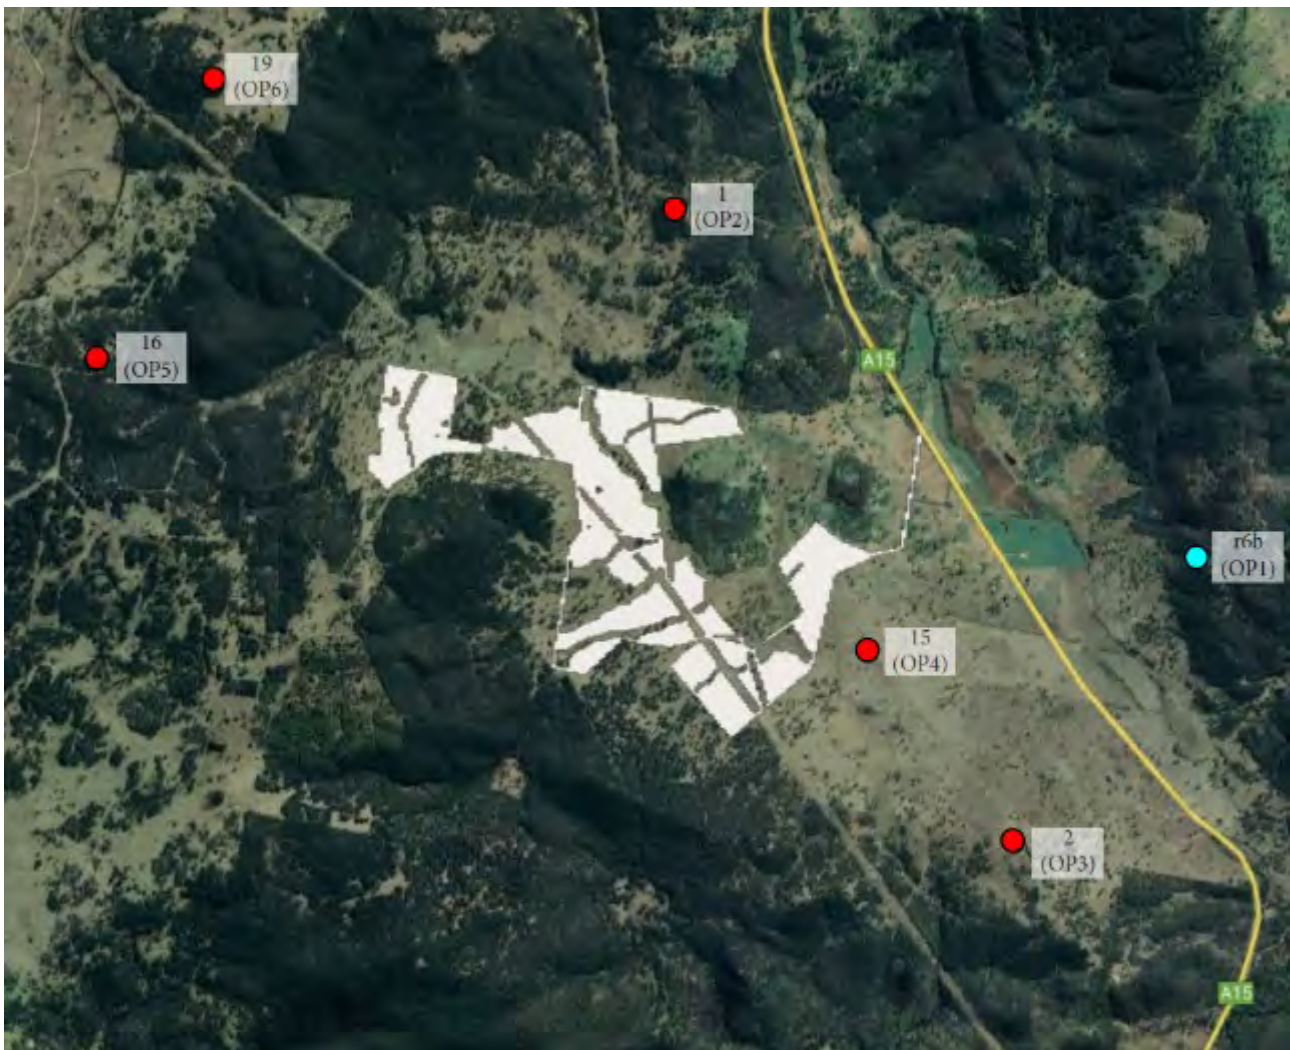
Figure 3-1 Visual receptors assessed for glint and glare impacts

The location of these receivers is presented in Figure 3-1.

- Glint would not be caused by the proposal. No receivers are expected to experience glint.
- Of the receivers identified to have some level of visual impact, three of the receivers (R6b, R2 and R15) would have nil glare impact.

- Receiver R19 would theoretically receive glare from 13:30 to 17:45 UTC in early Jan to mid April. Glare could occur from most sections of the proposed layout. However, this glare is expected to be entirely shielded by existing offsite vegetation.

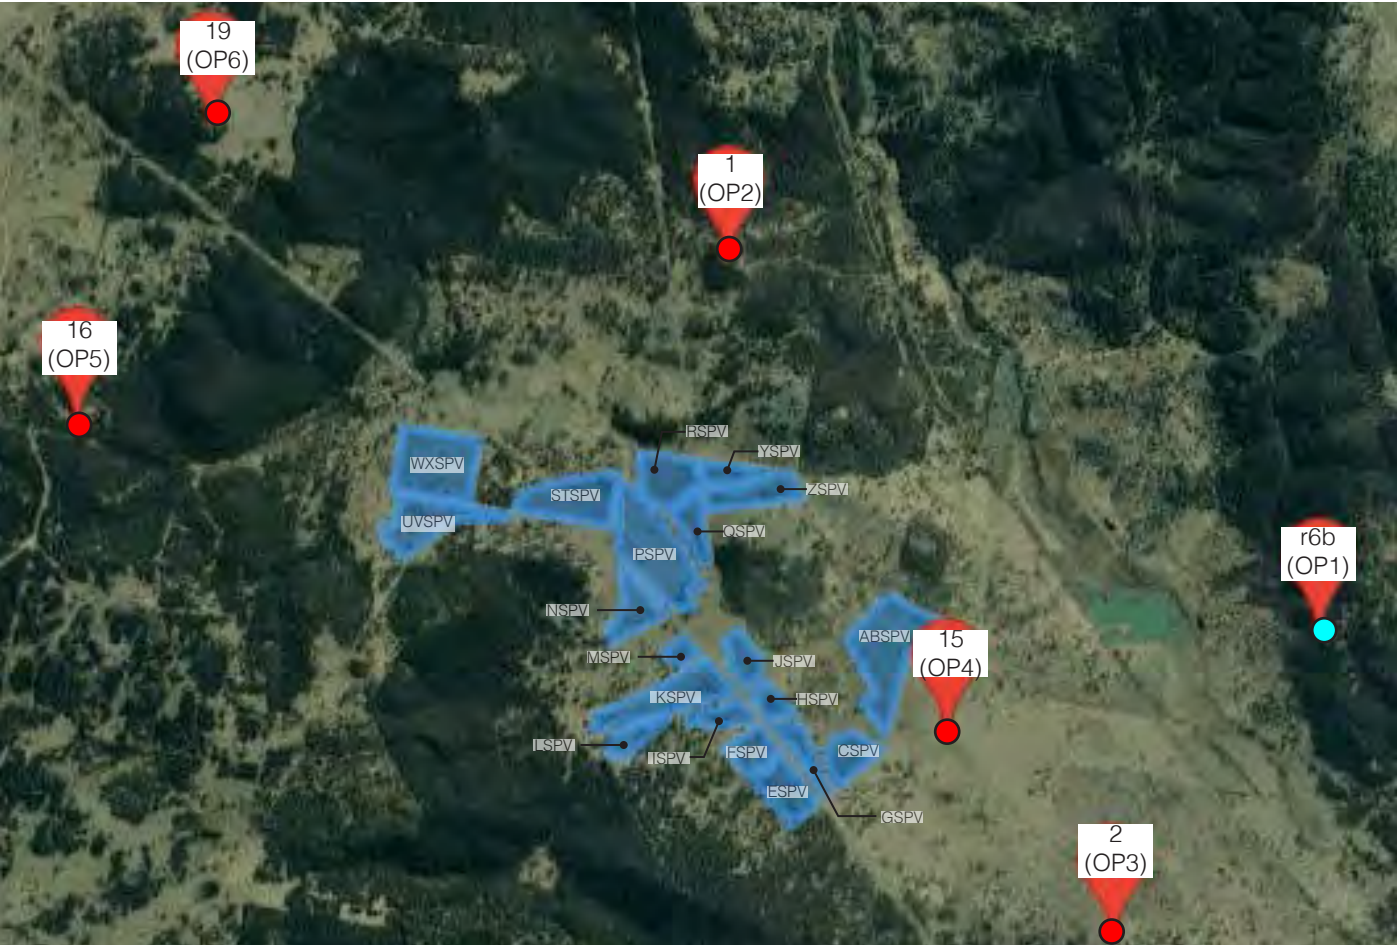
Figure 1: Locations of Receptors and Solar Farm Arrangement

The SGHAT tool was also used to assess potential glare of the 6 receptors next to the site. Refer to **Figure 1**. Due to the irregular shape of the development footprint, for the purposes of the assessment the development footprint has been divided into several sections. Table below summarises the months and times during which potential glare could be experienced by a receptor. This does not mean that reflections would occur continuously between the times shown. As the times of day at which reflections could start and stop vary throughout the days/months, the range of times at which reflections are geometrically possible is generally greater than the length of time for any particular day. Times are in UTC/GMT+11 which is the local time in New South Wales, Australia. **Appendix A** presents the detailed modelling output in cases where effects are possible.

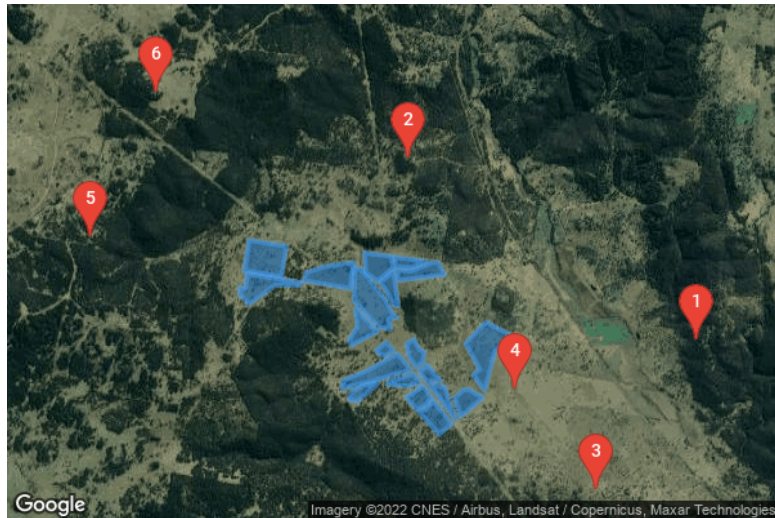
PV Array(s)

Name: ABSVP area
Axis tracking: Single-axis rotation
Backtracking: Instant
Tracking axis orientation: 0.0°
Tracking axis tilt: 0.0°
Tracking axis panel offset: 0.0°
Max tracking angle: 60.0°
Resting angle: 60.0°
Rated power: -
Panel material: Smooth glass with AR coating
Reflectivity: Vary with sun
Slope error: correlate with material

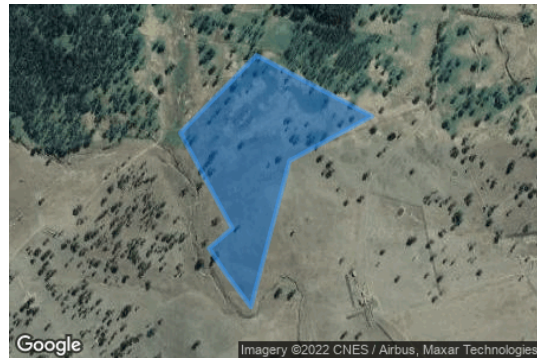
Vertex	Latitude (°)	Longitude (°)	Ground elevation (m)	Height above ground (m)	Total elevation (m)
1	-30.380056	151.660572	1061.09	3.00	1064.09
2	-30.377639	151.663336	1073.83	3.00	1076.83
3	-30.379536	151.667519	1070.03	3.00	1073.03
4	-30.380931	151.664536	1067.40	3.00	1070.40
5	-30.385486	151.663133	1054.15	3.00	1057.15
6	-30.384472	151.662250	1059.13	3.00	1062.13
7	-30.383661	151.661614	1059.17	3.00	1062.17
8	-30.383033	151.662456	1058.04	3.00	1061.04

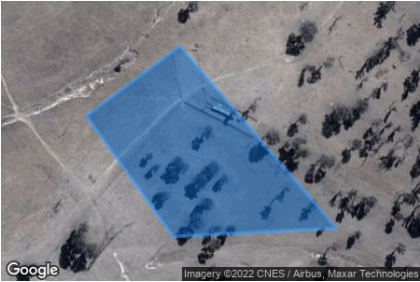
Name: HSVP area
Footprint area: 29,275 m²
Axis tracking: Single-axis rotation
Backtracking: Instant
Tracking axis orientation: 0.0 deg
Tracking axis tilt: 60.0 deg
Tracking axis panel offset: 0.0 deg
Maximum tracking angle: 60.0 deg
Resting angle: 60.0 deg
Rated power: -
Panel material: Smooth glass with AR coating
Vary reflectivity with sun position? Yes
Correlate slope error with surface type? Yes
Slope error: 8.43 mrad

Vertex	Latitude	Longitude	Ground elevation	Height above ground	Total elevation
	deg	deg	m	m	m
1	-30.382558	151.655456	1069.18	3.00	1072.18
2	-30.384358	151.657253	1071.04	3.00	1074.04
3	-30.384444	151.655386	1074.60	3.00	1077.60
4	-30.383247	151.654383	1072.32	3.00	1075.32

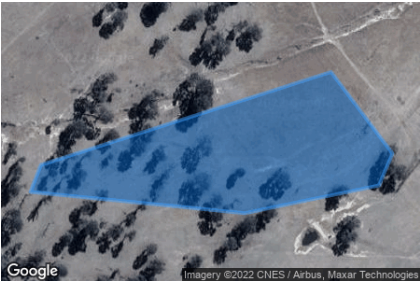
Name: ISVP area
Footprint area: 35,573 m²
Axis tracking: Single-axis rotation
Backtracking: Instant
Tracking axis orientation: 0.0 deg
Tracking axis tilt: 60.0 deg
Tracking axis panel offset: 0.0 deg
Maximum tracking angle: 60.0 deg
Resting angle: 60.0 deg
Rated power: -
Panel material: Smooth glass with AR coating
Vary reflectivity with sun position? Yes
Correlate slope error with surface type? Yes
Slope error: 8.43 mrad

Vertex	Latitude	Longitude	Ground elevation	Height above ground	Total elevation
	deg	deg	m	m	m
1	-30.383589	151.653644	1073.91	3.00	1076.91
2	-30.384511	151.650308	1086.63	3.00	1089.63
3	-30.384778	151.650189	1087.33	3.00	1090.33
4	-30.384989	151.652653	1079.27	3.00	1082.27
5	-30.384714	151.654194	1076.92	3.00	1079.92
6	-30.384397	151.654350	1076.22	3.00	1079.22

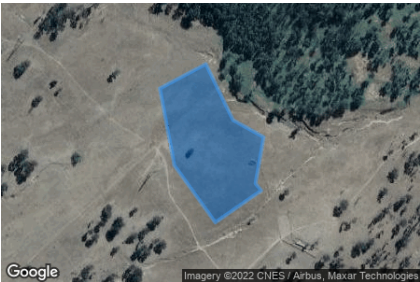
Name: JSVP area
Footprint area: 46,376 m²
Axis tracking: Single-axis rotation
Backtracking: Instant
Tracking axis orientation: 0.0 deg
Tracking axis tilt: 60.0 deg
Tracking axis panel offset: 0.0 deg
Maximum tracking angle: 60.0 deg
Resting angle: 60.0 deg
Rated power: -
Panel material: Smooth glass with AR coating
Vary reflectivity with sun position? Yes
Correlate slope error with surface type? Yes
Slope error: 8.43 mrad

Vertex	Latitude	Longitude	Ground elevation	Height above ground	Total elevation
	deg	deg	m	m	m
1	-30.382753	151.653967	1071.39	3.00	1074.39
2	-30.382122	151.655022	1066.91	3.00	1069.91
3	-30.381981	151.654892	1066.68	3.00	1069.68
4	-30.381061	151.655078	1066.37	3.00	1069.37
5	-30.380725	151.654375	1066.31	3.00	1069.31
6	-30.379614	151.653750	1067.50	3.00	1070.50
7	-30.380097	151.652692	1067.70	3.00	1070.70
8	-30.381619	151.653025	1073.32	3.00	1076.32

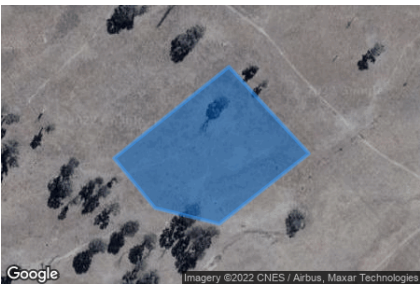
Name: MSVP area
Footprint area: 16,035 m^2
Axis tracking: Single-axis rotation
Backtracking: Instant
Tracking axis orientation: 0.0 deg
Tracking axis tilt: 60.0 deg
Tracking axis panel offset: 0.0 deg
Maximum tracking angle: 60.0 deg
Resting angle: 60.0 deg
Rated power: -
Panel material: Smooth glass without AR coating
Vary reflectivity with sun position? Yes
Correlate slope error with surface type? Yes
Slope error: 6.55 mrad

Vertex	Latitude	Longitude	Ground elevation	Height above ground	Total elevation
	deg	deg	m	m	m
1	-30.379953	151.650003	1077.19	3.00	1080.19
2	-30.380814	151.650922	1073.58	3.00	1076.58
3	-30.381511	151.649892	1078.95	3.00	1081.95
4	-30.381353	151.649153	1079.33	3.00	1082.33
5	-30.381353	151.649153	1083.24	3.00	1086.24
6	-30.380860	151.648683	1081.30	3.00	1084.30

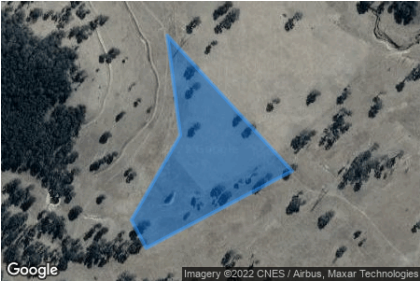
Name: NSVP area
Footprint area: 66,041 m²
Axis tracking: Single-axis rotation
Backtracking: Instant
Tracking axis orientation: 0.0 deg
Tracking axis tilt: 60.0 deg
Tracking axis panel offset: 0.0 deg
Maximum tracking angle: 60.0 deg
Resting angle: 60.0 deg
Rated power: -
Panel material: Smooth glass with AR coating
Vary reflectivity with sun position? Yes
Correlate slope error with surface type? Yes
Slope error: 8.43 mrad

Vertex	Latitude	Longitude	Ground elevation	Height above ground	Total elevation
	deg	deg	m	m	m
1	-30.378047	151.646167	1087.90	3.00	1090.90
2	-30.376067	151.645867	1079.90	3.00	1082.90
3	-30.378756	151.648739	1079.07	3.00	1082.07
4	-30.380286	151.645381	1090.07	3.00	1093.07
5	-30.379730	151.645042	1090.75	3.00	1093.75

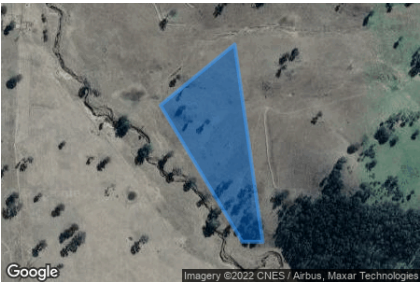
Name: QSVP area
Footprint area: 46,332 m²
Axis tracking: Single-axis rotation
Backtracking: Instant
Tracking axis orientation: 0.0 deg
Tracking axis tilt: 60.0 deg
Tracking axis panel offset: 0.0 deg
Maximum tracking angle: 60.0 deg
Resting angle: 60.0 deg
Rated power: -
Panel material: Smooth glass with AR coating
Vary reflectivity with sun position? Yes
Correlate slope error with surface type? Yes
Slope error: 8.43 mrad

Vertex	Latitude	Longitude	Ground elevation	Height above ground	Total elevation
	deg	deg	m	m	m
1	-30.371817	151.650958	1098.49	3.00	1101.49
2	-30.375733	151.651603	1099.64	3.00	1102.64
3	-30.375728	151.651131	1083.08	3.00	1086.08
4	-30.373025	151.649250	1080.38	3.00	1083.38

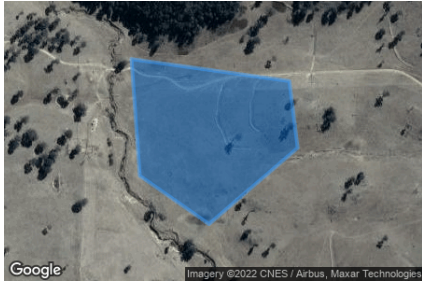
Name: RSVP area
Footprint area: 93,959 m²
Axis tracking: Single-axis rotation
Backtracking: Instant
Tracking axis orientation: 0.0 deg
Tracking axis tilt: 60.0 deg
Tracking axis panel offset: 0.0 deg
Maximum tracking angle: 60.0 deg
Resting angle: 60.0 deg
Rated power: -
Panel material: Smooth glass with AR coating
Vary reflectivity with sun position? Yes
Correlate slope error with surface type? Yes
Slope error: 8.43 mrad

Vertex	Latitude	Longitude	Ground elevation	Height above ground	Total elevation
	deg	deg	m	m	m
1	-30.369650	151.647078	1089.86	3.00	1092.86
2	-30.370086	151.650708	1105.64	3.00	1108.64
3	-30.371411	151.650900	1097.38	3.00	1100.38
4	-30.372922	151.648861	1082.41	3.00	1085.41
5	-30.371964	151.647269	1079.51	3.00	1082.51

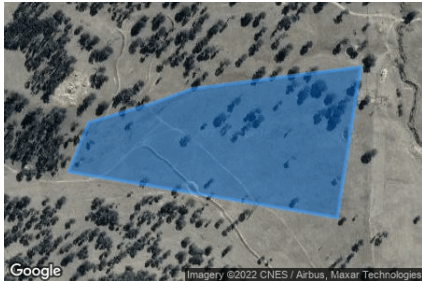
Name: STSVP area
Footprint area: 138,043 m²
Axis tracking: Single-axis rotation
Backtracking: Instant
Tracking axis orientation: 0.0 deg
Tracking axis tilt: 60.0 deg
Tracking axis panel offset: 0.0 deg
Maximum tracking angle: 60.0 deg
Resting angle: 60.0 deg
Rated power: -
Panel material: Smooth glass with AR coating
Vary reflectivity with sun position? Yes
Correlate slope error with surface type? Yes
Slope error: 8.43 mrad

Vertex	Latitude	Longitude	Ground elevation	Height above ground	Total elevation
	deg	deg	m	m	m
1	-30.370783	151.645697	1091.05	3.00	1094.05
2	-30.371219	151.641817	1104.39	3.00	1107.39
3	-30.371514	151.640889	1113.93	3.00	1116.93
4	-30.371886	151.639439	1128.49	3.00	1131.49
5	-30.372864	151.638975	1138.85	3.00	1141.85
6	-30.373775	151.645156	1097.16	3.00	1100.16

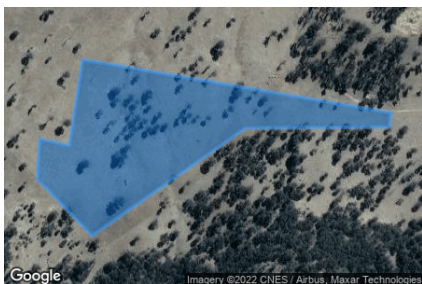
Name: UVSVP area
Footprint area: 117,871 m²
Axis tracking: Single-axis rotation
Backtracking: Instant
Tracking axis orientation: 0.0 deg
Tracking axis tilt: 60.0 deg
Tracking axis panel offset: 0.0 deg
Maximum tracking angle: 60.0 deg
Resting angle: 60.0 deg
Rated power: -
Panel material: Smooth glass without AR coating
Vary reflectivity with sun position? Yes
Correlate slope error with surface type? Yes
Slope error: 6.55 mrad

Vertex	Latitude	Longitude	Ground elevation	Height above ground	Total elevation
	deg	deg	m	m	m
1	-30.373097	151.638547	1139.28	3.00	1142.28
2	-30.373375	151.638497	1148.42	3.00	1151.42
3	-30.373400	151.635189	1166.72	3.00	1169.72
4	-30.375536	151.631667	1275.85	3.00	1278.85
5	-30.374406	151.630403	1259.06	3.00	1262.06
6	-30.373614	151.630461	1238.49	3.00	1241.49
7	-30.373744	151.631142	1209.48	3.00	1212.48
8	-30.372039	151.631447	1162.39	3.00	1165.39

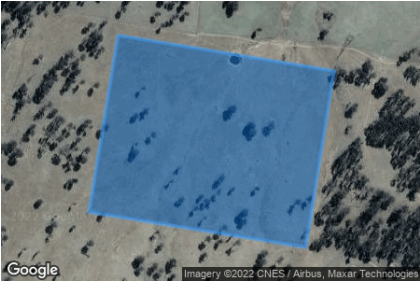
Name: WXSVP area
Footprint area: 190,953 m²
Axis tracking: Single-axis rotation
Backtracking: Instant
Tracking axis orientation: 0.0 deg
Tracking axis tilt: 60.0 deg
Tracking axis panel offset: 0.0 deg
Maximum tracking angle: 60.0 deg
Resting angle: 60.0 deg
Rated power: -
Panel material: Smooth glass with AR coating
Vary reflectivity with sun position? Yes
Correlate slope error with surface type? Yes
Slope error: 8.43 mrad

Vertex	Latitude	Longitude	Ground elevation	Height above ground	Total elevation
	deg	deg	m	m	m
1	-30.368922	151.636681	1118.54	3.00	1121.54
2	-30.372422	151.636028	1138.95	3.00	1141.95
3	-30.371722	151.631044	1129.38	3.00	1132.38
4	-30.368214	151.631711	1119.73	3.00	1122.73

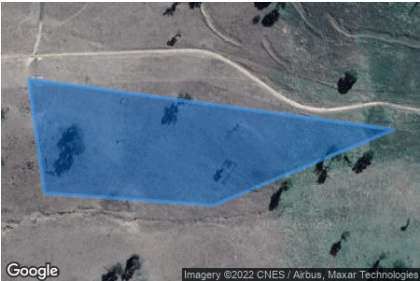
Name: YSVP area
Footprint area: 34,087 m²
Axis tracking: Single-axis rotation
Backtracking: Instant
Tracking axis orientation: 0.0 deg
Tracking axis tilt: 60.0 deg
Tracking axis panel offset: 0.0 deg
Maximum tracking angle: 60.0 deg
Resting angle: 60.0 deg
Rated power: -
Panel material: Smooth glass with AR coating
Vary reflectivity with sun position? Yes
Correlate slope error with surface type? Yes
Slope error: 8.43 mrad

Vertex	Latitude	Longitude	Ground elevation	Height above ground	Total elevation
	deg	deg	m	m	m
1	-30.370656	151.655342	1134.82	3.00	1137.82
2	-30.371406	151.653269	1110.78	3.00	1113.78
3	-30.371286	151.651328	1096.80	3.00	1099.80
4	-30.370156	151.651144	1103.53	3.00	1106.53

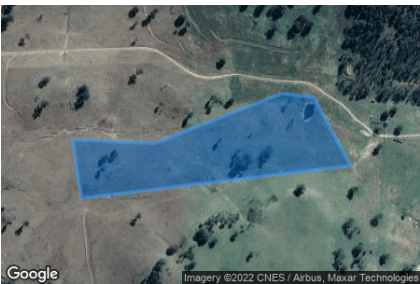
Name: ZSVP area
Footprint area: 77,242 m²
Axis tracking: Single-axis rotation
Backtracking: Instant
Tracking axis orientation: 0.0 deg
Tracking axis tilt: 60.0 deg
Tracking axis panel offset: 0.0 deg
Maximum tracking angle: 60.0 deg
Resting angle: 60.0 deg
Rated power: -
Panel material: Smooth glass with AR coating
Vary reflectivity with sun position? Yes
Correlate slope error with surface type? Yes
Slope error: 8.43 mrad

Vertex	Latitude	Longitude	Ground elevation	Height above ground	Total elevation
	deg	deg	m	m	m
1	-30.370769	151.656217	1131.60	3.00	1134.60
2	-30.370850	151.656939	1138.57	3.00	1141.57
3	-30.372203	151.657778	1139.44	3.00	1142.44
4	-30.372850	151.651594	1093.17	3.00	1096.17
5	-30.371689	151.651394	1092.67	3.00	1095.67
6	-30.371758	151.653297	1104.22	3.00	1107.22
