E.J. Cooper and Son Pty Ltd
Remediation Action Plan

Box Hill North, NSW

15 April 2015
43376/59205 (Rev 5)
JBS&G

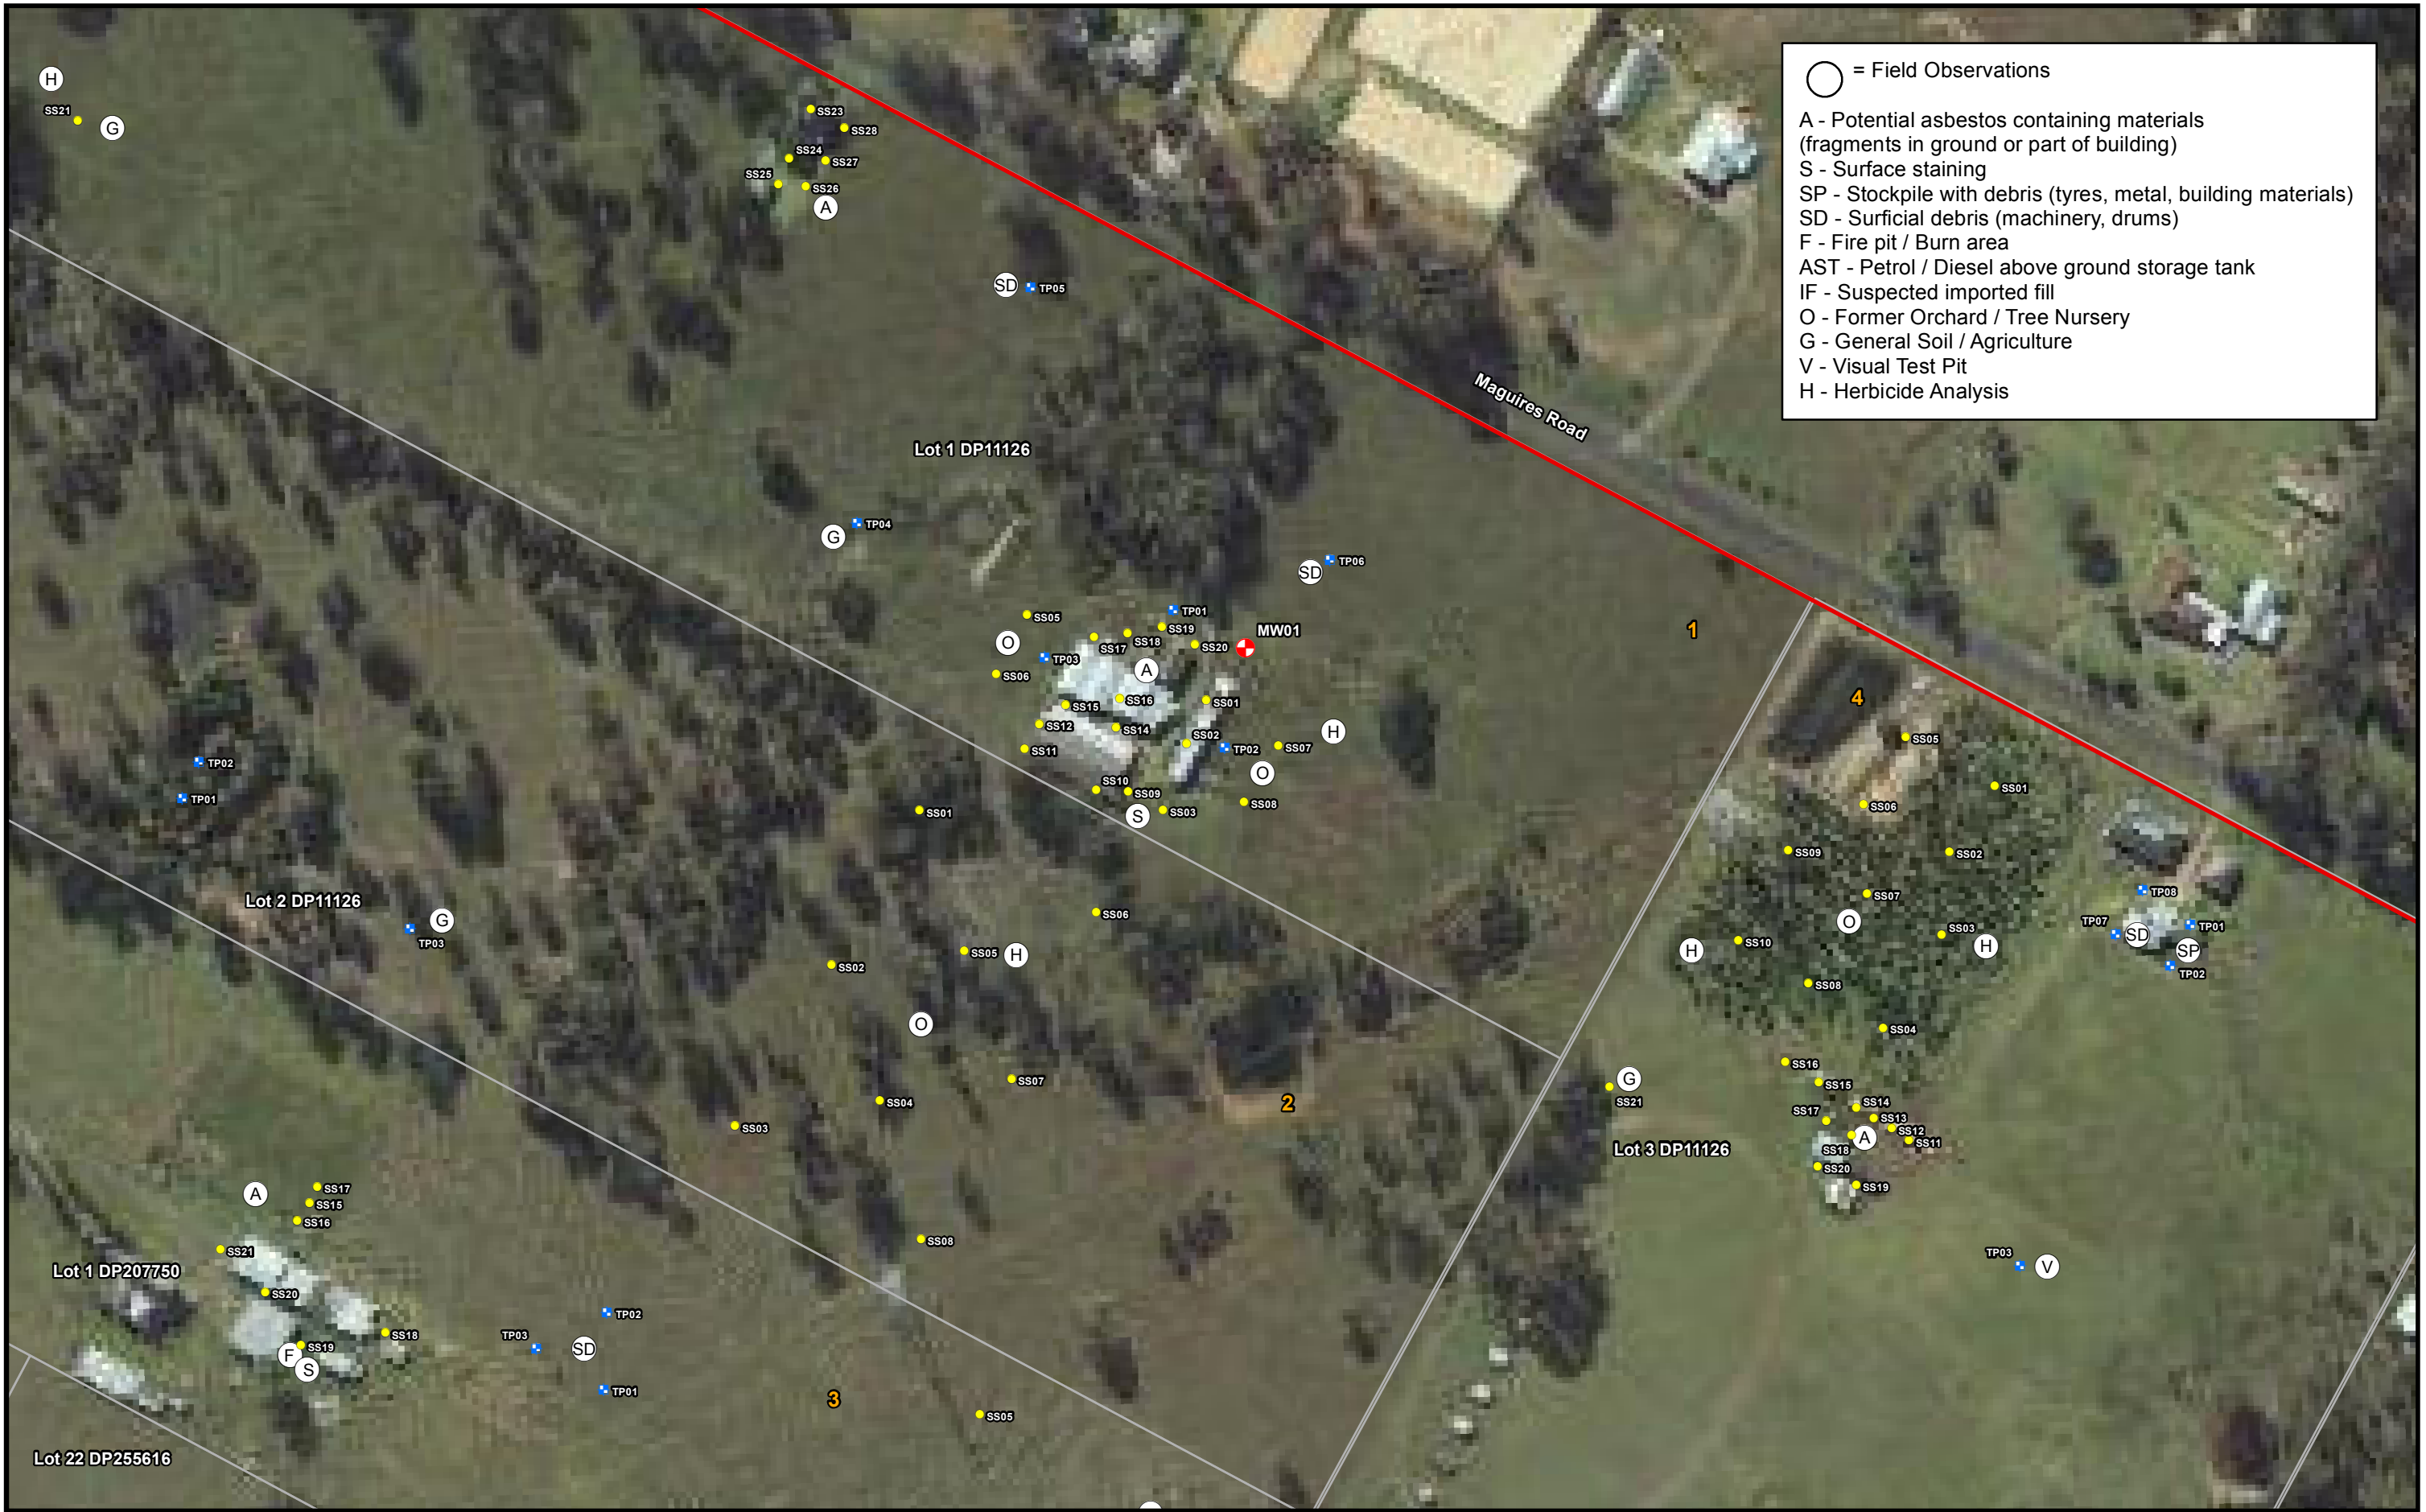
Figure 5a: Previous Soil Sample Locations - Northern Lots

- = Field Observations
- A - Potential asbestos containing materials (fragments in ground or part of building)
- S - Surface staining
- SP - Stockpile with debris (tyres, metal, building materials)
- SD - Surficial debris (machinery, drums)
- F - Fire pit / Burn area
- AST - Petrol / Diesel above ground storage tank
- IF - Suspected imported fill
- O - Former Orchard / Tree Nursery
- G - General Soil / Agriculture
- V - Visual Test Pit
- H - Herbicide Analysis

I	1/207750 181-191 Boundary Road, Maraylya (#3 on Figure 5a & 7a)	Residential Property, with several sheds. Stockpiles of building materials were present including drums. A burnt car was present adjacent to Boundary Road. The site appeared to have been used as a former orchard.	EILs: 1x copper, 3x zinc ACM in soil – 1	1 sample from 27 for copper reported above EIL with 240 mg/kg in 3-S-SS20 (0.0-0.1 m) 3 samples from 27 for zinc reported above EIL with 610 mg/kg in 3-S-SS18 (0.0-0.1 m), 580mg/kg in 3-S-SS20 (0.0-0.1 m) and 380 mg/kg in 3-TP03 (0.0-0.1 m). 1 sample from 14 with asbestos in soil (3-TP03 (0-0.1 m)). All other results below adopted criteria	0.1 m	Drum and shed present on lot	Bricks, concrete, plastic, cement tiles and charcoal present in fill

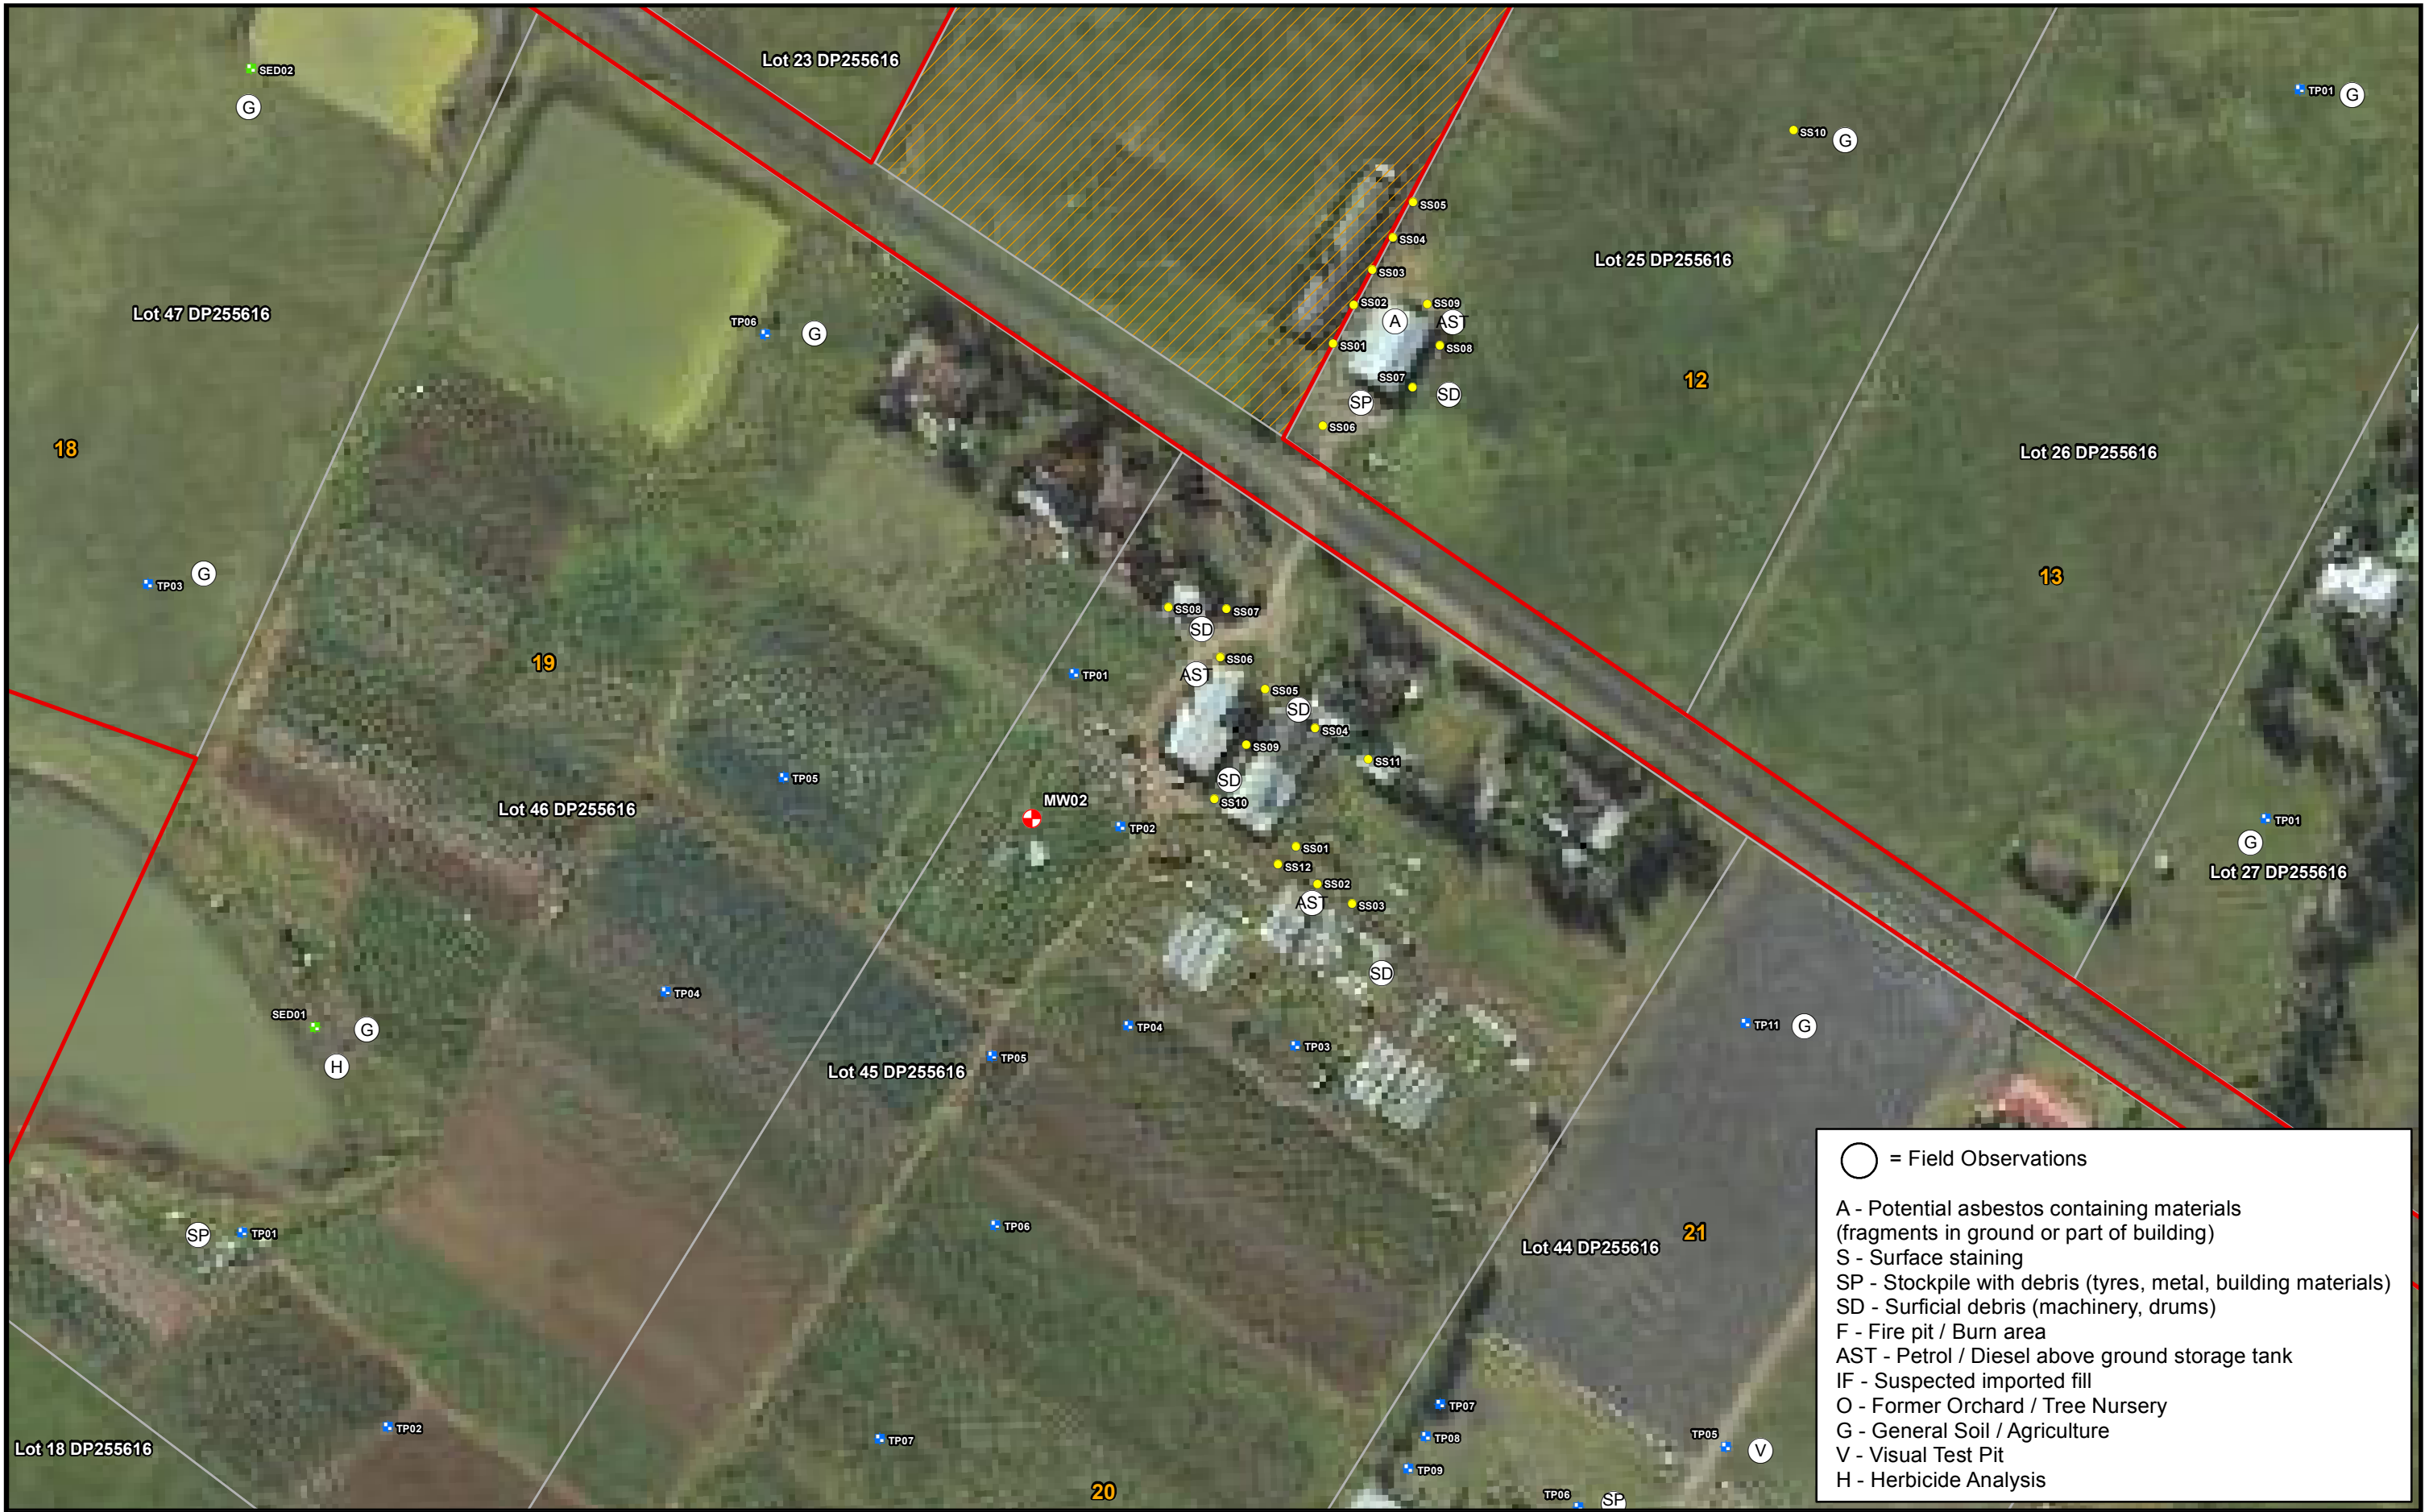
File Name: 43376_05c

○ = Field Observations

A - Potential asbestos containing materials (fragments in ground or part of building)
S - Surface staining
SP - Stockpile with debris (tyres, metal, building materials)
SD - Surficial debris (machinery, drums)
F - Fire pit / Burn area
AST - Petrol / Diesel above ground storage tank
IF - Suspected imported fill
O - Former Orchard / Tree Nursery
G - General Soil / Agriculture
V - Visual Test Pit
H - Herbicide Analysis

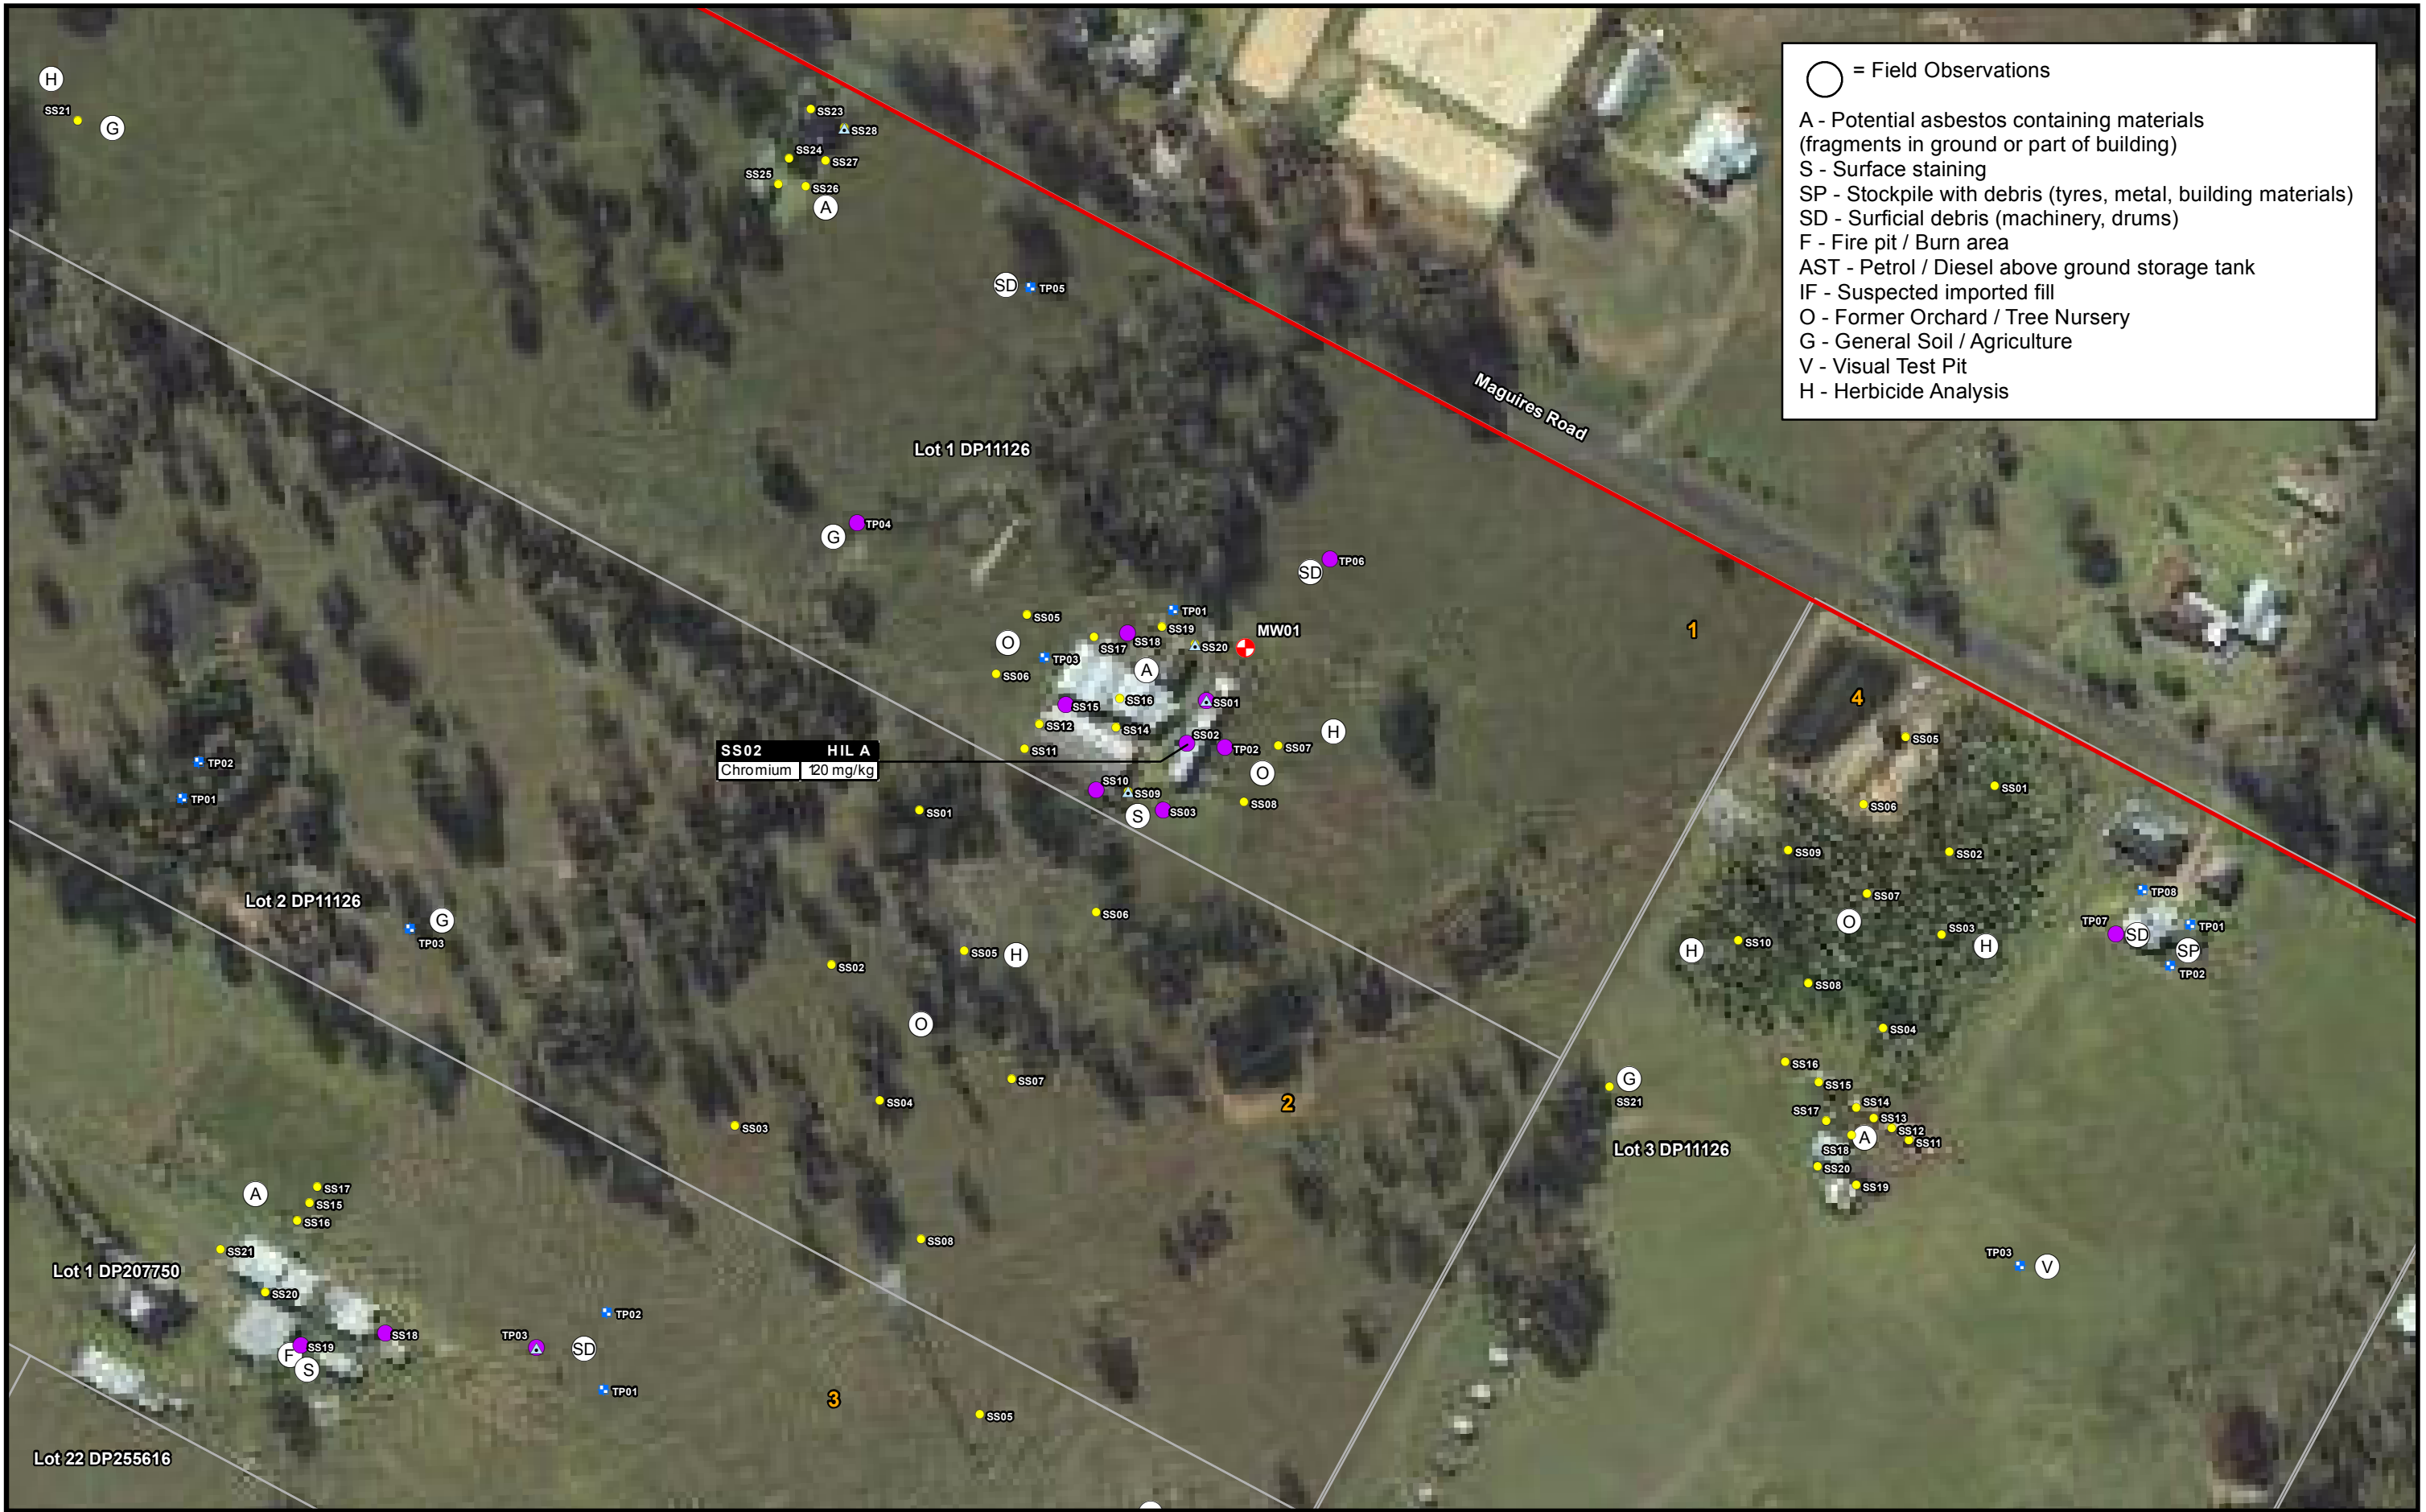
Figure 7a: Previous Soil Exceedances - Northern Lots

- = Field Observations
- A - Potential asbestos containing materials (fragments in ground or part of building)
- S - Surface staining
- SP - Stockpile with debris (tyres, metal, building materials)
- SD - Surficial debris (machinery, drums)
- F - Fire pit / Burn area
- AST - Petrol / Diesel above ground storage tank
- IF - Suspected imported fill
- O - Former Orchard / Tree Nursery
- G - General Soil / Agriculture
- V - Visual Test Pit
- H - Herbicide Analysis

The known areas of remediation are shown in **Table 5.1** following and in **Figures 8a-8e, 9 and 10**. The exceedances reported, depth and the likely AEC that is the potential cause of the exceedances are provided in **Table 5.1**.
