**Proposed Mixed Use Development, Gosford
Town Centre**

Phase 1 Contamination Assessment - Site B

29 May 2020

GEOTLCOV25439AA-AE Rev 1

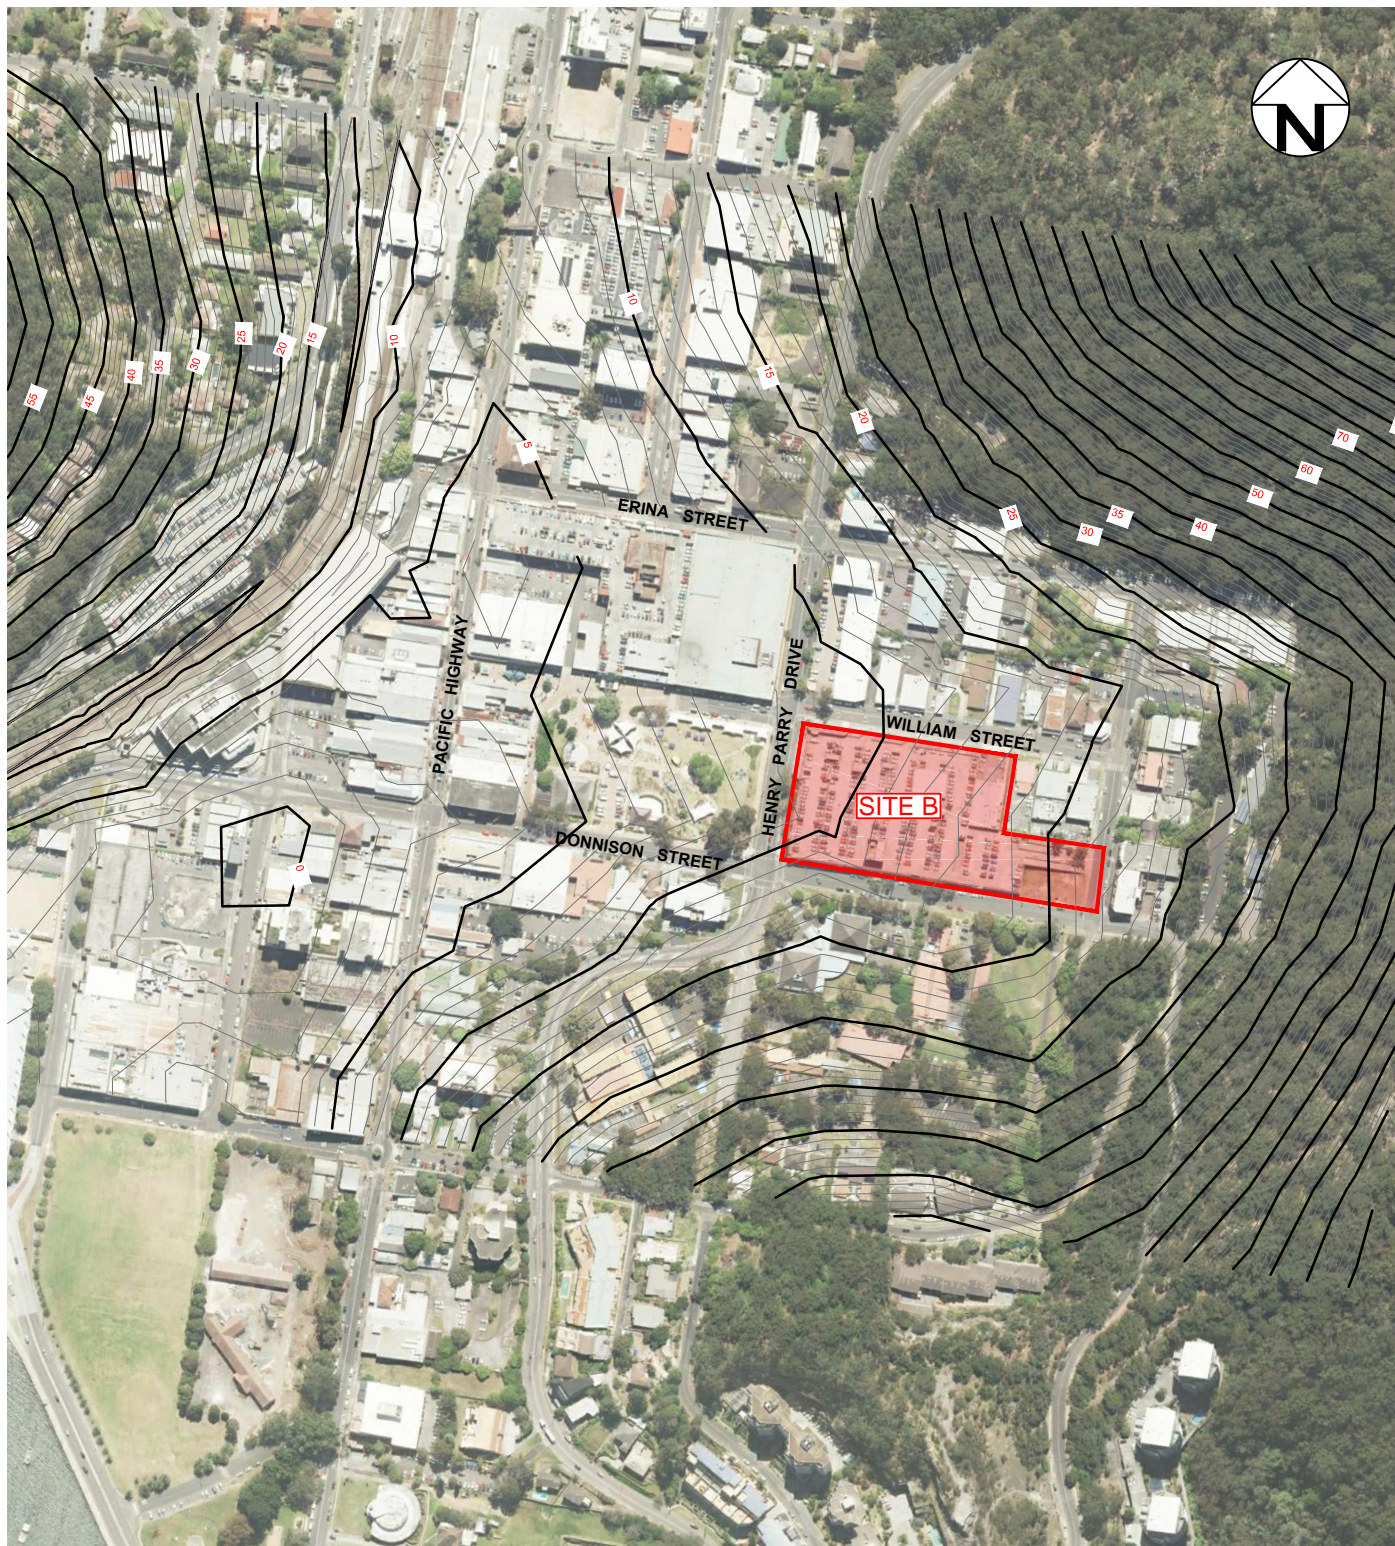
client:	CONYBEARE MORRISON INTERNATIONAL		
project:	GOSFORD DEVELOPMENT PROJECT		
title:	SITE LOCATION AND TOPOGRAPHY		
project no:	GEOTLCOV25439AA-AB	figure no:	FIGURE 1
		rev:	A

- SITE B BOUNDARY
- 10— ELEVATION CONTOURS (mAHD)

This report presents the Phase 1 Contamination Assessment (Phase 1 CA) for Site B. The location of the site is shown on Figure 1. Separate reports are provided for Sites A and C, as well as separate reports for each of the three sites that present the Geotechnical Assessments.

Site Location:	The site is located on the corner of Donnison Street and Henry Parry Drive, Gosford, NSW. The site location is shown on Figure 1 and the site layout is shown on Figure 2.
Approximate Total Site Area:	1.45ha
Title Identification Details	The site comprises: <ul style="list-style-type: none"> • Lot 6 DP 598833 • Lot 7 DP 6039 in the Parish of Gosford and the County of Northumberland
Current ownership	Gosford City Council
Previous Landuse:	Previous site uses included: <ul style="list-style-type: none"> • Various commercial uses, including general retail purposes, food outlets, and car parking; • Potential commercial/industrial use for manufacturing, electric retailer, and bus depot.
Current Landuse:	Commercial use – shopping centre and car park
Proposed Landuse:	Multi-storey commercial and residential development
Adjoining Site Uses:	<ul style="list-style-type: none"> • Donnison Street and commercial properties to the south. • Henry Parry Drive and commercial properties to the west (Site C). • William Street and commercial properties to the north (Site A to the north west). • Albany Street and commercial properties to the east.

Reference to the 1:25,000 Topographic Map for Gosford (<http://maps.six.nsw.gov.au/>) indicates that the site is situated in a low-lying area in the centre of Gosford. The topographic map indicates that the elevation of the site is between 10m and 20m AHD, with the eastern boundary at about 20m AHD.

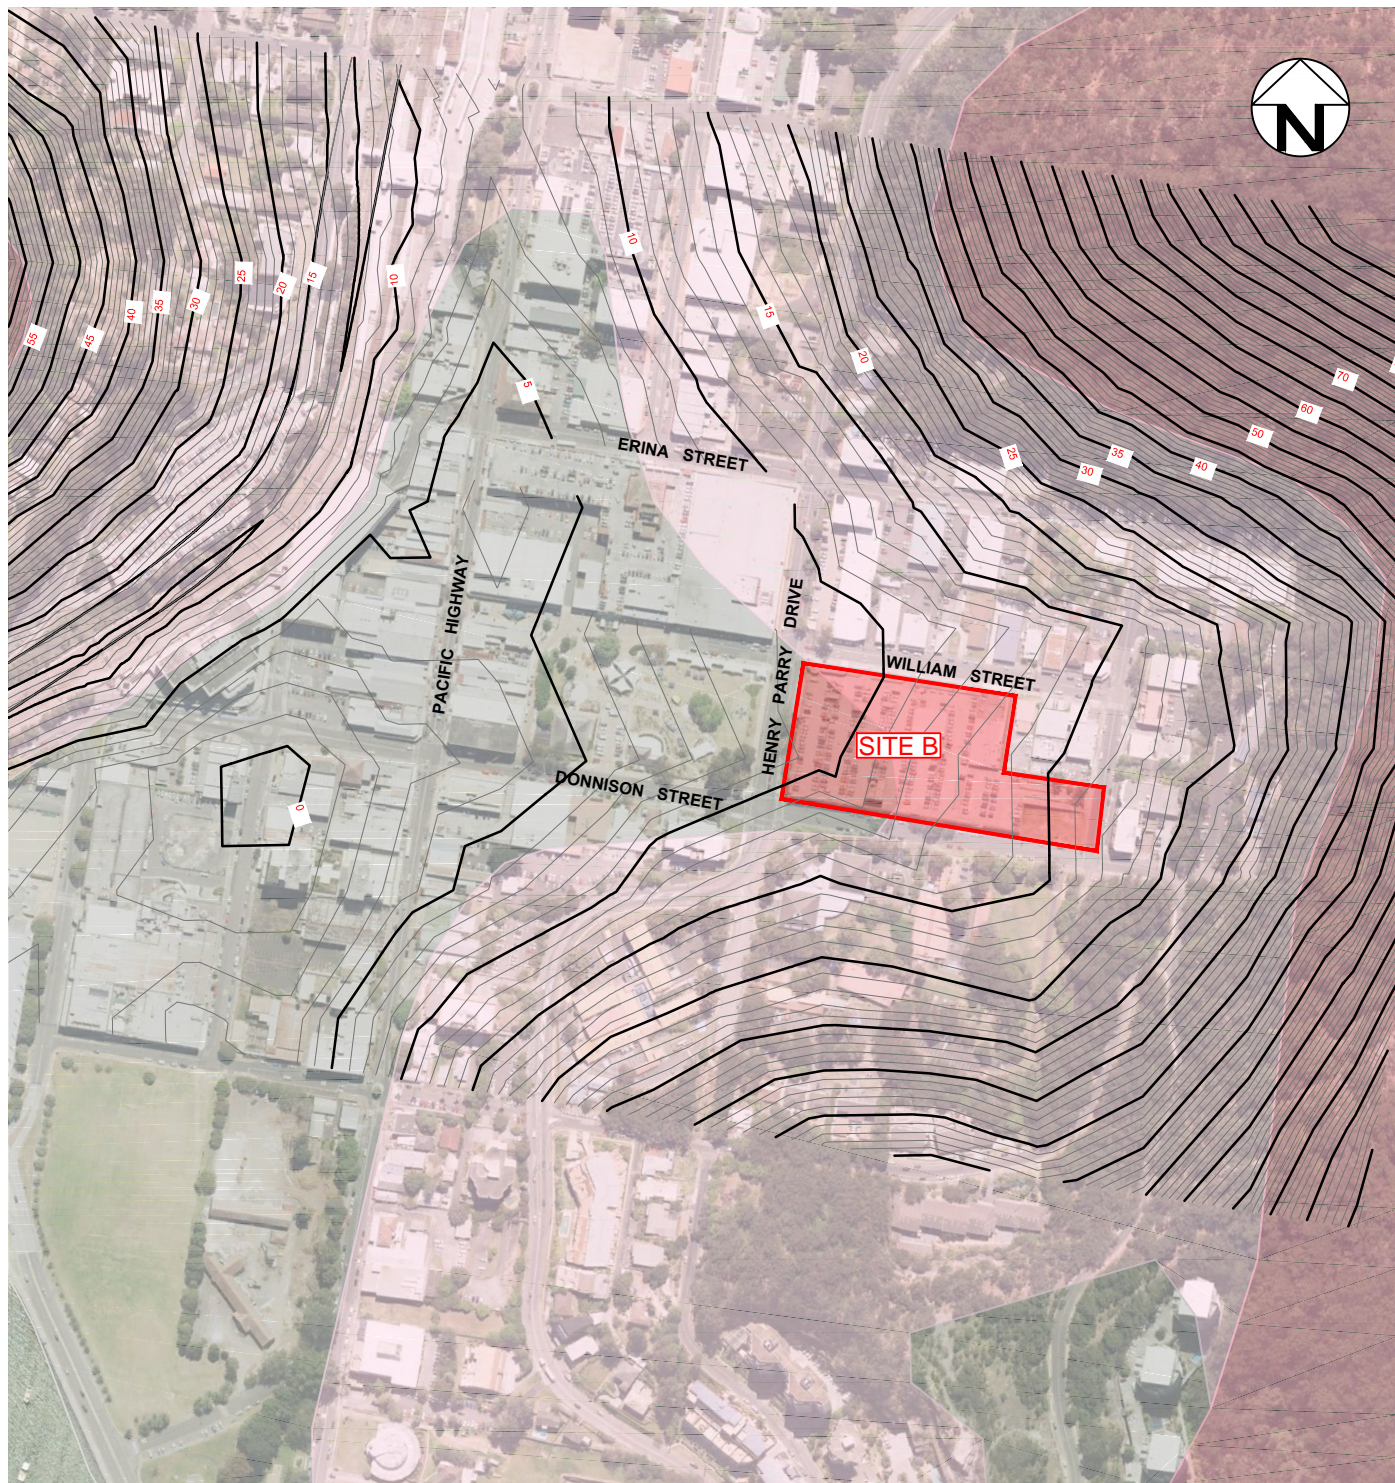
client:	CONYBEARE MORRISON INTERNATIONAL		
project:	GOSFORD DEVELOPMENT PROJECT		
title:	SOIL LANDSCAPE MAP		
project no:	GEOTLCOV25439AA-AB	figure no:	FIGURE 3
		rev:	A

- SITE B BOUNDARY
- DISTURBED TERRAIN
- EROSIONAL
- COLLUVIAL
- 10— ELEVATION CONTOURS (mAHD)

Reference to the CSIRO's Soil and Landscape Grid of Australia (<http://www.clw.csiro.au/aclep/soilandlandscapegrid/ViewData-KML.html>) indicated that the soil profile from surface to approximately 200mm below ground surface (bgs) consisted of silts (15% to 20%), sands (40% to 60%) and clays (10% to 20%). The pH of the soil ranges from 3 to 4.8 and effective Cation Exchange Capacity (CEC) ranges from 5 to 10 meq/100g.

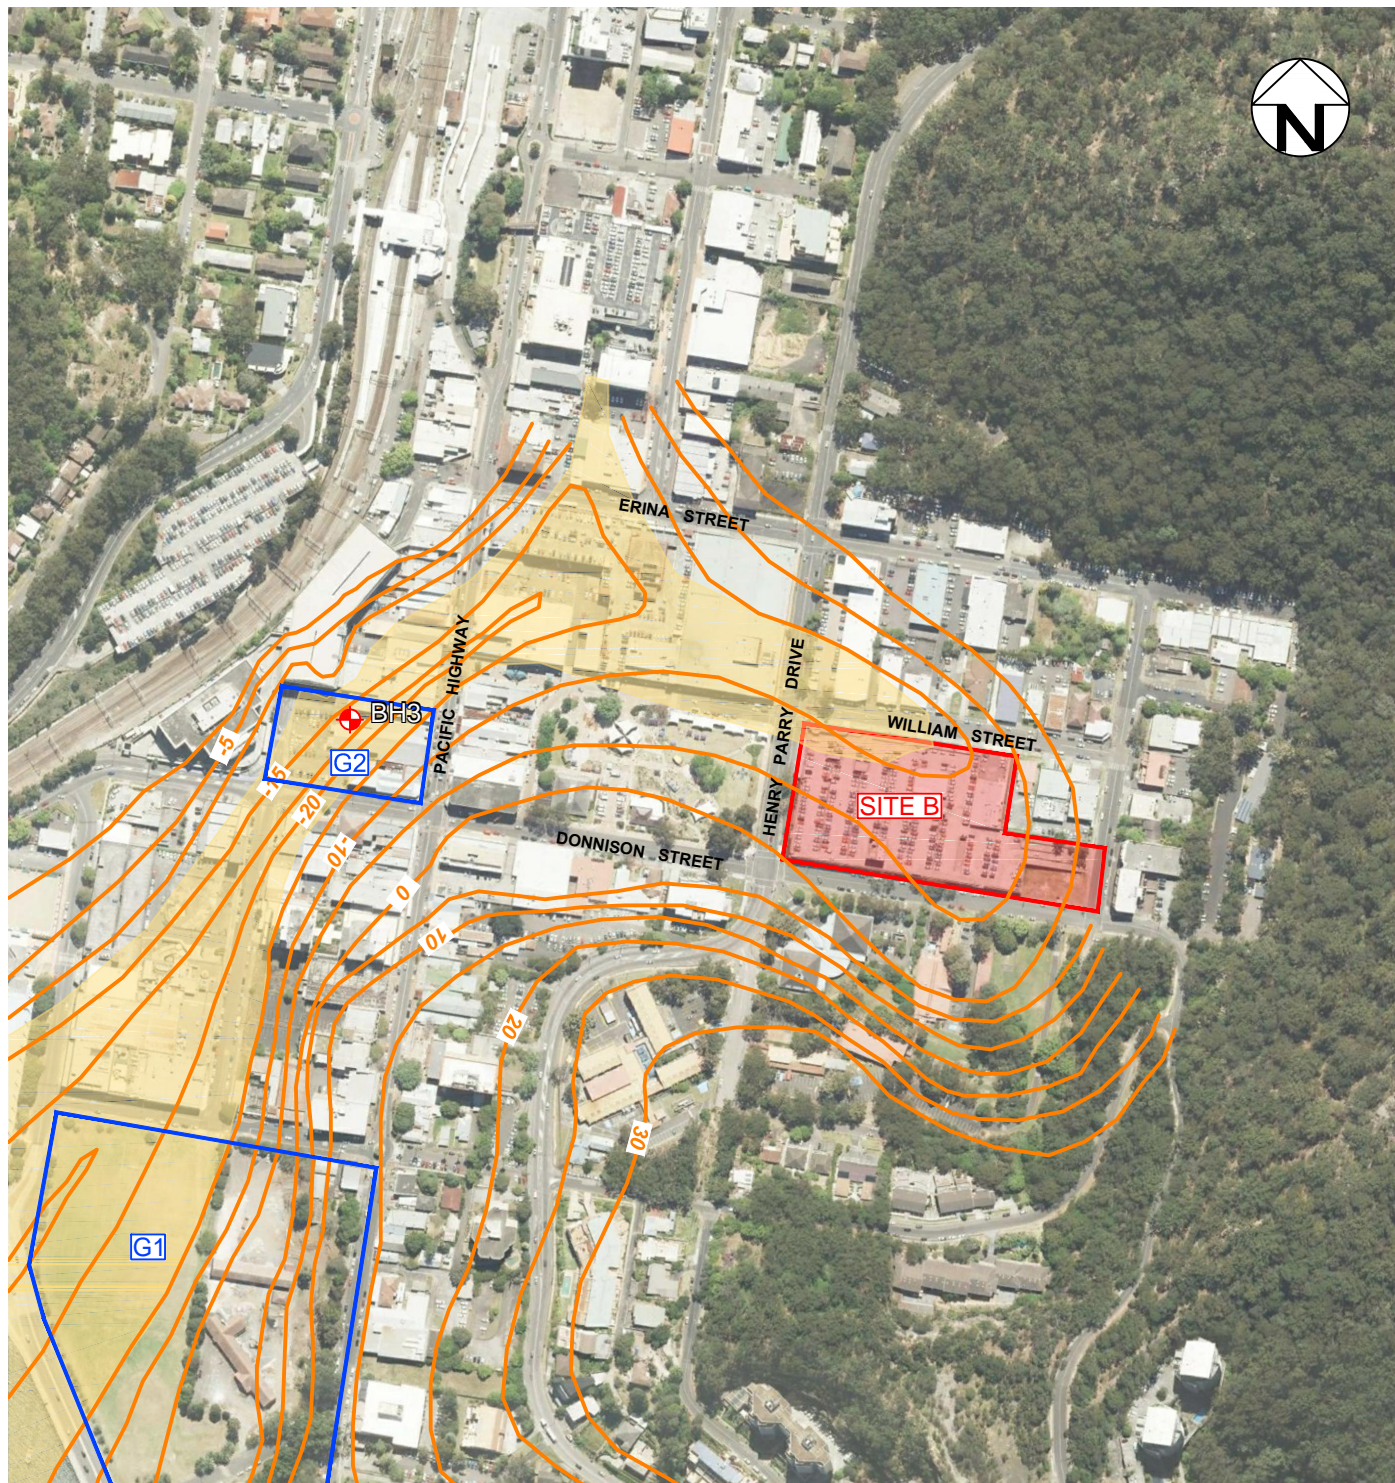
- SITE B BOUNDARY
- 30 — INDICATIVE TOP OF BEDROCK (mAHD)
- PALAEO-CHANNEL

Quaternary-age alluvial soils overlie the bedrock, which can be significantly deep along the centre alignment of the alluvial valley draining into The Broadwater. There is also a possibility of paleo-channels that are incised into the bedrock, formed during periods of lower sea level, which are infilled with older alluvium.

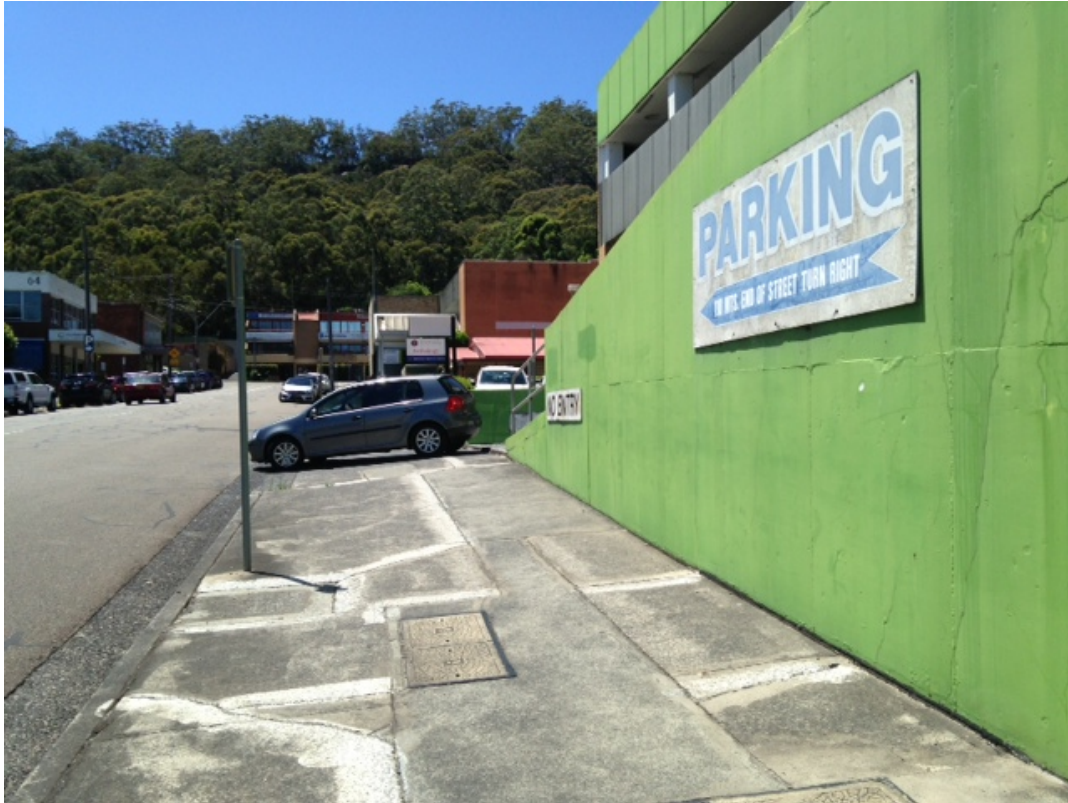
PHOTO 1: View of car park entrance ramp on William Street (view to east)

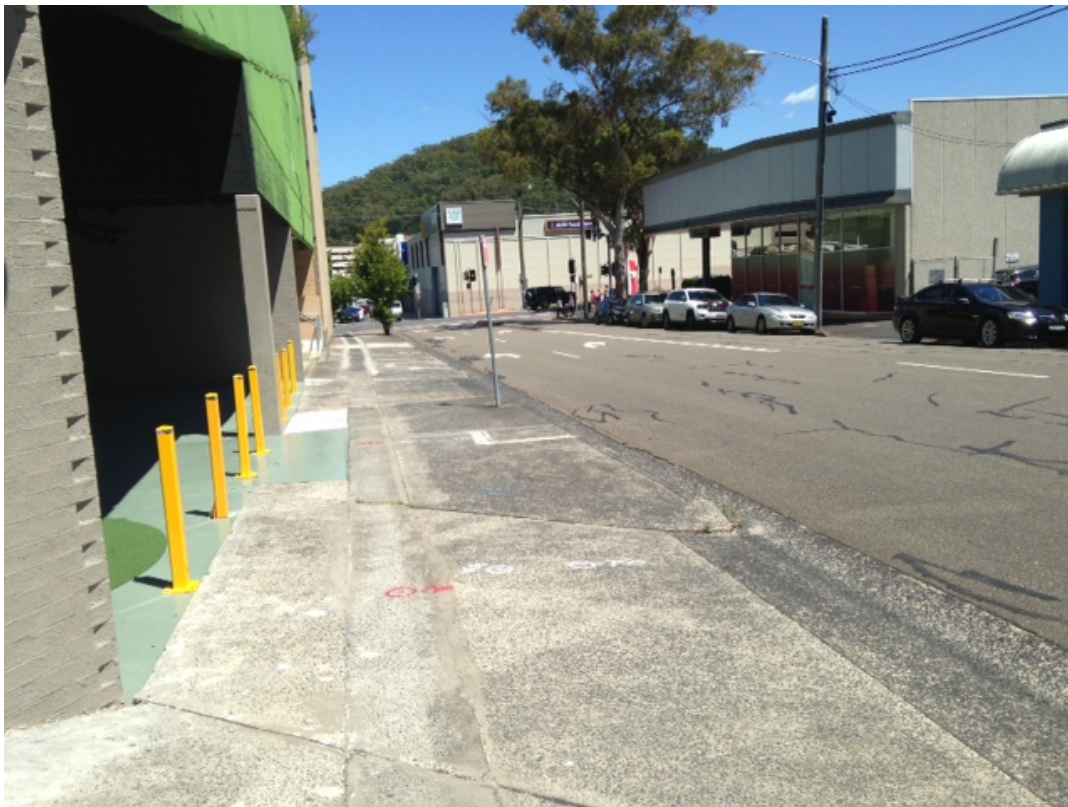
PHOTO 2: Ground level entrance on William Street (view to west)
