Report on
Geotechnical Investigation

Proposed Flight Training Centre
King Street, Mascot

Prepared for
Enstruct Group Pty Ltd

Project 85777.15
February 2019

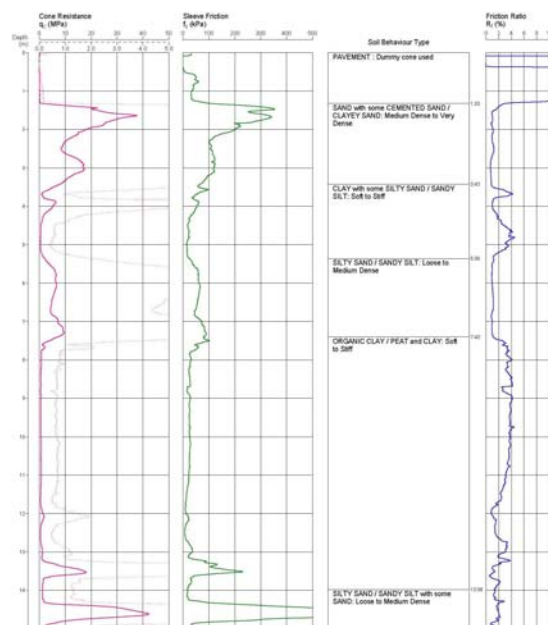
Figure 4: Sample Cone Plot

DP's in-house CPT software provides computer aided interpretation of soil strata, generating soil descriptions and strengths for each layer. The software can also produce plots of estimated soil parameters, including modulus, friction angle, relative density, shear strength and over consolidation ratio.

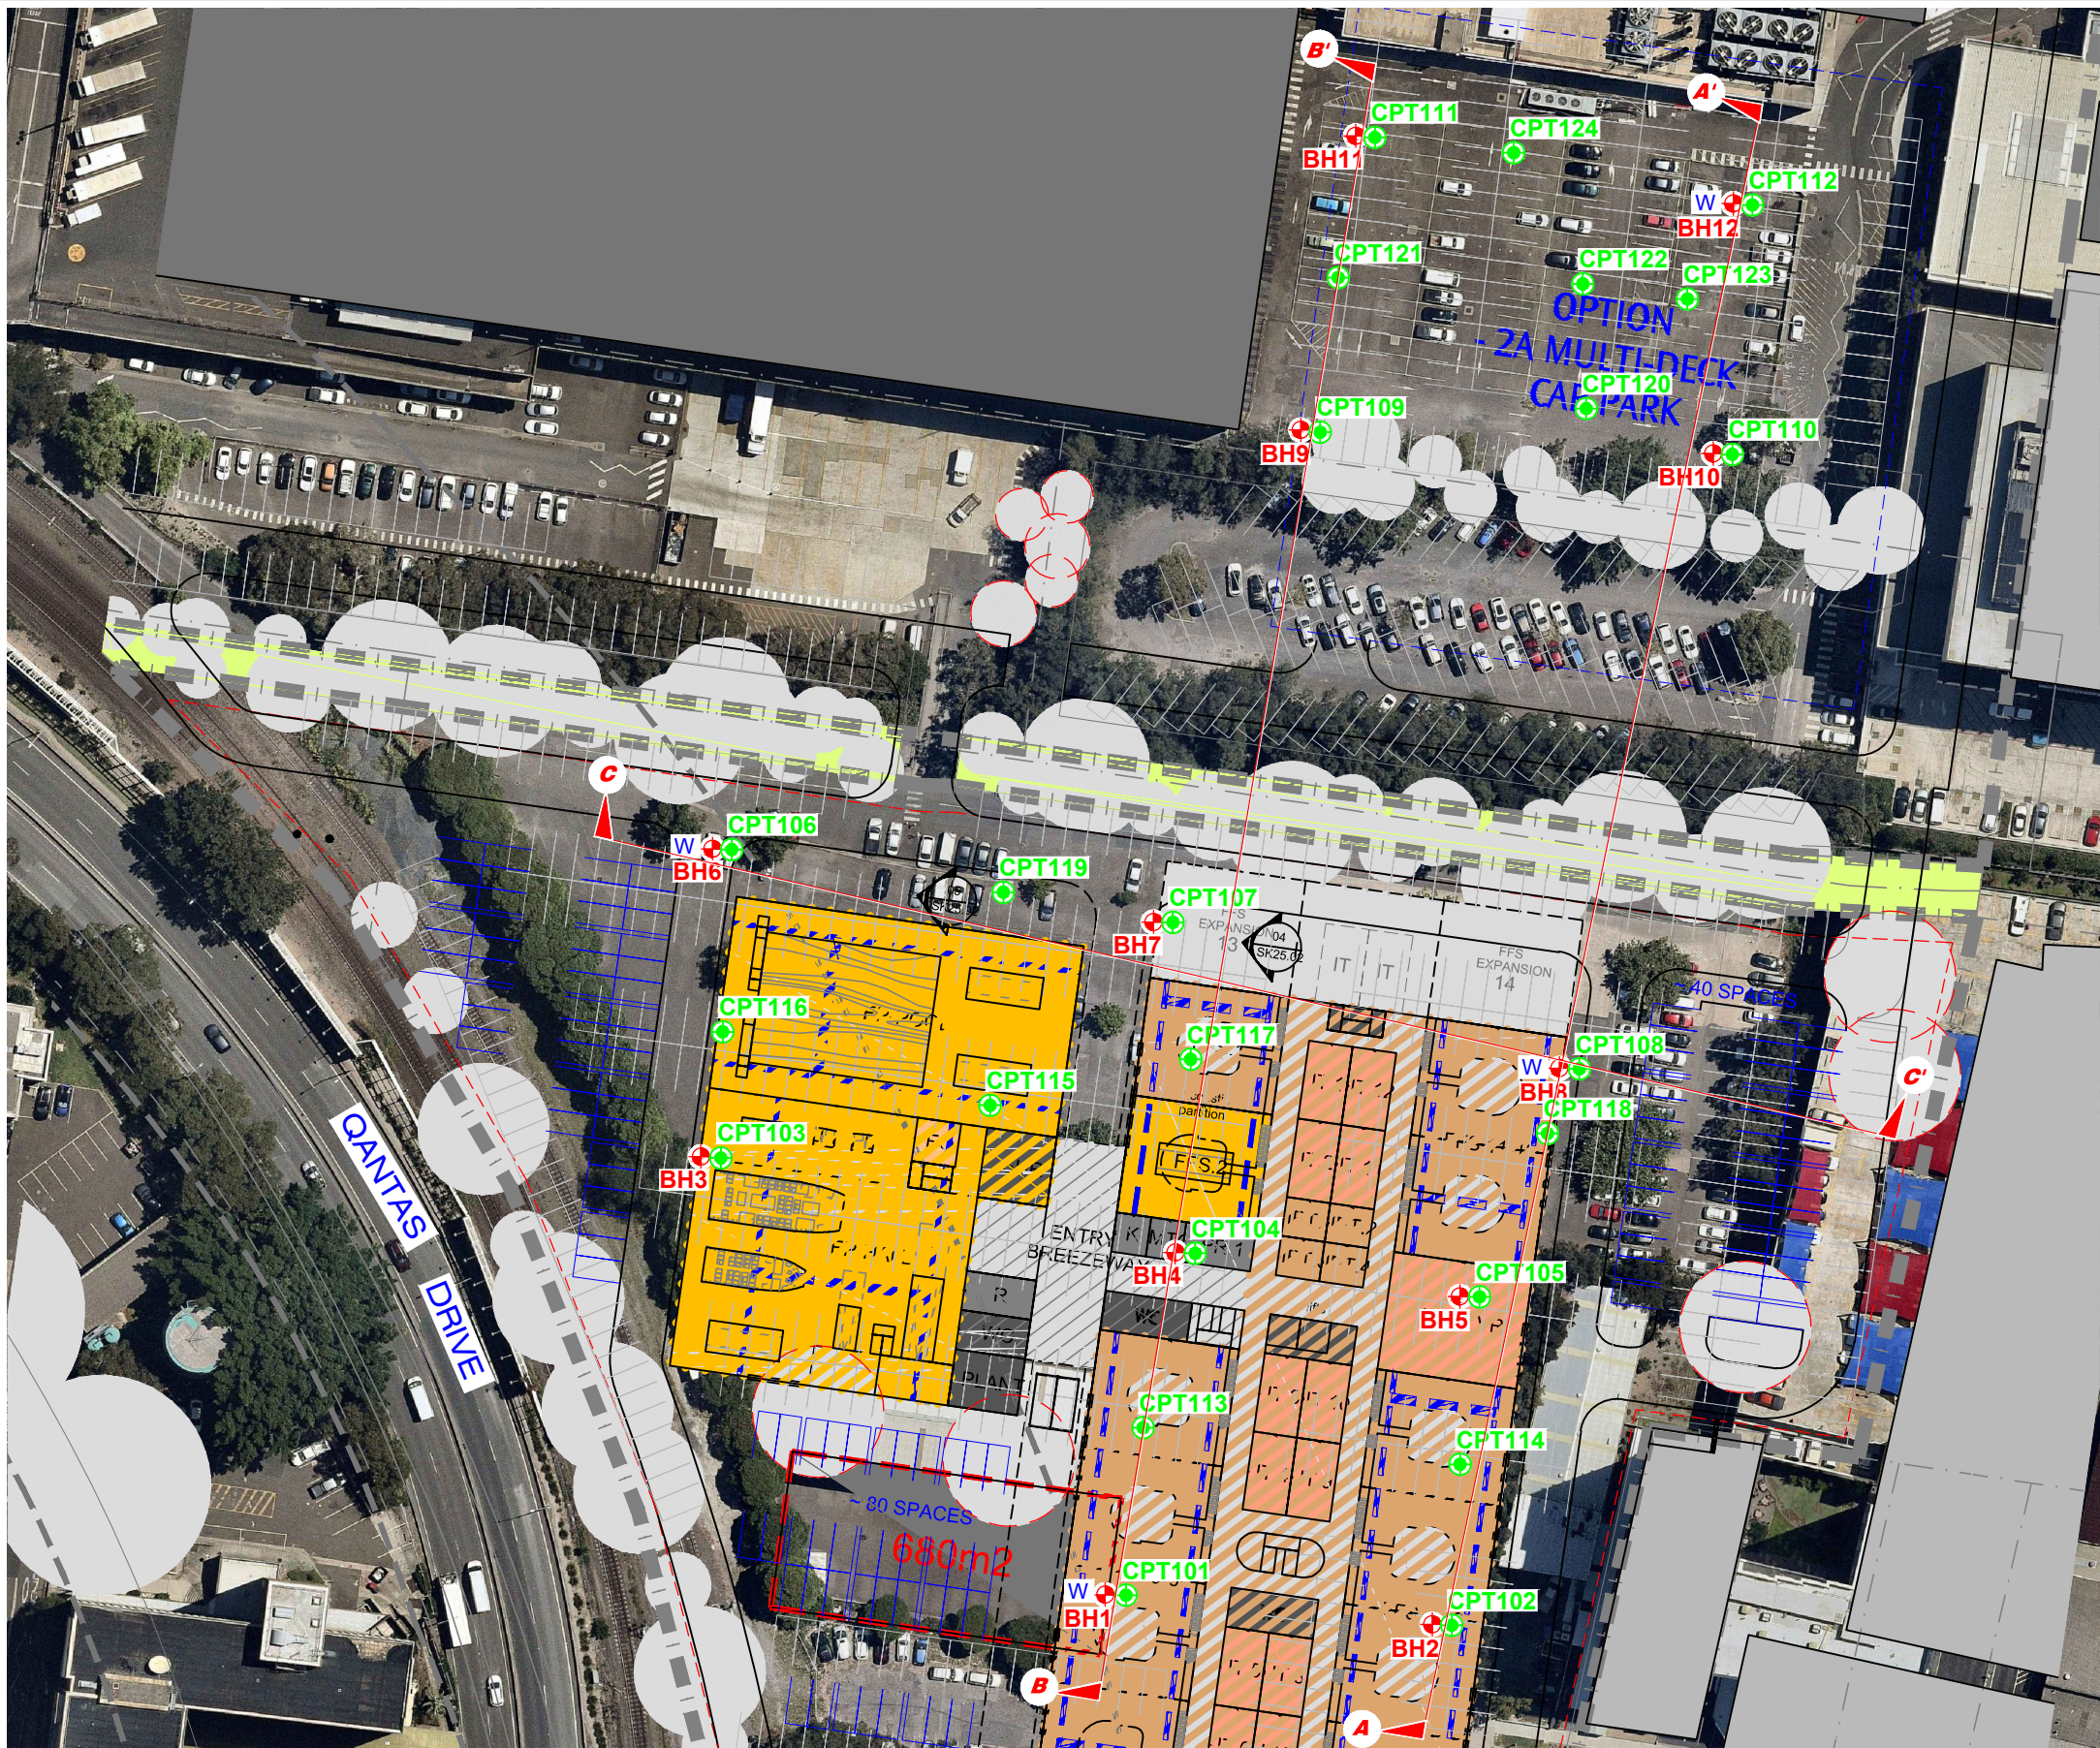
NOTE:
1: Base image from Nearmap.com
(Dated 27.12.2018)
2: Test locations are approximate only and
are shown with reference to existing features.

- Test Bore Location
- Cone Penetration Test Location
- Monitoring well location
- Geotechnical Cross Section A-A'

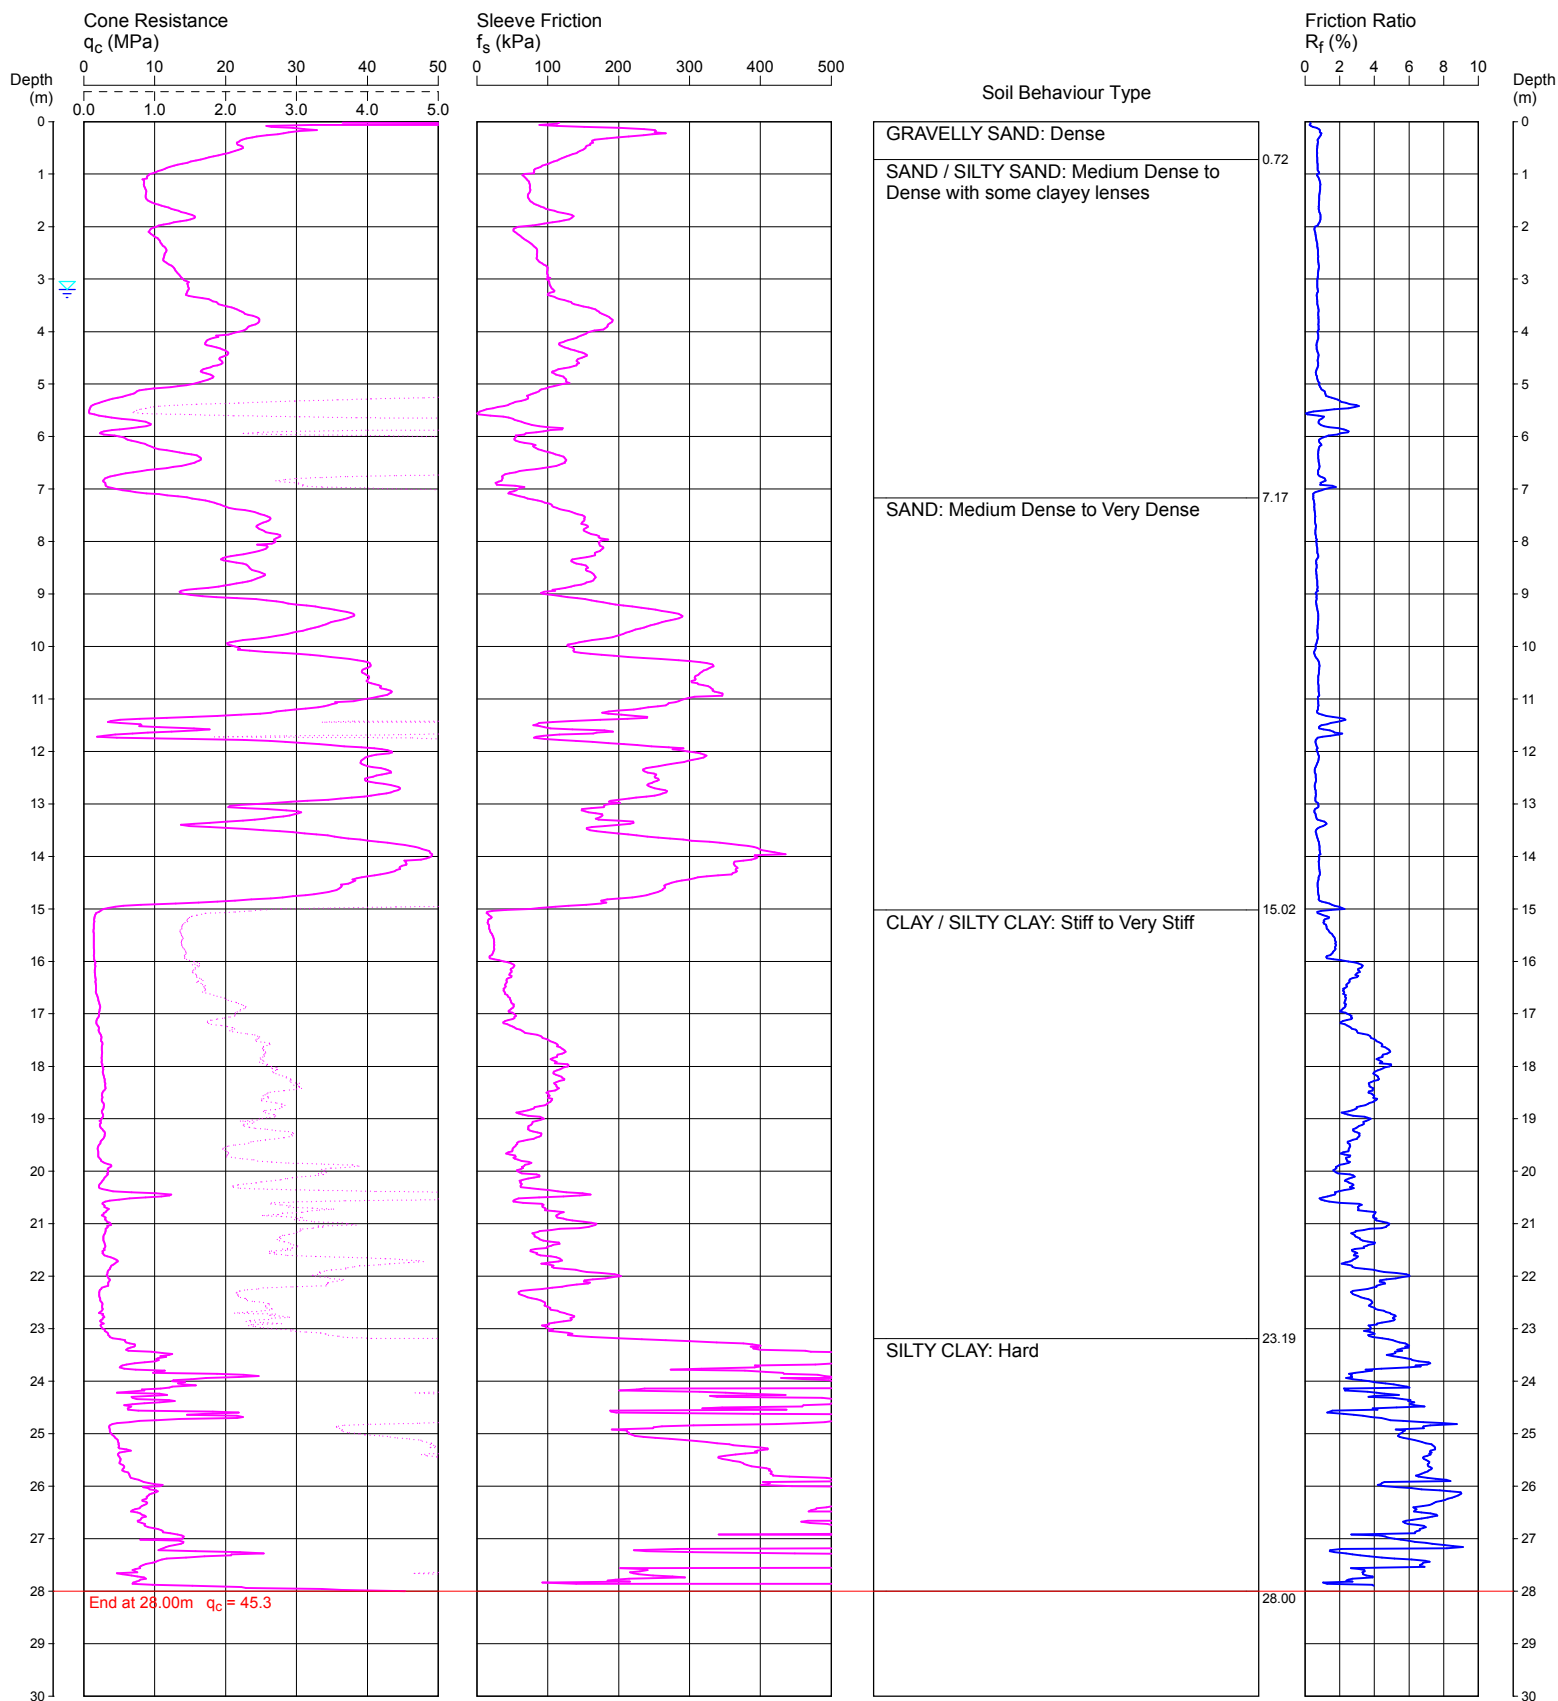
REMARKS: TEST DISCONTINUED DUE TO EXCESSIVE ROD BOWING.
GROUNDWATER OBSERVED AT 3.2 m AFTER WITHDRAWAL OF RODS.

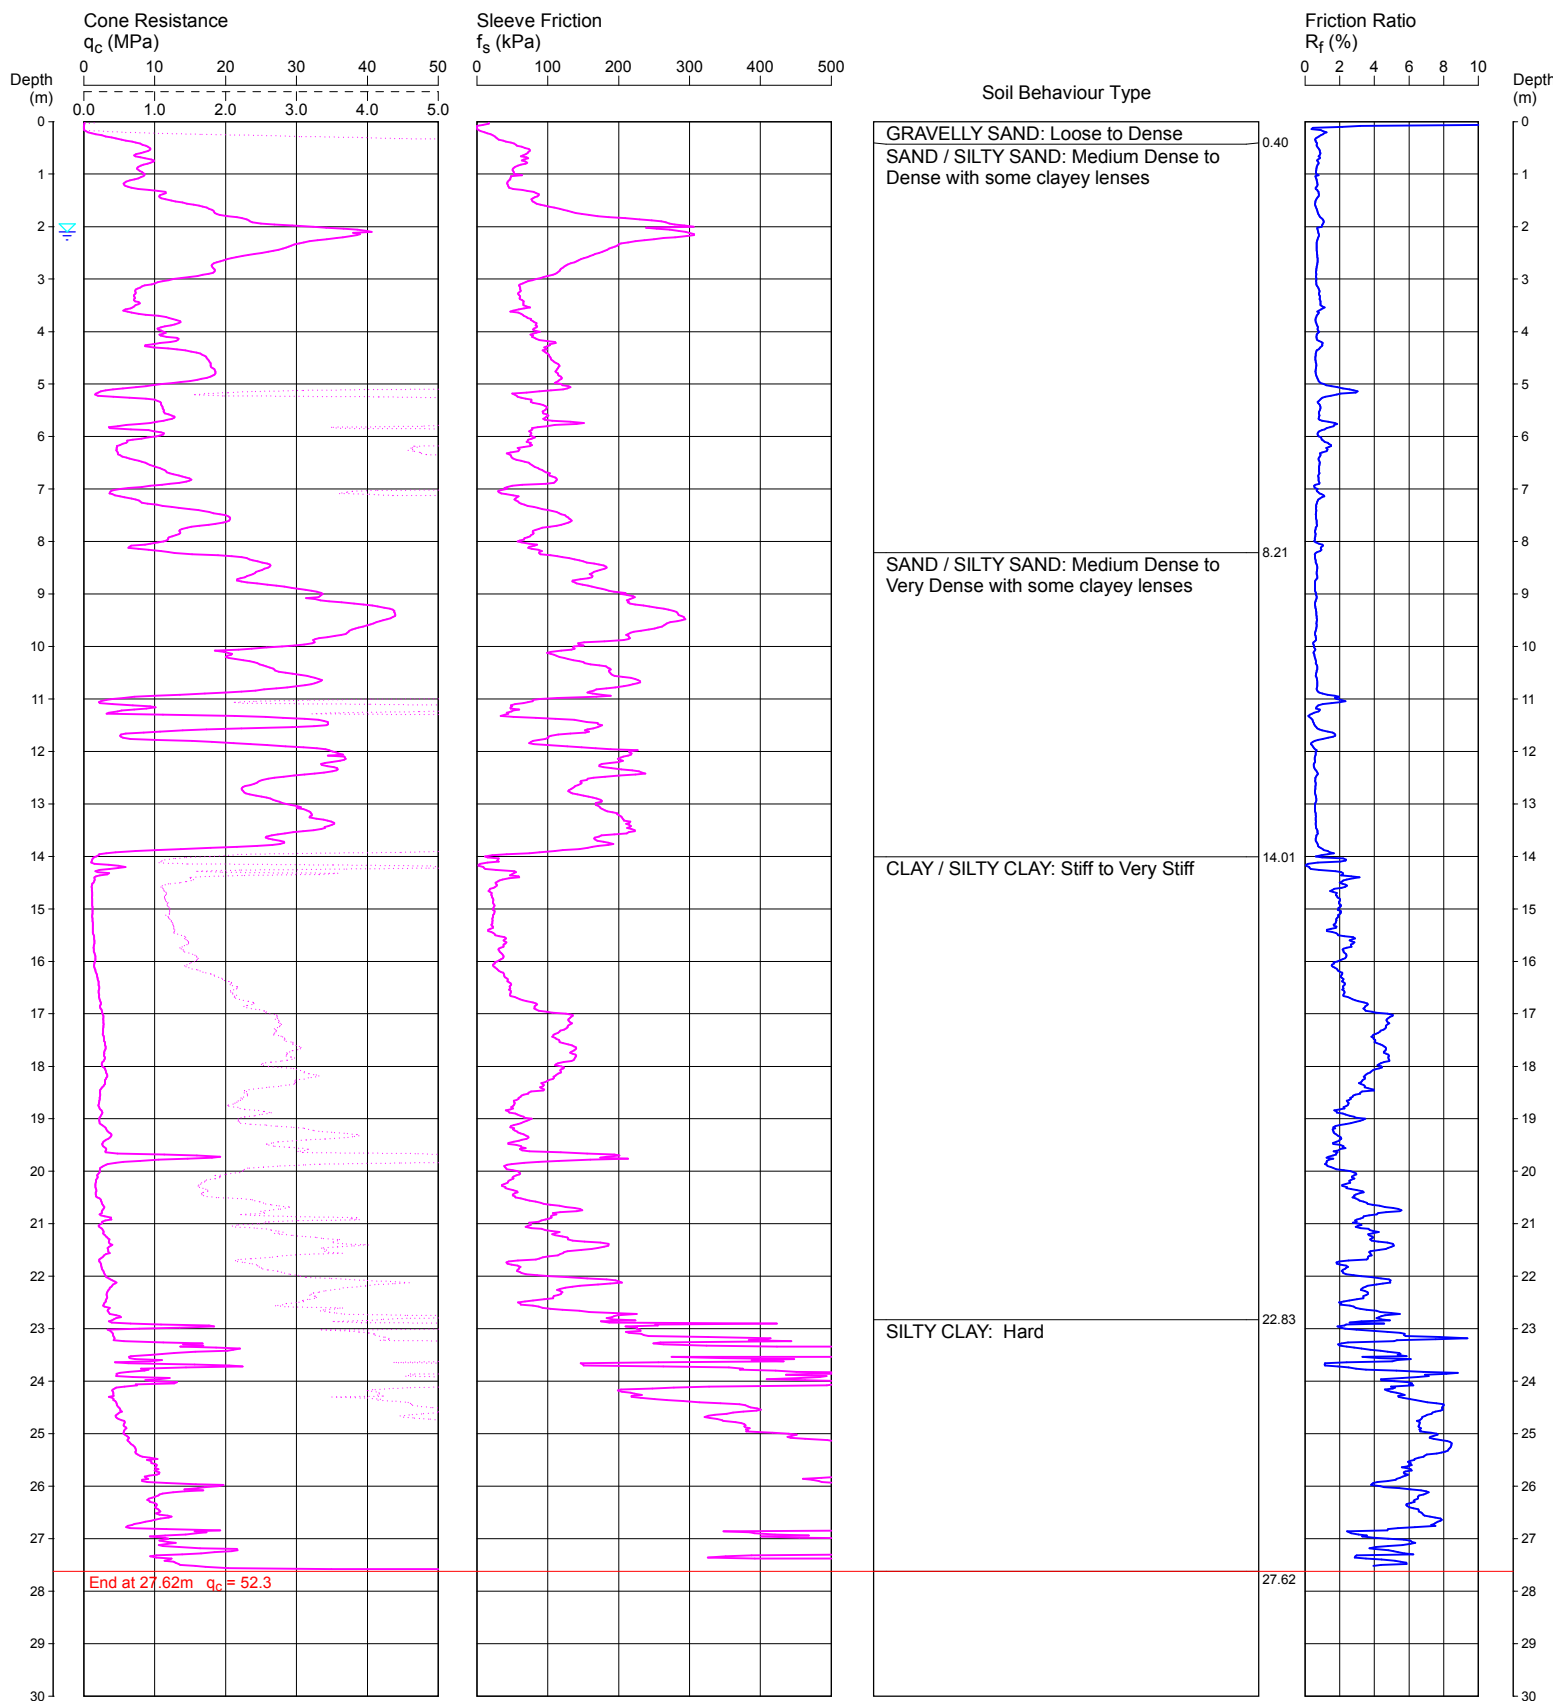
REMARKS: CONCRETE CORE TO 0.2 m DEPTH. TEST DISCONTINUED DUE TO CONE TIP REFUSAL.
HOLE COLLAPSE AT 0.8 m AFTER WITHDRAWAL OF RODS.

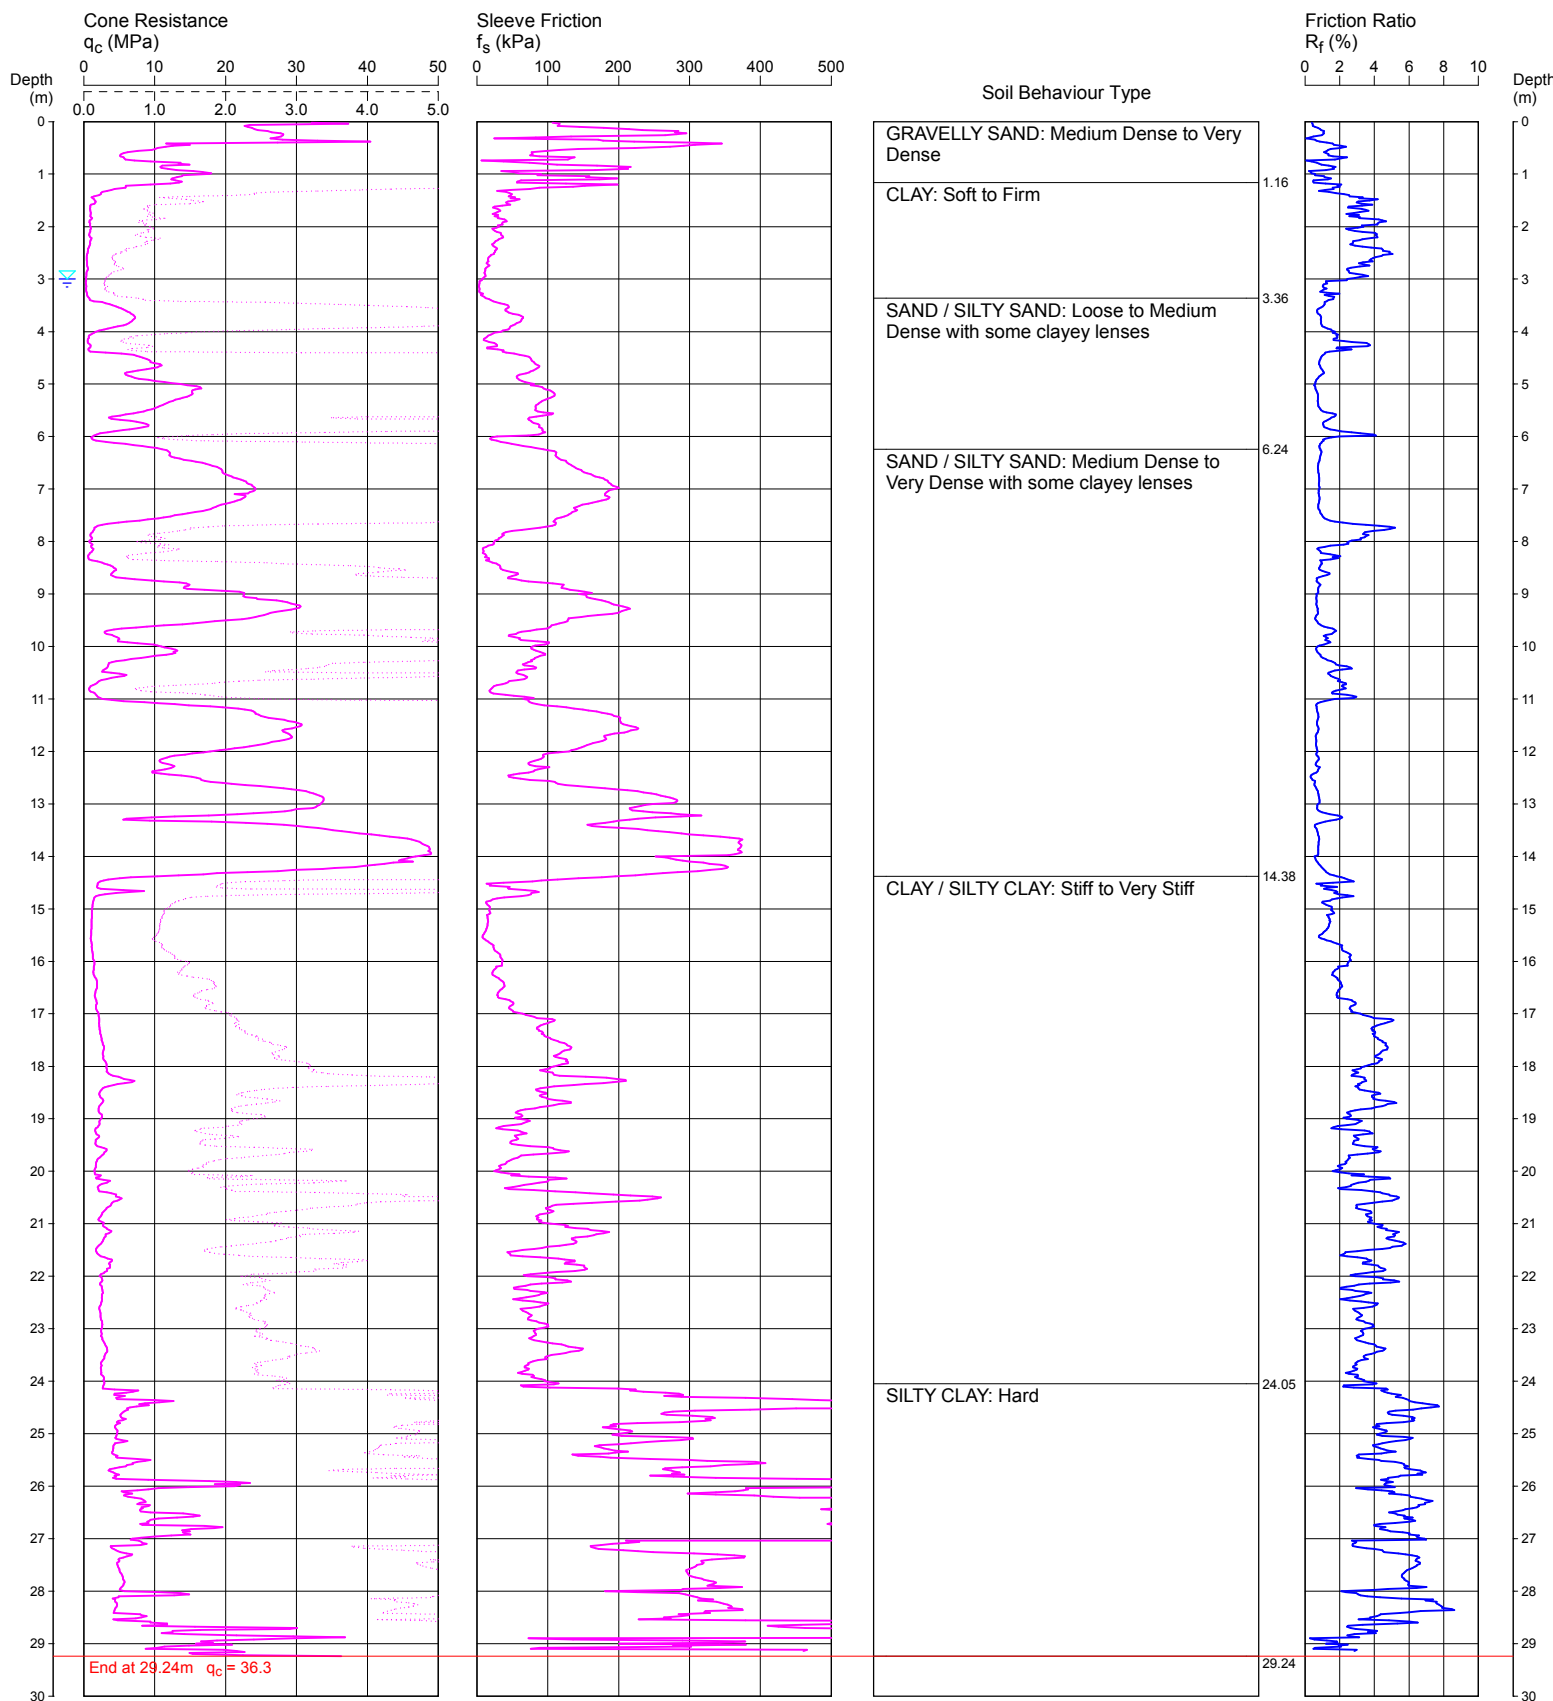
REMARKS: TEST DISCONTINUED DUE TO EXCESSIVE CONE BENDING. GROUNDWATER OBSERVED AT 3.0 m AFTER WITHDRAWAL OF RODS.

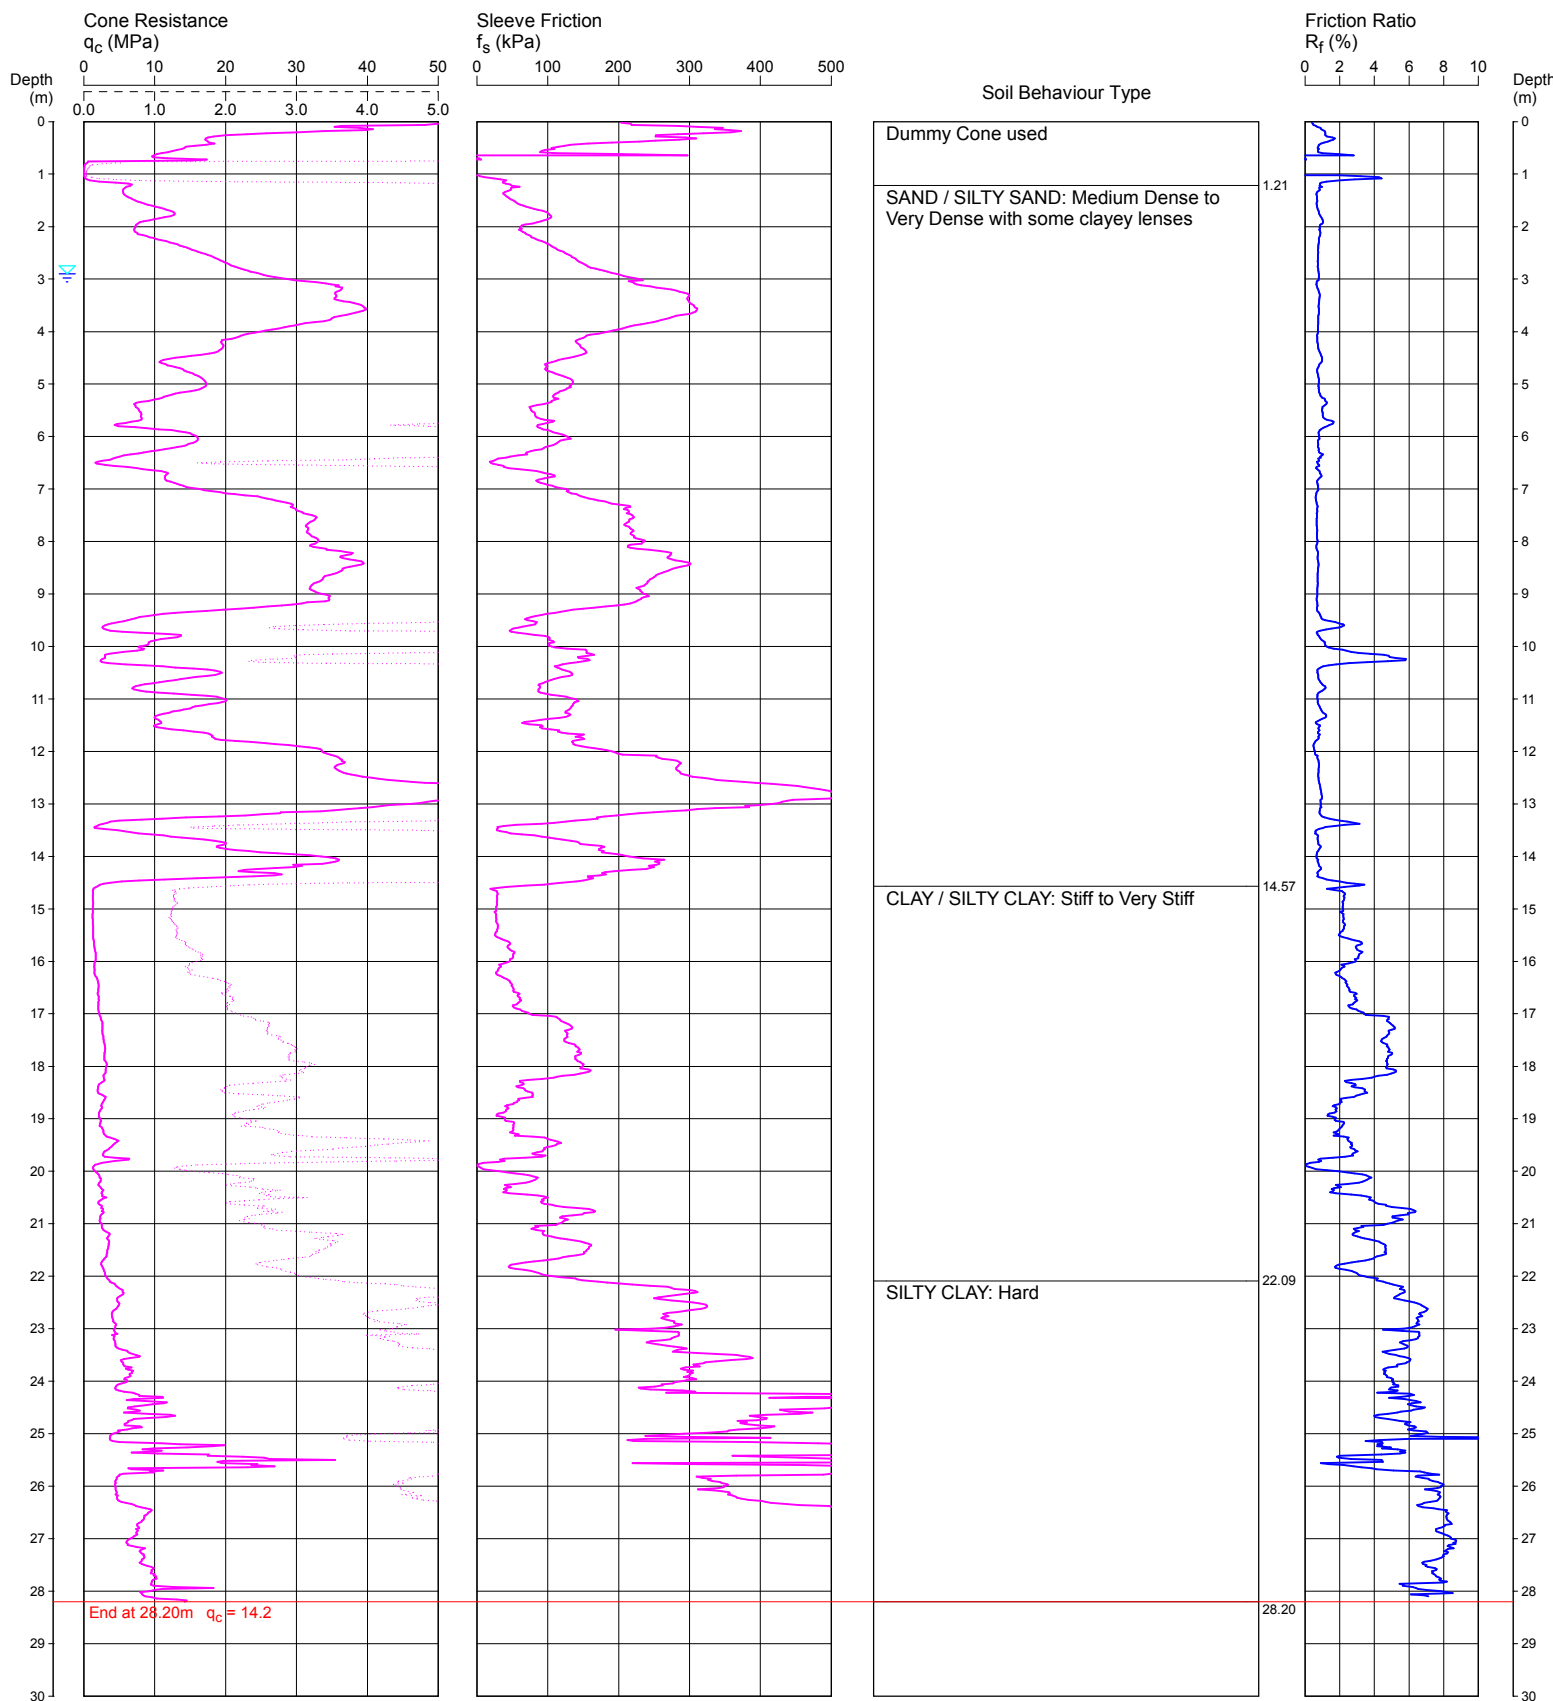
REMARKS: DUMMY CONE FROM 0.74 TO 1.2 m TO PENETRATE FILLING. TEST DISCONTINUED DUE TO EXCESSIVE ROD BOWING.
GROUNDWATER OBSERVED AT 2.9 m AFTER WITHDRAWAL OF RODS.

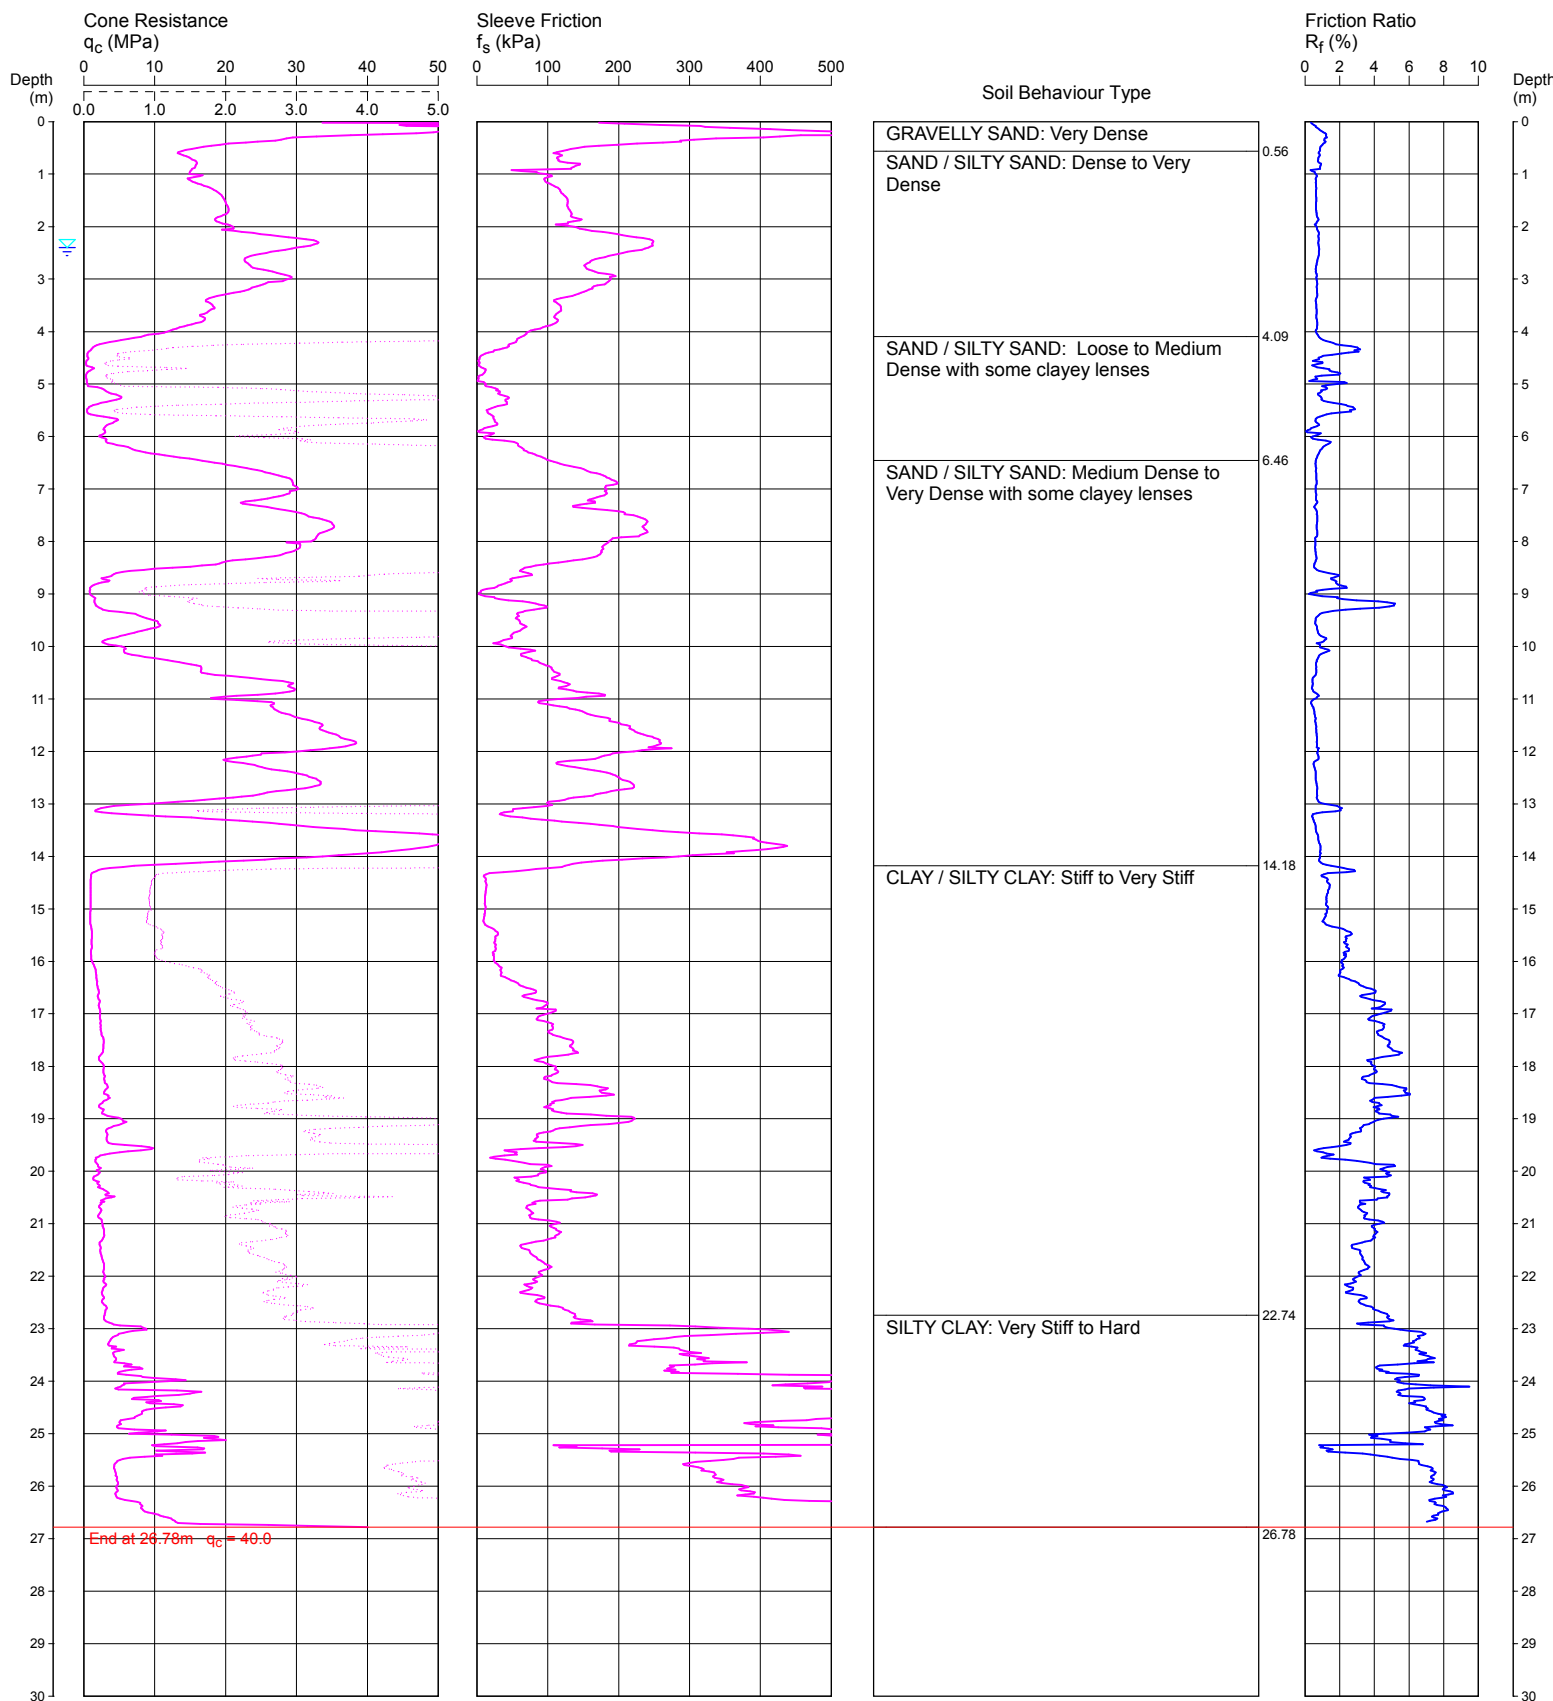
REMARKS: TEST DISCONTINUED DUE TO EXCESSIVE CONE BENDING.
GROUNDWATER OBSERVED AT 2.4 m AFTER WITHDRAWAL OF RODS.

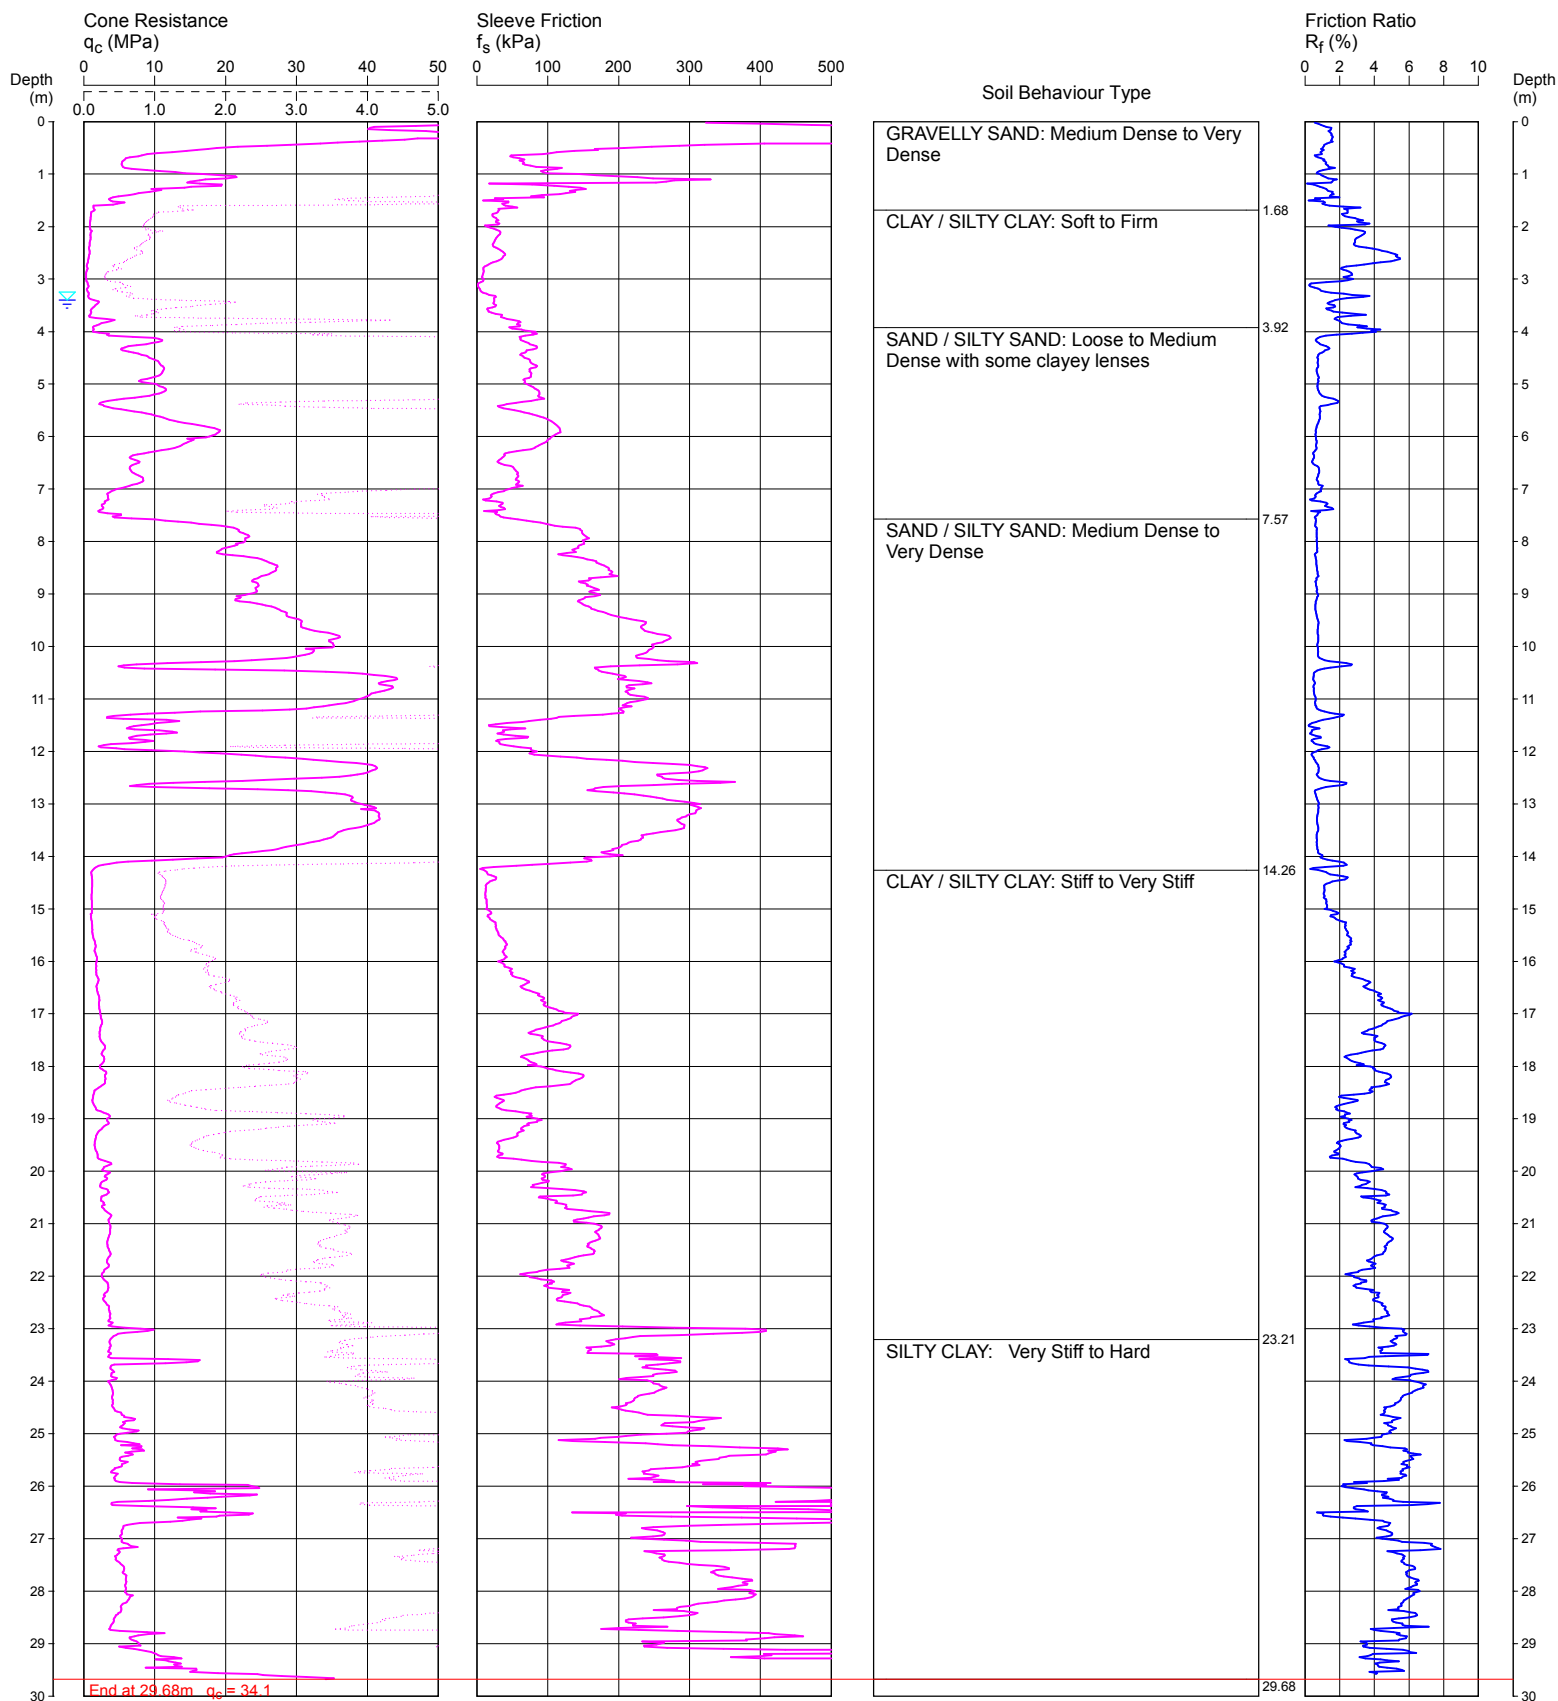
REMARKS: TEST DISCONTINUED DUE TO EXCESSIVE CONE BENDING.
GROUNDWATER OBSERVED AT 3.4 m AFTER WITHDRAWAL OF RODS.

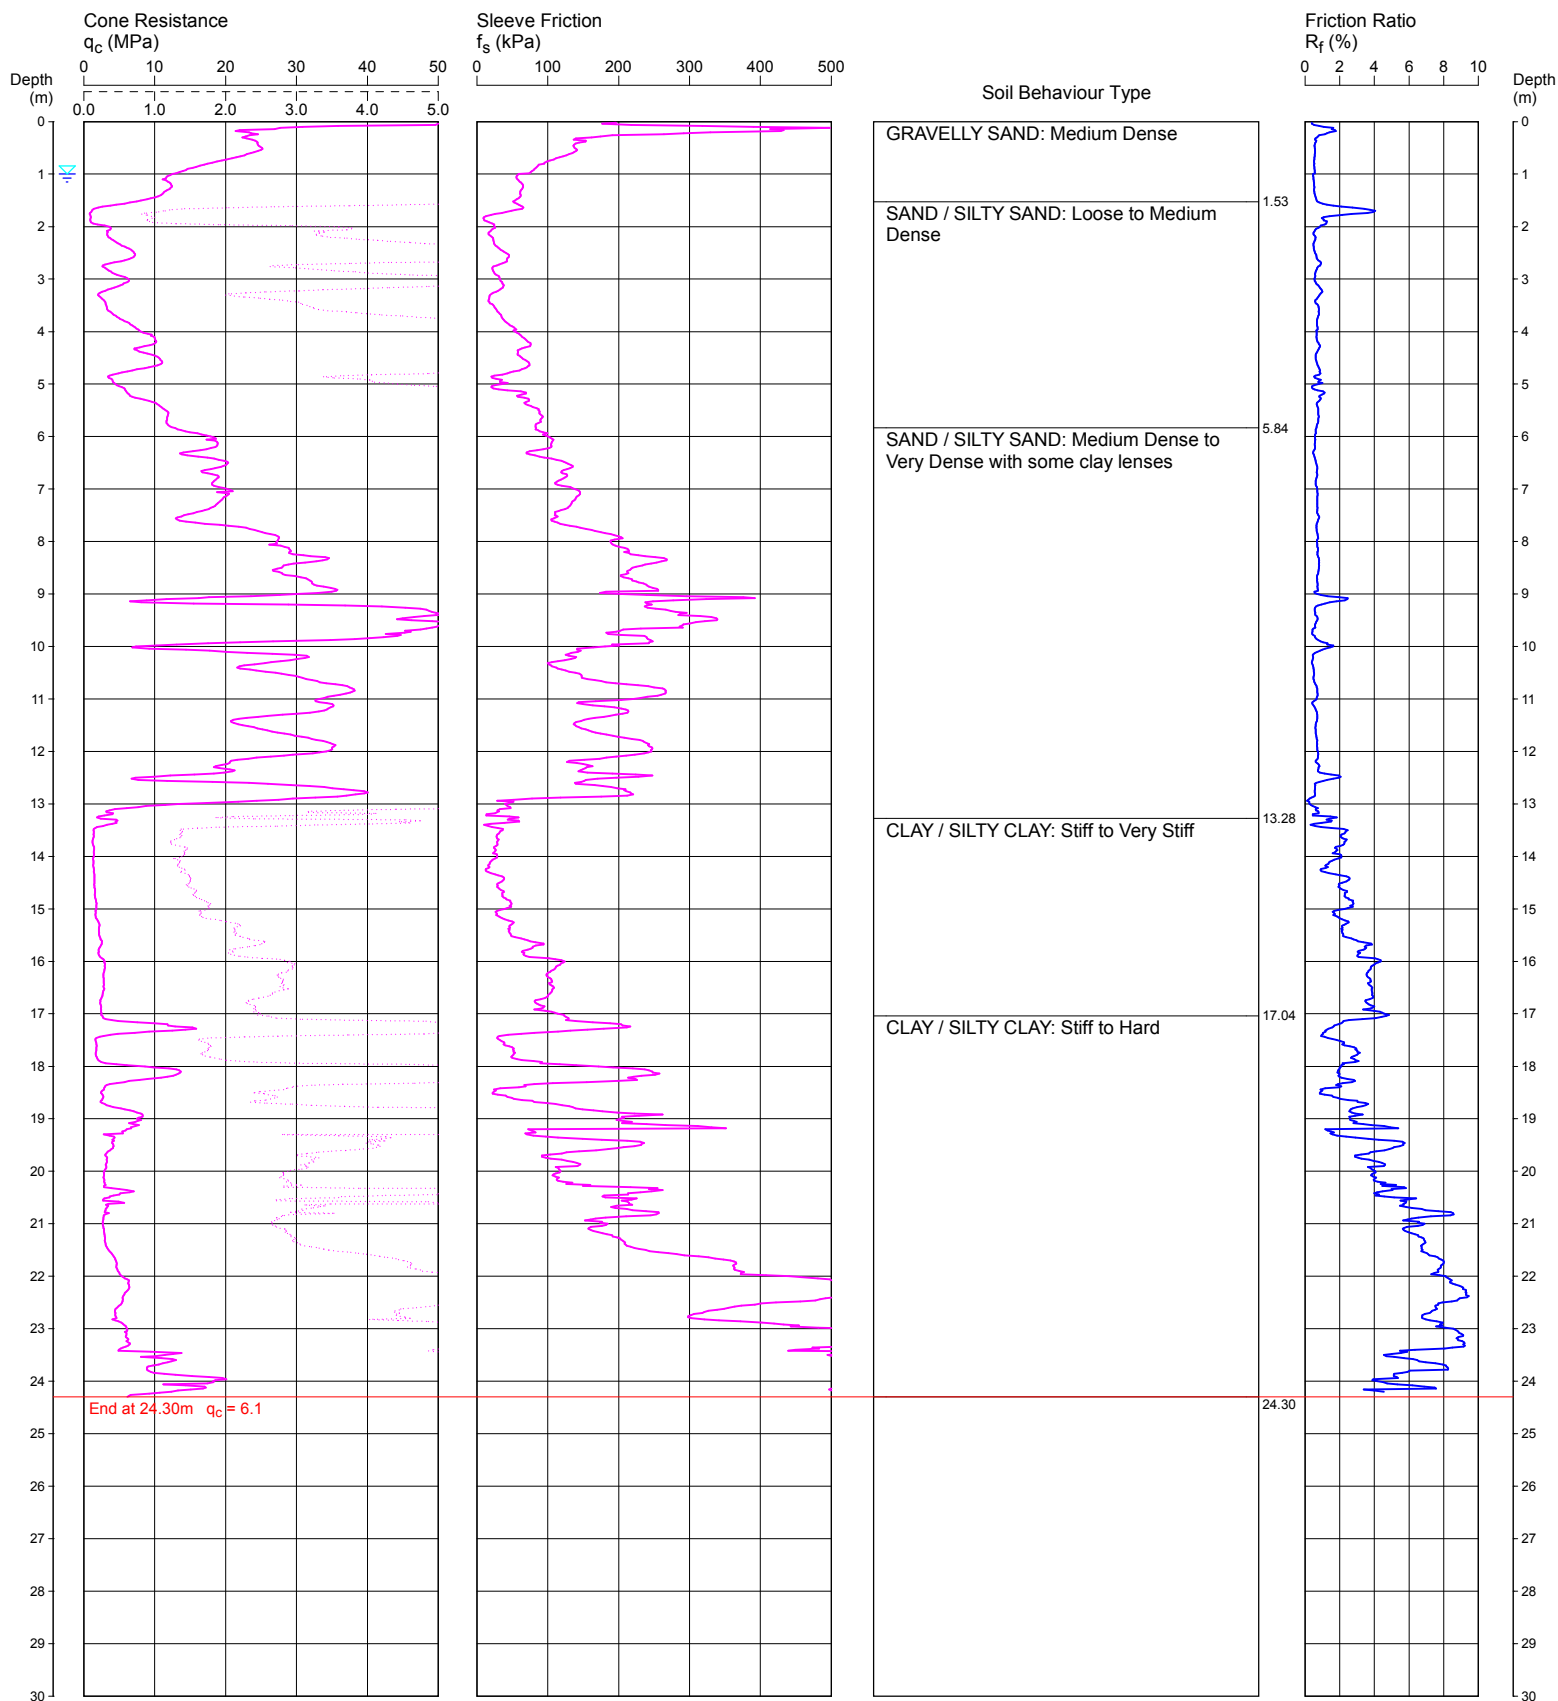
REMARKS: TEST DISCONTINUED DUE TO EXCESSIVE CONE BENDING.
GROUNDWATER OBSERVED AT 1.0 m AFTER WITHDRAWAL OF RODS.
