Report on
Geotechnical Investigation

Proposed Flight Training Centre
King Street, Mascot

Prepared for
Enstruct Group Pty Ltd

Project 85777.15
February 2019

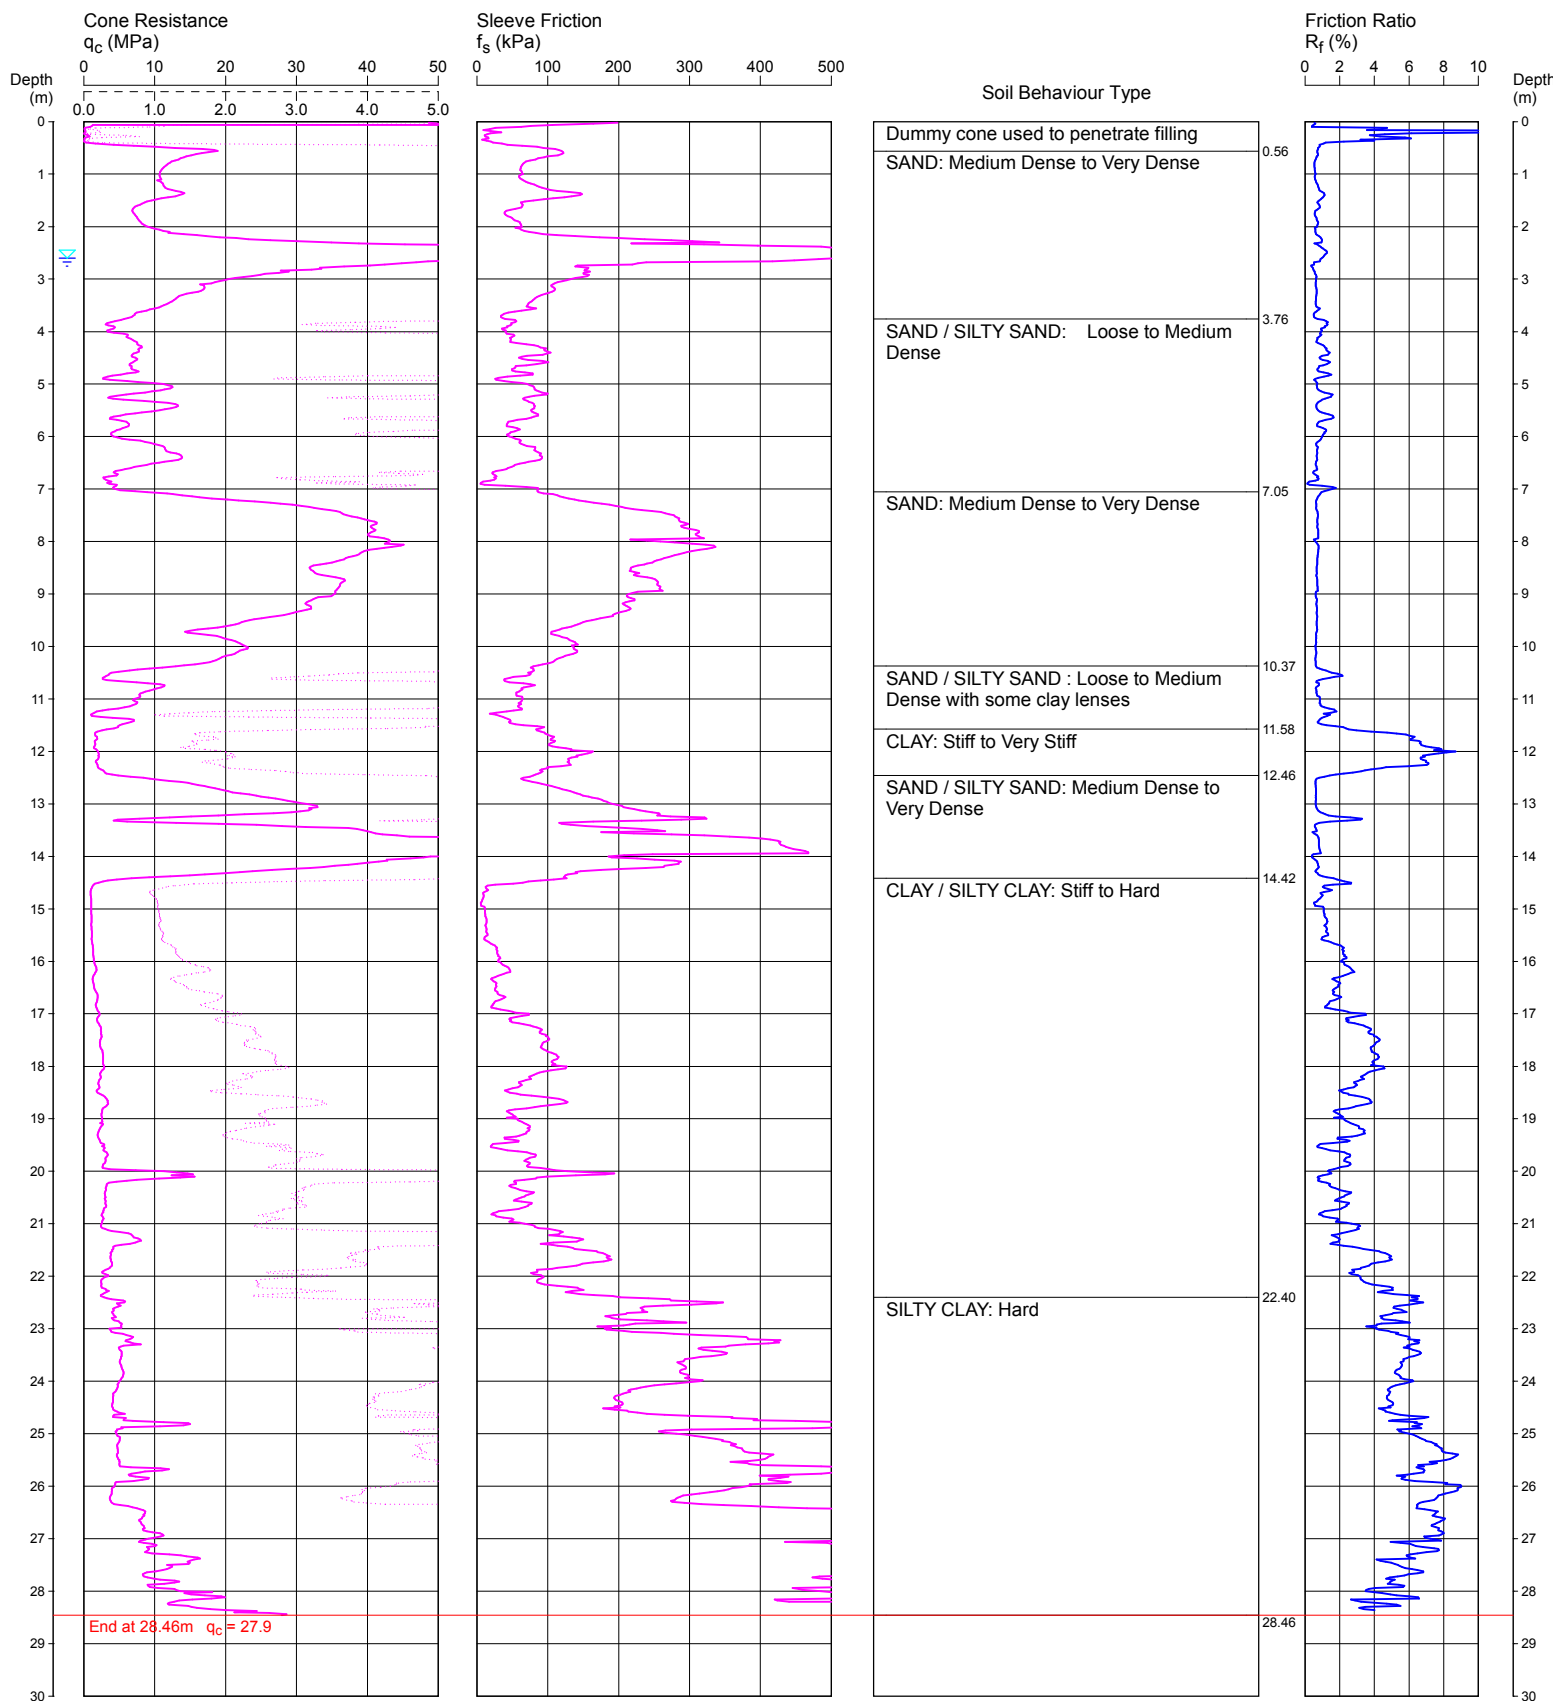
REMARKS: DUMMY CONE FROM 0.04 TO 0.5 m DEPTH TO PENETRATE FILLING. TEST DISCONTINUED DUE TO EXCESSIVE ROD BOWING.
HOLE COLLAPSE AT 2.6 m AFTER WITHDRAWAL OF RODS.

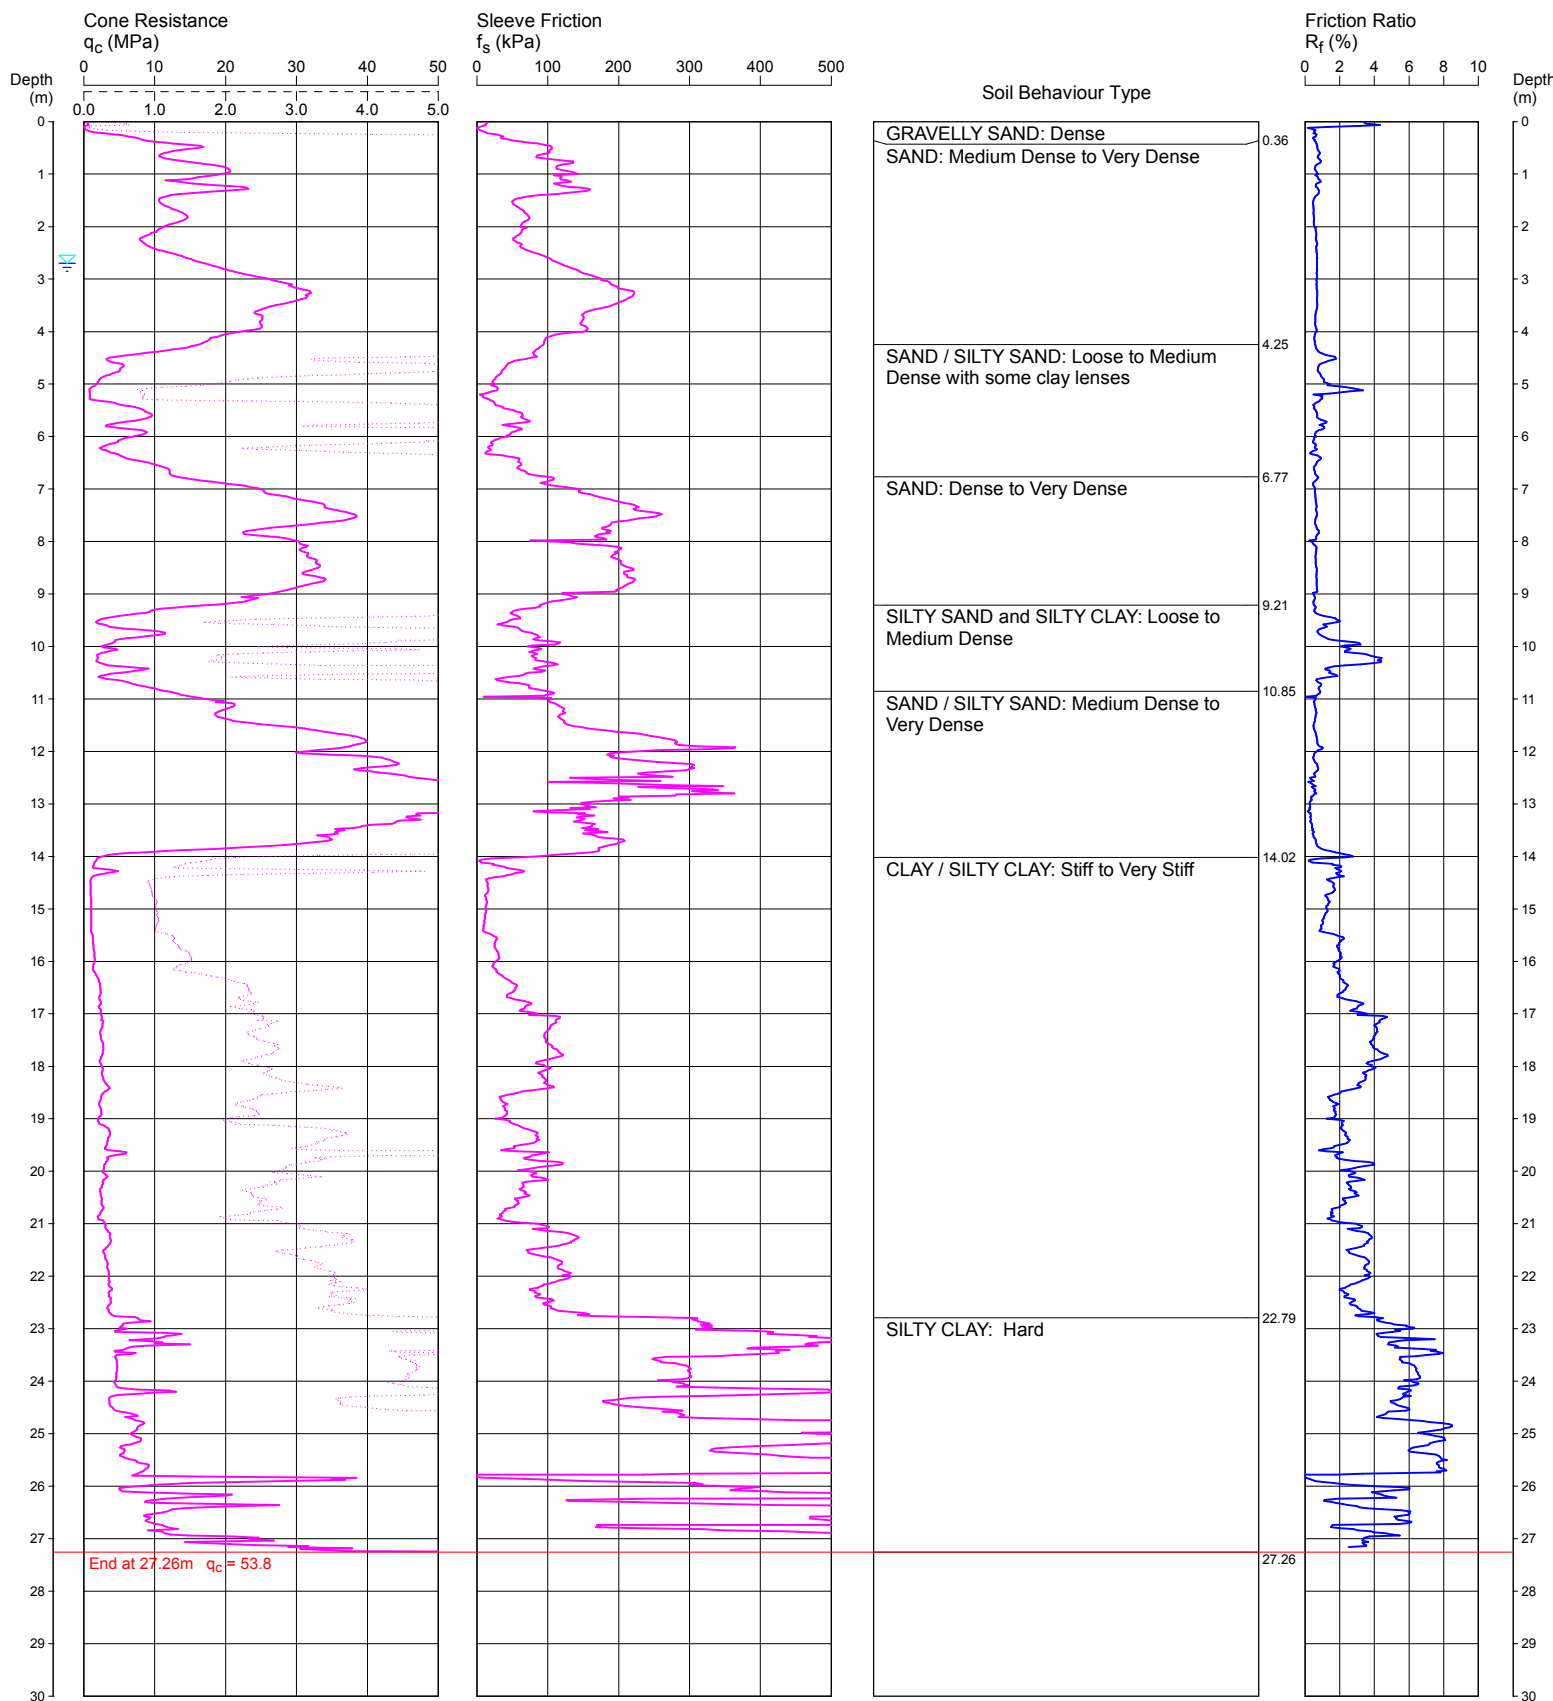
REMARKS: CONCRETE CORE TO 0.13 m DEPTH. TEST DISCONTINUED DUE TO CONE TIP REFUSAL.
GROUNDWATER OBSERVED AT 2.7 m AFTER WITHDRAWAL OF RODS.

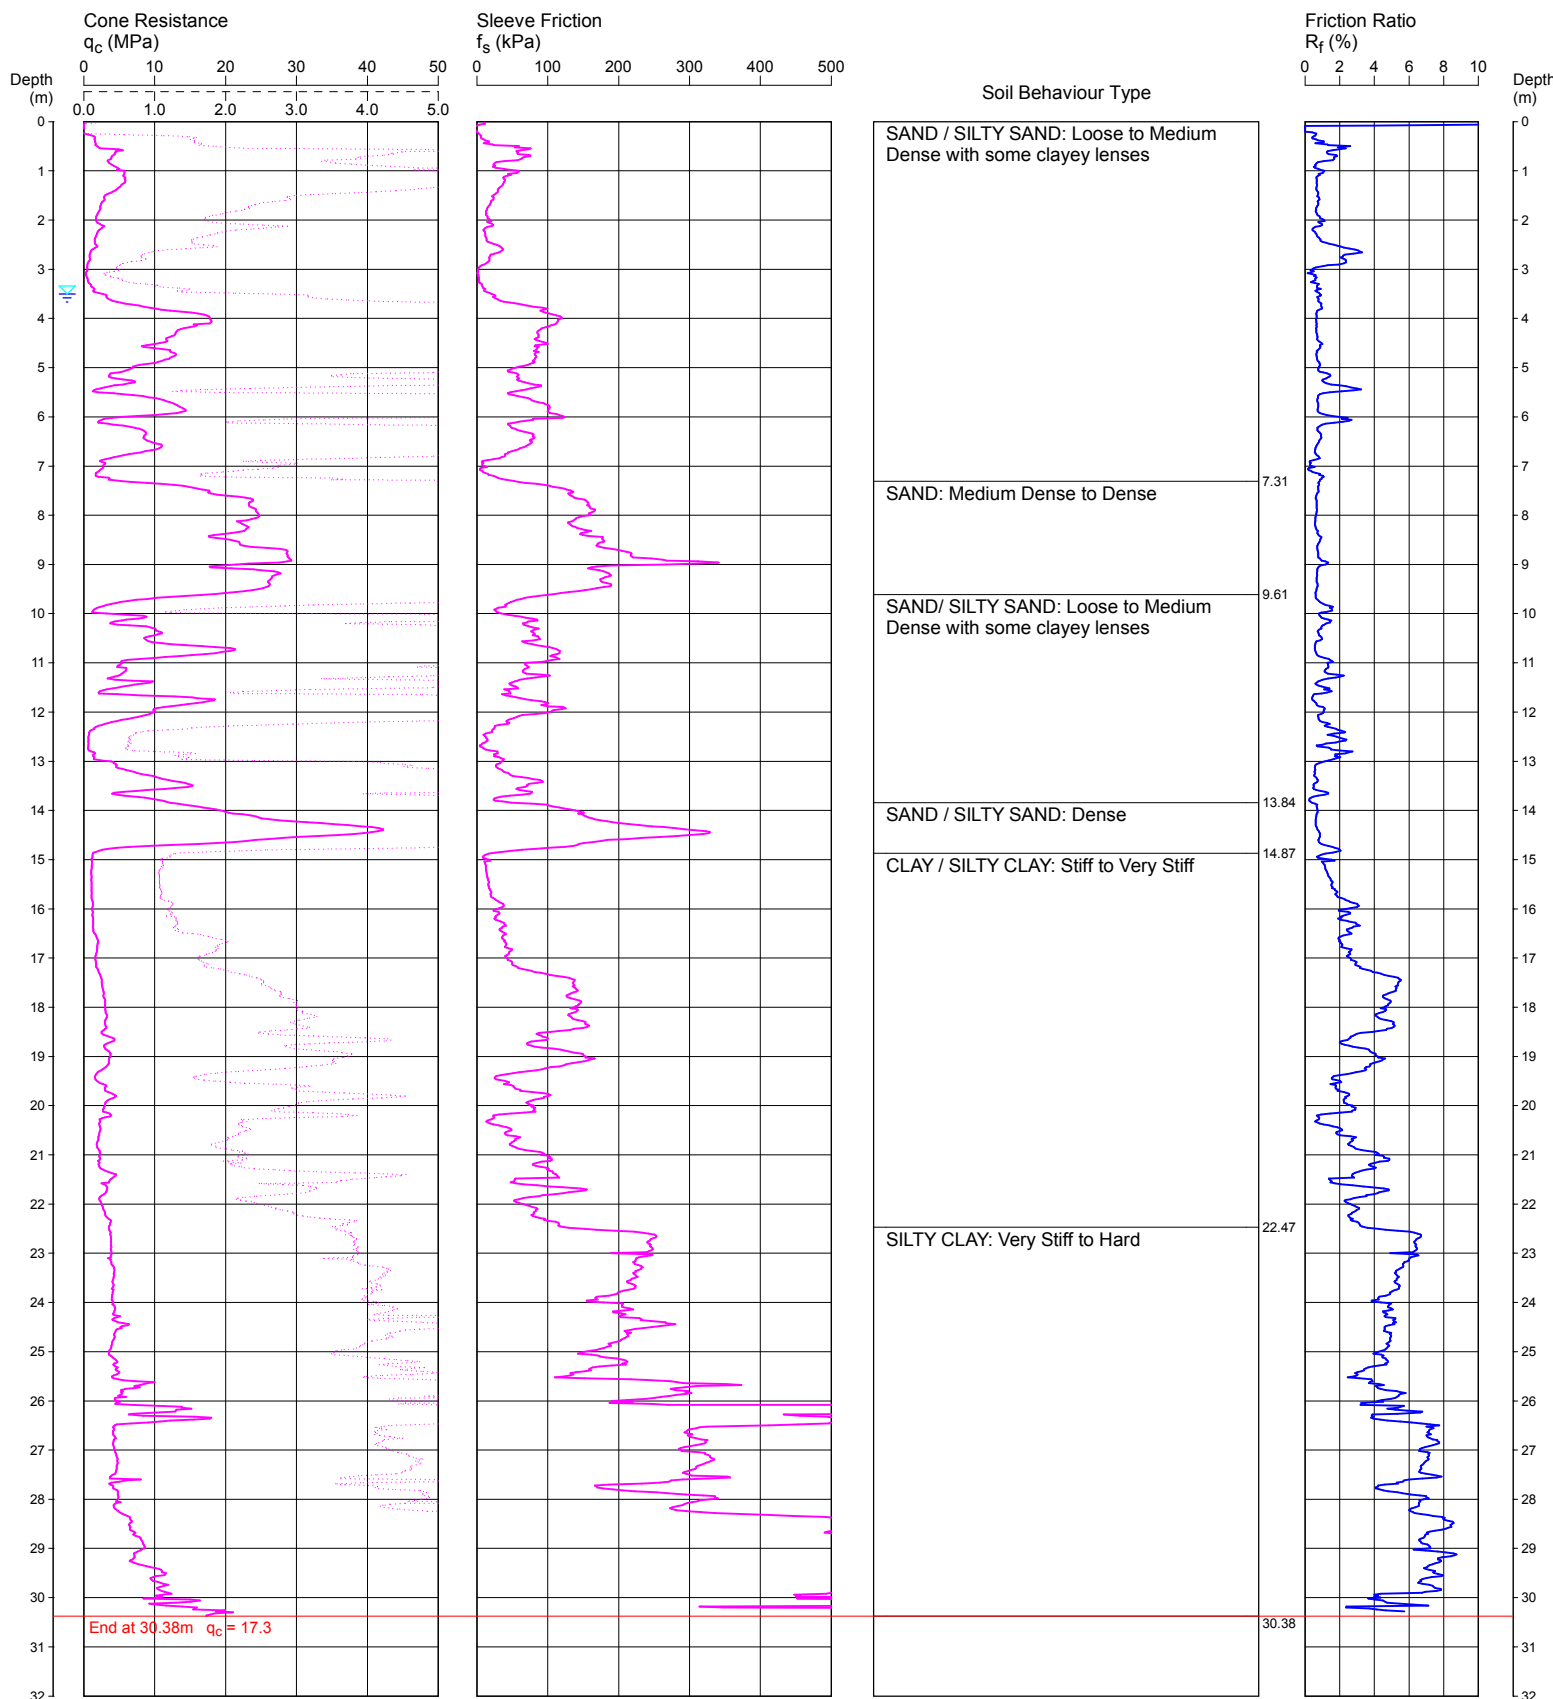
REMARKS: CONCRETE CORE TO 0.2 m DEPTH. TEST DISCONTINUED DUE TO EXCESSIVE CONE BENDING.
GROUNDWATER OBSERVED AT 3.5 m AFTER WITHDRAWAL OF RODS.

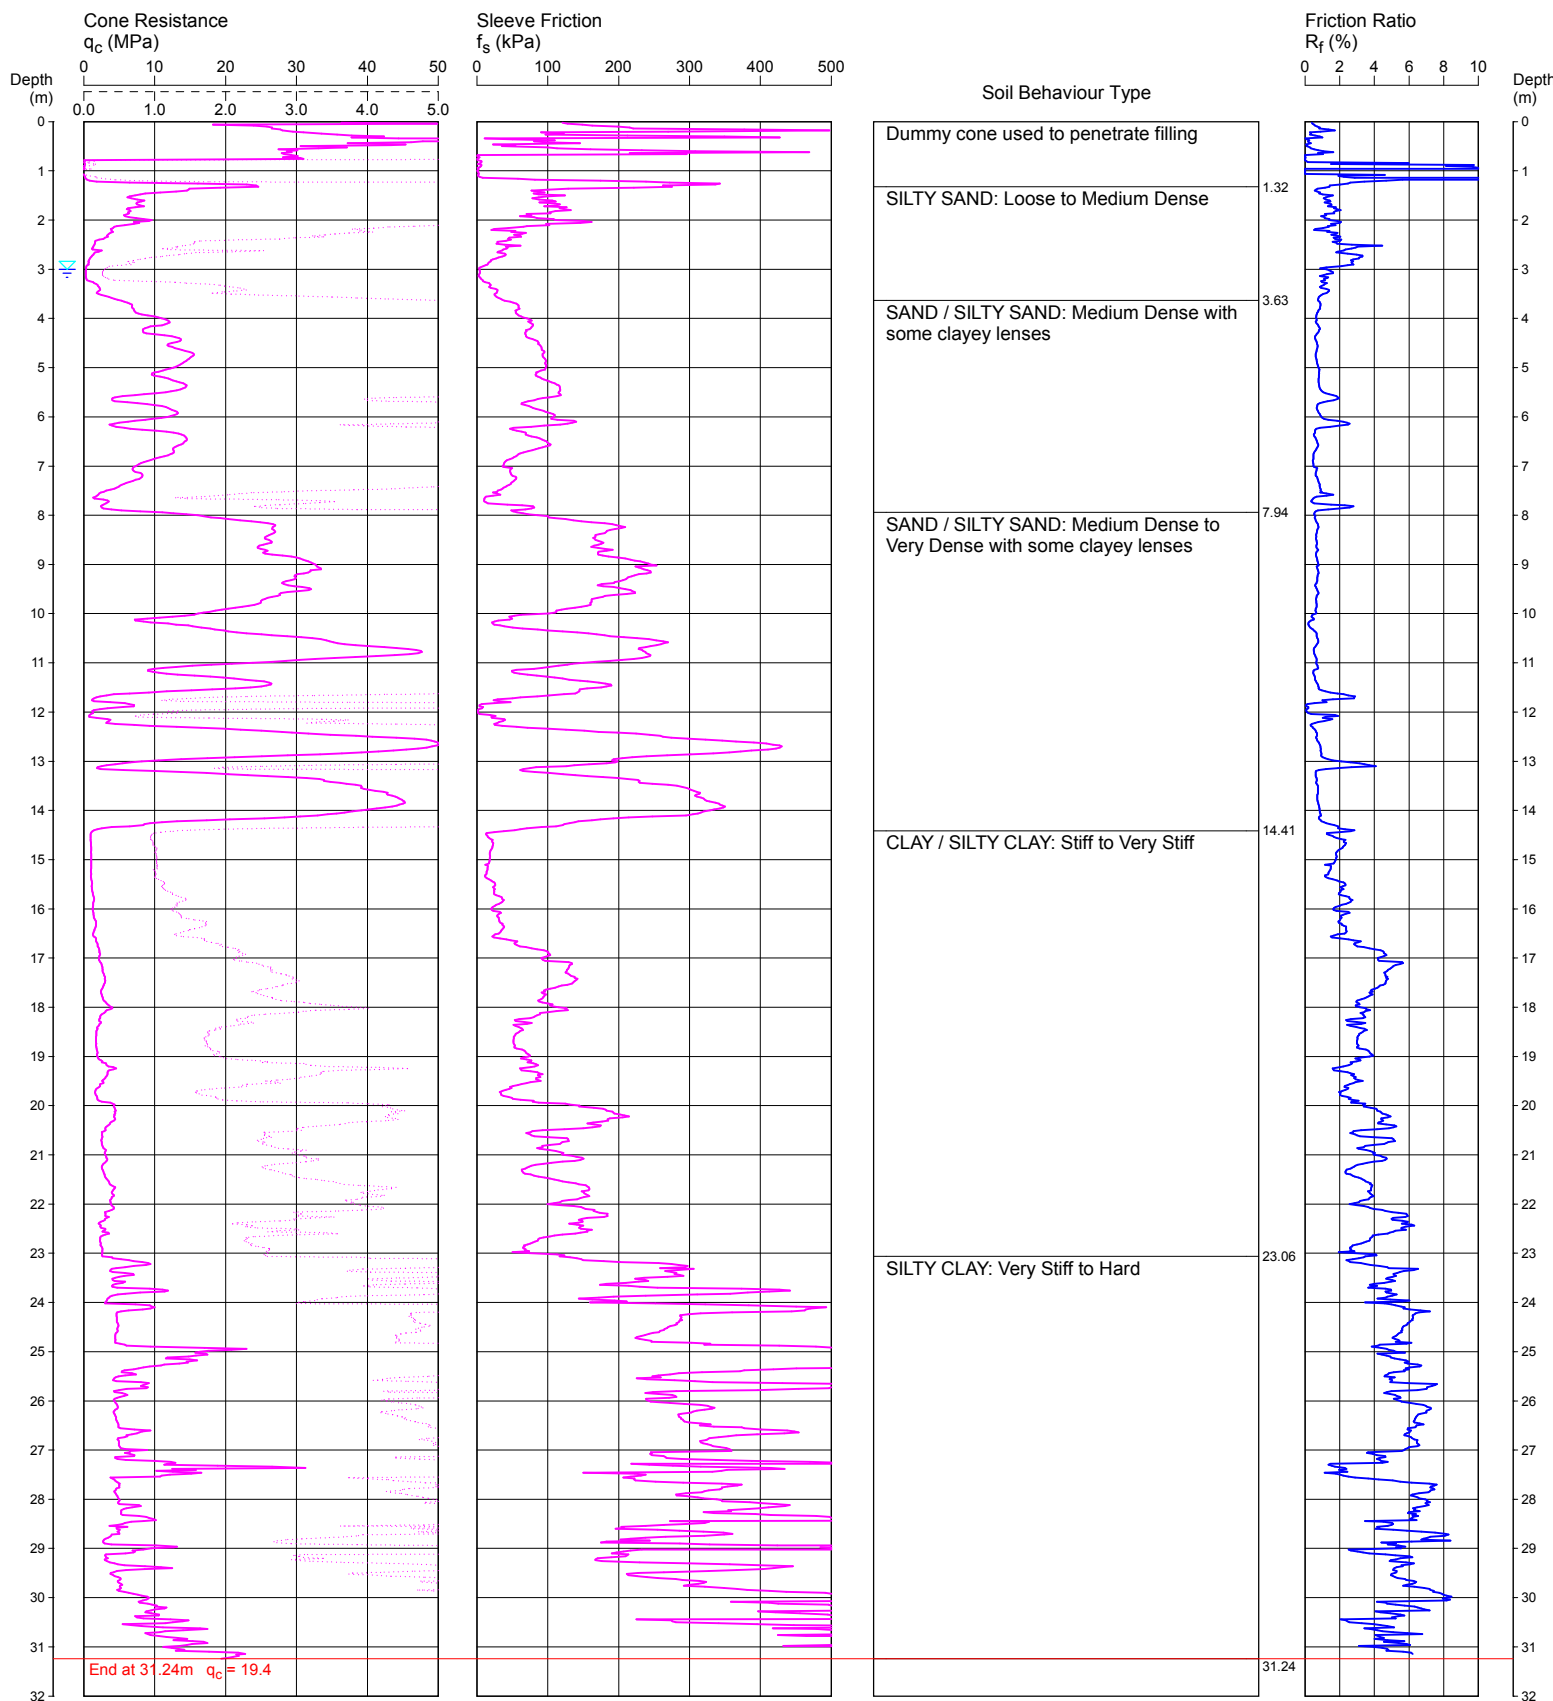
REMARKS: DUMMY CONE FROM 0.76 TO 1.3 m TO PENETRATE FILLING. TEST DISCONTINUED DUE TO SLEEVE REFUSAL.
HOLE COLLAPSE AT 3.0 m AFTER WITHDRAWAL OF RODS.

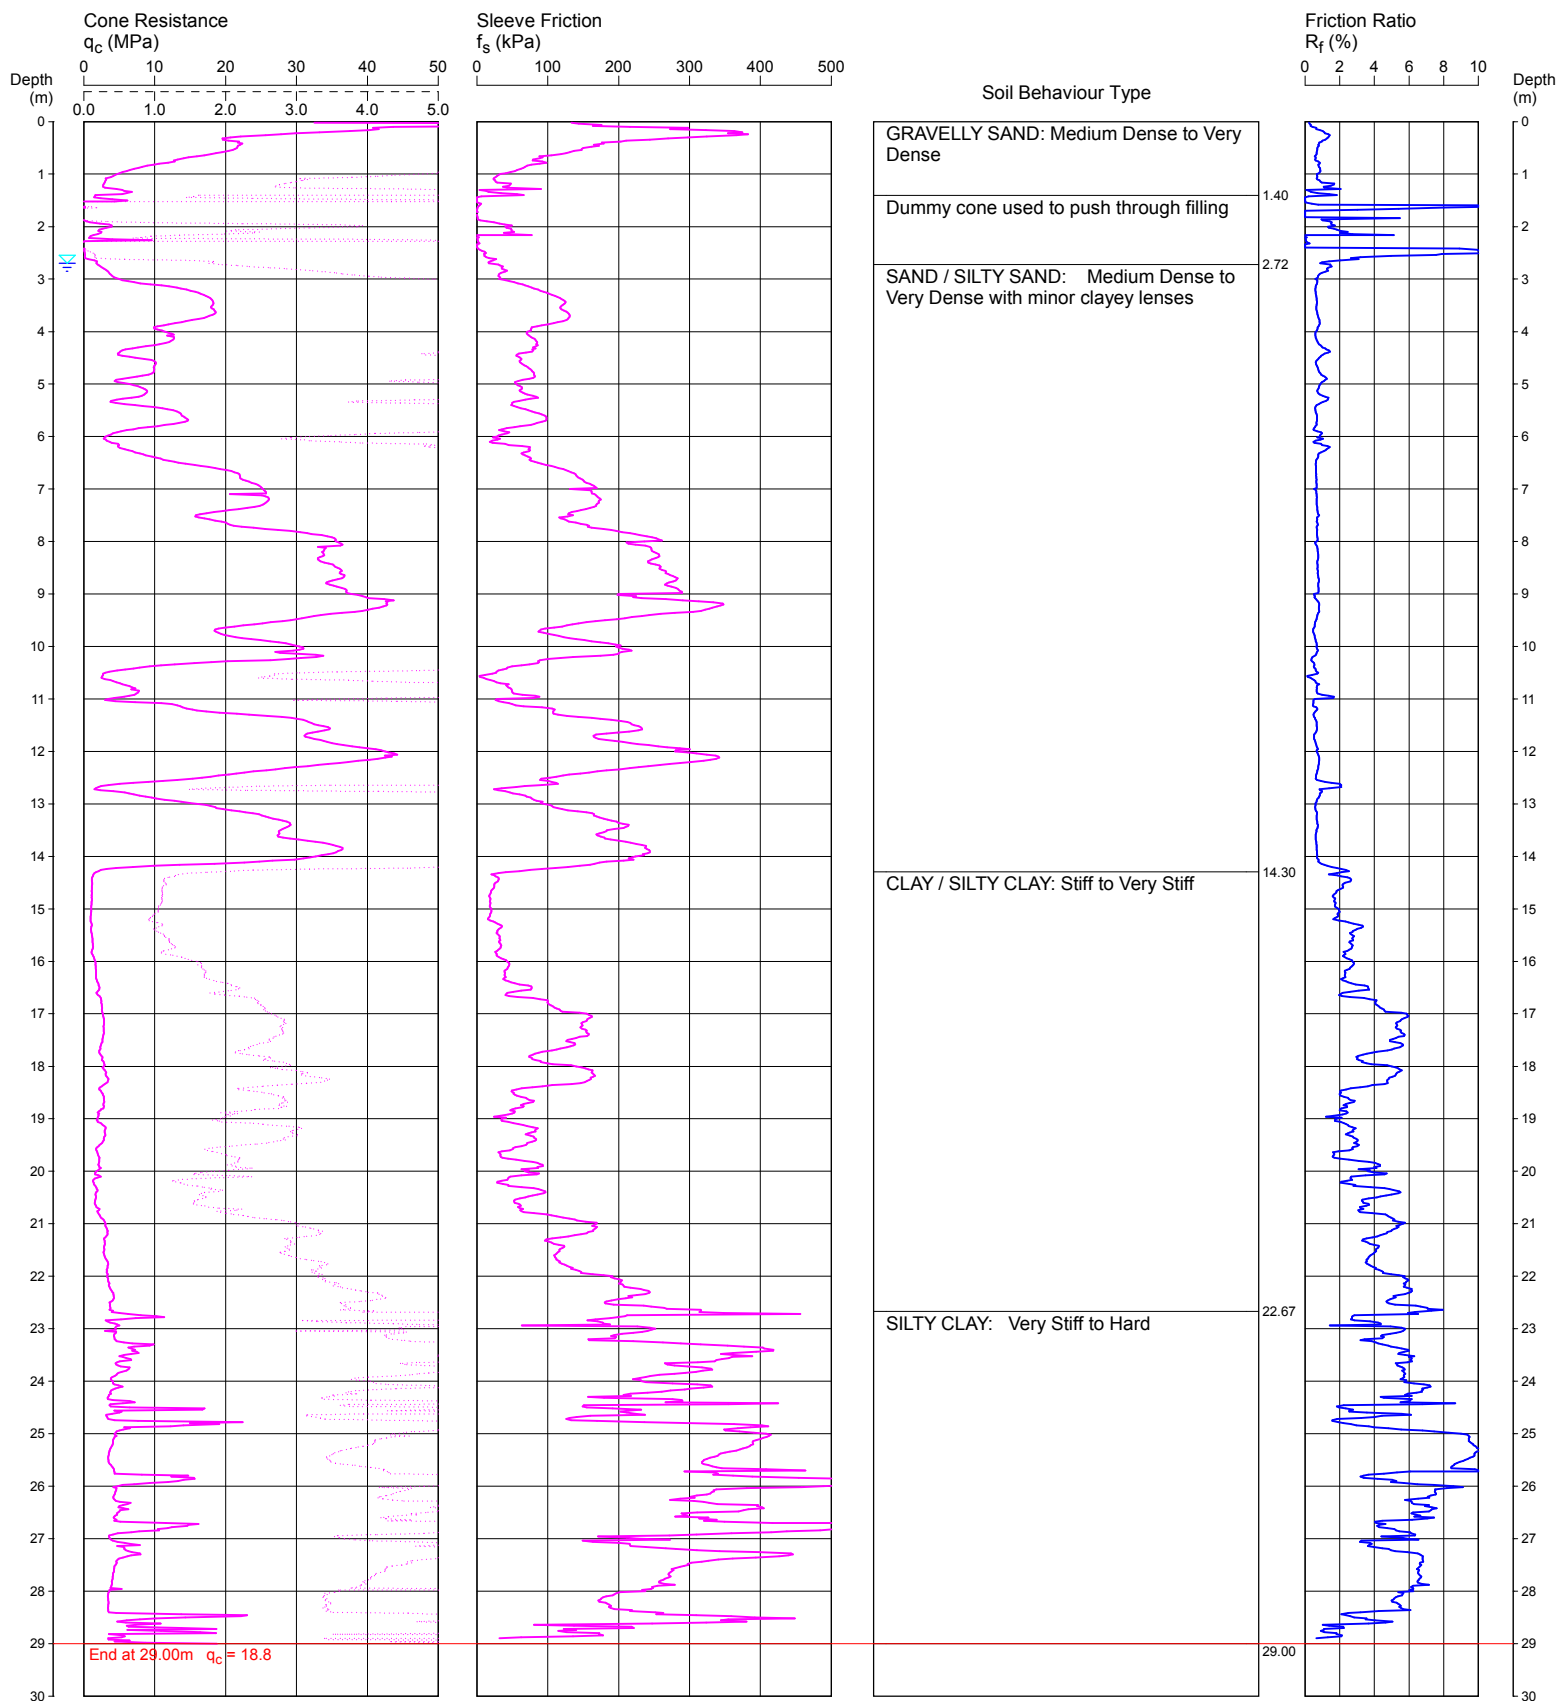
REMARKS: DUMMY CONE FROM 1.52 TO 2.0 m AND 2.26 TO 2.7 m TO PENETRATE FILLING. TEST DISCONTINUED DUE TO EXCESSIVE CONE BENDING. GROUNDWATER OBSERVED AT 2.7 m AFTER WITHDRAWAL OF RODS.

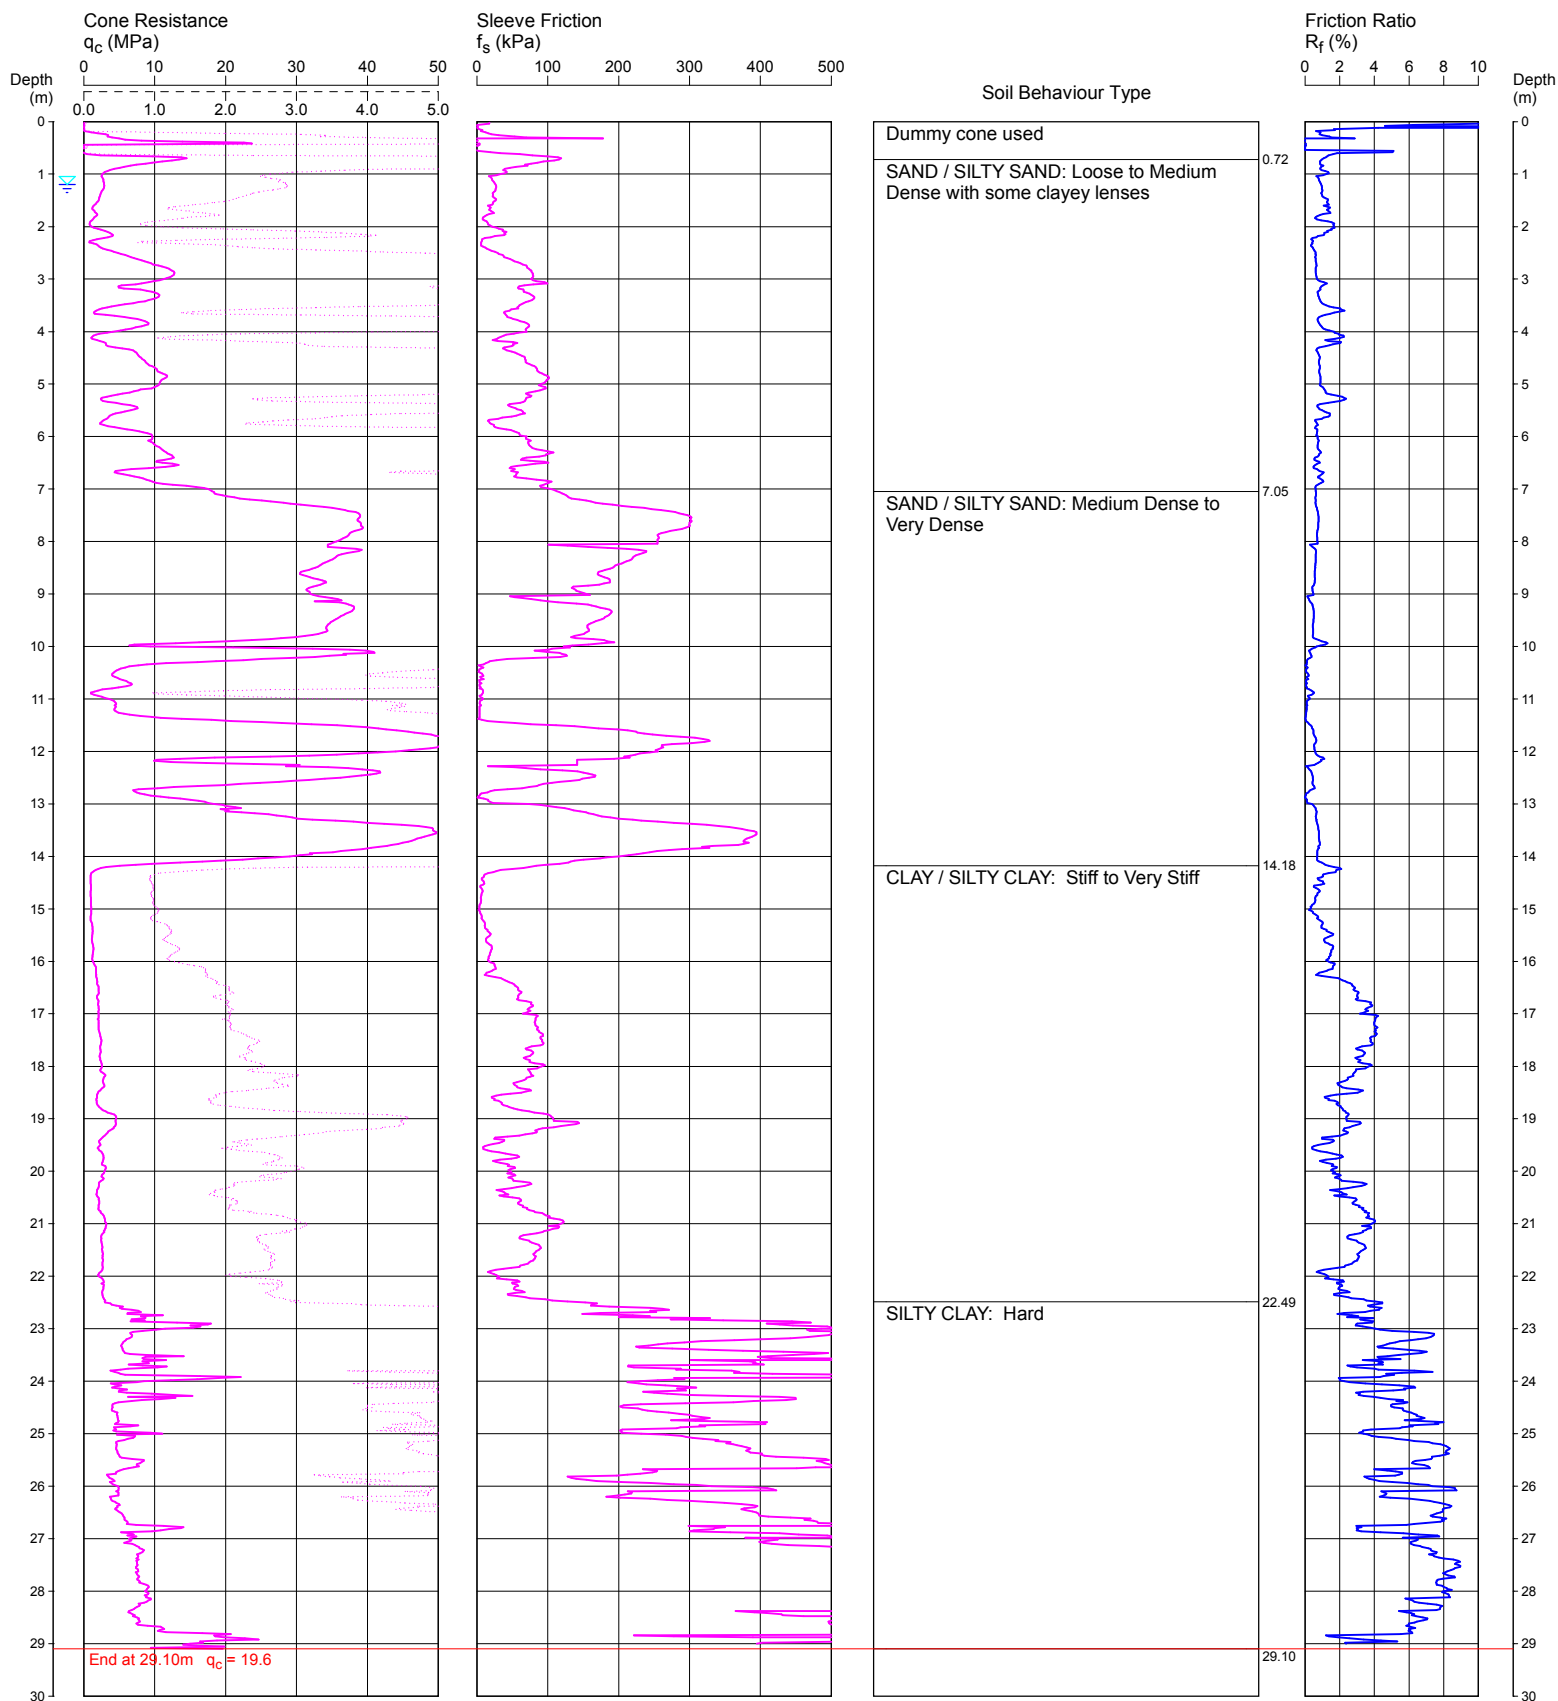
REMARKS: CONCRETE CORE TO 0.2 m DEPTH. DUMMY CONE FROM 0.42 TO 0.7 m DEPTH.
TEST DISCONTINUED DUE TO EXCESSIVE ROD BOWING. GROUNDWATER OBSERVED AT 1.2 m AFTER WITHDRAWAL OF RODS.

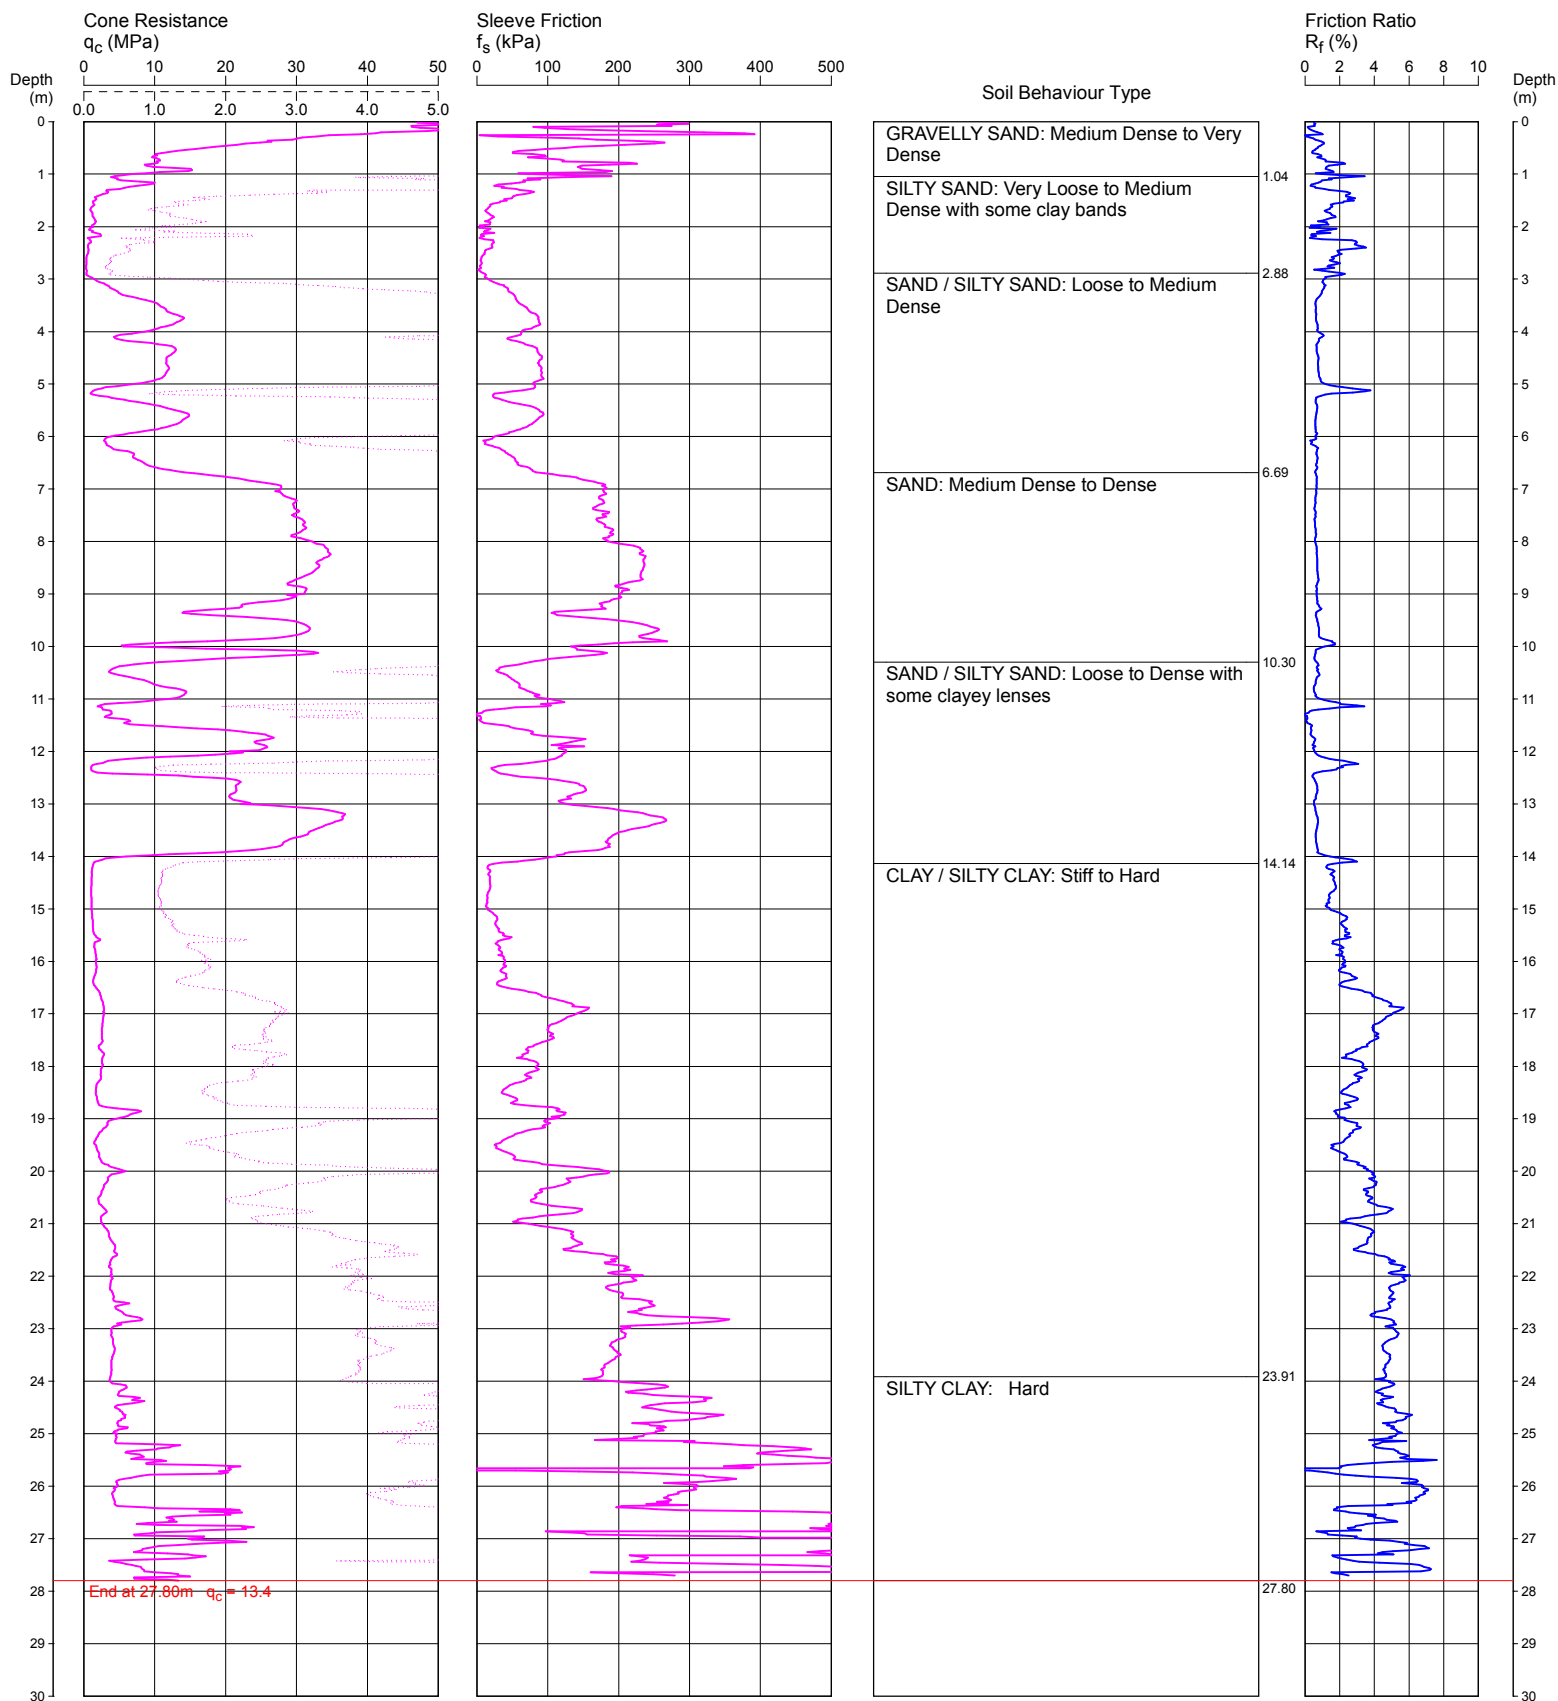
REMARKS: TEST DISCONTINUED DUE TO EXCESSIVE CONE BENDING.
HOLE COLLAPSE AT 1.0 m AFTER WITHDRAWAL OF RODS.

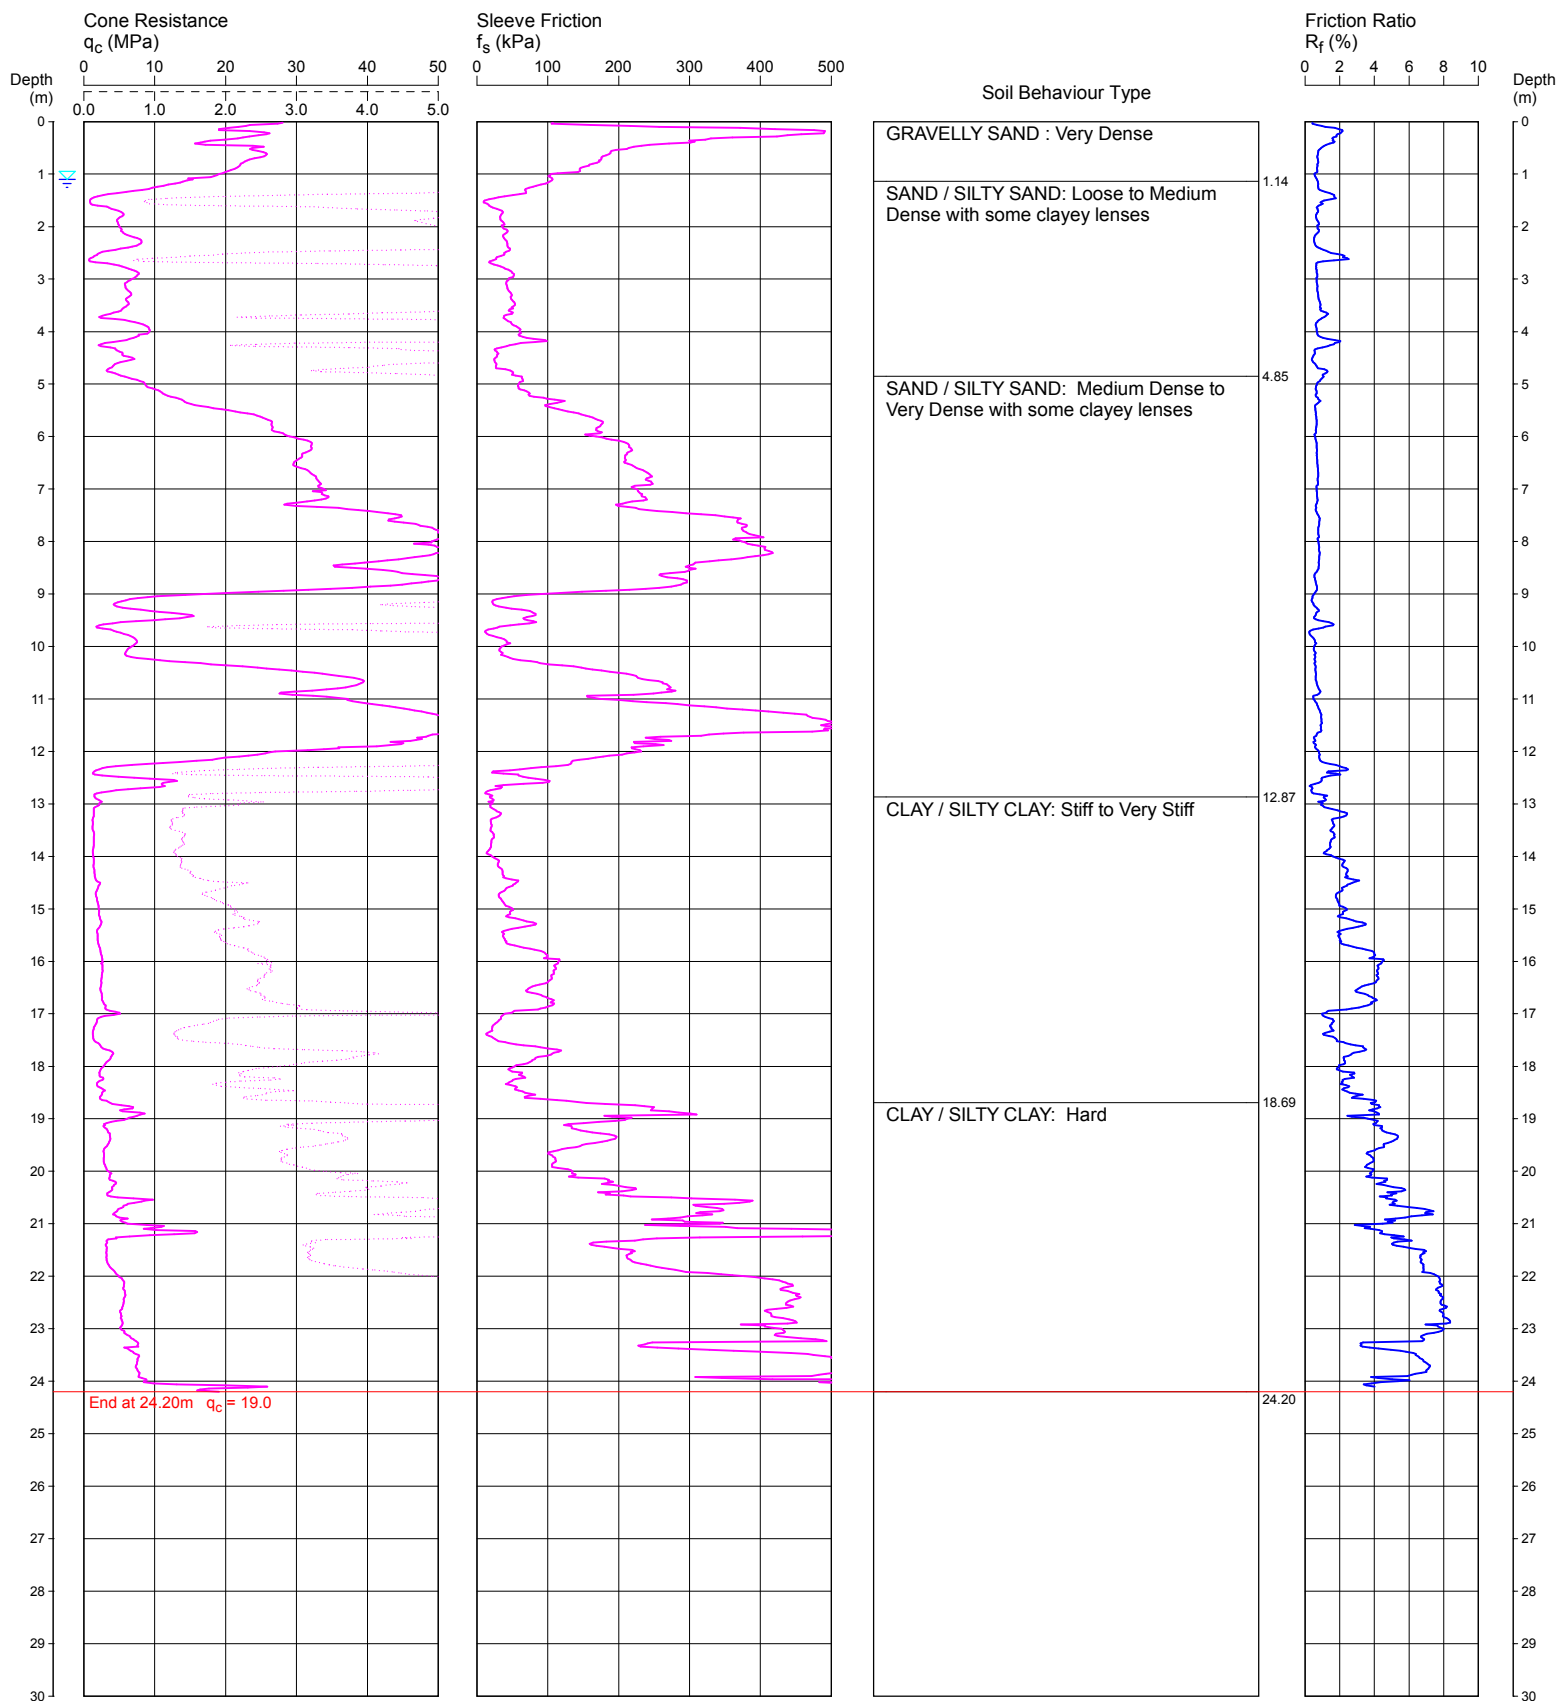
REMARKS: TEST DISCONTINUED DUE TO EXCESSIVE CONE BENDING.
GROUNDWATER OBSERVED AT 1.1 m AFTER WITHDRAWAL OF RODS.
