Report on
Geotechnical Investigation

Proposed Flight Training Centre
King Street, Mascot

Prepared for
Enstruct Group Pty Ltd

Project 85777.15
February 2019

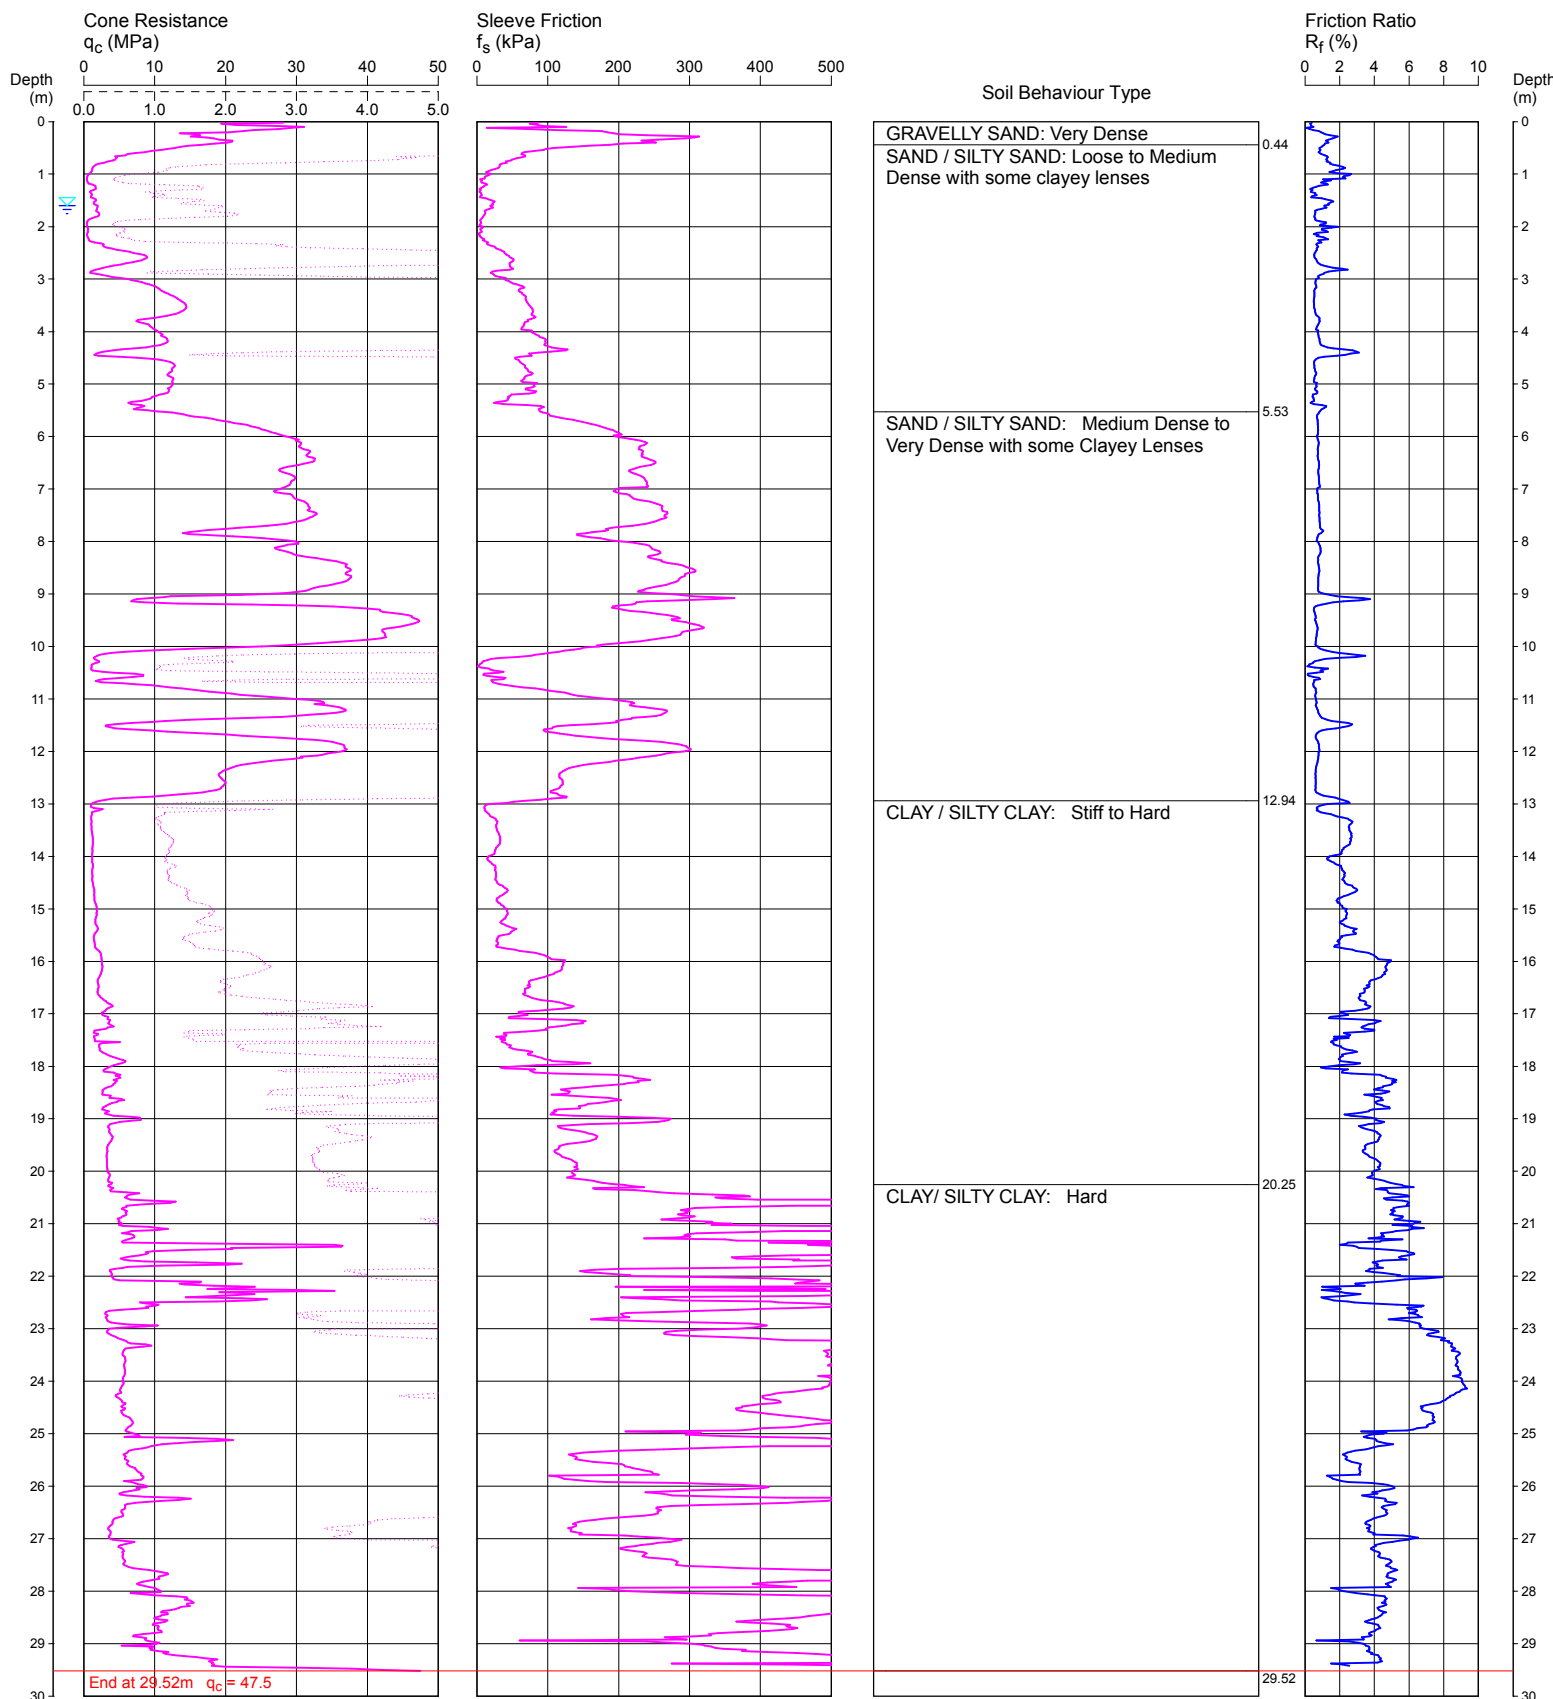
REMARKS: TEST DISCONTINUED DUE TO EXCESSIVE ROD BOWING.
GROUNDWATER OBSERVED AT 1.6 m AFTER WITHDRAWAL OF RODS.

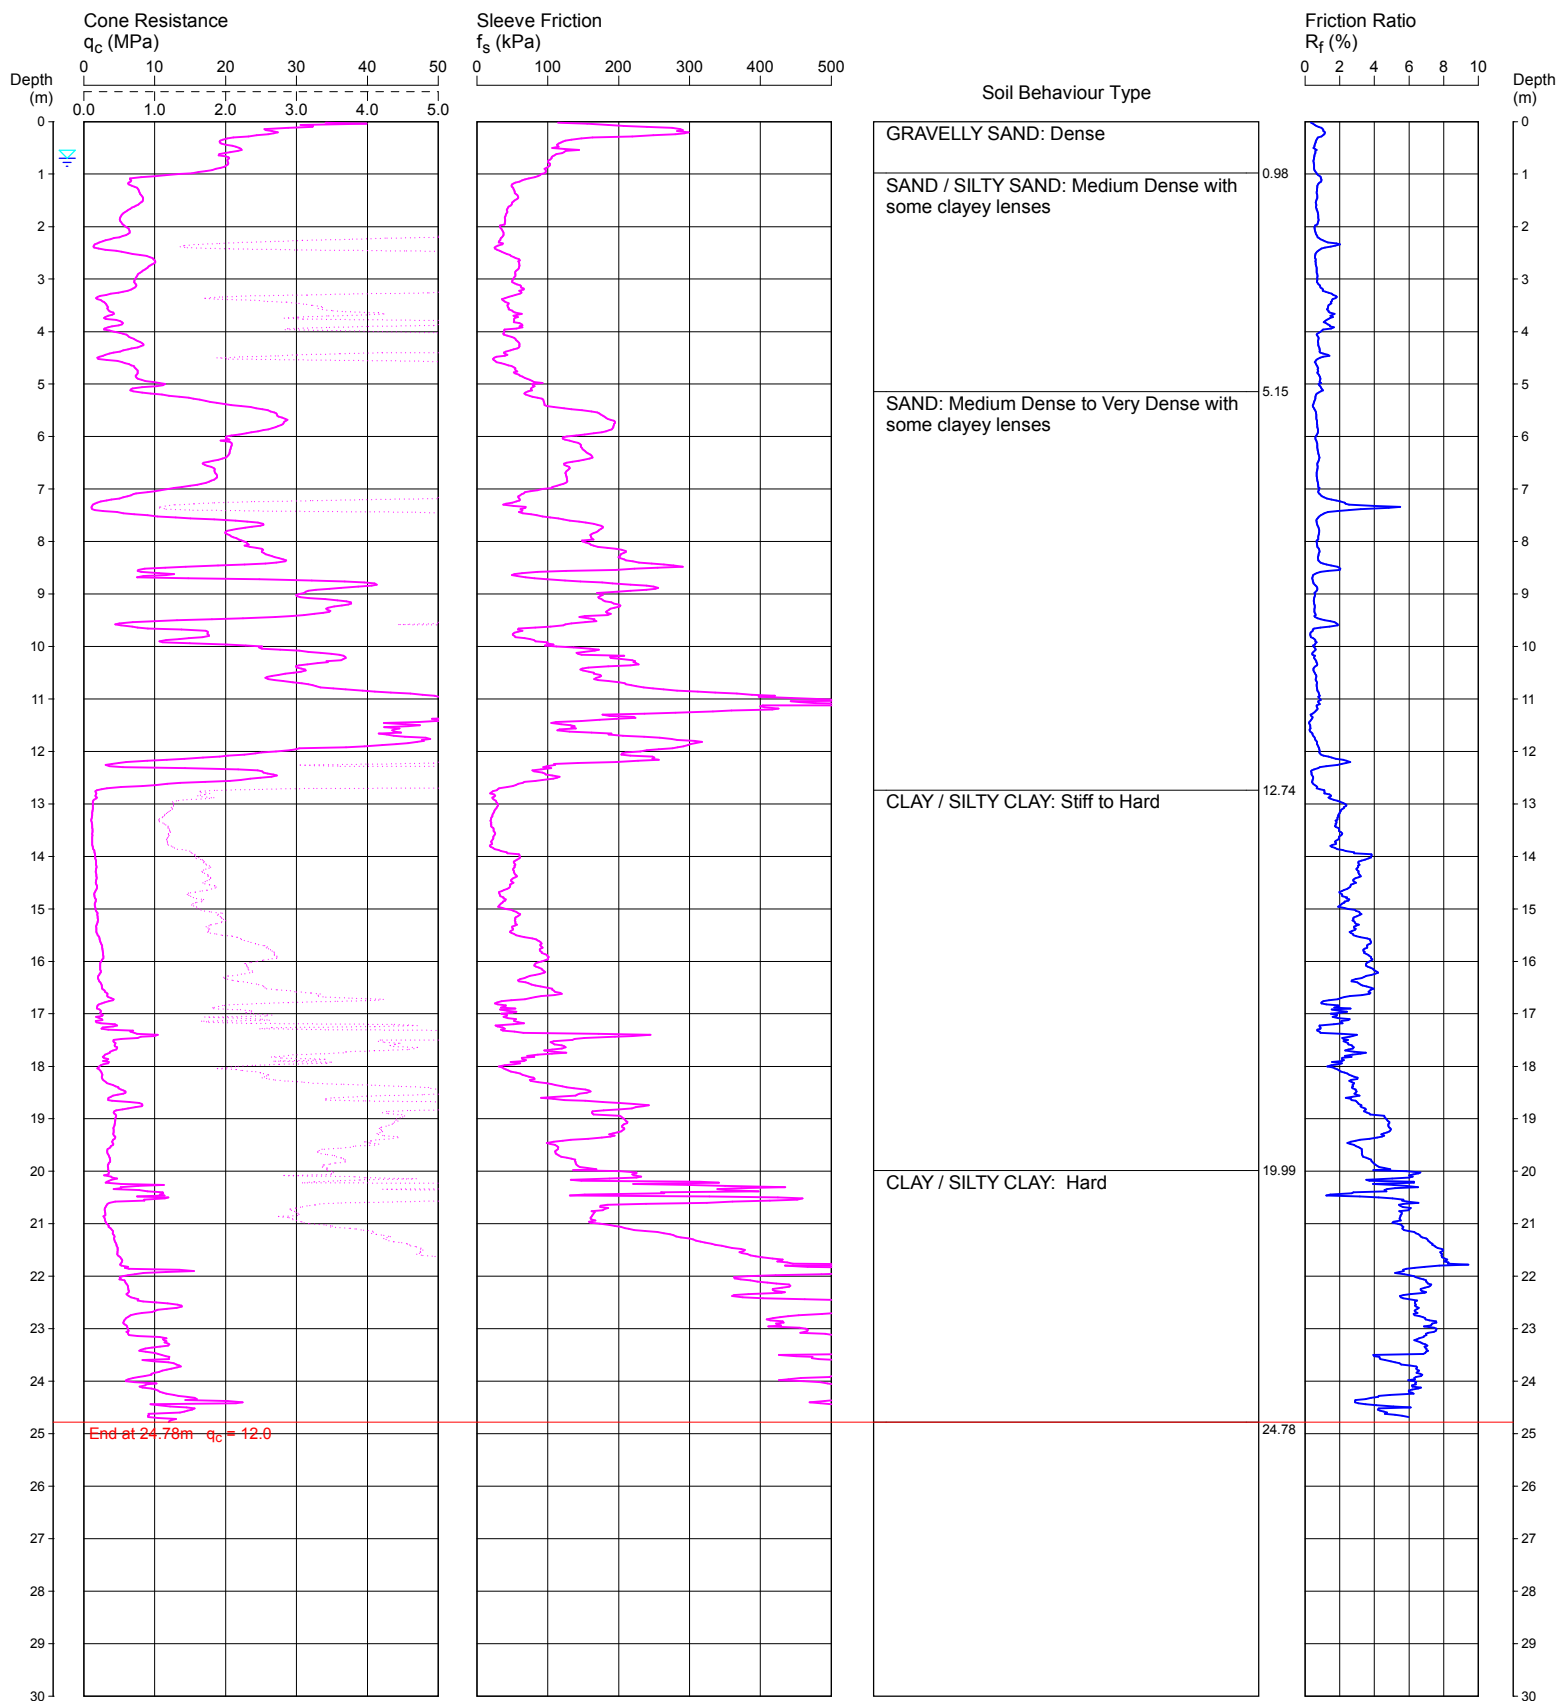
REMARKS: TEST DISCONTINUED DUE TO EXCESSIVE ROD BOWING.
GROUNDWATER OBSERVED AT 0.7 m AFTER WITHDRAWAL OF RODS.

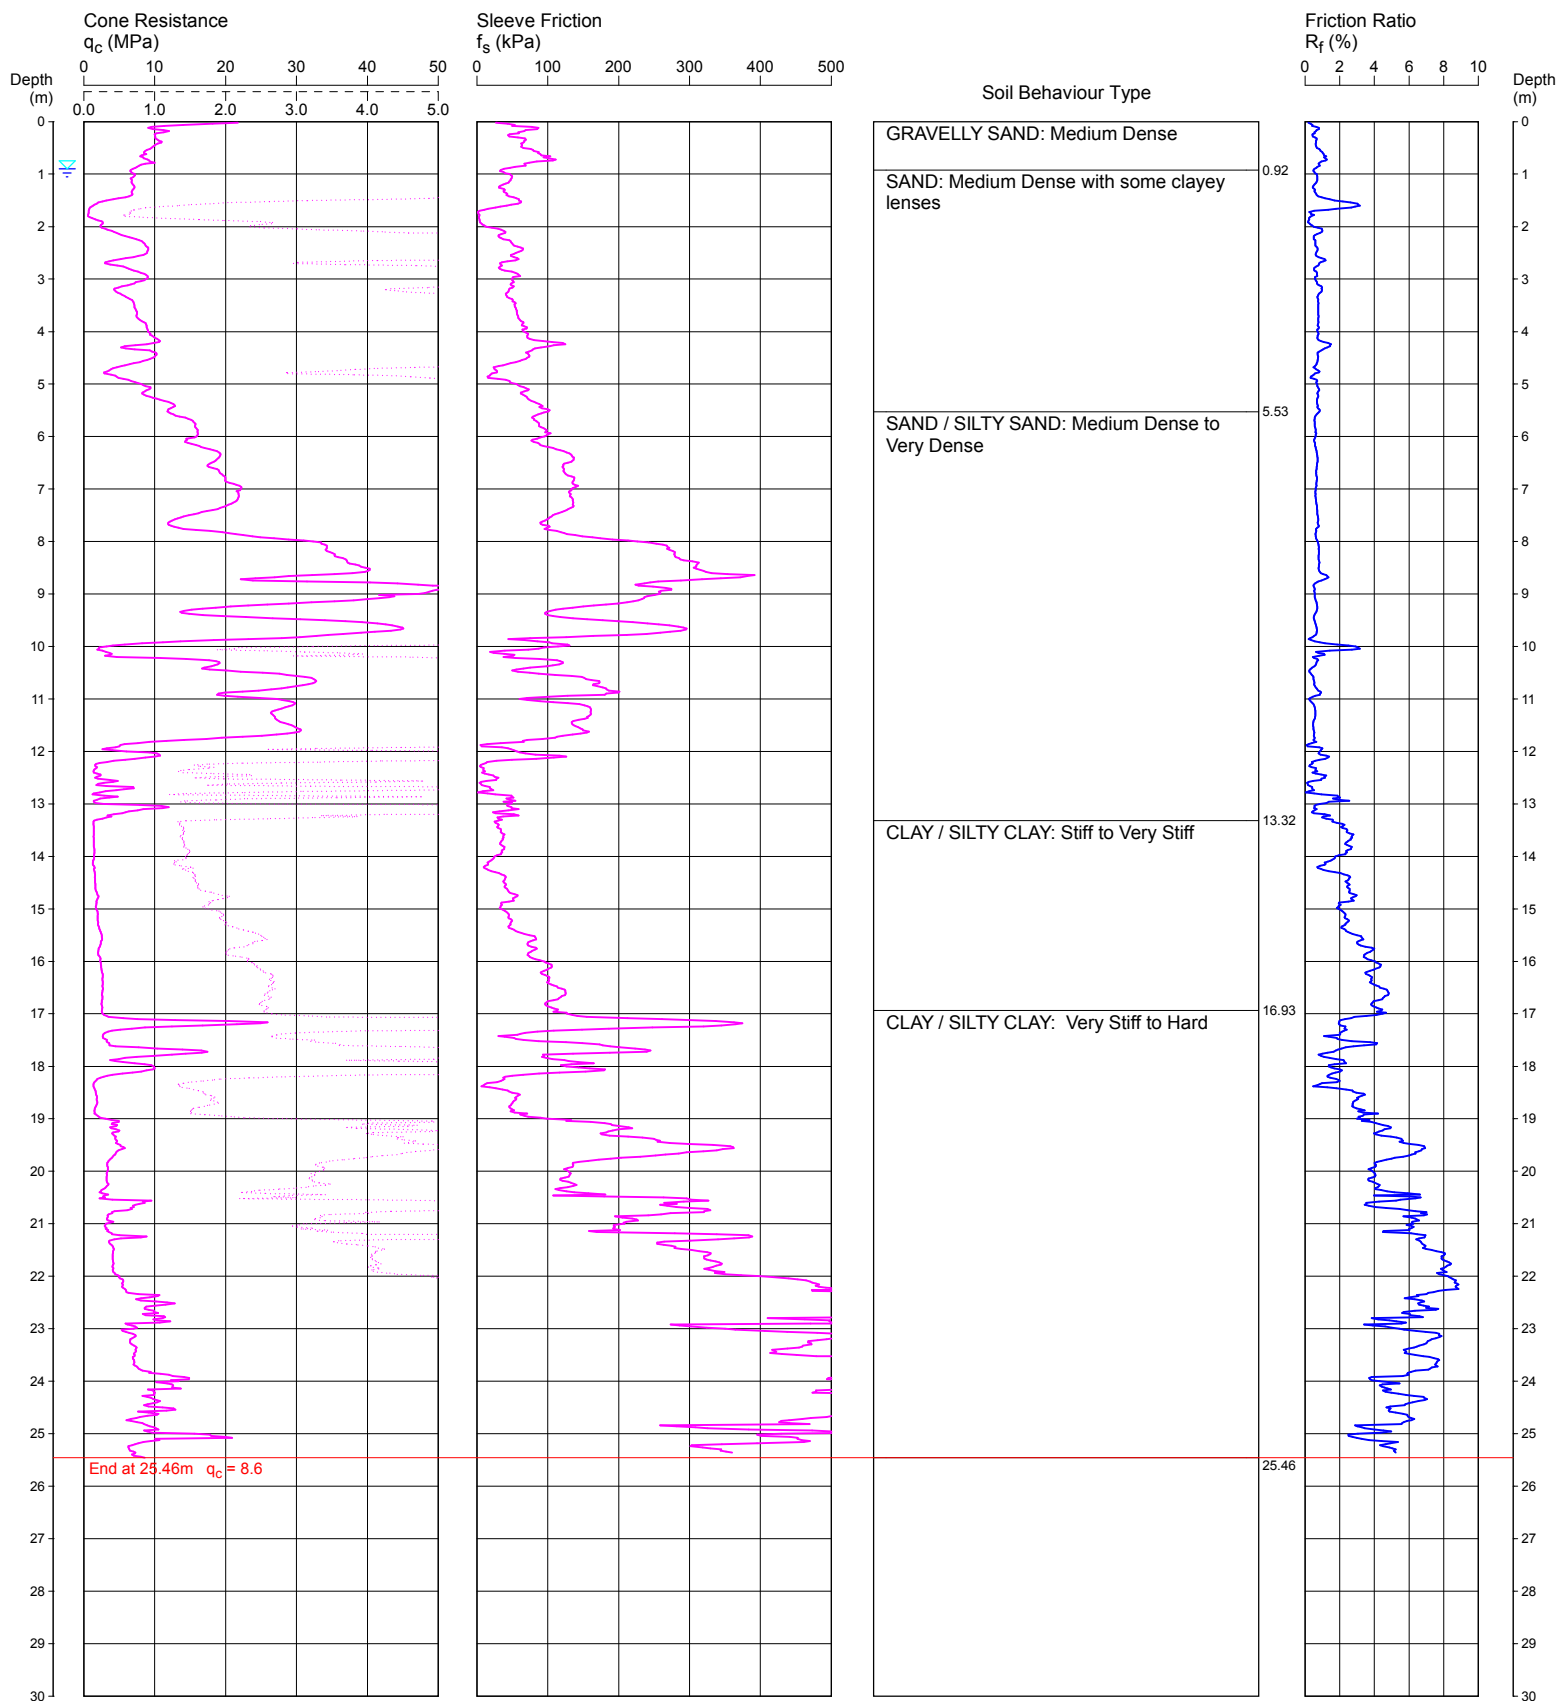
REMARKS: TEST DISCONTINUED DUE TO EXCESSIVE ROD BOWING.
GROUNDWATER OBSERVED AT 0.9 m AFTER WITHDRAWAL OF RODS.

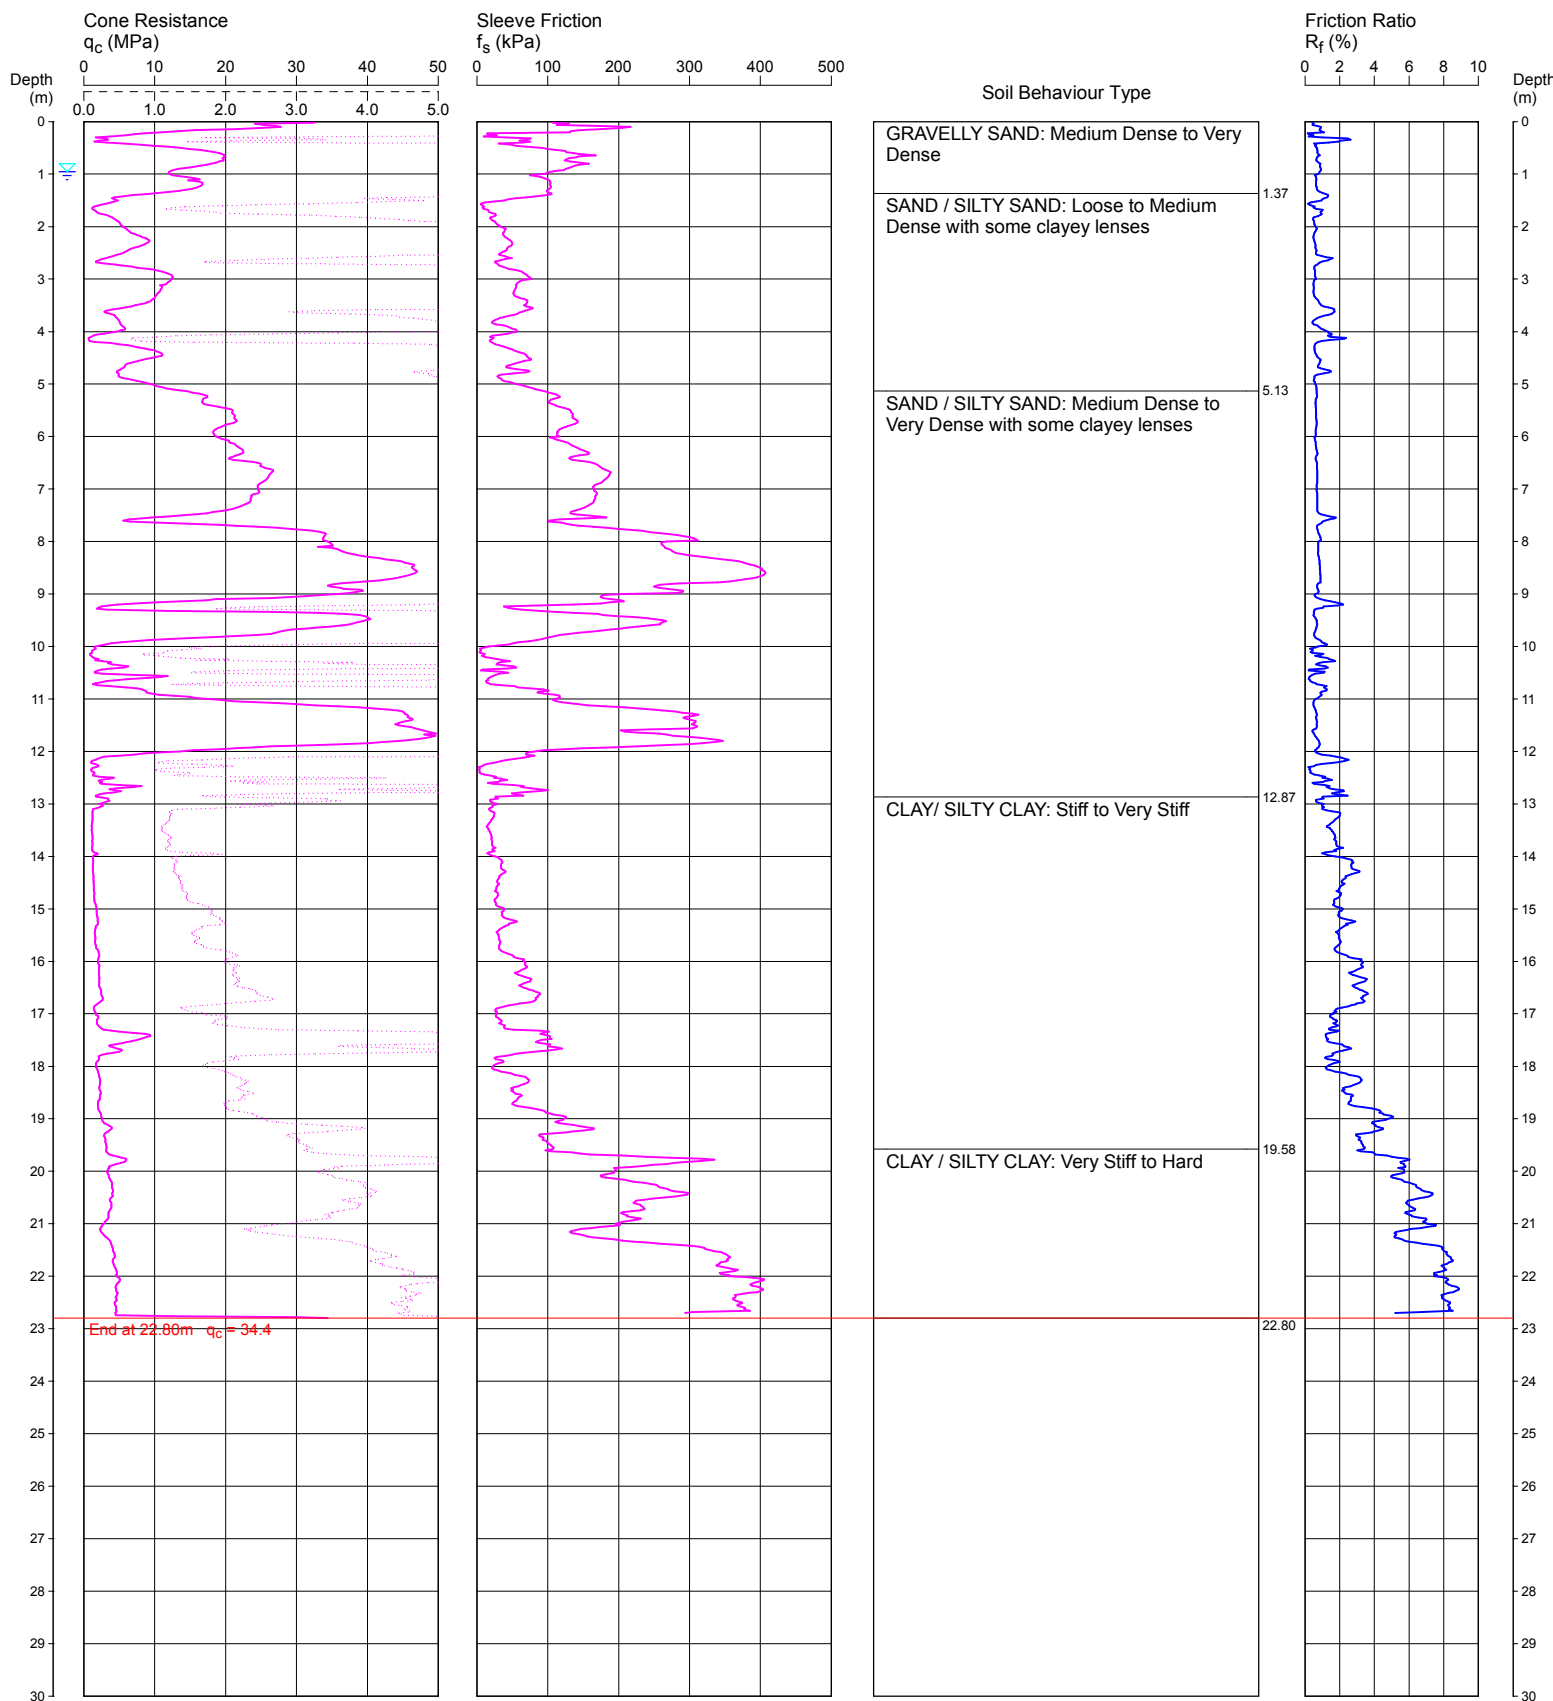
REMARKS: TEST DISCONTINUED DUE TO BENDING NEAR REFUSAL
GROUNDWATER MEASURED AT 0.95 m DEPTH AFTER WITHDRAWAL OF RODS

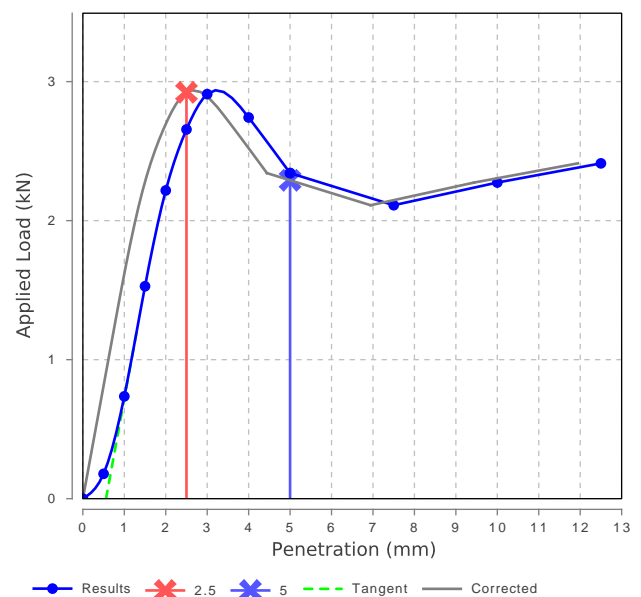
California Bearing Ratio (AS 1289 6.1.1 & 2.1.1)		Min	Max
CBR taken at	2.5 mm		
CBR %	20		
Method of Compactive Effort	Standard		
Method used to Determine MDD	AS 1289 5.1.1 & 2.1.1		
Method used to Determine Plasticity	Visual Assessment		
Maximum Dry Density (t/m^3)	1.76		
Optimum Moisture Content (%)	9.5		
Laboratory Density Ratio (%)	100.0		
Laboratory Moisture Ratio (%)	100.0		
Dry Density after Soaking (t/m^3)	1.77		
Field Moisture Content (%)	8.2		
Moisture Content at Placement (%)	9.3		
Moisture Content Top 30mm (%)	16.7		
Moisture Content Rest of Sample (%)	17.2		
Mass Surcharge (kg)	4.5		
Soaking Period (days)	4		
Curing Hours	26		
Swell (%)	-0.5		
Oversize Material (mm)	19		
Oversize Material Included	Excluded		
Oversize Material (%)	0

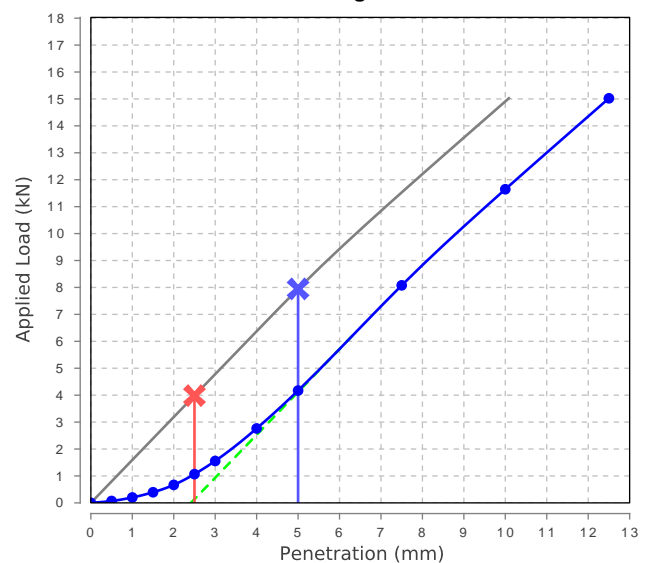
California Bearing Ratio

Min	Max
CBR taken at	5 mm	
CBR %	40	
Method of Compactive Effort	Standard	
Method used to Determine MDD	AS 1289 5.1.1 & 2.1.1	
Method used to Determine Plasticity	Visual Assessment	
Maximum Dry Density (t/m ³)	1.91	
Optimum Moisture Content (%)	13.0	
Laboratory Density Ratio (%)	100.0	
Laboratory Moisture Ratio (%)	100.0	
Dry Density after Soaking (t/m ³)	1.90	
Field Moisture Content (%)	10.8	
Moisture Content at Placement (%)	12.8	
Moisture Content Top 30mm (%)	13.0	
Moisture Content Rest of Sample (%)	12.1	
Mass Surcharge (kg)	4.5	
Soaking Period (days)	4	
Curing Hours	2.5	
Swell (%)	0.5	
Oversize Material (mm)	19	
Oversize Material Included	Excluded	
Oversize Material (%)	3

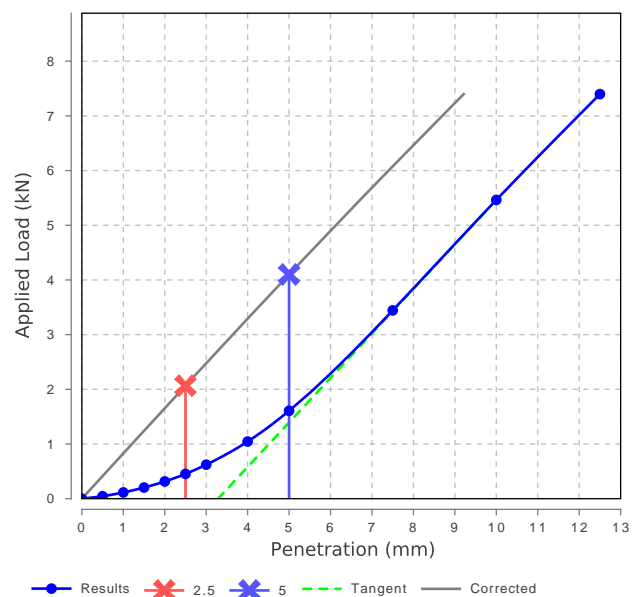
California Bearing Ratio (AS 1289 6.1.1 & 2.1.1)		Min	Max
CBR taken at	5 mm		
CBR %	20		
Method of Compactive Effort	Standard		
Method used to Determine MDD	AS 1289 5.1.1 & 2.1.1		
Method used to Determine Plasticity	Visual Assessment		
Maximum Dry Density (t/m^3)	1.97		
Optimum Moisture Content (%)	11.0		
Laboratory Density Ratio (%)	100.0		
Laboratory Moisture Ratio (%)	100.0		
Dry Density after Soaking (t/m^3)	1.97		
Field Moisture Content (%)	7.1		
Moisture Content at Placement (%)	11.2		
Moisture Content Top 30mm (%)	11.3		
Moisture Content Rest of Sample (%)	11.9		
Mass Surcharge (kg)	4.5		
Soaking Period (days)	4		
Curing Hours	26		
Swell (%)	-0.5		
Oversize Material (mm)	19		
Oversize Material Included	Excluded		
Oversize Material (%)	2
