Report on
Preliminary Geotechnical Investigation

Proposed Northside Private Hospital
Part Lot 2 in DP 1226923, Faunce Street West, West
Gosford

Prepared for
AA Crown Holdings Pty Ltd

Project 83574.00
March 2019

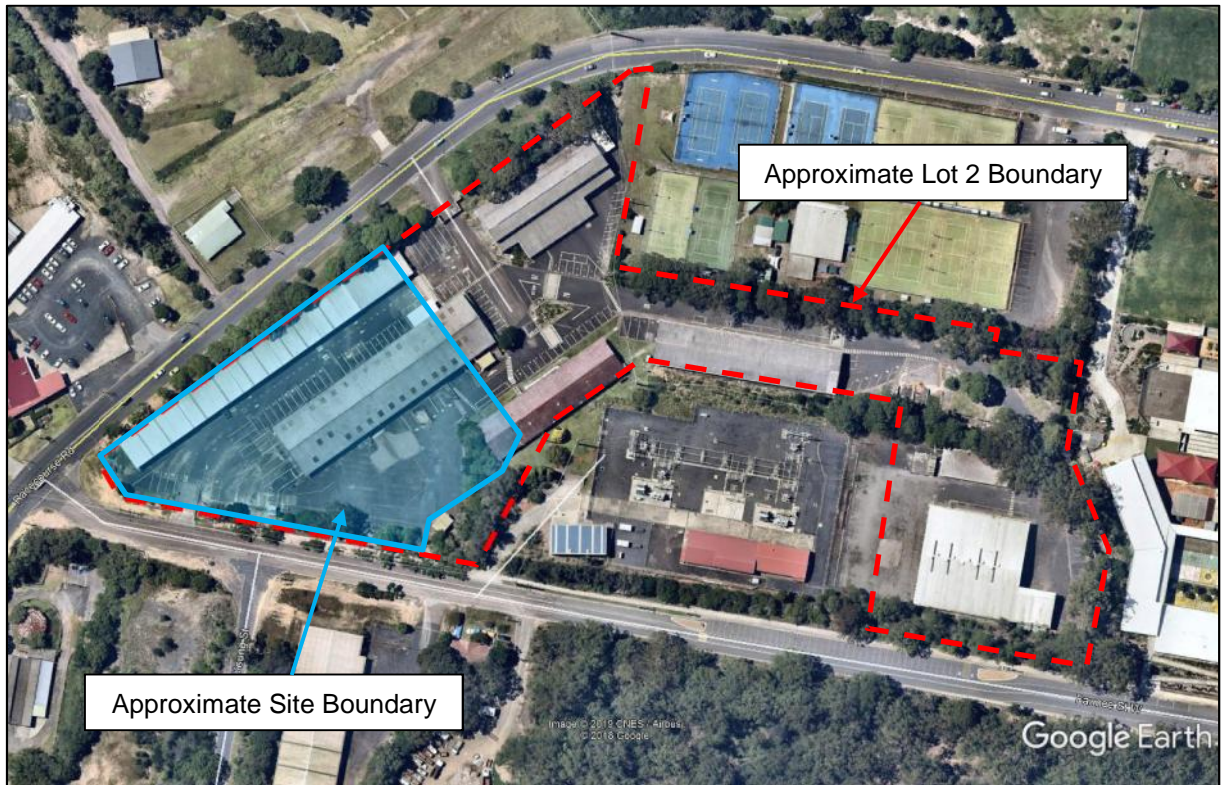
Figure 1 below, shows an aerial view of the site.

Figure 1 – Aerial view of site (sourced from Google Earth with Nearmap Overlay dated 27 December 2018)

The site is located within the south-western area of Lot 2 in DP 1226923, on the corner of Faunce Street West and Racecourse Road, West Gosford. The proposed Northside Private Hospital development (the 'site') covers an irregular shaped area of approximately 1 ha.

The site is bounded by Faunce Street West to the south, Racecourse Road to the west, an existing Ausgrid substation to the east and structures associated with a former Ausgrid depot to the north and north-east.

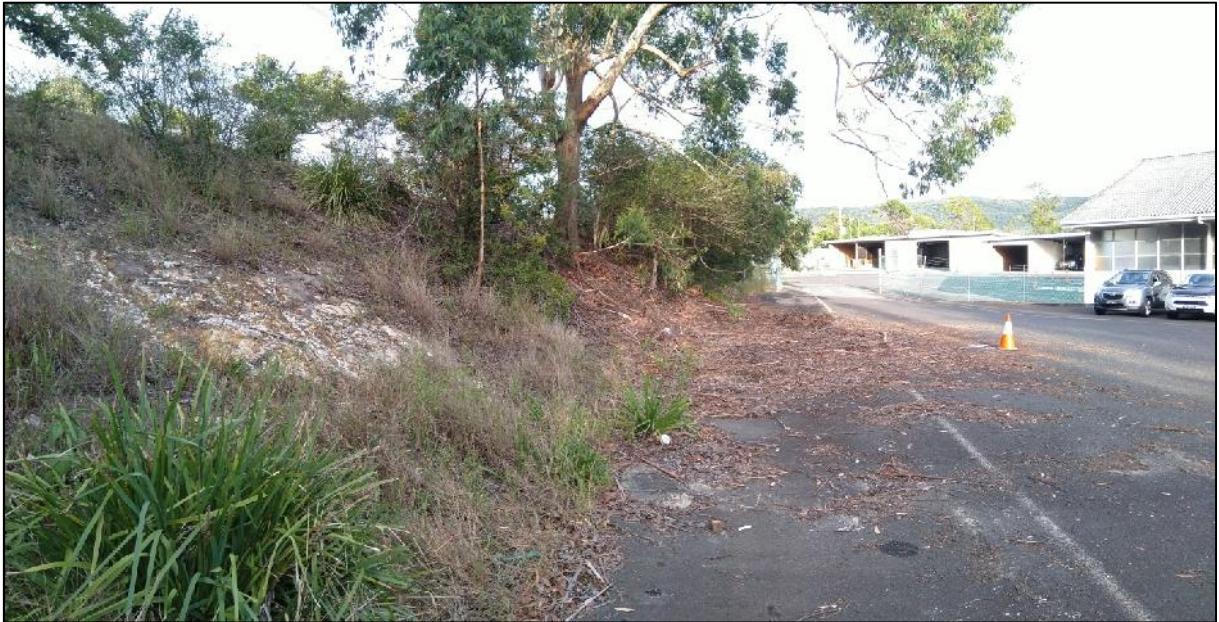
Figure 5 – View of the cut batter along the southern boundary, looking west

Along the southern boundary, in the eastern area of the site, a cut batter was also observed and sandstone bedrock was exposed.

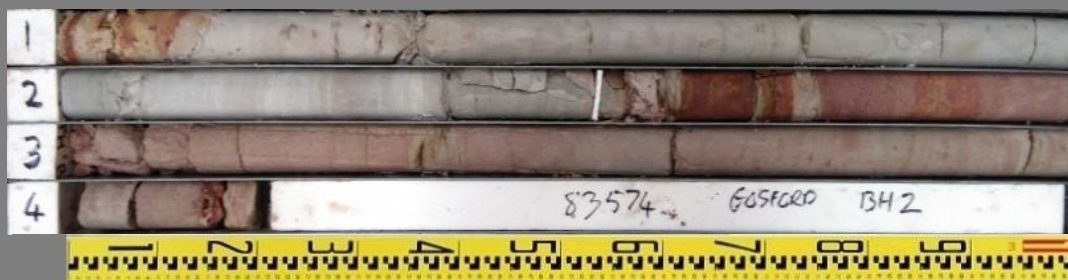
1.0 m – 4.2 m

CLIENT: AA Crown Holdings Pty Ltd	TITLE: Core Photograph Proposed Northside Private Hospital Part Lot 2 in DP 1226923, Faunce Street West, West Gosford		
PROJECT No: 83574.00			
OFFICE: Central Coast

Rock core photos for Bore 2 are provided in the photo plates in Appendix C.
