Report on
Preliminary Site Investigation for Contamination

Proposed Northside Private Hospital
Part of 22 Faunce Street West, West Gosford

Project 83574.02
July 2020

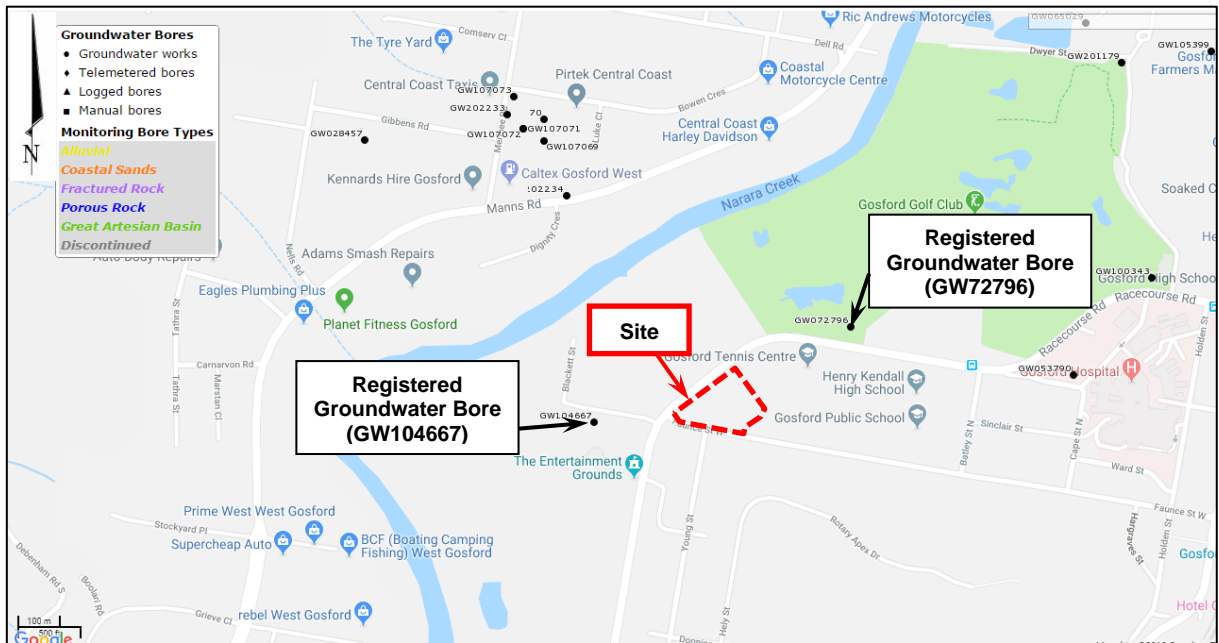
Figure 4: Registered Groundwater Bores

Figure 4 is a street map of the local area and shows the site in relation to the local registered groundwater bores.

(image sourced from Microsoft Virtual Earth with NSW Office of Water Registered Groundwater Bore location overlay)

A search for registered groundwater bores in the WaterNSW groundwater bore database indicated that there were four registered groundwater bores within a 500 m radius of the site in 2019. The information available from the reports suggests that the closest two bores (identified in Figure 4) have their status listed as cancelled. A copy of the search results is provided in Appendix B. Given the site topography and proximity of intermittent watercourses (i.e. within the nearby golf course) to the north-east it is considered unlikely that any potential groundwater contamination from the site would impact the any active registered groundwater bores.

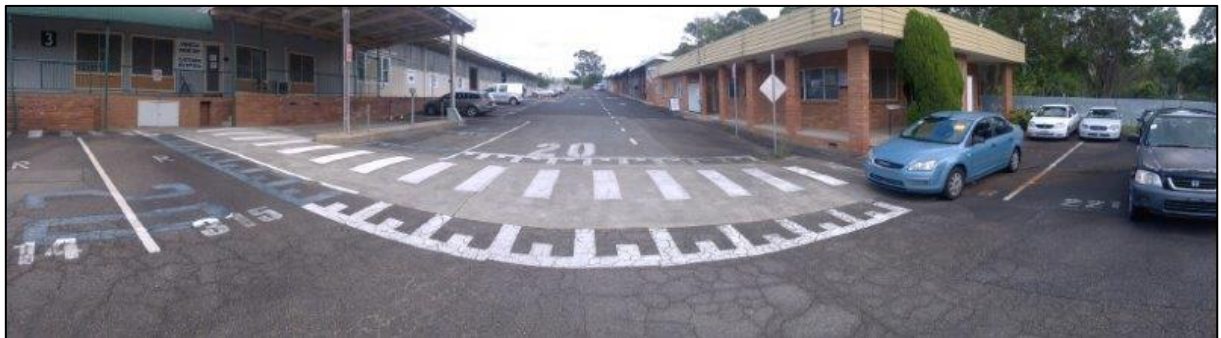
Figure 5 – Photograph from beyond the north-east corner of the site facing south-west, showing the former original UPSS area, with the former bowser island and awning visible. Some seepage discharging through the surface pavements at right side of photograph and down-slope of former UPSS. Some iron staining but no sheen visible on the seepage discharge.

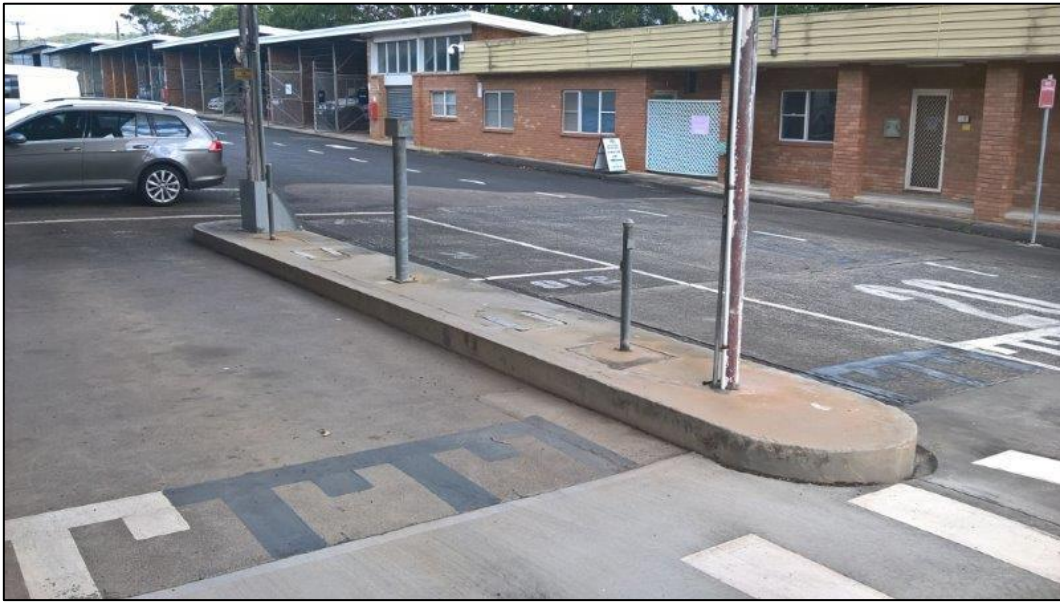
Figure 6 – Photograph of the original UPSS bowser island. The site boundary appears to bisect the former UPSS area. Inspection identified the former bowser plinth and two possible vent lines. No former dip or fill points were identified in the mapped location of the former UPSS. Hazardous chemical records search results indicated that this area historically comprised a single bowser island, with two bowzers and four USTs (north-west (right side) of bowser island).

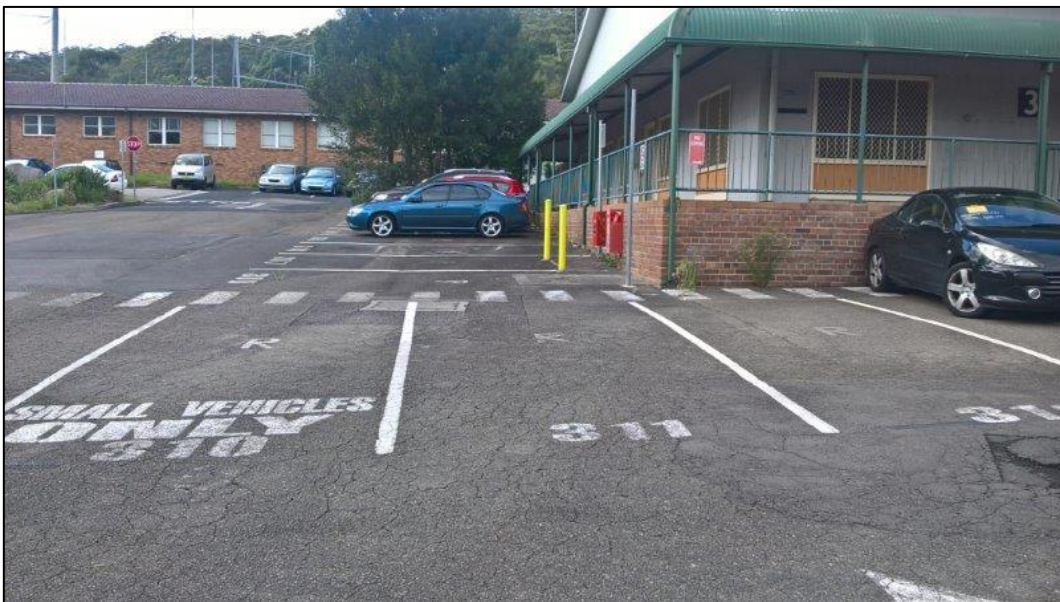
Figure 7 – Photograph of the second suspected former UPSS area (east of building and left side of photograph). The footprint of the second UPSS was located approximately 20 m beyond the eastern site boundary. No evidence of the former UPSS was identified during the site walkover, except for patched asphalt pavements.

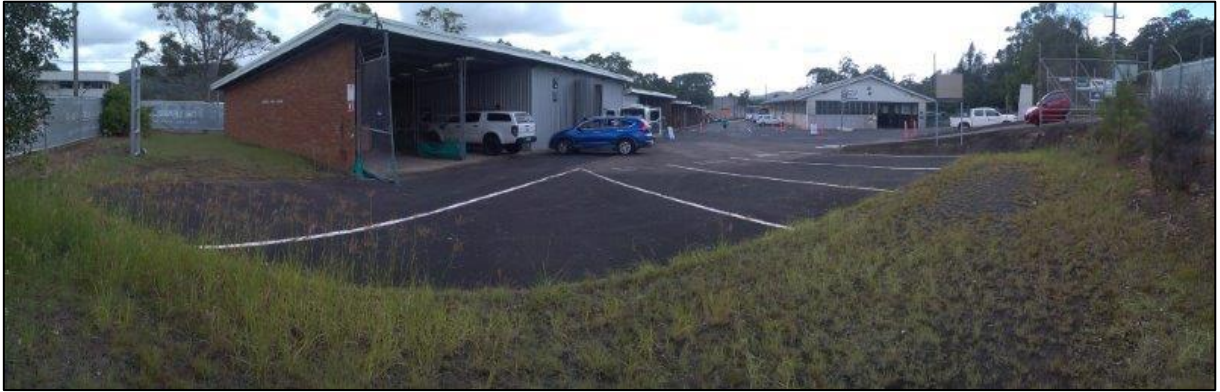
Figure 8 – Photograph from the western corner of the site facing north-east. The building on the left appeared to have remained consistent with the previous garage and office use (generally dry storage). The building on the right appeared to have remained consistent with the previous workshop, store and office uses.

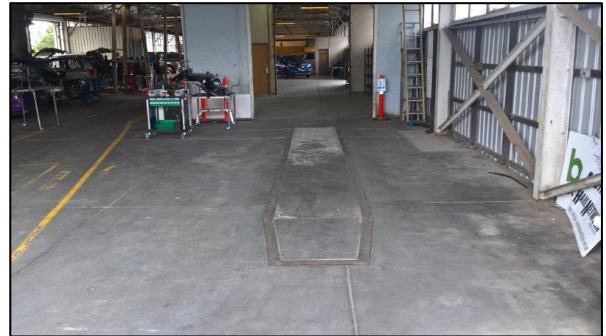
Figure 9 and Figure 10 – Photographs of the internal areas of the relatively large workshop, store and office building. Inspection identified signage that indicated past chemical storage, and oil filled equipment storage areas as well as an in-filled mechanics inspection pit. The building was being used as a hail-damage repair depot (paint-less dent removal) during the site walkover.

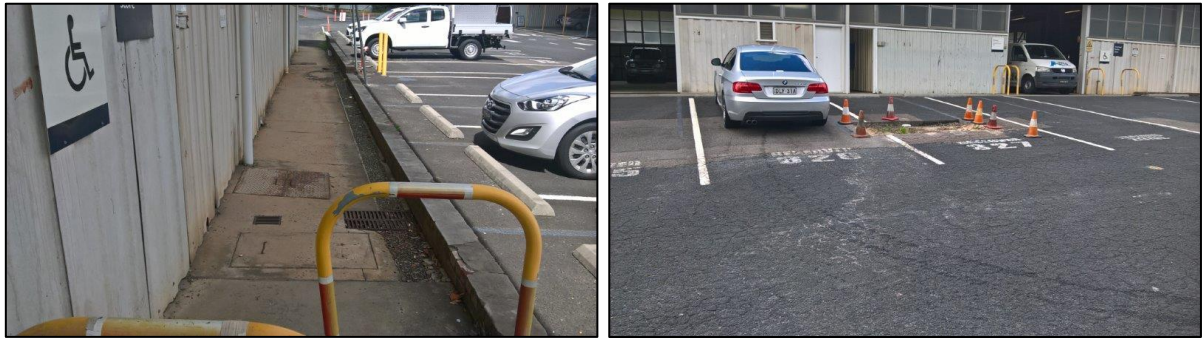
Figure 11 and Figure 12 – Photographs of the external areas of the relatively large workshop, store and office building. Inspection identified signage that indicated that asbestos cladding was present on the external building walls. A suspected trade waste pit (possible grease trap) was located on the northern side of the building which was possibly connected to nearby sewer infrastructure (suspected recent sewer connection point repair – witches hat area).

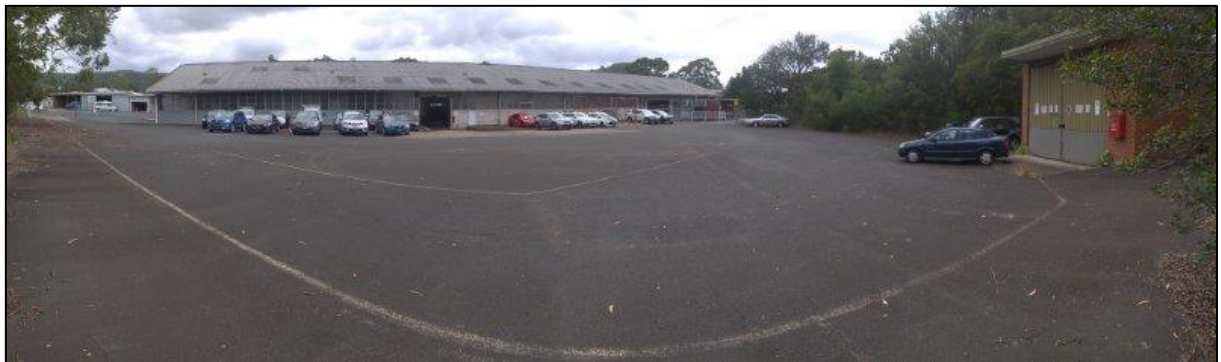
Figure 13 – Photograph from the southern corner of the site facing north. The large building in the background is the previously identified former workshop, store and office building. The smaller building on the right was a chemical store building that contained Class 3 hazardous chemicals (e.g. petroleum hydrocarbon based liquids).

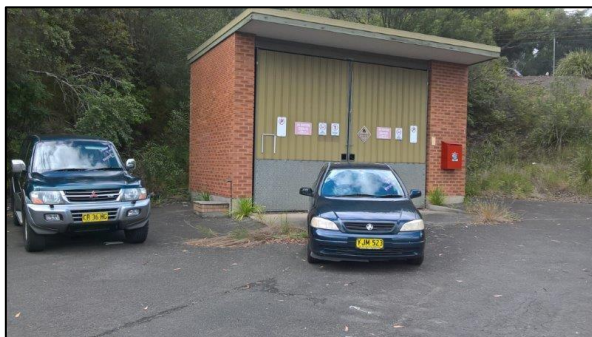
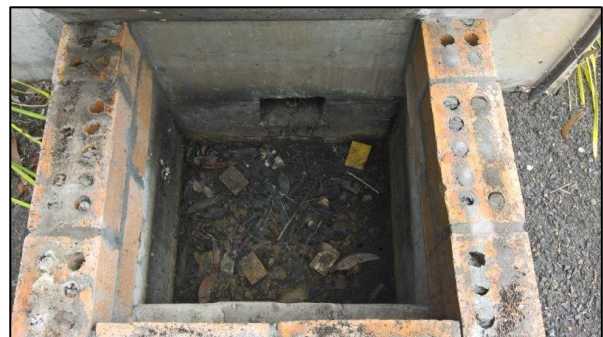
Figure 14 and Figure 15 – Photographs of the relatively small chemical store building, located adjacent to the southern site boundary. Inspection indicated some staining was visible on the concrete floor slab and that the store was designed to drain towards a small sump (pit – Figure 15) located externally on side of the building. The pit had fibre cement sheet (potential asbestos containing material) cover, that was observed to be in poor/average condition.

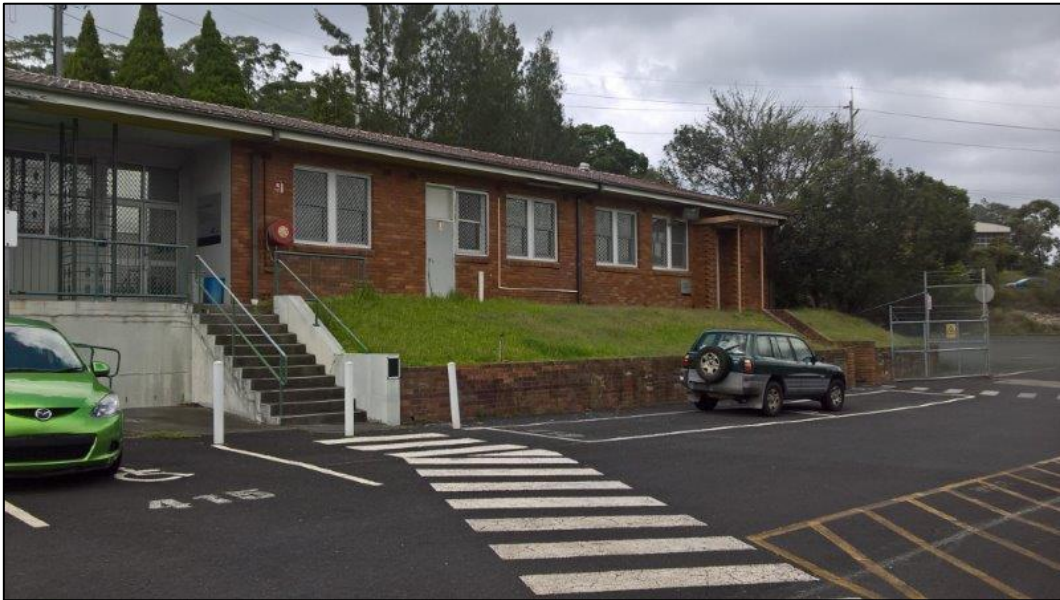
Figure 16 – Photograph of the south-east portion of the site (facing south-west), showing the identified staff amenities building. The photograph also demonstrated the extent of suspected cutting (maximum of approximately 4 m) in the southern portions of the site.
