Narrabri Underground Mine Stage 3 Extension Project

Agricultural Impact Statement

August 2020

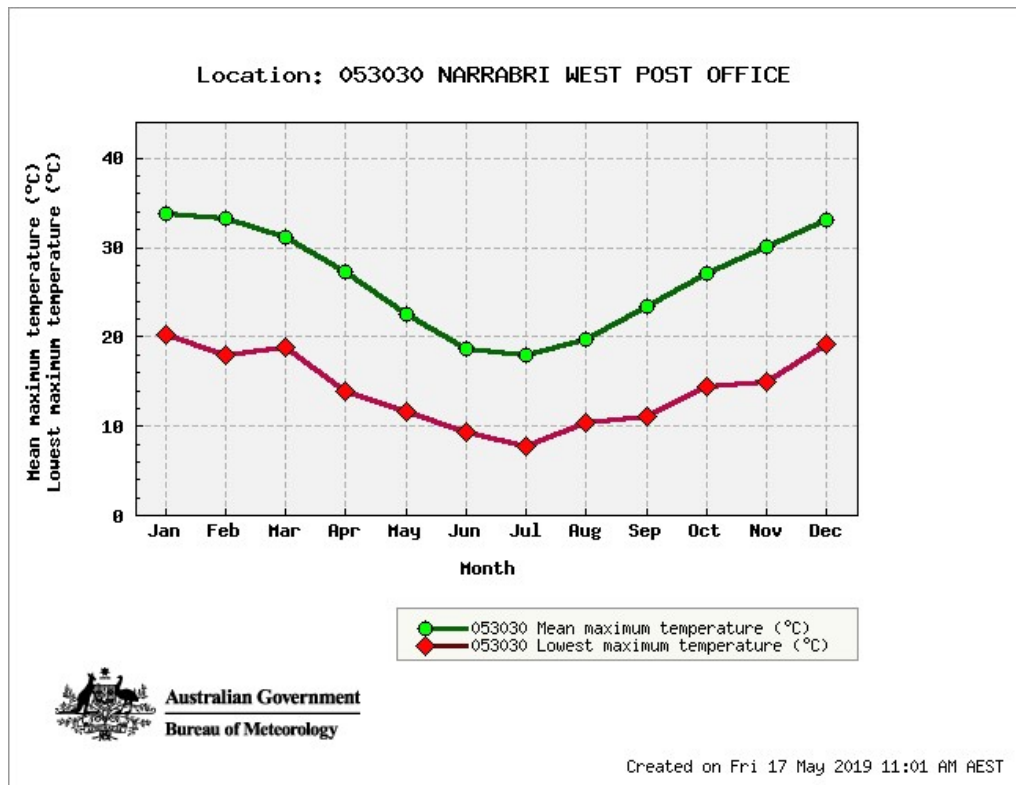
Figure 04-2 Mean monthly temperatures (maximum and minimum) recorded at Narrabri West Post Office (BOM 2020)

The monthly distribution of temperature and rainfall is recorded at Narrabri West Post Office (053030) (Figure 04-2 and Figure 04-3).

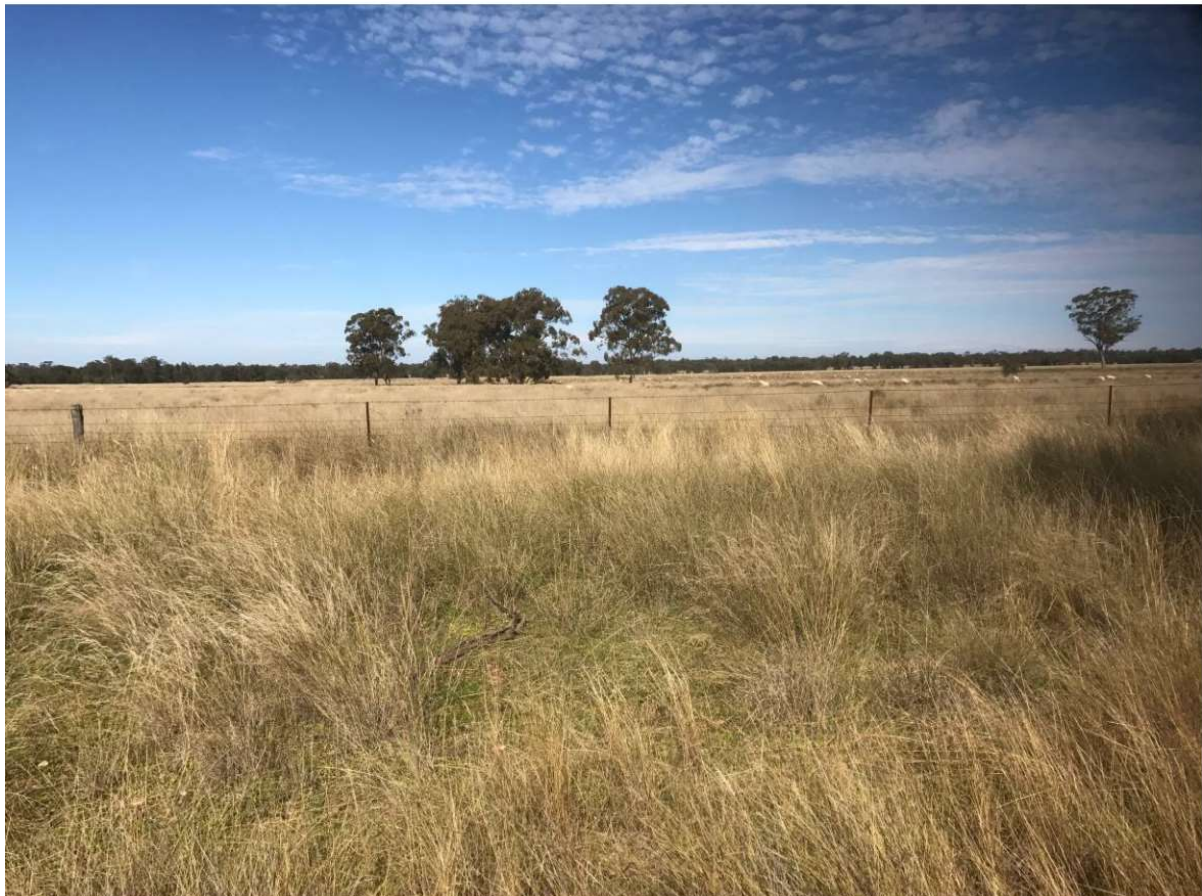
Plate 1: Yarranabee Grazing, View South from Yarranabee Road East of the Homestead (Source: Eco Logical Australia 2019).

The land use near the existing Narrabri Mine and the proposed Extension Project is dominantly devoted to sheep and cattle grazing, some cereal production and horticulture. The Pilliga and Jacks Creek State Forests adjoins the western extent of the EL 6243.

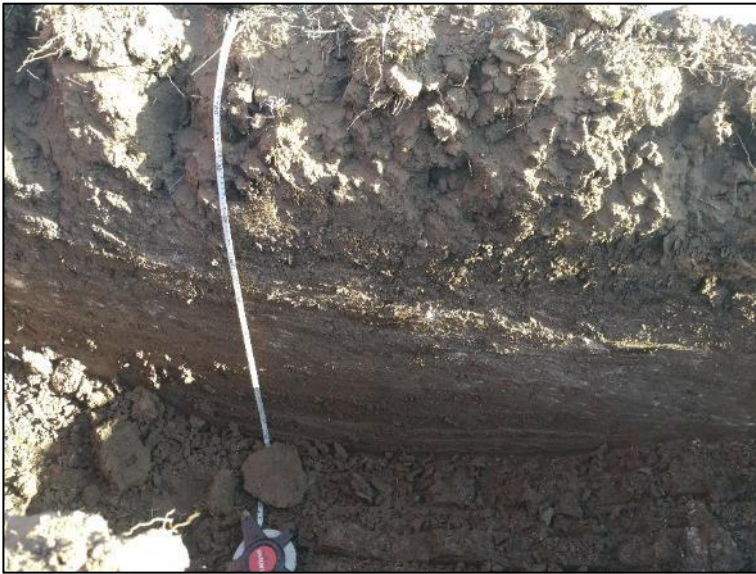
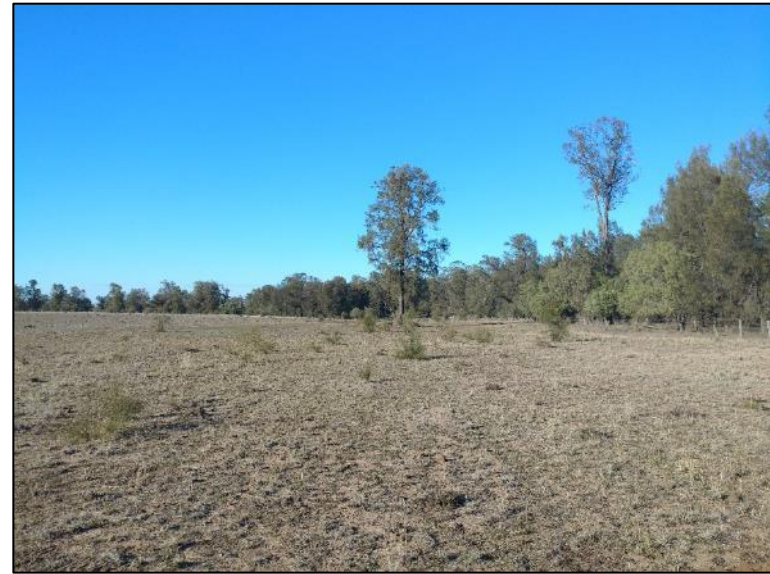
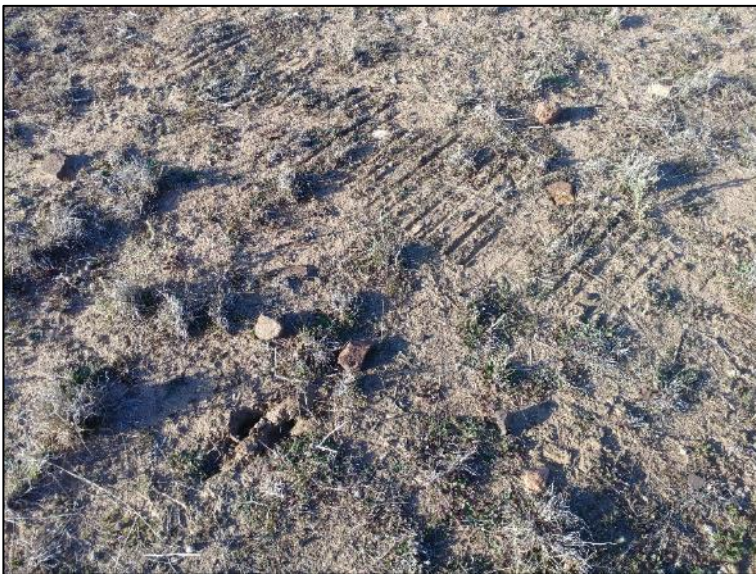
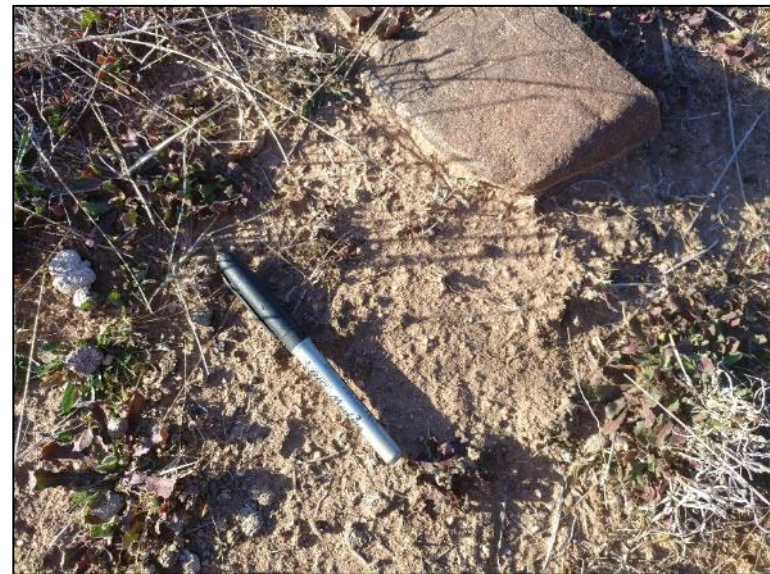
SITE 1 Plates

B21 0.12-0.38 Abrupt	Clay loam sandy	Moderate, weak	Nil inclusions / segregations	10YR2/2 Very dark brown Nil mottles / bleach	Dry, well drained	Few	0.30 / 7.5 0.15-0.35 <u>7.91 – BSAL Pass</u>		
				B22 0.38-0.78 Abrupt	Clay loam, sandy	Moderate, strong	<1% coarse fragments <1mm 10-20% calcium carbonate	10YR3/3 Dark brown Nil mottles / bleach <u>BSAL Pass</u>	Dry, moderately well drained <u>BSAL Pass</u>	Few	0.60 / 8.5 0.40-0.60 <u>9.51 – Not BSAL</u> <u>ERD Not BSAL</u> 0.60-0.75 <u>9.38 – Not BSAL</u>		
				B23 0.78-1.00 End of Borehole (EOBH)	Sandy clay loam	Moderate, strong	<2% calcium carbonate	10YR3/2 Very dark greyish brown Mottle: <1% 2.5YR3/6 Dark red Nil bleach	Dry, moderately well drained	Yes, very few very fine	0.90 / 7.5

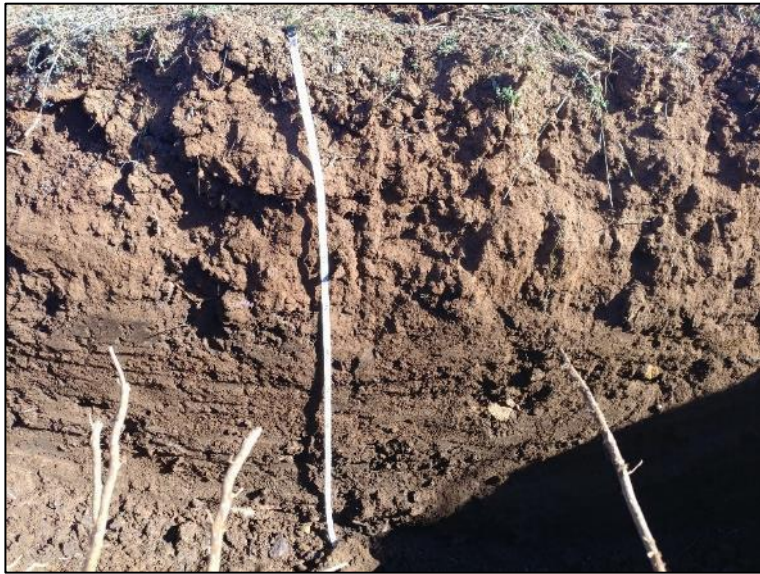
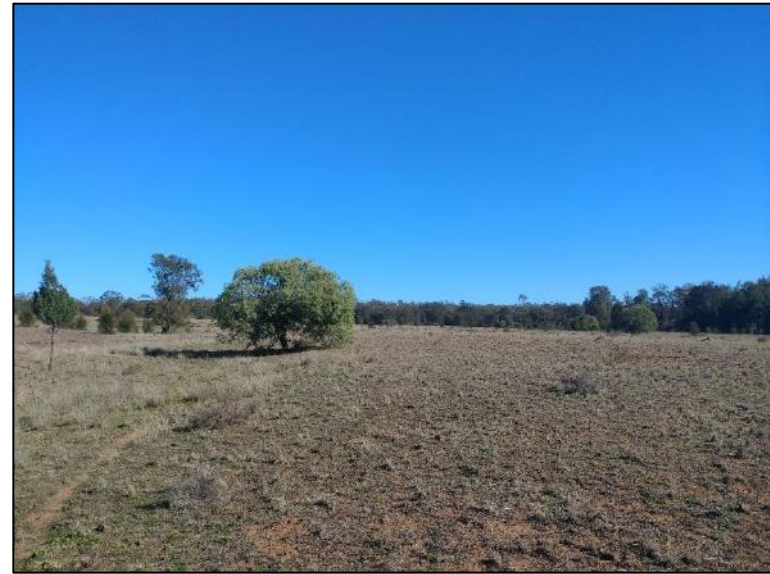
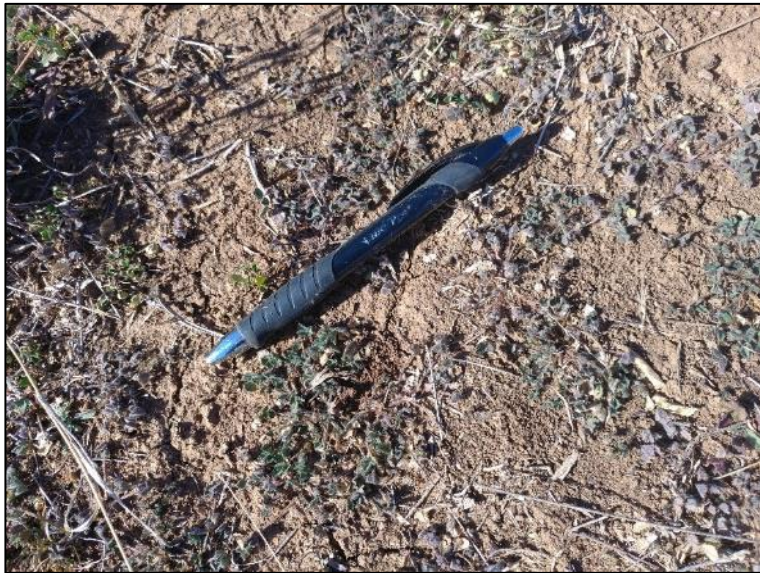
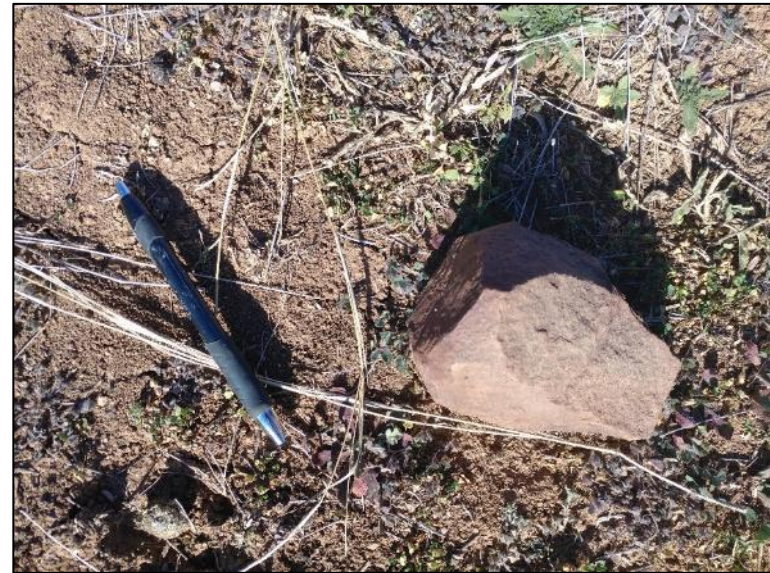
SITE 2 Plates

Map Unit / Map Code: GV-I	Location (GDA94 ZONE 55): 774922 mE 6611911 mN	Aust. Soil Class.: Eutrophic Brown Dermosol	Site Survey Type: Test Pit	Survey Date: August 2019
-------------------------------------	--	---	--------------------------------------	------------------------------------

B2 0.10-0.50 Abrupt	Silty clay loam	Moderate, subangular blocky, very firm	1% coarse fragments, 5-20mm	7.5YR5/2 Brown Nil mottles / bleach	Dry, moderately well drained	Few	0.30 / 7.0 0.10-0.30 <u>7.29 – BSAL Pass</u>		
				2D 0.50-1.00 EOBH <u>ERD BSAL Pass</u>	Sandy loam	Moderate, subangular blocky, very firm	1% rocks 100-200mm 5% coarse fragments 206mm	7.5YR3/2 Dark brown Nil mottles / bleach <u>BSAL Pass</u>	Dry, moderately well drained <u>BSAL Pass</u>	Very few to Nil roots	0.60 / 7.0 0.90 / 7.0 0.30-0.60 <u>7.69 – BSAL Pass</u> 0.60-0.75 <u>7.74 – BSAL Pass</u>

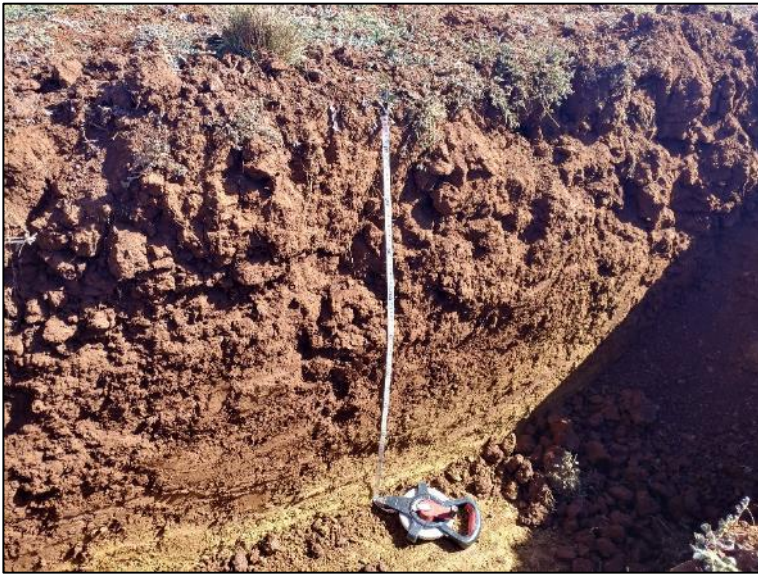
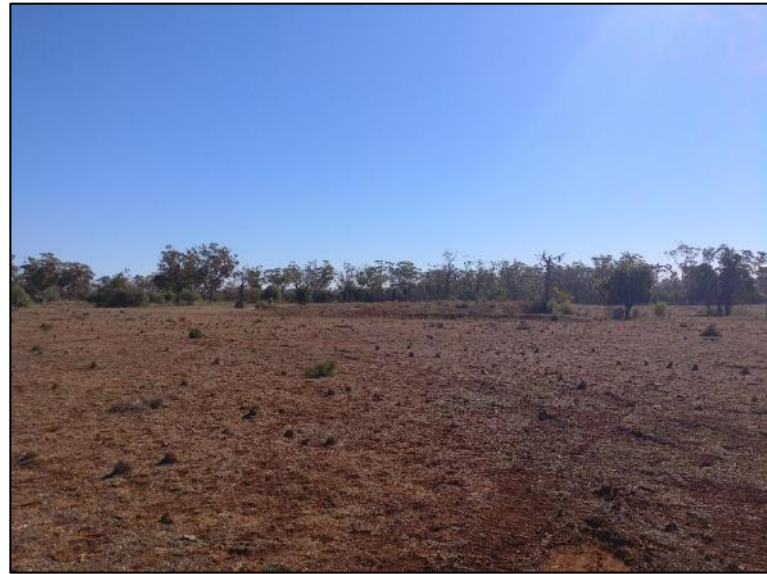
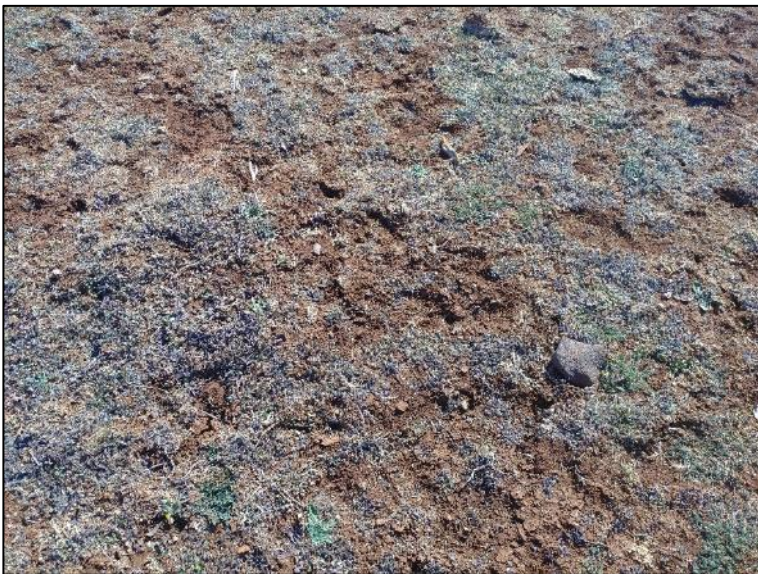
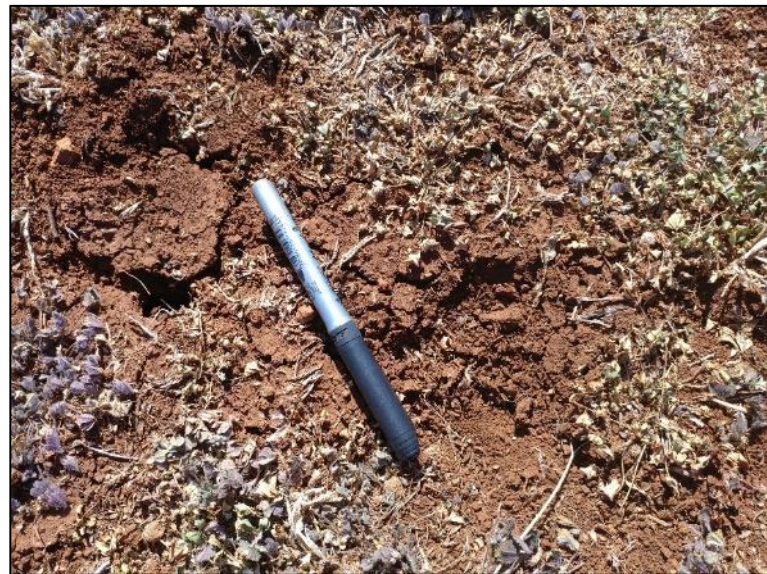
SITE 3 Plates

Map Unit / Map Code: GV-I	Location (GDA94 ZONE 55): 775506 mE 6611731 mN	Aust. Soil Class.: Eutrophic Red Dermosol	Site Survey Type: Test Pit	Survey Date: August 2019
-------------------------------------	--	---	--------------------------------------	------------------------------------

B21 0.10-0.50 Abrupt	Light clay	Moderate, subangular blocky, peds 30+mm, very firm	<1% coarse fragments <2mm	5YR3/4 Dark reddish brown Nil mottles / bleach	Dry, moderately well drained	Few	0.30 / 6.5 0.15-0.30 <u>7.14 – BSAL Pass</u> 0.30-0.60 <u>7.5 – BSAL Pass</u>		
				B22 0.50-0.85 Abrupt	Medium clay	Moderate, strong	<1% coarse fragments 2-6mm	5YR3/4 Dark reddish brown Nil mottles / bleach <u>BSAL Pass</u>	Dry, moderately well drained <u>BSAL Pass</u>	Few, very fine	0.60 / 7.5 0.60-0.75 <u>8.02 – BSAL Pass</u>		
				B23 0.85-1.05 EOBH <u>ERD BSAL Pass</u>	Medium clay	Moderate, strong	5% coarse fragments <1mm 2% calcium carbonate	5YR4/6 Yellowish red Mottles: 2% red 2% red brown Nil bleach	Dry, imperfectly drained	Nil roots	0.90 / 8.0

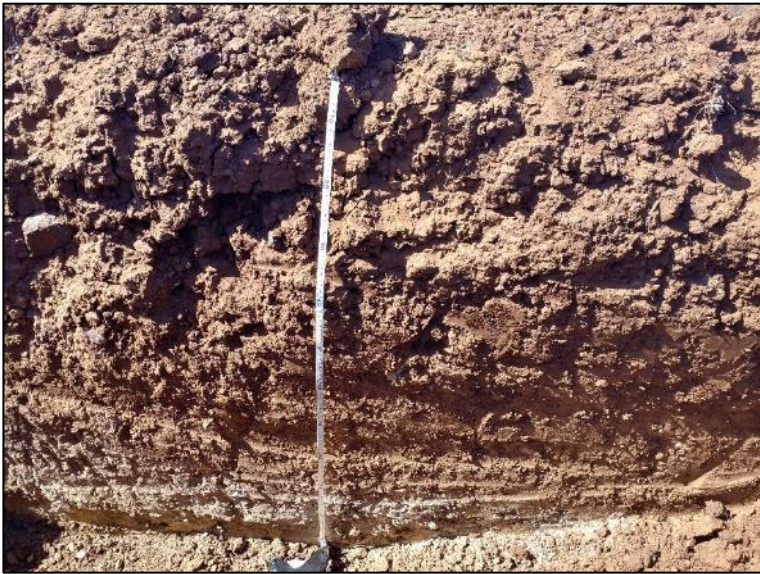
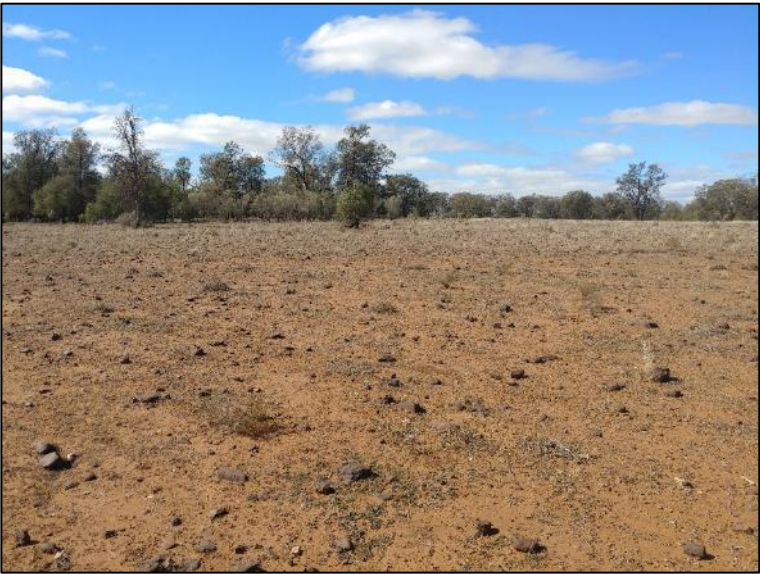
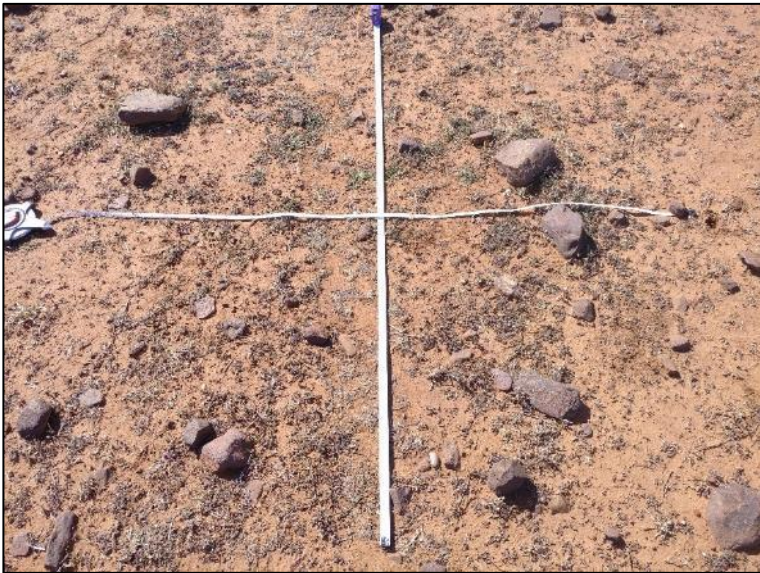
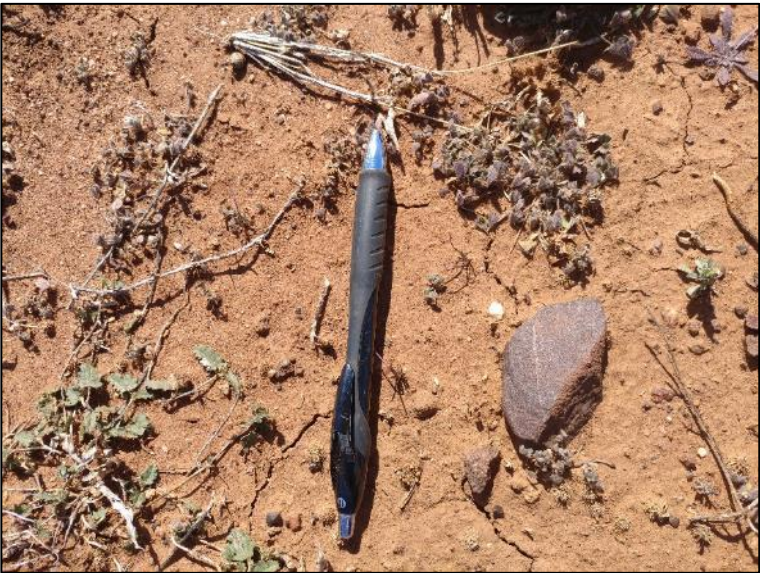
SITE 4 Plates

Map Unit / Map Code: GV-I	Location (GDA94 ZONE 55): 775506 mE 6611731 mN	Aust. Soil Class.: Eutrophic Red Dermosol	Site Survey Type: Test Pit	Survey Date: August 2019
-------------------------------------	--	---	--------------------------------------	------------------------------------

B21 0.10-0.33 Abrupt	Light clay	Moderate, subangular blocky, peds 30+mm, very firm	<1% coarse fragments <2mm 1% Rocks 10-20mm	5YR4/4 Reddish brown Nil mottles / bleach	Dry, moderately well drained	Few	0.30 / 7.5 0.15-0.30 <u>8.14 – BSAL Pass</u>		
				B22 0.33-0.94 Abrupt	Light clay	Moderate, strong	<2% coarse fragments <5mm	5YR4/6 Yellowish red Nil mottles / bleach <u>BSAL Pass</u>	Dry, moderately well drained <u>BSAL Pass</u>	Very fine	0.60 / 8.0 0.30-0.60 <u>8.93– ERD Not BSAL</u>		
				B23 0.94-1.10 EOBH ERD <u>Not BSAL</u>	Light clay	Moderate, strong	5% coarse fragments <1mm 2% calcium carbonate	7.5YR4/4 Reddish brown Brown Mottles: 2% red 2% red brown Nil bleach	Dry, imperfectly drained	Nil roots	0.90 / 7.5

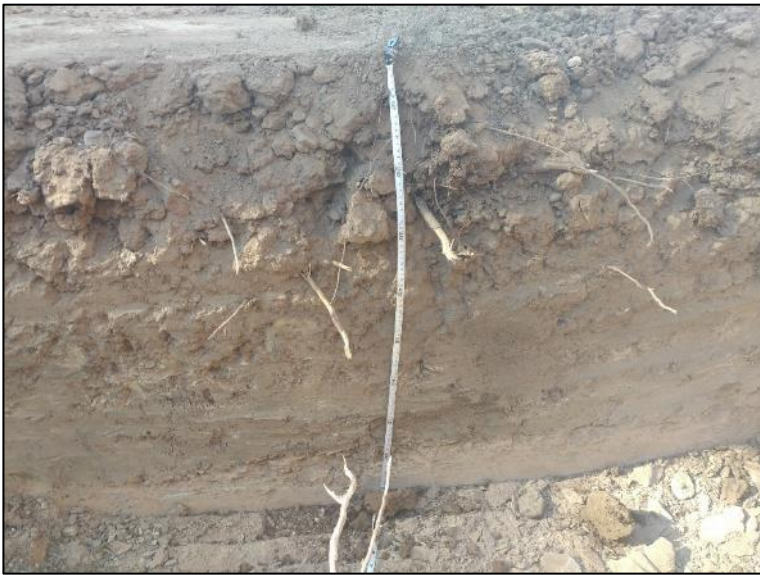
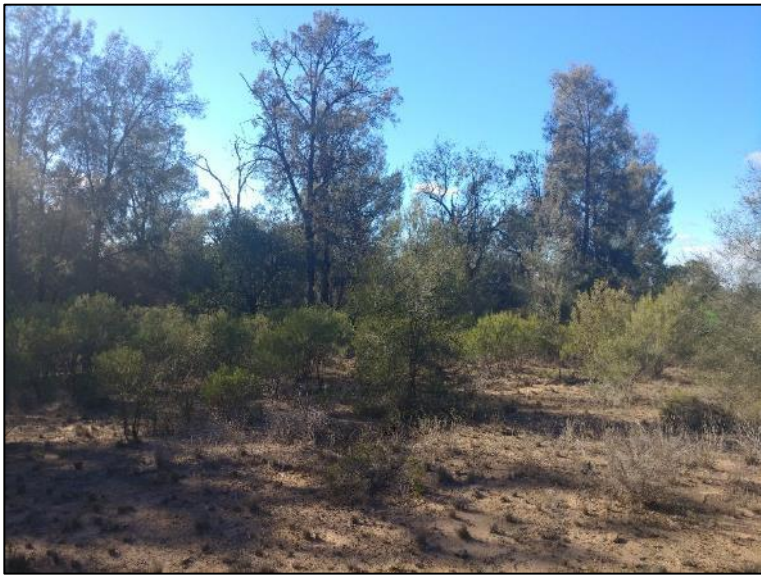
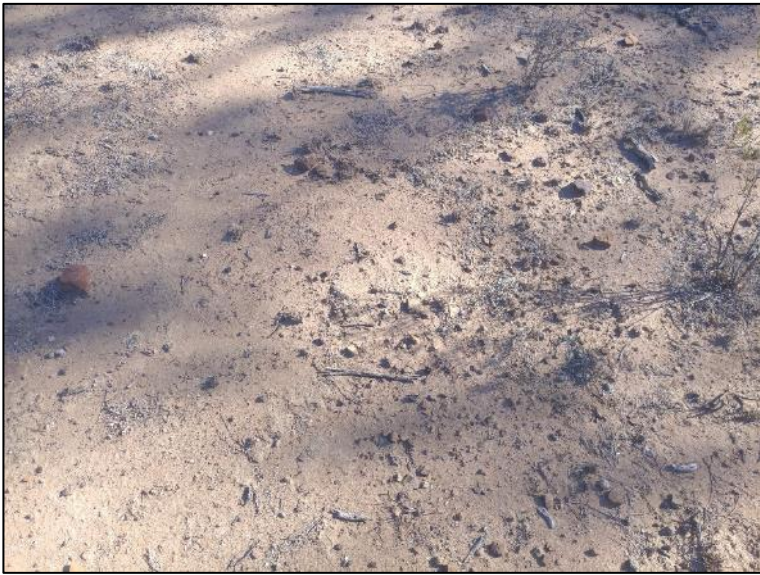
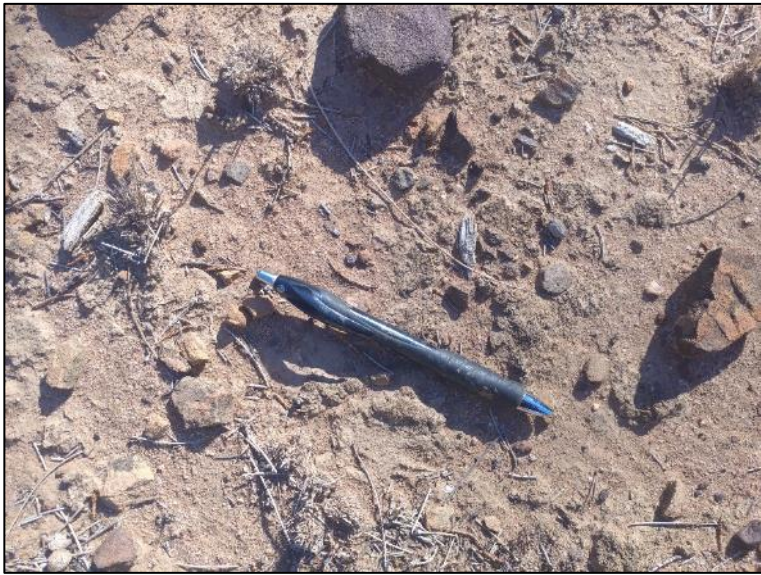
SITE 5 Plates

Map Unit / Map Code/ Map Code GV-S	Location (GDA94 ZONE 55): 774511 mE 6611439 mN	Aust. Soil Class.: Eutrophoic Brown Sodosol	Site Survey Type: Test Pit	Survey Date: August 2019
--	--	---	--------------------------------------	------------------------------------

B22 0.36-0.60 Abrupt	Clay loam	Moderate, very strong	<5% <5mm coarse fragments	7.5YR4/2 Brown Nil mottles / bleach	Dry, well drained	Few	0.60 / 6.5 0.30-0.60 <u>8.74 – BSAL Pass</u>		
				B23 0.60-0.75 Abrupt	Light clay	Moderate, subangular blocky, strong	<5% <5mm coarse fragments	10YR5/3 Brown Nil mottles / bleach <u>BSAL Pass</u>	Dry, well drained <u>BSAL Pass</u>	Nil roots	0.90 / 7.5 0.60-0.75 <u>9.06 – ERD Not BSAL</u>		
				R 0.75-0.77+ EOBH <u>ERD Not BSAL</u>	Bedrock	-	-	-	-	-	-

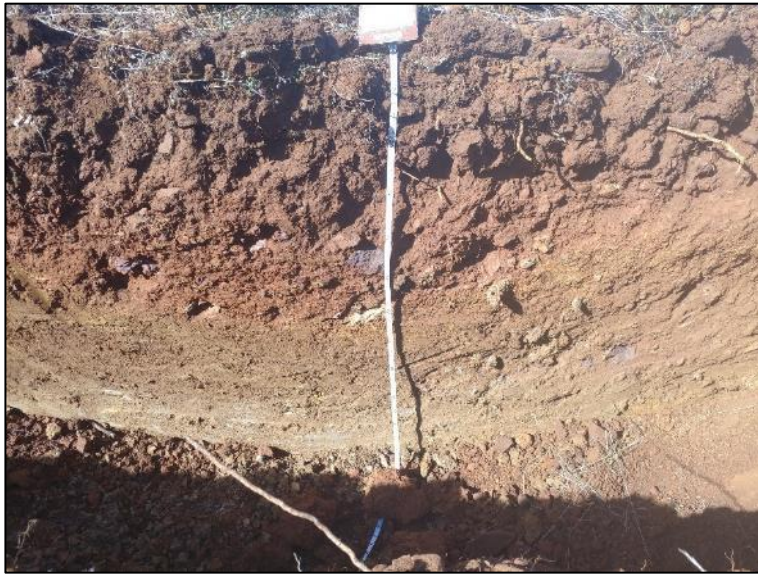
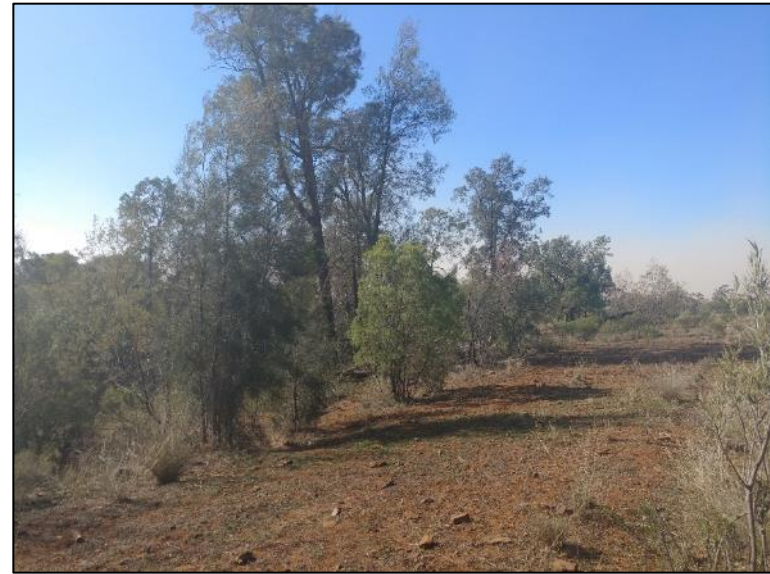
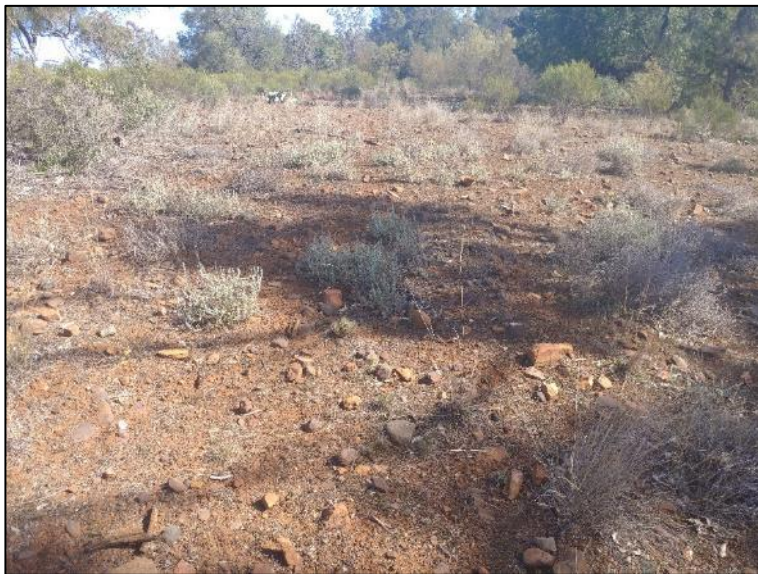
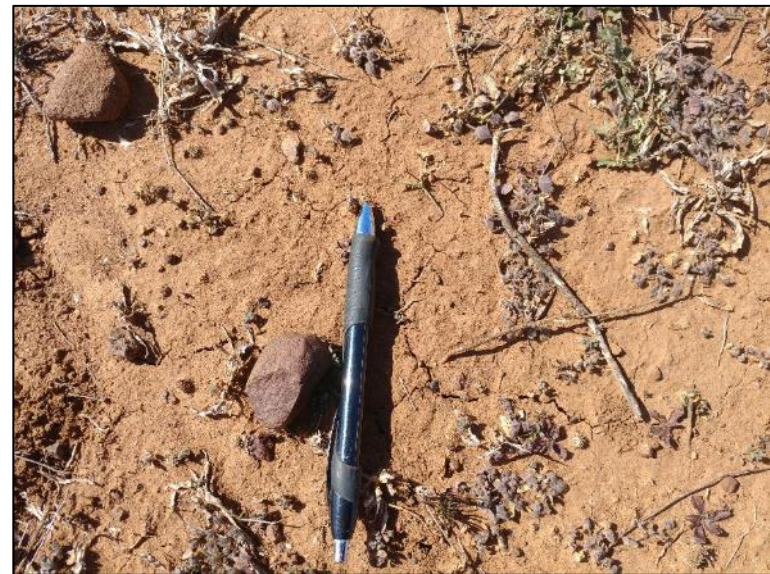
SITE 6 Plates

Map Unit / Map Code: GV-I	Location (GDA94 ZONE 55): 775029 mE 6611233 mN	Aust. Soil Class.: Eutrophic Red Dermosol	Site Survey Type: Test Pit	Survey Date: August 2019
-------------------------------------	--	---	--------------------------------------	------------------------------------

B22 0.28-0.65 Clear	Sandy clay loam	Moderate, subangular blocky, strong	1% rocks, incl. quartz 5-100mm	2.5YR3/4 Dark reddish brown Nil mottles / bleach	Dry, well drained	Few	0.60 / 6.5 0.30-0.60 <u>7.24 – BSAL Pass</u>		
				B23 0.65-1.00 EOBH <u>ERD BSAL Pass</u>	Sandy clay loam	Moderate, subangular blocky, very strong	10% coarse fragments 1-2mm	7.5YR4/4 Reddish brown Nil mottles / bleach <u>BSAL Pass</u>	Dry, well drained <u>BSAL Pass</u>	Nil roots	0.90 / 7.0 0.60-0.75 <u>7.61 – BSAL Pass</u>

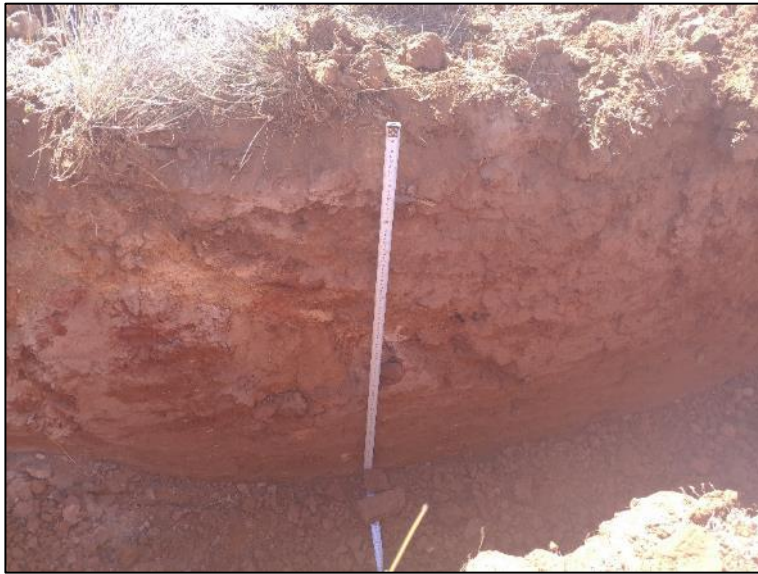
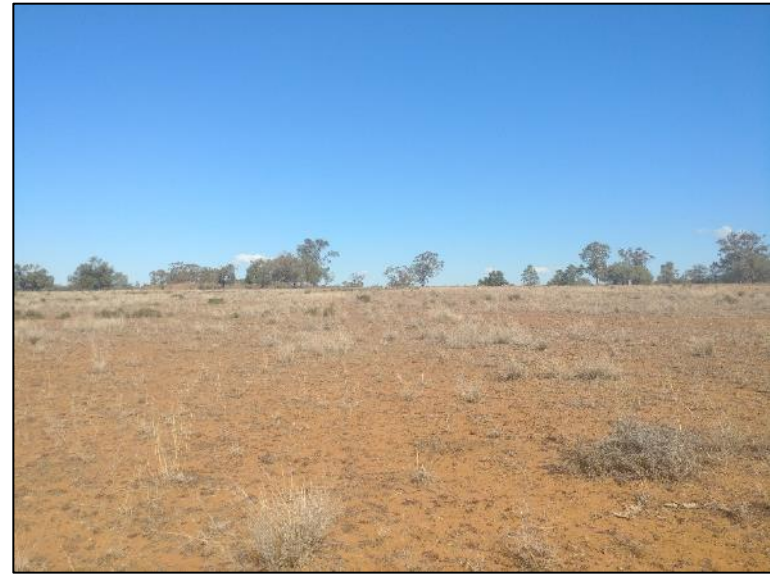
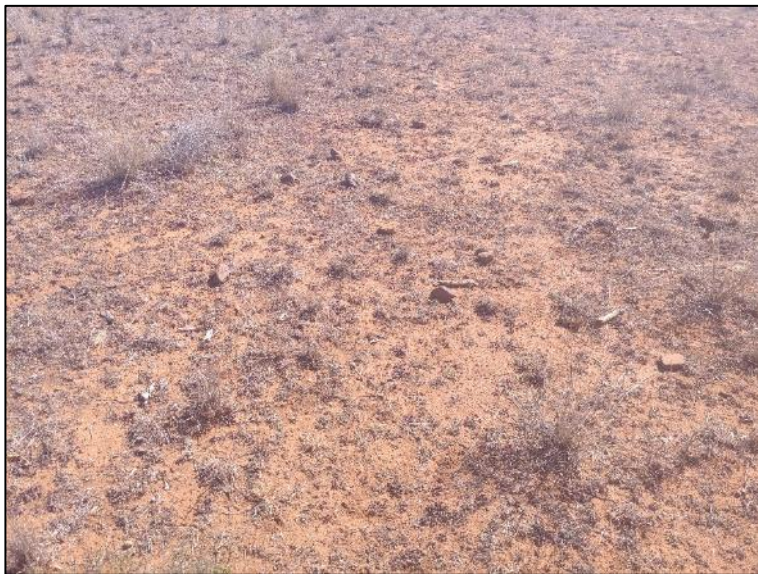
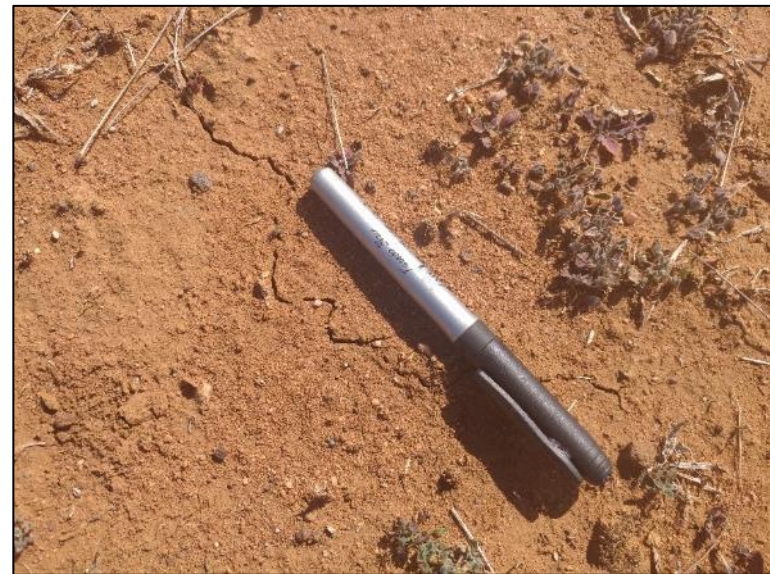
SITE 7 Plates

Map Unit / Map Code: GV-I	Location (GDA94 ZONE 55): 775443 mE 6611270 mN	Aust. Soil Class.: Eutrophic Red Chromosol	Site Survey Type: Test Pit	Survey Date: August 2019
-------------------------------------	--	--	--------------------------------------	------------------------------------

B22 0.53-1.00 EOBH <u>ERD BSAL Pass</u>	Medium clay	Moderate, subangular, firm	<2% Mg nodules <1% calcium carbonate	2.5YR4/4 Reddish brown Yellowish brown <5% Mottle: Dark brown Nil bleach <u>BSAL Pass</u>	Dry, imperfectly drained <u>BSAL Pass</u>	Nil roots	0.60 / 7.0 0.90 / 7.0 0.60-0.75 <u>8.46 – BSAL Pass</u>

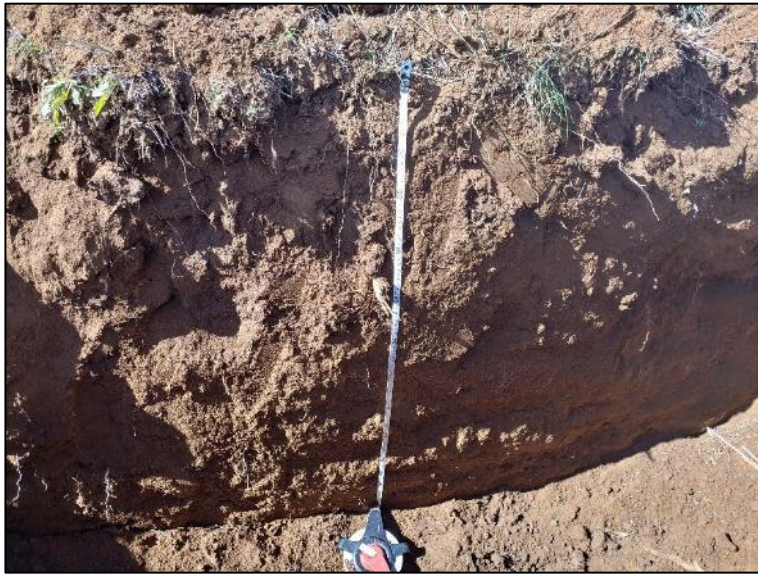
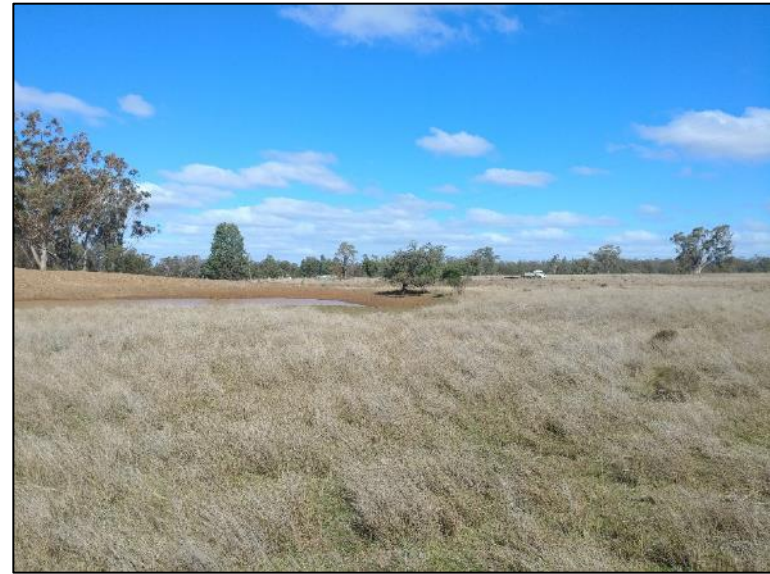
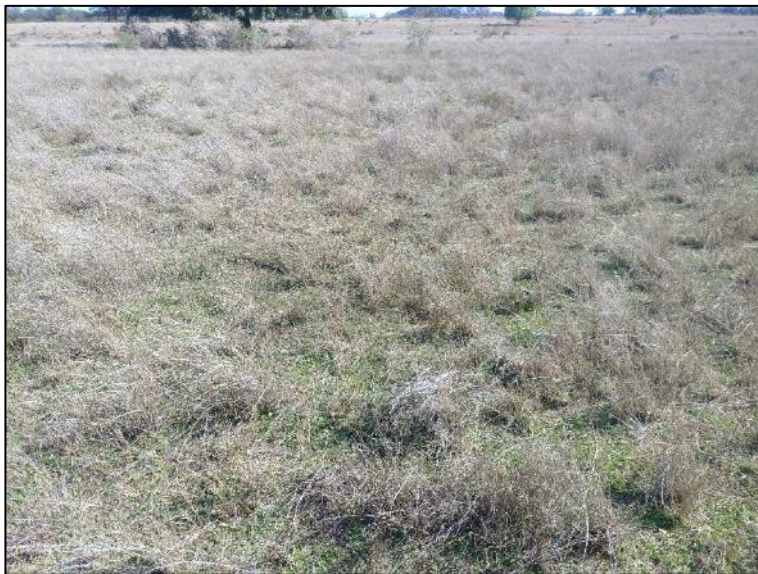
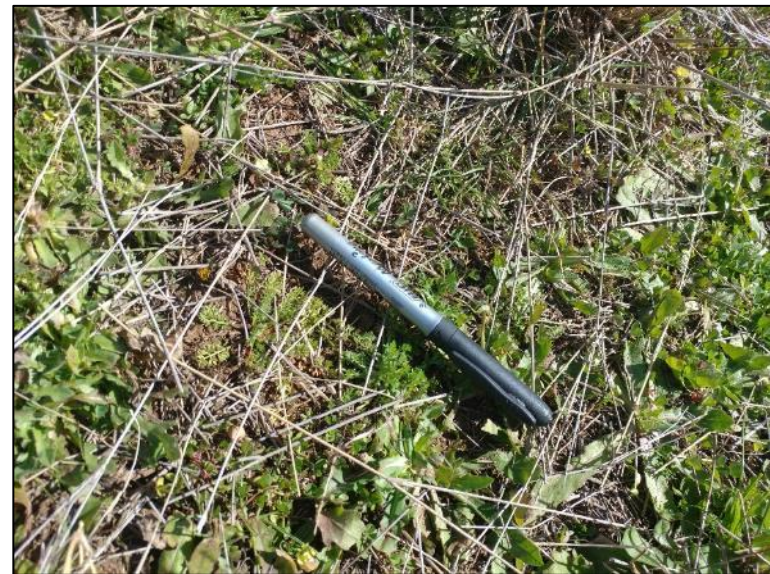
SITE 8 Plates

Map Unit / Map Code: N	Location (GDA94 ZONE 55): 775913 mE 6611057 mN	Aust. Soil Class.: Stratic Rudosol	Site Survey Type: Test Pit	Survey Date: August 2019
----------------------------------	--	--	--------------------------------------	------------------------------------

A22 0.32-0.50 Abrupt	Clayey sand	Massive to weak, weak	<2% <1mm coarse fragments	7.5YR3/4 Dark brown Nil mottles / bleach	Dry, rapidly drained	Few	0.60 / 6.5 0.30-0.60 <u>7.24 – BSAL Pass</u>		
				A23 0.50-1.00 EOBH <u>ERD BSAL Pass</u>	Loamy sand	Weak, loose	<30% <1mm coarse fragments	7.5YR3/4 Dark brown Nil mottles / bleach <u>BSAL Pass</u>	Dry, rapidly drained <u>BSAL Pass</u>	Few	0.90 / 6.5 0.60-0.75 <u>7.32 – BSAL Pass</u>

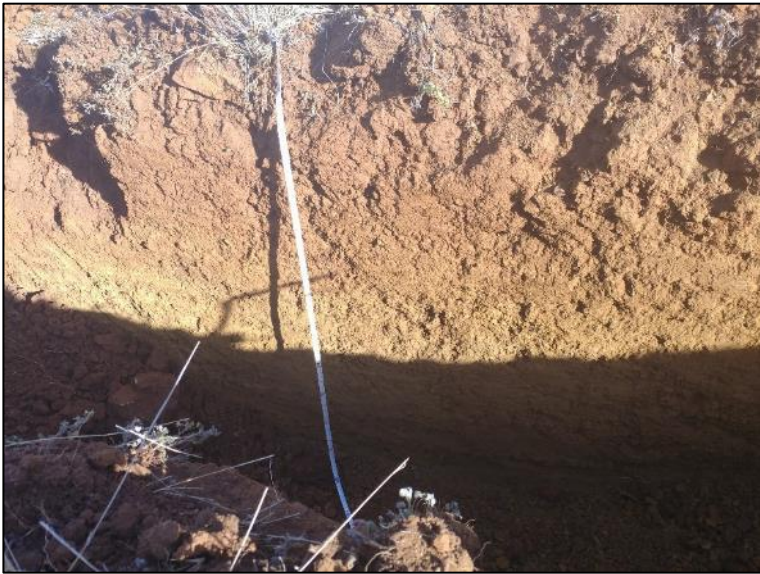
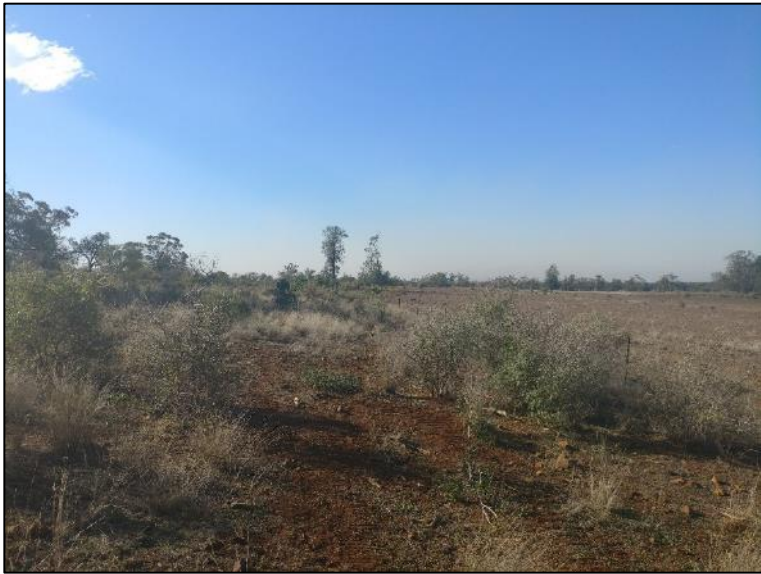
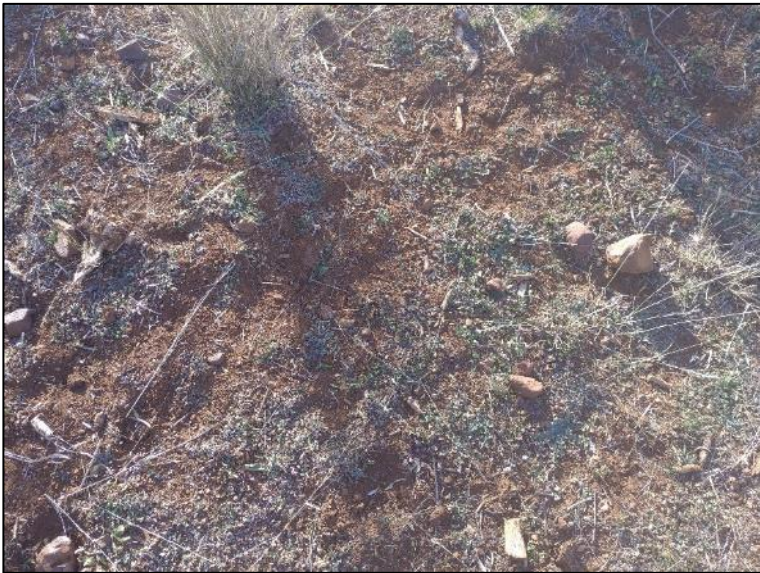
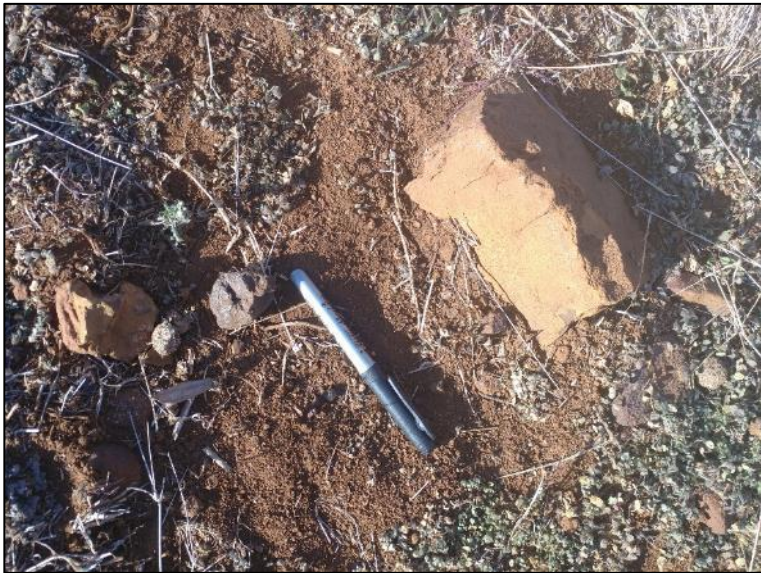
SITE 10 Plates

Map Unit / Map Code: GV-I	Location (GDA94 ZONE 55): 775000 mE 6610910 mN	Aust. Soil Class.: Eutrophic Red Dermosol	Site Survey Type: Test Pit	Survey Date: August 2019
-------------------------------------	--	---	--------------------------------------	------------------------------------

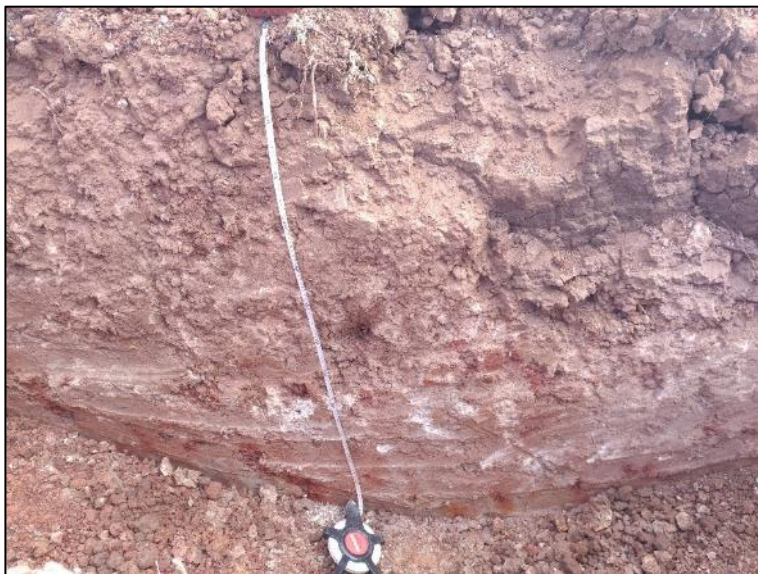
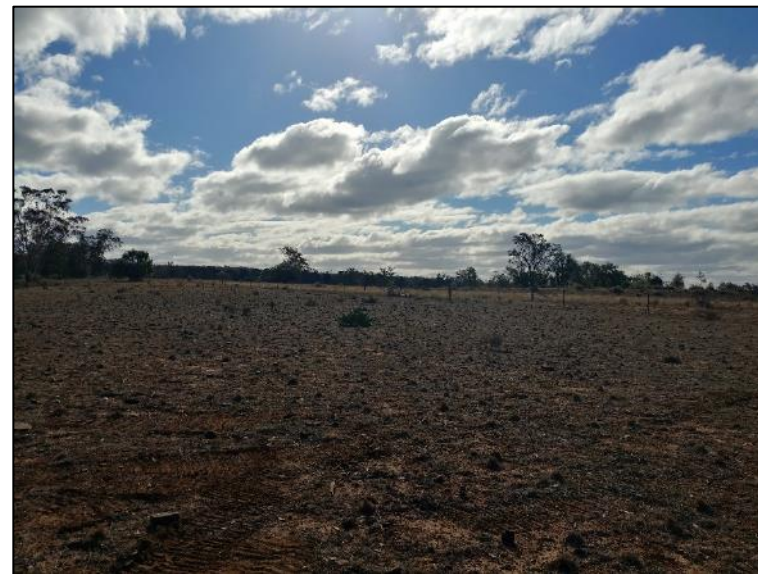
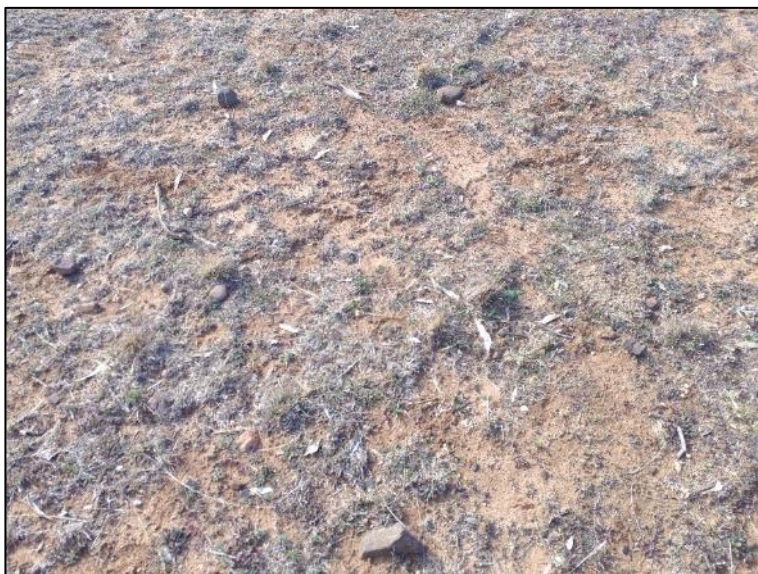
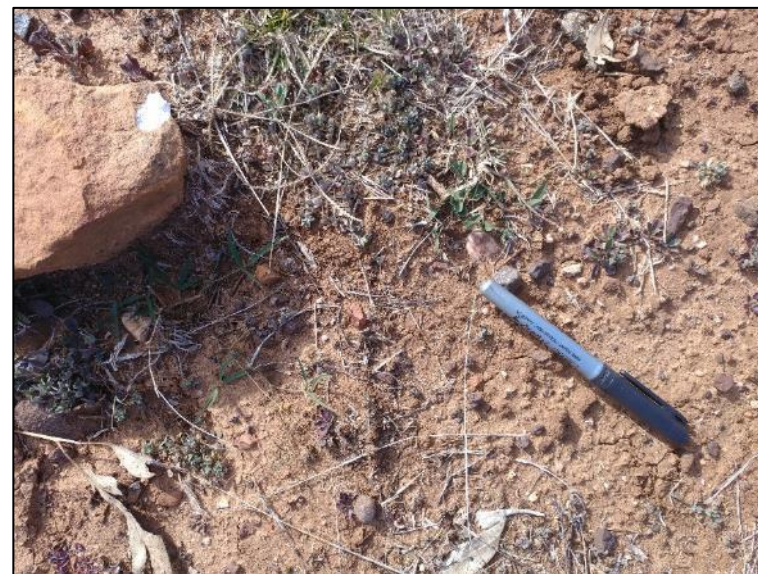
SITE 11 Plates

Map Unit / Map Code: GV - I	Location (GDA94 ZONE 55): 775471 mE 6610939 mN	Aust. Soil Class.: Calcic Red Dermosol	Site Survey Type: Test Pit	Survey Date: August 2019
---------------------------------------	--	--	--------------------------------------	------------------------------------
