Narrabri Underground Mine Stage 3 Extension Project

Agricultural Impact Statement

August 2020

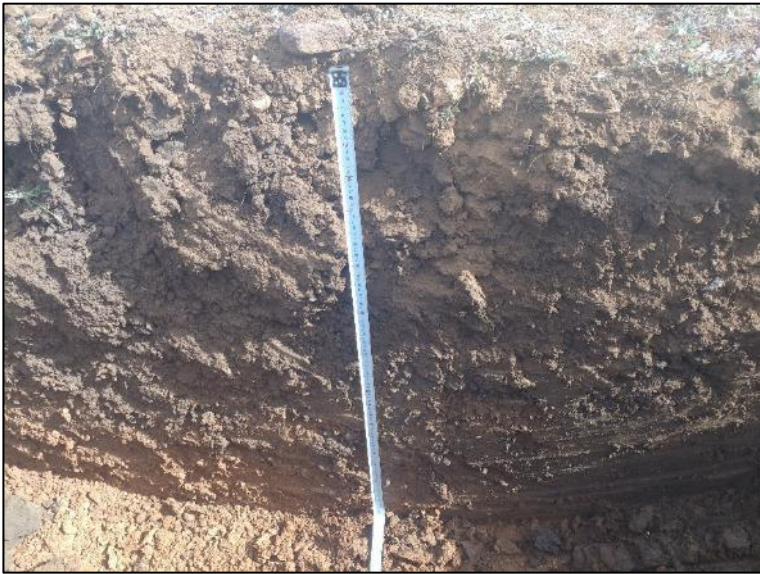
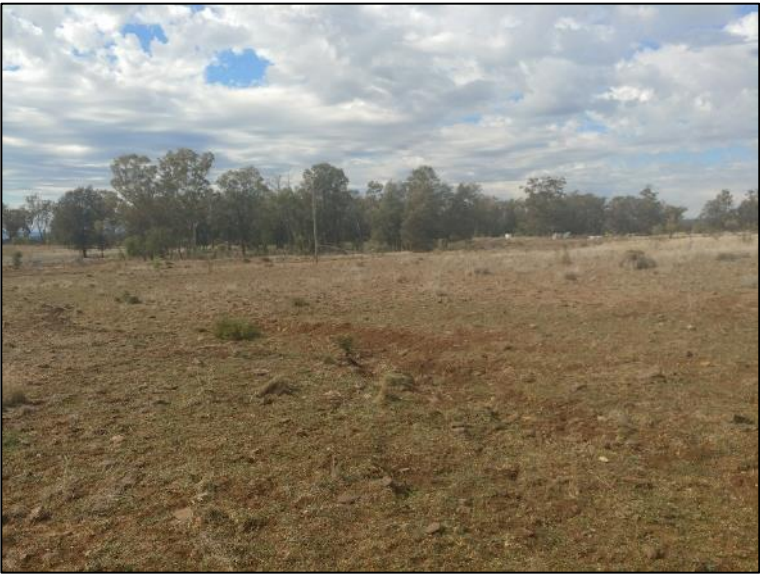
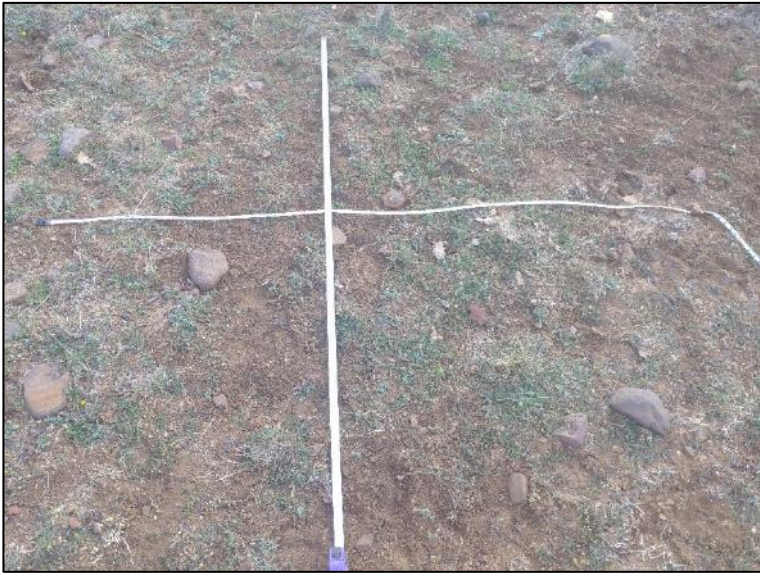
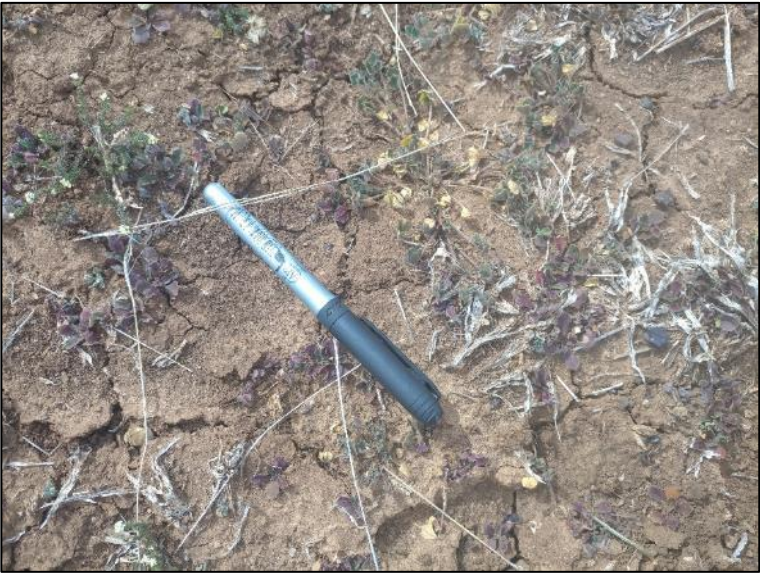
SITE 12 Plates

Map Unit / Map Code: GV-C	Location (GDA94 ZONE 55): 775903 mE 6610892 mN	Aust. Soil Class.: Epipedal Brown Vertosol	Site Survey Type: Test Pit	Survey Date: August 2019
-------------------------------------	--	--	--------------------------------------	------------------------------------

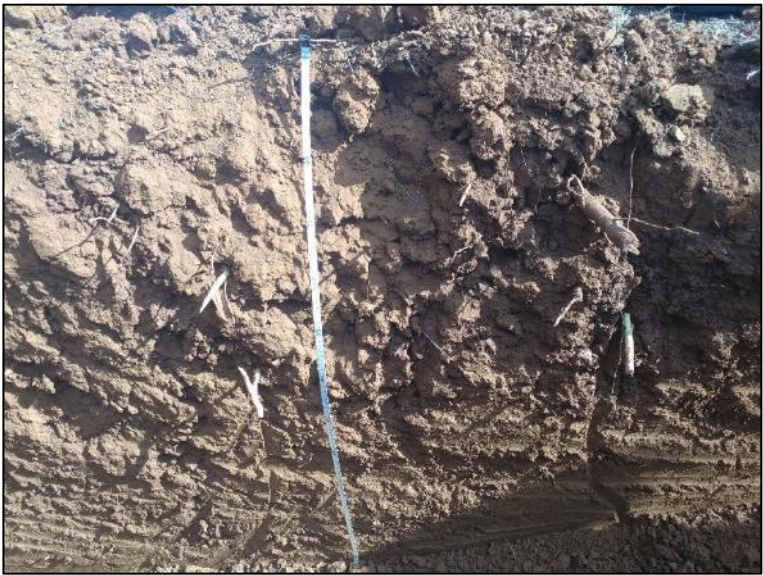
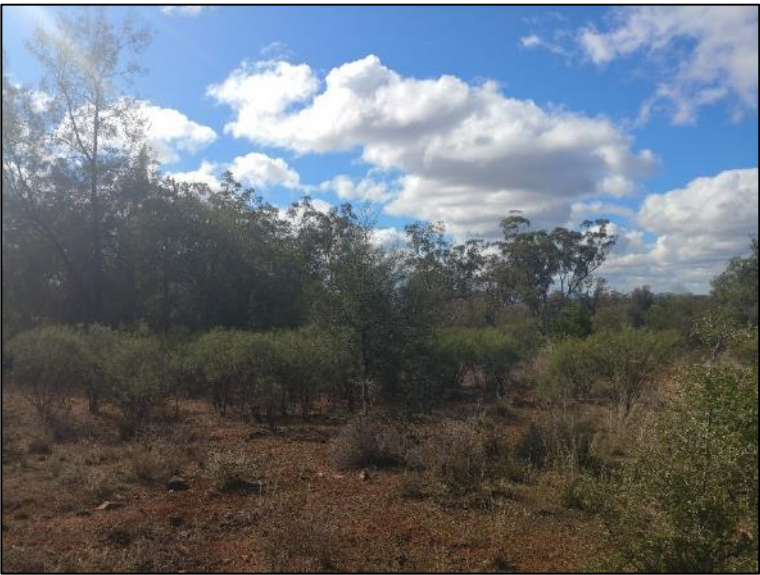
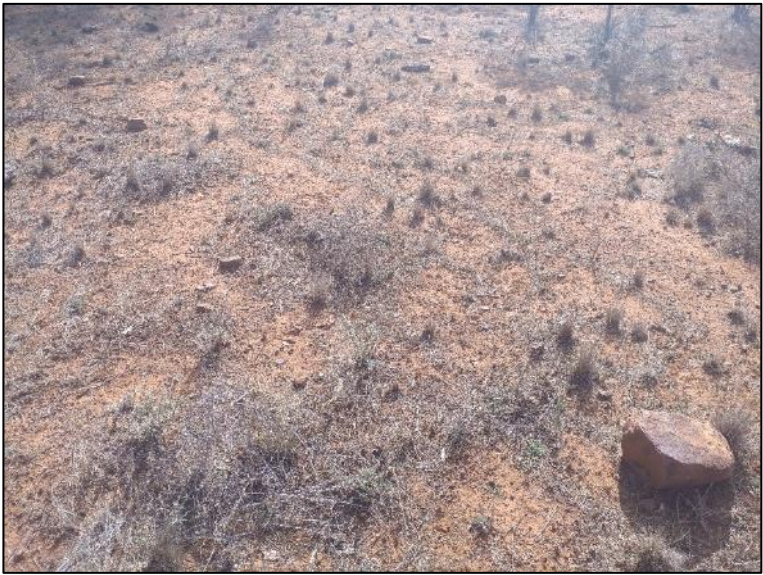
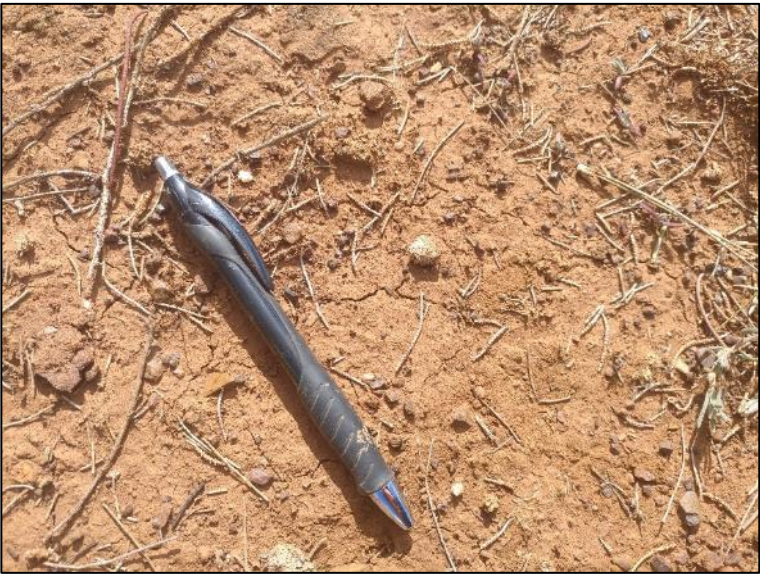
SITE 13 Plates

Map Unit / Map Code: GV-S	Location (GDA94 ZONE 55): 774624 mE 6610526 mN	Aust. Soil Class.: Subnatic Red Sodosol	Site Survey Type: Test Pit	Survey Date: August 2019
-------------------------------------	--	---	--------------------------------------	------------------------------------

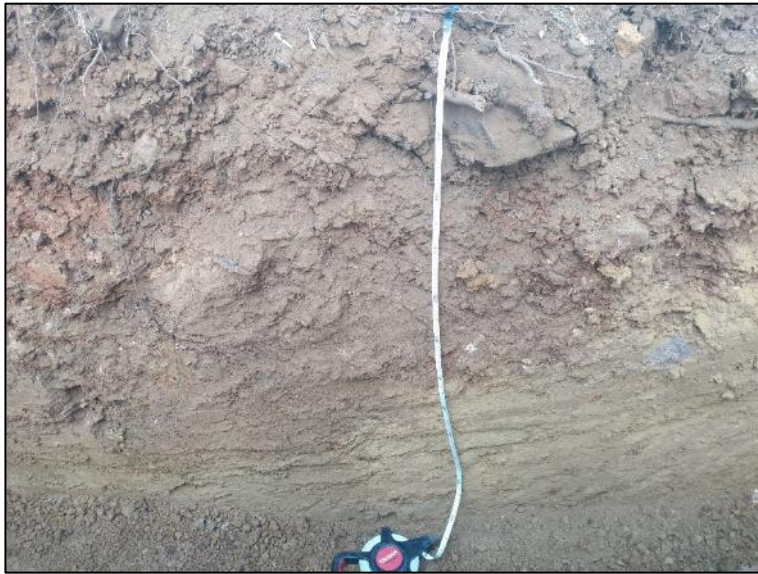
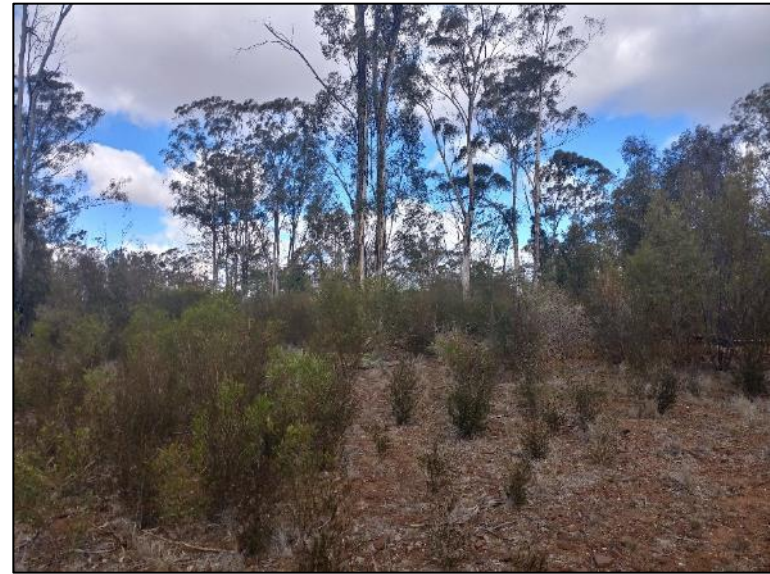
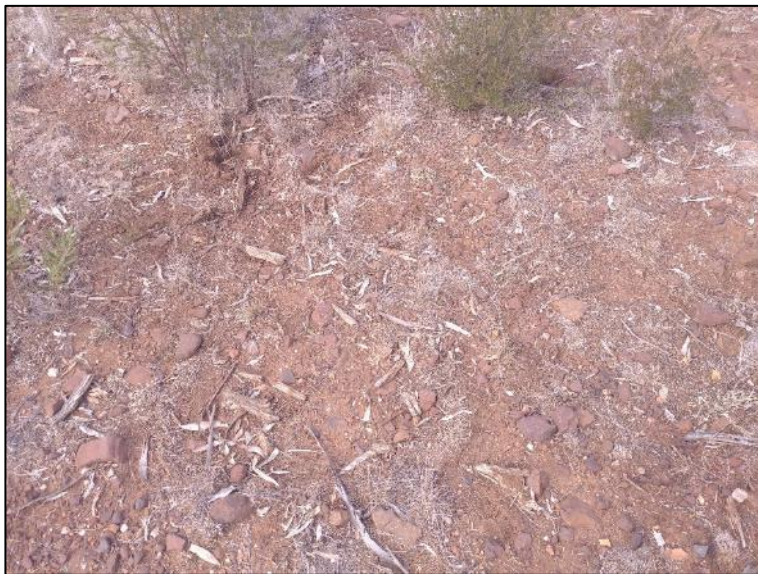
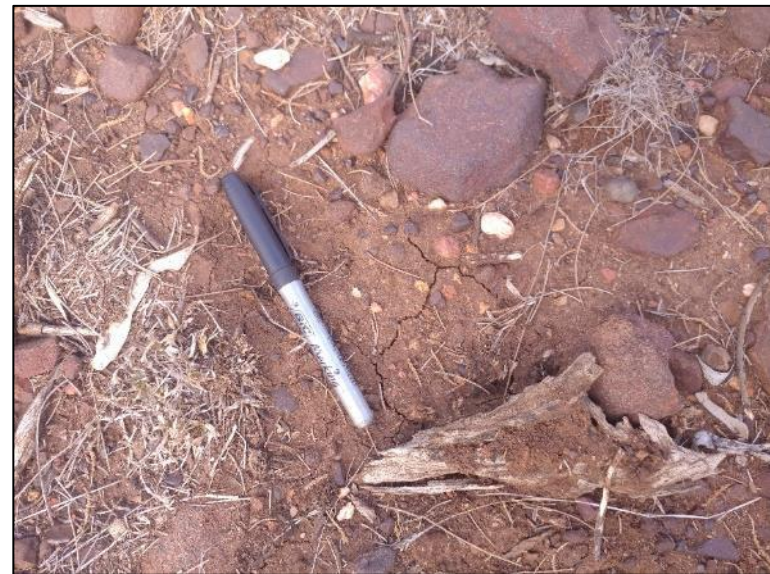
SITE 14 Plates

Map Unit / Map Code: GV-S/V	Location (GDA94 ZONE 55): 775358 mE 6610384 mN	Aust. Soil Class.: Epipedal Red Vertosol	Site Survey Type: Test Pit	Survey Date: August 2019
---------------------------------------	--	--	--------------------------------------	------------------------------------

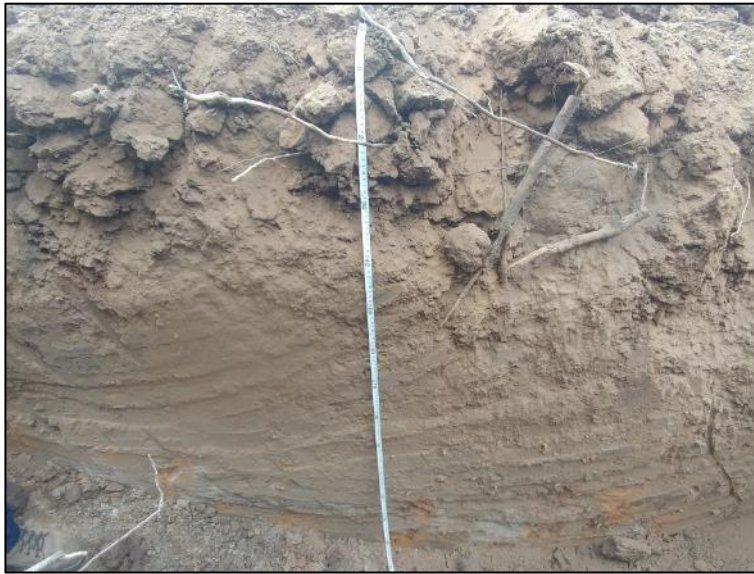
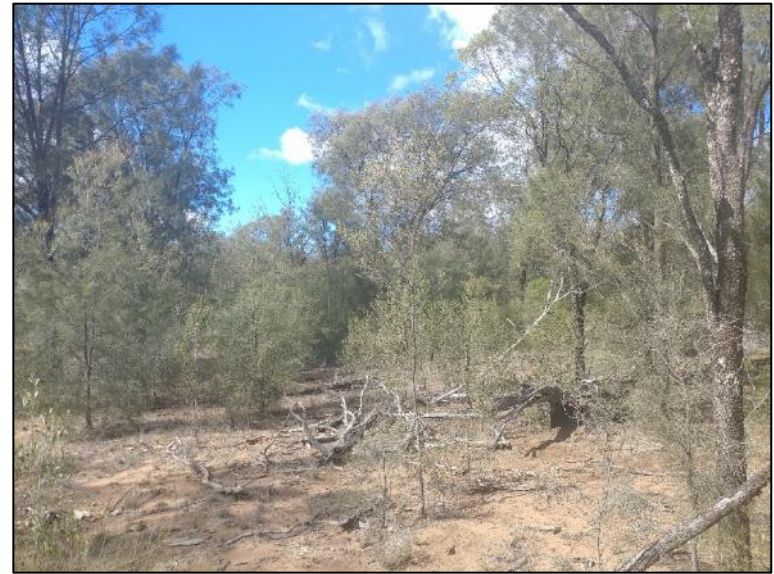
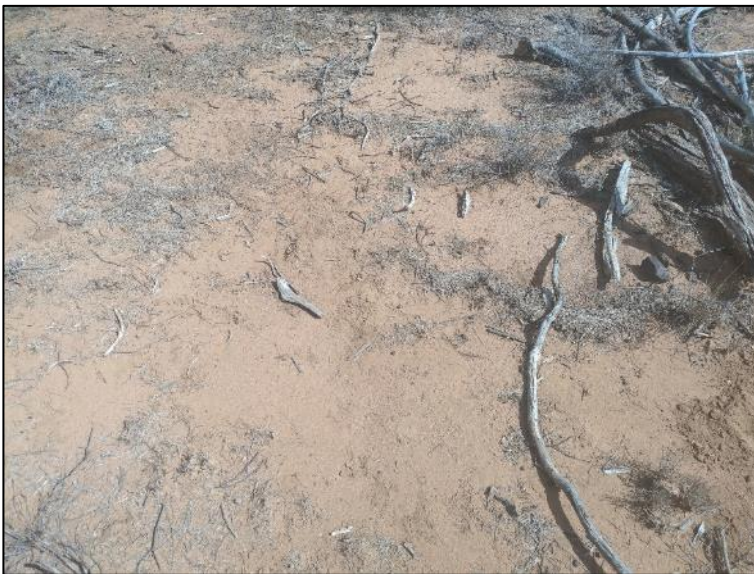
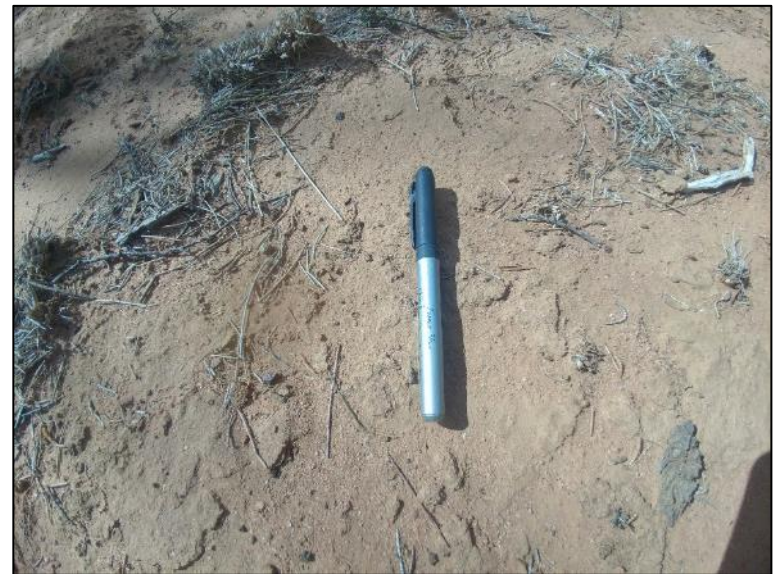
SITE 15 Plates

Map Unit / Map Code: GV-S	Location (GDA94 ZONE 55): 775806 mE 6610344 mN	Aust. Soil Class: Hypocalcic Brown Sodosol	Site Survey Type: Test Pit	Survey Date: August 2019
-------------------------------------	--	--	--------------------------------------	------------------------------------

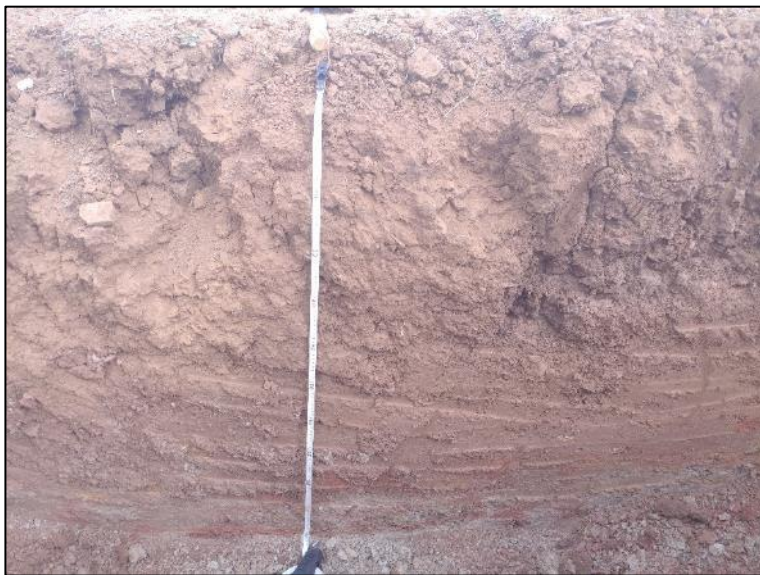
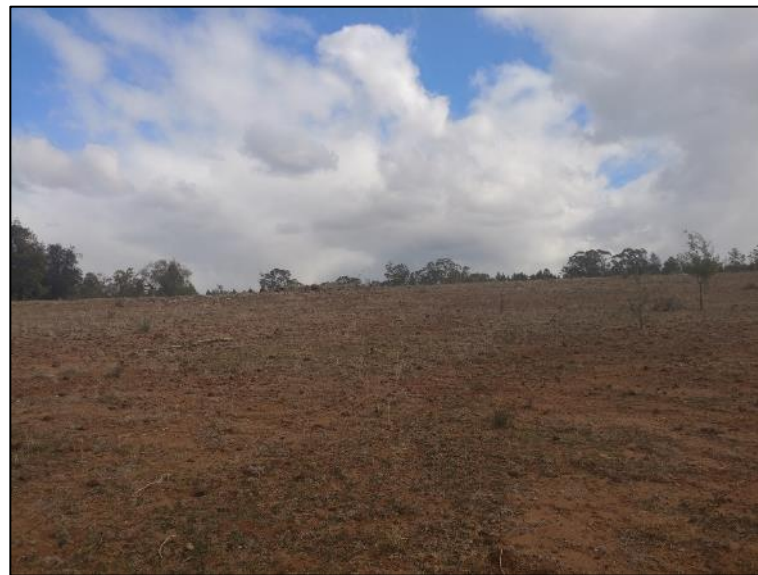
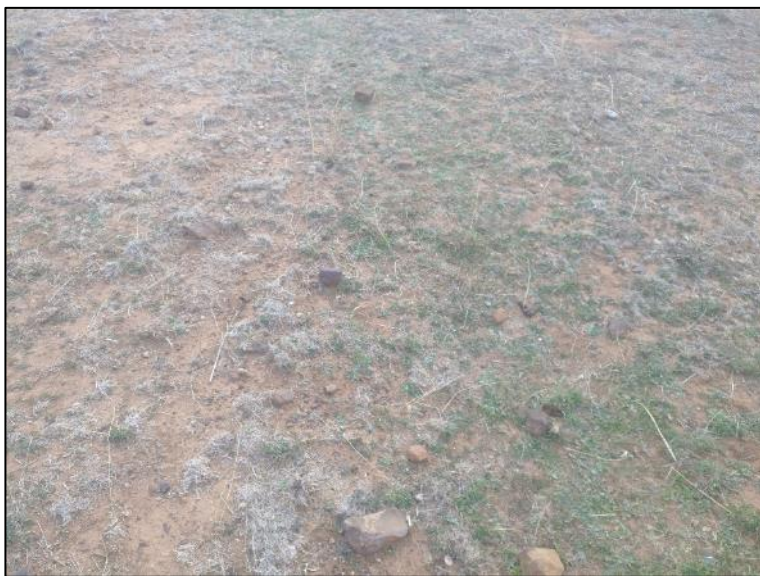
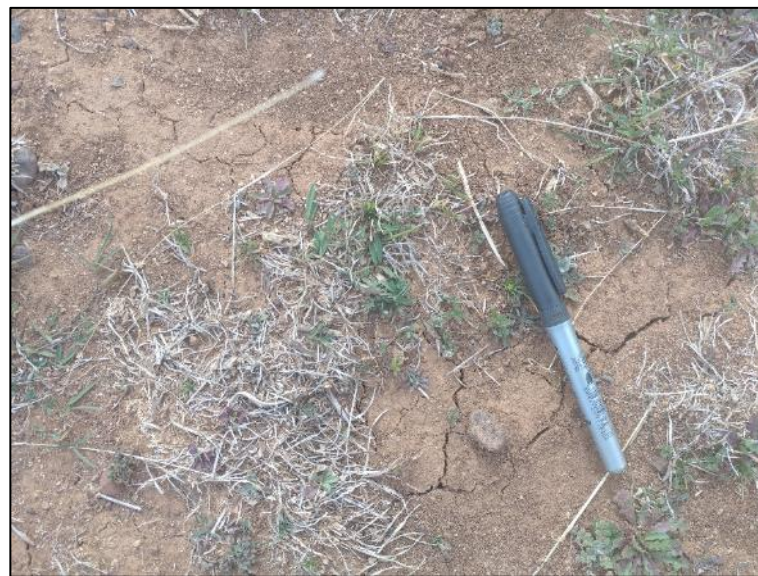
SITE 16 Plates

Map Unit / Map Code: GV-S/V	Location (GDA94 ZONE 55): 774247 mE 6610105 mN	Aust. Soil Class: Epipedal Brown Vertosol (Sodic)	Site Survey Type: Test Pit	Survey Date: August 2019
---------------------------------------	--	---	--------------------------------------	------------------------------------

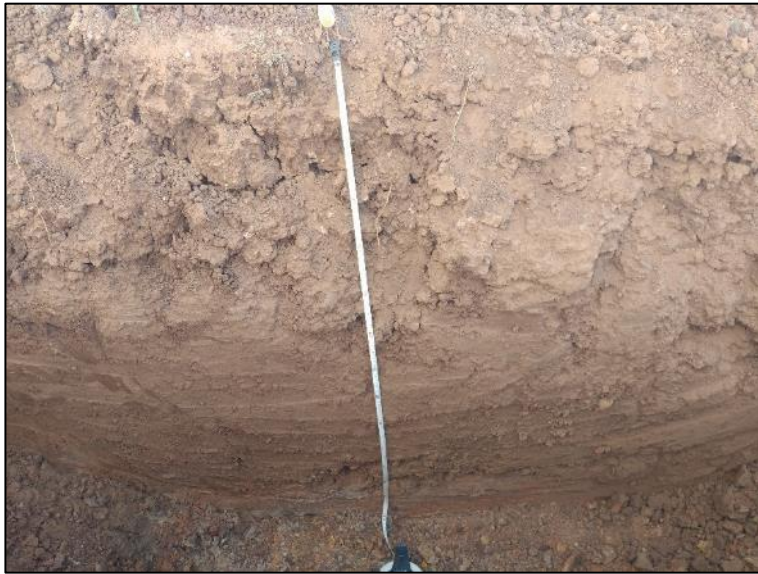
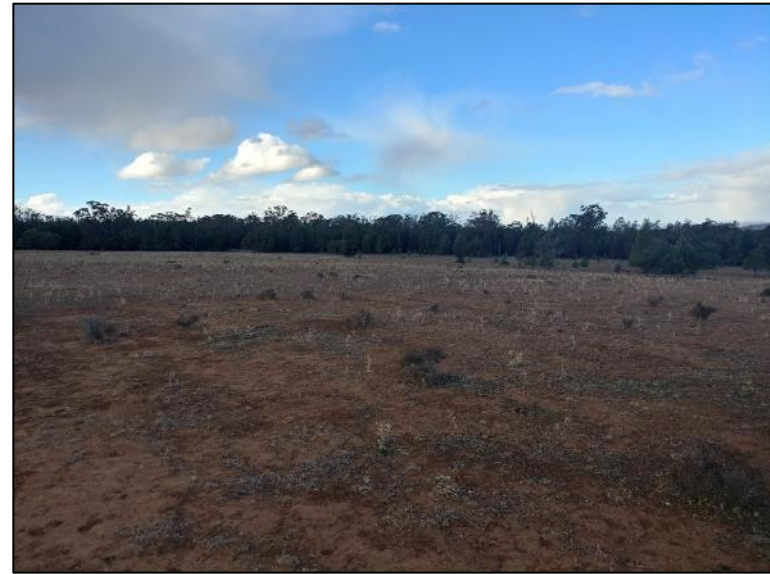
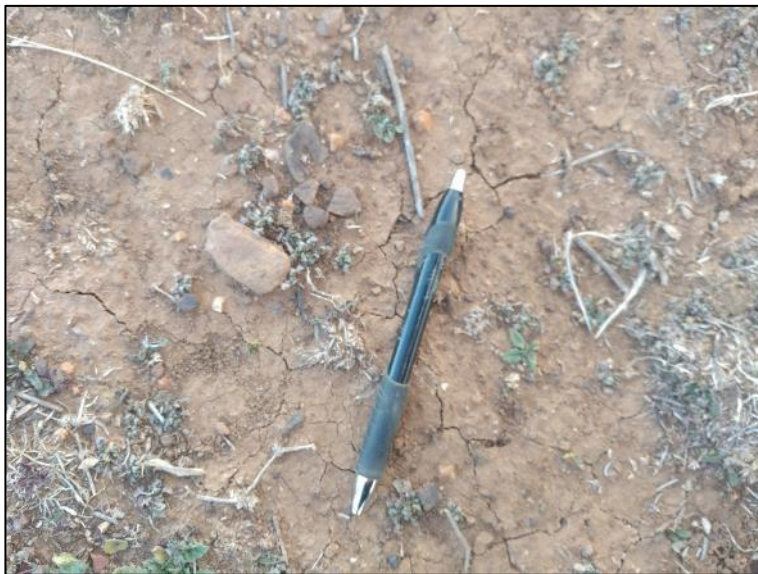
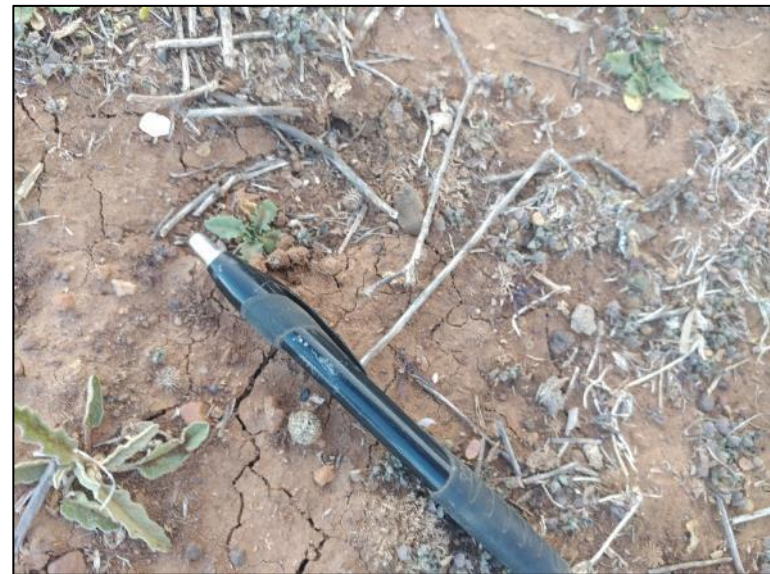
SITE 17 Plates

Map Unit / Map Code: GV-S/V	Location (GDA94 ZONE 55): 773751 mE 6609610 mN	Aust. Soil Class.: Epipedal Brown Vertosol (Sodic)	Site Survey Type: Test Pit	Survey Date: August 2019
---------------------------------------	--	--	--------------------------------------	------------------------------------

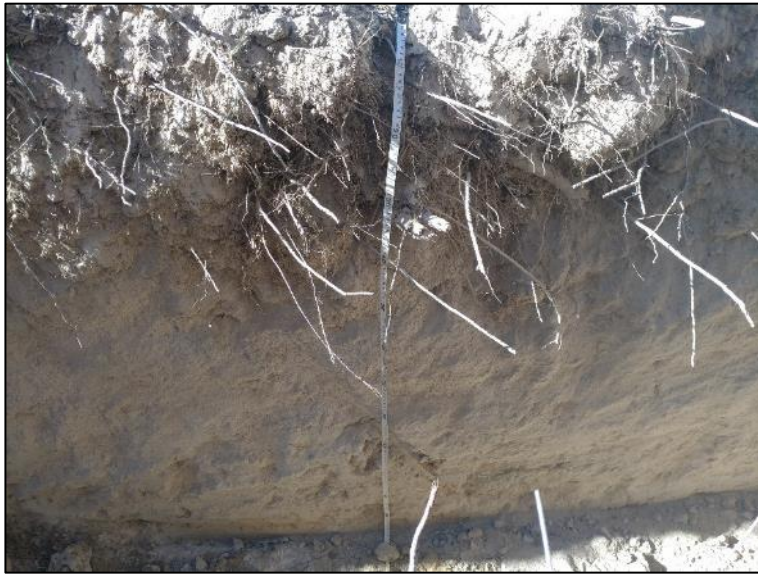
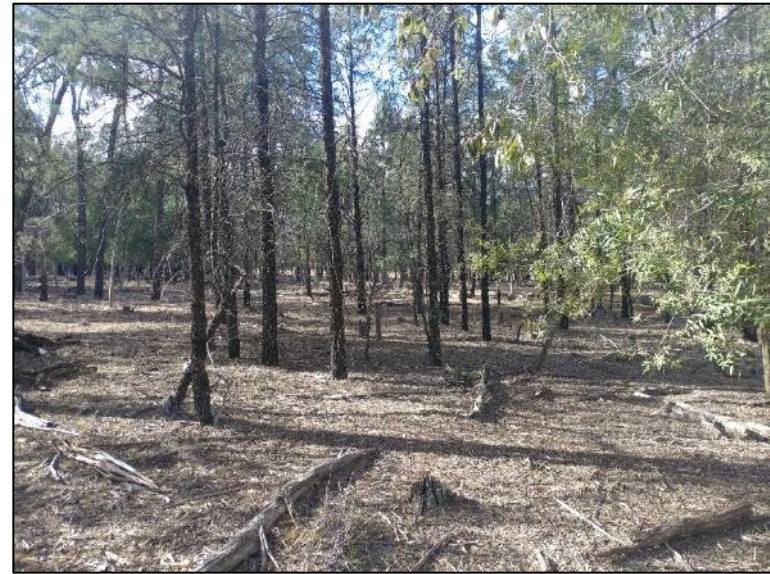
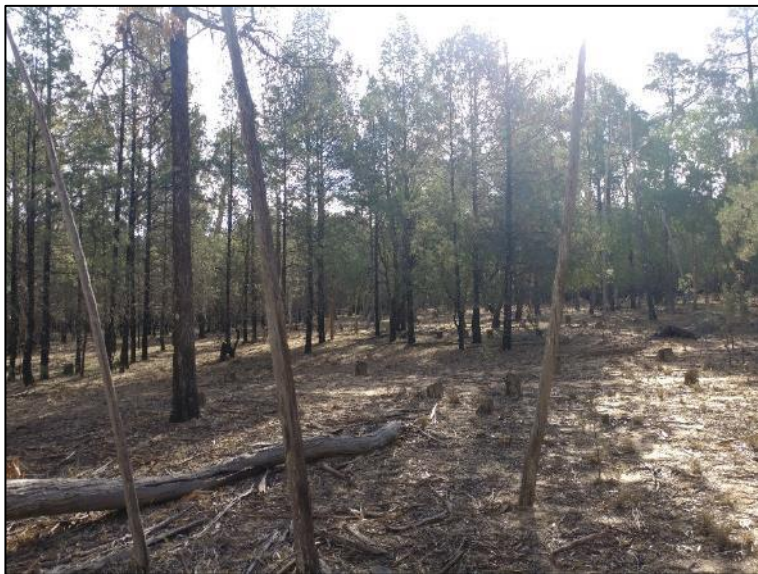
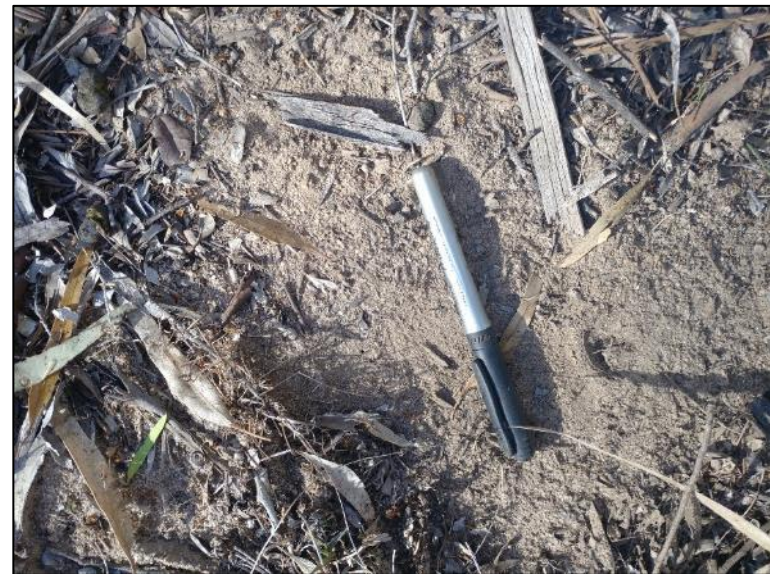
SITE 21 Plates

Land use Landform Pattern, Element, Slope	Vegetation	Microrelief Disturbance Erosion	Surface condition, surface rock	Soil Profile Description									
				Horizon Depth (m), Boundary	Field Texture	Structure, Strength	Inclusions Segregations	Colour, Mottle, Bleaching	Moisture, Drainage	Roots	Depth (m) / Field pH. Lab Sample, pH level and BSAL Assessment	Sample (m)	Observations
Grazing, gently undulating plain, upper slope, 5% / 3%	Tall woodlands	Nil microrelief <u>BSAL Pass</u> Nil disturbance Nil Erosion	Soft, loose, no coarse fragments No rock outcrops <u>BSAL Pass</u>	A11 0.00-0.40 Abrupt	Loamy sand	Single grain, loose	Nil inclusions / segregations	10YR6/1 Grey Nil mottles / bleach	Dry, rapidly drained	Common	0.10 / 5.5 0.00-0.05 <u>5.8 – BSAL Pass</u> 0.15-0.30 <u>5.46 – BSAL Pass</u>	0.00-0.10 0.15-0.30 0.40-0.60 0.60-0.75 0.85-1.00	Nil additional observations
				A12 0.40-0.85 Abrupt	Loamy sand	Single grain, loose	Nil inclusions / segregations	10YR6/2 Light brownish grey Nil mottles / bleach <u>BSAL Pass</u>	Dry, rapidly drained <u>BSAL Pass</u>	Nil roots	0.50 / 6.0 0.30-0.60 <u>5.27 – BSAL Pass</u> 0.60-0.75 <u>5.8 – BSAL Pass</u>

A2 0.85-1.20 EOBH	Loamy sand	Massive, loose	Nil inclusions / segregations	10YR6/2 Light brownish grey Nil mottles / bleach	Dry, rapidly drained	Nil roots	1.00 / 6.0		
				<u>ERD BSAL Pass</u>

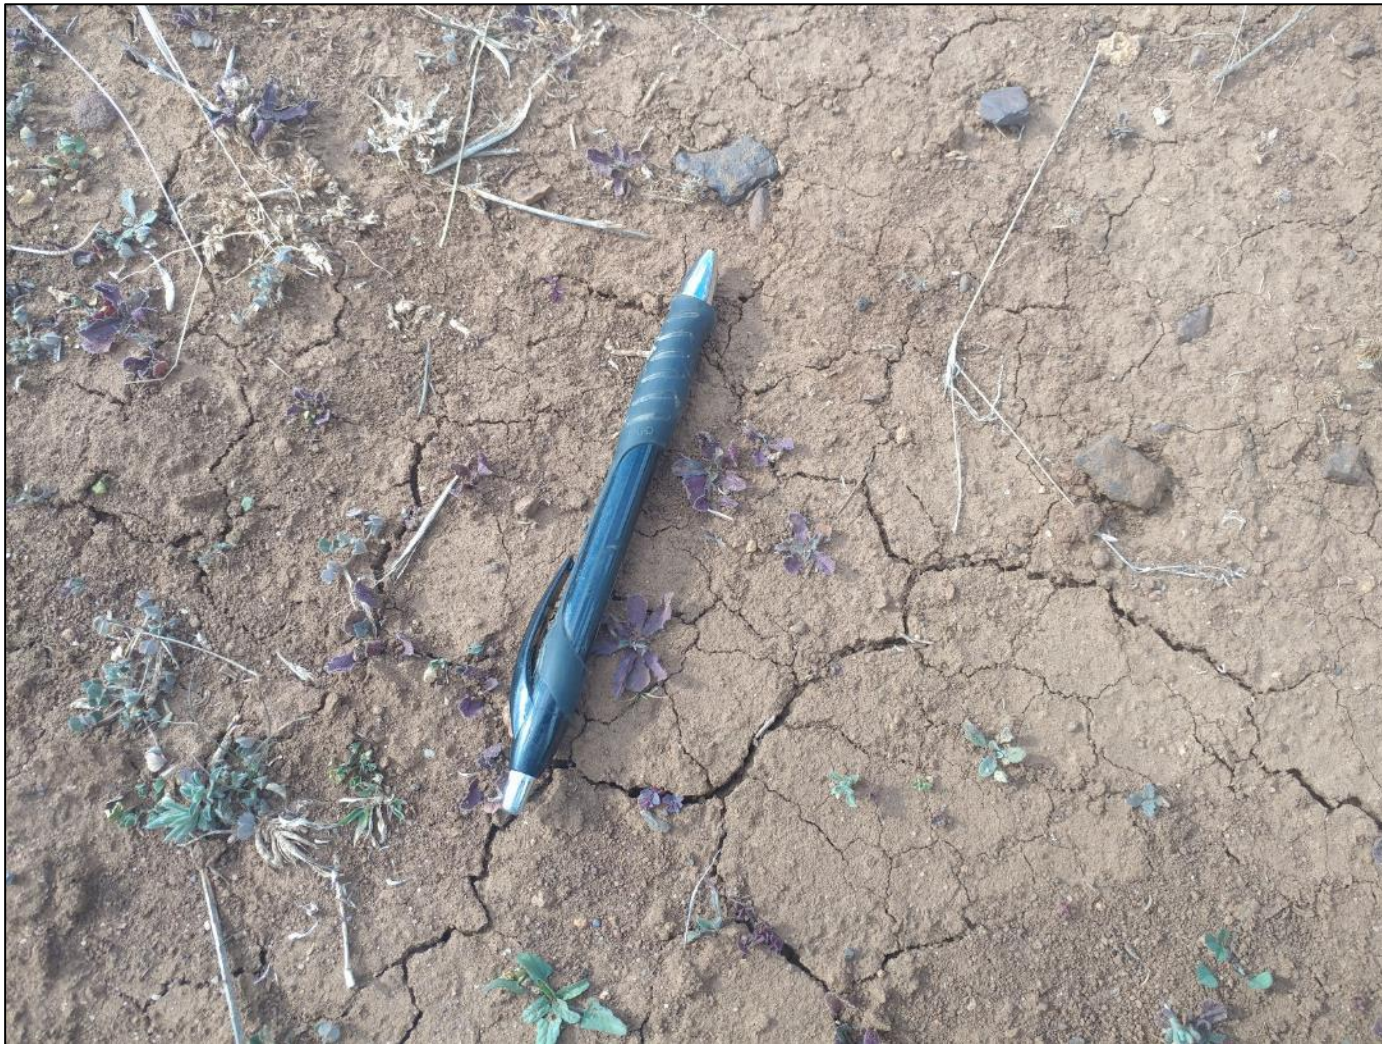
SITE C5 Picture

Land use Landform Pattern, Element, Slope	Vegetation	Microrelief Disturbance Erosion	Surface condition, surface rock	Soil Profile Description									
				Horizon Depth (m), Boundary	Texture	Structure, Strength	Inclusions Segregations	Colour, Mottle, Bleaching	Moisture, Drainage	Roots	Depth (m) / Field pH	Sample (m)	Observations
Grazing, Undulating plain, Lower slope 5.0%	Grasses	Nil microrelief Extensively disturbed Nil Erosion	Cracking 2mm No coarse fragments	-	-	-	-	-	-	-	-	-	Passes BSAL criterion for surface rock

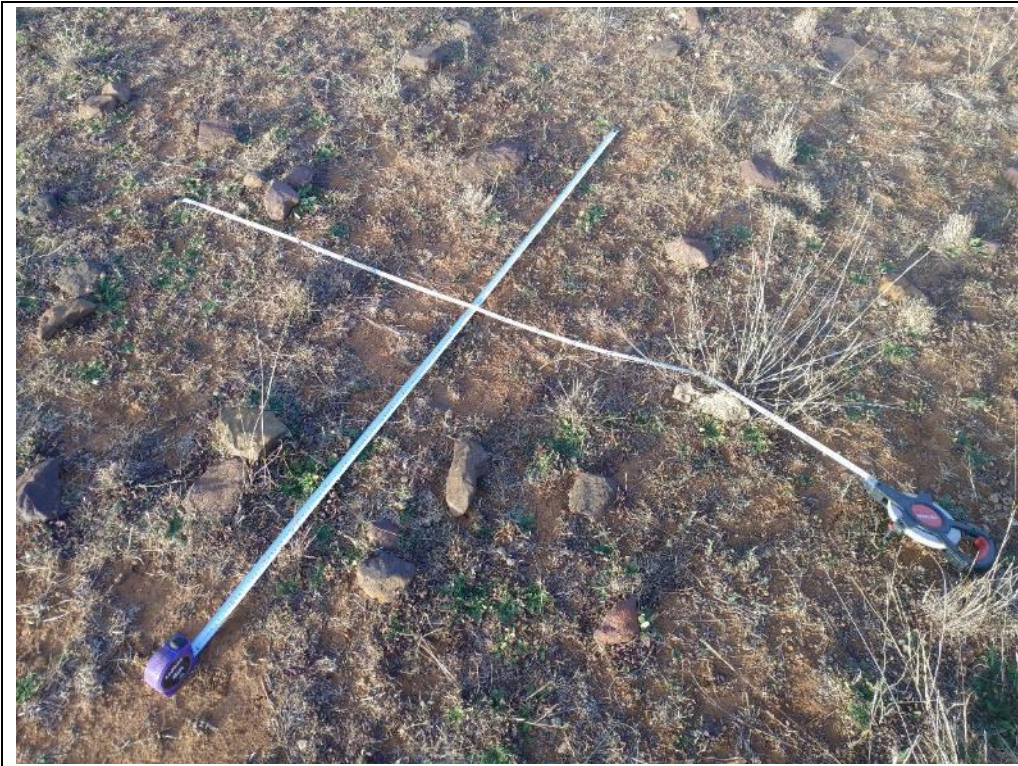
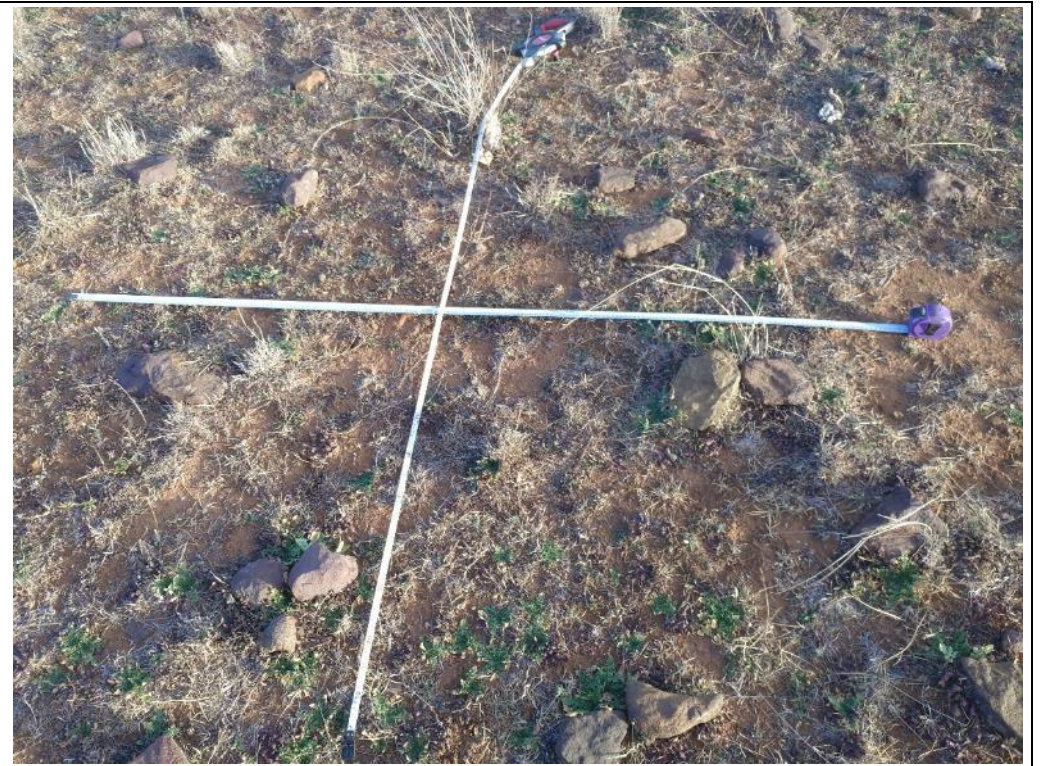
SITE C6 Plates

Land use Landform Pattern, Element, Slope	Vegetation	Microrelief Disturbance Erosion	Surface condition, surface rock	Soil Profile Description									
				Horizon Depth (m), Boundary	Texture	Structure, Strength	Inclusions Segregations	Colour, Mottle, Bleaching	Moisture, Drainage	Roots	Depth (m) / Field pH	Sample (m)	Observations
Grazing, Undulating plain, Upper slope	Grasses	Nil microrelief Extensively disturbed Nil Erosion	-	-	-	-	-	-	-	-	-	-	Four quadrants of 1.0m x 1.0m assessed for unattached rock fragments >60mm Quadrant 1 - <20% Quadrant 2 - <20% Quadrant 3 - <20% Quadrant 4 - <20% Passes BSAL criterion for surface rock

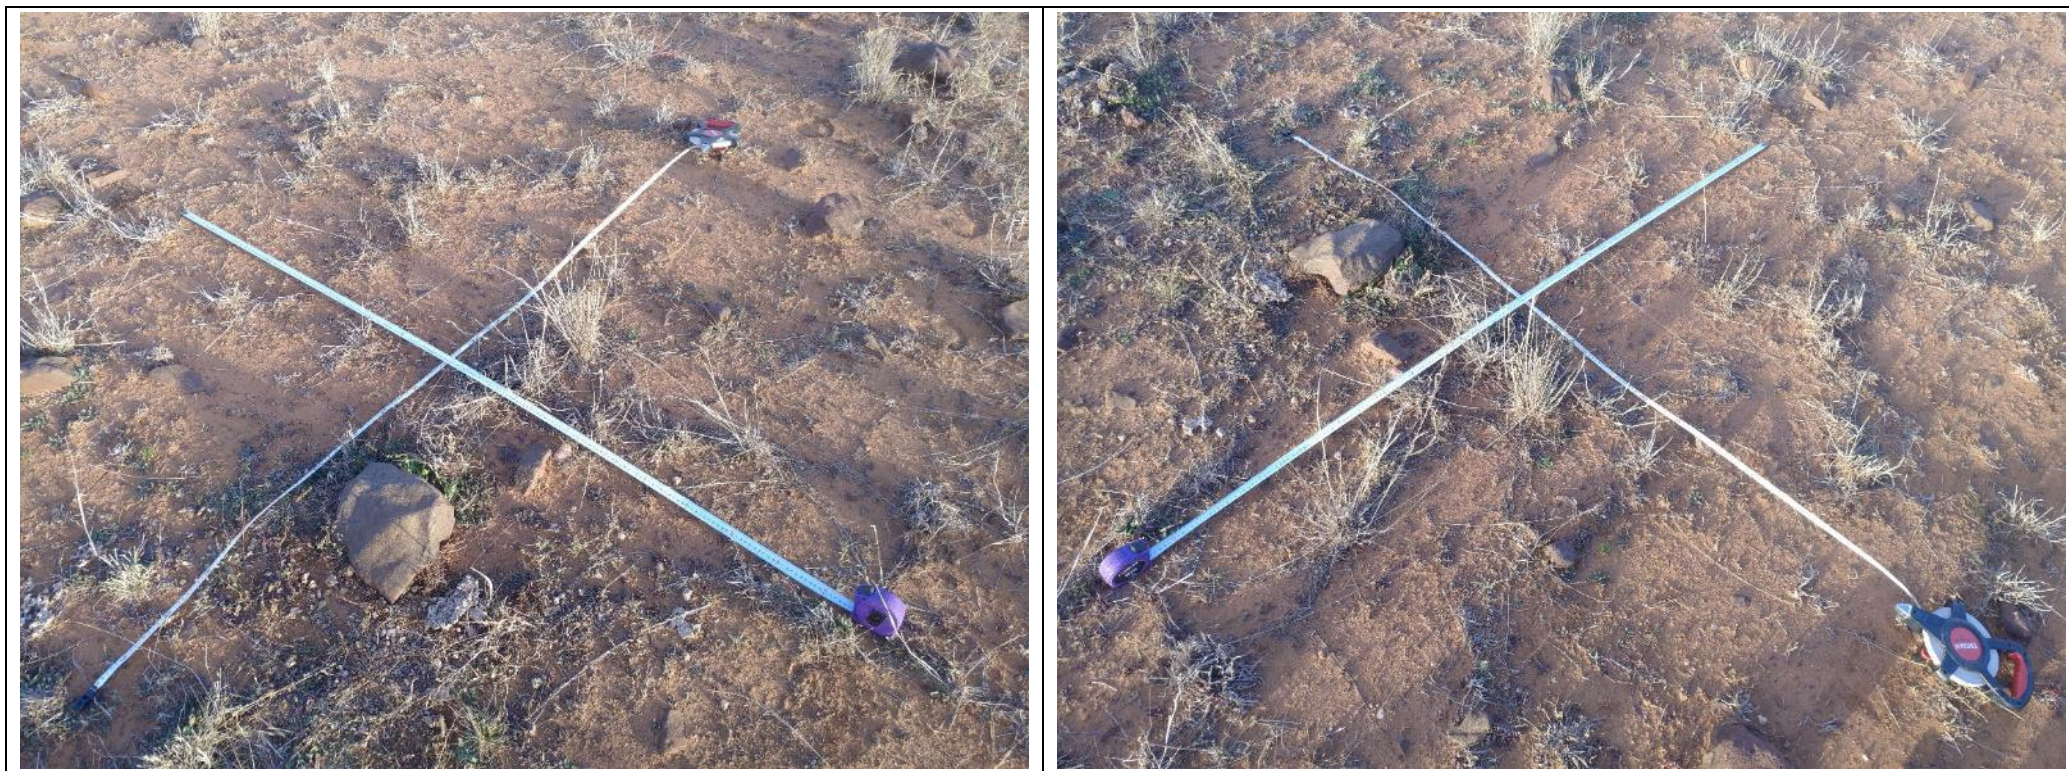
SITE C7 Plates

Land use Landform Pattern, Element, Slope	Vegetation	Microrelief Disturbance Erosion	Surface condition, surface rock	Soil Profile Description									
				Horizon Depth (m), Boundary	Texture	Structure, Strength	Inclusions Segregations	Colour, Mottle, Bleaching	Moisture, Drainage	Roots	Depth (m) / Field pH	Sample (m)	Observations
Grazing, Undulating plain, Upper slope	Grasses	Nil microrelief Extensively disturbed Nil Erosion	-	-	-	-	-	-	-	-	-	-	Four quadrants of 1.0m x 1.0m assessed for unattached rock fragments >60mm Quadrant 1 - <20% Quadrant 2 - <20% Quadrant 3 - <20% Quadrant 4 - <20% Passes BSAL criterion for surface rock

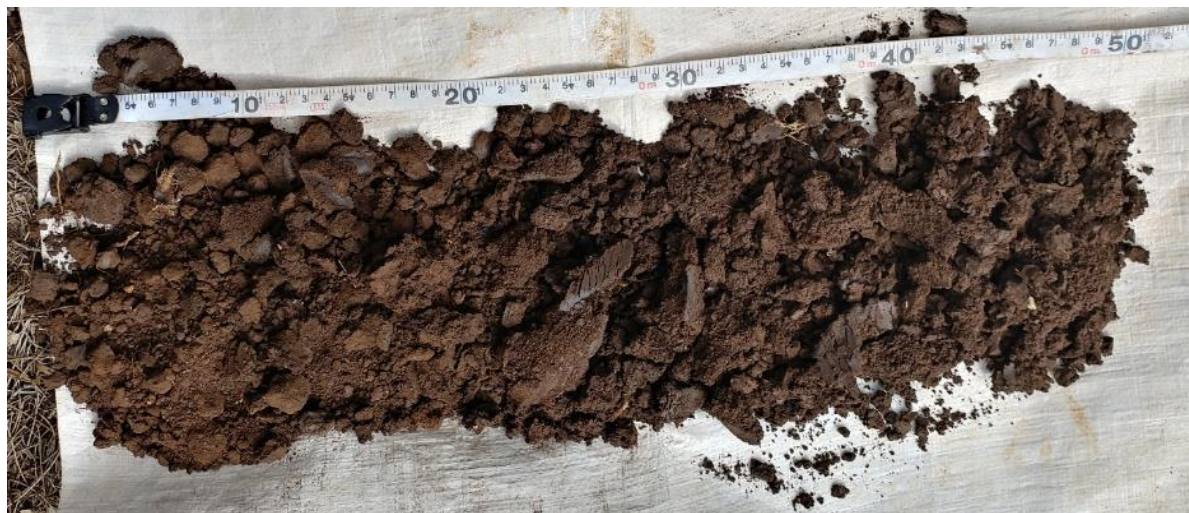
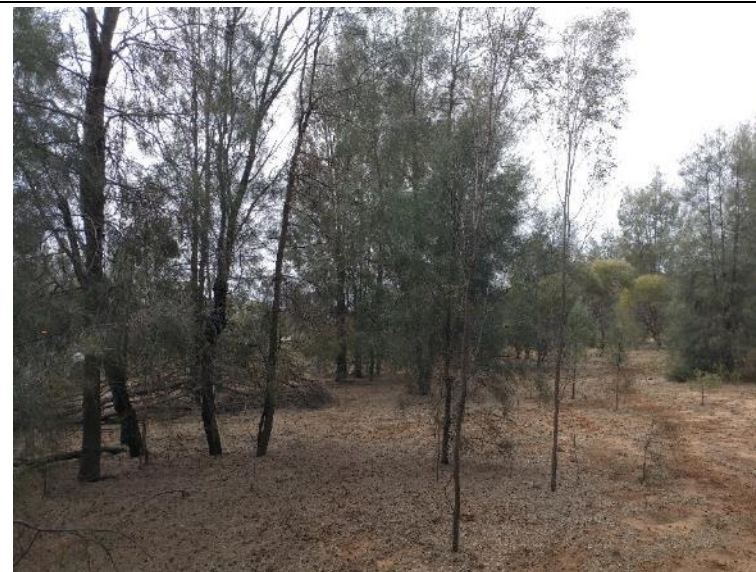
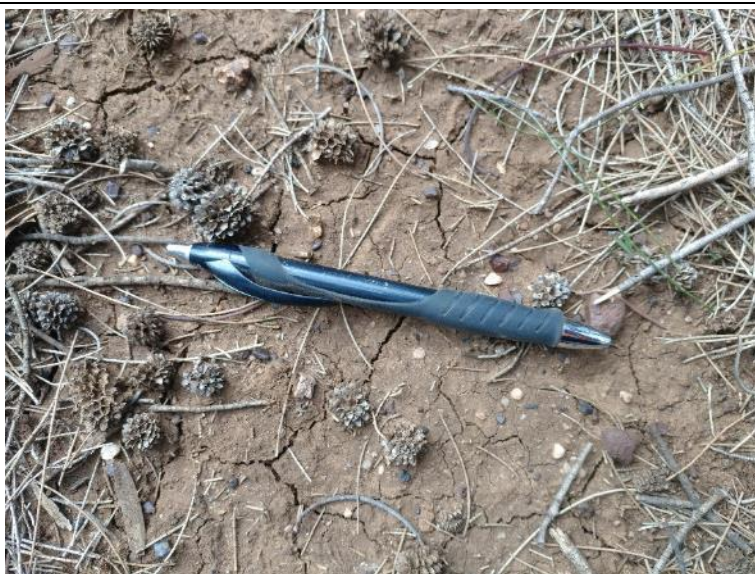
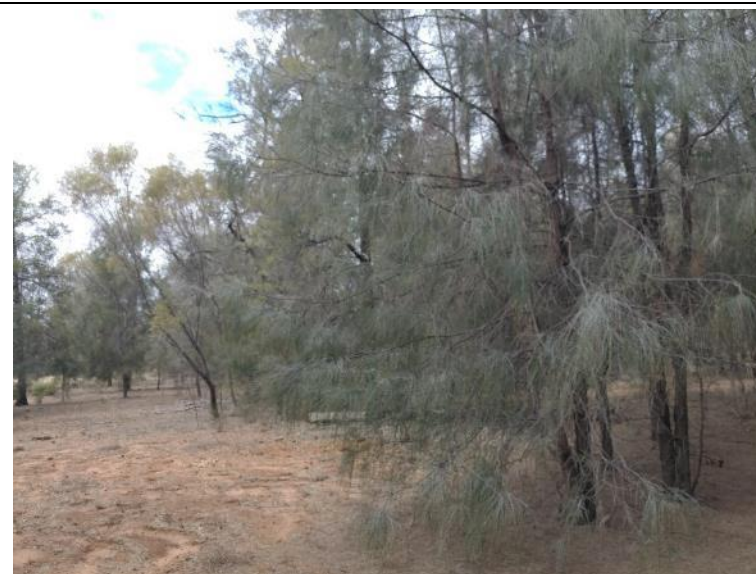
SITE C8 Plates

Land use Landform Pattern, Element, Slope	Vegetation	Microrelief Disturbance Erosion	Surface condition, surface rock	Soil Profile Description									
				Horizon Depth (m), Boundary	Texture	Structure, Strength	Inclusions Segregations	Colour, Mottle, Bleaching	Moisture, Drainage	Roots	Depth (m) / Field pH	Sample (m)	Observations
Grazing, Gently undulating plain, Lower slope 3% / 1%	Tall woodland	Nil microrelief Nil disturbed Nil Erosion	Cracking, soft	A1 0.00-0.10 Abrupt	Light clay	Weak, firm	Nil inclusions / segregations	10YR4/3 Brown Nil mottles / bleaching	Dry, well drained	Common	0.05 / 6.5	-	Nil additional observations
				B21 0.10-0.50 EOBH	Light clay	Moderate, firm	Nil inclusions / segregations	10YR3/3 Dark brown Nil mottles / bleaching	Dry, well drained	Few	0.30 / 7.5

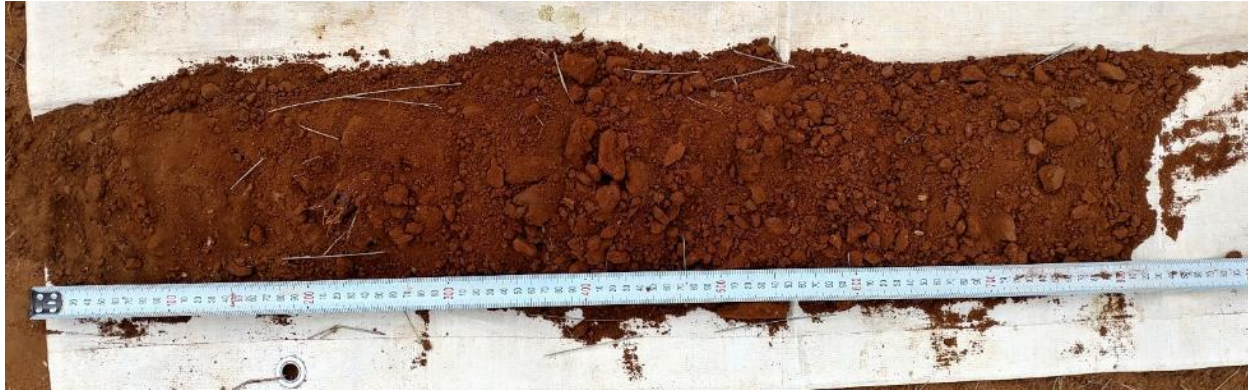
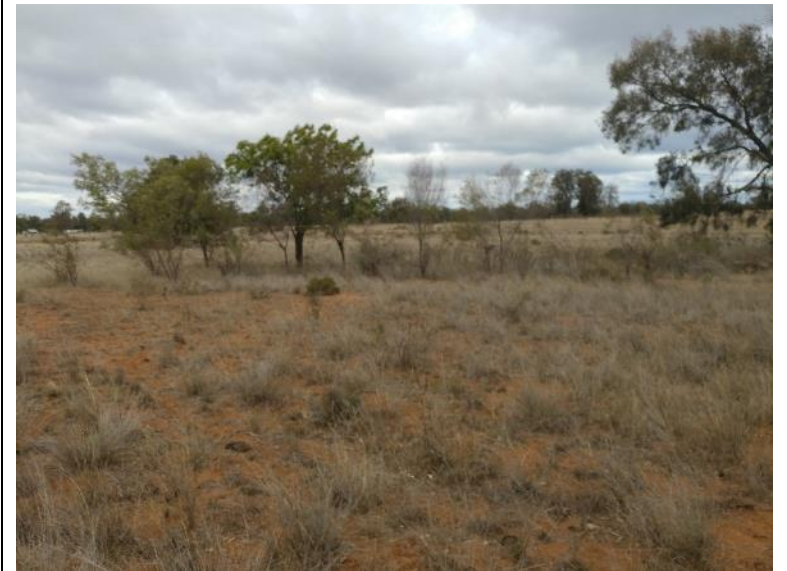
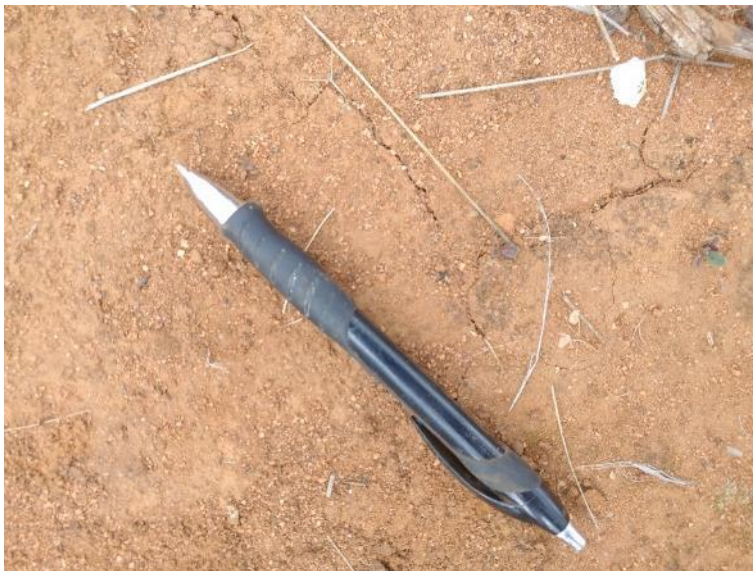
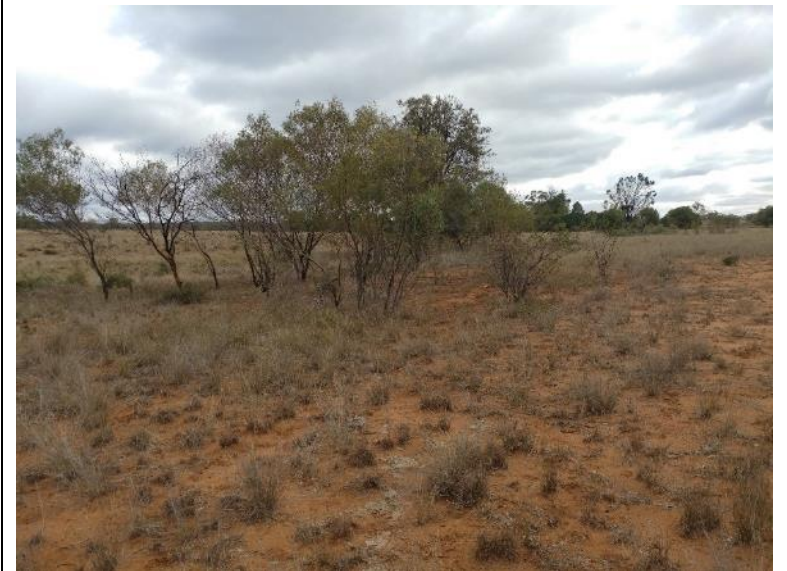
SITE C9 Plates

Land use Landform Pattern, Element, Slope	Vegetation	Microrelief Disturbance Erosion	Surface condition, surface rock	Soil Profile Description									
				Horizon Depth (m), Boundary	Texture	Structure, Strength	Inclusions Segregations	Colour, Mottle, Bleaching	Moisture, Drainage	Roots	Depth (m) / Field pH	Sample (m)	Observations
Grazing, Gently undulating plain, Wide depression	Mixed sparse vegetation	Nil microrelief Semi disturbed Nil Erosion	Firm, minor cracking	A11 0.00-0.15 Abrupt	Clayey sand	Loose, massive	Nil inclusions / segregations	2.5YR3/3 Dark reddish- brown Nil mottles / bleaching	Dry, rapid	Common	-	-	Nil additional observations
				B21 0.15-0.40 Abrupt	Sandy loam	Weak, soft	Nil inclusions / segregations	2.5YR3/4 Dark reddish- brown Nil mottles / bleaching	Dry, well drained	Few	-		
				B22 0.40-0.80 EOBH	Sandy clay loam	Weak, firm	Nil inclusions / segregations	2.5YR3/4 Dark reddish- brown Nil mottles / bleaching	Dry, well drained	Few	-
