# Preliminary Site Investigation

*754-770 & 784-786  
Mamre Road,  
Kemps Creek,  
NSW*

23 March 2021

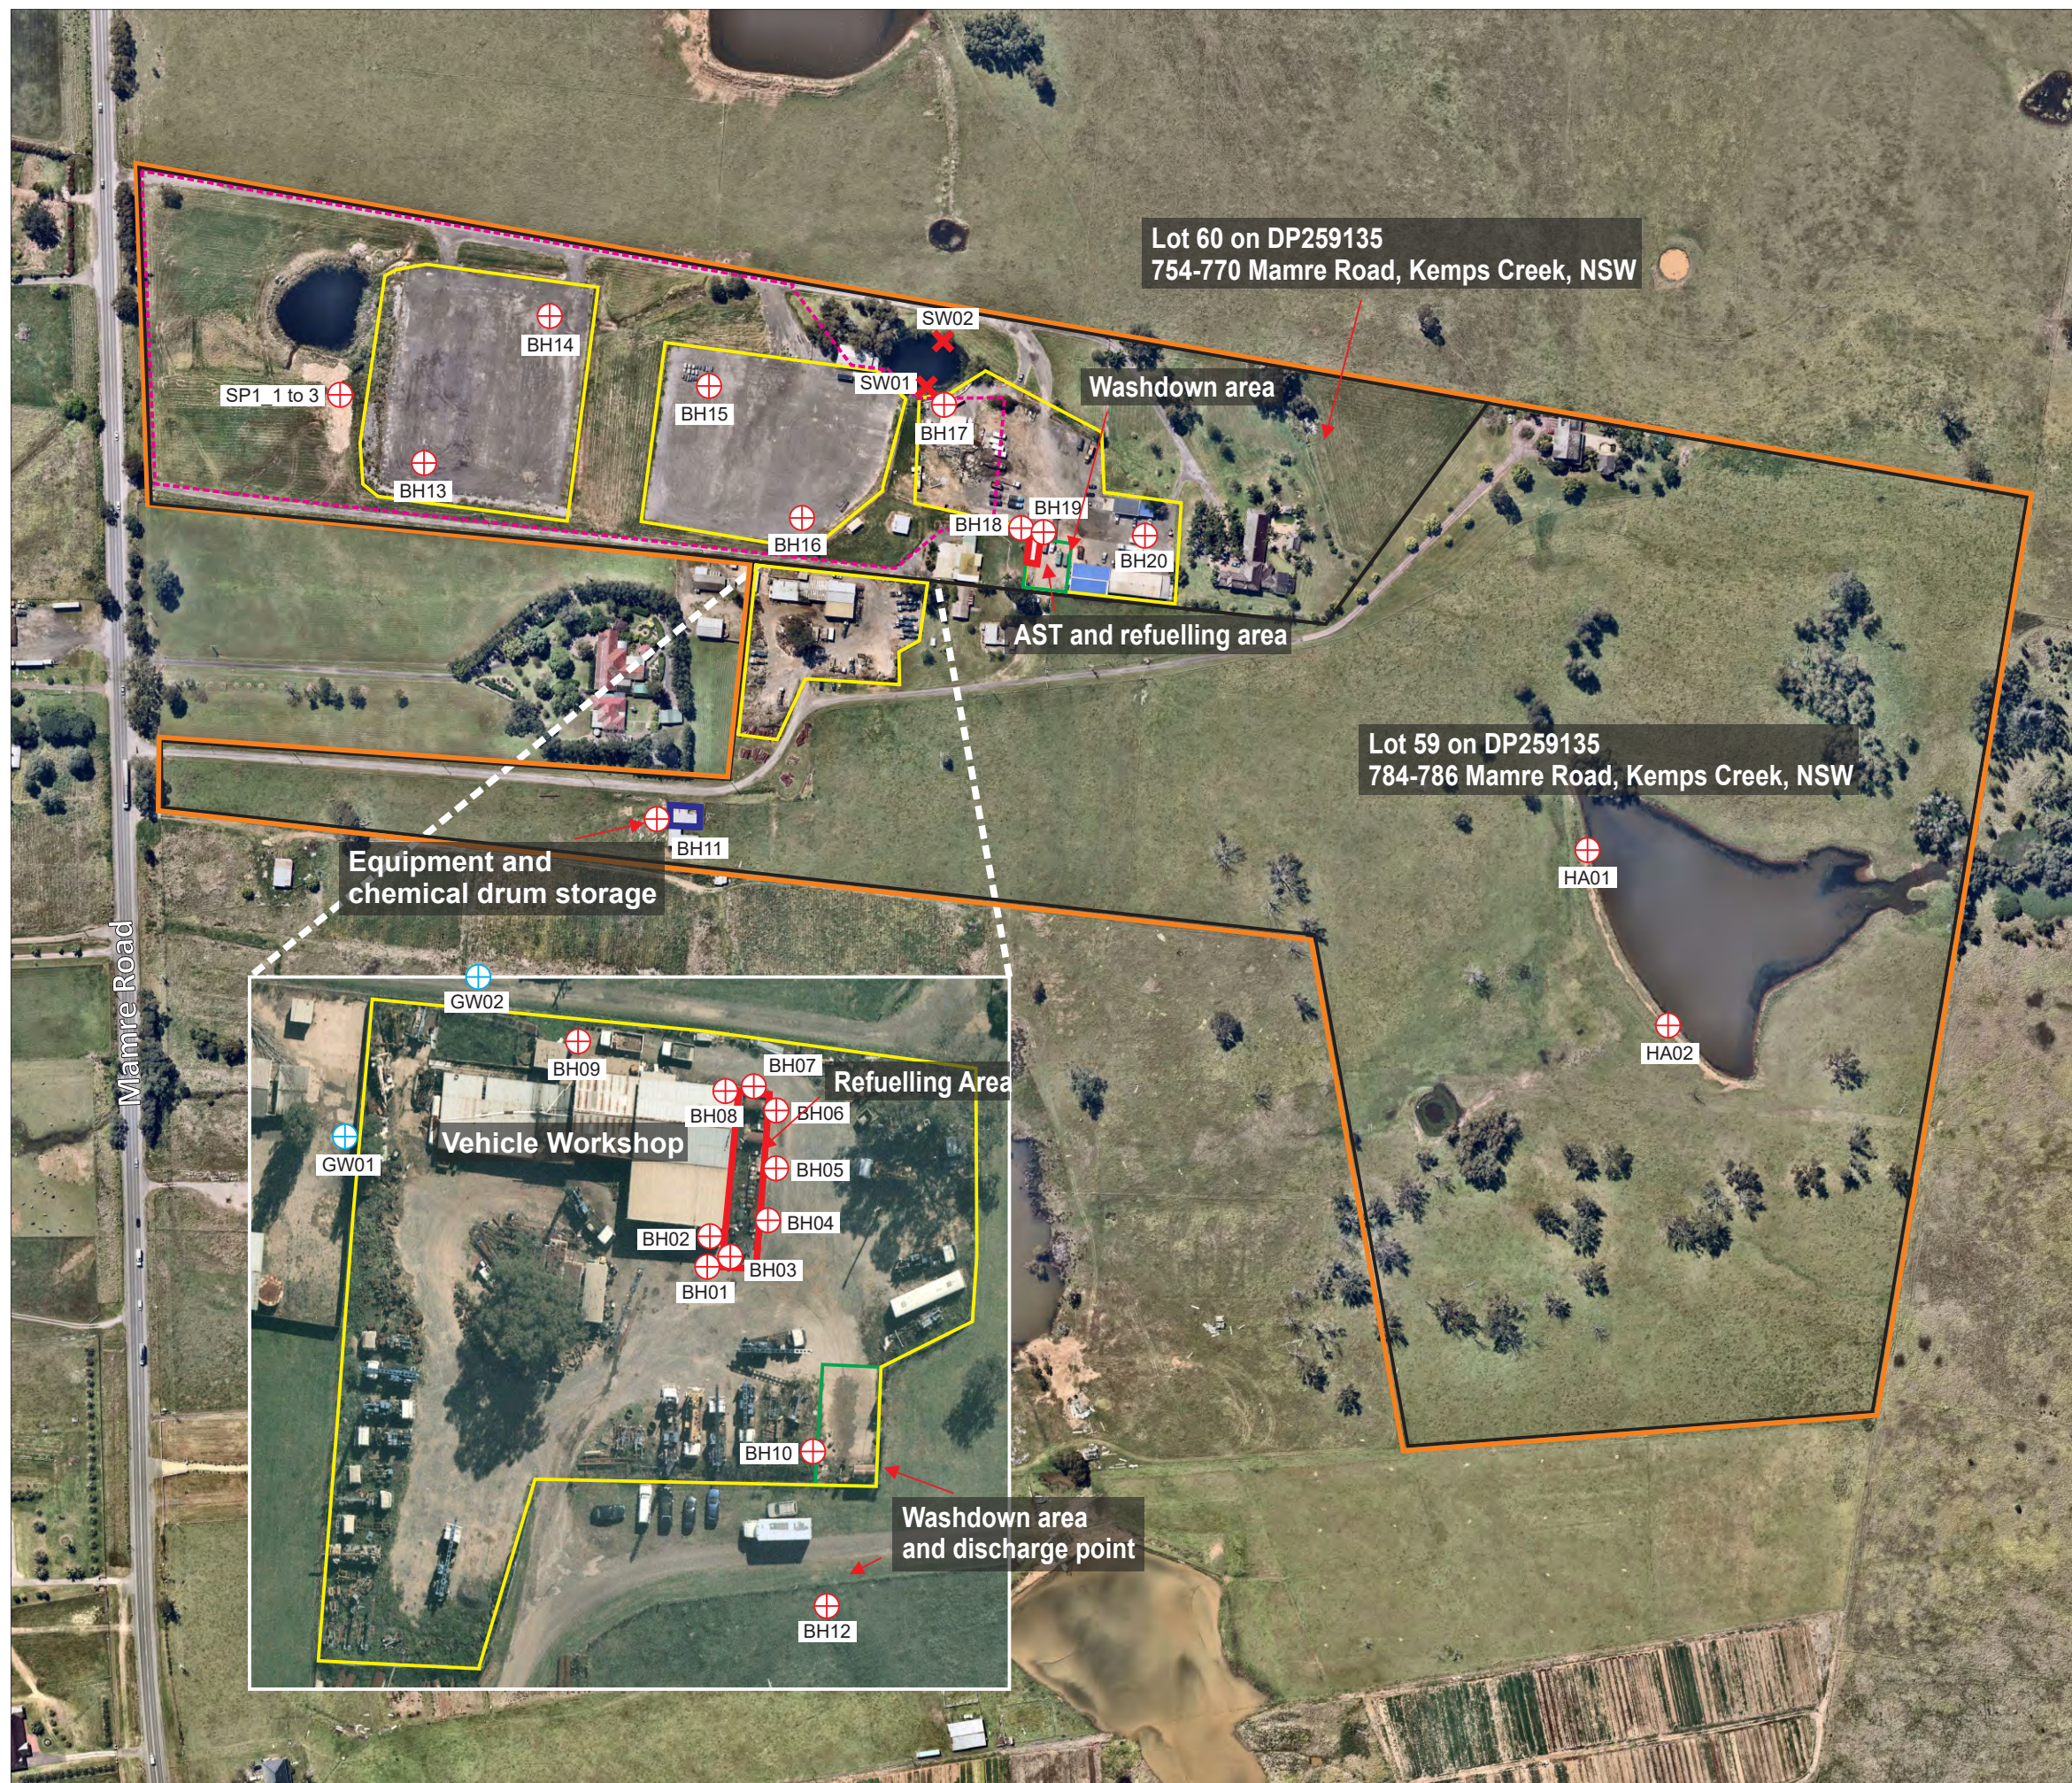
- Site Boundary
- Property Boundary
- Areas of Environmental Concern
  - Vehicle Workshop and Vehicle Storage
  - Refueling Area:
    - 4,000 L petrol UST
    - 20,000 L diesel UST
    - three (3) ASTs
    - several drums
  - Other Chemical / Equipment Storage
  - Vehicle Washdown Area
  - Former Horticultural Area

- Previous Investigation Sampling Locations
  - KPMG 2019 Soil Sampling Location
  - KPMG 2020c Groundwater Sampling Location
  - KPMG 2020c Surface Water Sampling Location

The physical boundaries of the investigation areas were limited to the soil sampling points depicted in Figure 2, Appendix A. The study is limited to site conditions at the time of the investigation.

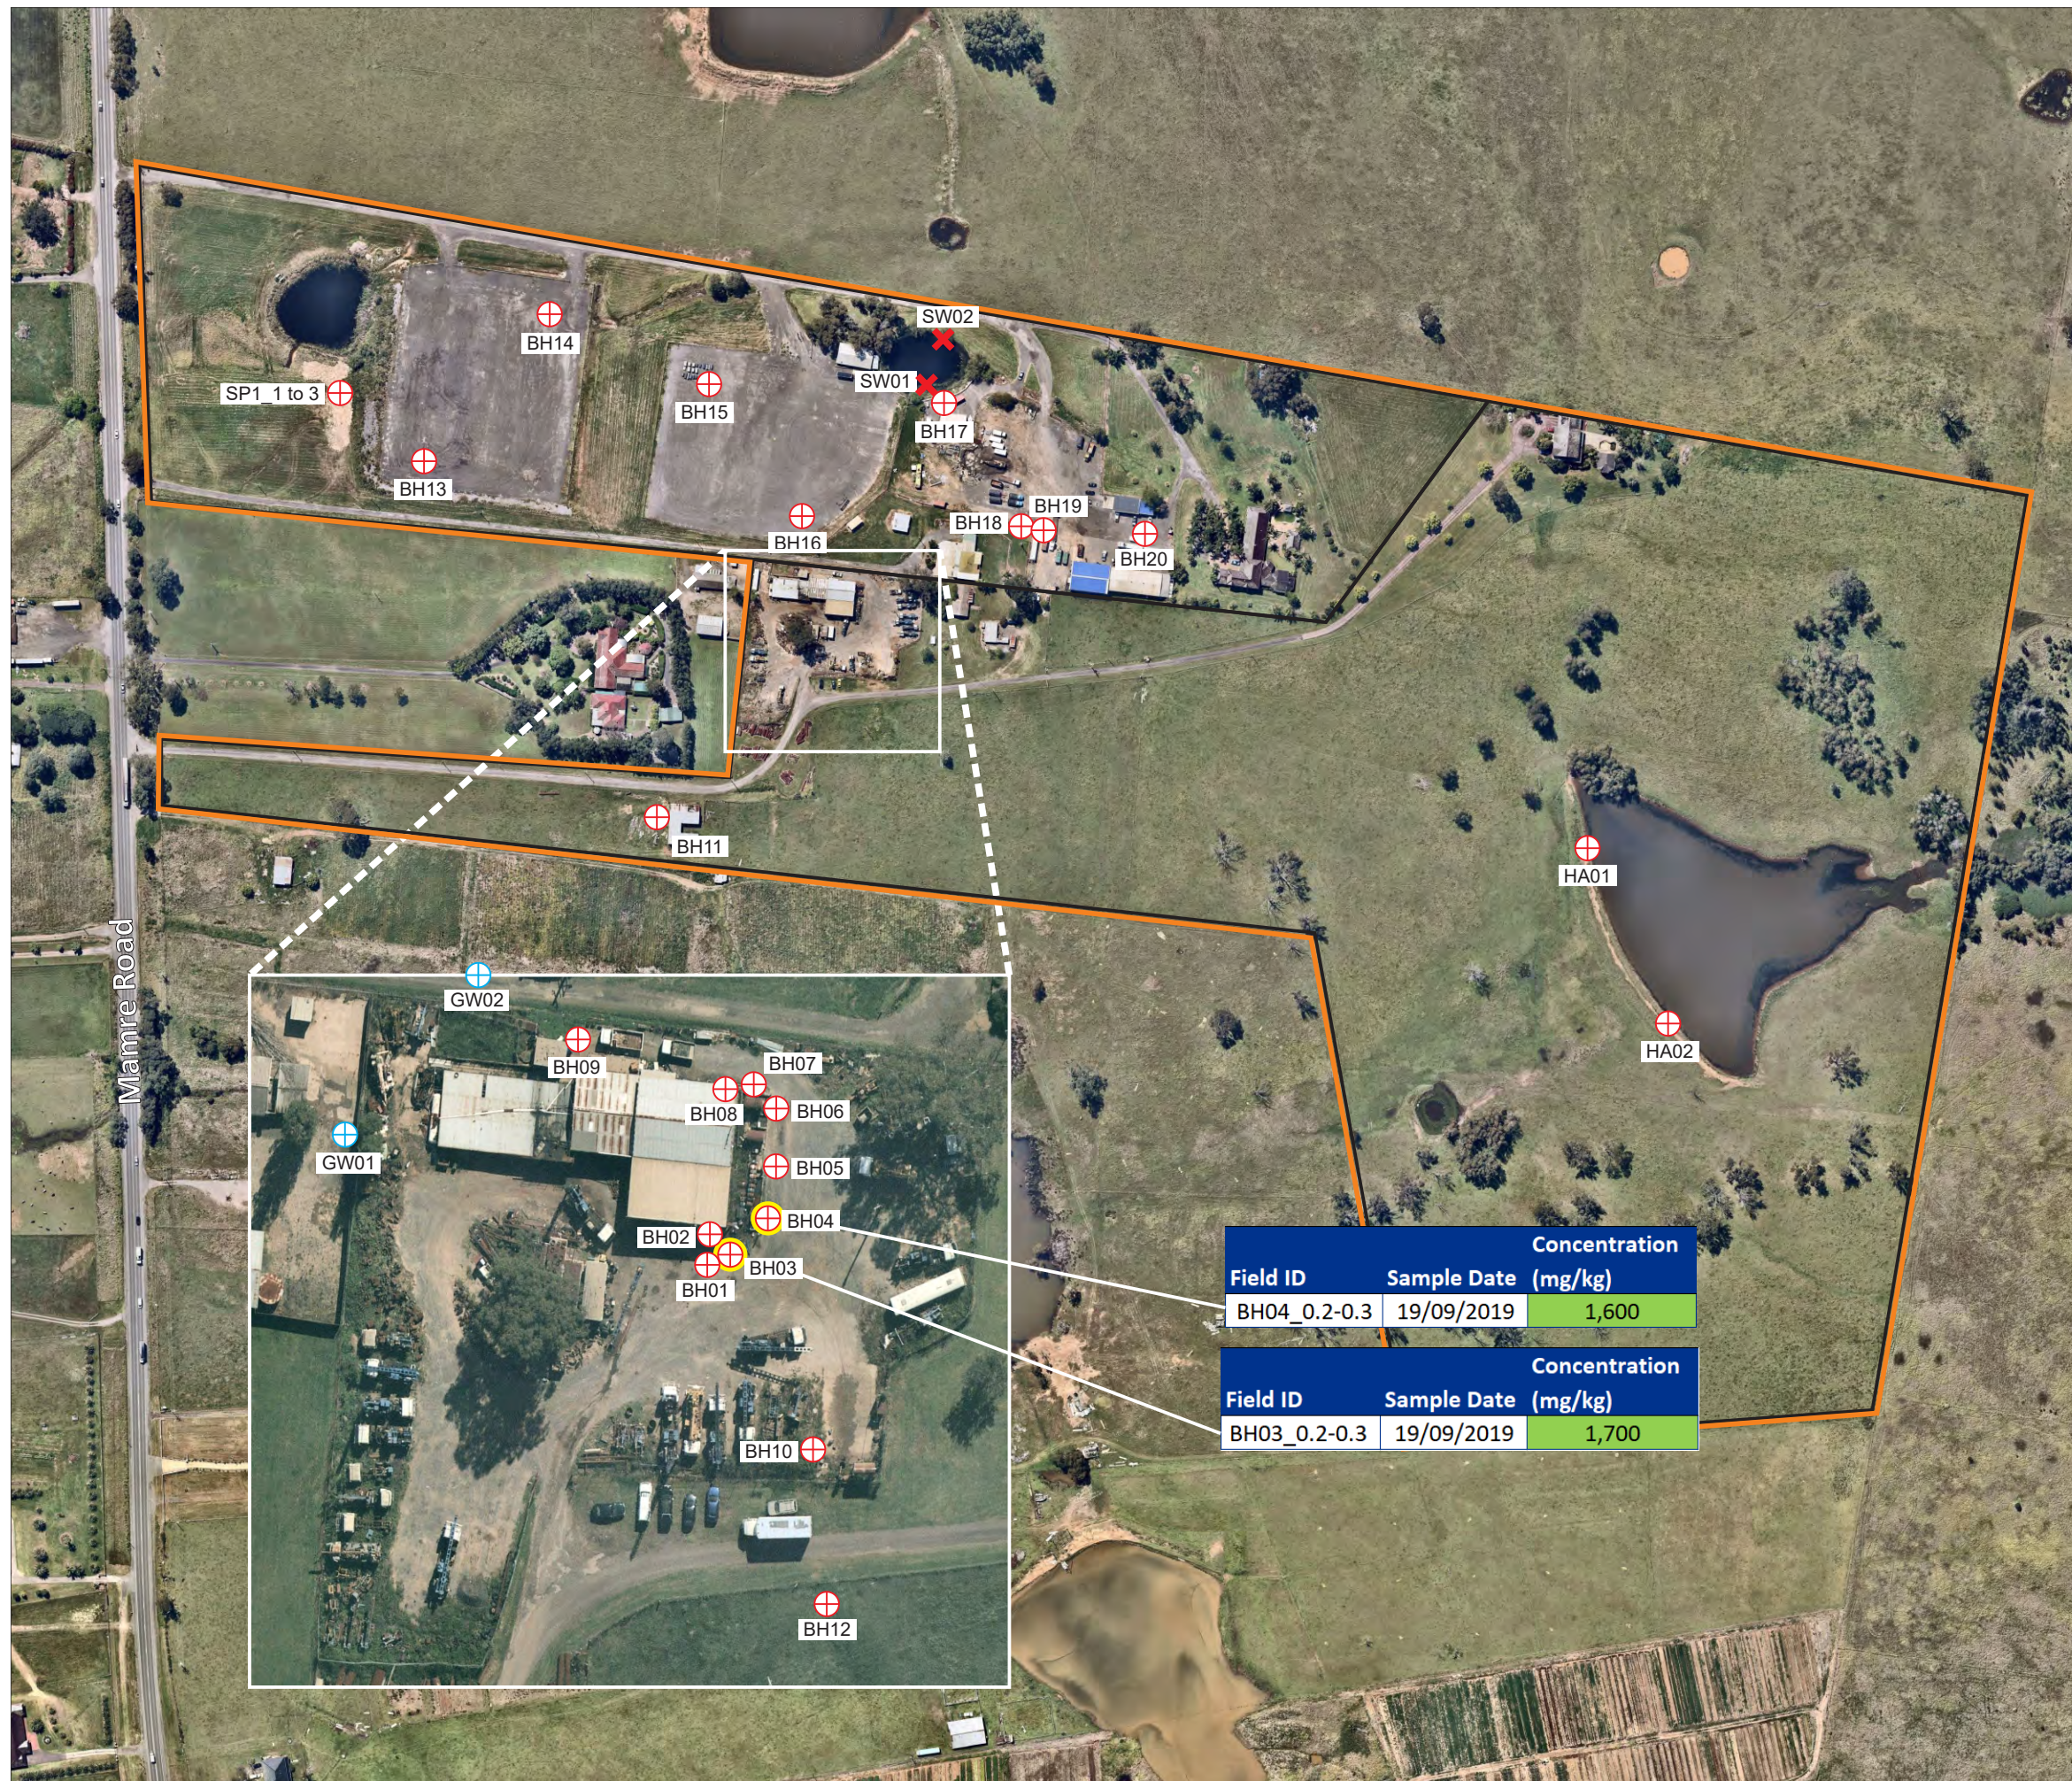
NEPM 2013 Table 1B(5)  
Generic EIL  
Commercial / Industrial

Chromium Concentration Above Guideline Criteria

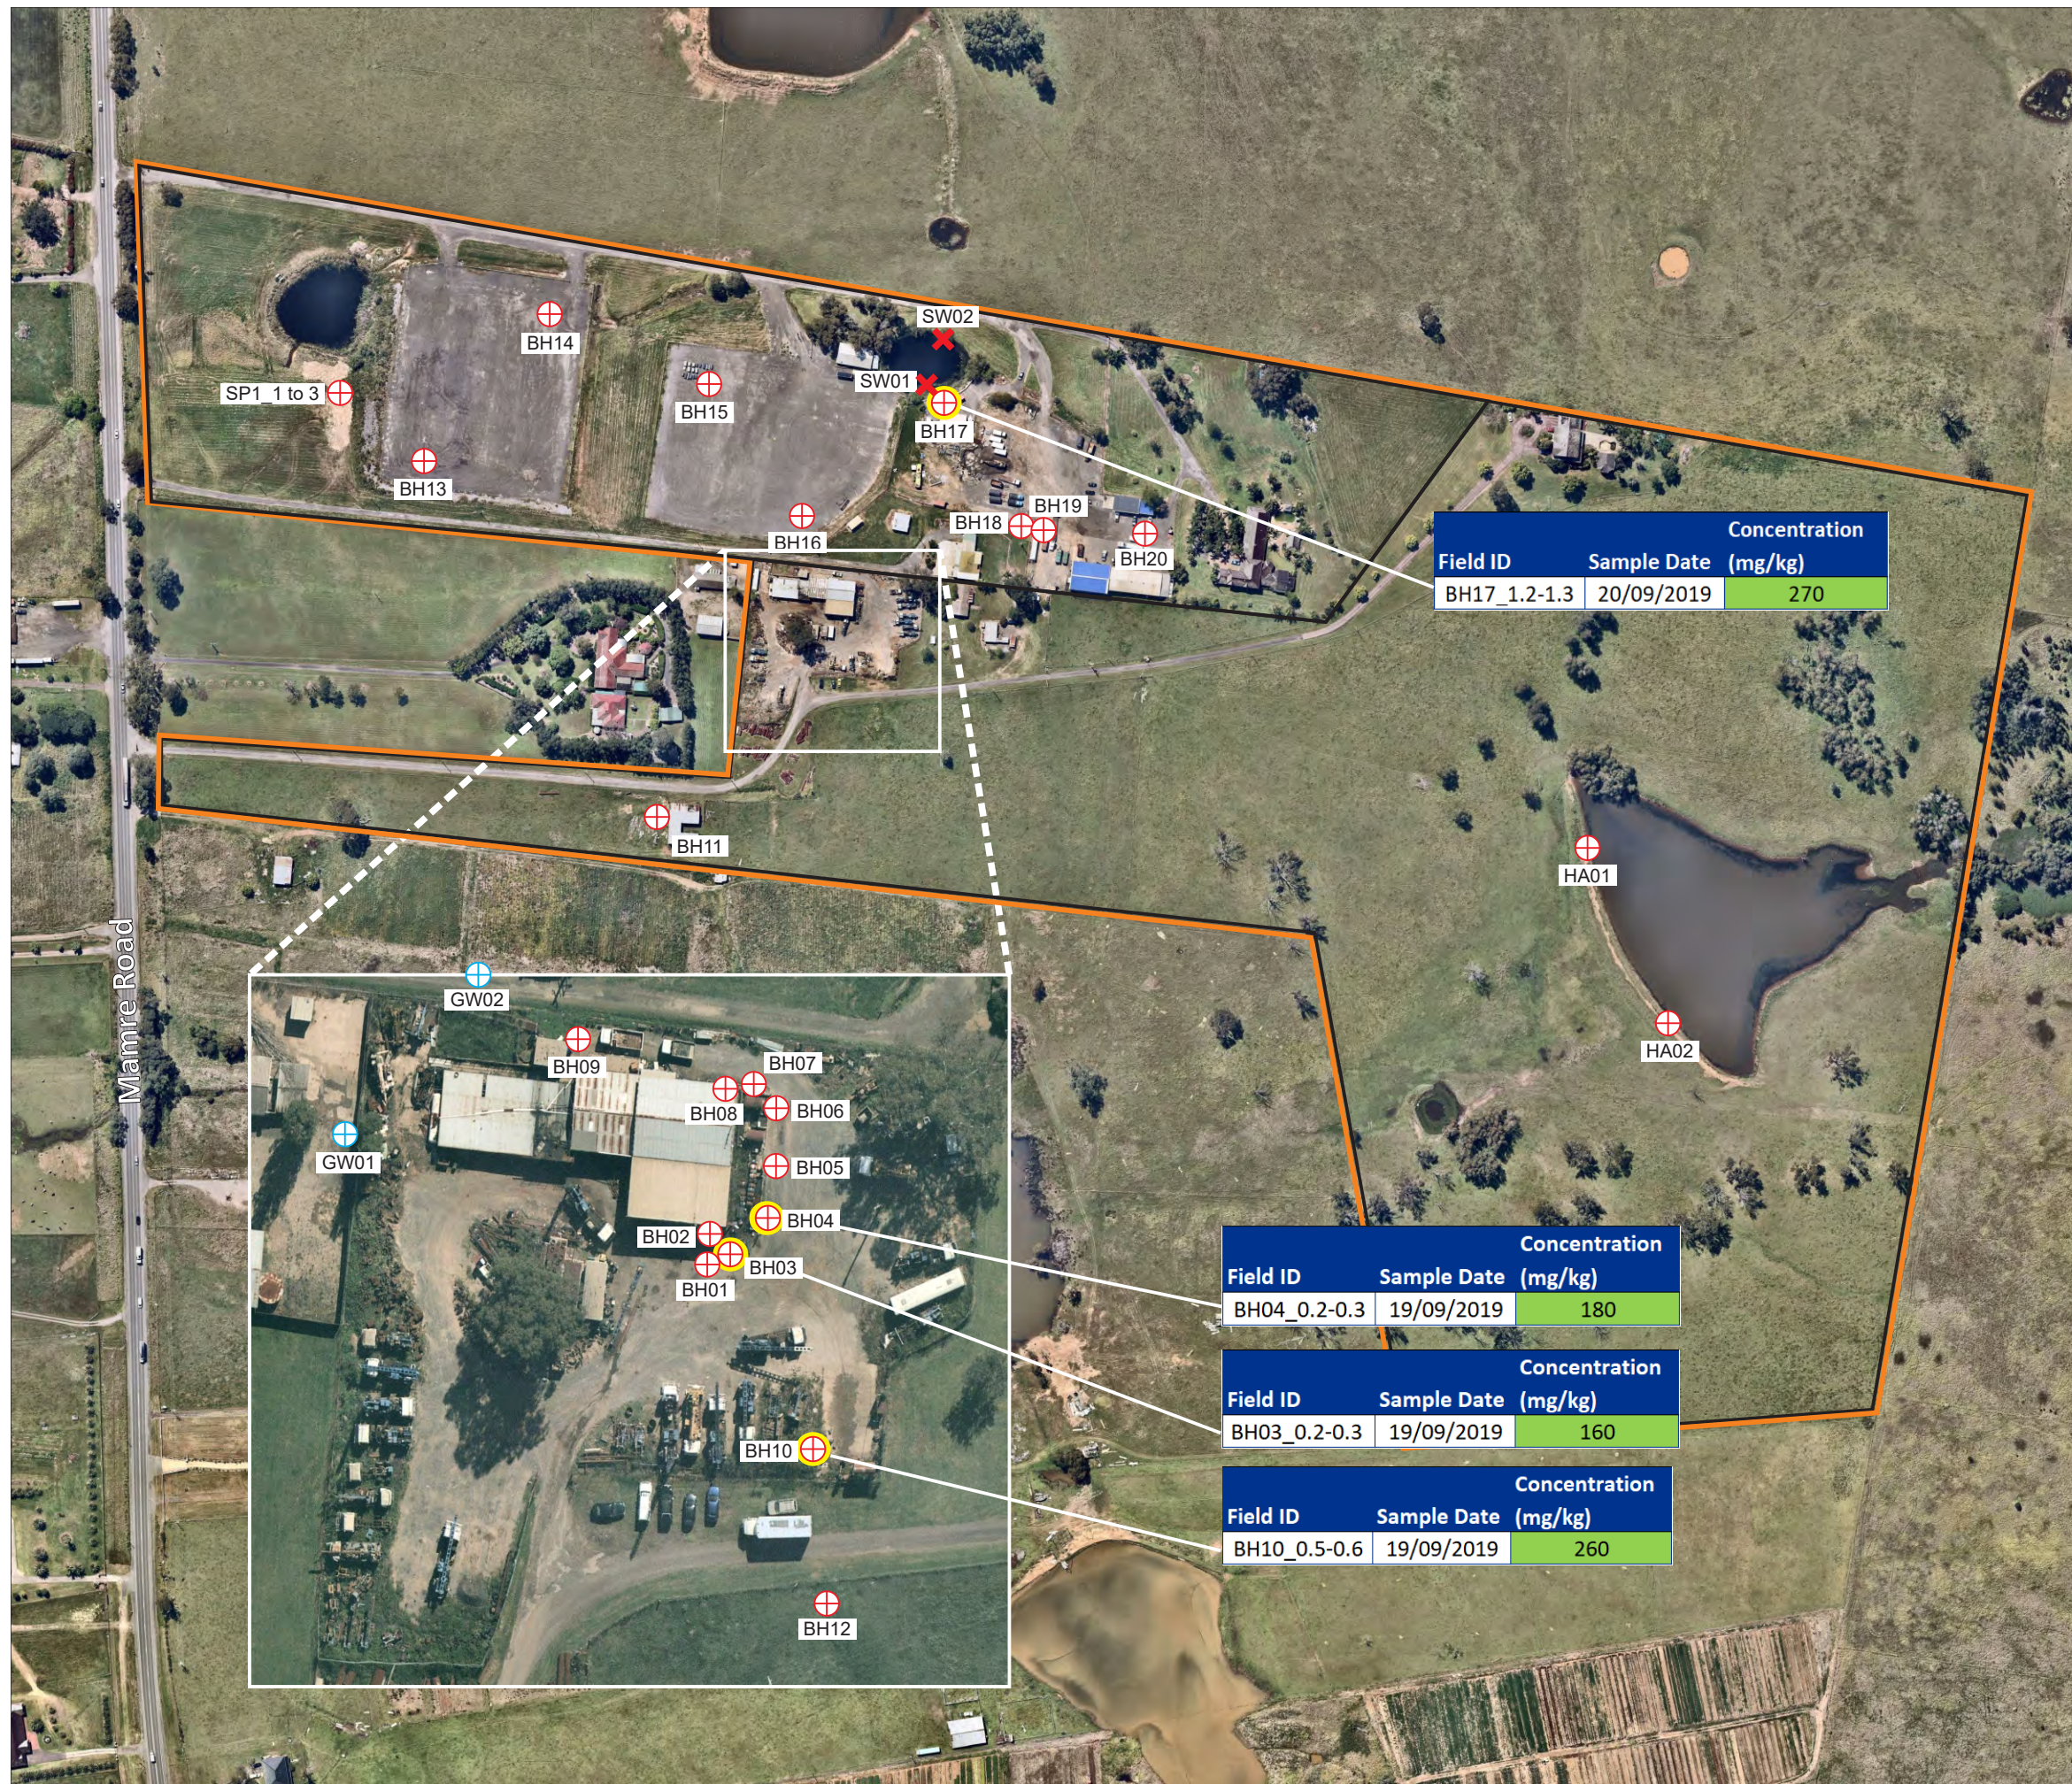
NEPM 2013 Table 1B(5)  
Generic EIL  
Commercial / Industrial

Copper Concentration Above Guideline Criteria

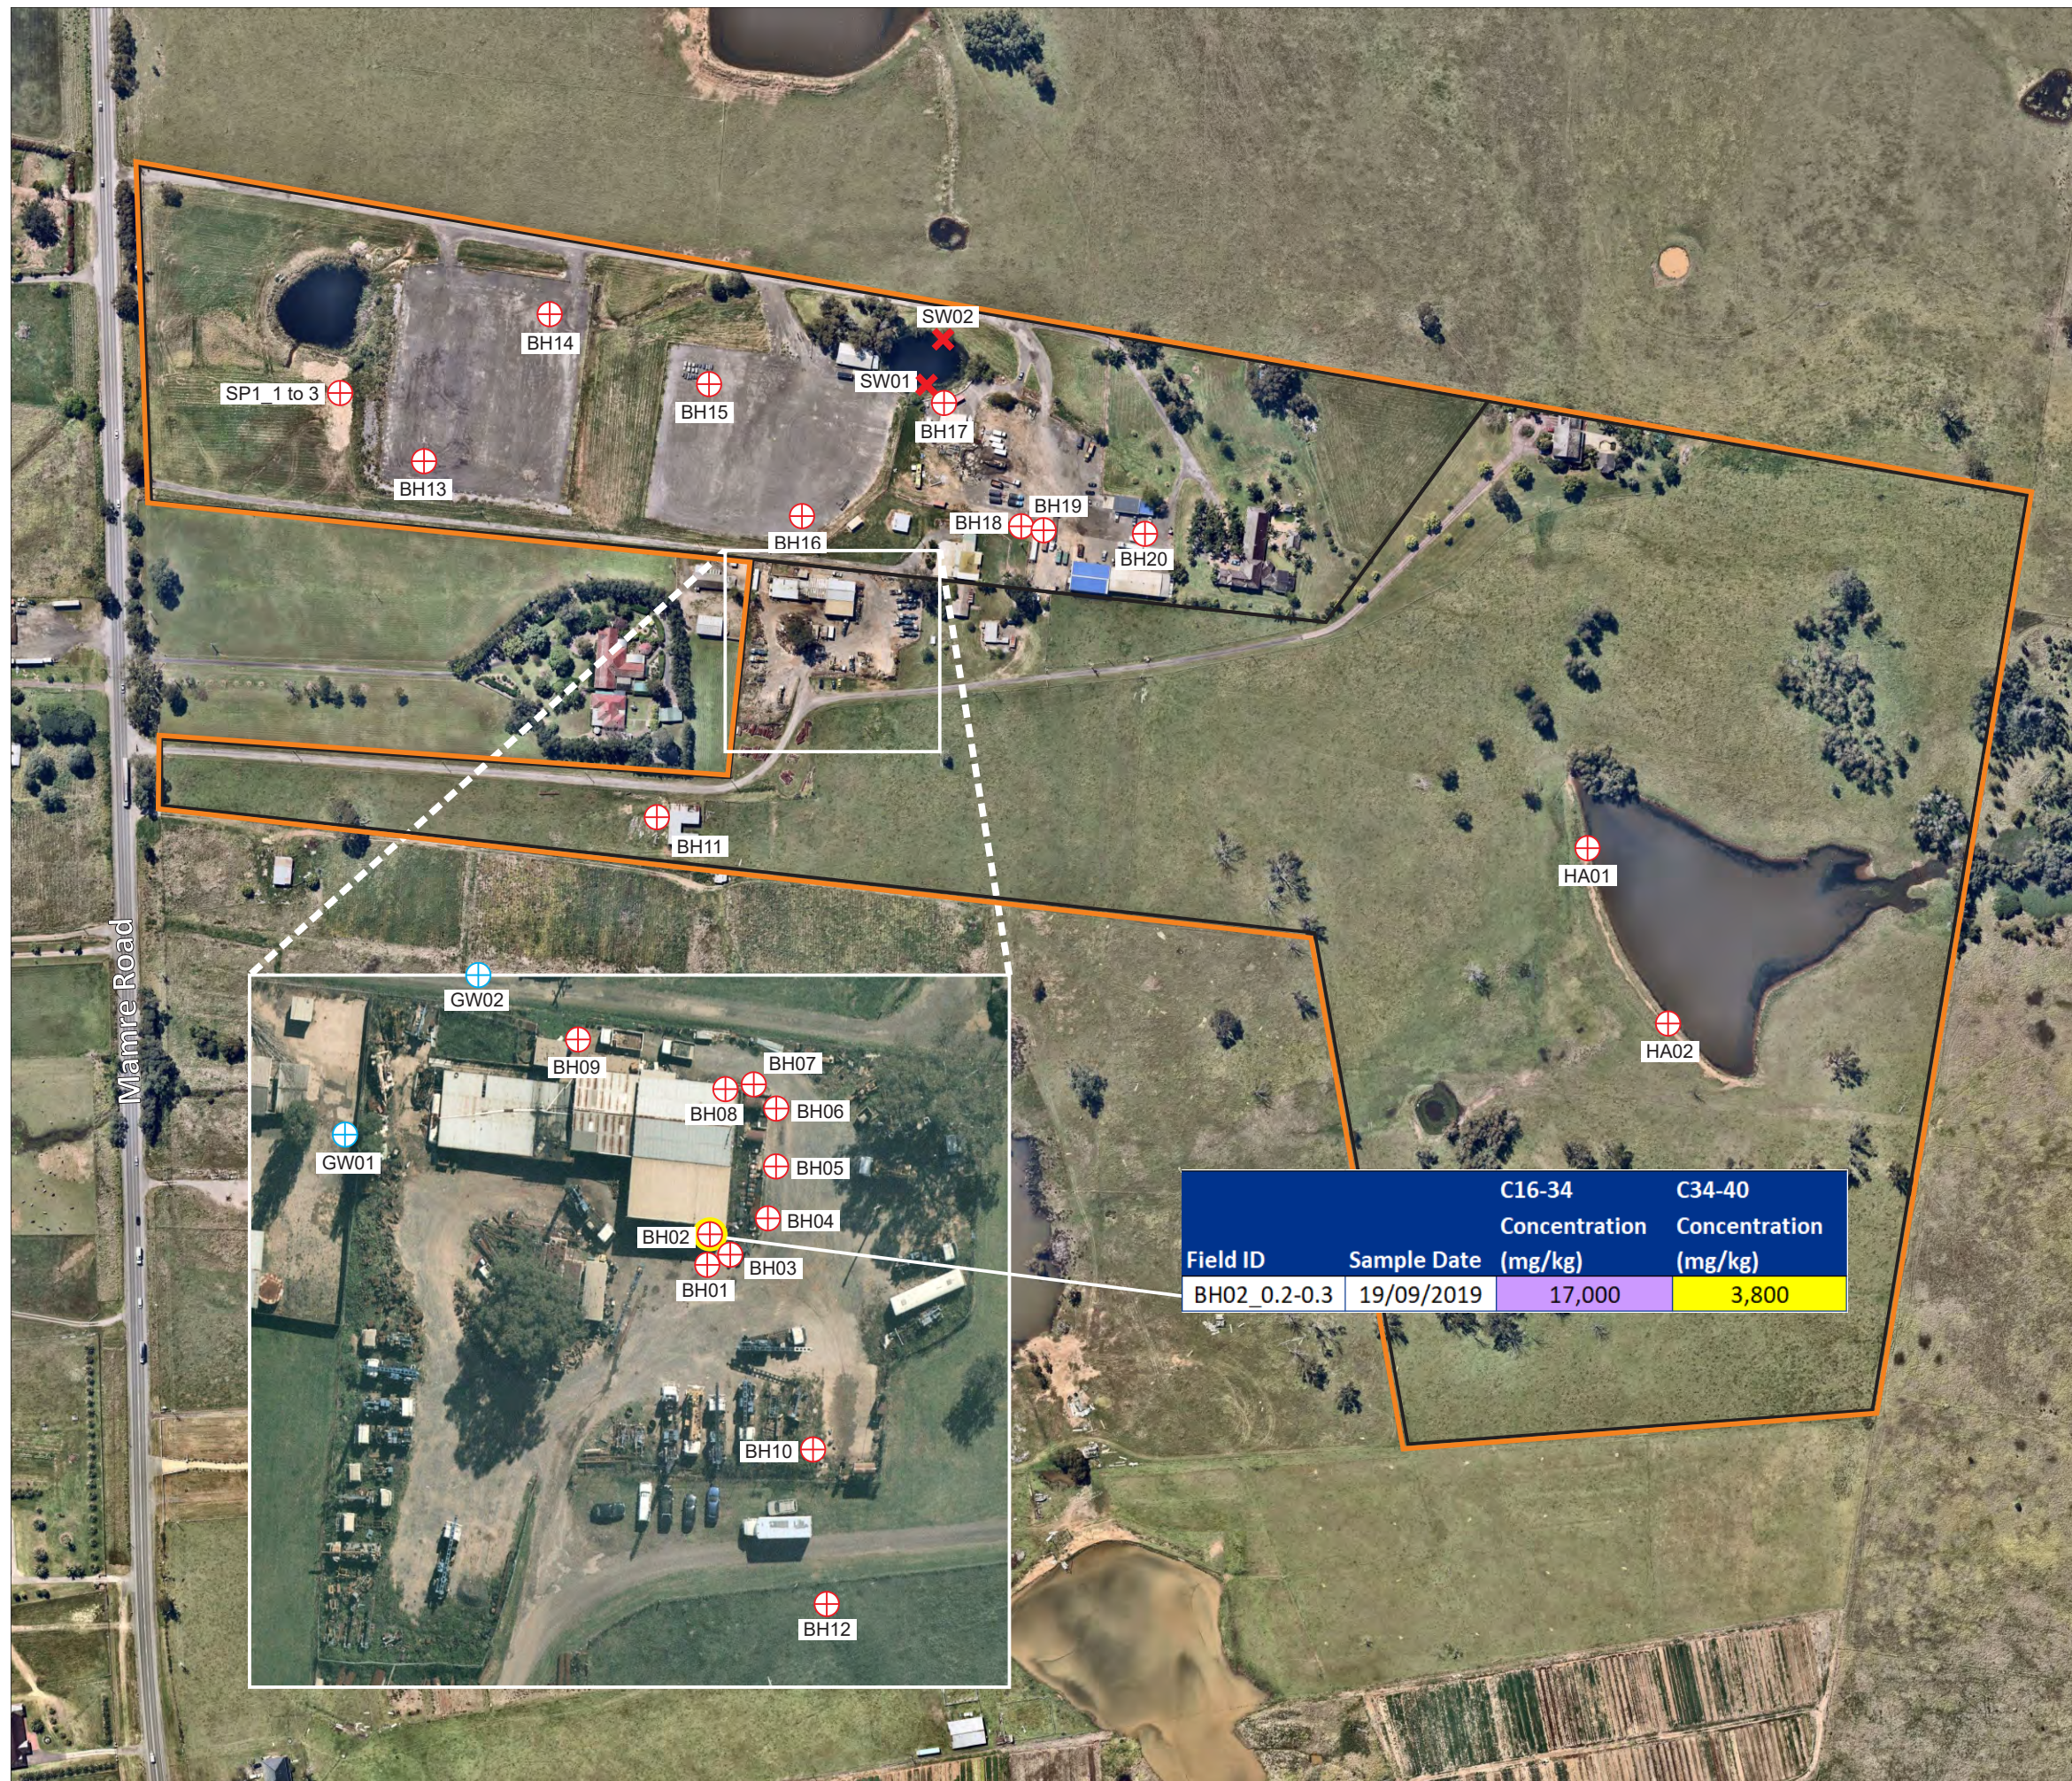
- Guideline Criteria**
- 3500 mg/kg NEPM 2013 Table 1B(7) Management Limits Commercial / Industrial (Coarse Soil)
- 3300 mg/kg NEPM 2013 Table 1B(6) ESLs for Commercial / Industrial (Coarse Soil)
- TRH Concentration Above Guideline Criteria

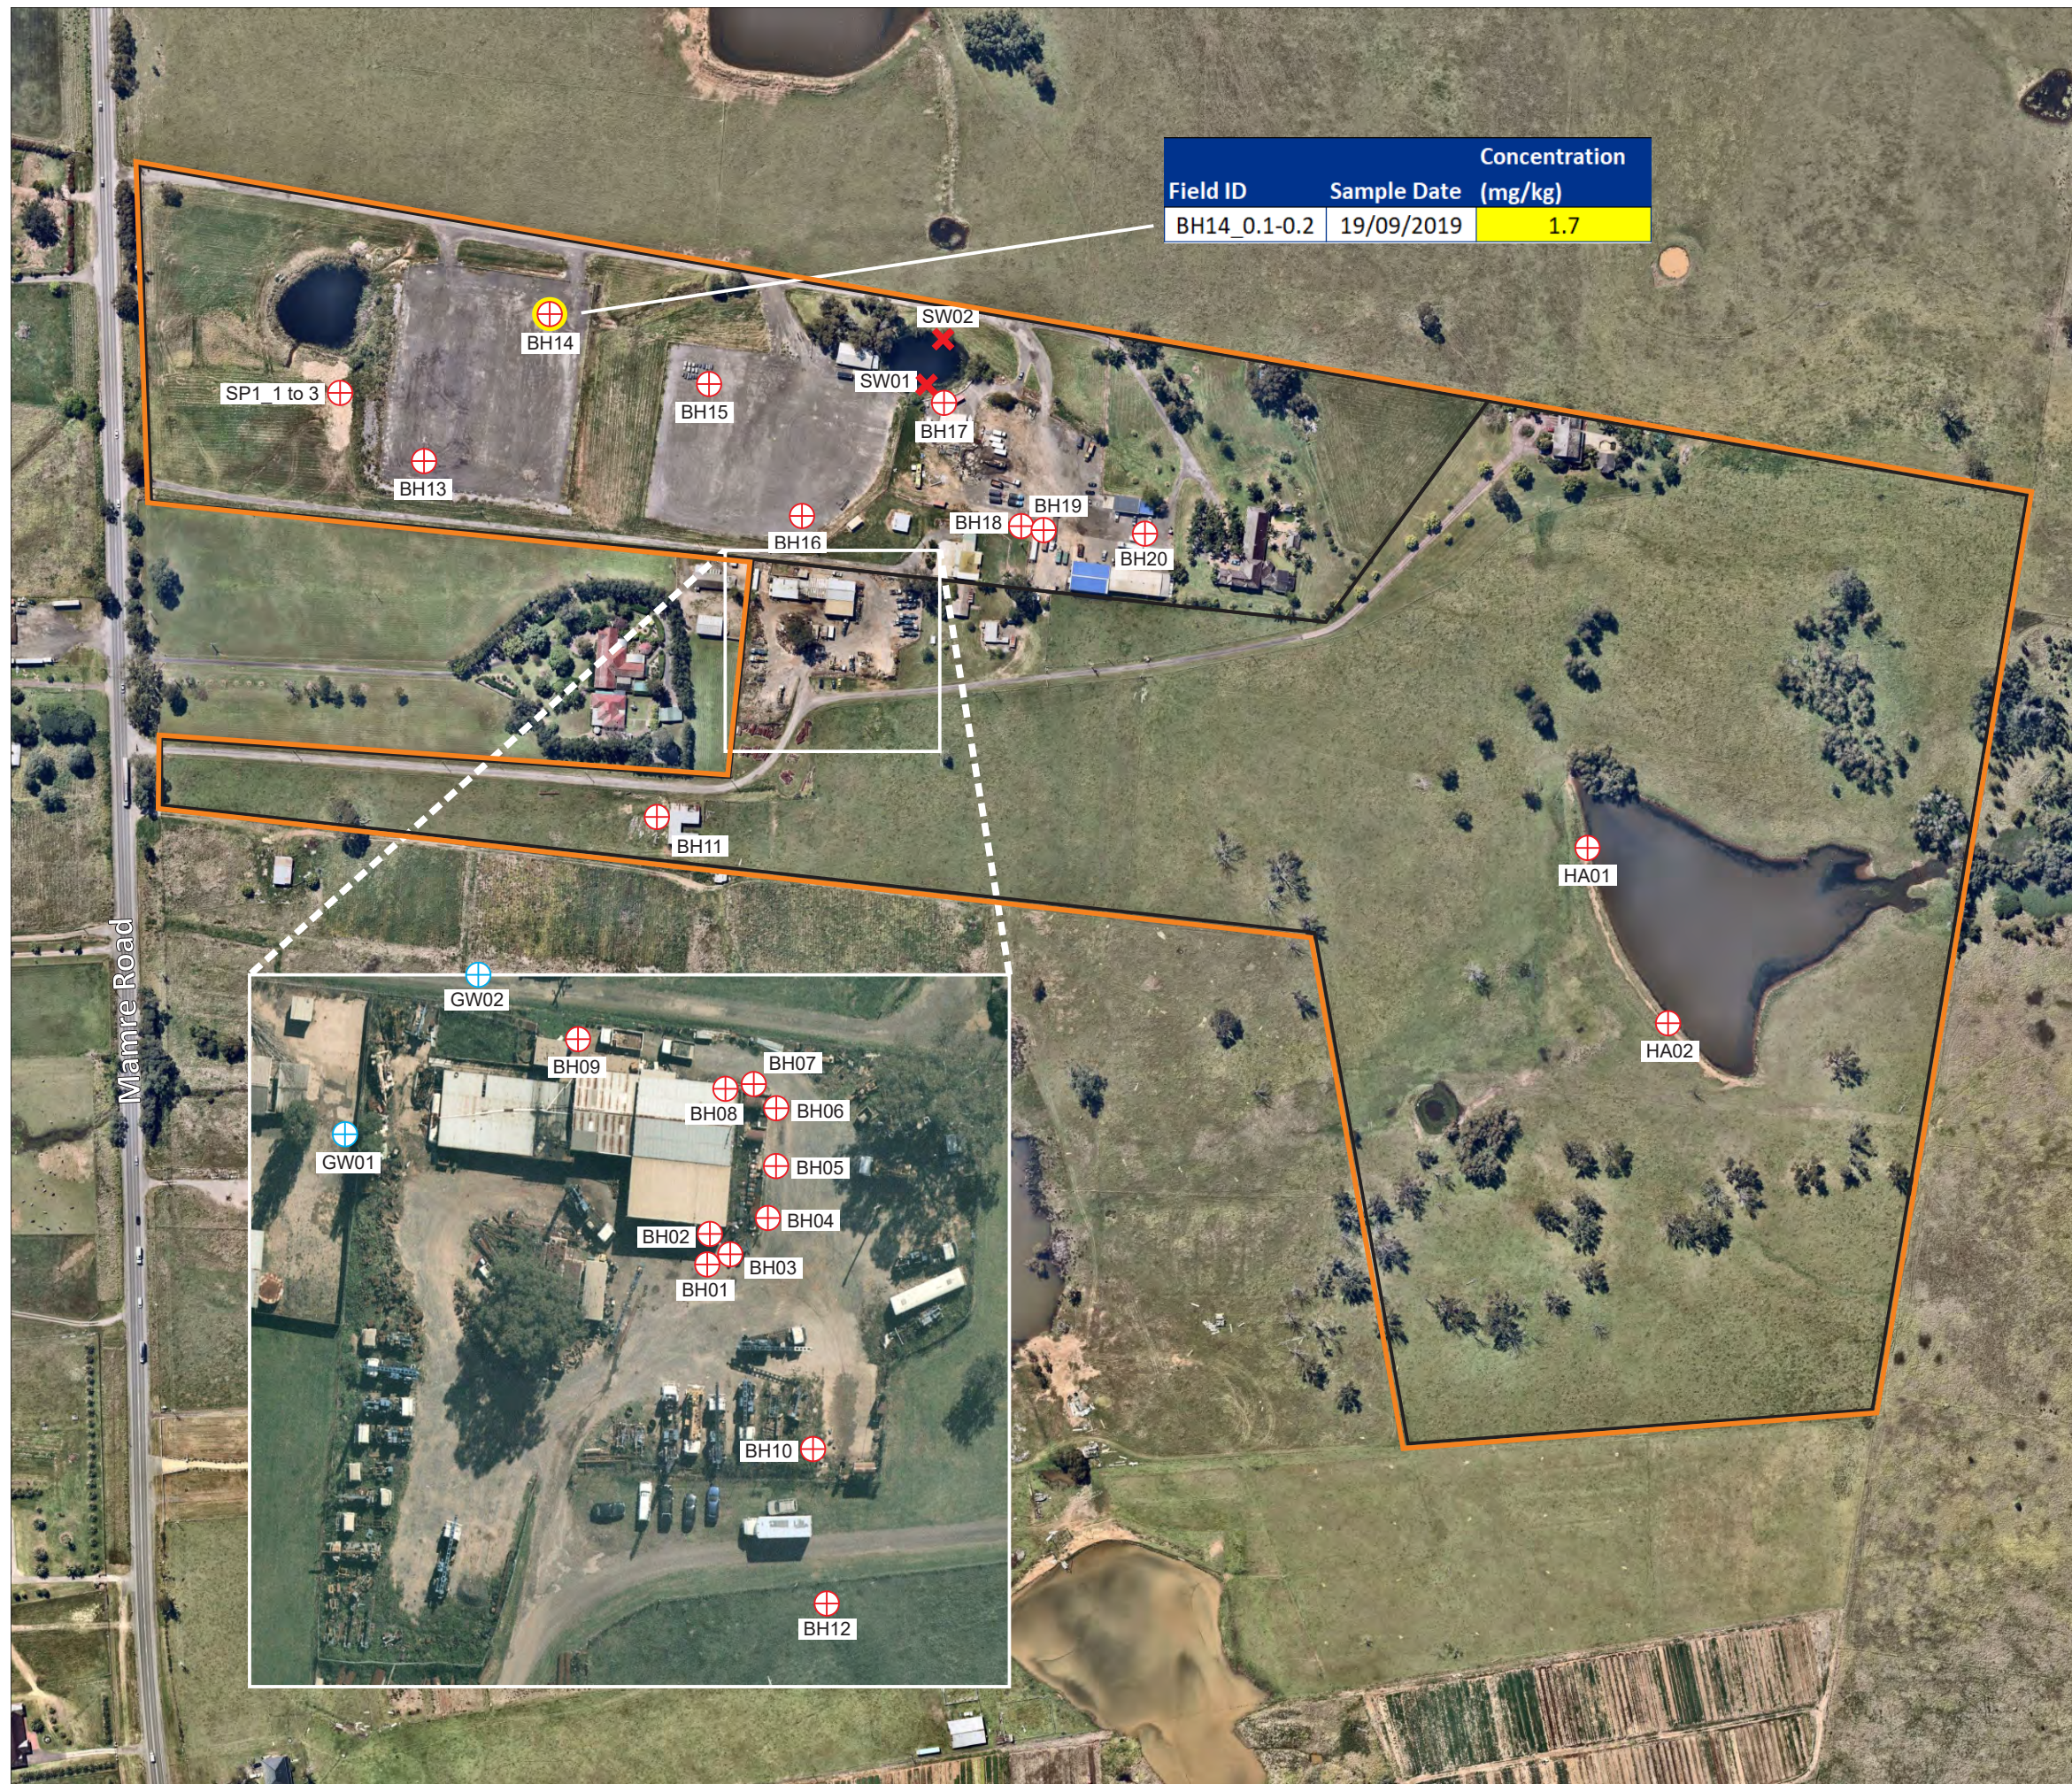
Field ID	Sample Date	Concentration (mg/kg)
BH14_0.1-0.2	19/09/2019	1.7

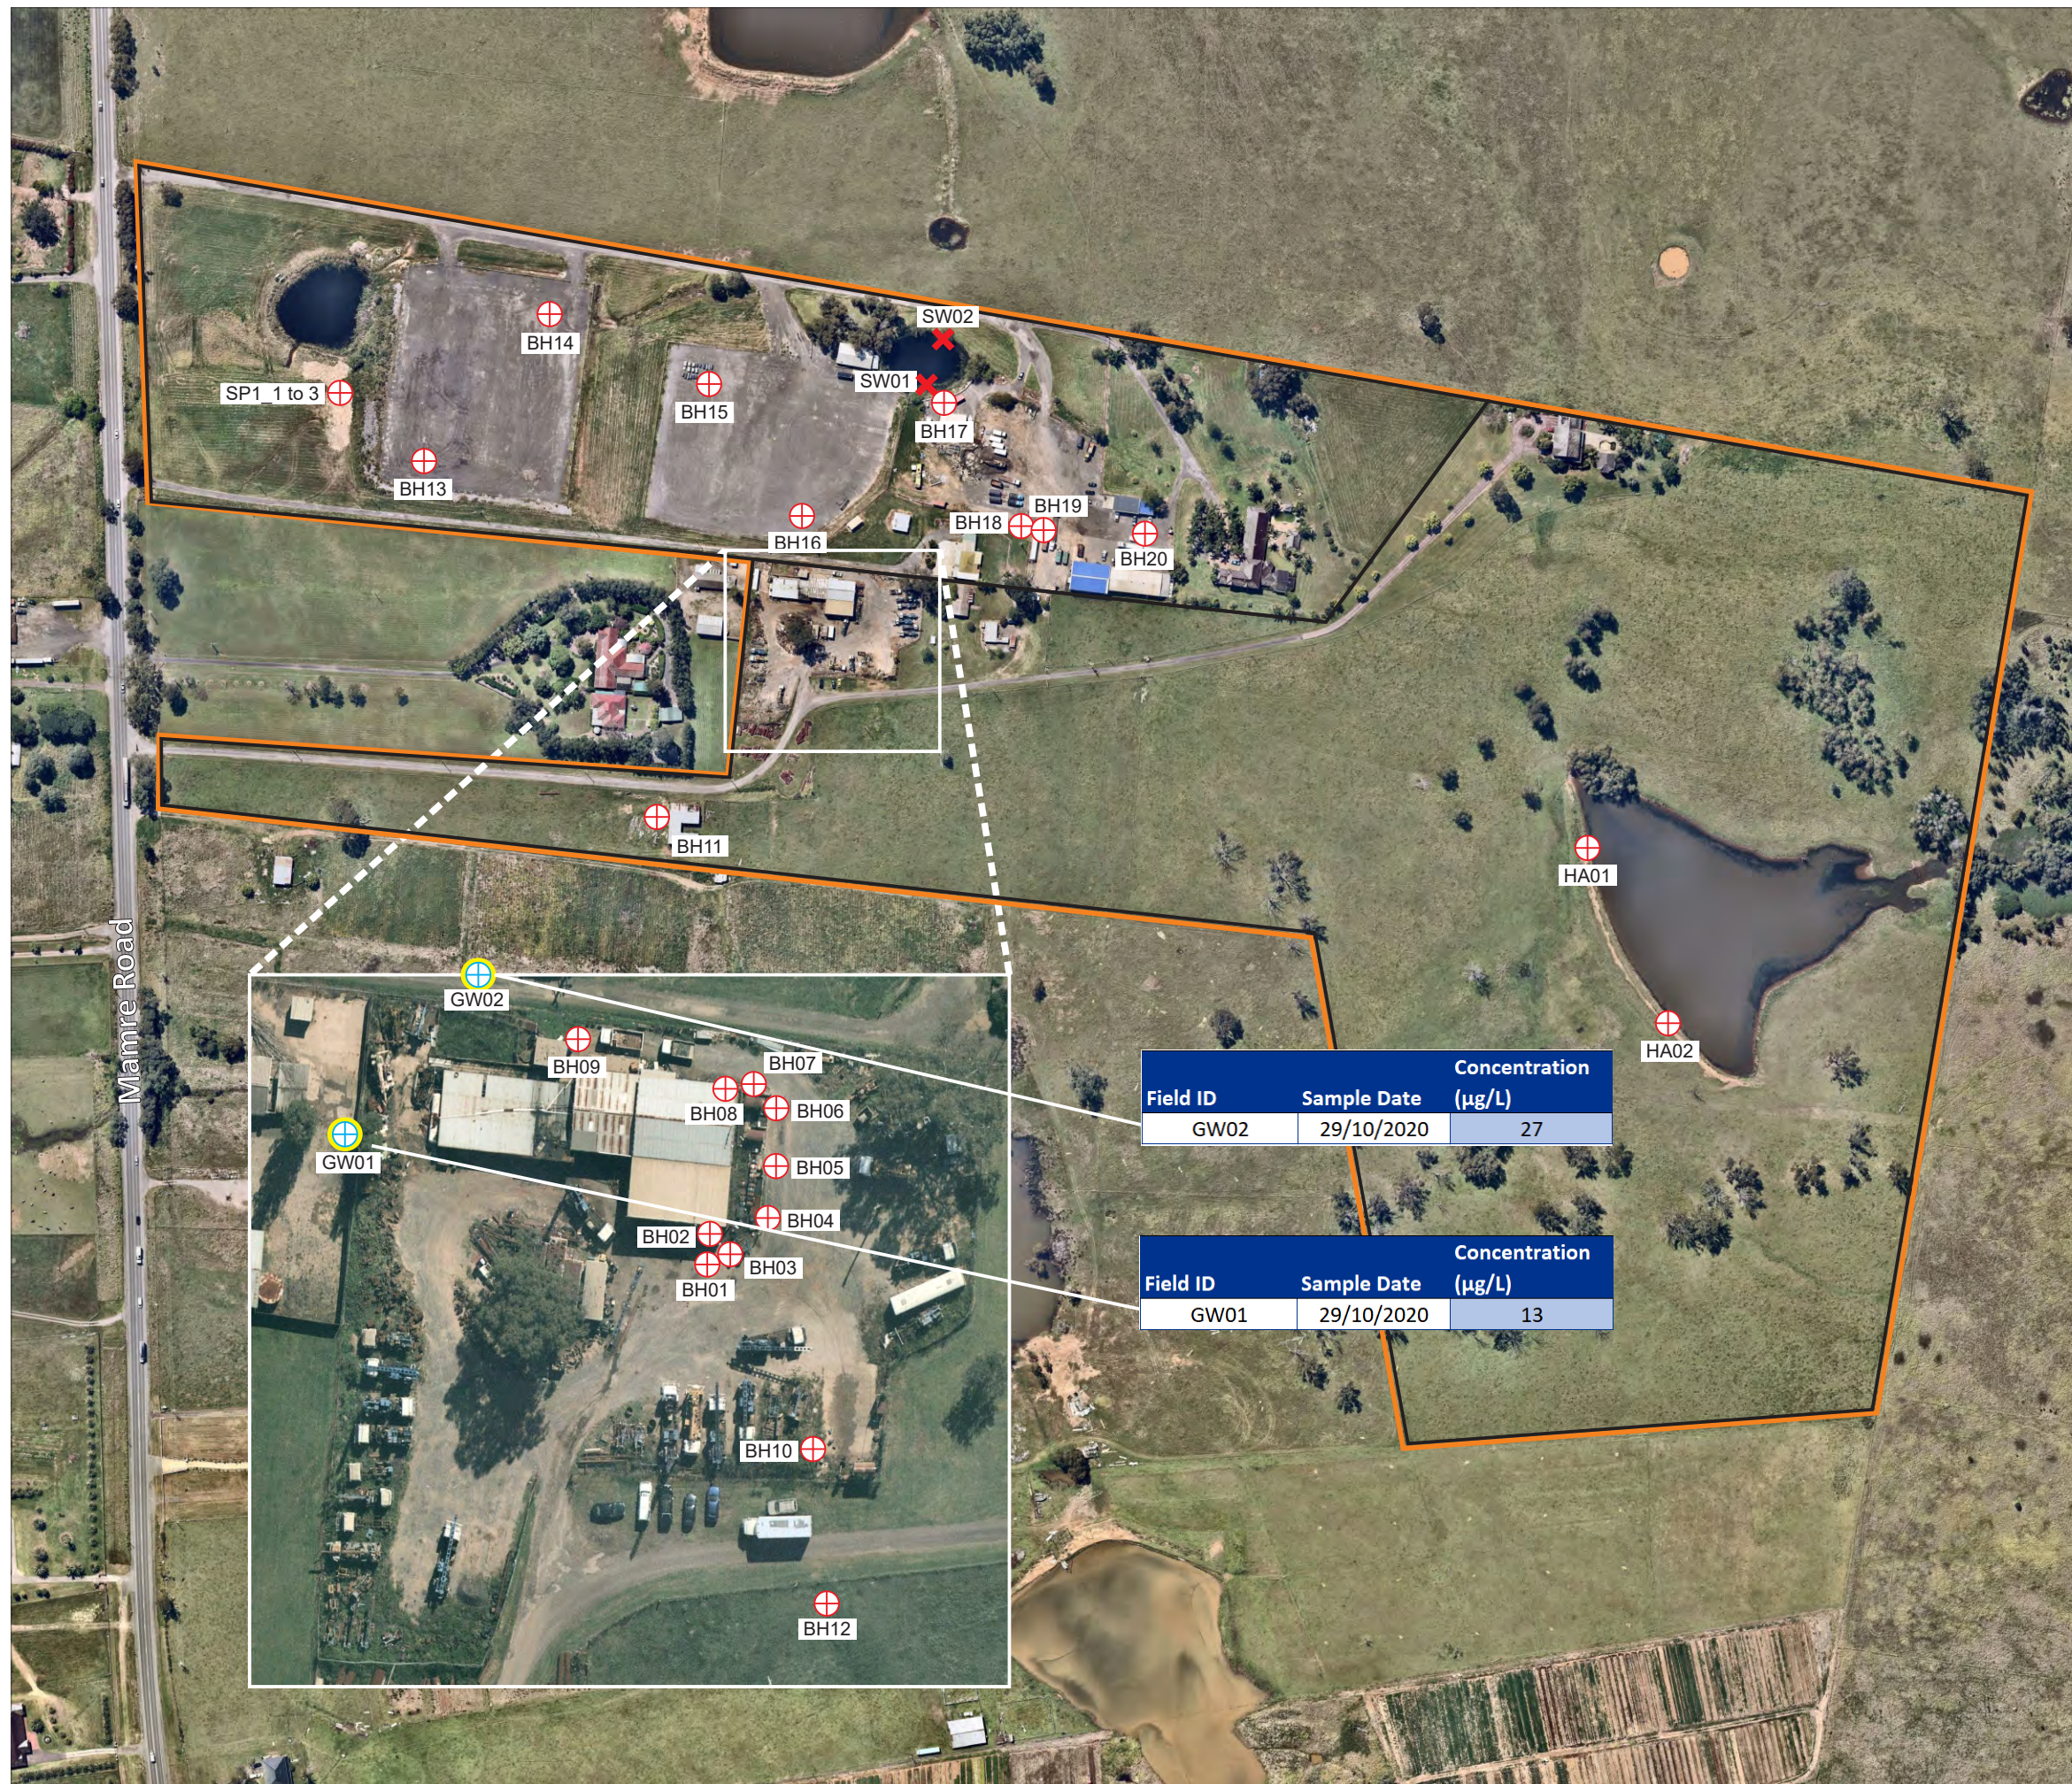
Nickel (Filtered) Concentration Above Guideline Criteria

Note: GW01 is located offsite
