# Preliminary Site Investigation

*754-770 & 784-786  
Mamre Road,  
Kemps Creek,  
NSW*

23 March 2021

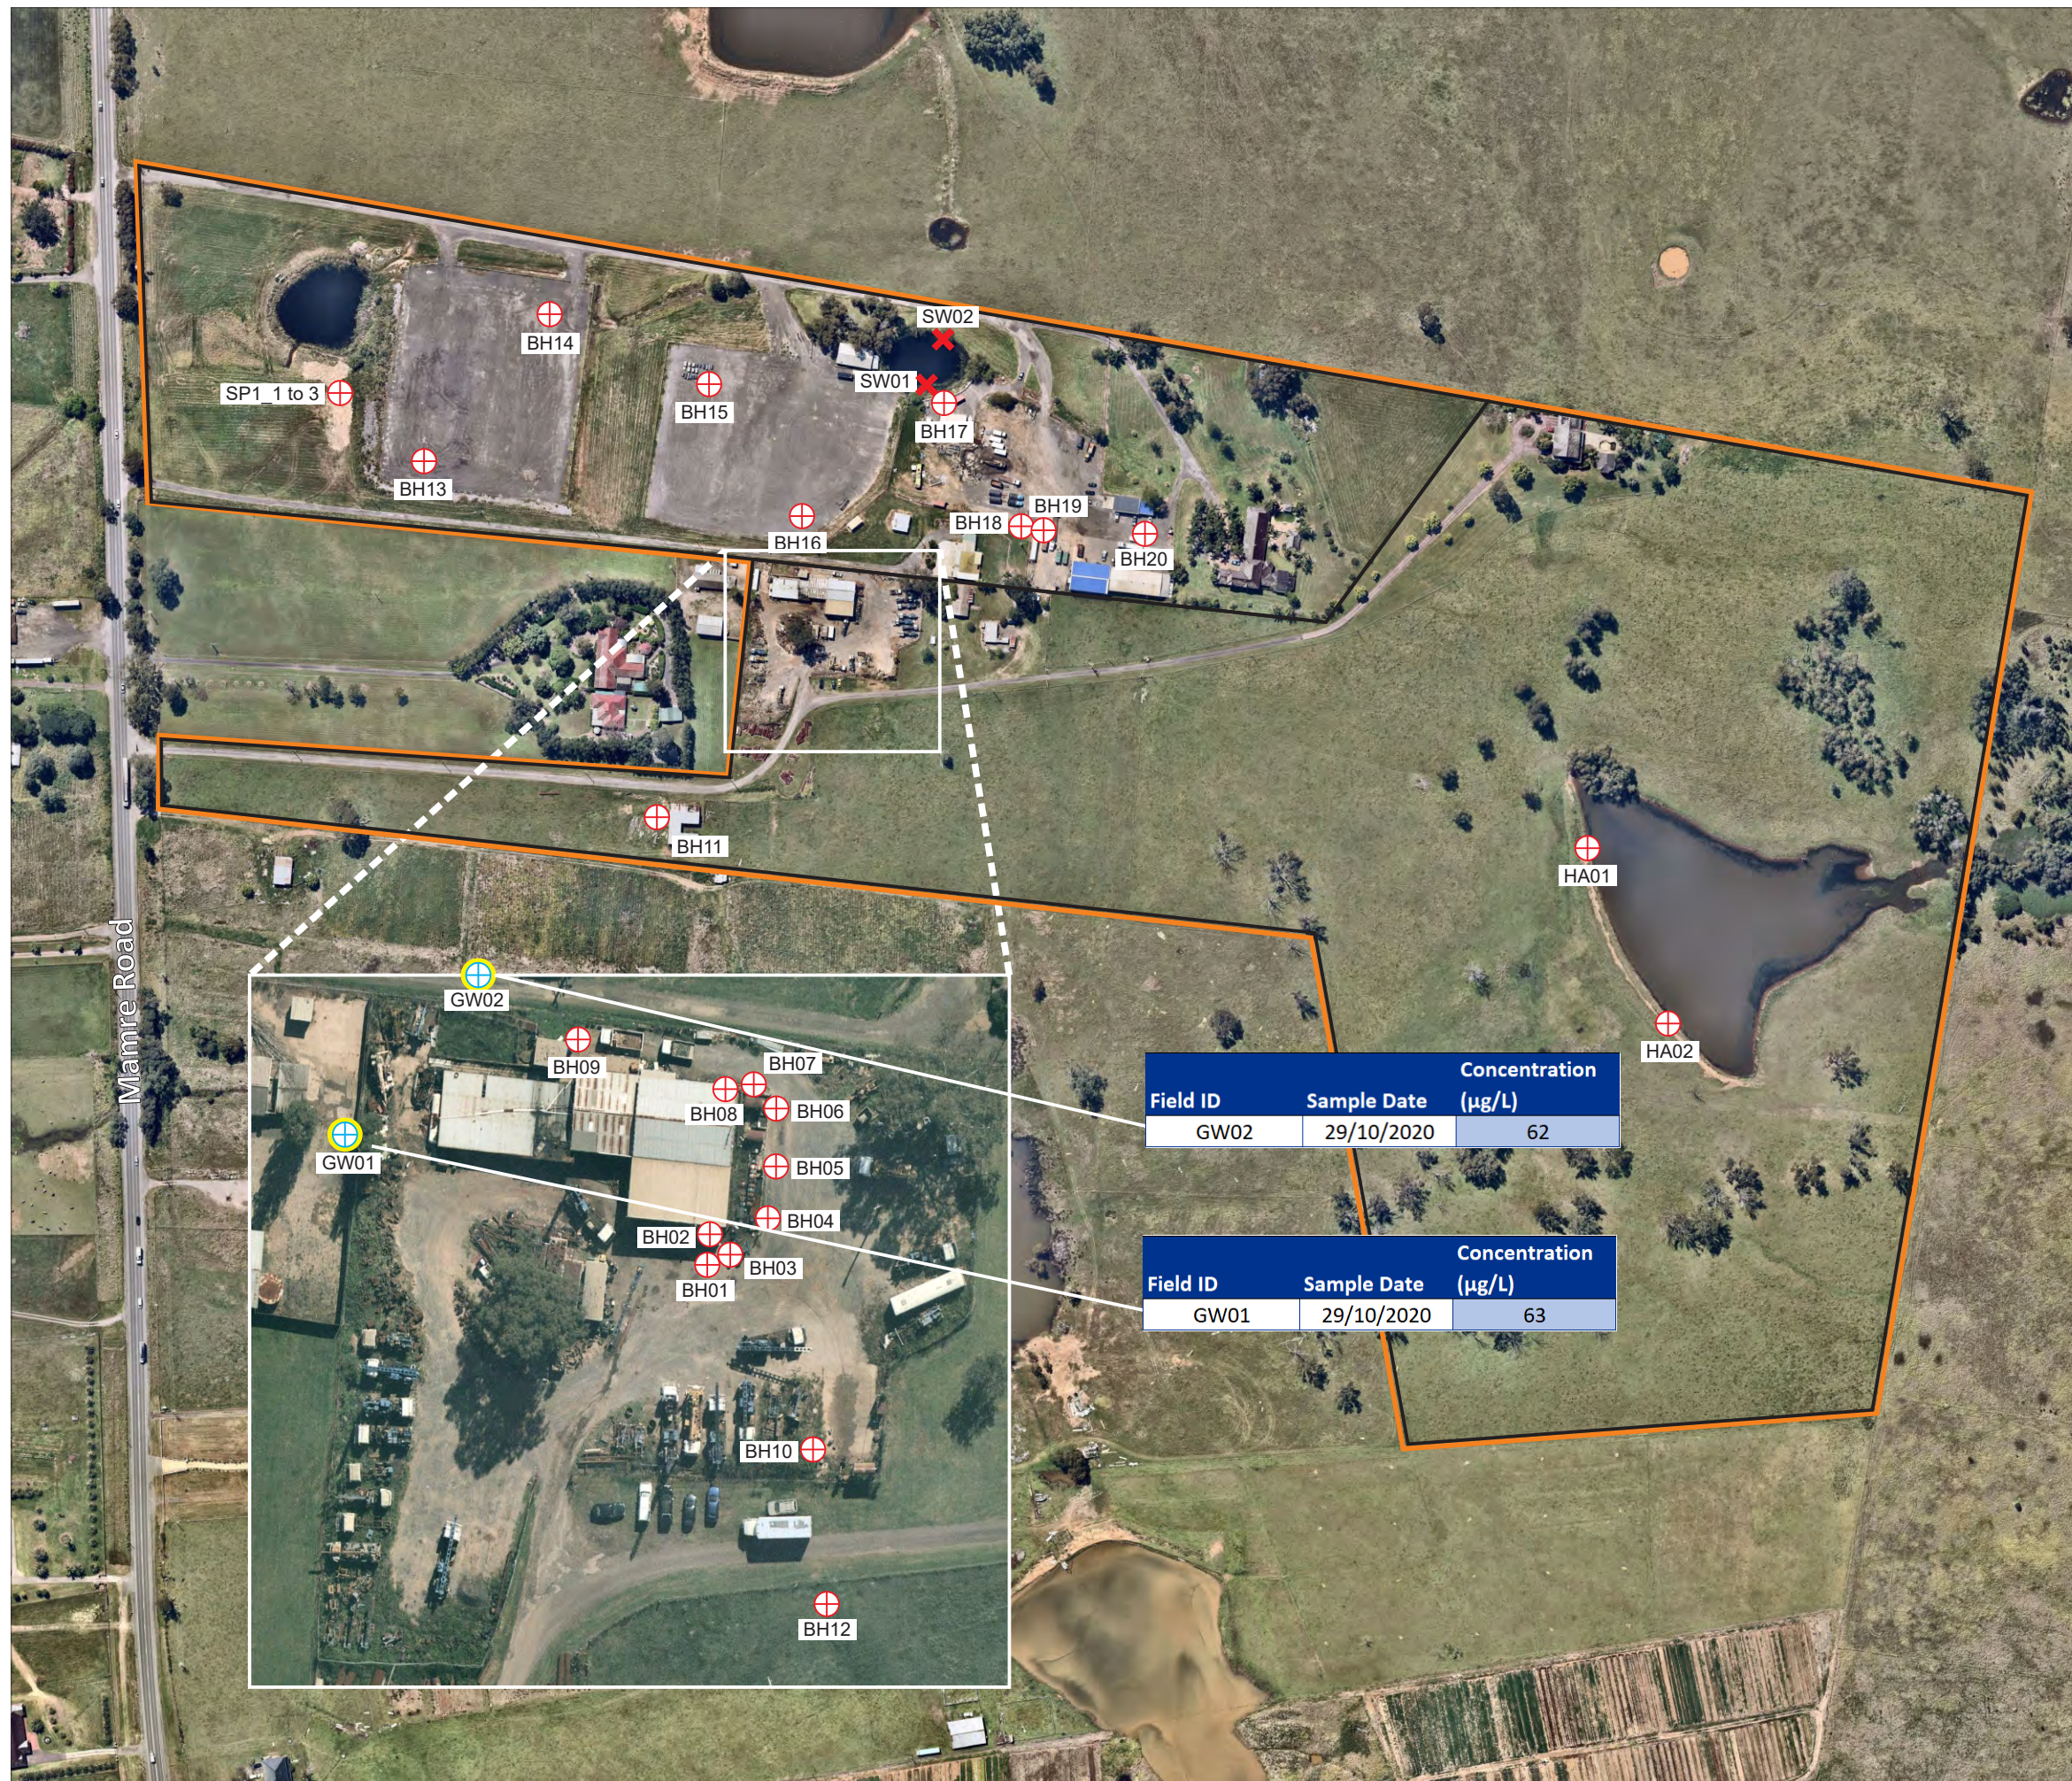
- Site Boundary
- Property Boundary
- Previous Investigation Sampling Locations**
- KPMG 2019 Soil Sampling Location
- KPMG 2020c Groundwater Sampling Location
- KPMG 2020c Surface Water Sampling Location

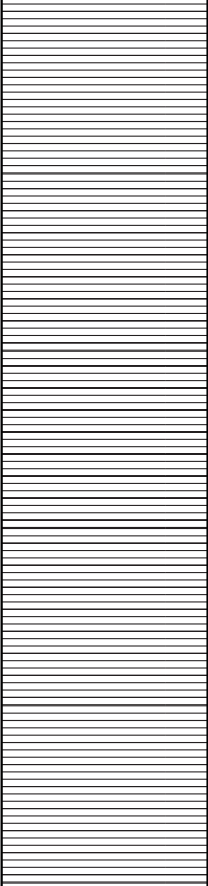
CLAY: Stiff, dark orange and tan clay, low plasticity	No odours
			0.6				
			0.8				
			1.0				All PID <0.1 ppm
BH02_1.0-1.1	N	UD					
			1.2

D	SHALE: Hard, tan shale, low plasticity	
			1.4				
			1.6				
			1.8				
			2.0				
BH02_2.0-2.1	N	D					
			2.2				
			2.4				
			2.6				
			2.8				
			3.0				
BH02_3.0-3.1	N	D					
			3.2				
			3.4				
			3.6				
			3.8				
			4.0				
BH02_4.0-4.1	Y	D					
			4.2			End of hole: 4.1 m refusal on weathered shale	
			4.4				
			4.6				
			4.8

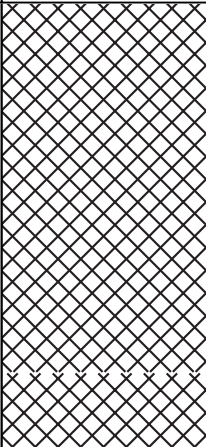
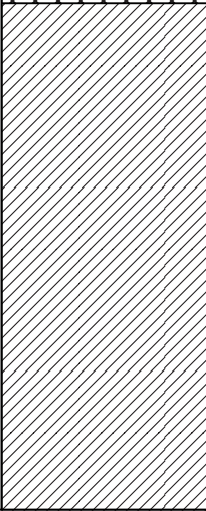
M	FILL: Firm, dark brown, gravelly clay, low plasticity	Crushed sandstone fill  All PID <0.1 ppm
BH17_0.4-0.5	N	UD	0.4				
			0.6				
			0.8				
			1				
BH17_1.2-1.3 / QA2	Y	UD	1.2				
			1.4				
			1.6				
			1.8				
			2				
			2.2

CLAY: Firm, black / brown clay, medium plasticity  becoming maroon at 1.5 to 3.2 m  ironstone gravels at 3.2 m	
			2.4				
			2.6				
			2.8				
			3				
BH17_3.0-3.1	Y	UD	3.2				
			3.4				
			3.6				
			3.8				
			4				
			4.2			End of hole: 3.2 m target depth achieved	
			4.4				
			4.6				
			4.8
