HISTORICAL ARCHAEOLOGICAL ASSESSMENT

WINX STAND - LEGER LAWN, ROYAL RANDWICK RACECOURSE

30 OCTOBER 2019
P0005973
FINAL
PREPARED FOR THE AUSTRALIAN TURF CLUB

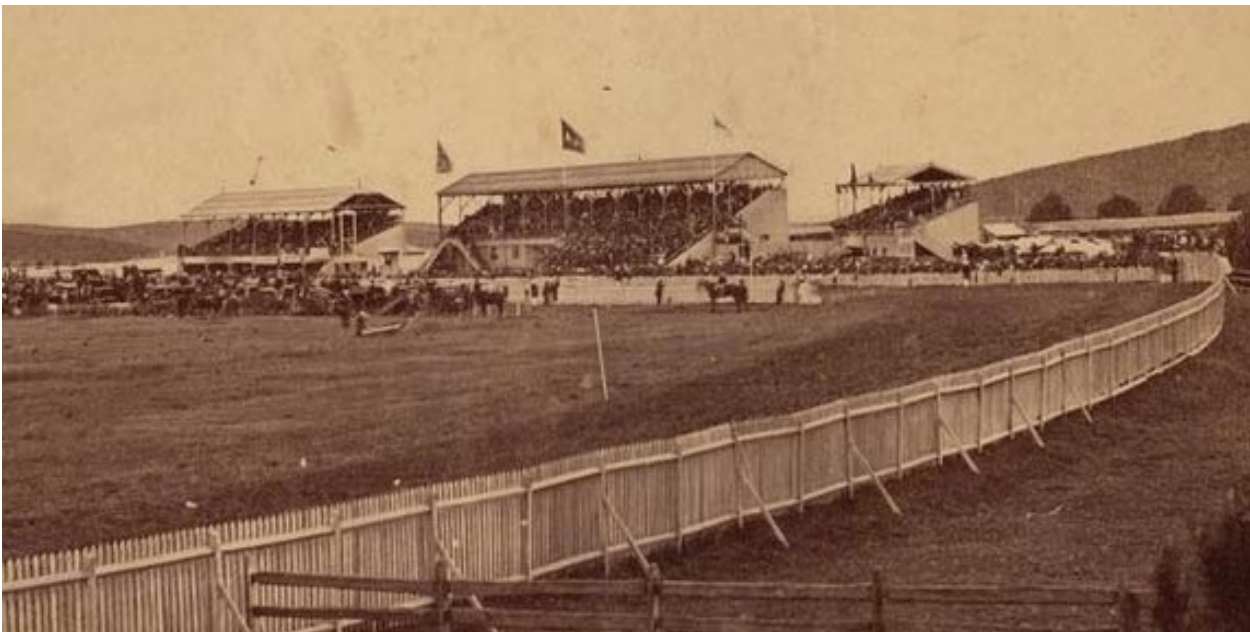
Figure 6 - View of the racecourse, before commencement of construction works in the mid-1870s. The St Leger Stand is at far left (demolished 1882); the 1860 Hilly Grandstand at centre (demolished 1875); and the Derby Stand at right (demolished 1880)

Overall, this was a period of widespread development for the entire racecourse. Within the subject area, this period saw the construction of the original St Leger Stands, both of which were built out of wood (Figure 6). The first stand was constructed in 1867 and demolished in 1882 to make way for the second St Leger Stand (Figure 7), which survived until 1910. These stands were made of wood and there is a low potential for any remaining parts within the subject area due to later development such as the construction of the last St Leger Lawn in 1911. Figure 8 shows the northern section of the St Leger Stand within the subject area and Figure 9 confirms that with additional structures are also included within the subject area including the Grand Stand and a small building in between the two stands.

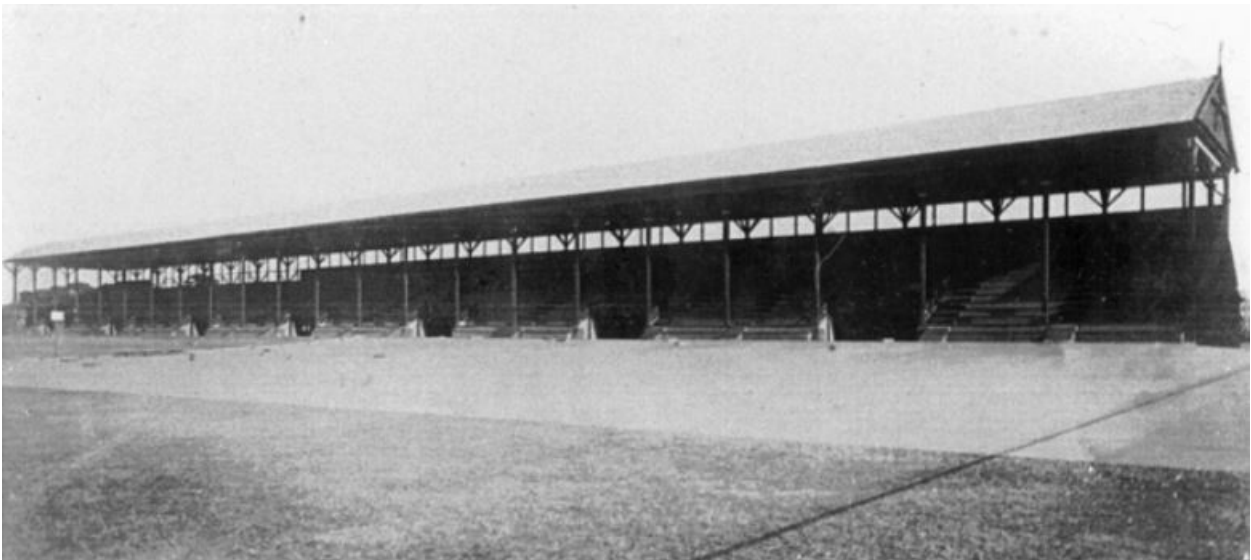
Figure 7 – The second St Leger Stand in 1882. Note the substantial structural change compared to the first stand and landscaping in the foreground.

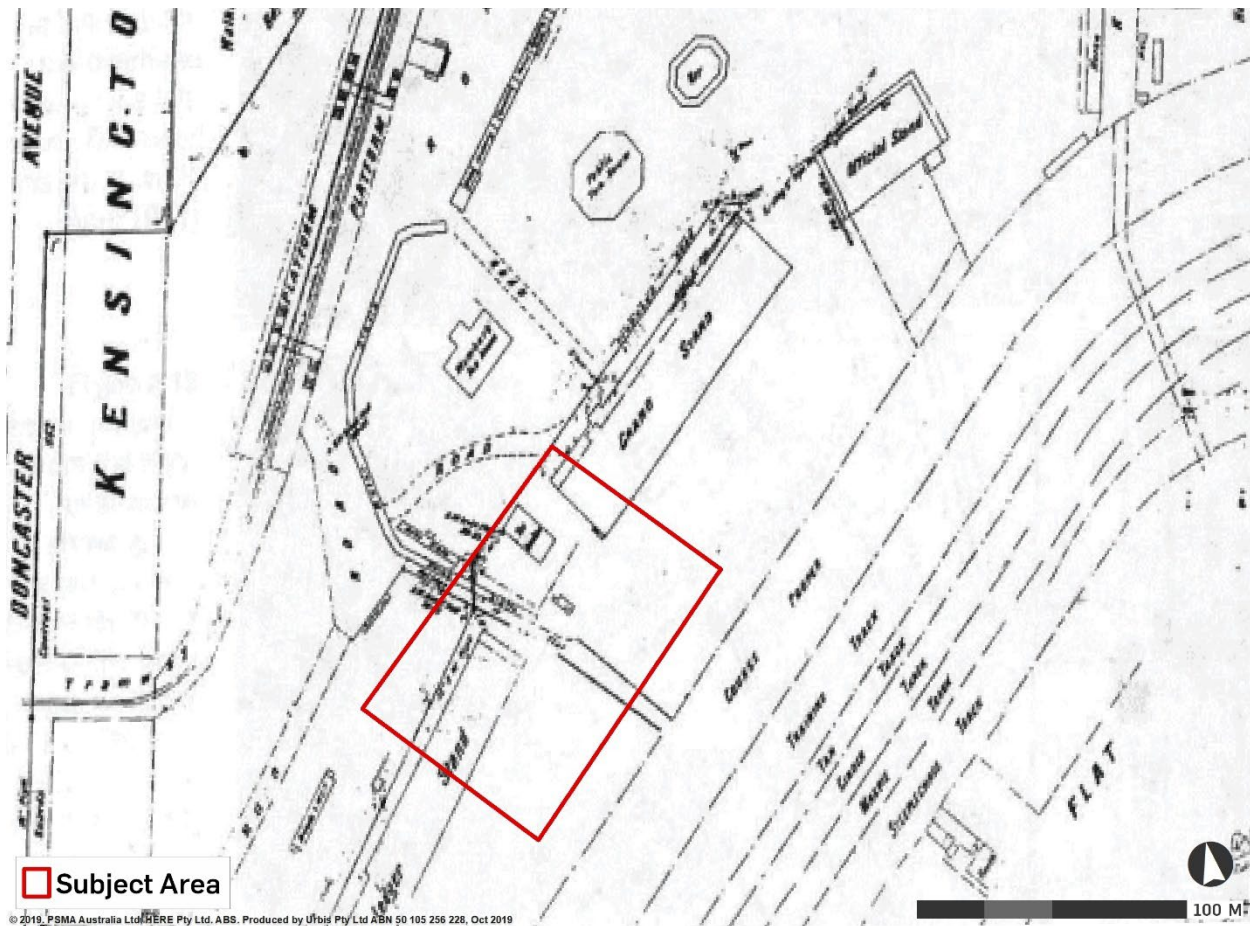
Figure 9 - Detail of Sydney Water Board survey of the racecourse, 1907. Note that apart from the St Leger Stand, part of the Grand Stand and a small building are also included within the subject area.

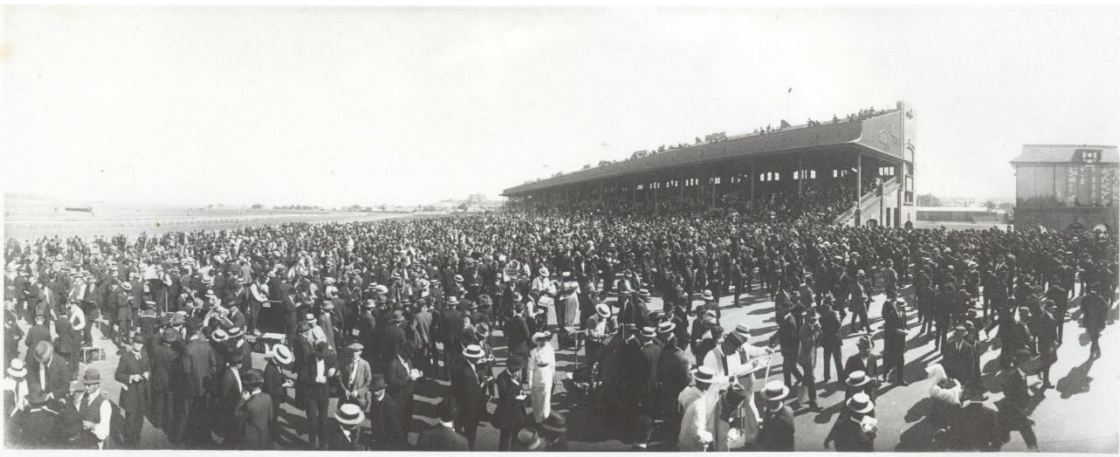
St. Leger enclosure, with Betting Ring in foreground. Stand and Scratching Tower

Figure 10 – Race day in 1914. Note the Scratching Tower on the right side of the photo.

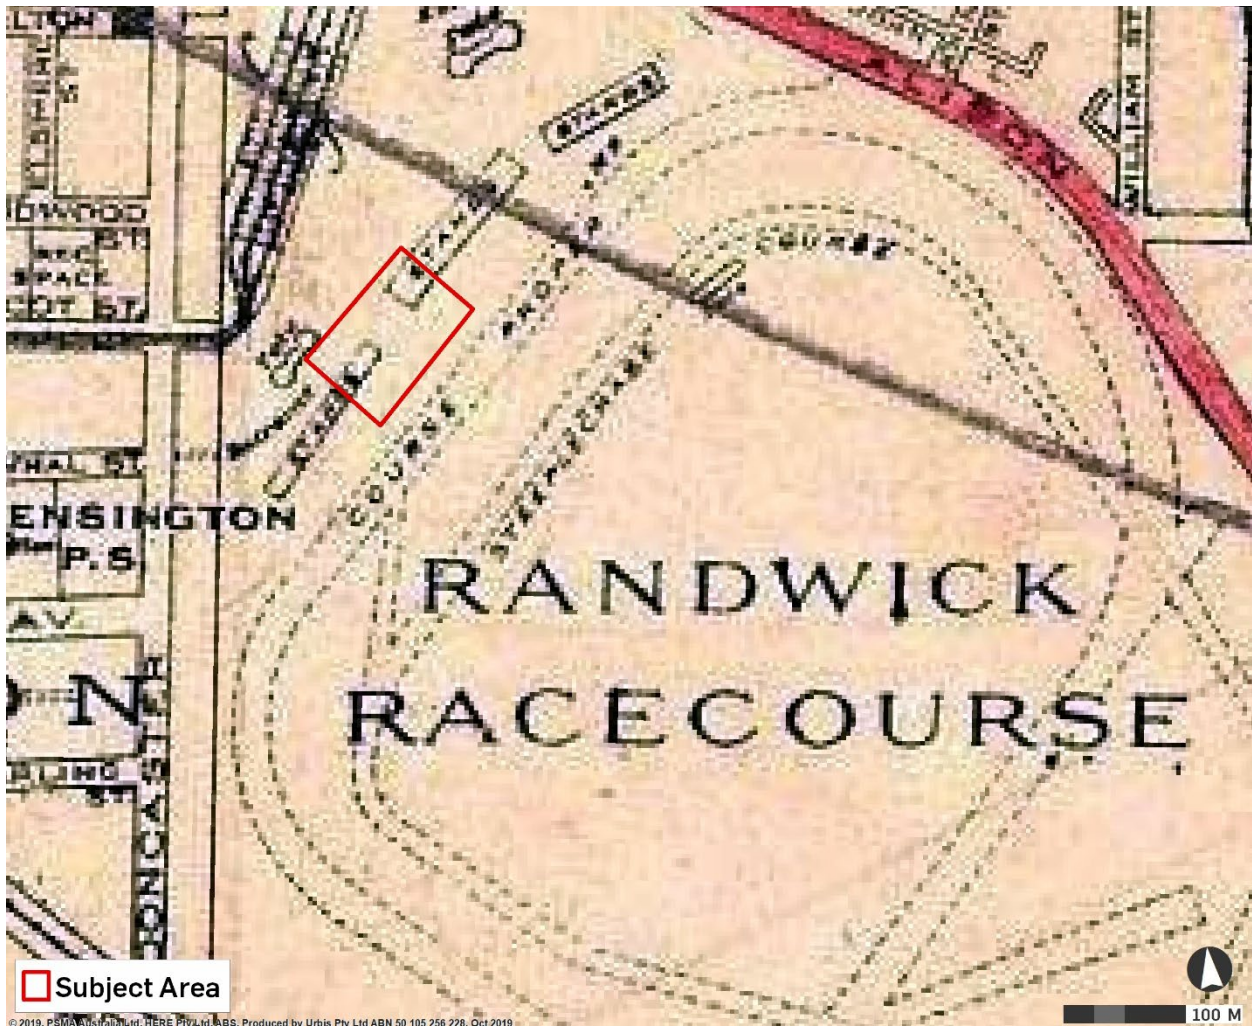
Figure 11 – Post 1917 map showing the three stands on site. Note that the subject area encompasses both part of the St Leger Stand as well as the Queen's Stand.

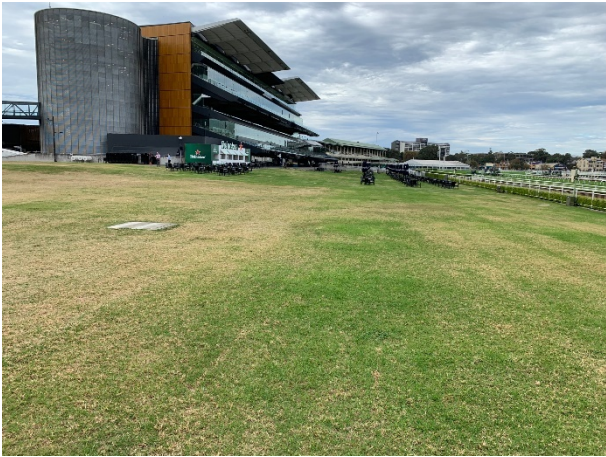
Figure 13 – subject area looking towards the Paddock Stand. Aspect NE.

Field inspection was carried out on 2 May 2019 with highly limited ground surface visibility (GSV) as a result of the landscaping of the subject area. The subject area comprises a turf, and partially paved area, just south-west of the Paddock Stand (Figure 13, Figure 14, Figure 15 and Figure 16). The entire area is covered by turf and imported fill. Based on the geotechnical investigation, there is a minimum of 1 m imported fill on top of the original sand dune landscape. No visible signs of previously constructed structures of the St Leger Lawn, the Queen's Stand or the Scratching Tower were found. No invasive archaeological investigation has been undertaken to inform this HAA.

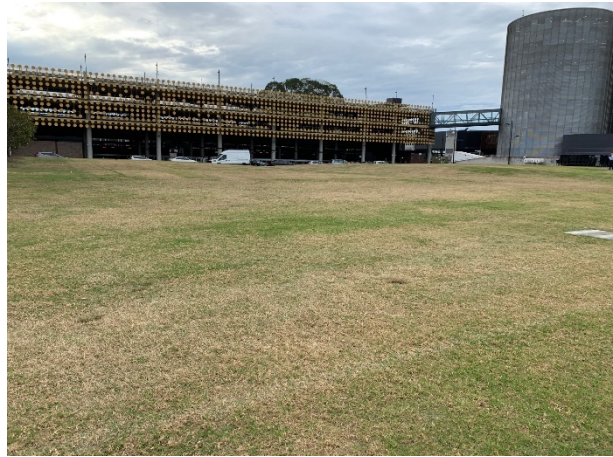
Figure 14 – Subject area looking towards the multi-level carpark. Aspect N.

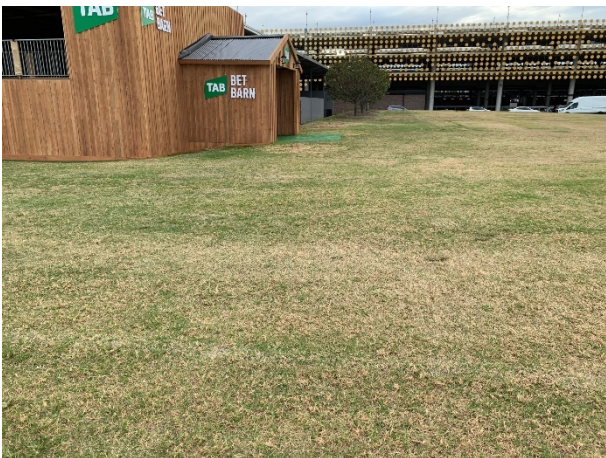
Figure 15 – Subject area looking towards the multi-level carpark and the temporary race stalls. Aspect NW.

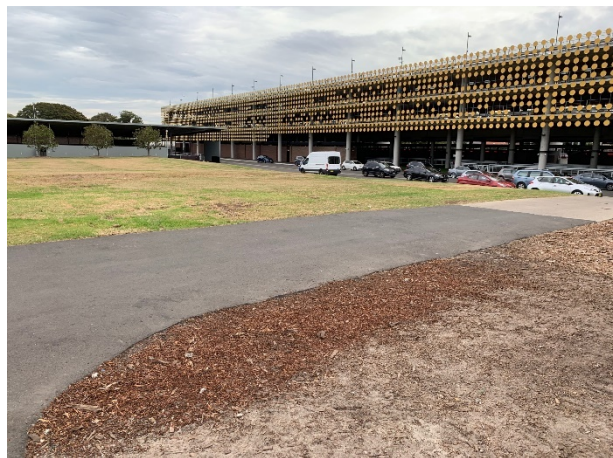
Figure 16 – Subject area looking towards the multi-level carpark. Aspect W.

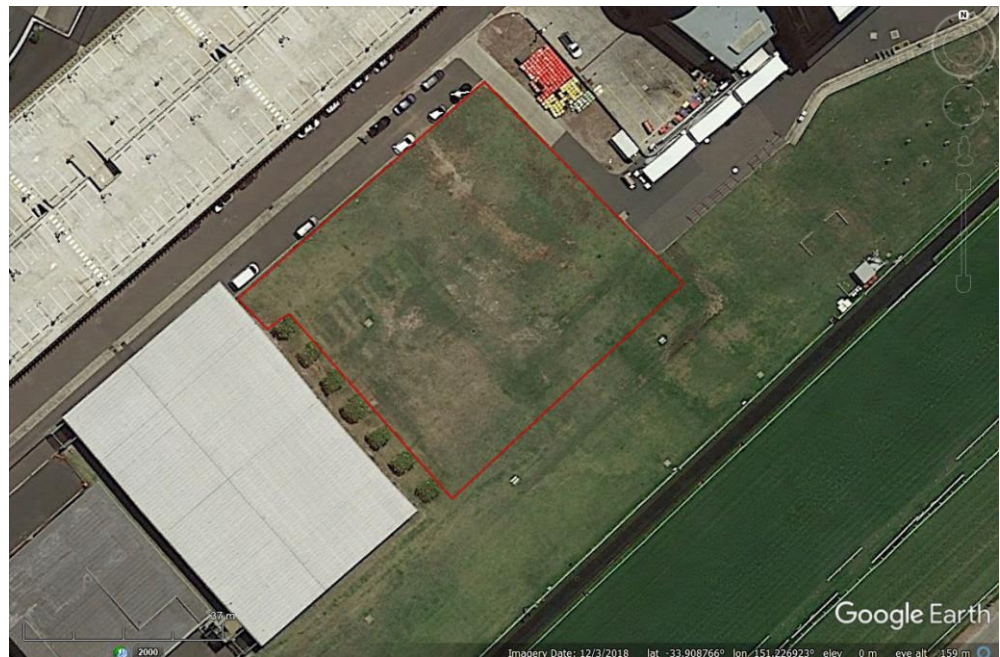
Figure 1: Approximate survey area (outlined in red) within the Leger Lawn area.

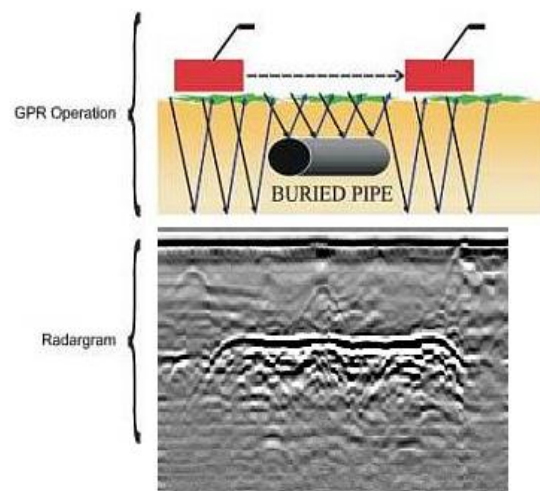
Figure 2: GPR operation and the reflection profile across the length of a buried pipe. A similar anomaly would be presented due to a subsurface footing/foundation.

Ground penetrating radar (GPR) is a geophysical method that uses radar pulses to image the subsurface (figure 2). GPR uses transmitting and receiving antennas. The transmitting antenna radiates short pulses of high-frequency radio waves into the ground/material. When the wave hits a buried object or a boundary with different dielectric constants, the receiving antenna records variations in the reflected return signal. The depth range of GPR is limited by the electrical conductivity of the ground. As ground conductivity increases, the signal penetration depth decreases. This is caused when the electromagnetic pulse emitted by a GPR transmitter is more quickly dissipated into heat, causing a loss in signal strength at depth.

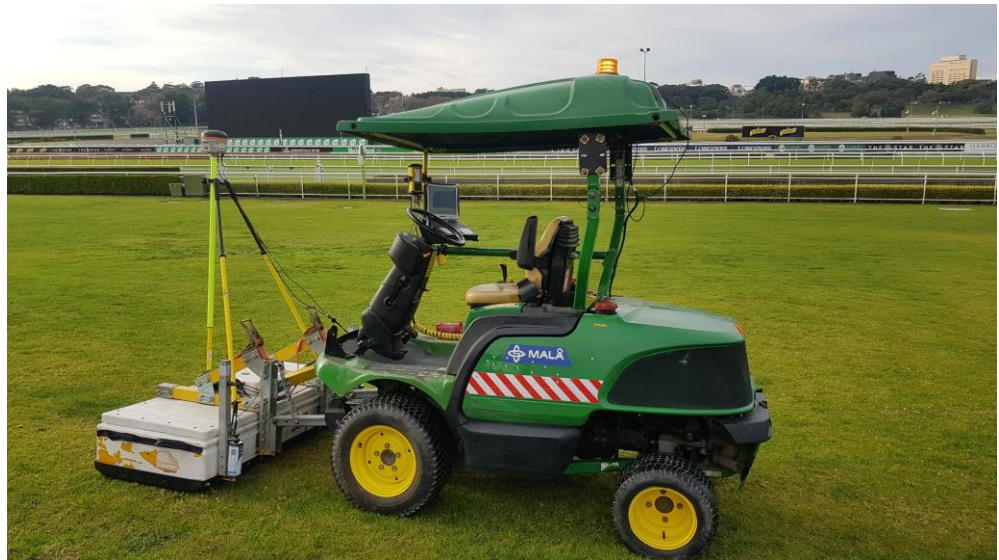
Figure 3: MALA 400MHz 3D MIRA acquiring data on site.

The MIRA instrument has the ability to quickly and easily gather full 3D data in broad paths, called "swats" using 16 channels. This allows for data collection in one pass (i.e. a swat needs to be covered only once, in singular direction) as opposed to single channel systems which require multiple passes in multiple directions. The MIRA system is an efficient and effective solution for large scale ground penetrating radar mapping and subsurface object identification. Results are processed in 3D depth slices and are displayed and interpreted through a dedicated software package (rSlicer) and then exported into suitable GIS or CAD data formats (.dxf).

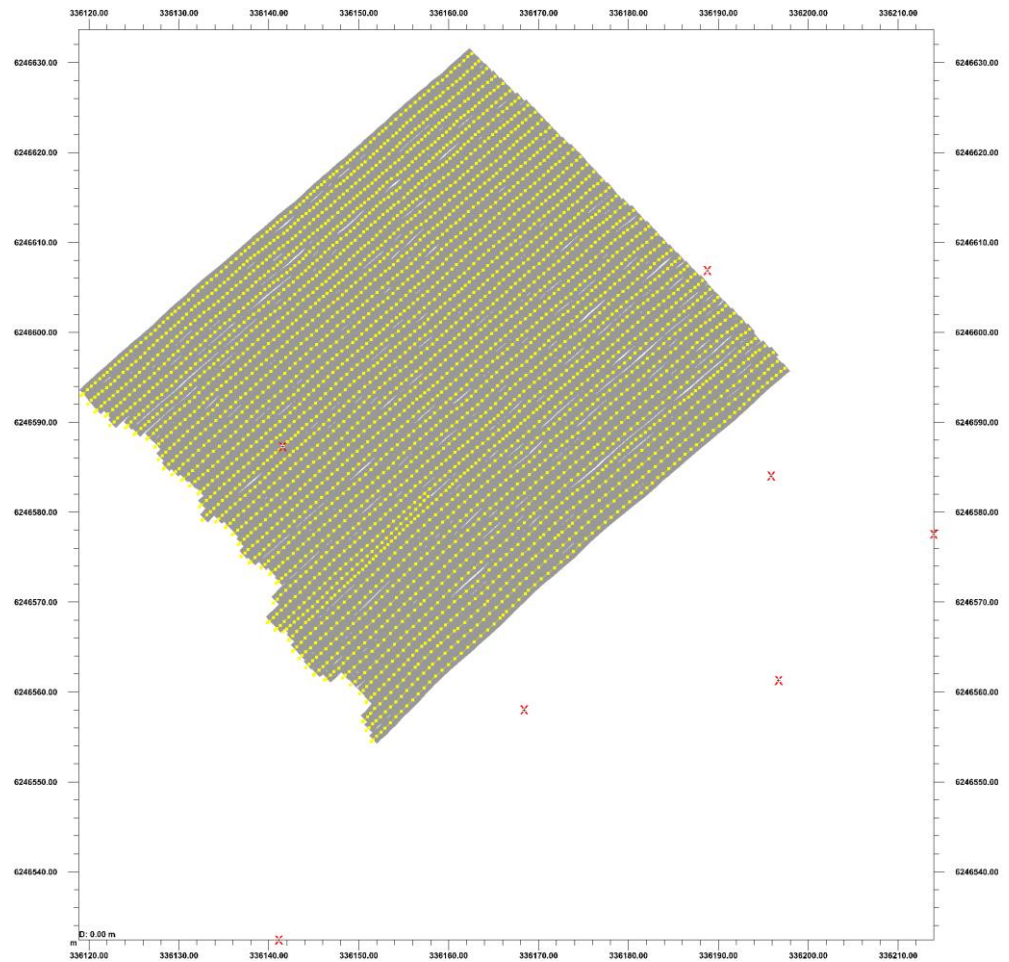
Figure 4: Yellow dots and lines indicate Individual GPS points and GPR lines conducted, respectively. The survey achieved 100% site coverage. Red 'X' markers indicate manhole pit covers that were surveyed into the dataset.

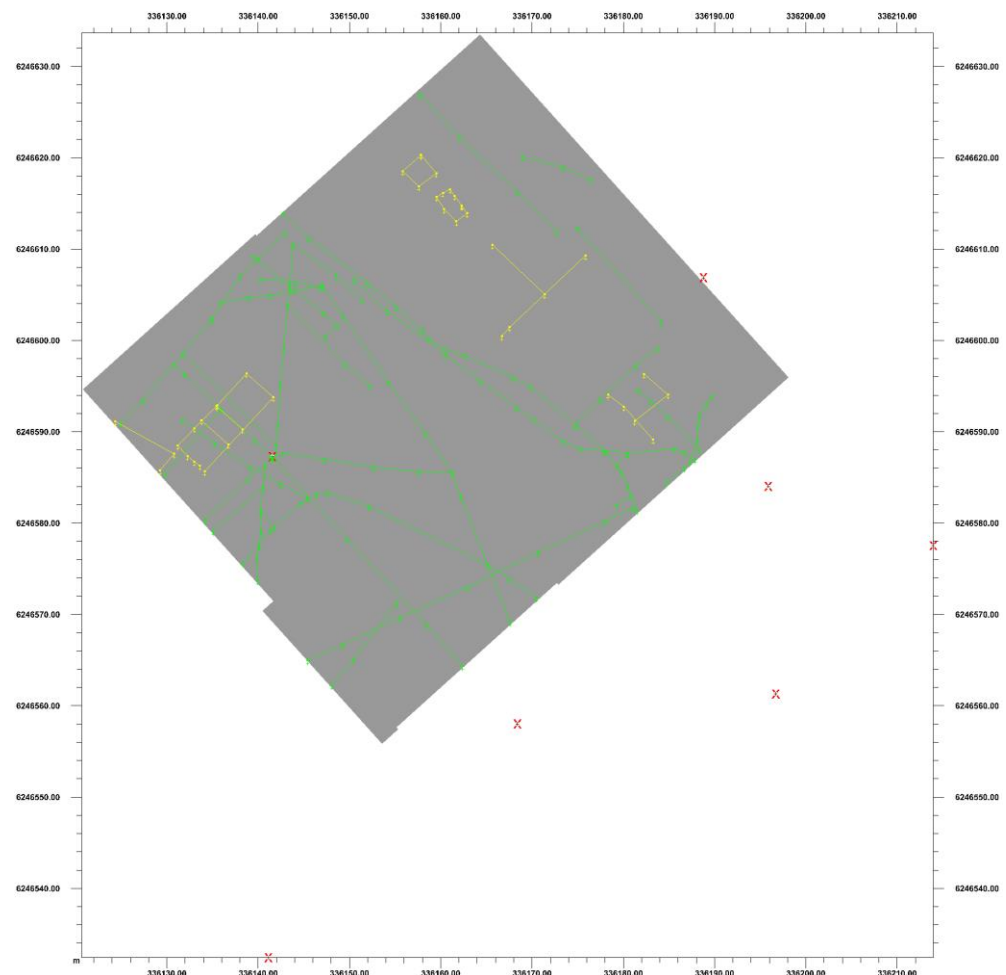
Figure 5: Plan view displaying every interpretation marker inserted into the dataset. (Green = Potential service/redundant service; Yellow = Potential footing/foundation).

Many anomalies were evident within the processed dataset, mainly those of linear nature. For each anomaly detected, interpretation markers (polylines) were inserted into the dataset at different depths. Different interpretation colours represent different interpreted targets and are discussed further in detail below. Figure 5 below displays all interpretations made within the dataset. Note all plots within the report are North facing.

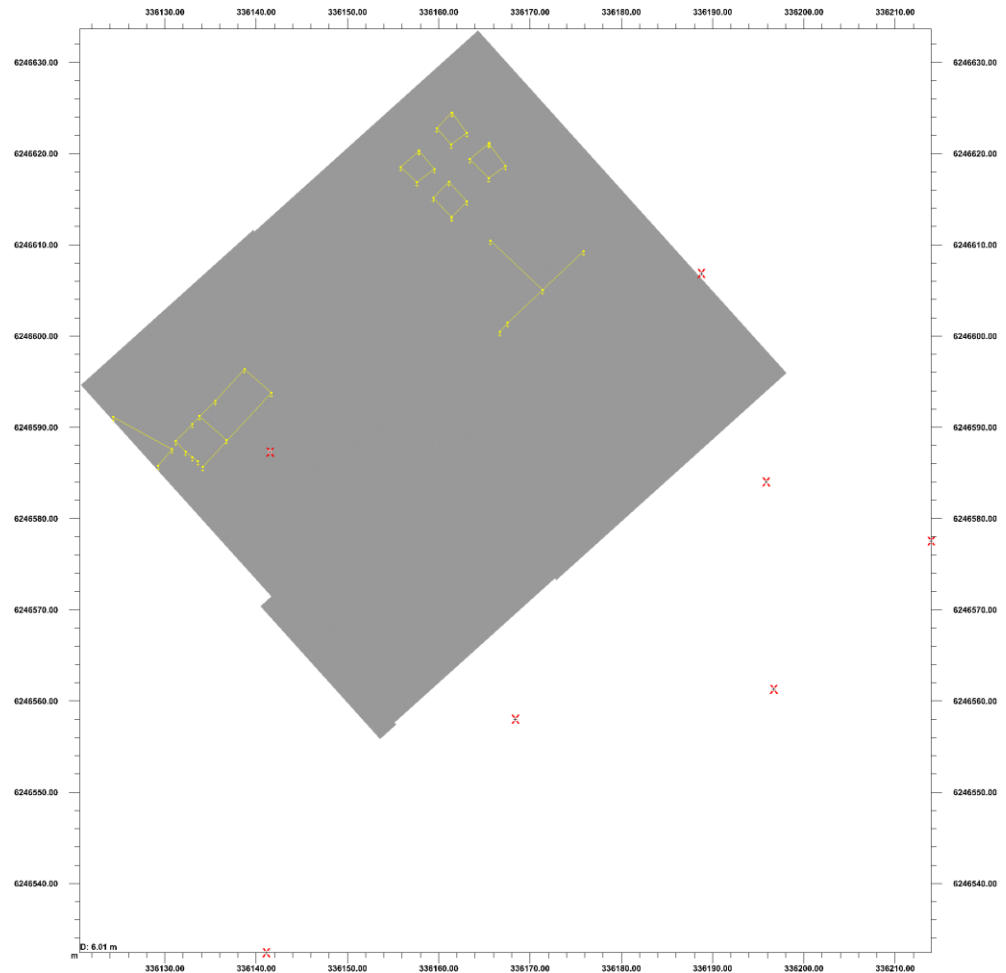
Figure 6: Yellow polylines indicated areas where subsurface anomalies were detected that were interpreted as potential subsurface footings/foundations. Note the anomalies occur at different depths and this plan view is an overall visual only.

The target for the survey focuses on linear anomalies that could represent subsurface foundations or footings. Such linear anomalies evident in the dataset contained high contrast resolution and appeared of a larger relative size to other anomalies detected, that may represent services and utilities (pipes, cables, etc). These anomalies appear to display a distinct pattern, such as square/rectangular orientations, in line with existing buildings and dwellings. Figure 6 below shows ALL anomalies interpreted as potential subsurface footings/foundations.

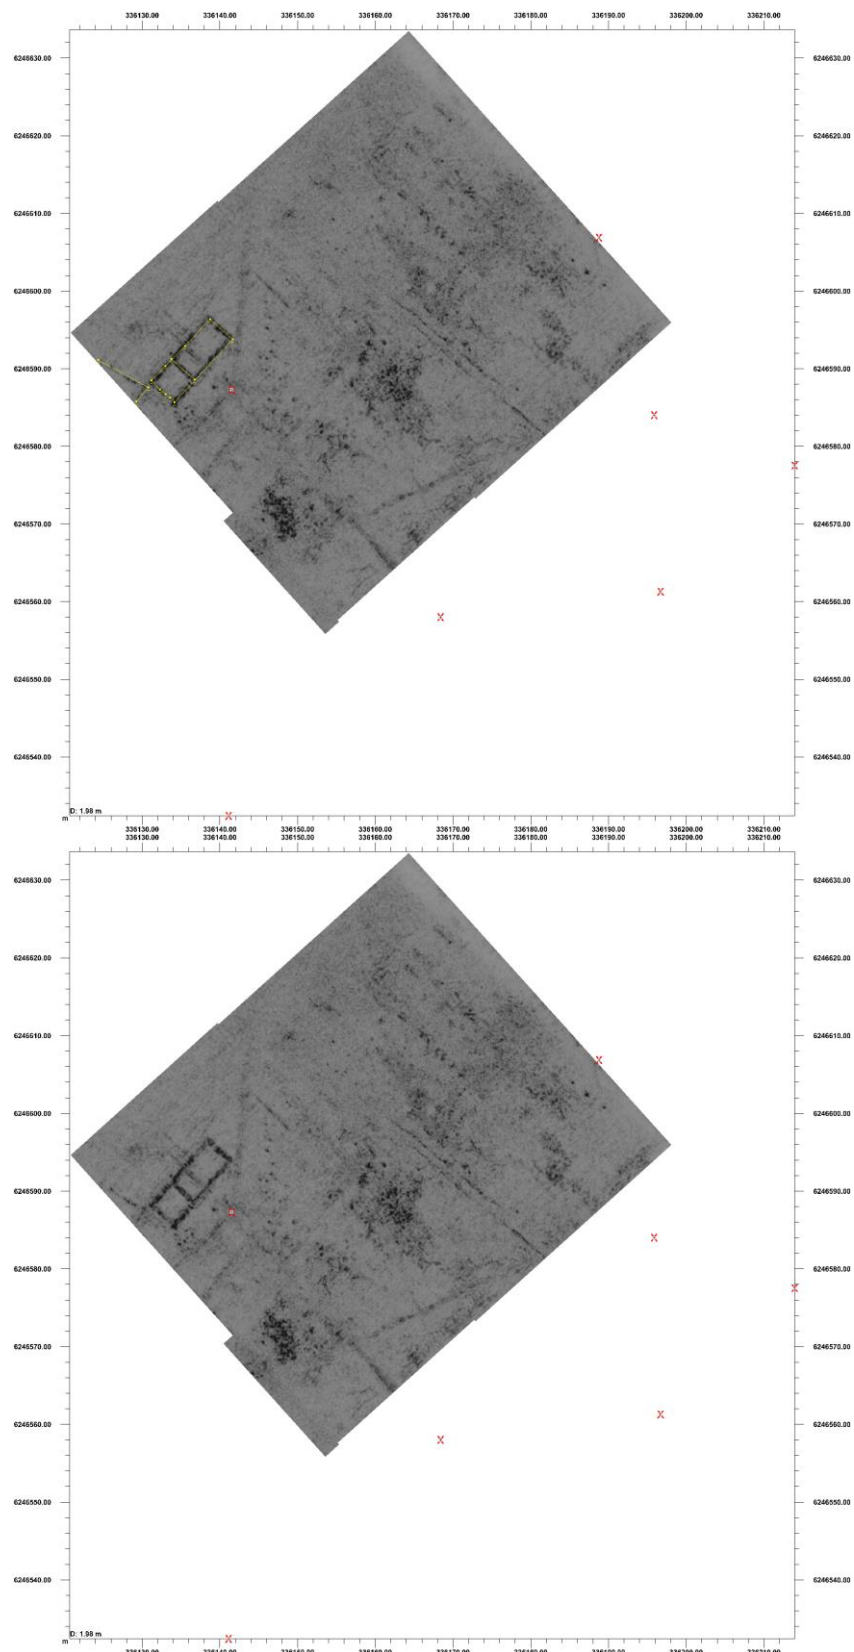
Figure 7: Zone 1 anomaly; Both images displaying a depth slice of migrated data at ~1.98m depth.

Figure 7 above displays an anomaly detected at ~1.98m depth. The anomaly is of extremely high contrast and takes the pattern of a foundation (rectangular feature). The relative size of the anomaly differs greatly to surrounding linear anomalies that may represent services and utilities. This anomaly has high confidence from the interpreter towards being a foundation/footing feature.

Interpretations made towards those of subsurface footings are both of high and medium levels of confidence. Zone 1 for instance (figure 7) displays a very high contrast, large/wide, rectangular anomaly. This anomaly takes the pattern of a subsurface footing/foundation. It should be noted that this shape can also be seen imprinted onto the grass in satellite imagery (visible in Figure 1). Zone 2 displays lower contrast, less intense anomalies, however a pattern is still visible in the anomalies, displaying a 'group' of four rectangular features, relatively evenly spaced between each other. Zone 3 displays anomalies that could take the shape of a large subsurface footing however the limitation here is the depth it was detected, allowing for lost contrast and anomaly shape. Another 500mm of depth penetration would've aided this interpretation and associated confidence of interpretation.

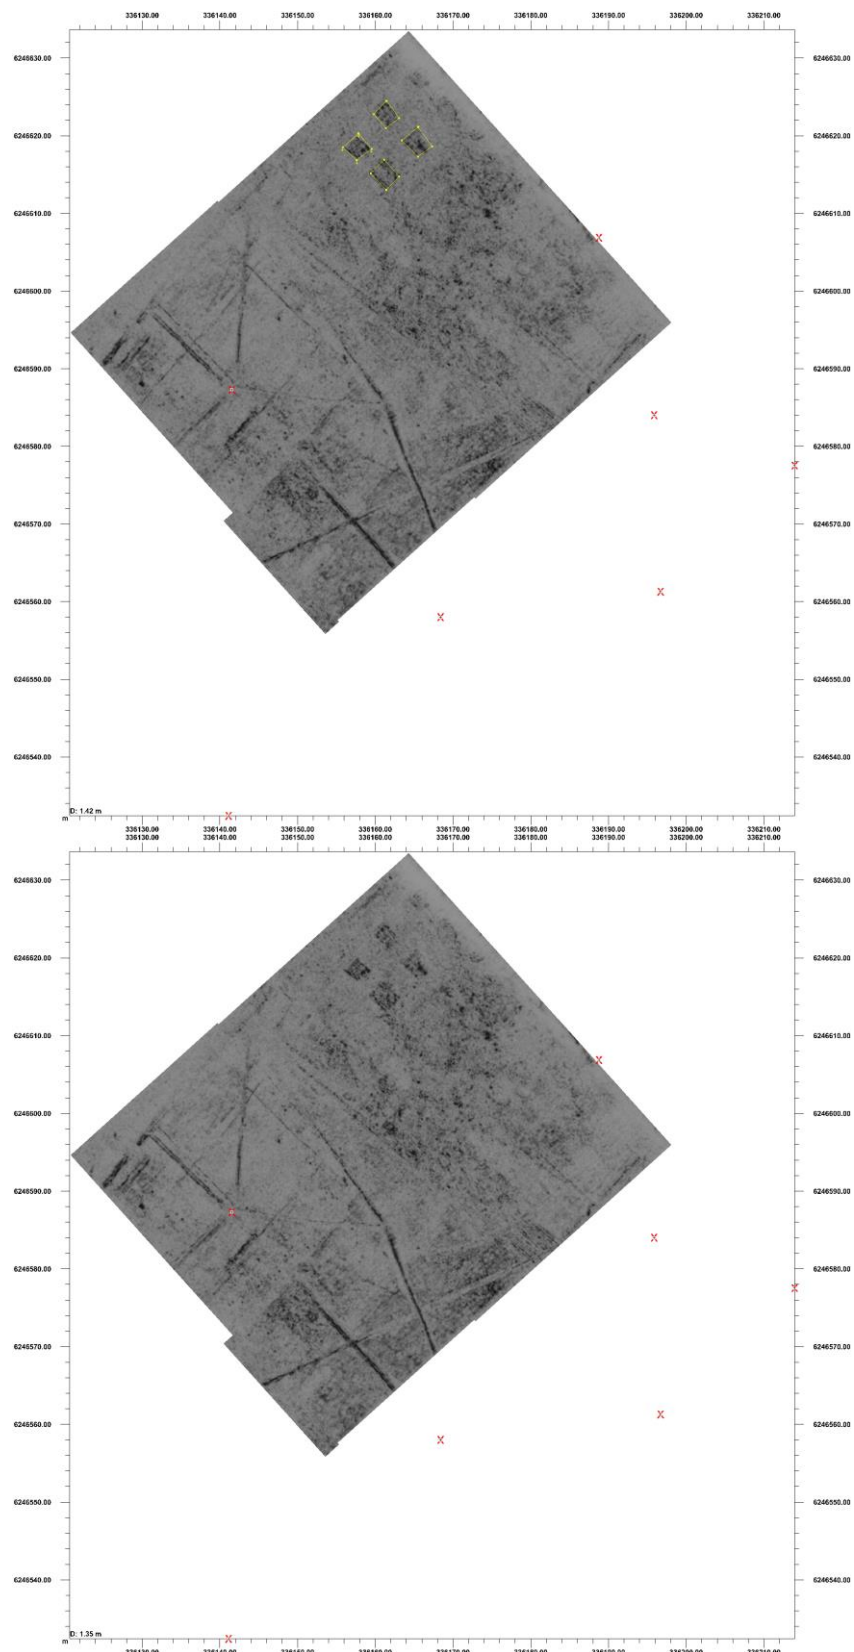
Figure 8: Zone 2 anomaly; Both images displaying a depth slice of migrated data at ~1.42m depth.

Figure 8 above displays four anomalies at ~1.42m depth. The anomalies are of different nature to that discussed in Zone 1, being of lower contrast and more of a localised shape, not a linear anomaly. They do however occur in a 'group' with some form of pattern visible. This anomaly has medium confidence from the interpreter towards being a foundation/footing feature.

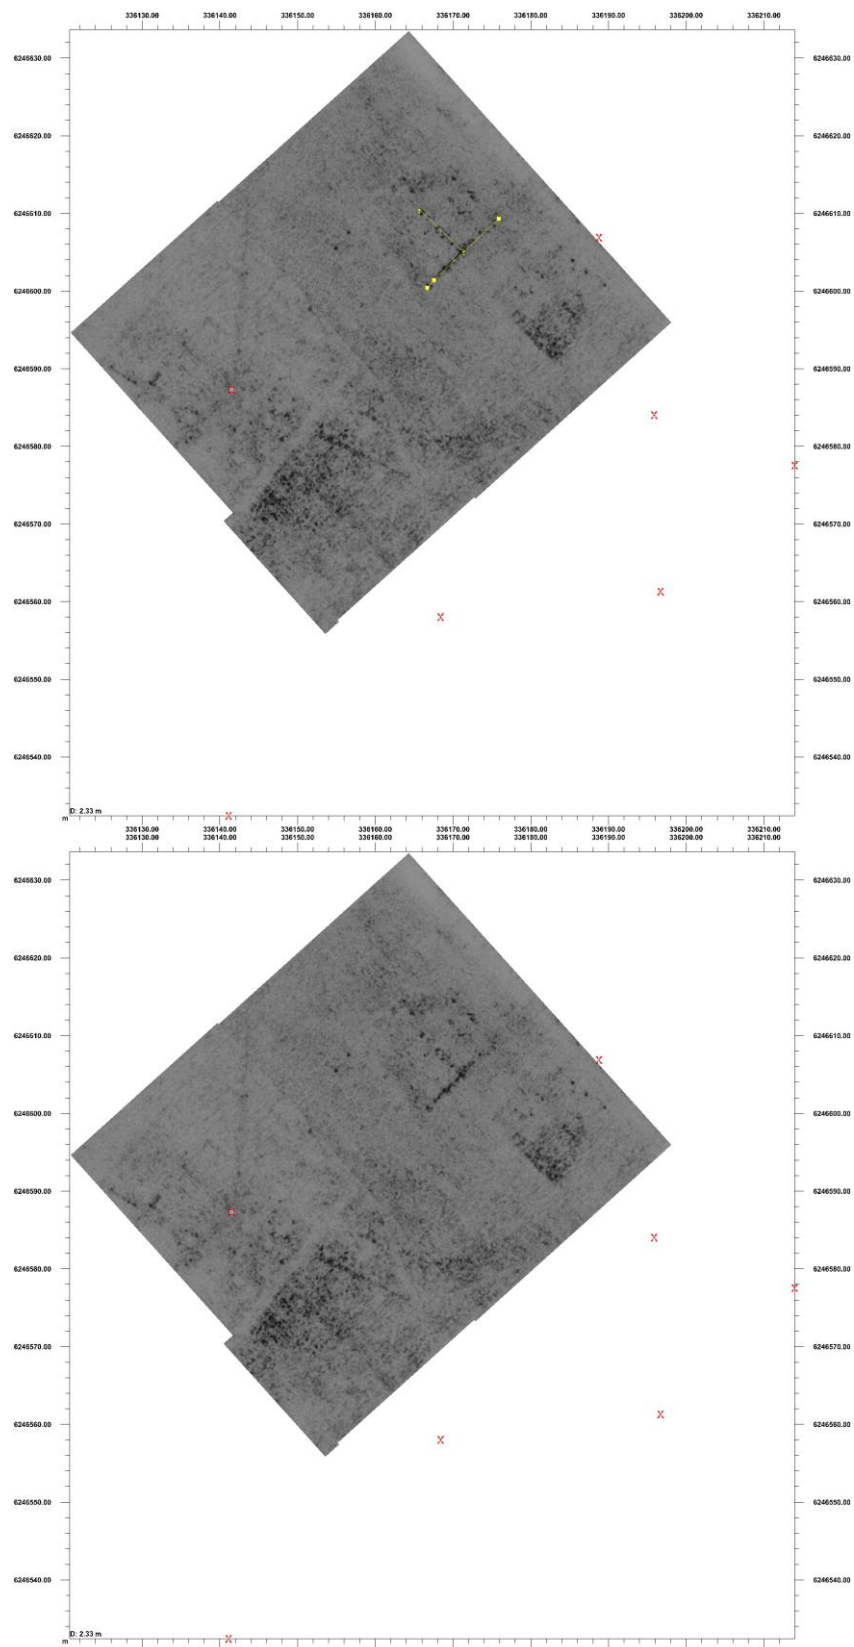
Figure 9: Zone 3 anomaly; Both images displaying a depth slice of migrated data at ~2.33m depth.

Figure 9 above displays an anomaly detected at ~2.33m depth. The anomaly is of low contrast (most likely due to the depth encountered). Two relatively large linear lines are seen to create a feature that has potential to be a subsurface footing. The orientation of the anomalies lines up with existing dwellings. This anomaly has medium confidence from the interpreter towards being a foundation and it is recommended it is investigated further for confirmation.

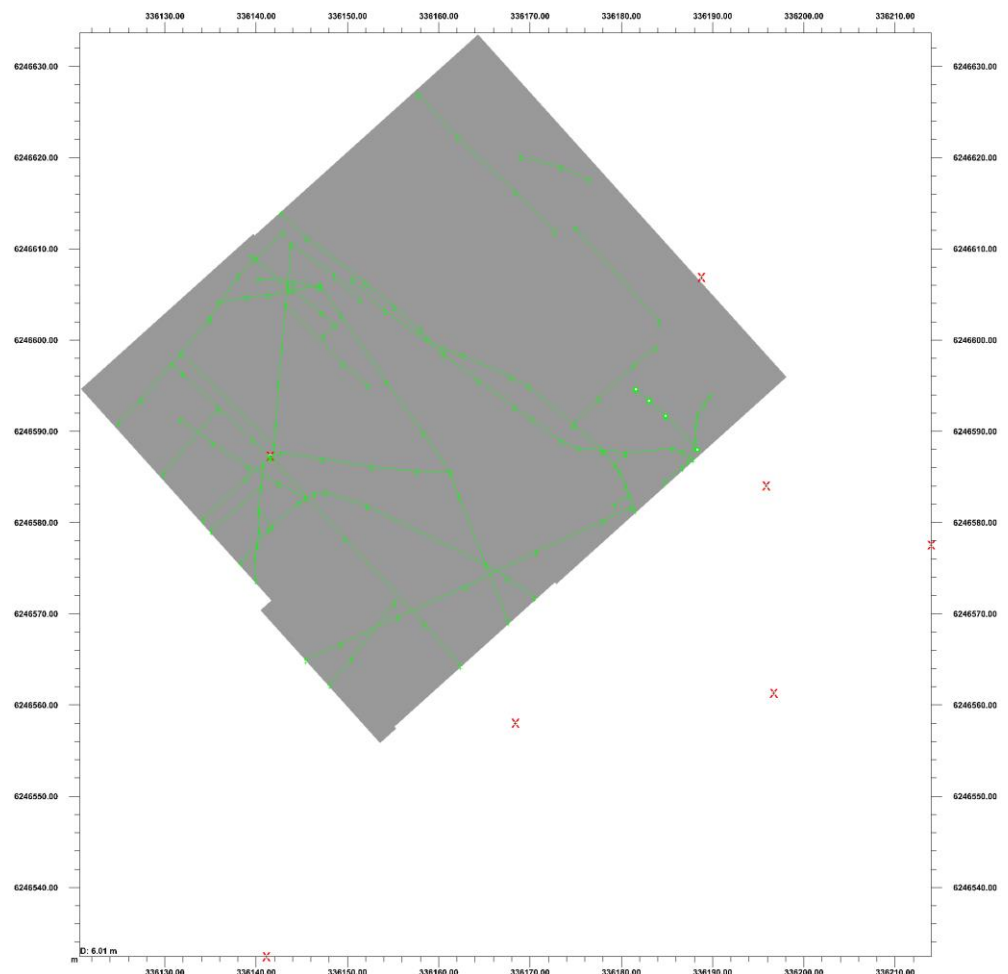
Figure 10: Green polylines indicated areas where subsurface anomalies were detected that were interpreted as potential subsurface live/redundant services. Note the anomalies occur at different depths and this plan view is an overall visual only.

Figure 10 below displays all interpretations made towards potential live/redundant services. Note; these interpretations were made so due to the nature of the anomalies, being depth, contrast and orientation. It is possible that these anomalies could in fact represent subsurface footings however have been interpreted differently.
