Bankstown North Public School 322 Hume Highway, Bankstown Aboriginal Archaeological Assessment

Prepared by:	Tory Stening				
Report to:	JDH Architects on behalf of the				
	Department of Education				
LGA:	Canterbury-Bankstown Council				
Date:	March 2019				
Version:	C.2019.1015

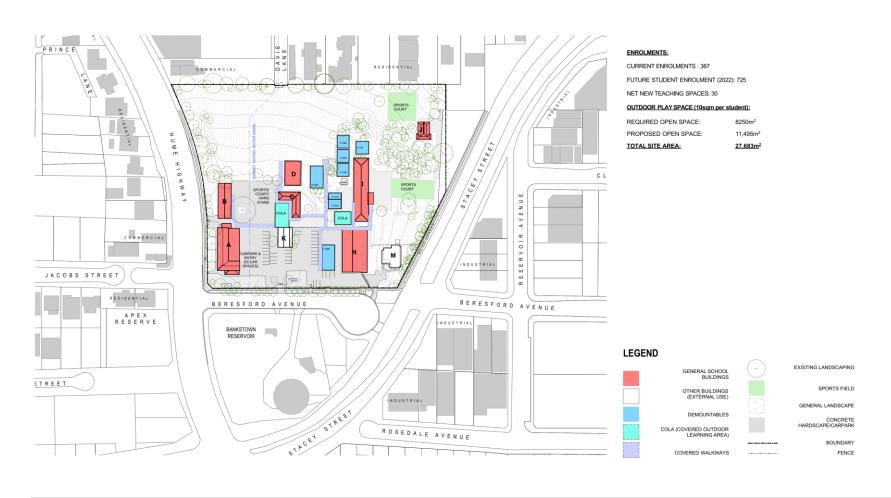
CD06 EXISTING SITE PLAN

Figure 4: Showing the existing site plan of Bankstown North Public School (plan courtesy of JDH Architects).

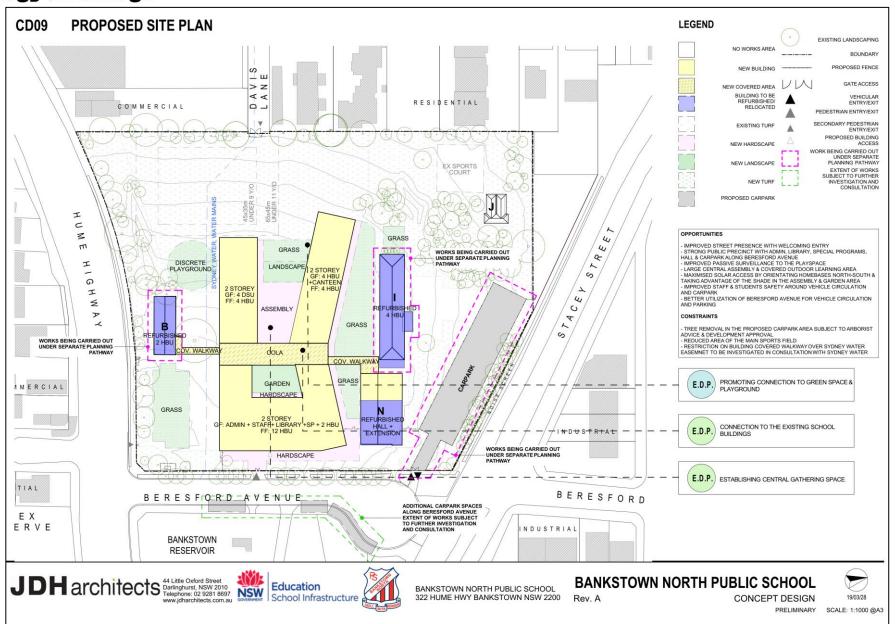
Figure 5: Showing the proposed works plan for Bankstown North Public School (plan courtesy of JDH Architects).

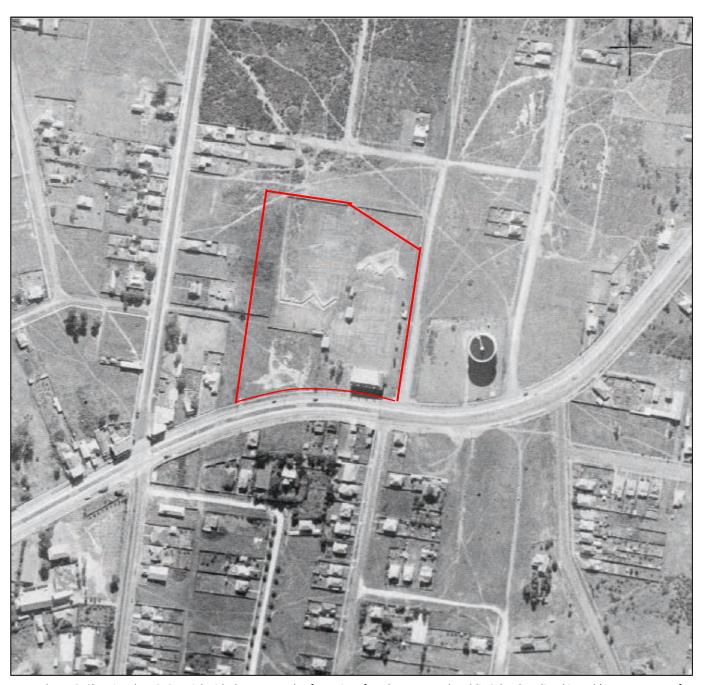
Figure 8: Showing the 1943 aerial with the present day footprint of Bankstown North Public School outlined in red (map courtesy of www.maps.six.gov.nsw.au).

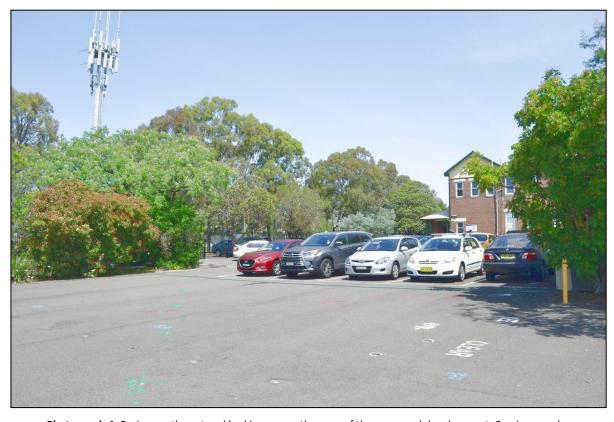
Photograph 4: Facing south east and looking across the area of the proposed development. Services can be seen marked in spray-paint on the asphalt surface.

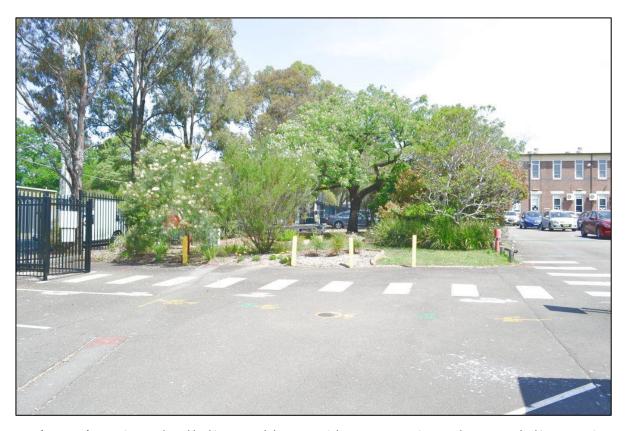
Photograph 5: Facing south and looking toward the Hume Highway. Many services can be seen marked in spray paint on the asphalt surface. .

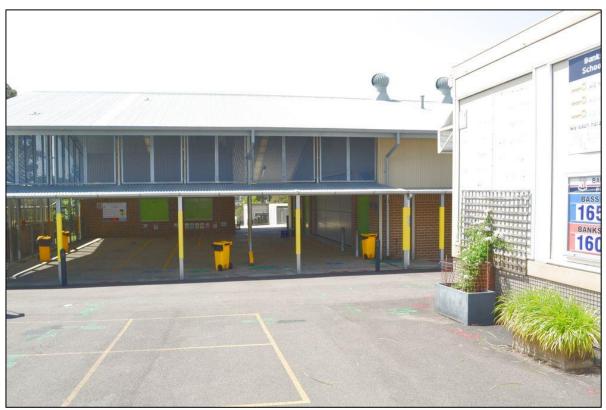
Photograph 7: Looking across the area proposed for developmetn and showing the buildings and manufactured topography to provide a level playing surface.

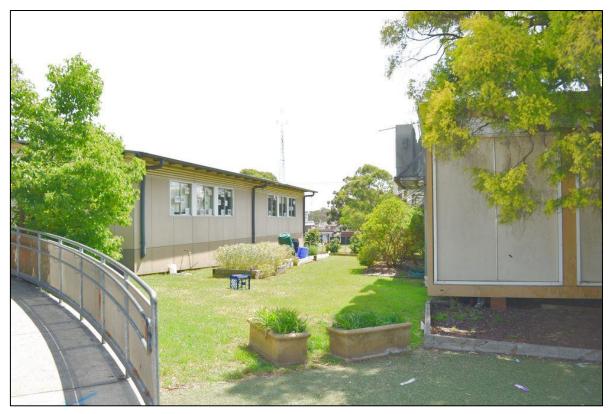
Photograph 8: Looking between the demountables which will be removed as part of the proposed works. The landscape in this area has been manufactured and any upper layers of soil have been removed.
