**REPORT TO
KINCOPPAL-ROSE BAY SCHOOL**

**ON
REMEDIATION ACTION PLAN**

**FOR
PROPOSED DEVELOPMENT AT KINCOPPAL-ROSE
BAY SCHOOL**

Date: 29 October 2020
Ref: E32915BArpt-RAP

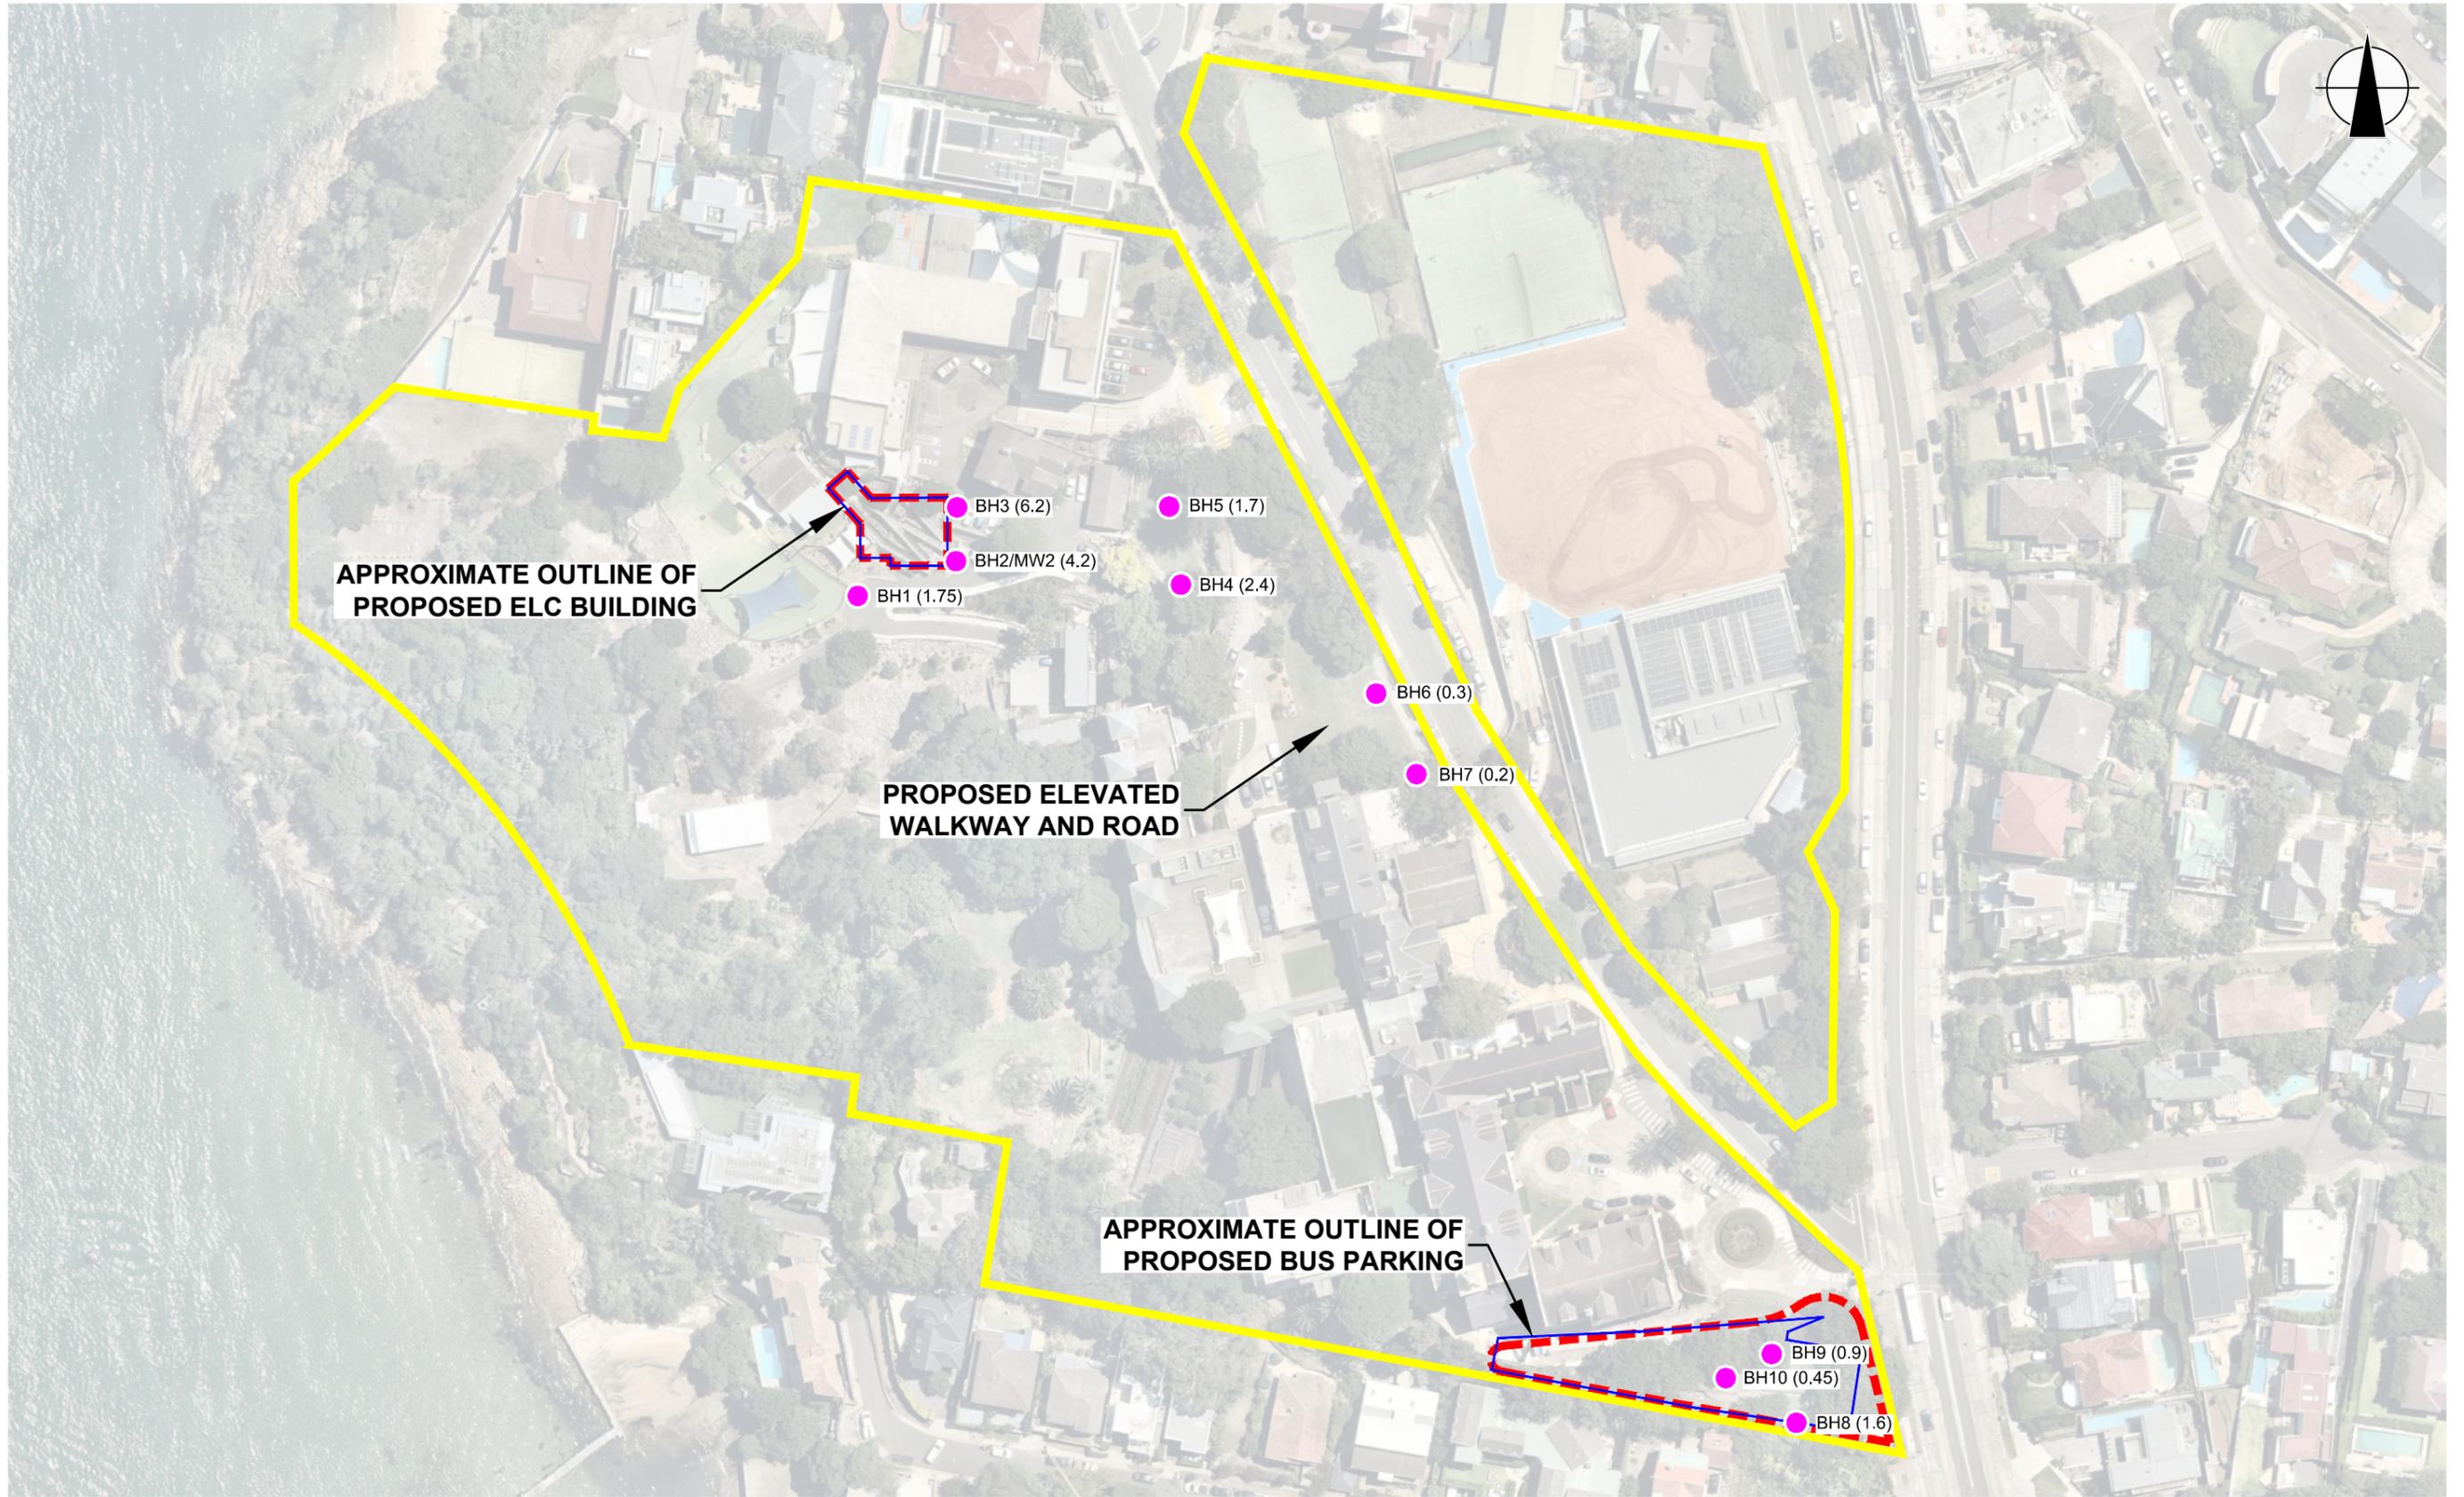
The JKE PSI identified polycyclic aromatic hydrocarbons (PAHs), total recoverable hydrocarbons (TRHs) and heavy metals contamination in soil within areas of proposed development works (see Figure 3 in Appendix A). The source of contamination was identified as the fill material historically imported onto site. The contaminants requiring remediation include: lead contamination hotspot in the northern part of the site where the new ELC building is proposed, carcinogenic PAHs and also TRH F3 within the southern part of the site area where the new two-storey bus/carpark is proposed. It was noted that TRH F3 impact is co-located with carcinogenic PAHs contamination and can be remediated concurrently.

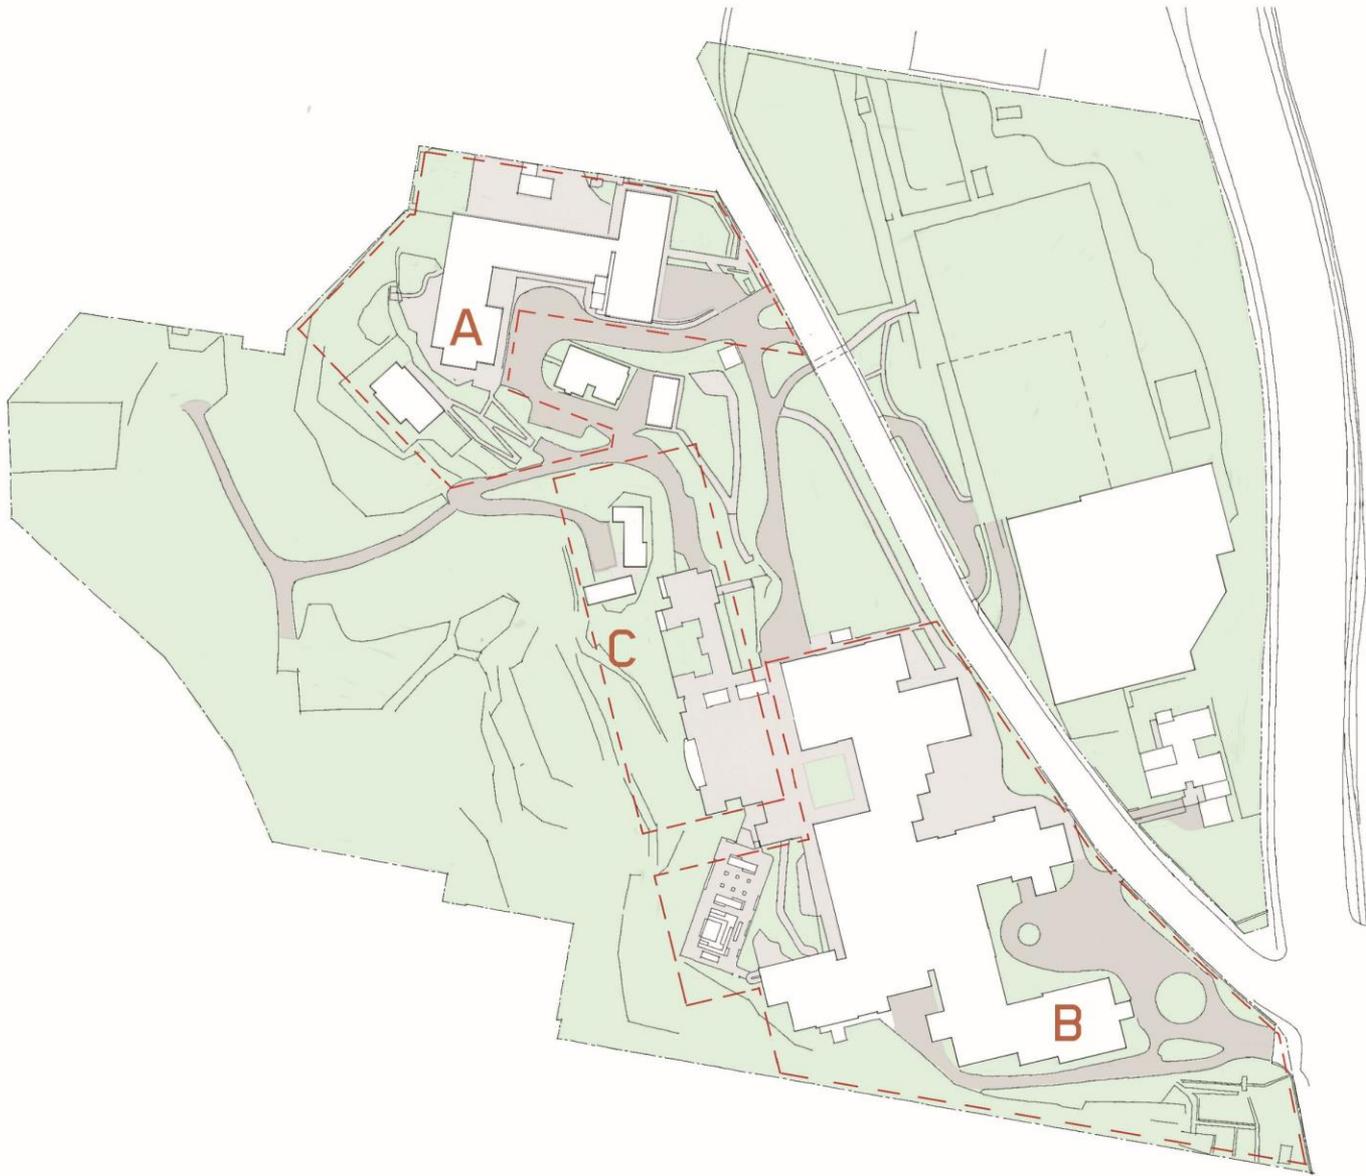
EXISTING BUILDINGS + PRECINCTS
SITE PLAN

PRECINCT A:

PRECINCT C (CONCEPT DA):

- 14. BOARDING ACCOMMODATION - EXTENSION

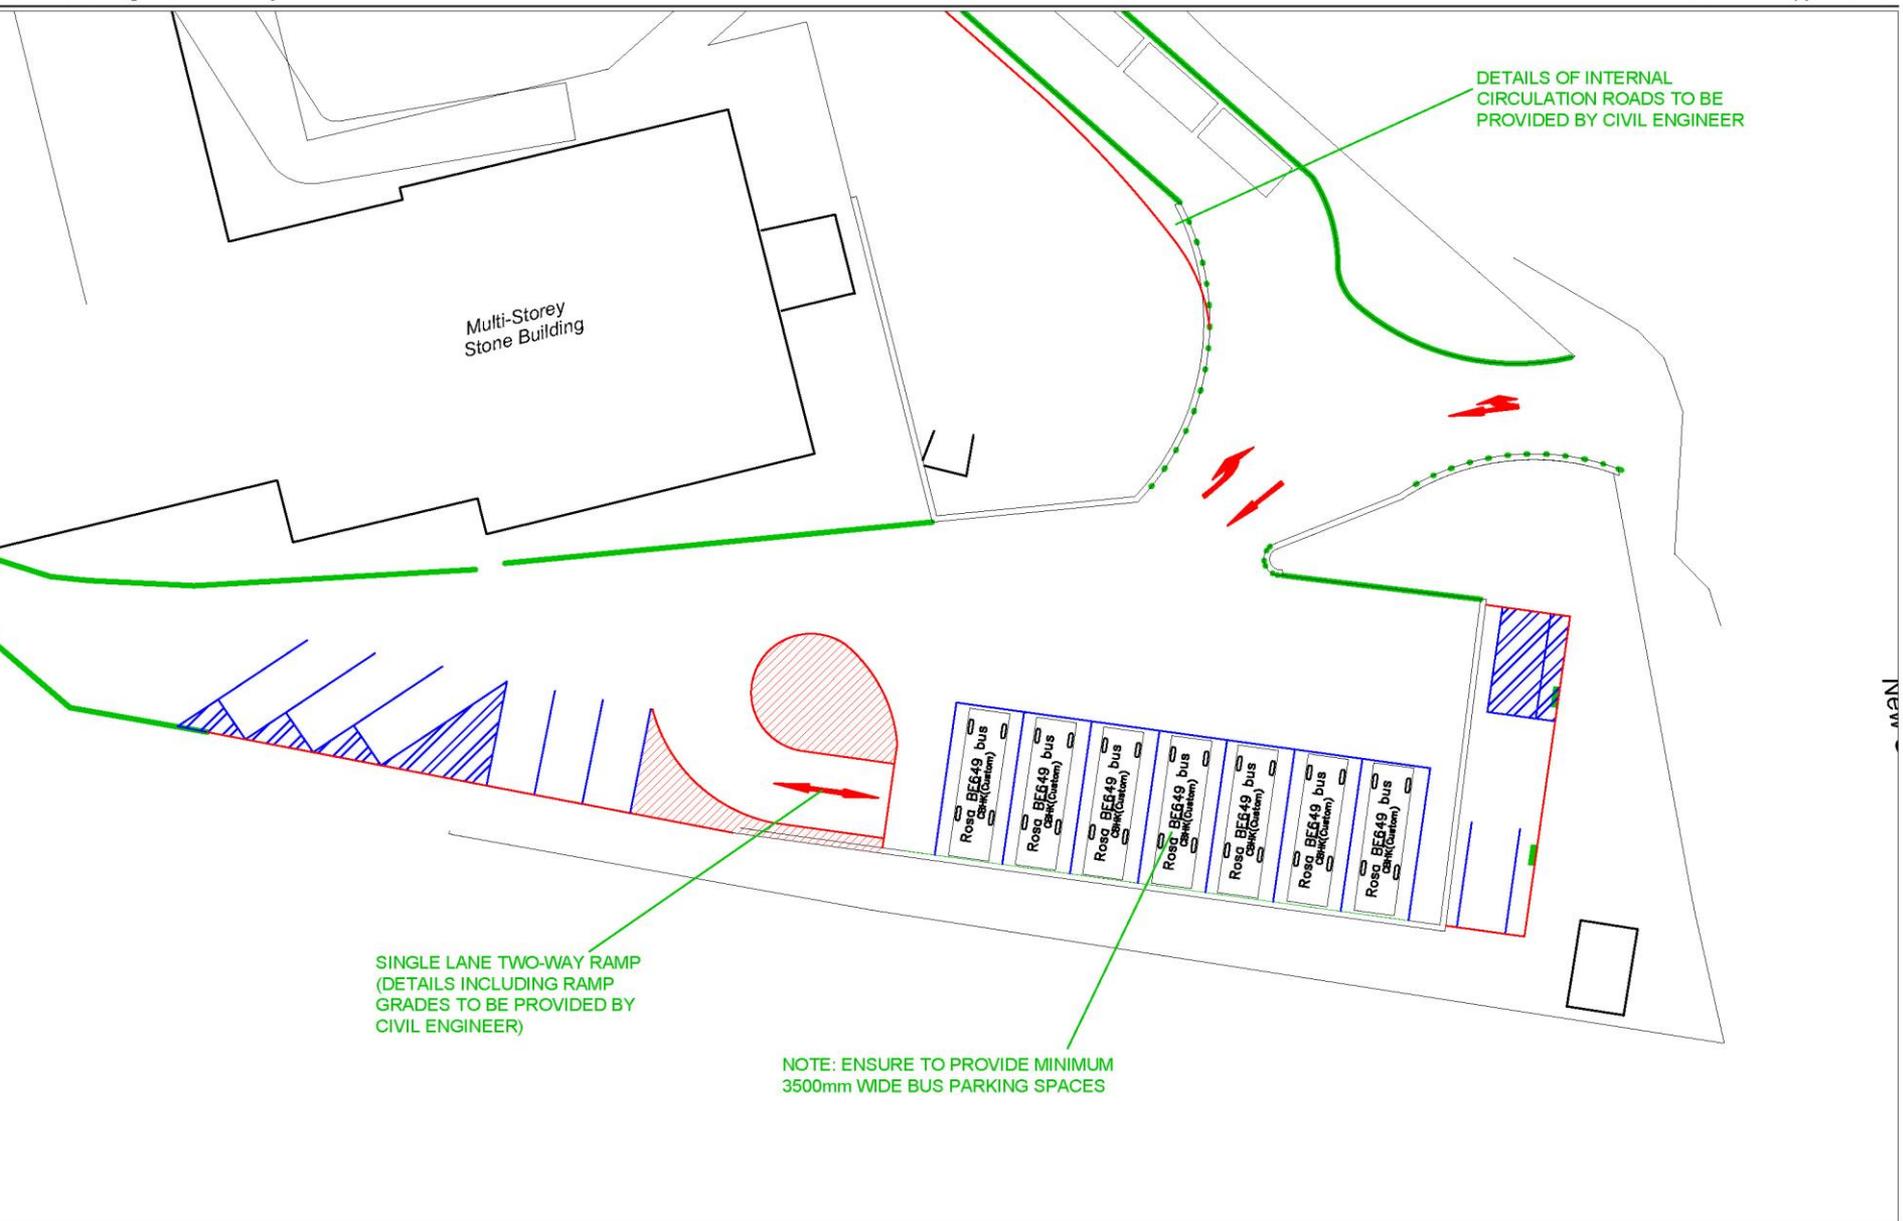
CONCEPT BUS PARKING LAYOUT

NOTE:
 DRAFT CONCEPT PLAN ONLY. PROPERTY BOUNDARIES,
 UTILITIES, KERBLINES & DIMENSIONS ARE SUBJECT TO
 SURVEY AND FINAL DESIGN. TRAFFIC MEASURES
 PROPOSED IN THIS PLAN ARE CONCEPT ONLY AND
 ARE SUBJECT TO FINAL DESIGN BY CIVIL ENGINEERS.

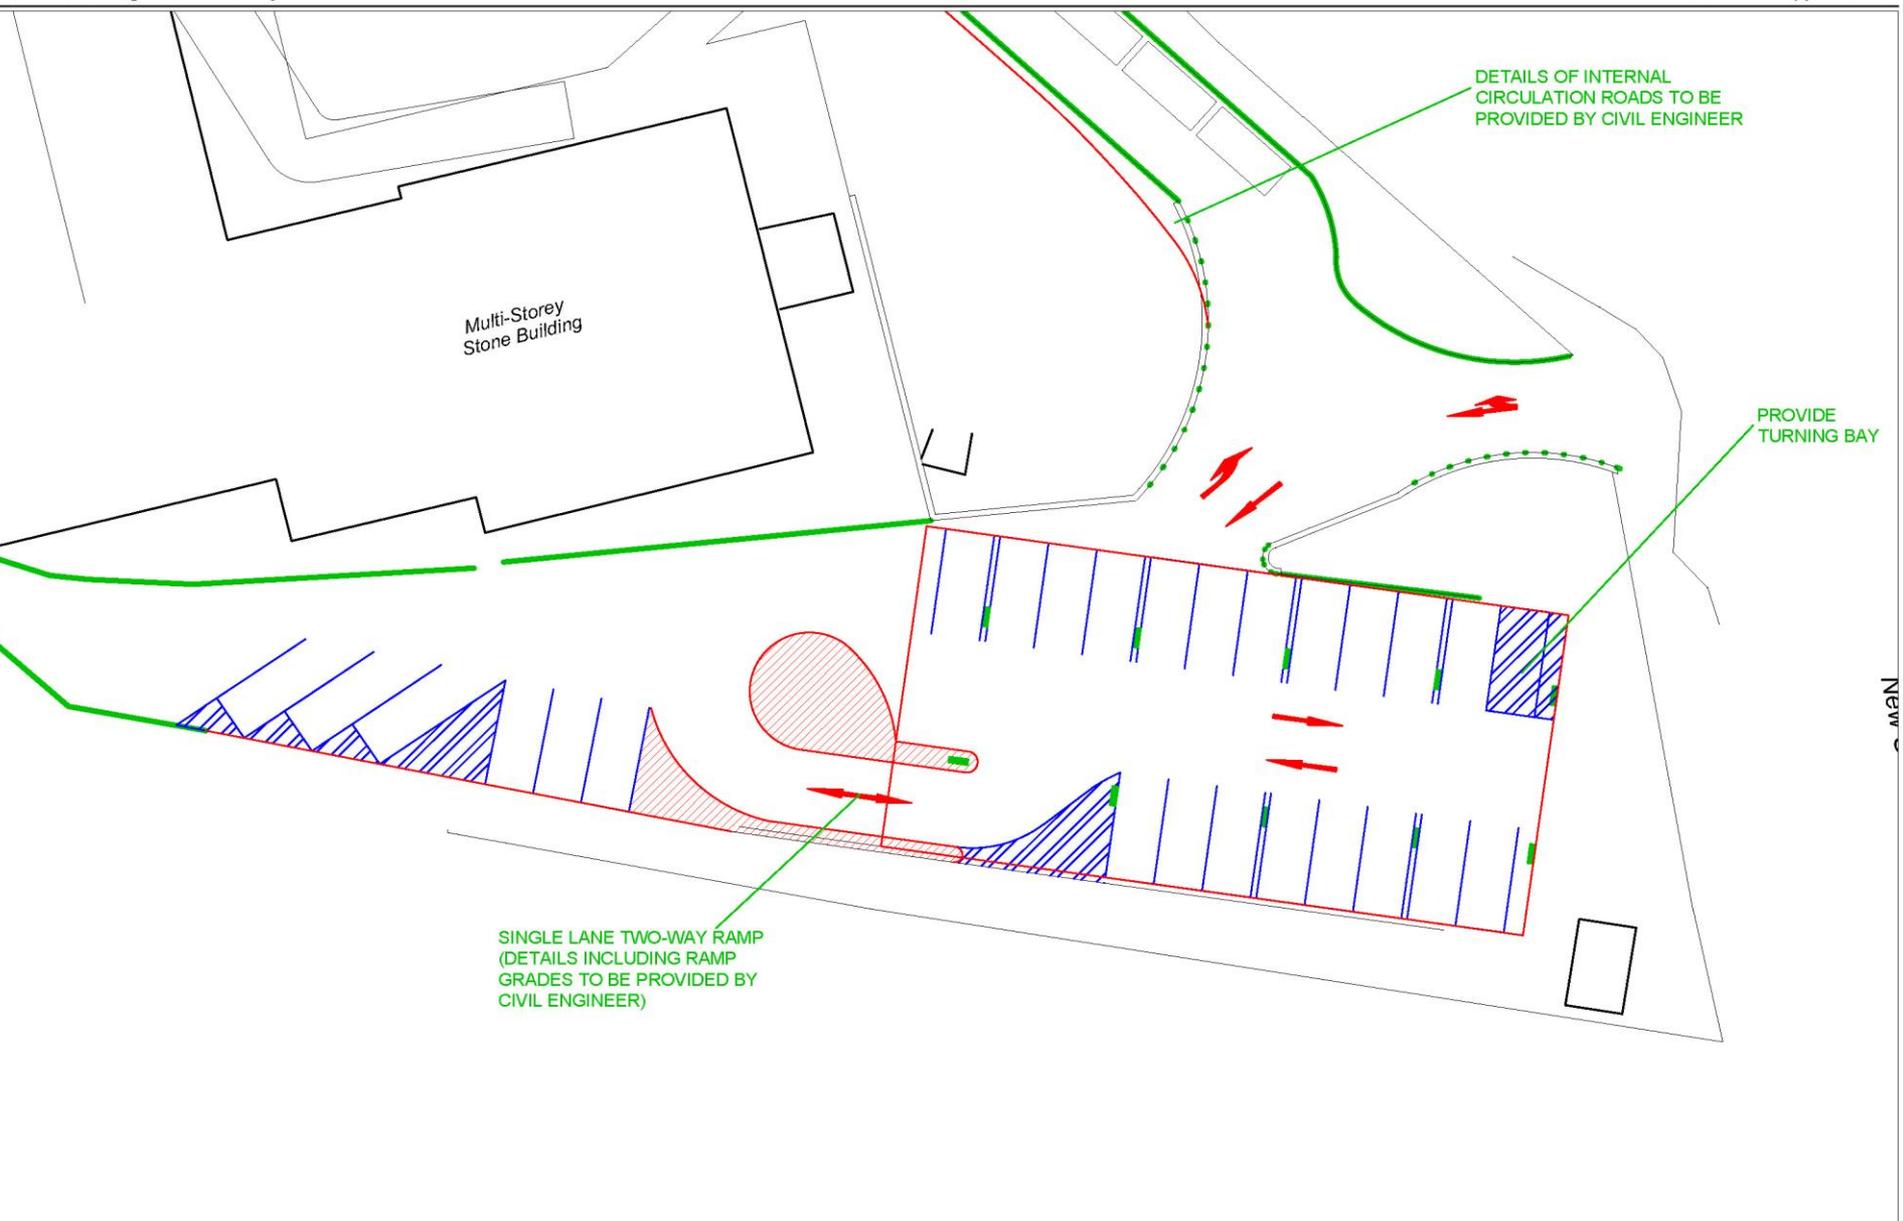
CONCEPT BASEMENT PARKING LAYOUT

NOTE:
CONCEPT PLAN ONLY. PROPERTY BOUNDARIES,
UTILITIES, KERBLINES & DIMENSIONS ARE SUBJECT TO
SURVEY AND FINAL DESIGN. TRAFFIC MEASURES
PROPOSED IN THIS PLAN ARE CONCEPT ONLY AND
ARE SUBJECT TO FINAL DESIGN BY CIVIL ENGINEERS.

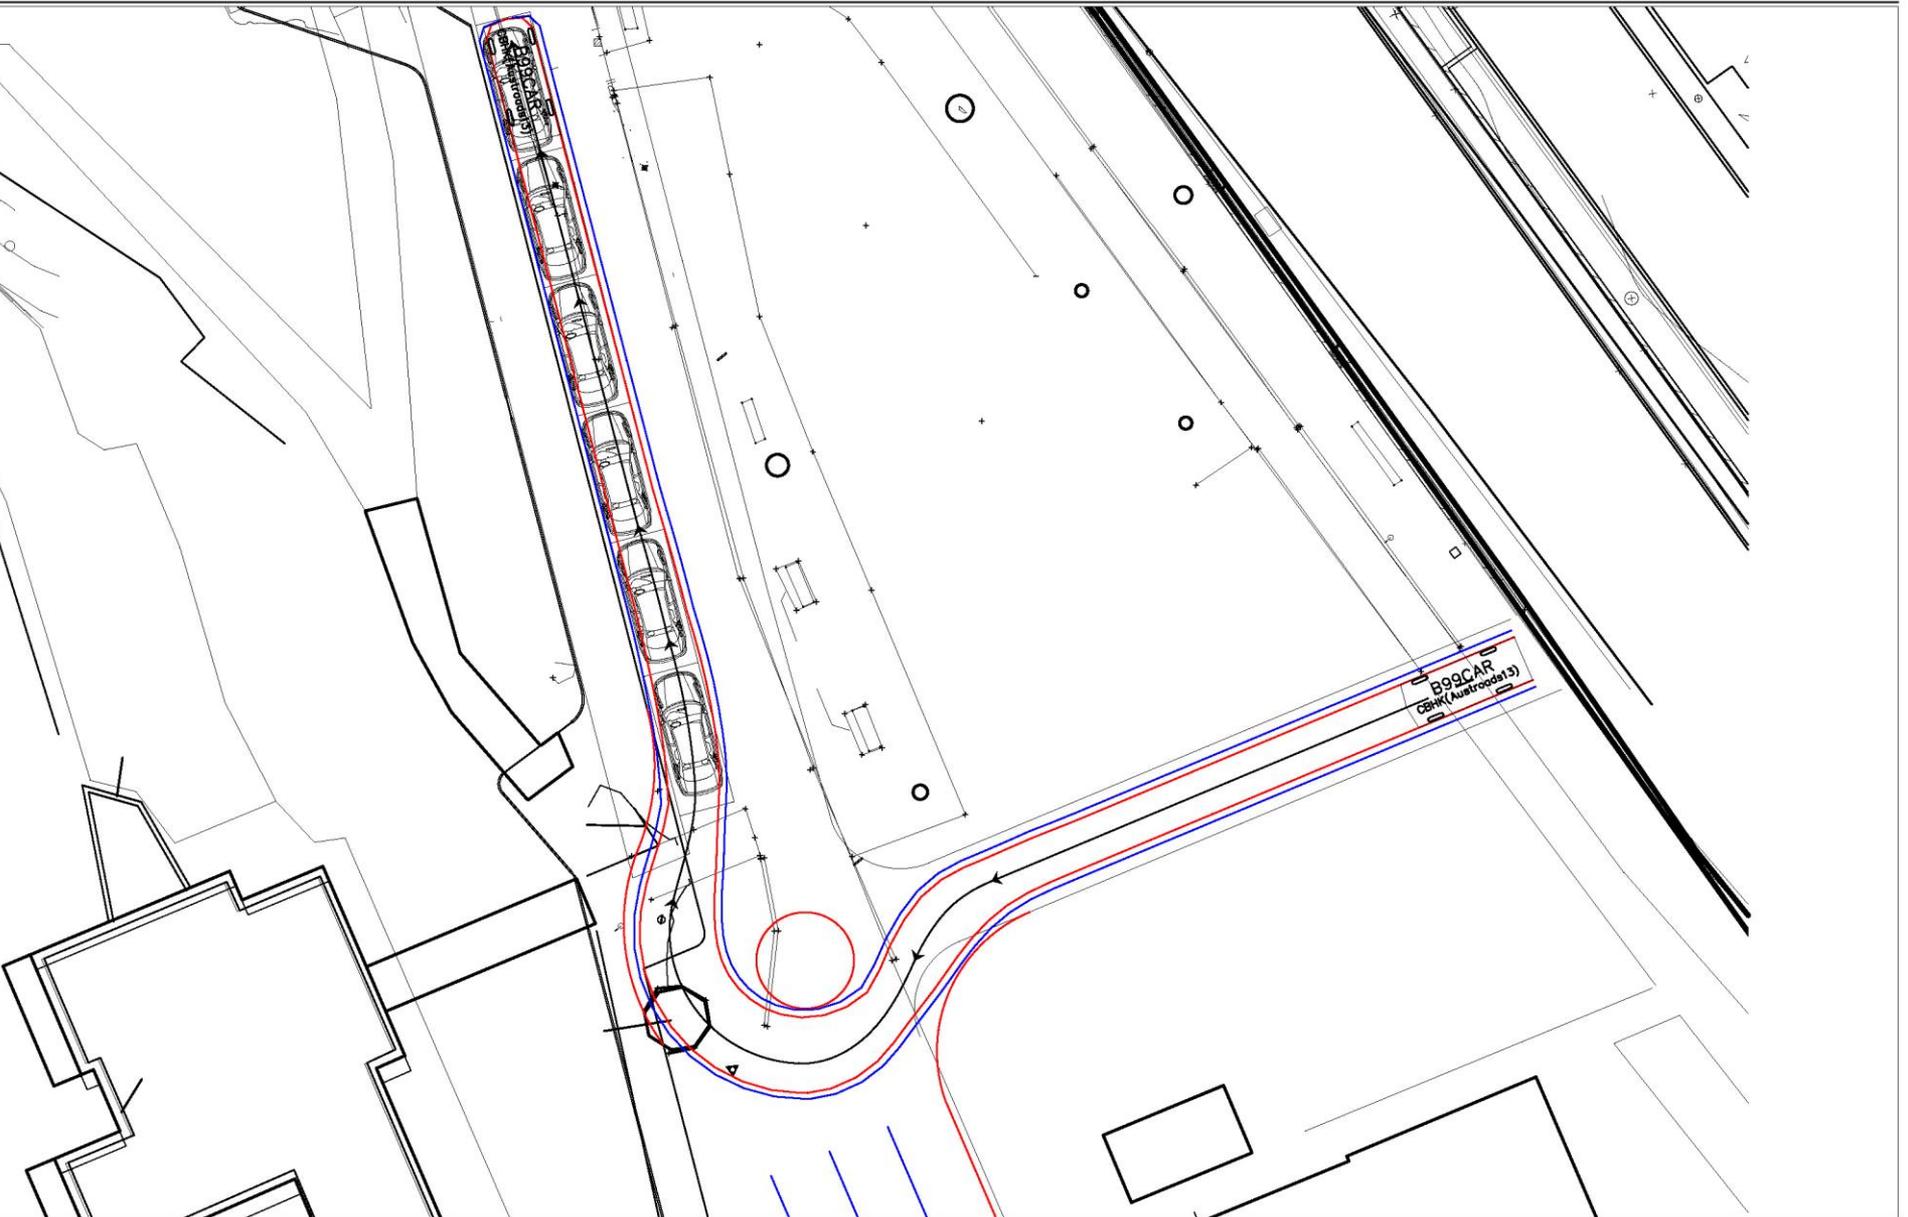
— Swept Path of Vehicle Body
— Swept Path of Clearance to Vehicle Body
