KINCOPPAL - ROSE BAY

SCHOOL OF THE SACRED HEART

CONSERVATION MANAGEMENT PLAN

Final Report - August 2020

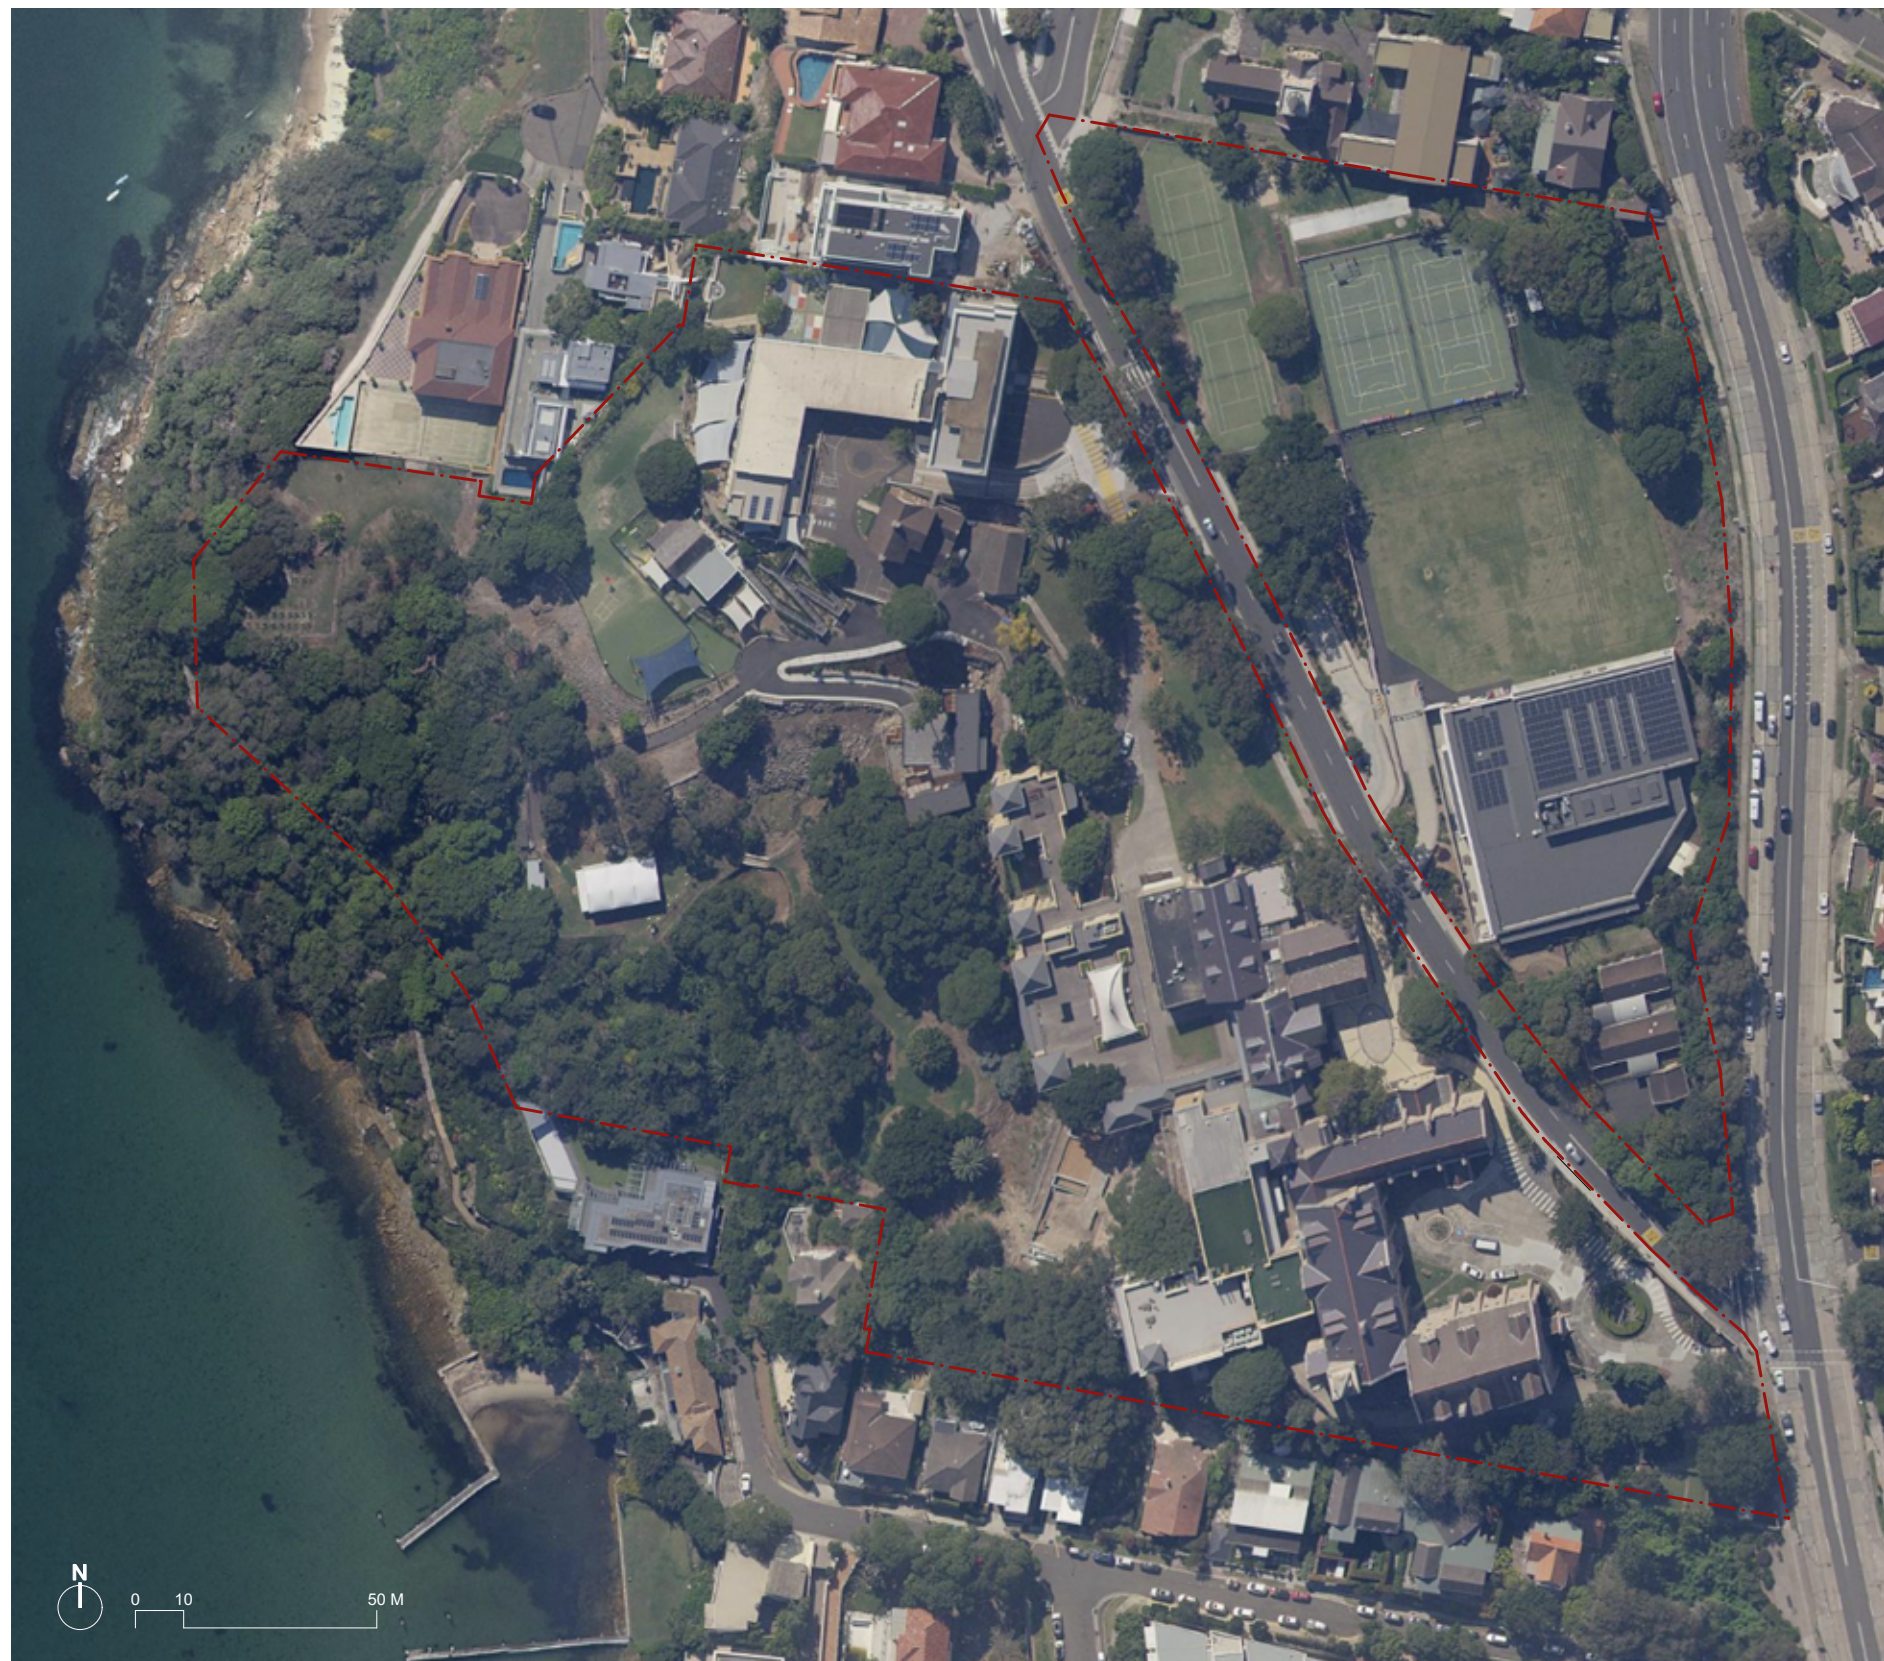
Figure 1.2: The property boundaries of the subject area of this report are outlined in red. Lot 104 and 101 DP 1092747. Source: 2019 Sixmaps aerial with Design 5 Architects overlay

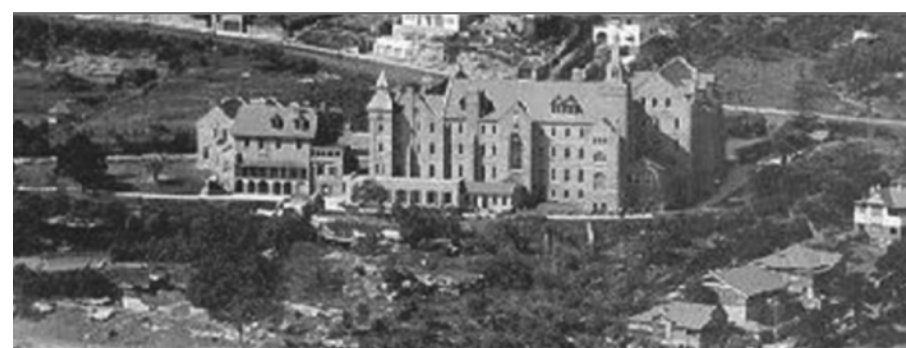
Figure 2.16: An undated image of the main group of school buildings, from the west. Possible rockshelters are evident in two lines of sandstone escarpment below the building platform. Source: BVN 2013: 25

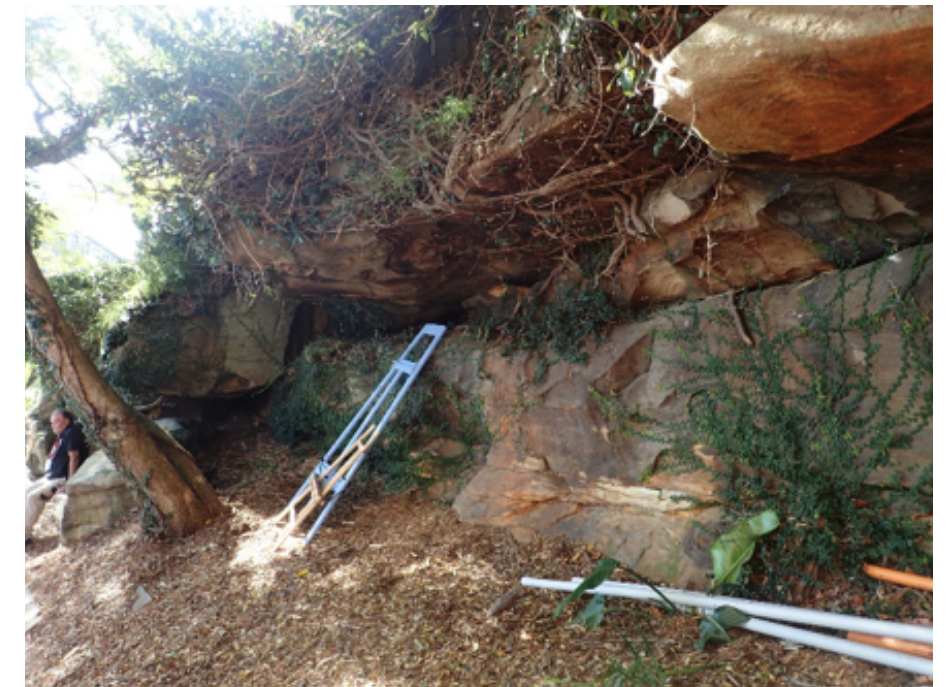
Figure 2.20: KRB Rockshelter, looking north-east.

A possible Aboriginal archaeological site has been identified within the school. This is a rock overhang in the escarpment below the main building group. No Aboriginal art or artefacts were found, but it is possible that Aboriginal people once used this as a shelter and that archaeological deposits are present below the ground.

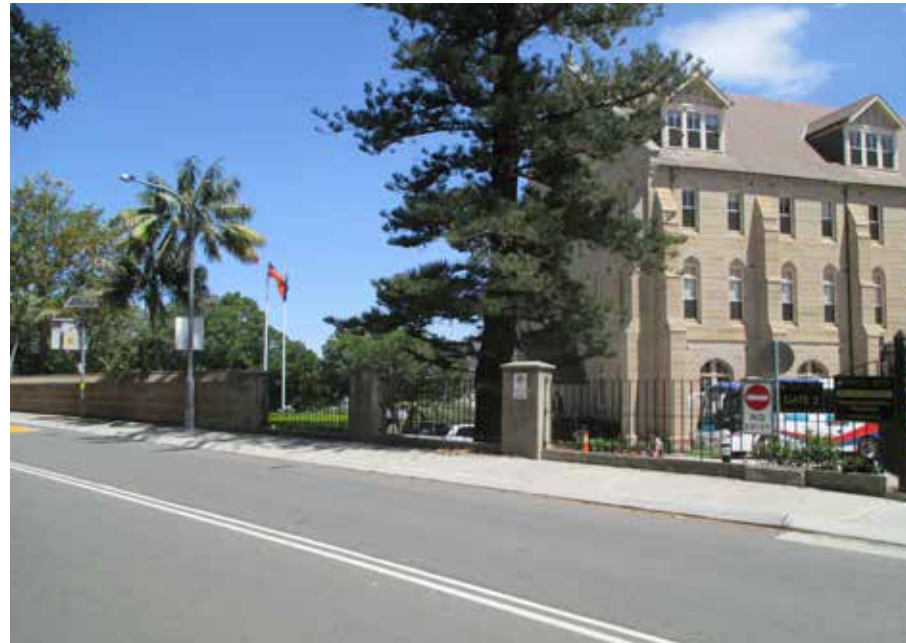
Figure 2.4: The sandstone boundary wall and modern aluminium fence panels on Vacluse Road just south of the Kincoppal exit gates.

The school property is bound by a variety of different types of sandstone ashlar and concrete block boundary walls interrupted by modern aluminium fence panels and gates on the Vacluse Road frontage. The Senior School is predominantly bound by a formal sandstone ashlar wall (picked finish), with a similar triangular capping to the former Convent school buildings, a low plinth course and sandstone gateposts to the Jubilee Gates. Part way along Vacluse Road, the wall becomes an imitation sandstone wall, constructed of rendered concrete block work. The majority of this wall is solid, however a section south of the Kincoppal Gates is visually open with modern aluminium panels above a low plinth course. There are two raised mulched garden beds in front of the Junior School entrance gates with mature trees and a timber edging.

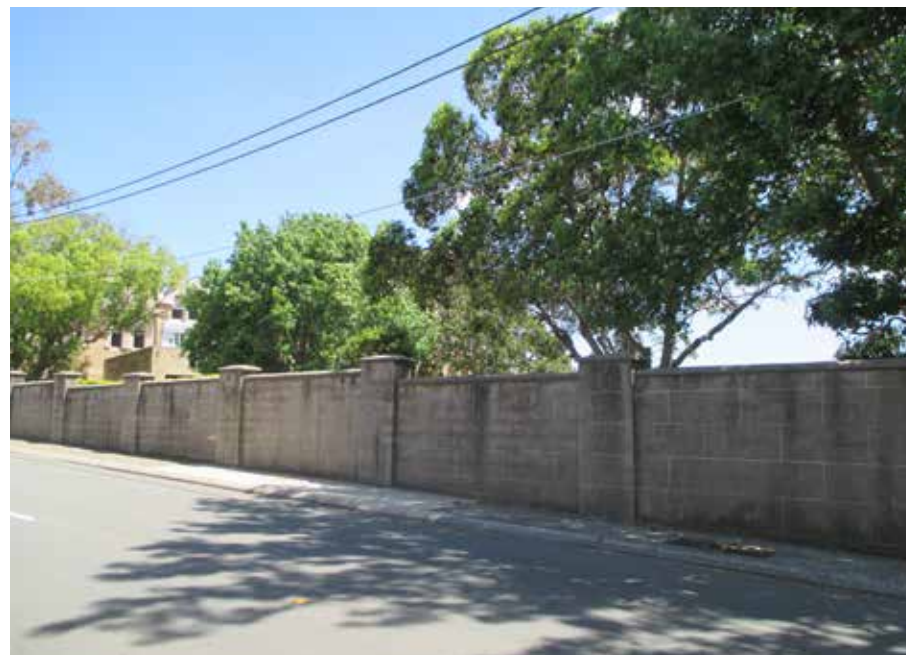
Figure 2.5: Imitation sandstone wall along Vacluse Road on the Senior School Complex side.

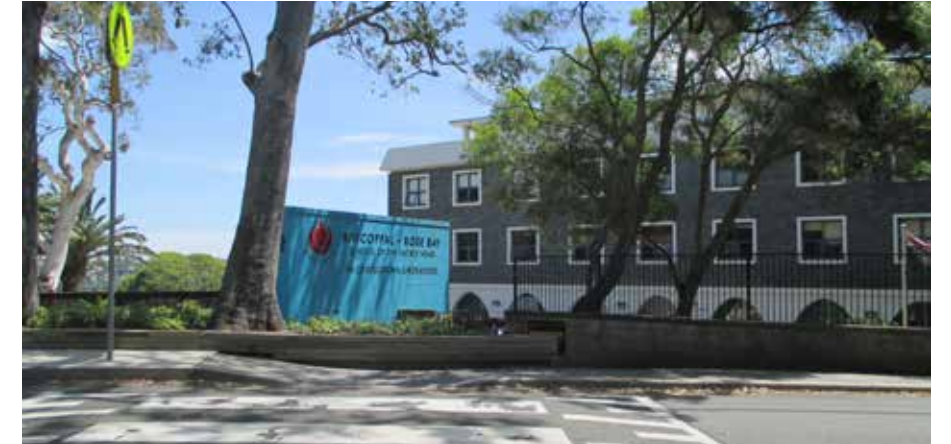
Figure 2.6: Barat Burn Junior School entry boundary wall and raised garden bed with timber edging.

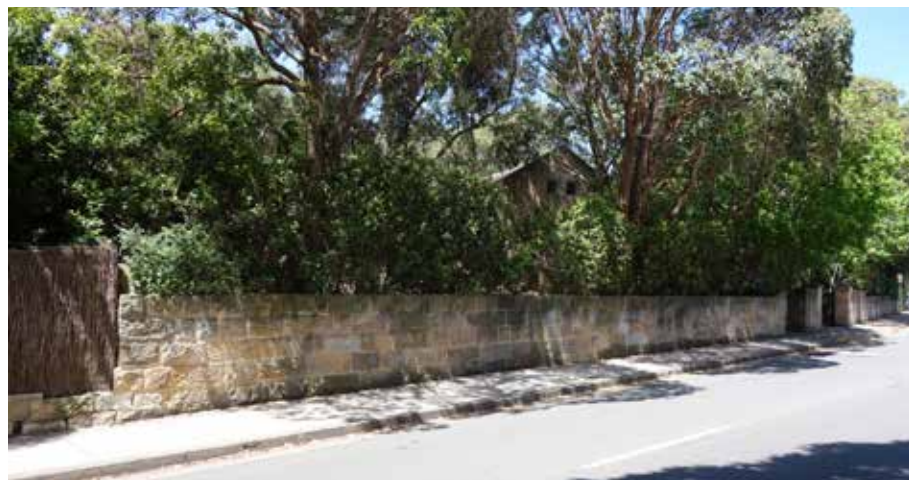
Figure 2.7: Medium height sandstone ashlar wall with picked finish and brushwood fencing surrounding Claremont Cottage on Vacluse Road.

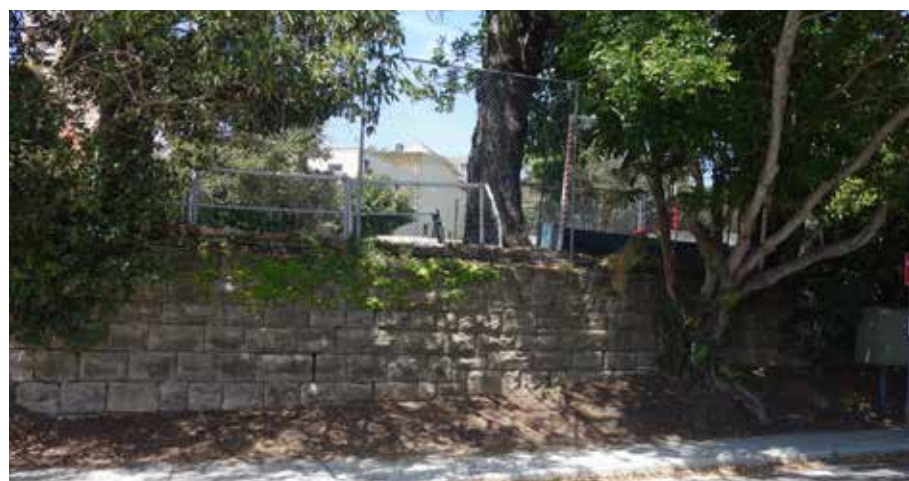
Figure 2.8: Sandstone retaining wall and chain link wire mesh fence at the northern end of the playing fields, close to the corner of Vacluse Road and Gilliver Avenue.

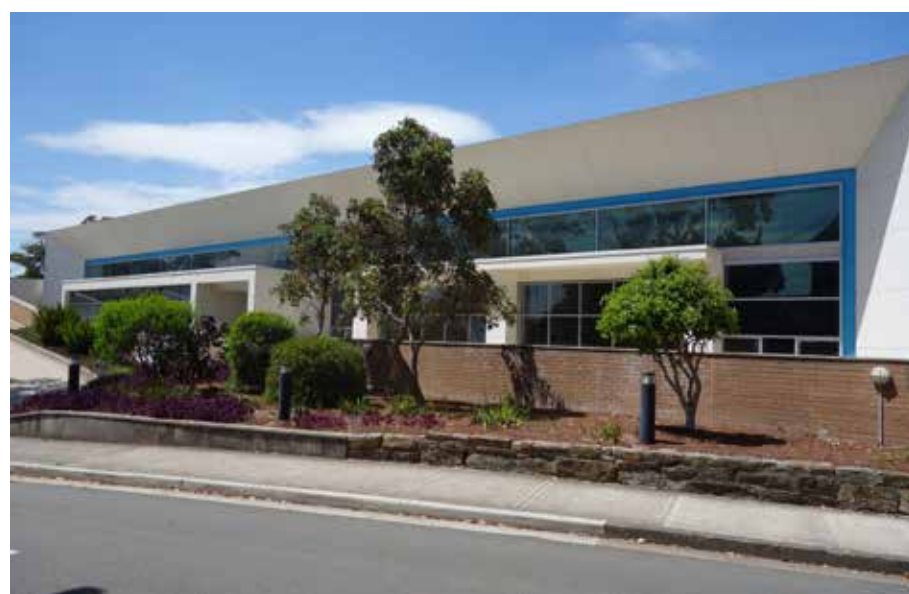
Figure 2.14: Low red, face brick wall with low sandstone retaining wall and raised garden bed, forming part of the driveway to the carpark at the MTC.

The MTC is set back from Vacluse Road with a low red face brick wall, which increases in height to form the driveway to the carpark and back-of-house areas under the playing field. It is separated from the roadside pavement with a sparsely planted mulched garden bed with shrubs and is bound by a low random rubble sandstone wall, which changes to a low concrete retaining wall about half way through. Services are enclosed with a mid-height concrete block and brick wall and modern aluminium fence.

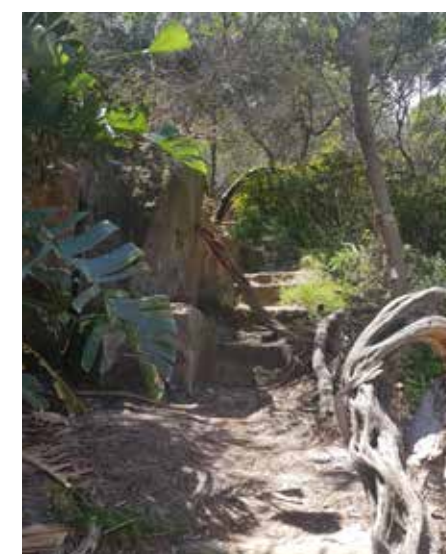
Figure 2.11: The cut stone steps leading down to the former Claremont jetty from the Hermitage Foreshore Track.

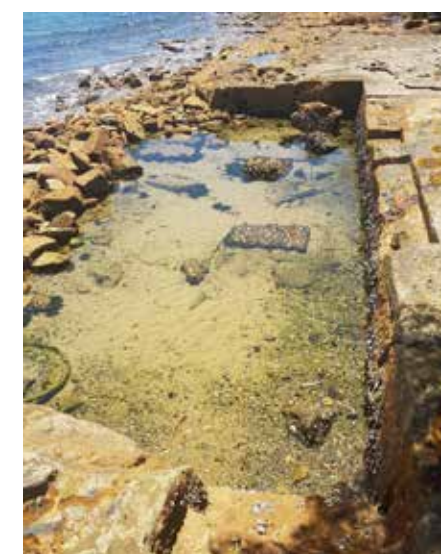
Figure 2.13: The second cut stone rock pool to the south of ‘Erika’s Crystal Baths’ and the former Claremont jetty with a set of cut steps leading into the pool.

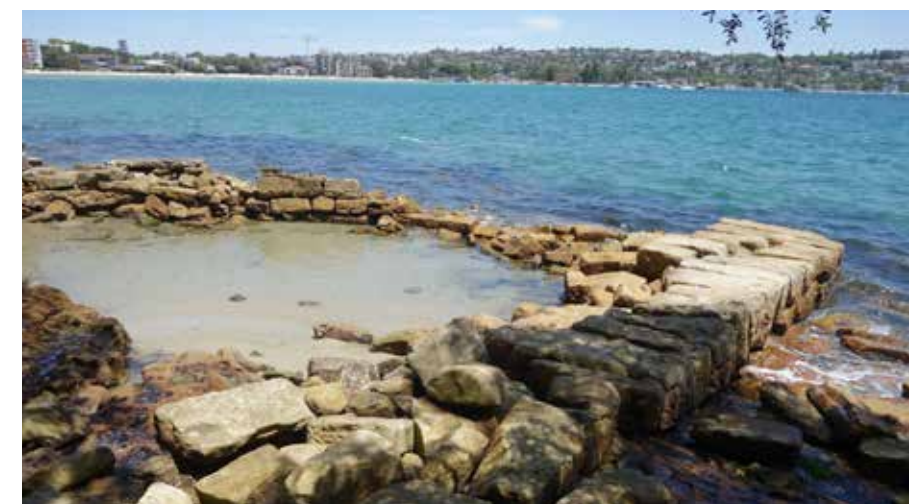
Figure 2.12: The remains of Claremont jetty and the rock pool below the western boundary of Kincoppal-Rose Bay with Rose Bay beach in the background.

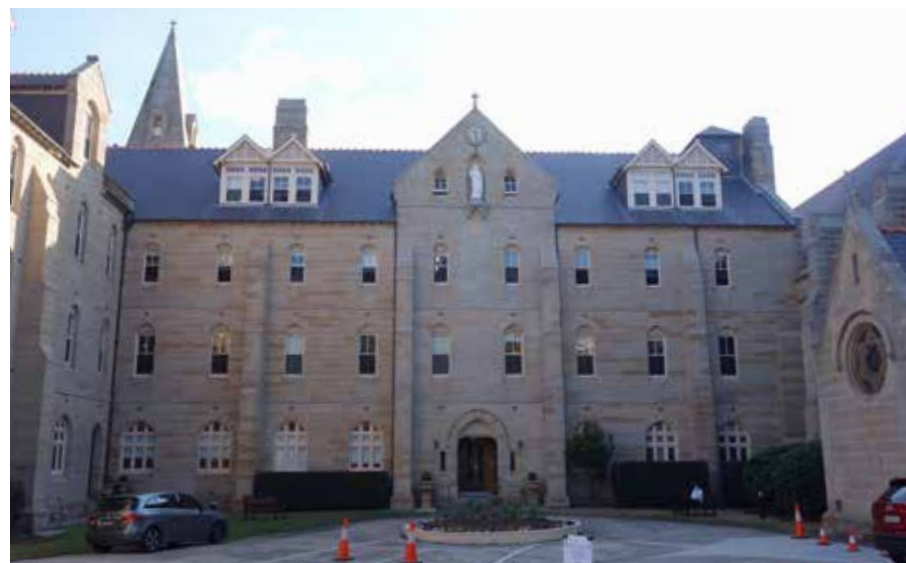
Figure 2.29: Eastern elevation and main entry of the Main School building.

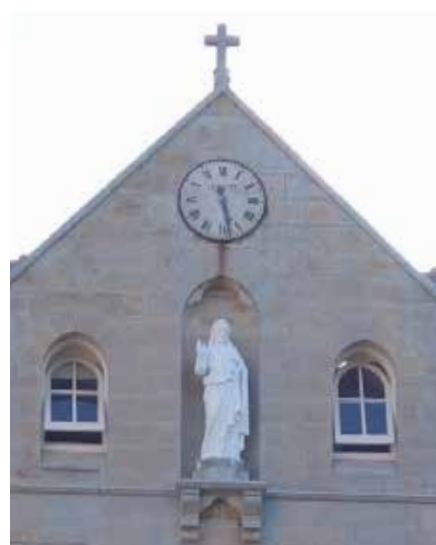
Figure 2.30: Lepaute clock and statue of Jesus in eastern central gable.

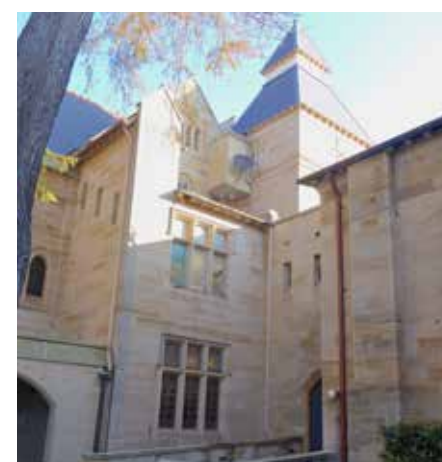
Figure 2.31: Northern tower of Main School Building and link to Claremont, seen from Chapel Square. The three stepped windows indicate a former stair.

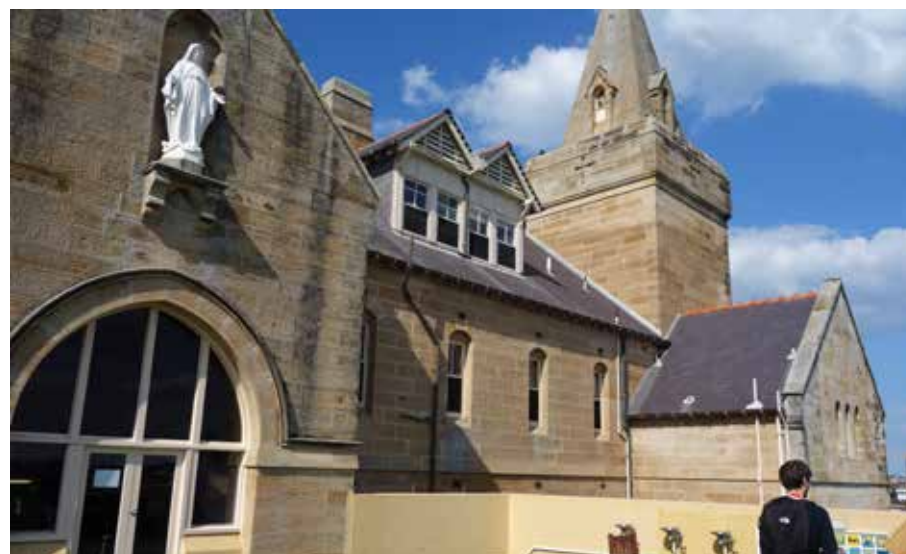
Figure 2.32: Access to the Hughes Centre roof terrace is through the original former full height window within the central bay of the Main School Building.

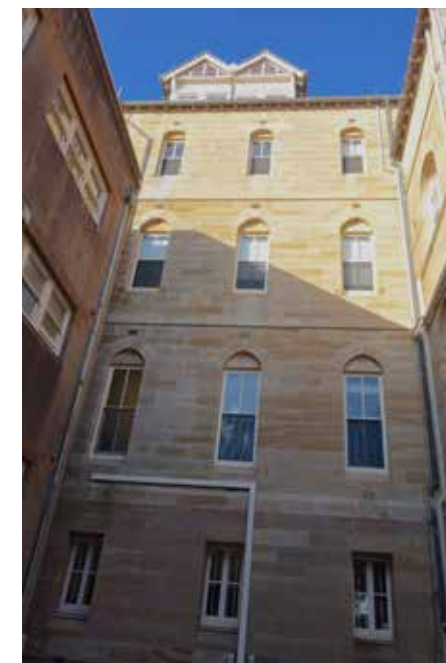
Figure 2.33: Western elevation of the Main School Building between Hughes Centre (left) and 'bathroom tower' (right).

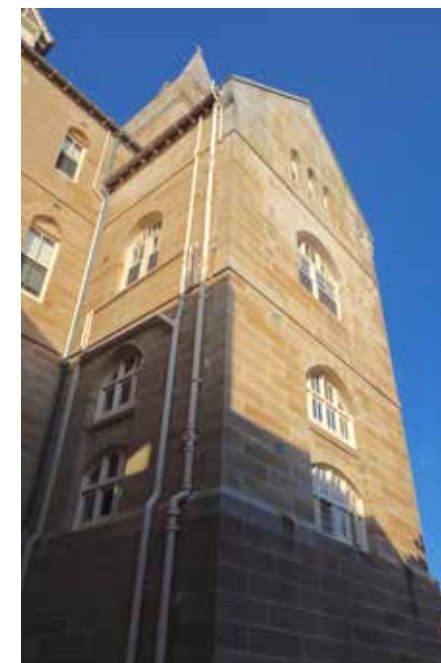
Figure 2.34: Main School Building 'bathroom tower' at the south western corner.

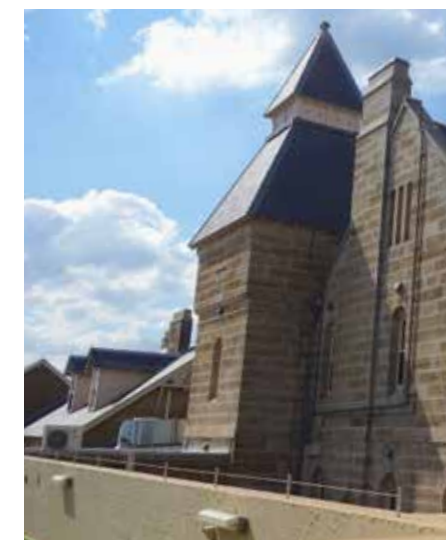
Figure 2.35: Western elevation and northern tower above the Hughes Centre roof terrace.

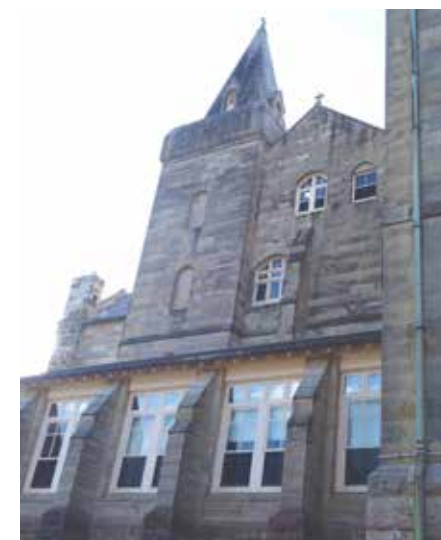
Figure 2.36: Southern elevation of the Main School Building with two storey 'verandah and balcony' in the foreground.

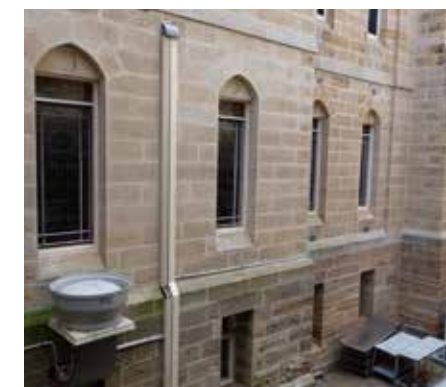
Figure 2.37: Courtyard between western elevation of the Main School Building and the Hughes Centre. Note the stained glass windows on the ground level and services (Level 2).

The majority of services such as air conditioning units, infrastructure and cabling are located within this lightwell, and run along the original stone walls. There is substantial moss and lichen growth on the sandstone and paving in this area. It is particularly found on sills, the plinth course and any protruding stonework in the courtyard.

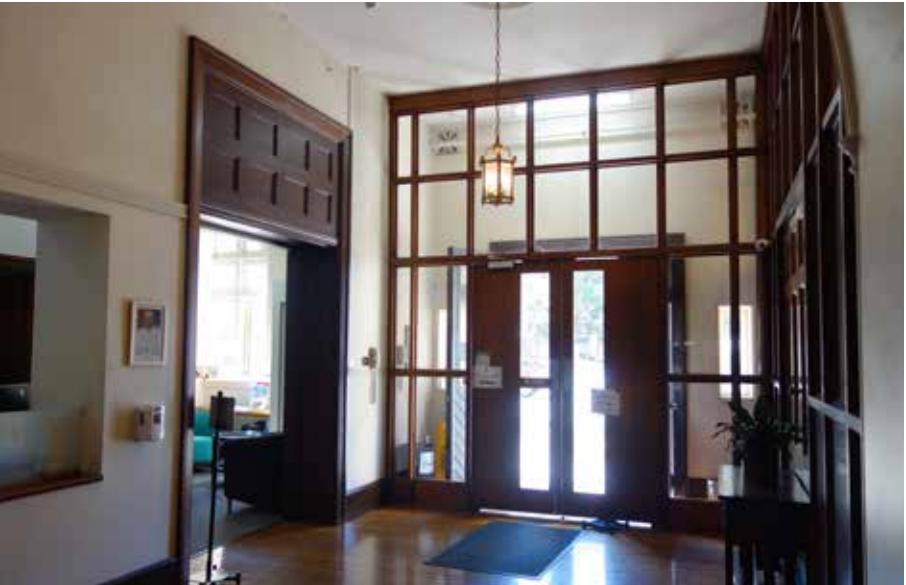
Figure 2.38: Main entrance foyer showing the modern timber partition (centre and right). The doorcase to the reception and waiting area on the left would appear to be original / early joinery.

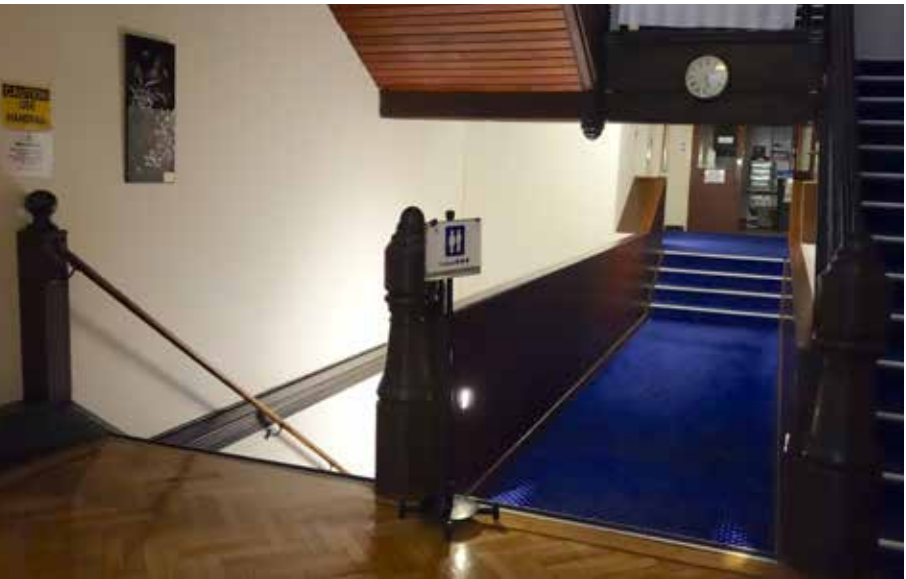
Figure 2.39: Non-original bridge through the main staircase provides access to the Hughes Centre at Level 2.

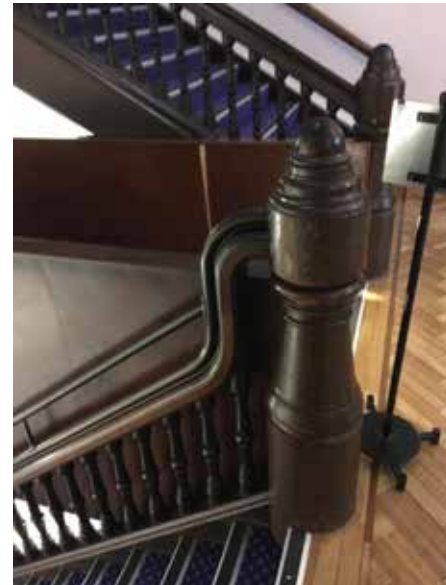
Figure 2.41: Detail of the timber balustrade, newel post and parquet floor of the main staircase on Level 2.

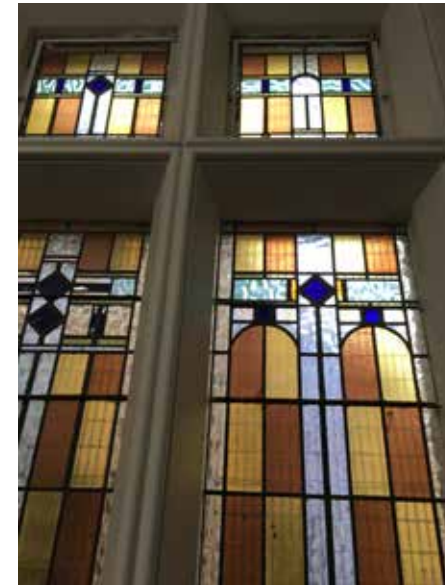
Figure 2.45: Detail of the stained glass windows on Level 2. Externally these windows front Chapel Square.

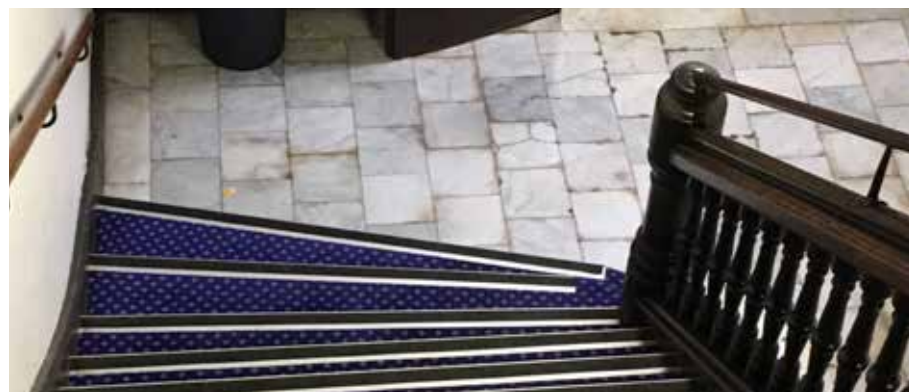
Figure 2.42: Original marble tiled floor in basement (main central stair Level 1).

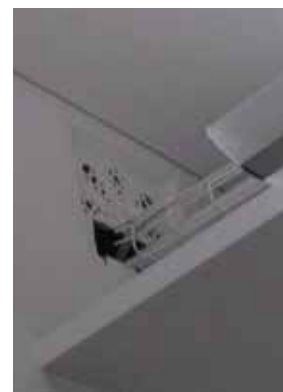
Figure 2.46: Some of the original external wall vents have been used as outlets for modern services such as air-conditioning or have been painted shut.

The 1888 buildings were originally designed with a passive ventilation system in external and internal walls, however now mostly rely on modern air-conditioning and ceiling fans. Most of the original vents and openings remain however are no longer operational, having been painted shut, sealed or blocked by other services.

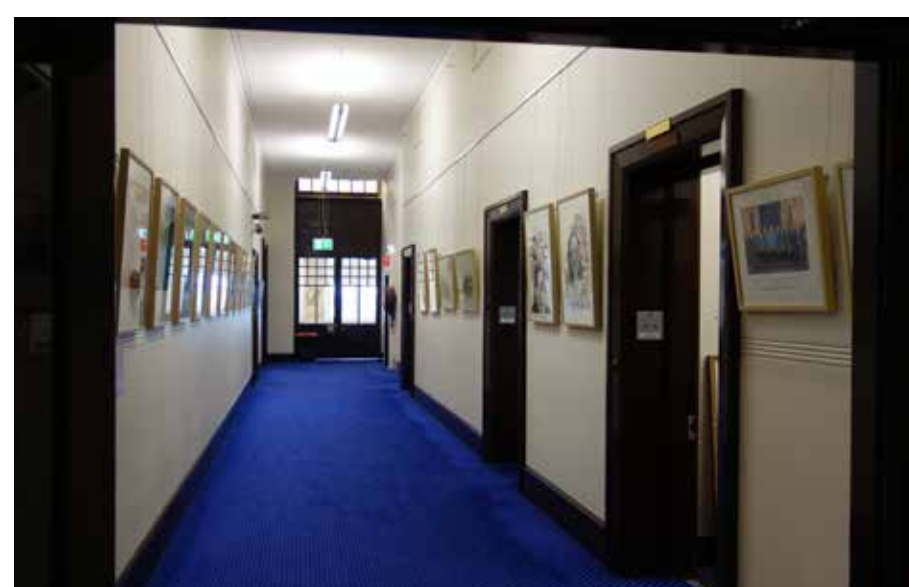
Figure 2.47: Level 2 corridor, looking south towards the 1888 'verandah and balcony'. This view shows the collection of modern prints along the modern aluminium picture rail.

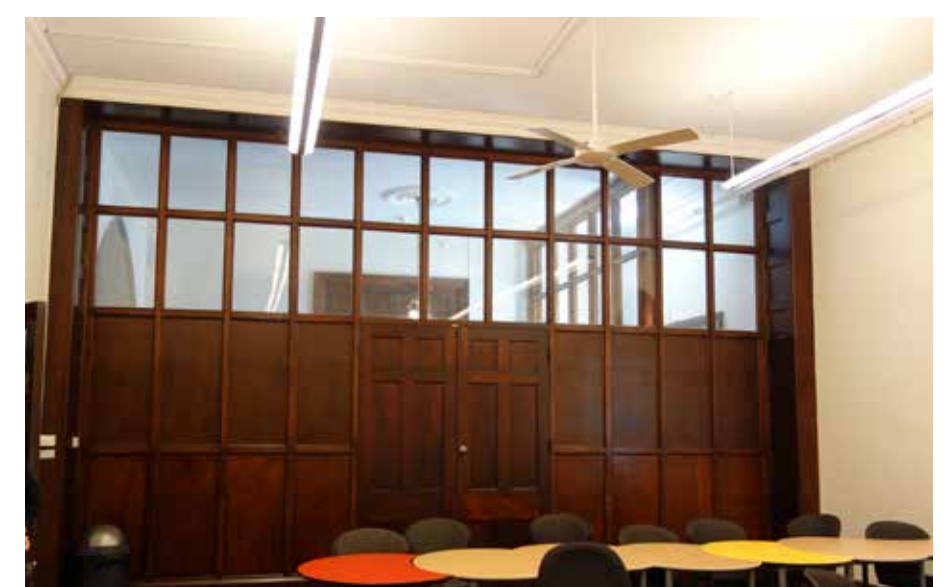
Figure 2.51: The classroom adjacent the main entry is separated by a 1990 timber partition. On either side of this opening can be seen original / earlier joinery, similar to the doorcase to the main reception area.

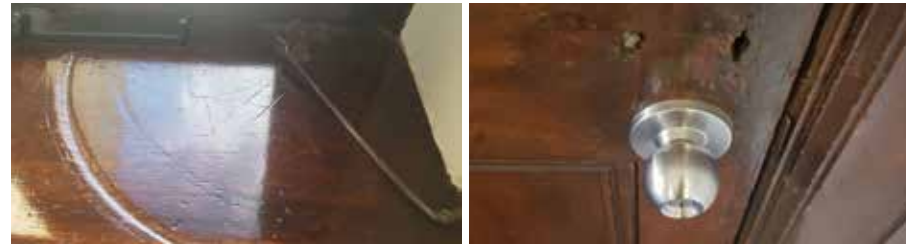
Figure 2.52: Evidence of original window and door hardware remains in parts (eg. on Level 4), although no longer used, with many items replaced with modern security locks.

Most rooms retain their original joinery including double hung windows and four panelled doors and architraves. For security reasons, one panel in most doors has been replaced with a clear glass panel. Many original doors retain evidence of the location of former door furniture (through later modifications) although generally new door and window furniture has been installed and only very few original elements remain.

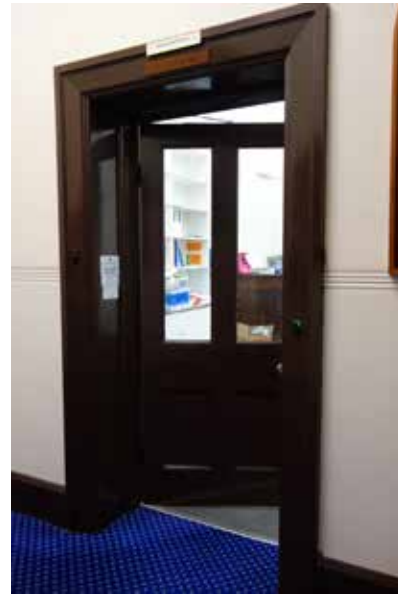
Figure 2.53: Typical signage and modified door leaf.

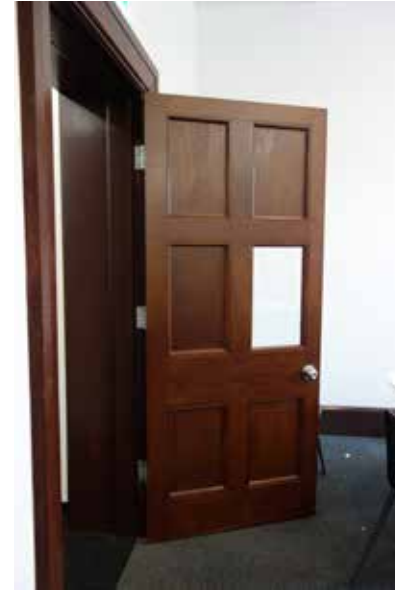
Figure 2.54: The original doors have been modified throughout to include a glass panel for security reasons.

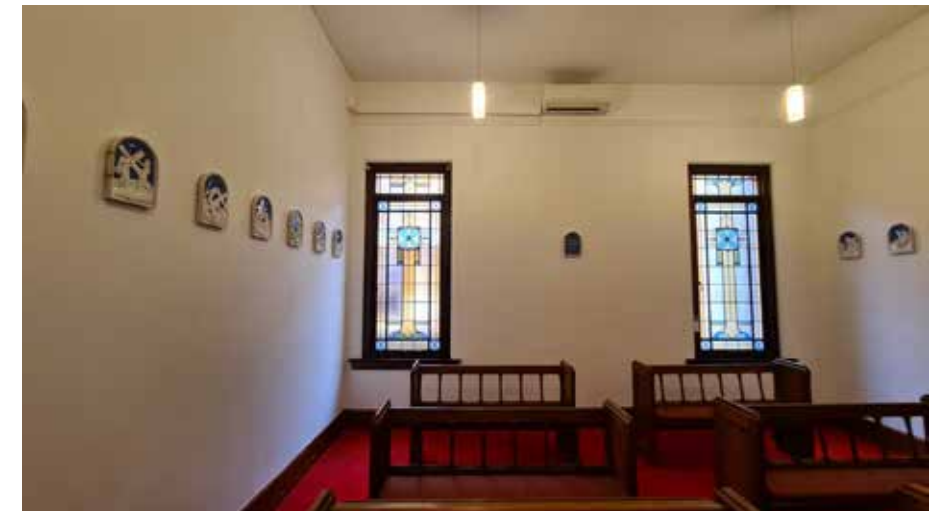
Figure 2.57: The original Hunt designed stained glass windows to the west of the Main School Building in the Chapel of Mater Admirabilis.

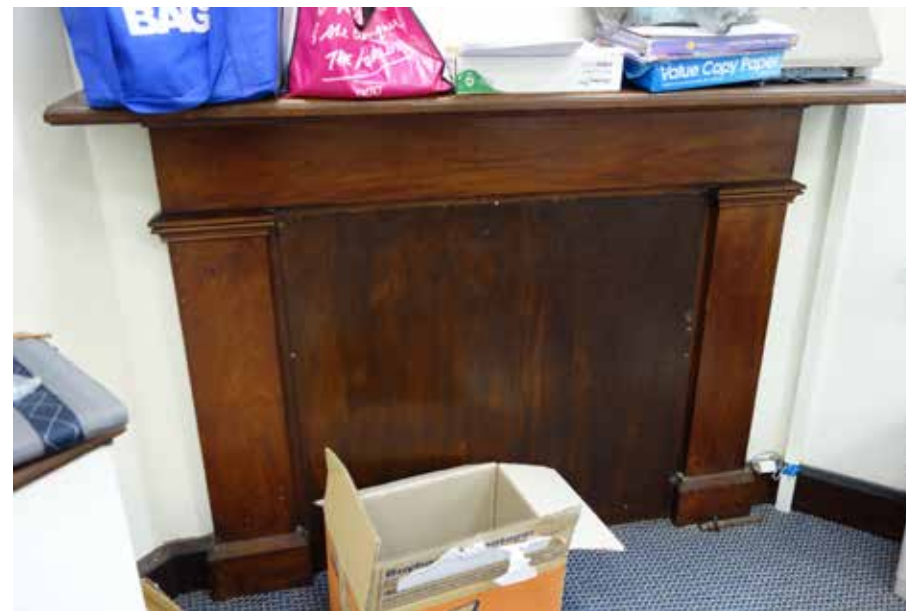
Figure 2.55: Original fireplace on Level 2, infilled with timber.

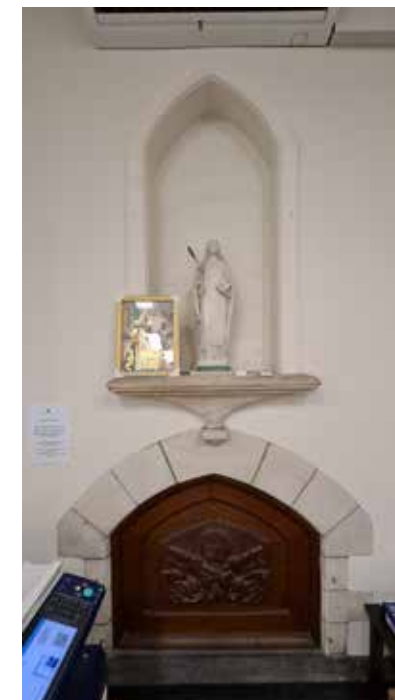
Figure 2.58: Stone fireplace and carved timber inset in the administration area.

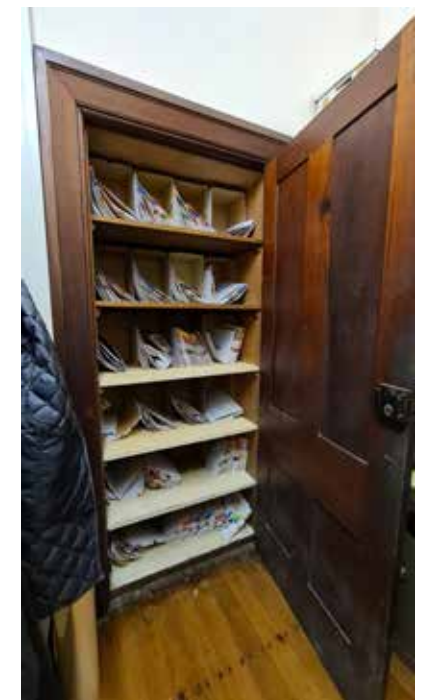
Figure 2.59: Cupboard disguised as door between Chapel and Administration space..

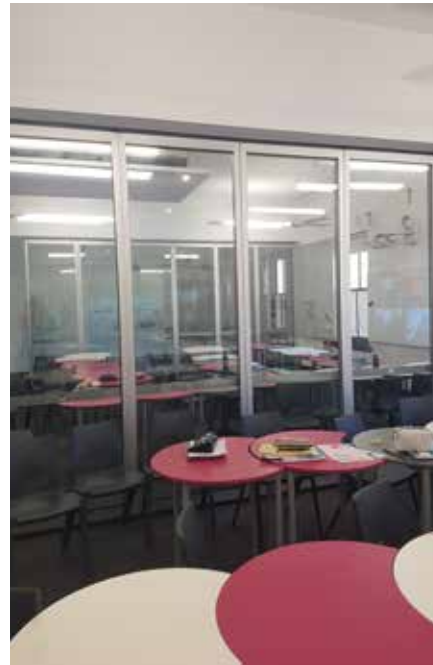
Figure 2.61: Level 3 classroom showing modern furniture, projectors and lowered false ceilings to accommodate services above. This former large space is now divided into three, by modern aluminium sliding door panels.

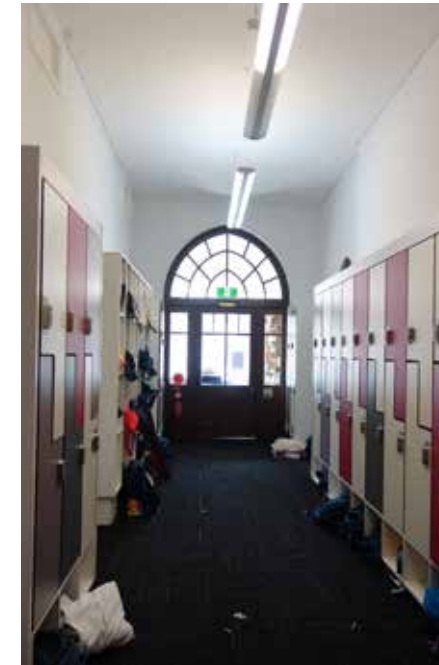
Figure 2.62: Many of the internal high level vents have been filled in on the corridor side, prohibiting natural cross ventilation. Image taken on Level 3 main corridor, looking north.

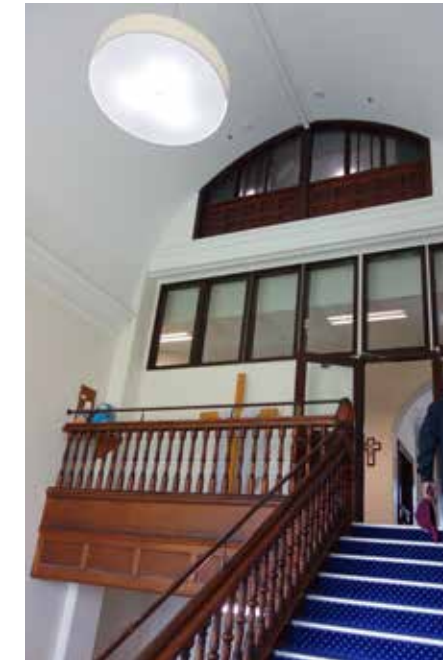
Figure 2.65: Later security partition on Level 4. Note the elaborate polished cedar highlight into the attic space above.

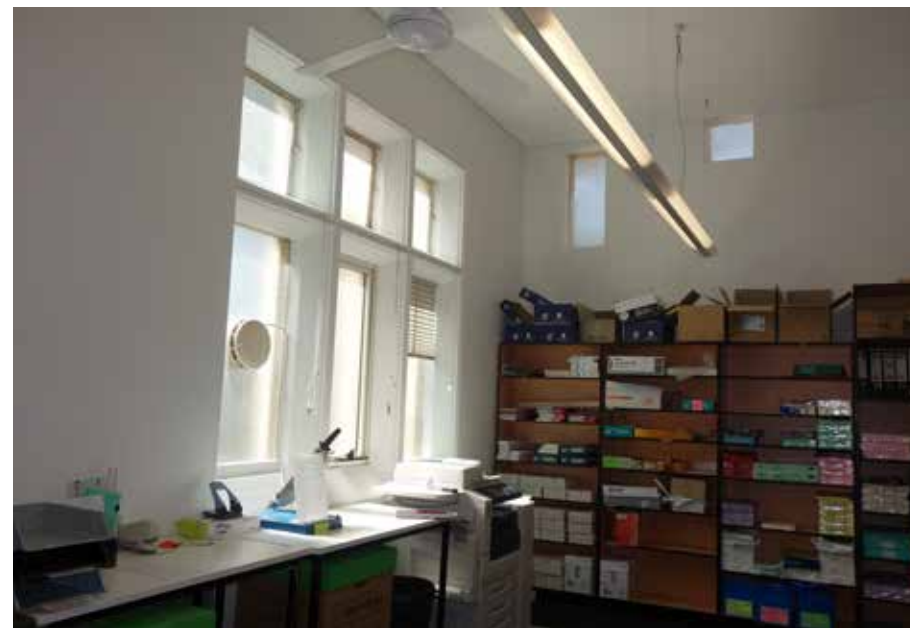
Figure 2.60: A view of the print room on Level 3 with the stepped opaque glass openings on the eastern wall (right), indicating a former stair along this wall.

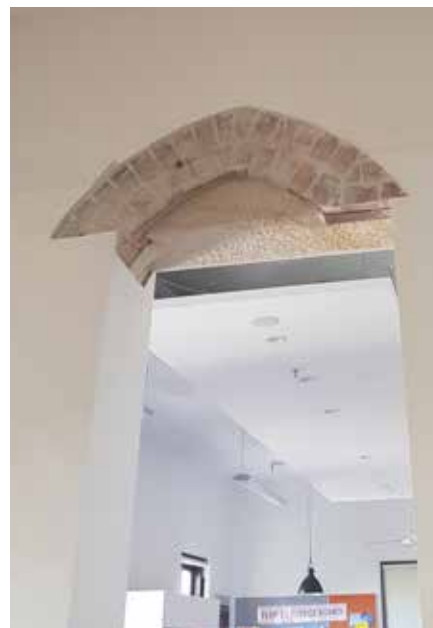
Figure 2.63: A pointed brick archway uncovered by recent works has been left exposed as an interpretive element. (Level 3)

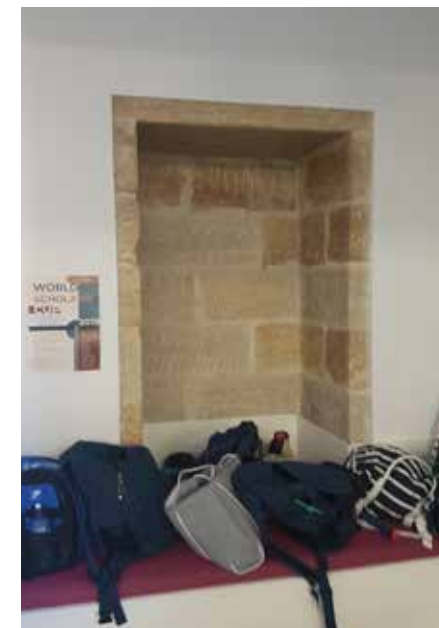
Figure 2.64: Stone niche located in the position of a former fireplace, has been left exposed as an interpretive element. (Level 3)

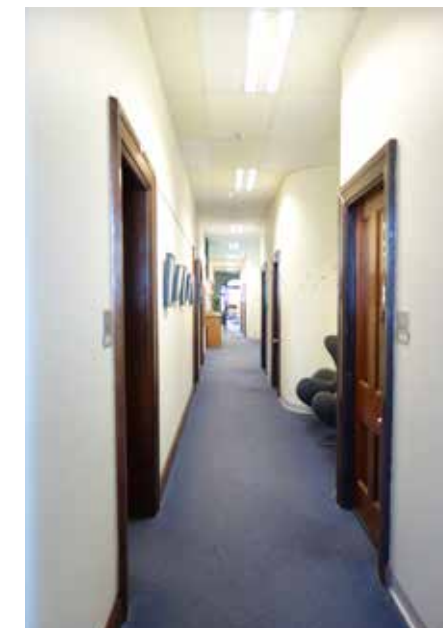
Figure 2.67: Central corridor on Level 4 with the original plaster wall on the left and modern curved walls with aluminium skirting on the right.

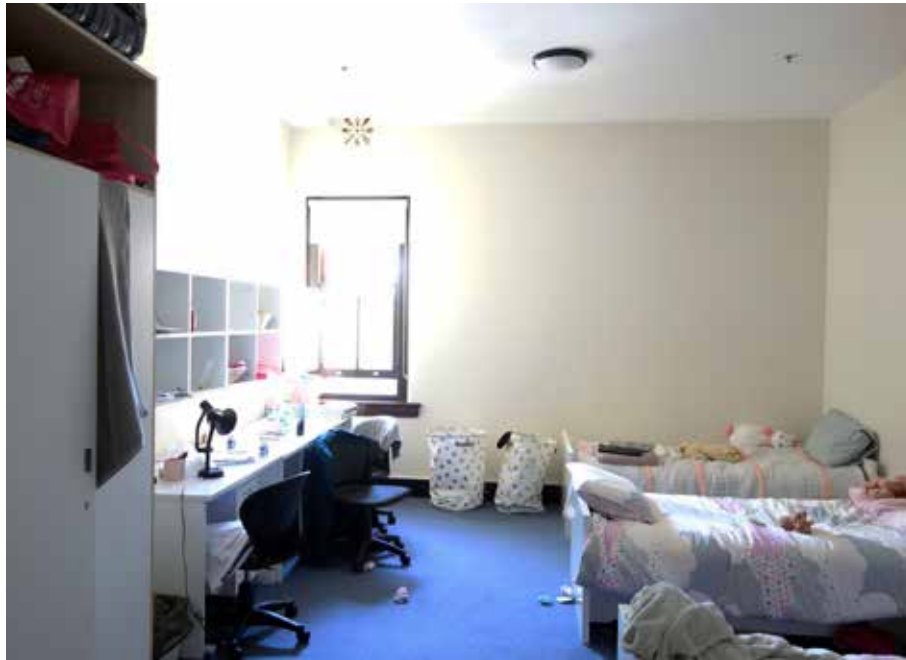
Figure 2.69: Typical dorm room on Level 4 with modern bedroom furniture for each student. The original windows are unpainted and retain wall vents over.

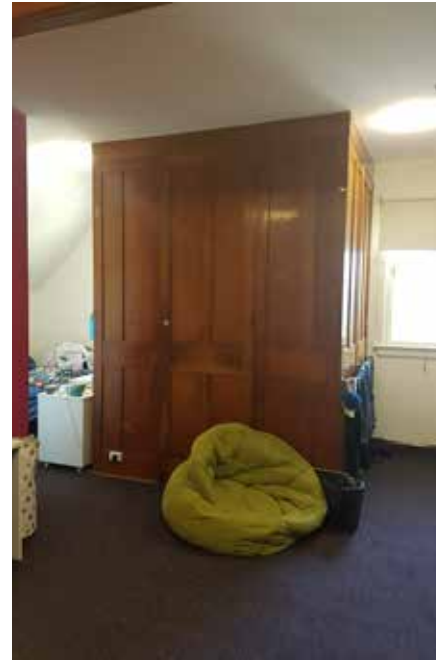
Figure 2.72: The timber cabinet enclosing the Lepaute clock mechanism in the Main School Building gable is located on Level 5.

Of note on this level is the timber cabinet enclosing the working of the French clock, located within the bedroom at the central core of the building on the eastern side. This room also retains its large polished timber built in wardrobes, with modern stainless steel towel rails and locks attached.

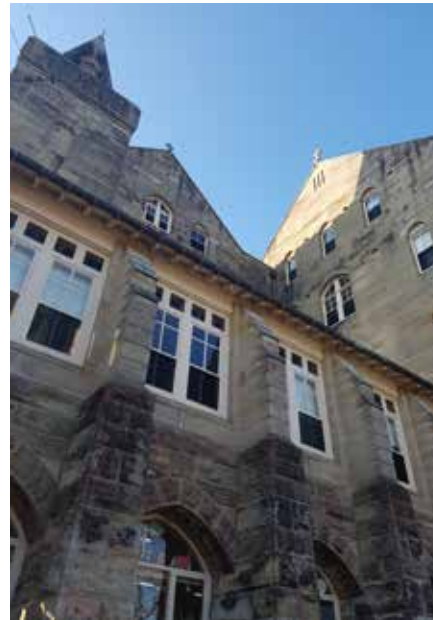
Figure 2.74: 'Verandah and balcony' with relation to the western elevation of the South wing and the southern tower in the background. Note also the 'dog holes' at the centre of some stones.

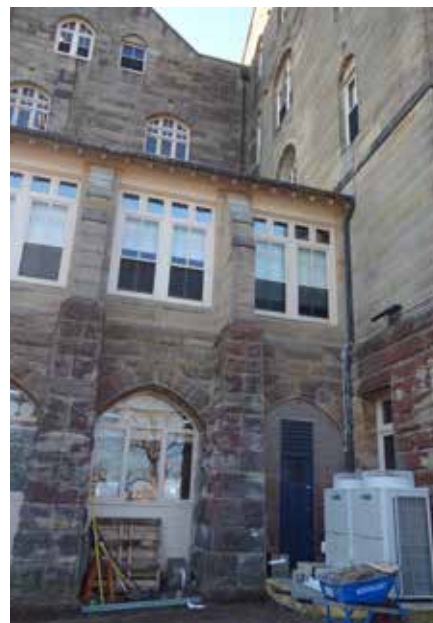
Figure 2.76: The eastern most bay of this elevation is infilled with masonry, rendered, lined and finished to resemble sandstone.
