KINCOPPAL - ROSE BAY

SCHOOL OF THE SACRED HEART

CONSERVATION MANAGEMENT PLAN

Final Report - August 2020

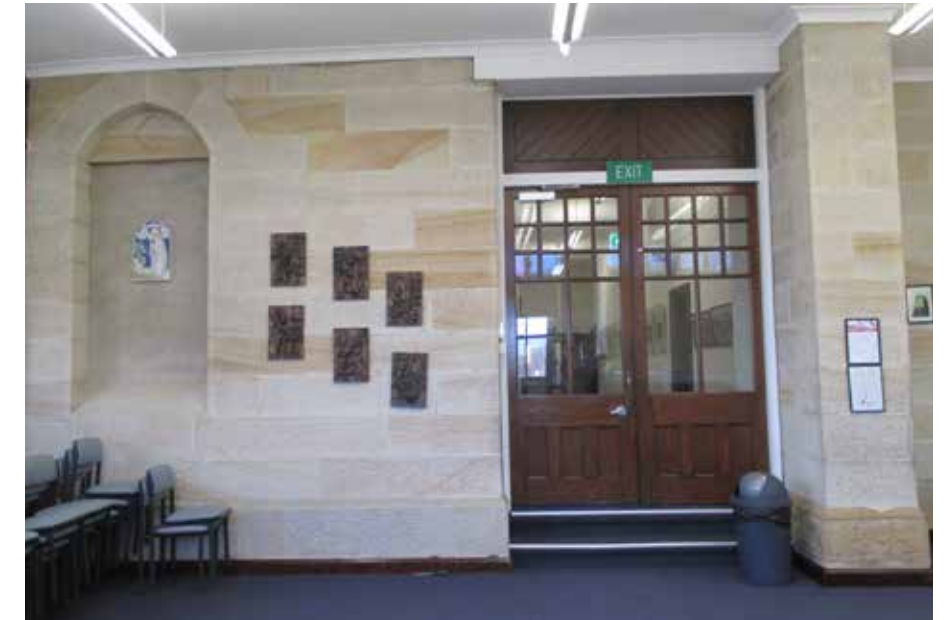
Figure 2.77: The interior of the 'verandah and balcony' on Level 2, looking towards the exposed sandstone wall of the main building and southern tower. The niche to the left in this image is one of the blind windows on the southern tower elevation. The exposed sandstone is evidence that this space was formerly an external space.

Level 2 is accessed at the end of the central corridor through the main building, and is currently used as a music class room. Walls are exposed sandstone ashlar. One of the blind openings to the southern tower is visible internally. A false plasterboard ceiling has been installed at a lower level to the original. All windows are fitted with white canvas block-out roller blinds. The room contains a piano, modern classroom furniture, a projector and pull down screen and smartboard. The smartboard is located across an original opening, concealing part of the architectural quality of the space.

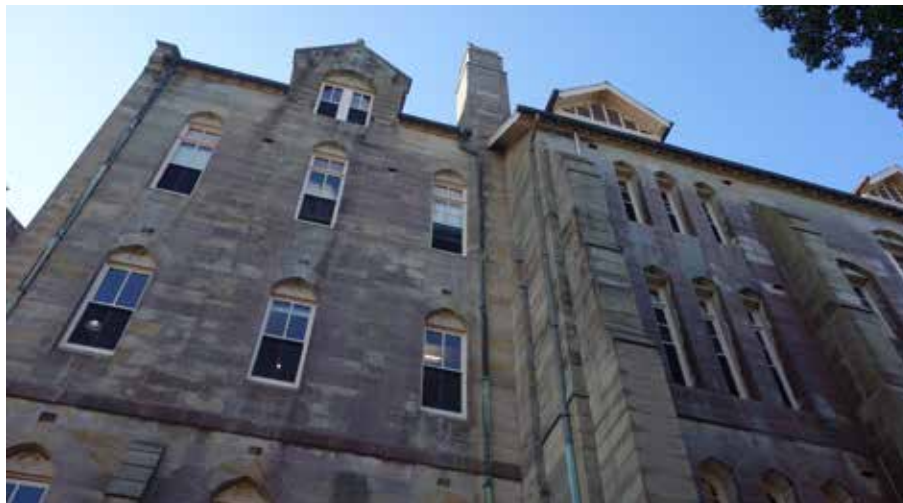
Figure 2.80: Junction between the 1888 wing and 1922 extension, marked by the setback and chimney. Note the different styles of dormer windows.

An existing chimney on the southern side marks the junction of the original 1888 wing and 1922 extension, which is also legible in the jointing of the stonework below. This chimney was extended in 1922 with the construction of an additional storey and replacement of the earlier north-south orientated roof with the current east-west orientated gable roof form (including attic accommodation). External fabric dating from 1888 includes the north-south sandstone walls (buttressed on the southern side) and the timber sash windows in pointed arch openings (Levels 1 to 3), and timber and glass panelled door at the north western corner.

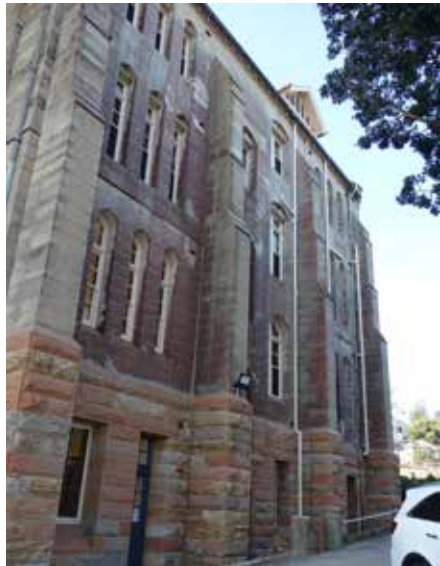
Figure 2.83: The southern elevation of the 1922 South wing with rock faced ashlar plinth and fine sparrow pecked ashlar above.

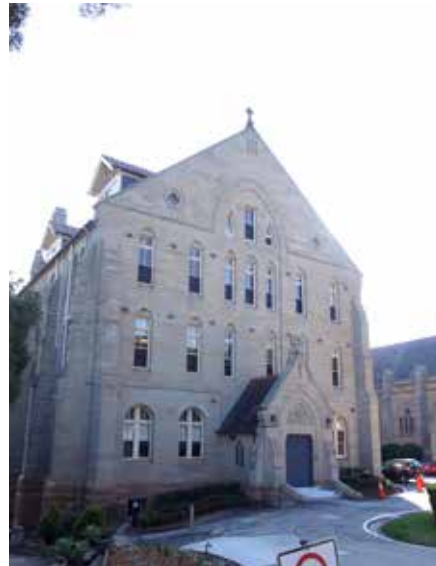
Figure 2.84: Eastern elevation and entry to the 1922 South wing. Note the two quatrefoil lead light windows in the gable and carved stone Celtic Cross atop the apex of the gable.

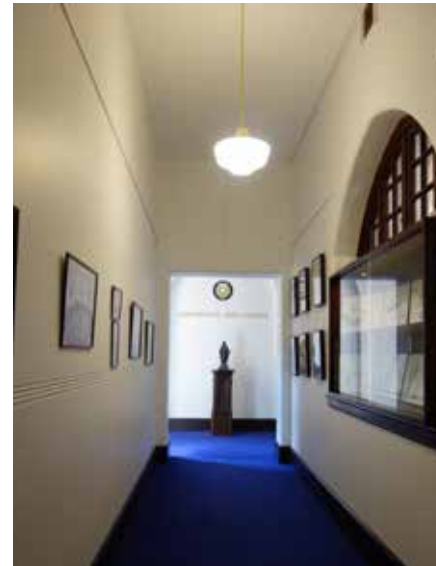
Figure 2.85: Looking towards the 1888 portion of South wing. The display cabinet in the pointed arch opening on the right is a former window to the 'verandah and balcony'.

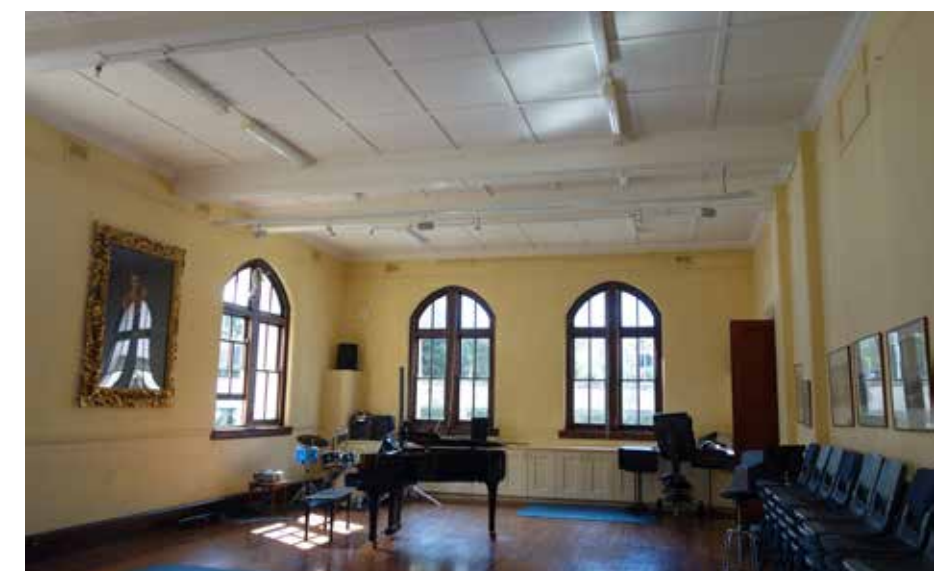
Figure 2.90: The main hall / music room, which was formerly used for receptions is divided from the board room with a modern plasterboard wall and acoustic curtain (not visible in this image). Note the battened ceiling, typical of the 1922 extension to the South wing.

The main hall / music room has a fibrous plaster boarded ceiling with decorative cornice and is painted yellow. The concertina doors between the boardroom and music room identified in the 2002 CMP have been replaced by a new plasterboard wall, which has been covered with an acoustic curtain.

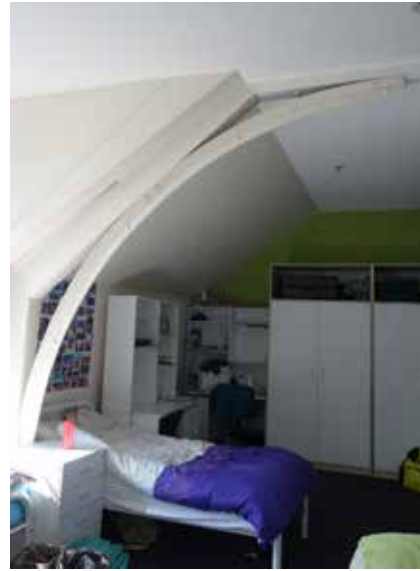
Figure 2.95: Typical bedroom on Level 5 of the South wing. Note the exposed steel roof trusses.

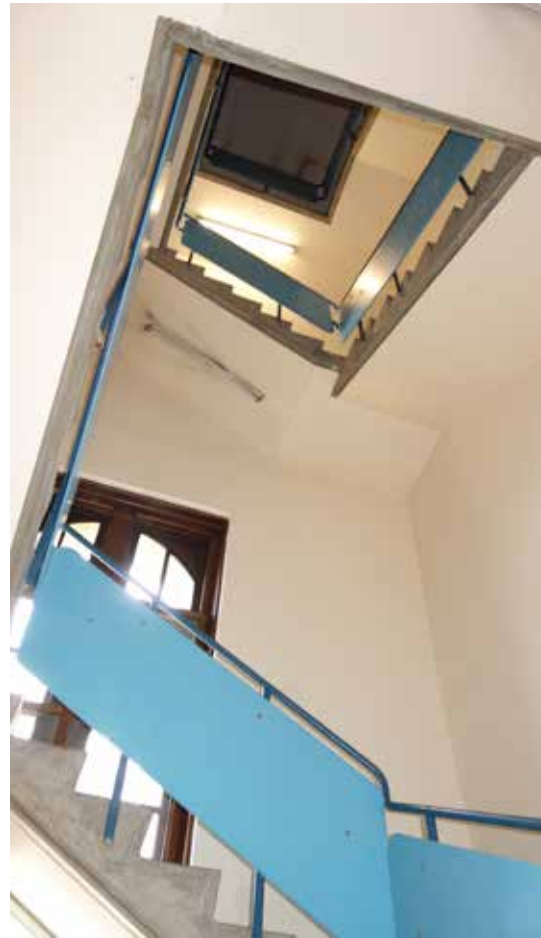
Figure 2.96: View of the modern concrete fire stair within South wing.

A modern concrete fire stair with a steel handrail is located midway along the southern elevation, and appears to be used as storage and for some art related projects such as spray painting. The original timber double hung windows with arched highlights over, are sealed by a timber framed metal mesh screen and are no longer operable.

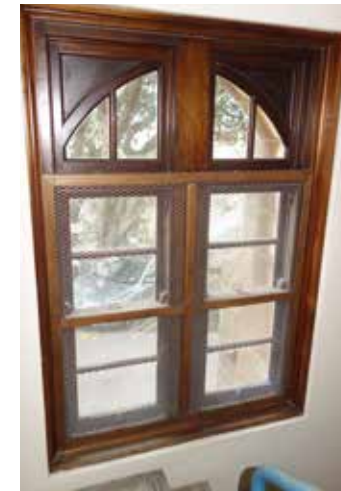
Figure 2.97: Original timber double hung windows with arched highlight over. Note the secondary timber framed meshed screen, resulting in them no longer being operable.

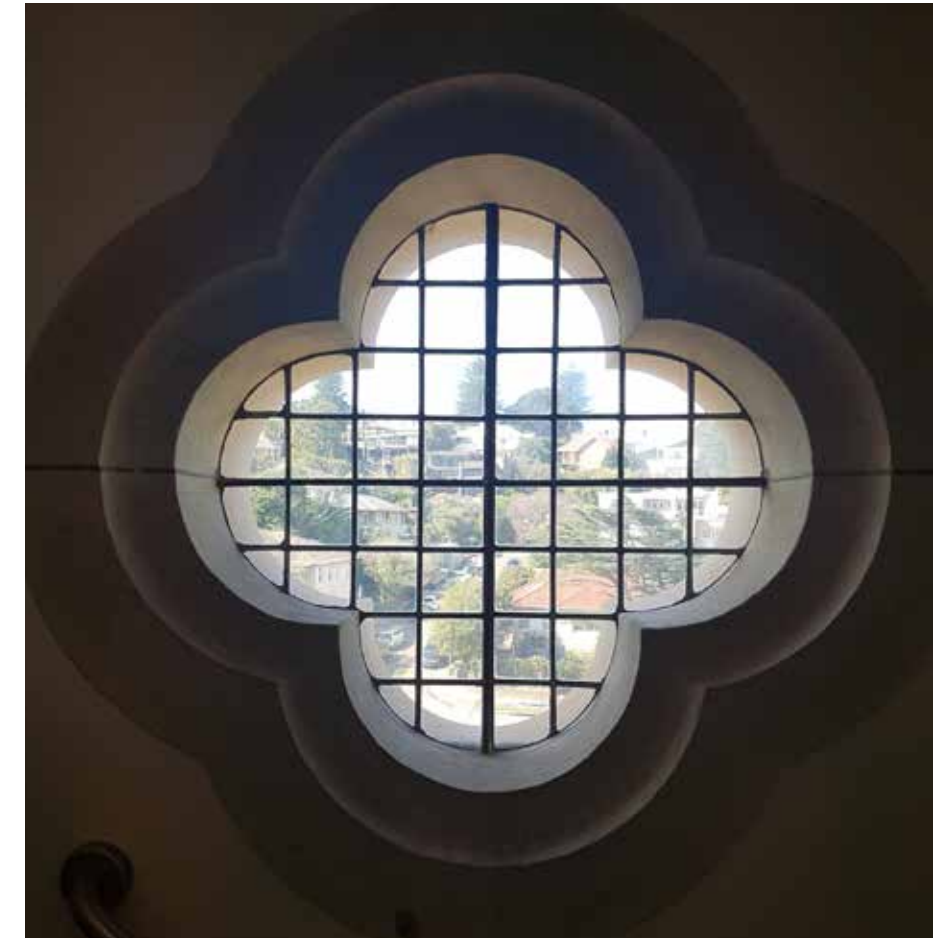
Figure 2.99: Close-up of the quatrefoil shaped window on the eastern elevation of South wing with its stone surrounds and clear, square leaded glass.

Similar to the Main School Building, bedrooms and recreational facilities have colourful feature walls. The quatrefoil shaped windows, visible on the eastern elevation, have clear and square leaded glass and stone surrounds. This forms the focal point of the modern bathroom fitout at this location.

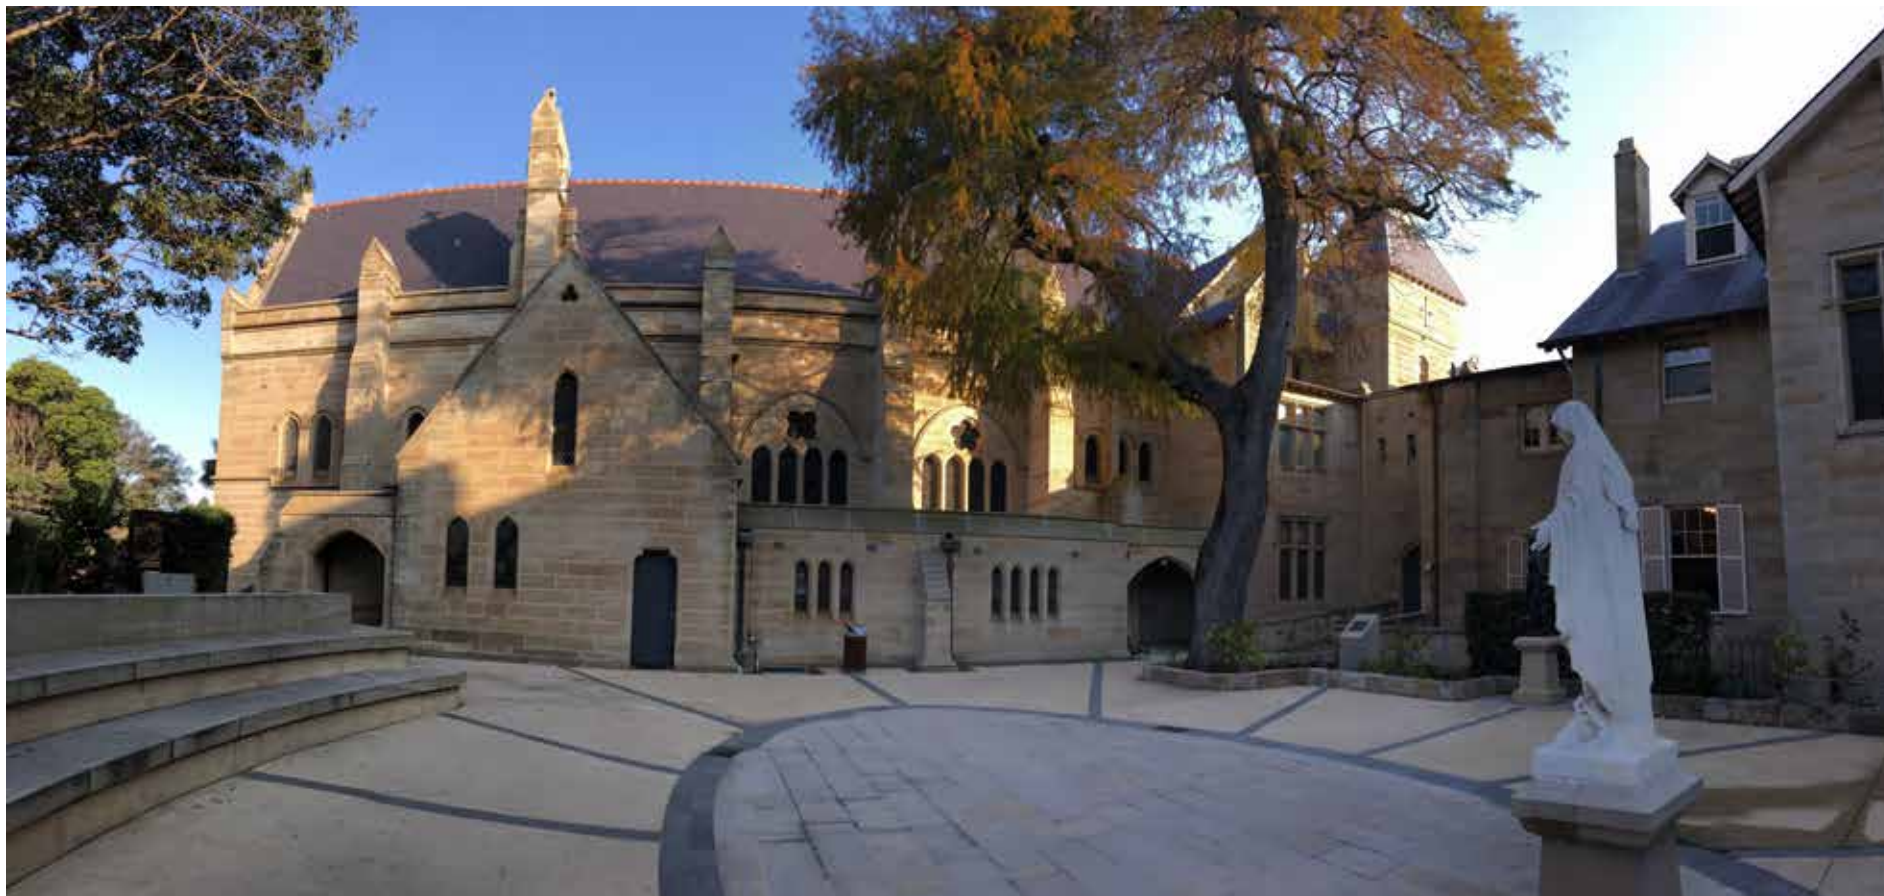
Figure 2.100: The northern elevation of the Chapel, the Claremont link and northern tower and part of Claremont as seen from Chapel Square. The Sacristy is located in the foreground to the Chapel. Note the Montezuma Bald Cypress (*Taxodium mucronatum*) and Statue of Our Lady to the right of the image.

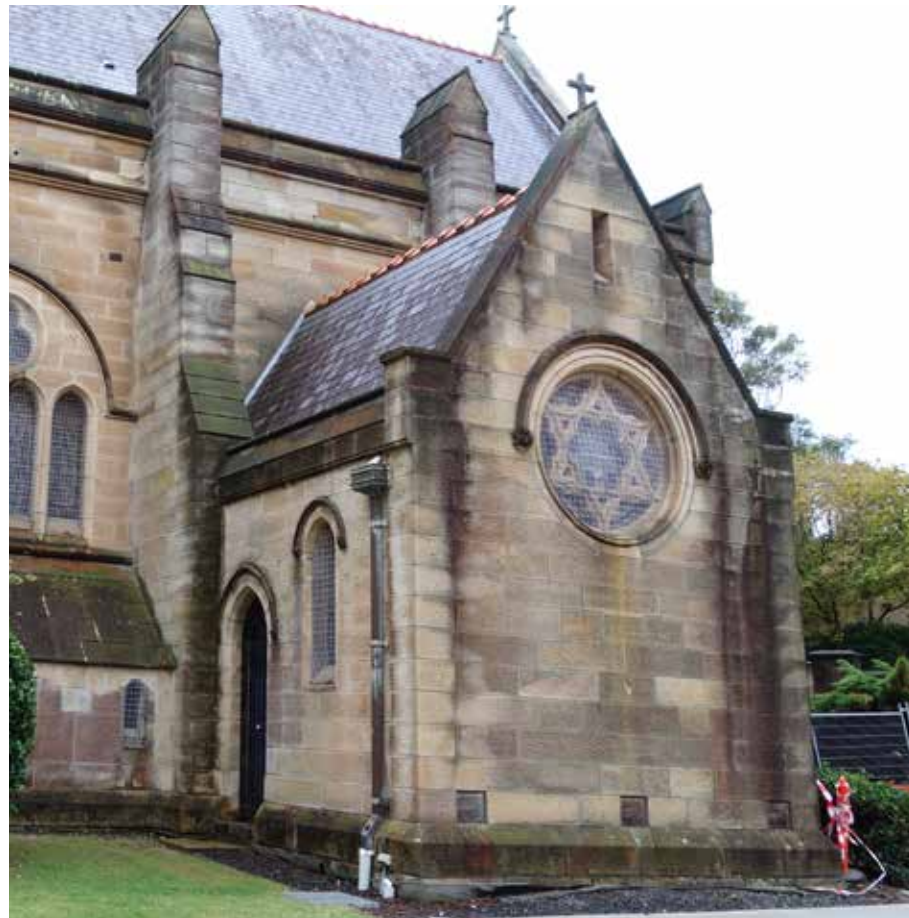
Figure 2.102: The western and southern elevations of the Side / Stranger's Chapel with the circular Gothic tracery rose window.

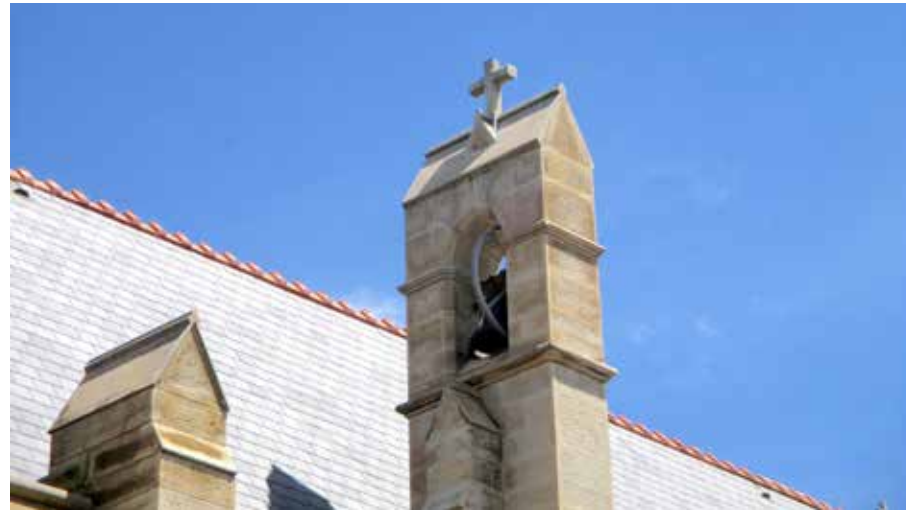
Figure 2.103: The bell tower to the north of the Chapel is called "Rosario" and acts as a memorial to Reverend Mother Vercruysse.

height. The existing bell tower is said to have been added by Hunt at his own expense after Reverend Mother Vercruysse's death. It acts as a memorial to her work and was named "*Rosario*" as she paced the length and breadth of the Chapel foundations while saying the Rosary.⁸ The bell has been in its position since its arrival in 1901.

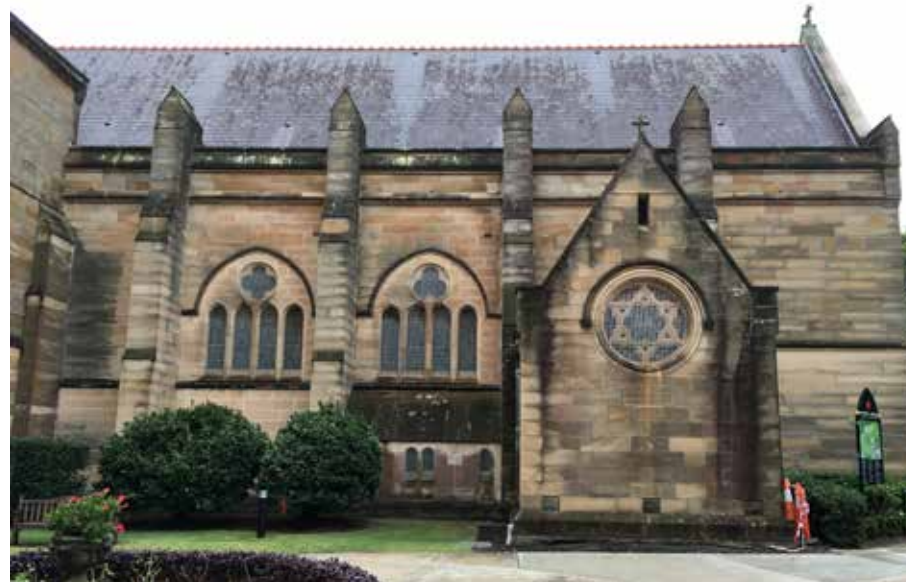
Figure 2.104: Southern elevation of the Chapel, showing the division of the Chapel into bays, defined by the evenly spaced buttresses and the Side / Stranger's Chapel.

From above, the three main spaces of the chapel, namely the Chapel, Side / Stranger's Chapel on the south and the Sacristy on the north, are expressed by three traditional steeply gabled roofs, finished in Welsh slate with terracotta ridge capping tiles and small lead roof vents. The roofs are bound by a stone parapet with a simple moulded string course to the north and south elevations. Box gutters are hidden behind the stone parapets of the chapel, side chapel and sacristy, and flow into rainwater heads and rectangular downpipes, which are a mix of original and replacement copper items. The steeply pitched gable ends of the chapel, side chapel and sacristy are finished with a simple stone cross.

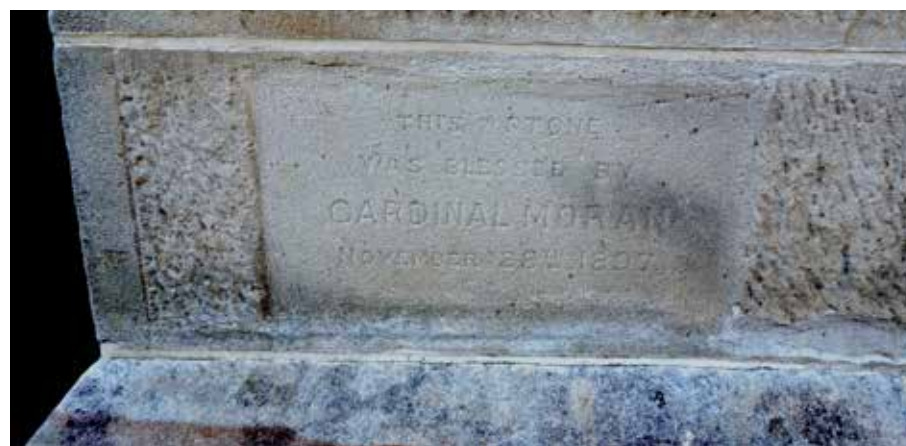
Figure 2.105: The foundation stone of the Chapel laid in 1887 in the south eastern corner of the building.

The eastern elevation of the chapel is defined by the five-light lancet window that was gifted to the convent by former students in memory of Reverend Mother Vercruysse. To the exterior the windows have a rounded arch moulding over and single string course below the sill. A narrow ventilation opening is located towards the top of the gable. The laying of the foundation stone was celebrated by around 200 visitors in a ceremony that was performed by the Cardinal-Archbishop in 1897. It is located at the southeastern corner and reads "*This stone was blessed by Cardinal Moran November 28th 1897*".

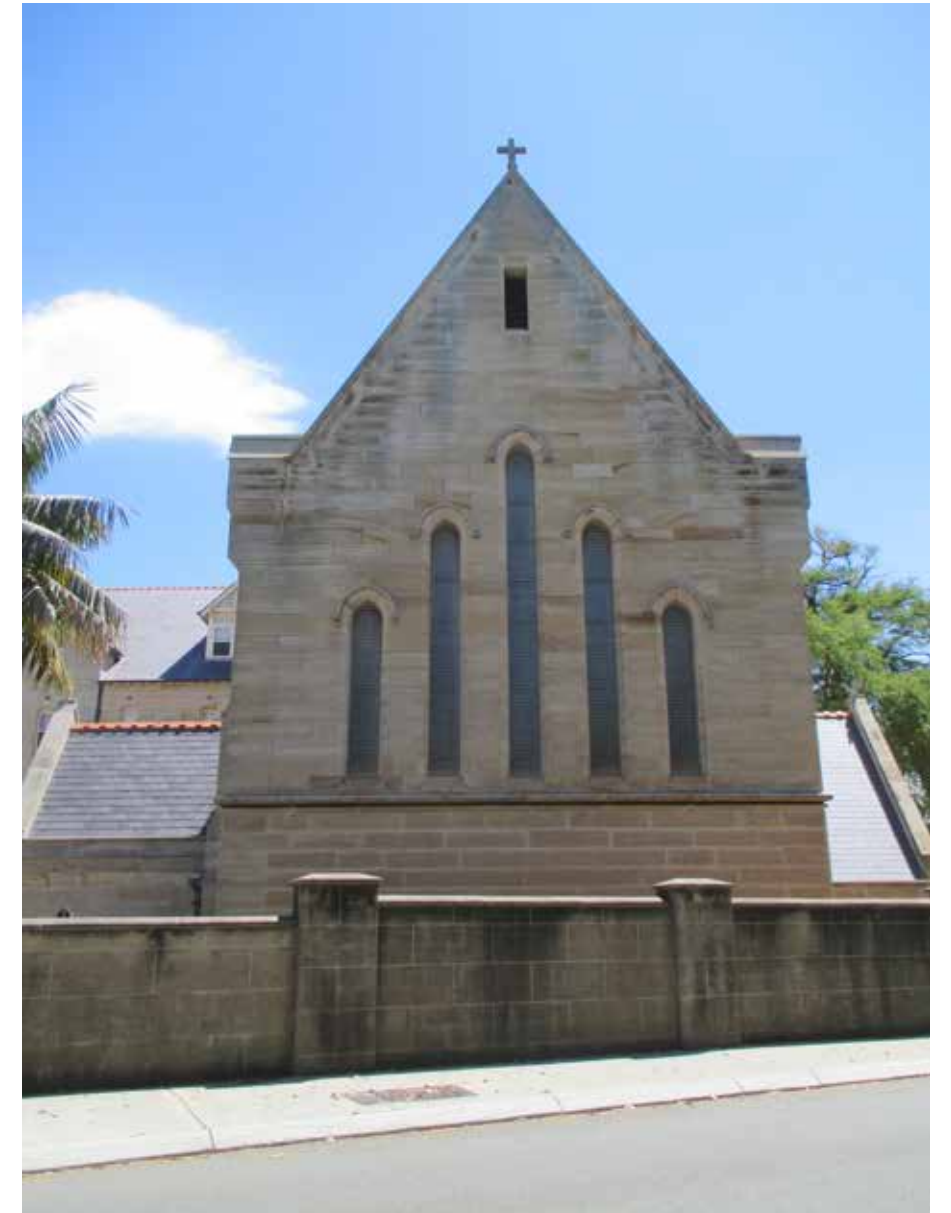
Figure 2.106: The eastern elevation of the Chapel as seen from Vaucluse Road, with the stone boundary wall in the front. The five-light memorial window to Mother Vercruysse defines this elevation.

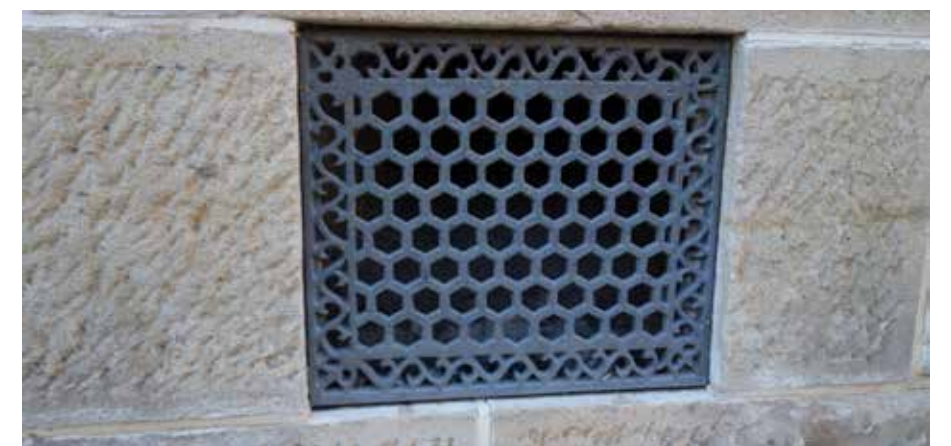
Figure 2.107: Detail of original floor vent located above the plinth course.

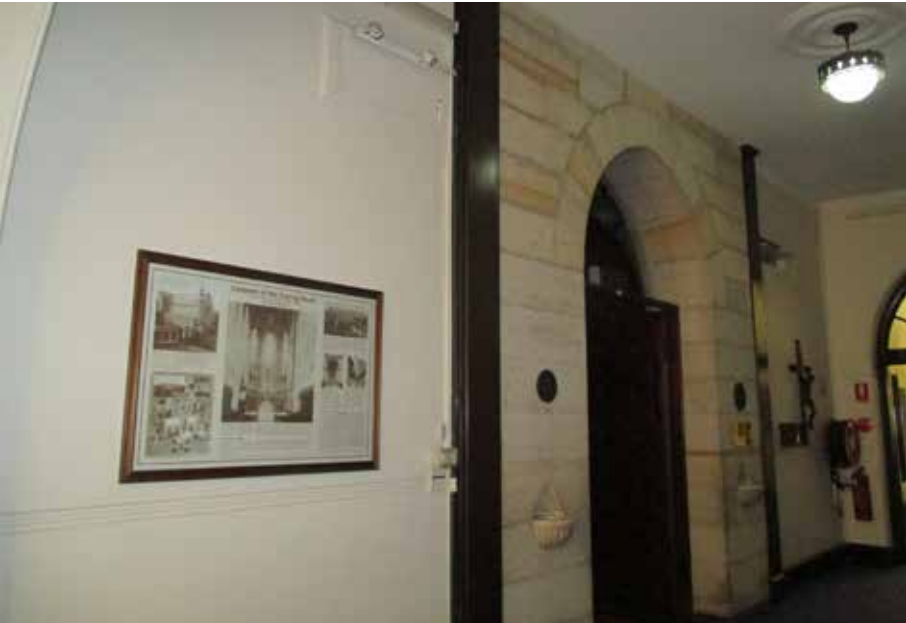
Figure 2.108: The main entry to the Chapel from Level 2 of the Main School building. Note the unfinished sandstone ashlar wall adjacent rendered walls.

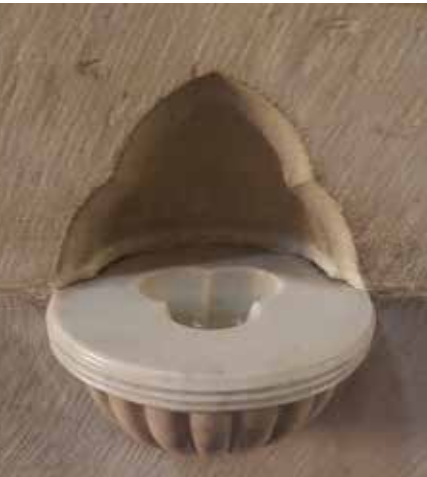
Figure 2.109: Detail of the marble holy water font set into a trefoil pointed arch recess in the sandstone adjacent the entrance doors to the Chapel.

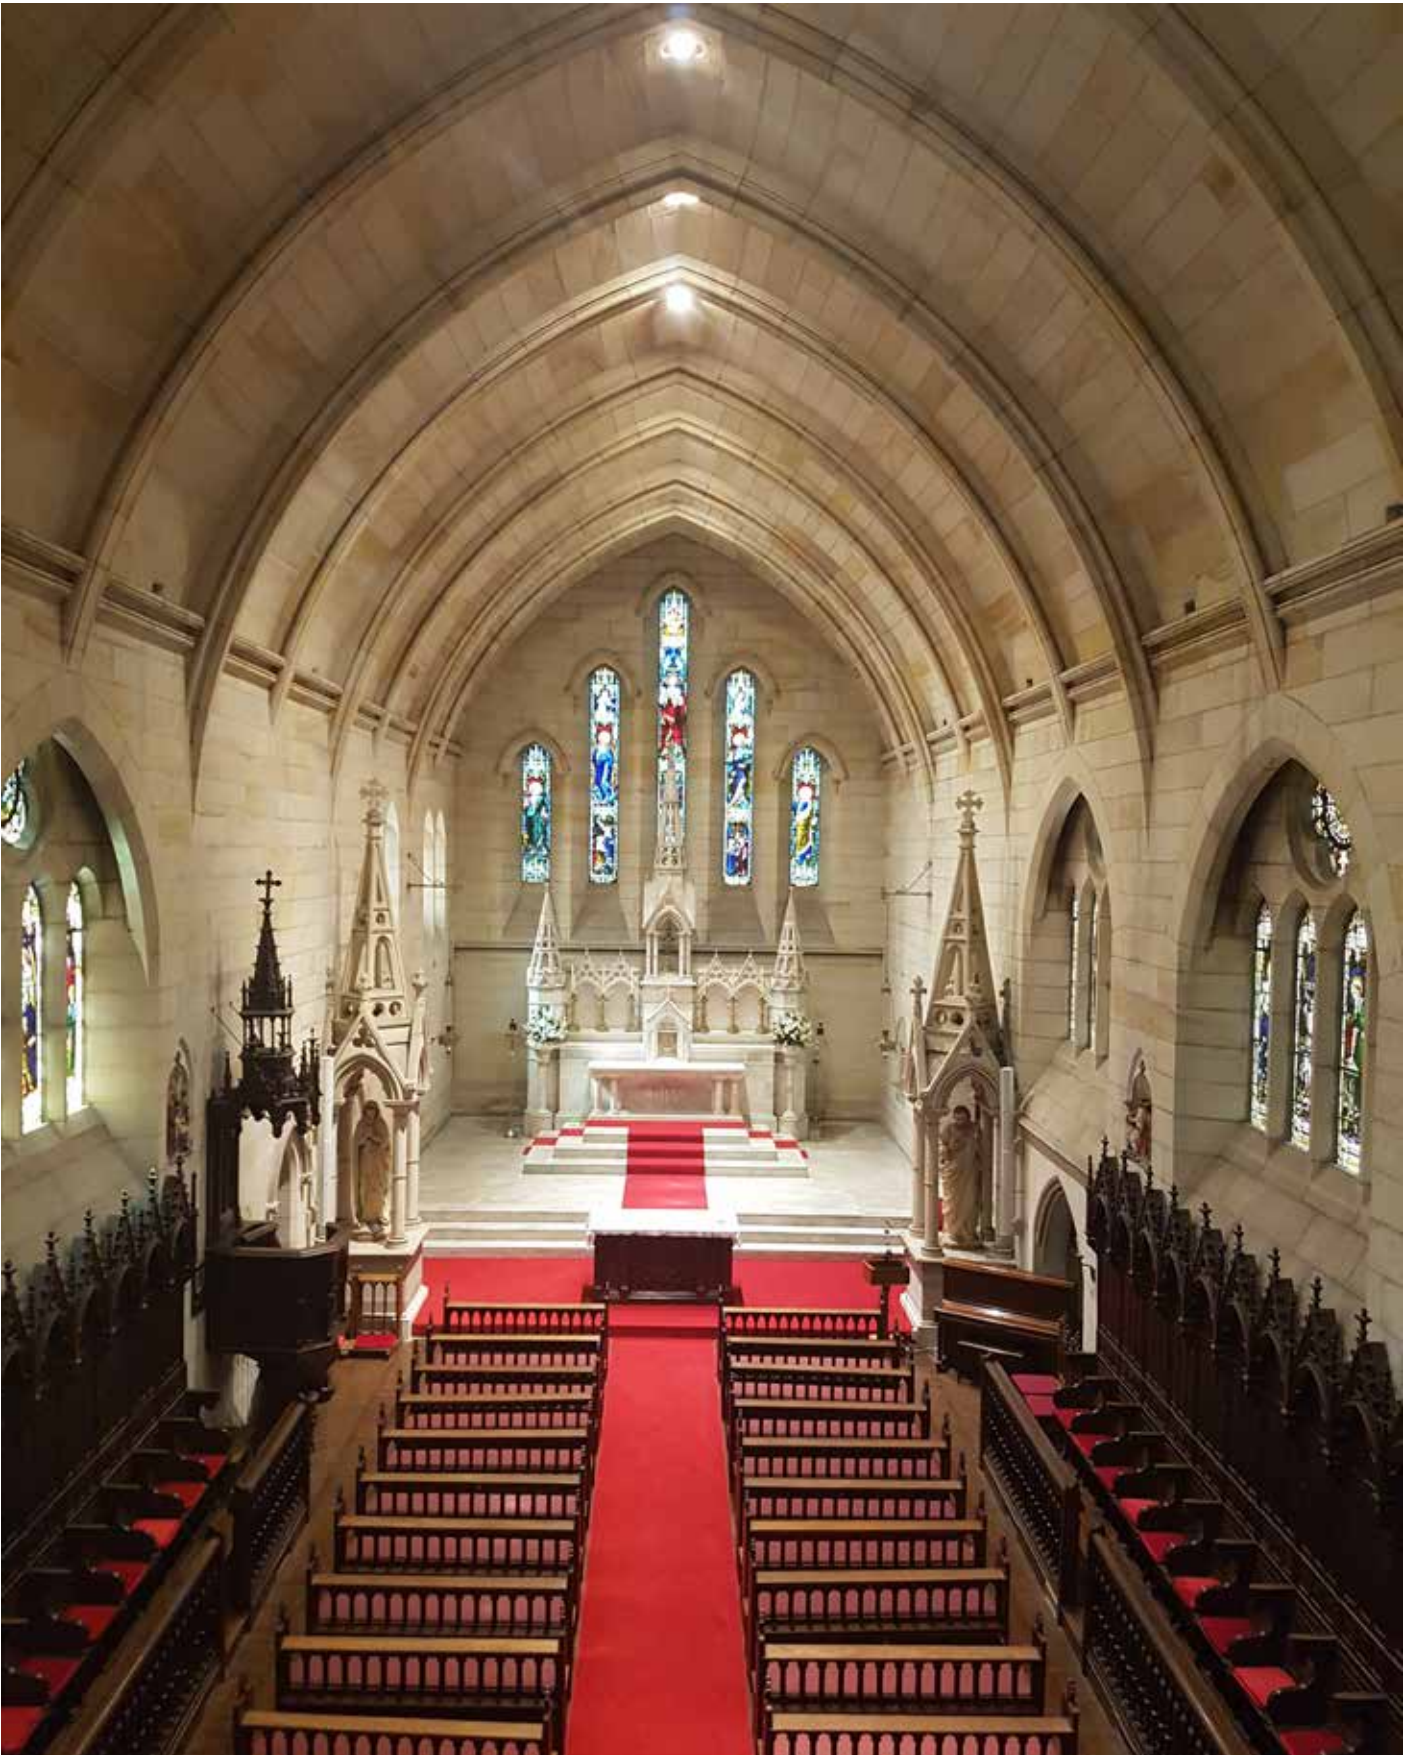
Figure 2.110: A view of the Chapel as seen from the organ gallery looking east towards the original Hunt designed marble high altar and memorial five-light stained glass window. The ribbed, stone barrel-vaulted ceiling is the defining architectural feature of the Chapel.

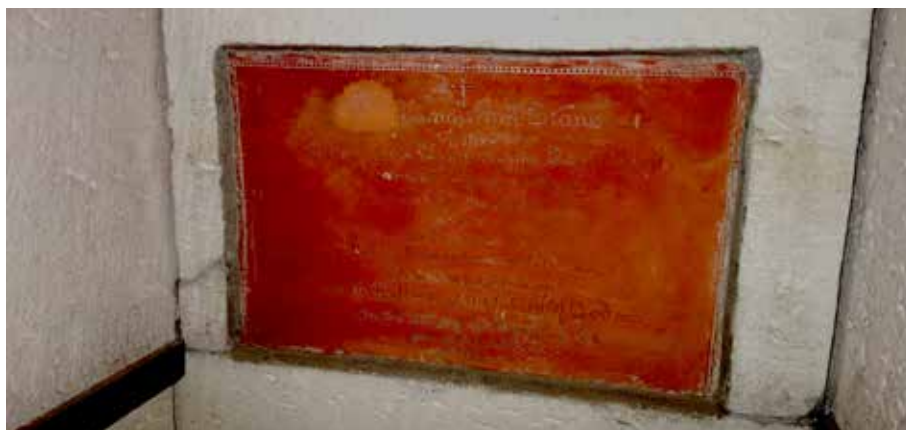
Figure 2.116: The 1897 terracotta tablet set in the wall of the Chapel by Horbury Hunt.

A terracotta tablet was set in a cavity in the bed of the memorial stone (instead of the usual parchment record placed in a bottle) in 1897. It was inscribed by Horbury Hunt and can be found in the recessed niche under the eastern windows behind the altar, reading:

Foundation stone of the Chapel of the Convent of the Sacred Heart. "Claremont" – Rose Bay – Sydney. Was set in place by His Eminence Patrick Francis Cardinal Moran. Archbishop of Sydney. To the Honour and Glory of God. On the 28th Day of November in the year of Our Lord 1897.

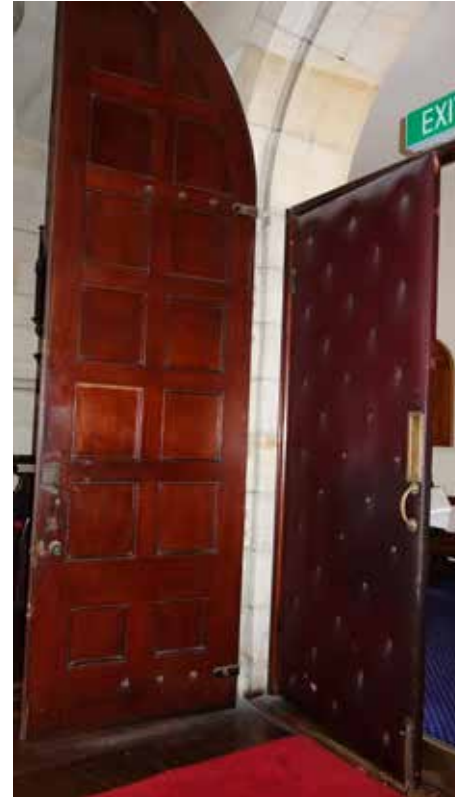
Figure 2.117: Detail of the original entry door to the Chapel and later soundproof vinyl door.

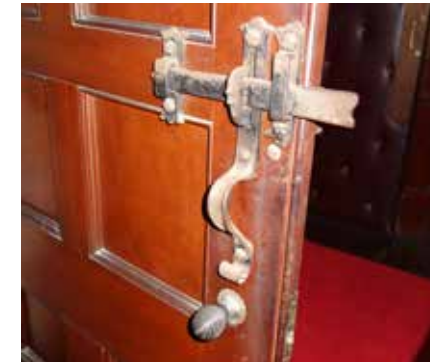
Figure 2.118: Detail of the original wrought iron hardware to the interior of the Chapel.

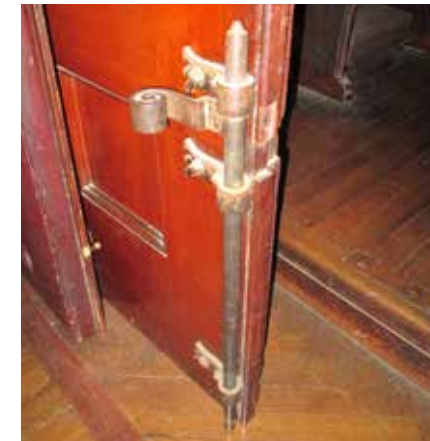
Figure 2.119: Detail of the hardware to the exterior of the Chapel, facing the Main School Building corridor.

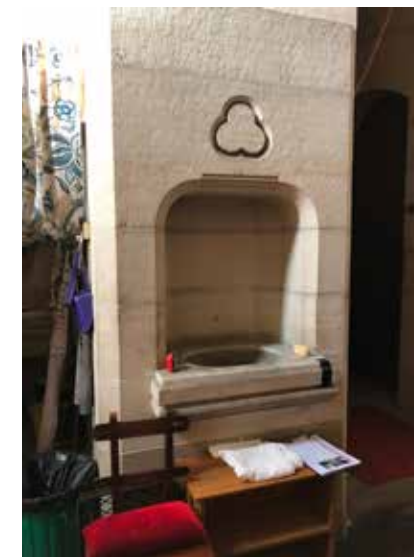
Figure 2.126: Recessed niche with marble font and stone carved trefoil above in the Sacristan's Sacristy.

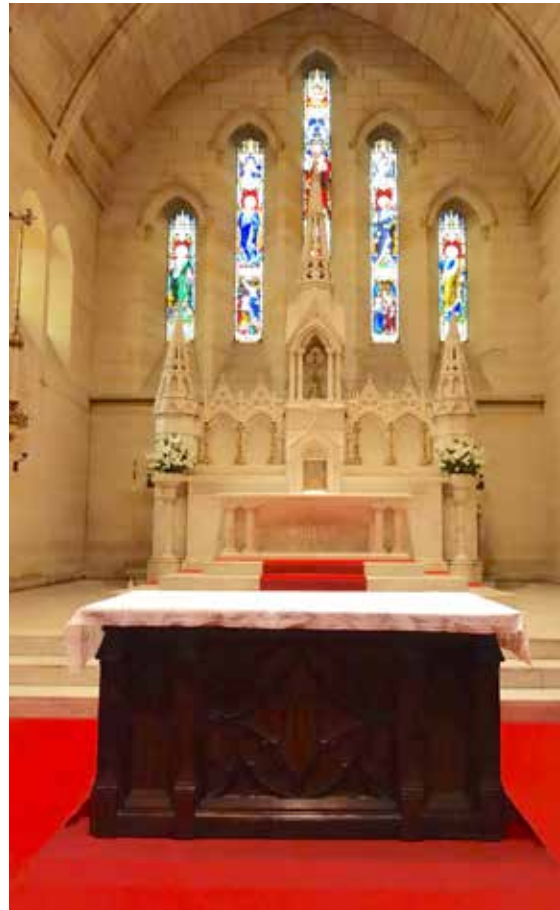
Figure 2.128: High altar, designed by Horbury Hunt, in front of the memorial five-light stained glass window to Mother Vercruysse. The timber altar in the foreground is that which was brought out to Australia by Mother Vercruysse, a gift of her family, in 1882.

Three octagonal and pierced spires, one at each end, and a central higher tower create the dominant form of the altar. The central tower holds a brass crucifix for ceremonies. Other loose items that form part of the high altar are six golden candle holders. Two sets of stairs at the rear of the altar meet in the centre and have an iron handrail.

The oak altar that was brought out to Australia with Mother Vercruysse in 1882, was donated back to the school by Patricia Horseley and family in 2000 and is presently located within the Chapel, in front of the high altar.

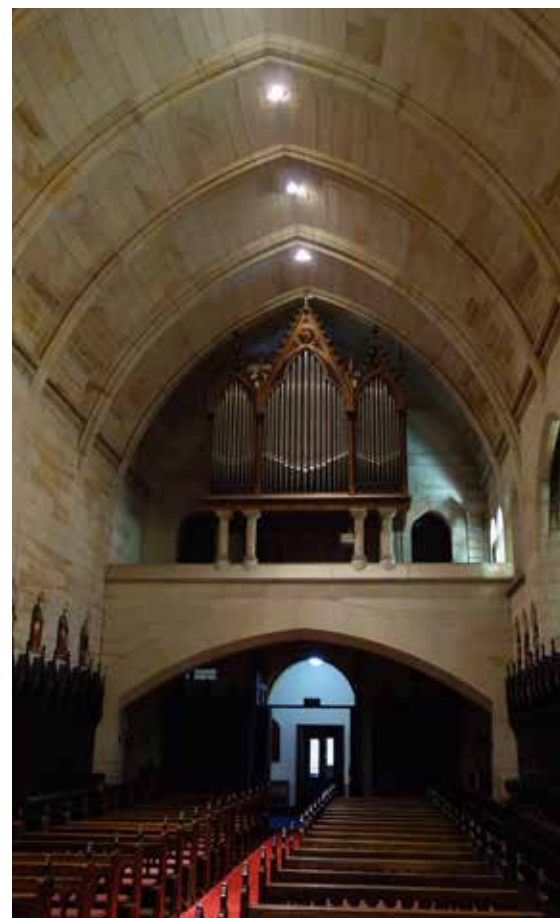
Figure 2.129: The organ gallery at the western end of the Chapel. Note the single span arch of the supporting structure.

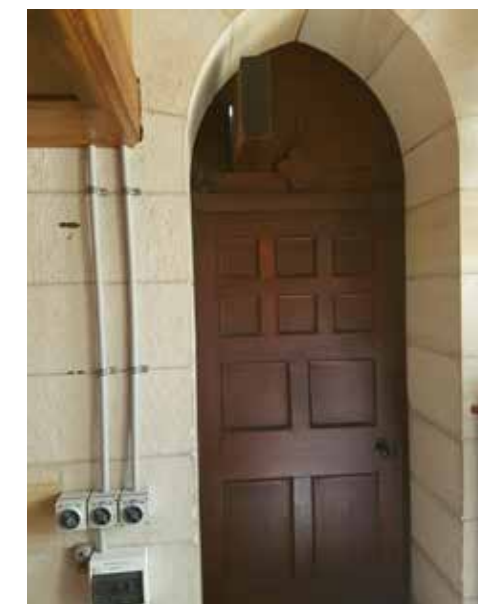
Figure 2.130: The panelled oak door as seen from the organ gallery and unsympathetic ductwork piercing through the panel above the door.

The gallery for the organ at the western end of the Chapel is accessed through two panelled oak doors on level three in the main block. The doorways have pointed arches and the infill panel bears a timber quatrefoil pattern on both sides. These panels are pierced with a timber lined ductwork, however whether this ductwork is still in use is unknown. A secondary architrave to the passage side would indicate that the current panelled doors are later (albeit early) replacements. The gallery has a stone balustrade and stone floor, supported on a single span arch. The front of the organ is supported by four stone columns, designed by Hunt.

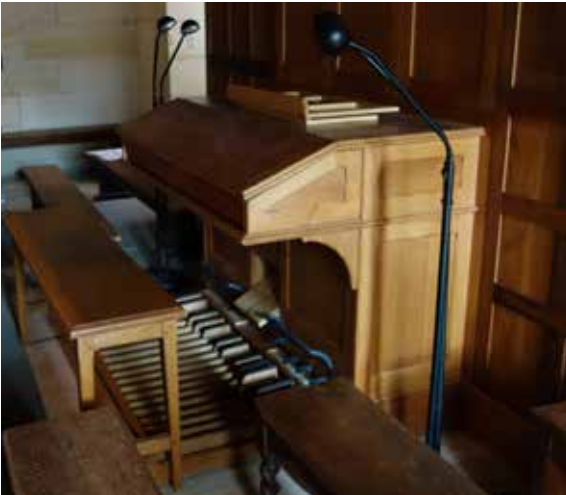
Figure 2.131: The organ console, originally facing the altar now faces the wall, with the nave and chancel behind in the main Chapel space.

The third and latest major restoration works commenced in 2005 and were completed in 2011, which included major restoration and reconstruction to original specification and detail. In the works, parts of disused and disassembled Puget organs from other religious institutions were recycled for the Rose Bay organ. Pieces such as the straight flat pedal board, foot rests and iron accessory pedals were replaced such that they are more closely aligned with the original design of the organ before the second major alteration. The console, originally located under the organ with the organist facing the altar, was rotated at this time such that the organist presently faces the wall, with the nave and chancel behind.

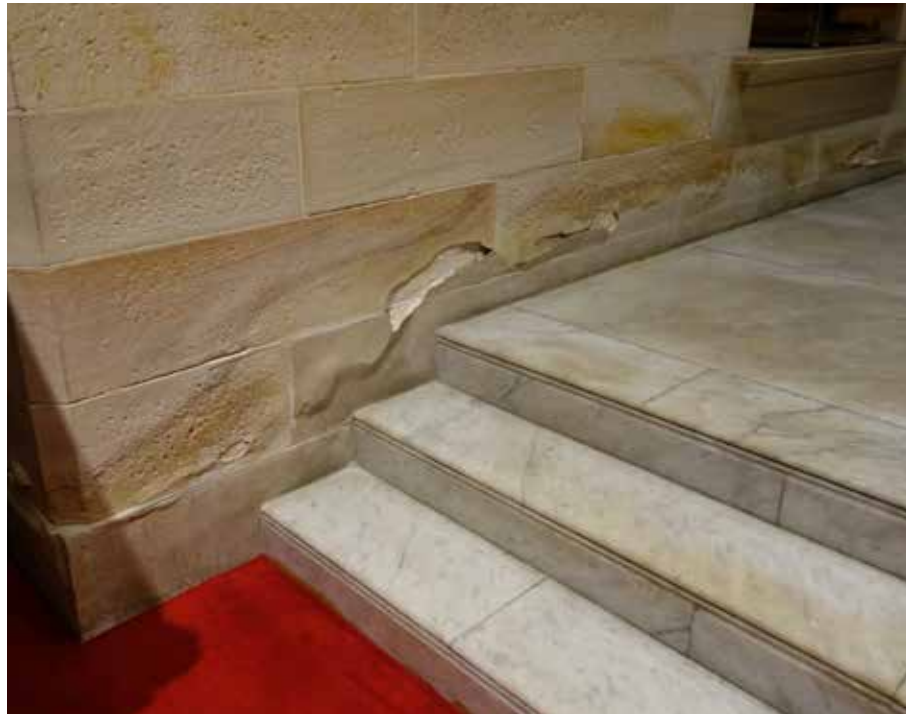
Figure 2.132: Image showing some of the blistering and erosion of the stonework from rising damp.

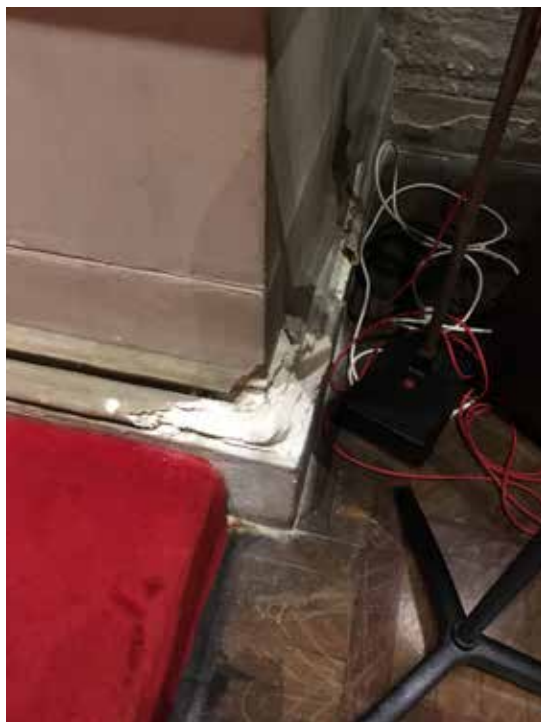
Figure 2.133: Detail of the base of the Statue of St Joseph before conservation works.

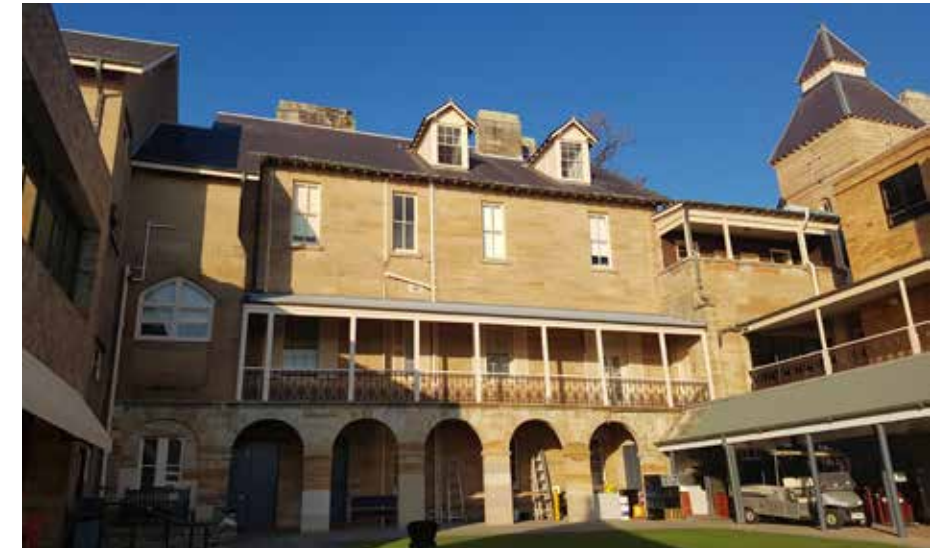
Figure 2.134: Western elevation of Claremont, with the 1851 stone arched loggia (Level 1) and verandah above (Level 2). The Hughes Centre balcony and covered way to Cloister Courtyard are visible to the far right of the image. Level 3 with the four sash windows and the hipped roof were constructed as part of Hunts 1882 remodelling of the building. The dormer windows were added in the 1920s. The timber shingled balcony and rooms behind on Level 3 were added in the 1930s.

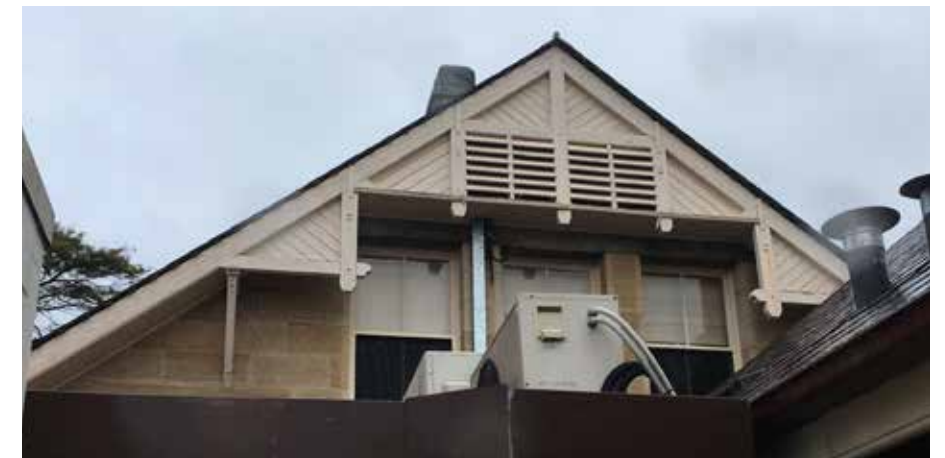
Figure 2.135: Timber gable bracket and screen on the northern elevation at Claremont.

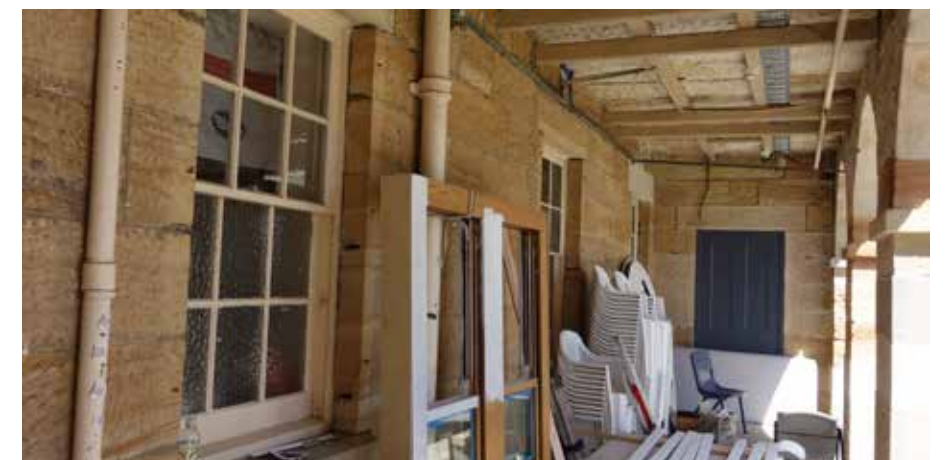
Figure 2.136: Stone arched loggia on Level 1, with the stone flagged floor of the verandah above. Note loose material and furniture stored in front of this elevation.

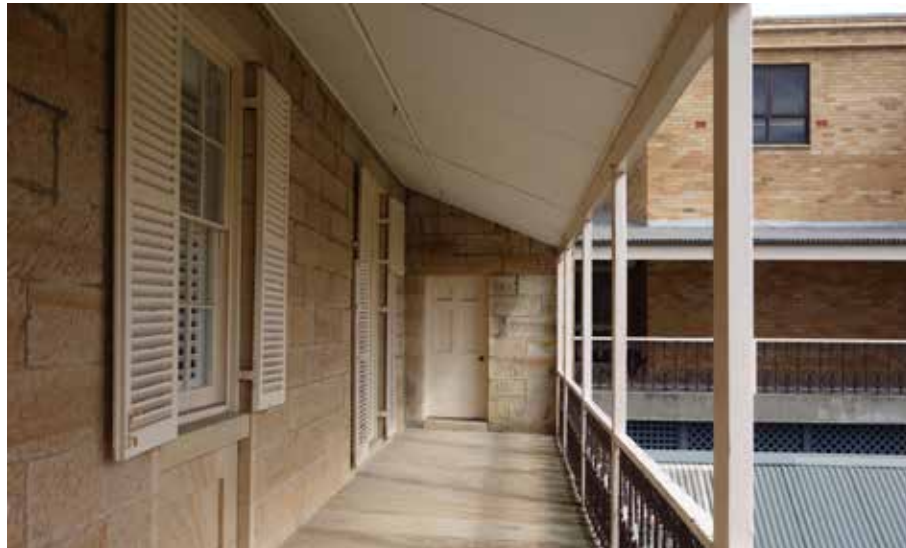
Figure 2.141: Level 2 verandah with stone flagging, looking south towards the Hughes Centre.

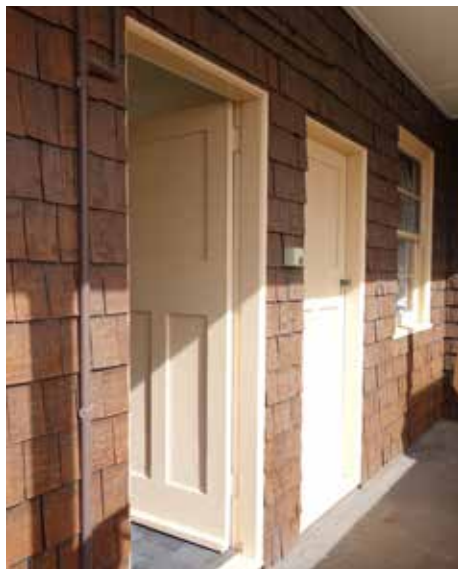
Figure 2.142: Timber shingled wall to the Level 3 verandah / balcony.

The original / early two storey wing at the southwest corner of Claremont was extended in the 1930s with an additional storey (at Level 3) containing two offices fronting onto a narrow verandah on the western side. This extension required the removal of the hipped roof, and its replacement with a shallower profile, currently clad in copper sheeting and with copper gutters. The external sandstone ashlar walls were extended to create the balustrade for the new balcony. The earliest photographs indicate that this balcony may have been enclosed, however no evidence remains. The verandah has timber posts, the southern bay of which is enclosed with glazing and a fibre cement ceiling. External walls are clad with timber shingles and these have a stained finish. Fenestration is of a style typical of the 1930s, and doors are timber panelled and retain their original brass hardware, while the windows are timber framed sash.

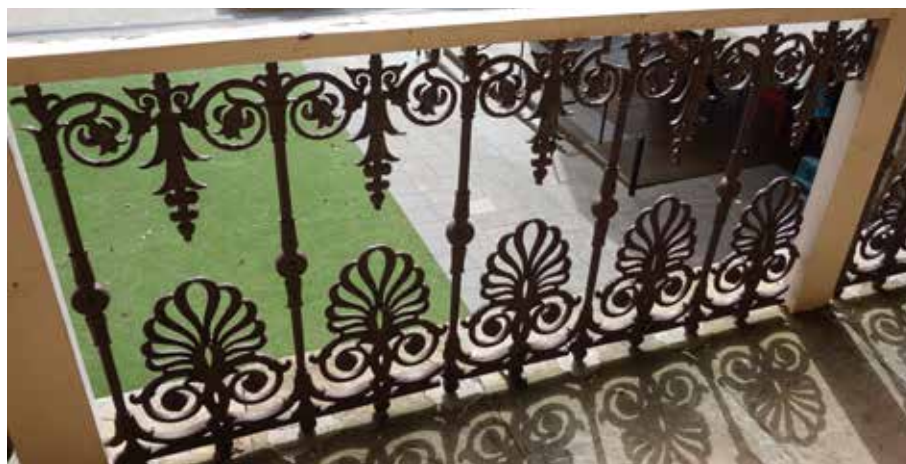
Figure 2.143: Detail of the cast iron balustrade to the verandah on Level 2, reportedly designed by Henry Shaw.
