KINCOPPAL - ROSE BAY

SCHOOL OF THE SACRED HEART

CONSERVATION MANAGEMENT PLAN

Final Report - August 2020

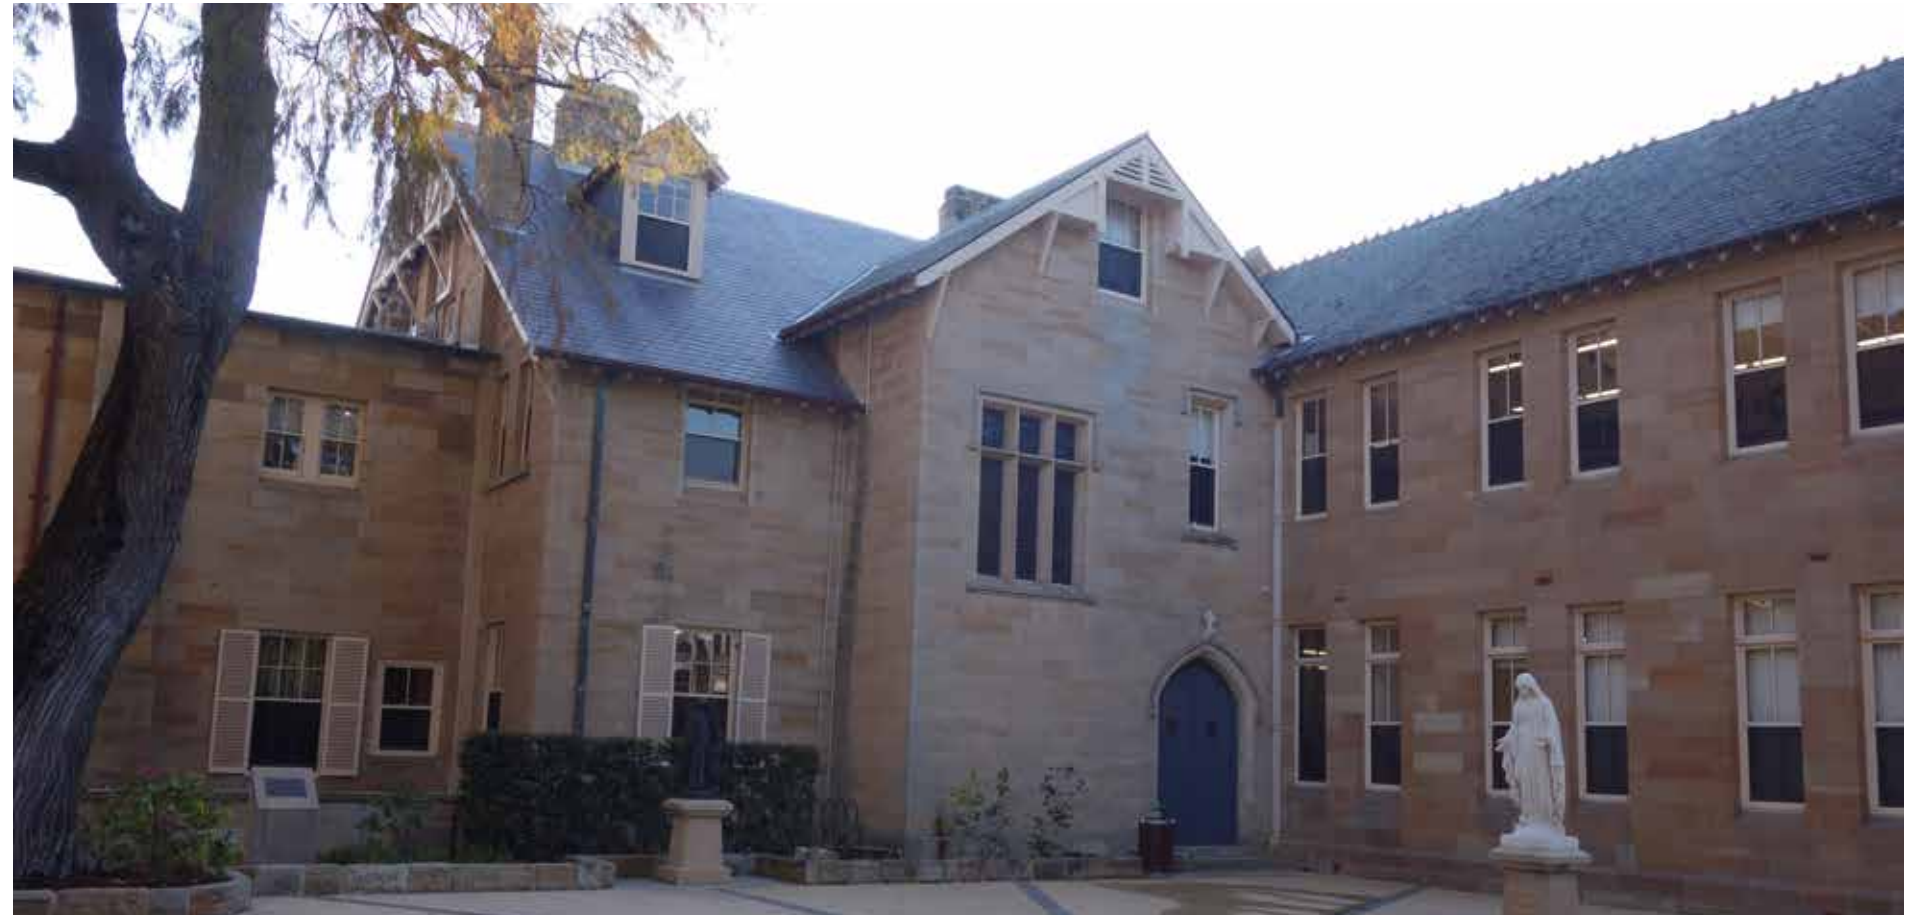
Figure 2.137: View of the eastern elevation of Claremont (centre) and the southern elevation of the Noviceship wing as seen from Chapel Square. The statue of Our Lady can be seen in the foreground.

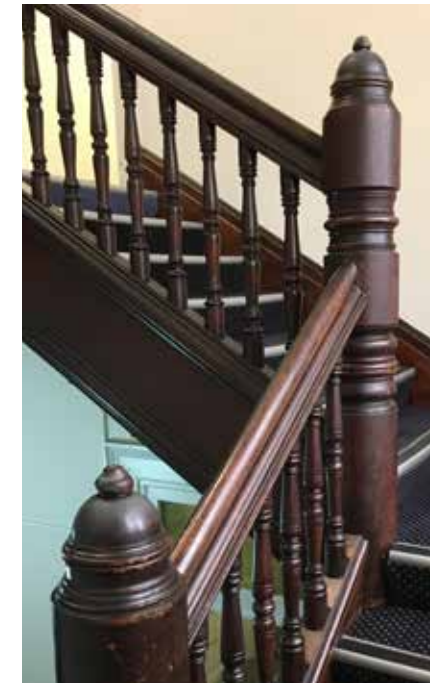
Figure 2.144: Detail of the turned balusters and newel posts of the staircase within Claremont.

The main stair is a Hunt design, and is polished cedar, featuring decorative turned balusters and newel posts. The stair itself is carpeted and modern nosings have been applied such that it was not possible to ascertain the condition of the stair treads below. The leadlight glass panes of the tripartite window at the stair landing is separated by fine sandstone mullions and rails. It dates from the 1882 reconstruction of Claremont as a private residence for the Thomas family by Hunt. The leadlight panels features geometric patterns of diamonds, circles and triangles, as was typical of Victorian era leadlight.

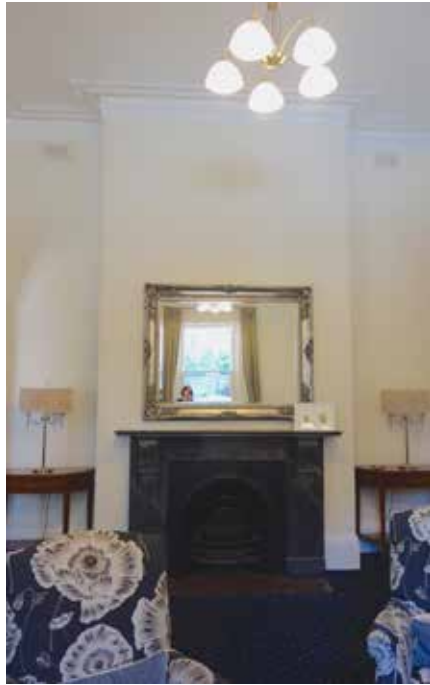
Figure 2.147: Level 2 reception room in Claremont with decorative cornice and black marble fireplace mantle and surrounds.

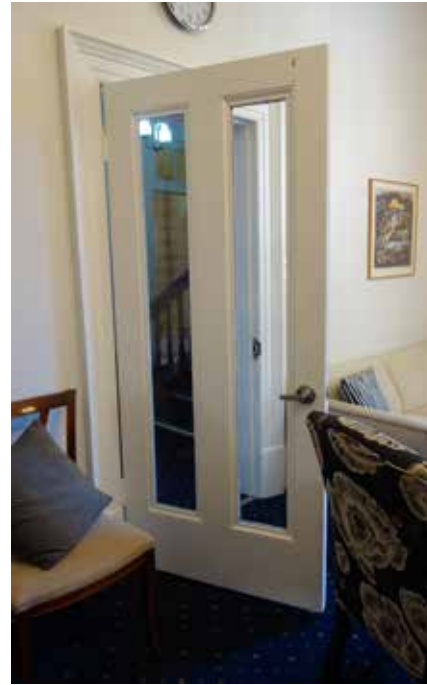
Figure 2.148: Typical door at Level 2 which has been modified with glass panels for security reasons.

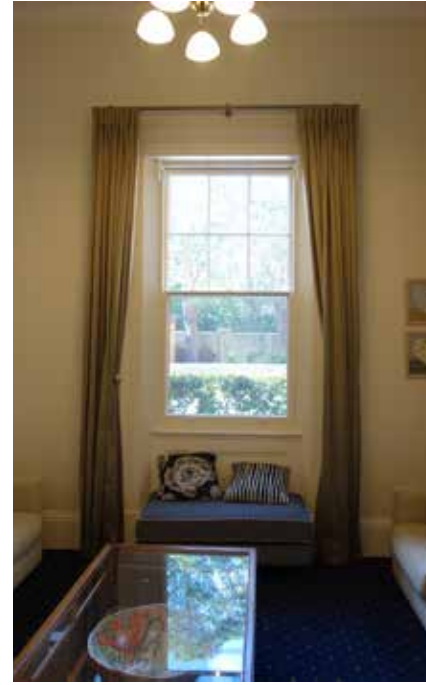
Figure 2.150: Bay window in Level 2 reception room within Claremont.

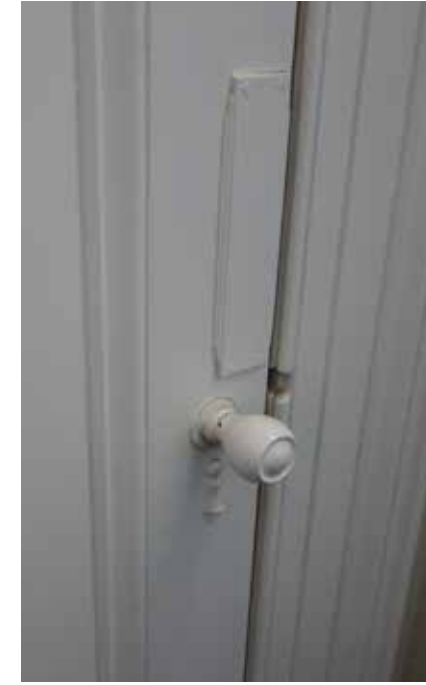
Figure 2.151: Detail of some early door hardware at Claremont. (Level 2)

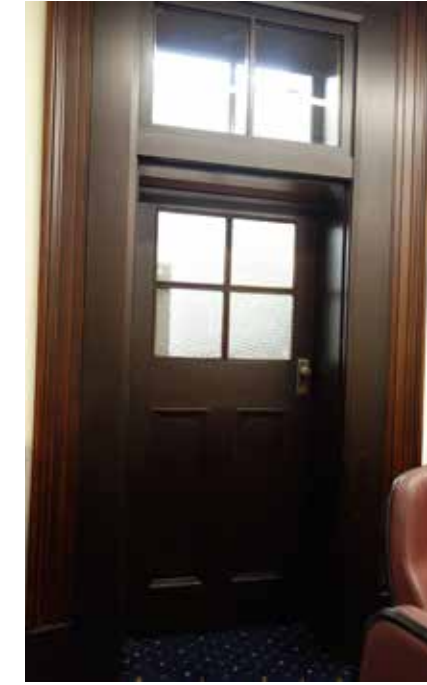
Figure 2.153: 1920s door with double highlight over between the boardroom at Claremont and the 1928 Noviceship wing.

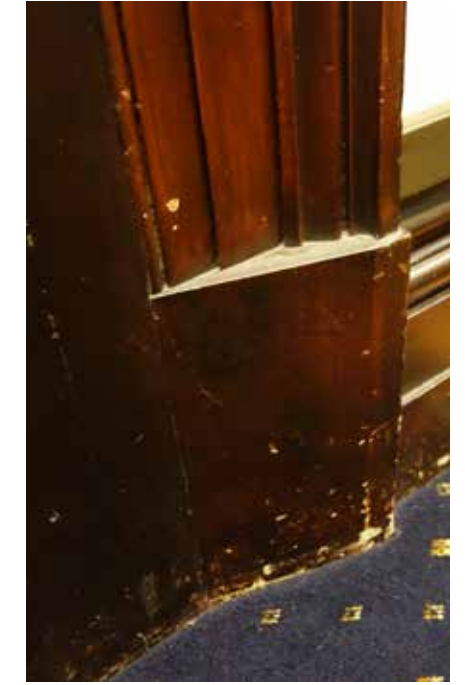
Figure 2.154: Detail of the skirting and architrave profiles on Level 2 at Claremont, likely dating from 1851.

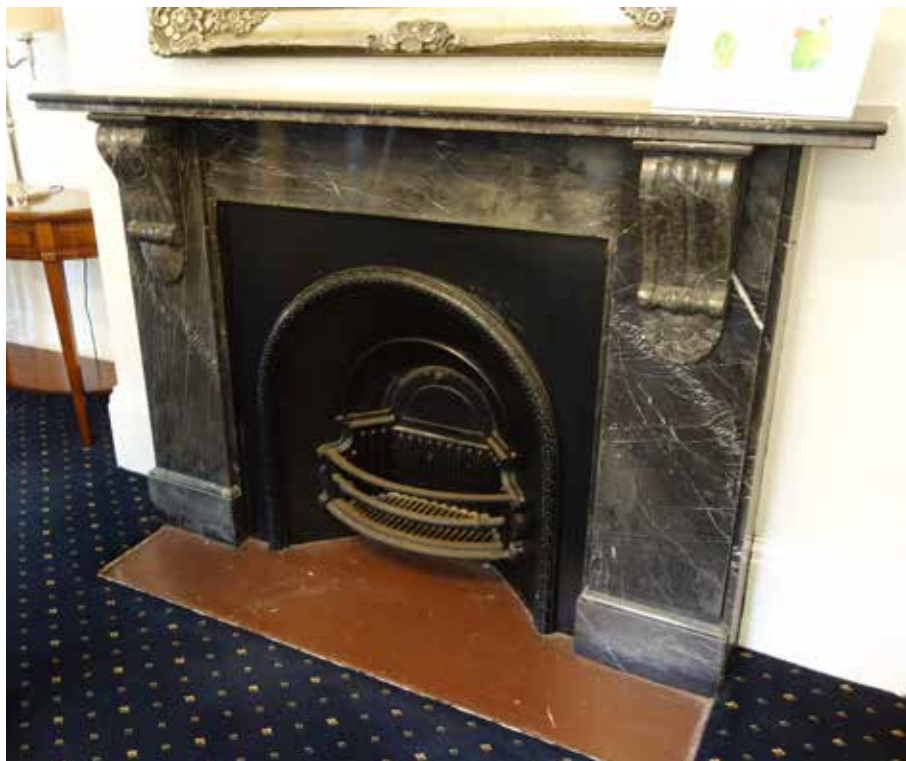
Figure 2.149: Detail of the black marble fireplace mantle and surrounds within the reception room.

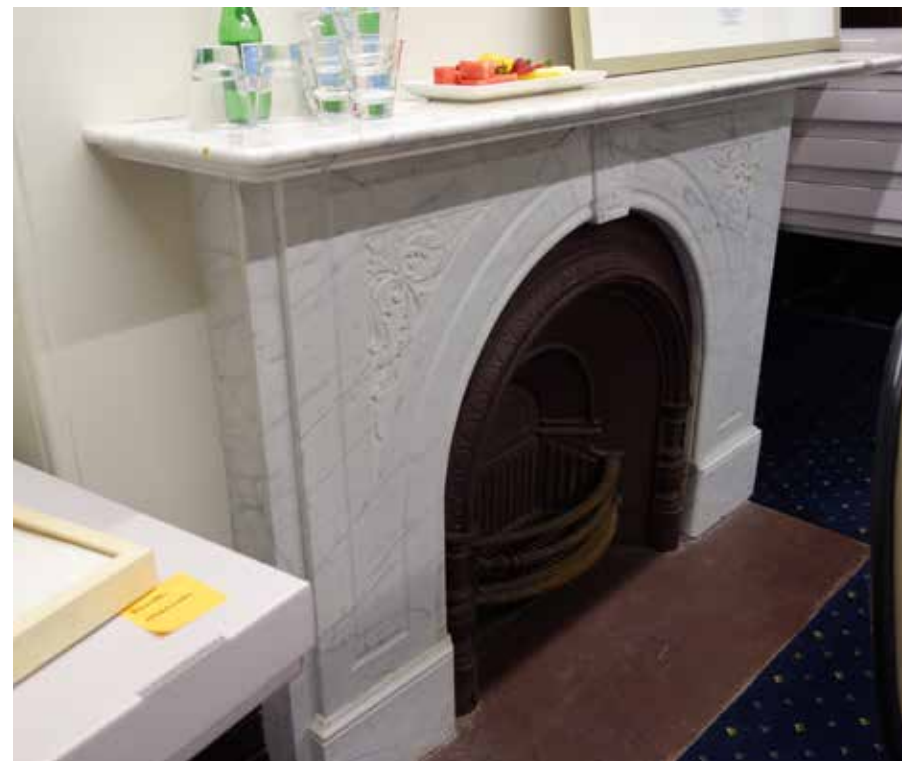
Figure 2.152: Detail of the white marble surrounds and mantle in the boardroom at Claremont. (Level 2)

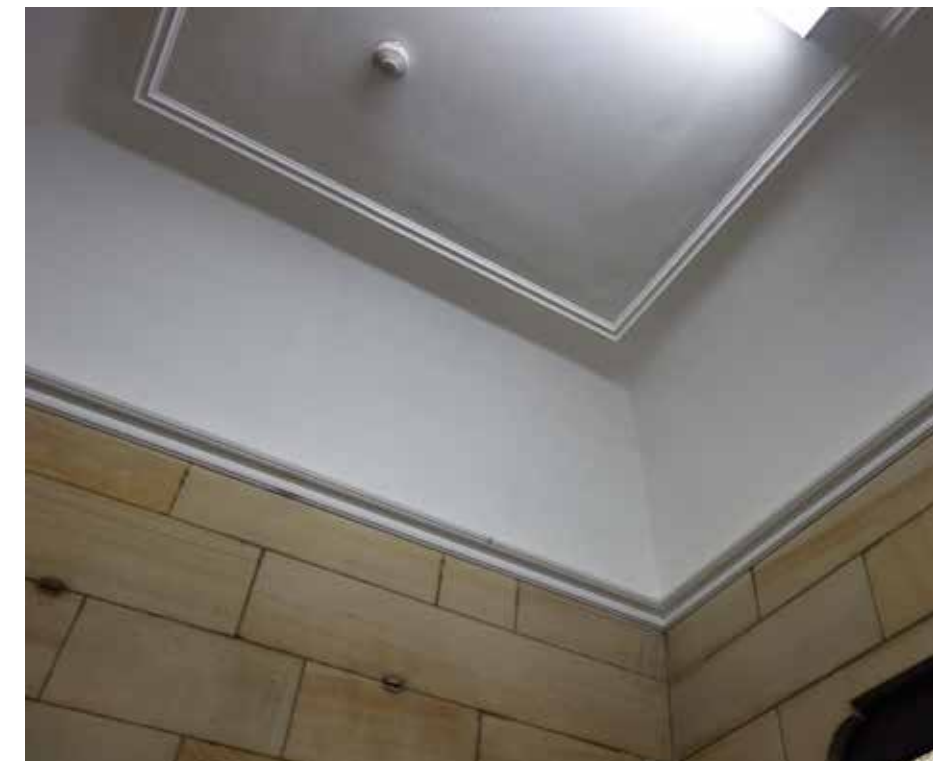
Figure 2.155: Coffered ceiling within the Claremont entrance porch.

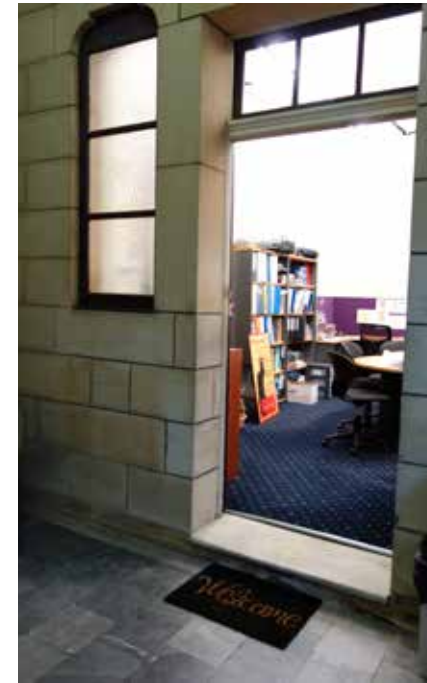
Figure 2.157: 1920s door opening between the entrance porch to Claremont and the 1928 Noviceship wing. Opening on the left dates from 1882, while the glazing is from the 1920s.

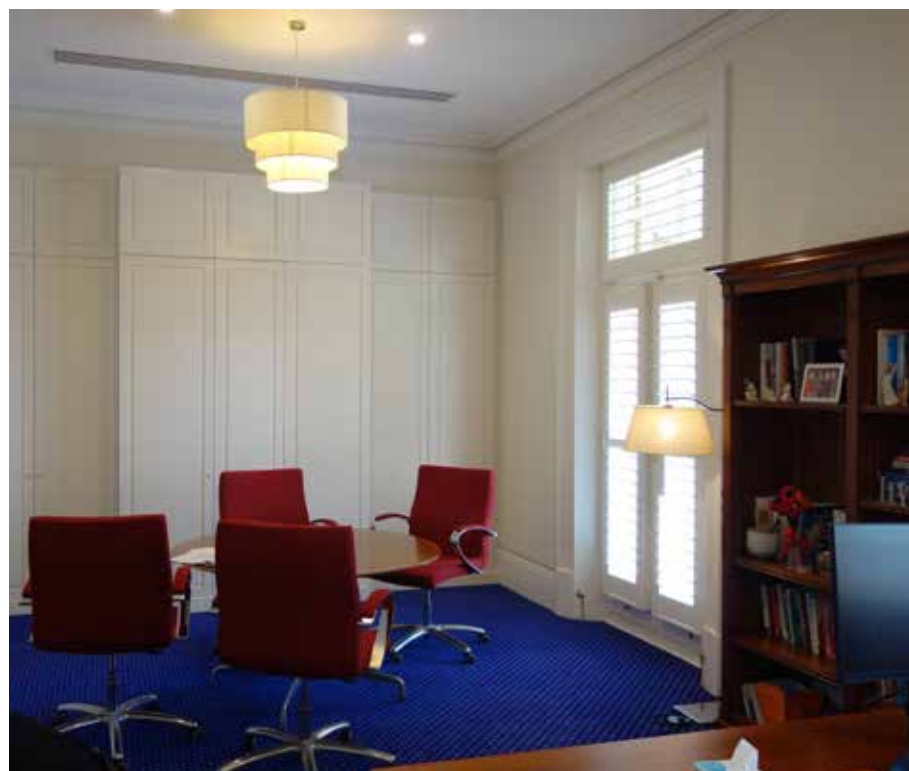
Figure 2.159: Fine glass French doors with side lights and timber panelled internal shutters and reveals dating from 1851. These appear to be painted shut and inoperable at present

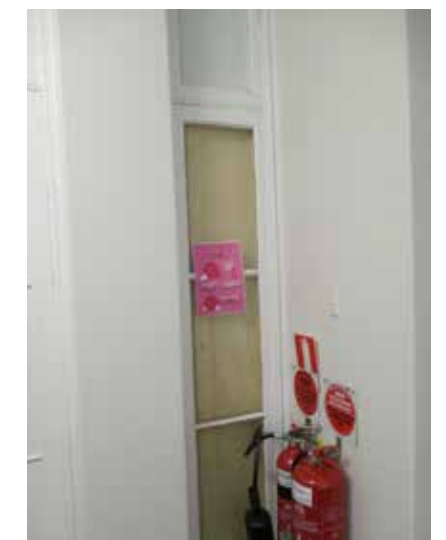
Figure 2.160: Detail of the fine glass French doors with side lights and timber panelled internal shutters from the corridor to the north.

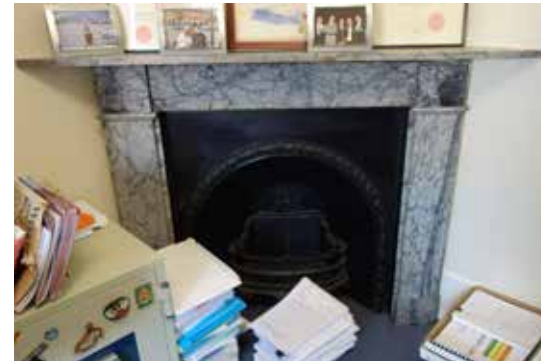
Figure 2.167: 1882 fireplace on Level 3 at Claremont, of simpler design than on Level 2.

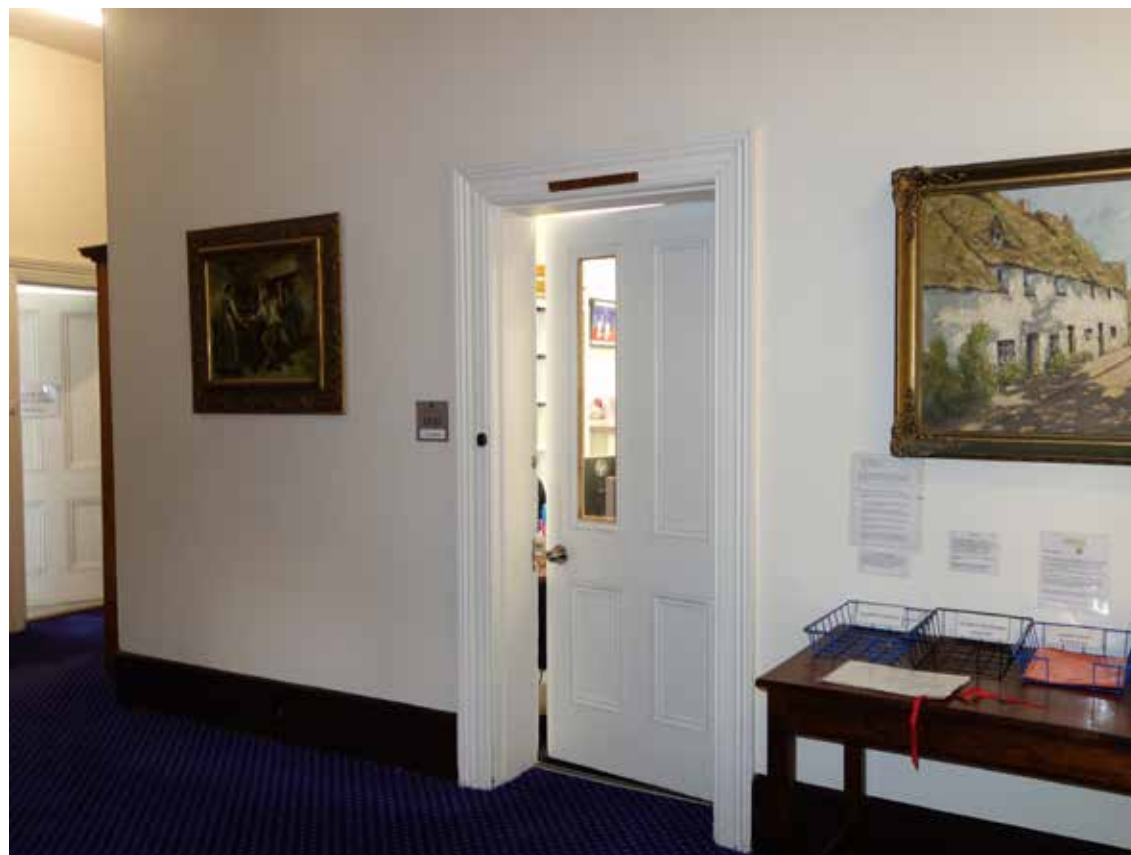
Figure 2.166: Typical timber panelled door and architrave at Level 3, dating from the 1882 reconstruction of Claremont by Hunt.

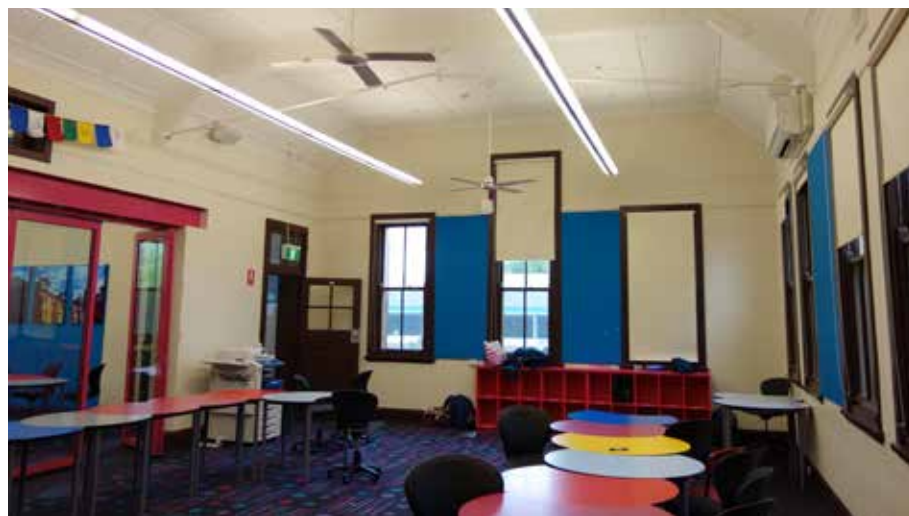
Figure 2.175: Level 3 classroom looking towards Vaucluse Road. Note the battened mansard form ceiling, exposed trusses and steel bracing.

The dividing masonry wall between the two class rooms on the upper floor has been substantially removed, and replaced with a modern glass folding panel wall with steel beam over. The centre wall has two timber windows above the new opening. Original features include the high level mansard form ceiling of battened fibrous plaster, simple circular ceiling rose and painted timber roof trusses, with steel support bracing and brackets.

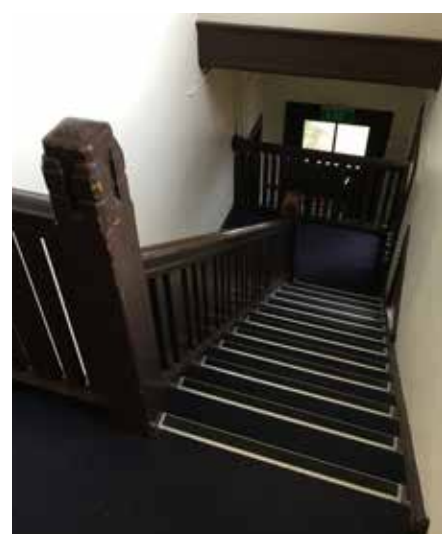
Figure 2.178: Timber staircase in the Noviceship wing.

There remains a number of original doors at both ground and first floor levels. Doors are timber and glass panelled with opaque glass infill and two-paned highlights over. At the south eastern corner there remains the original timber stair. The timber balustrade has solid square newel posts, simple rectangular balusters and square handrail with rounded top. The tread and risers have been carpeted. All timberwork, including windows, doors, skirting and stair balustrade are painted brown.

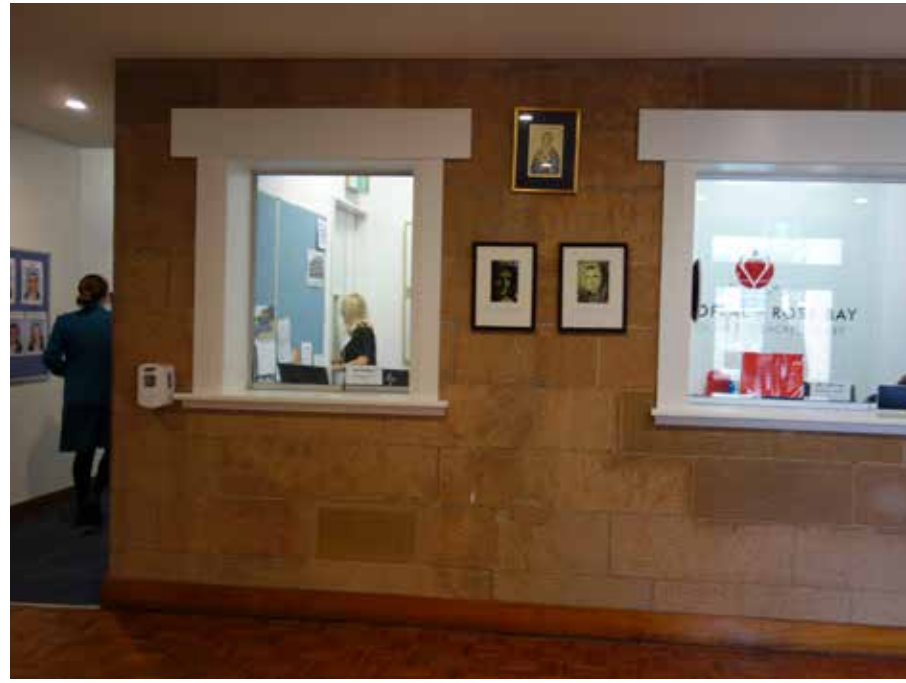
Figure 2.185: The student reception in the southeast corner of the 1959 Noviceship wing additions. This wall was formerly an external wall and the foundation stone is visible below the counter on the left.

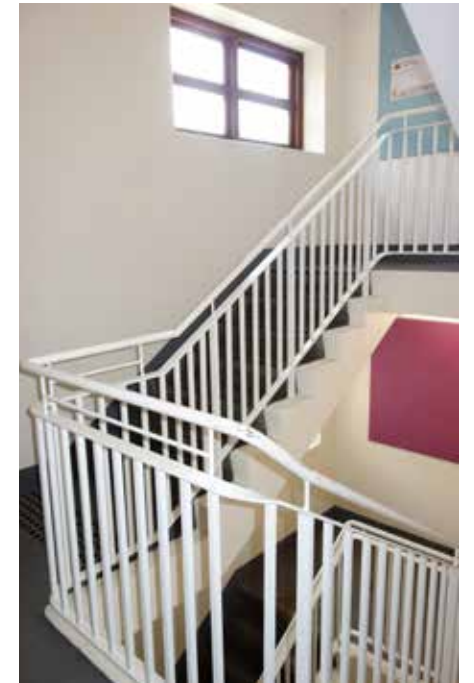
Figure 2.188: Concrete and steel fire stair at the southwestern corner of the building.

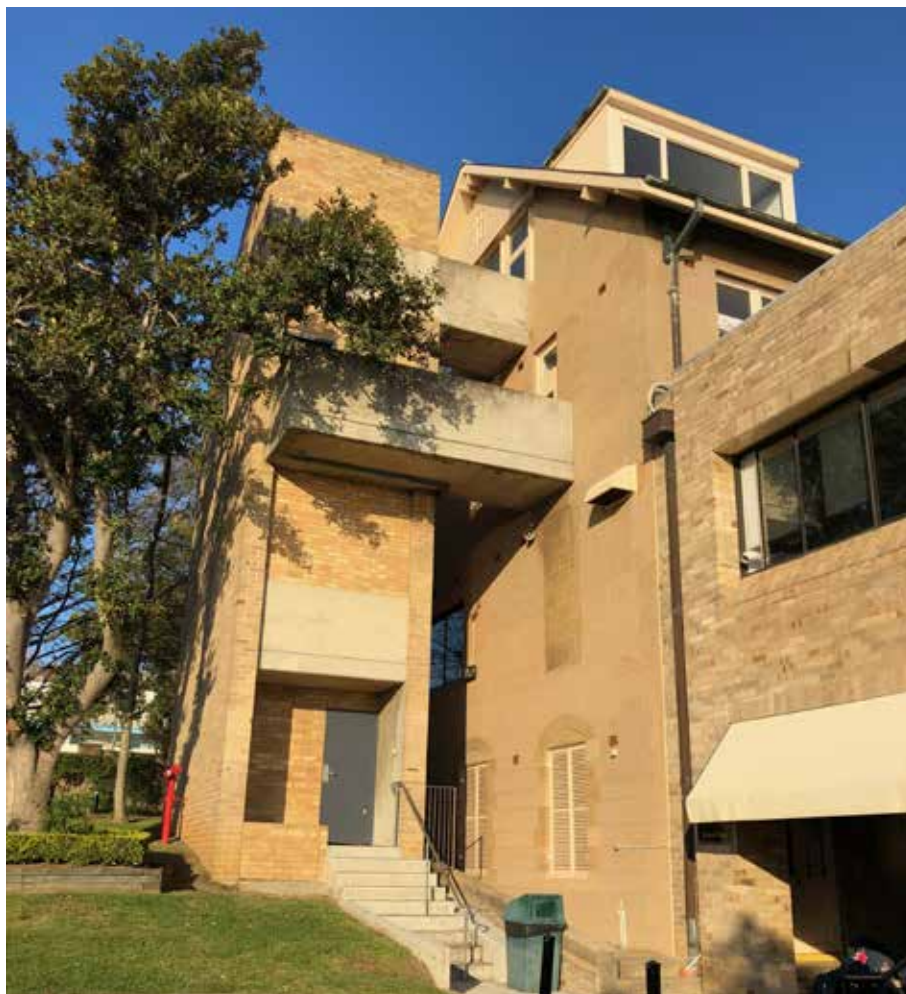
Figure 2.184: 1976 firestair at the northern elevation of the 1959 Noviceship wing additions.

A three storey fire stair on the northern side of the Noviceship wing additions dates from a similar construction period. It is detached and linked via an external walkway on Levels 3 and 4.

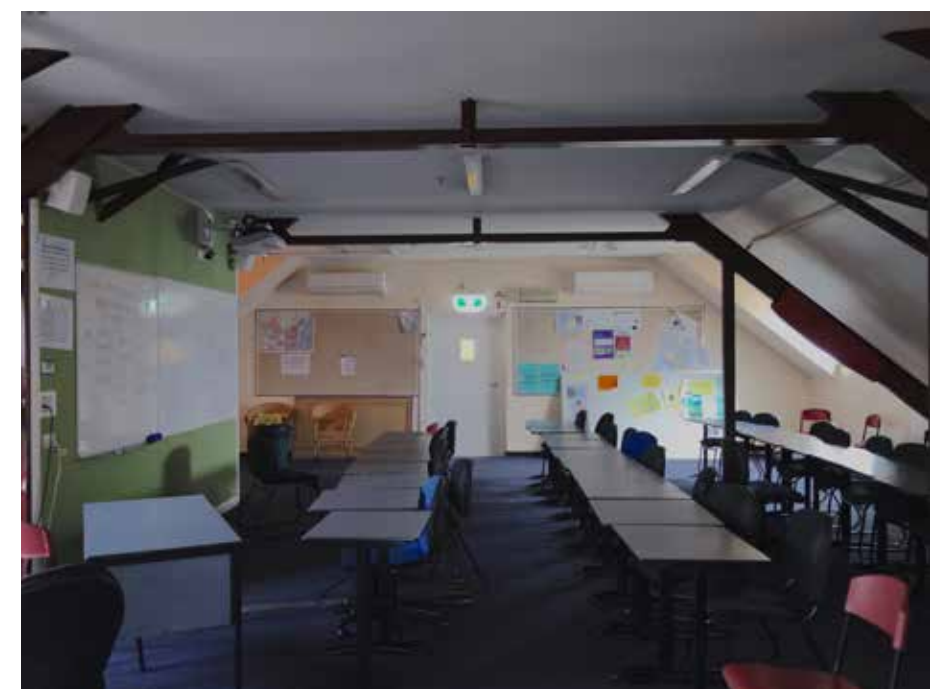
Figure 2.189: Level 4 / attic classroom with exposed steel ceiling trusses.

The attic level is subdivided onto two large spaces, formerly class rooms, and has raked walls (following the roofline) and low flat ceiling, both lined with plasterboard. Neither room is presently used, and foam cushioning wrapped around the exposed steel ceiling trusses indicate that the low head heights may have been a contributing factor.

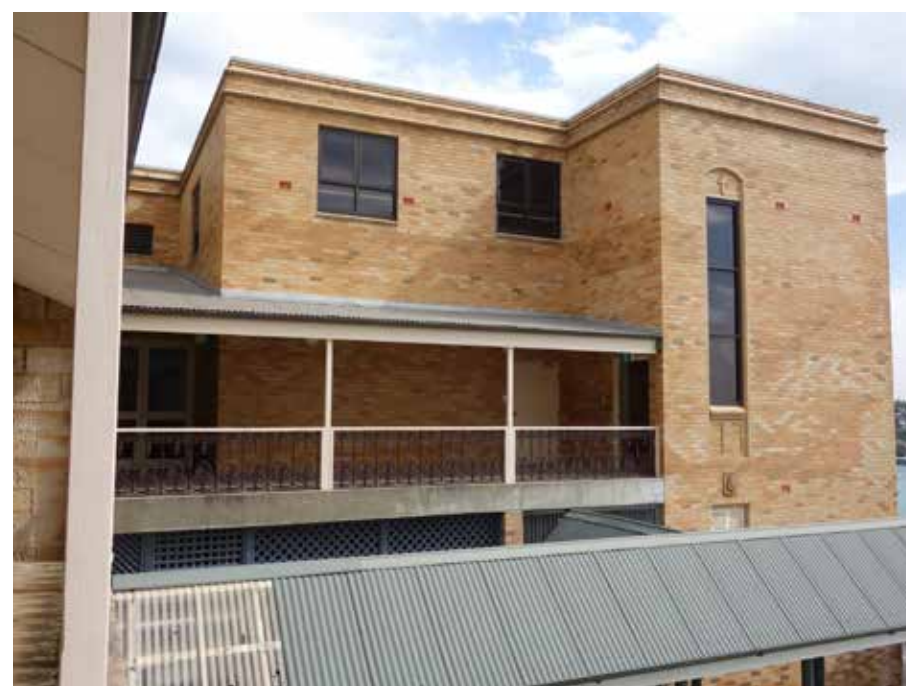
Figure 2.192: Northern elevation of the Hughes Centre. The design of the cast iron balustrade matches that of Claremont.

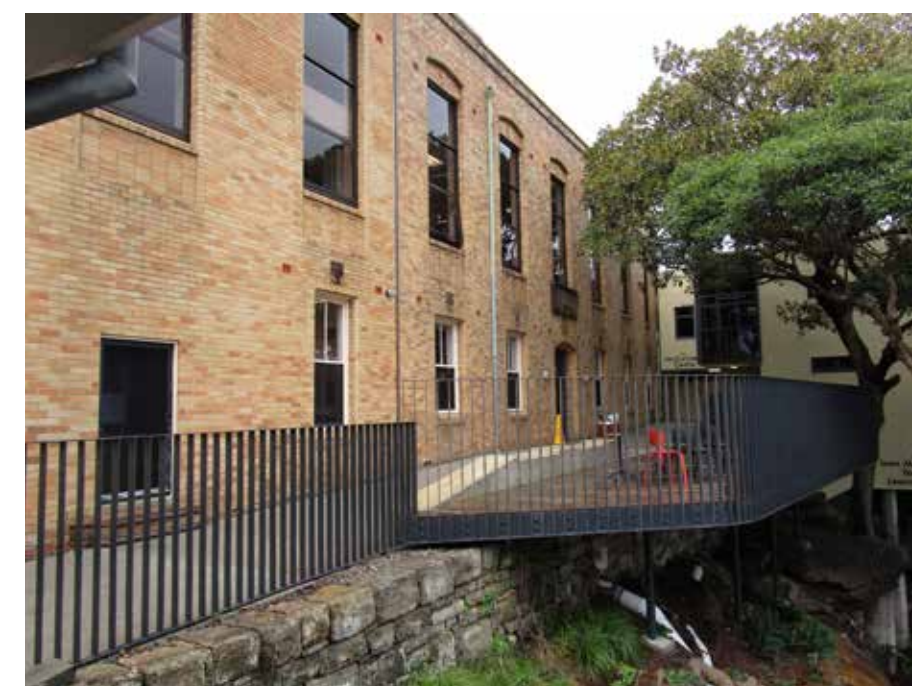
Figure 2.195: Western elevation of the Hughes Centre with part of the Hunt Retaining Wall in the foreground and the McGuinness Centre in the background.

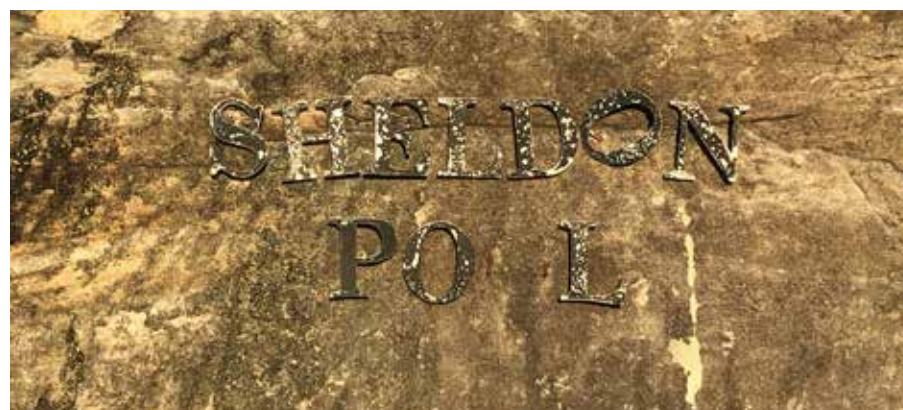
Figure 2.203: Remains of the lettering of the former Sheldon Pool located on a sandstone outcrop to the east of the recently finished Dunphy Foundation Outdoor Space.

There remains evidence of the former stone steps to the pool from the Main School Building, albeit these are no longer able to be used due to the construction of a series of new cantilevered timber and steel platforms above (associated with the refurbishment of the Science block to create the new Year 12 hub). The original 'Sheldon Pool' signage remains in place on the natural rockface, although it is in need of repair.

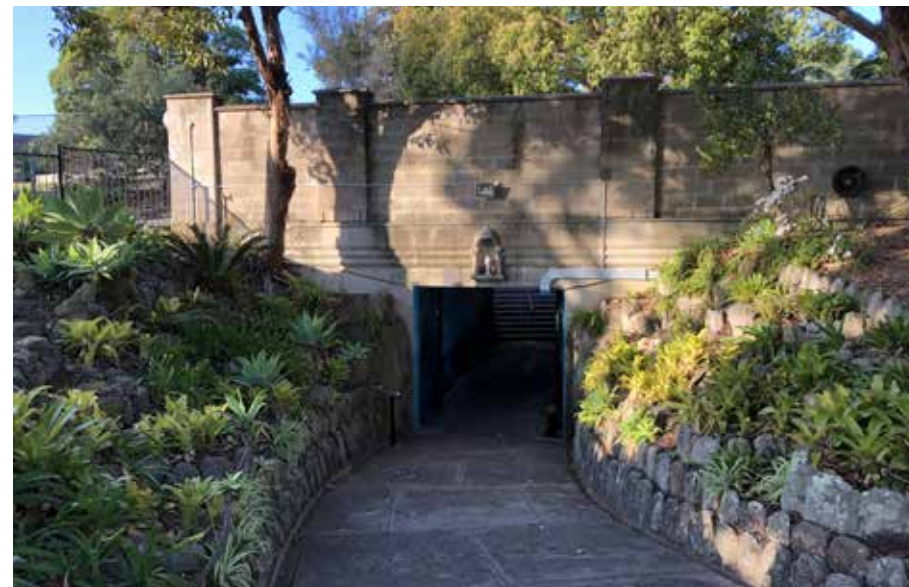
Figure 2.209: The 1933 Vacluse Road Tunnel / Underpass looking east towards the MTC site.

Provision for lighting has been made by way of cabling along the concrete block wall and cabling running into the tunnel via a duct. The interior of the tunnel has been painted, and the gates closing off the tunnel appear to be original. Access to the tunnel on the eastern side of Vacluse Road is via a set of concrete steps with later modern central handrail.

The stone rockery landscaping appears to be in poor condition, with some stones missing and the terracing unlevelled from eroded soil. The former planting of individual flowers and light shrubs has been replaced with ferns, agave and bromeliads.

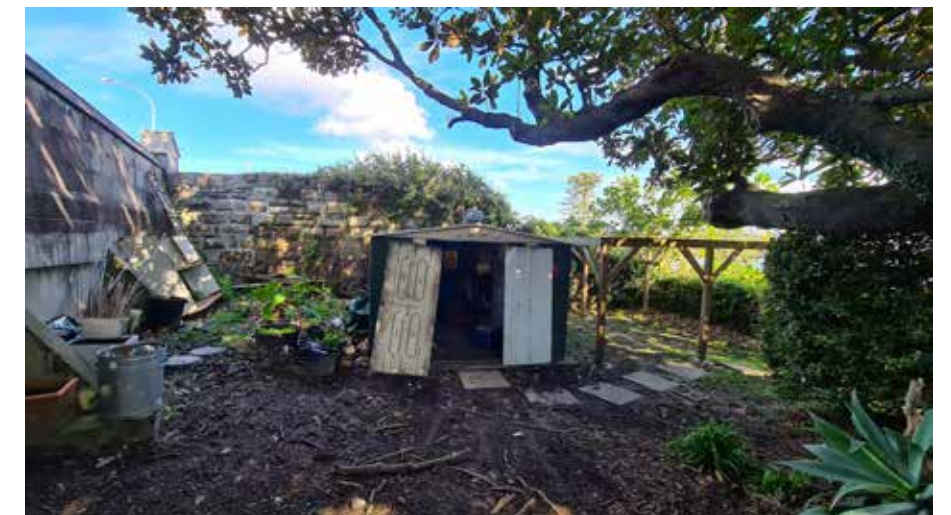
Figure 2.211: South-eastern most corner of the former conservatory site. Note the junction between the formal sandstone ashlar eastern boundary wall and earlier southern sandstone boundary wall.

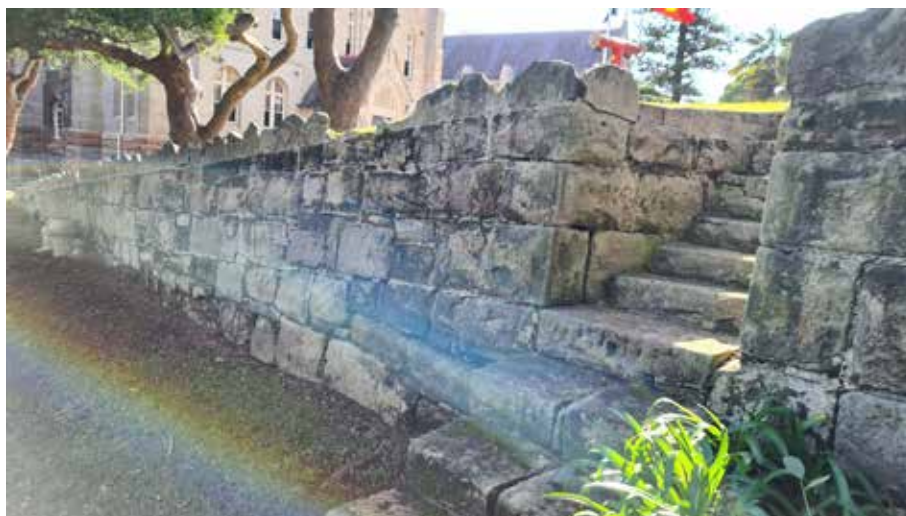
Figure 2.212: The stone retaining wall with rugged cut stone edge and stairs to the first terrace at the former conservatory site.

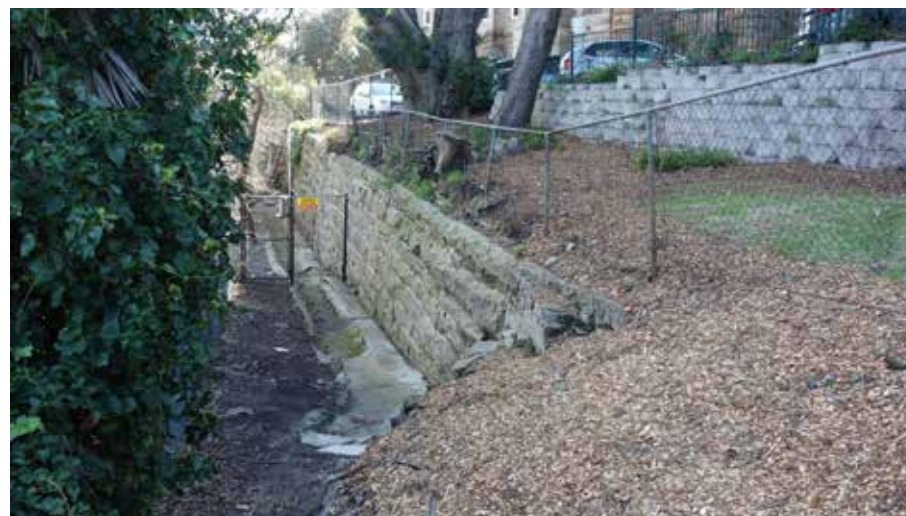
Figure 2.215: The southern part of the Hunt retaining wall between South wing and the southern boundary. This area includes the stone site drainage channel.

Overall the wall is in good condition with no apparent stone deterioration or cracking. There is however extensive lichen, moss and algae growth as well as ferns and creeper roots that have found hold in the cracks between courses. A large Moreton Bay Fig growing out of the wall may cause the wall to collapse due to its weight pulling on the structure. A large section in the centre has structural steel support bolted through and a small length of the wall at the south eastern end appears in better condition and has been repointed.

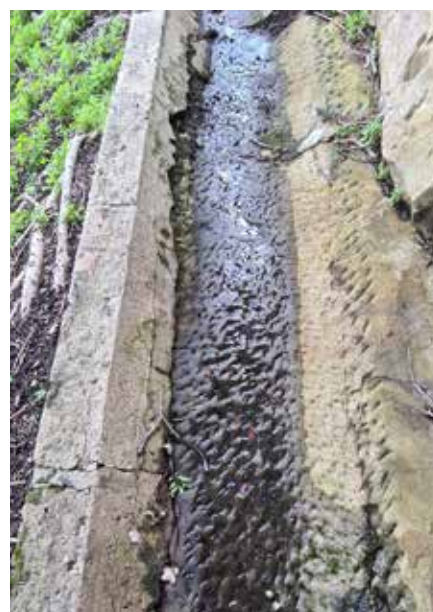
Figure 2.216: Sandstone channel at base of Hunt retaining wall.

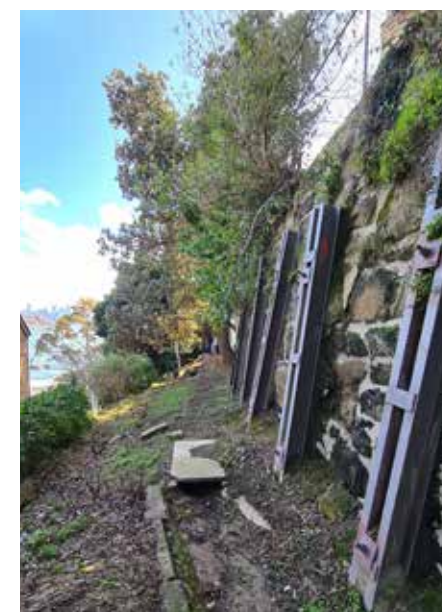
Figure 2.217: Structural support to Hunt retaining wall.

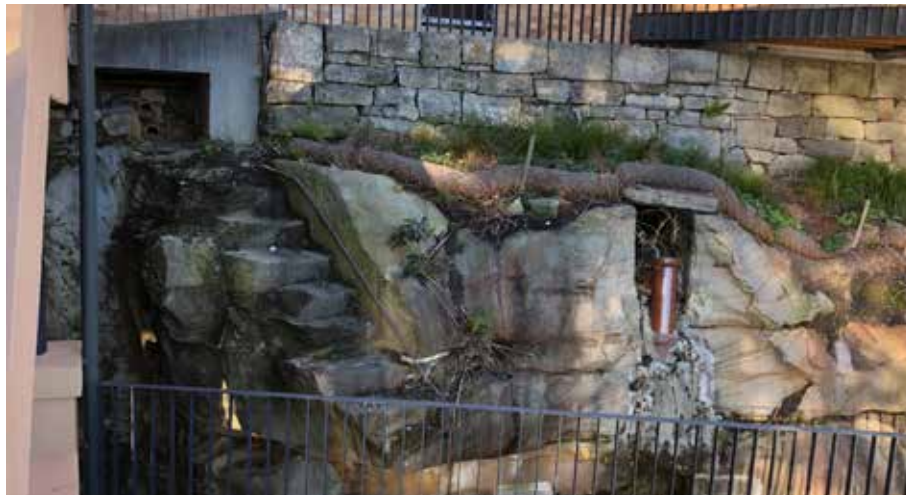
Figure 2.222: Hunt retaining wall, west of the Hughes Centre adjacent O'Neil Library. The wall is both cut bedrock and stone ashlar, note the stone steps.

A large section of the 1880s Hunt retaining wall was demolished during the construction of the O'Neil Library. Stone blocks were salvaged and reused in the recent landscaping of the remainder of the site, and are stored in the undercroft of the cut bedrock wall. The majority of the formerly exposed cut bedrock wall, once a dominant feature in views to the school buildings is now obscured by the Library and Sheldon House.

An 1888 photograph taken at the time of opening of the Main School Building shows a lower terrace accessible via two sets of stone steps. Today only a disconnected and inaccessible remnant of one of these stairs remains. A newly constructed ramping system and stairs connect the O'Neil Library with the upper and lower terraces and the former Sheldon pool site (Dunphy Foundation Outdoor Learning Centre), bypassing the old stairs. The original path system has been replaced with plantings and landscaped areas.

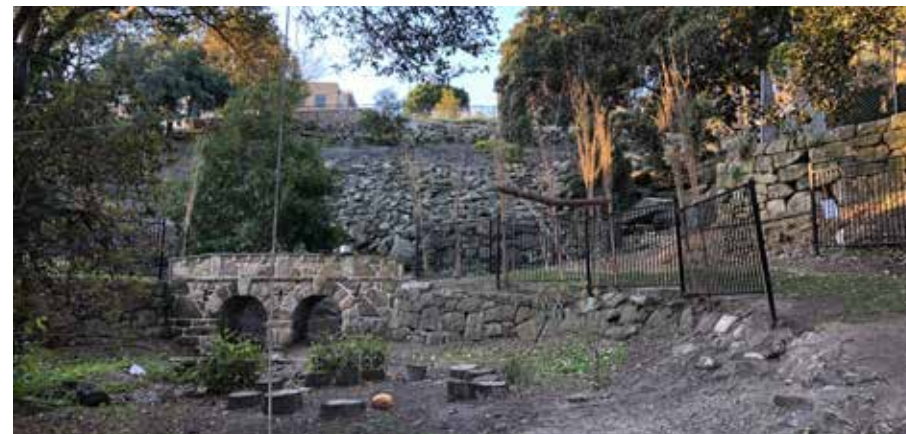
Figure 2.224: Little Stone Bridge, looking north towards the Villa and Barat Burn.

A defining element of this work is the small sandstone bridge located at the centre of the site. Present interpretative signage close by the stone bridge on the path leading to the cemetery, identify the path along the bridge as "*The Heritage Path*" and the bridge as "*The Little Stone Bridge*". The historic photographs show an upright rugged cut stone edge to the random rubble stone retaining walls along the stream and path, a detail that is presently missing. A modern black steel fence now secures the edge. There appear to be some stones and, in some parts, whole sections of the top course of the walls missing.

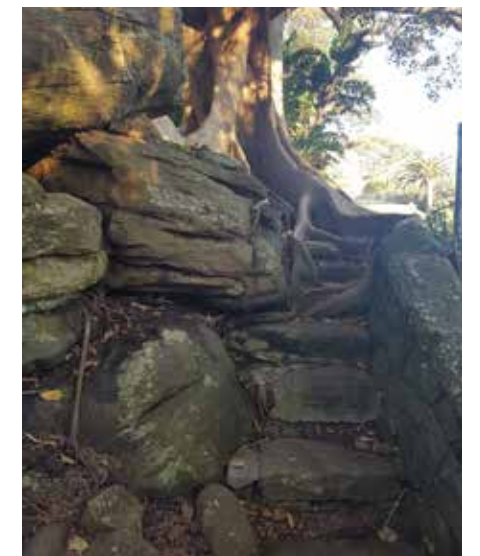
Figure 2.227: Remnants of the now disconnected Depression era path system and steps to the mid and lower slopes

The land was extensively cleared and ornamental gardens were laid out with an elaborate system of paths, steps and retaining walls. These link the terraces, Sheldon Pool, the Grotto of Our Lady Lourdes, the former tennis courts and the cemetery to the main school buildings. Many of the details included sandstone or mock rock concrete construction, of which only few remain.

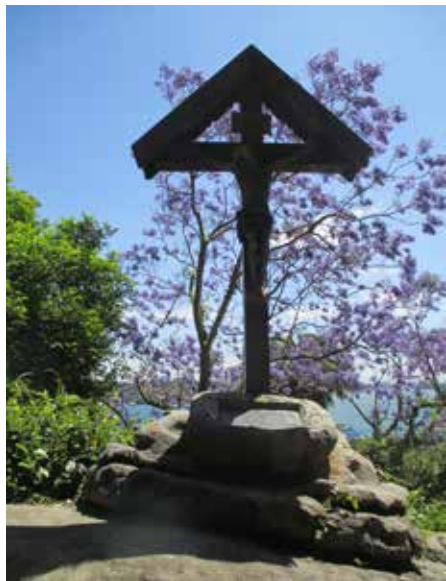
Figure 2.233: Memorial Crucifix located at the southern approach to the grotto, looking west over the harbour.

A Memorial Crucifix was erected in 1940 in memory of Mrs Clara Barbara Regan (born Porter) who died in 1934, located at the top of the stairs leading to the grotto from the upper terrace. It forms part of the formal landscaping, mounted on a rounded rock plinth mound with a plaque to the front. The timber cross has a gabled canopy with scalloped 'bargeboards' and a statue of Jesus.

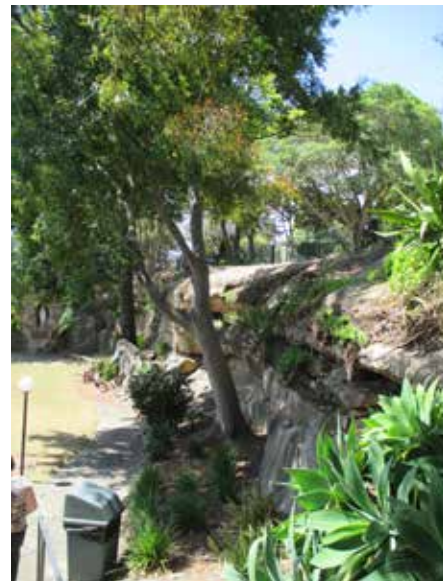
Figure 2.234: View of the eastern sandstone edge to the grotto, looking north.

The former garage and workshop associated with the Villa is located to the west. The grotto wall is constructed of random rubble sandstone and includes two niches, one for the white marble statue of Our Lady Lourdes (mounted on a rock plinth) and one larger niche which includes a stone bench seat incorporated in the coursing of the structure. Planting surrounding the grotto includes various different ferns and palms. Directly above the grotto is a concrete structure platform, utilised for bin storage.

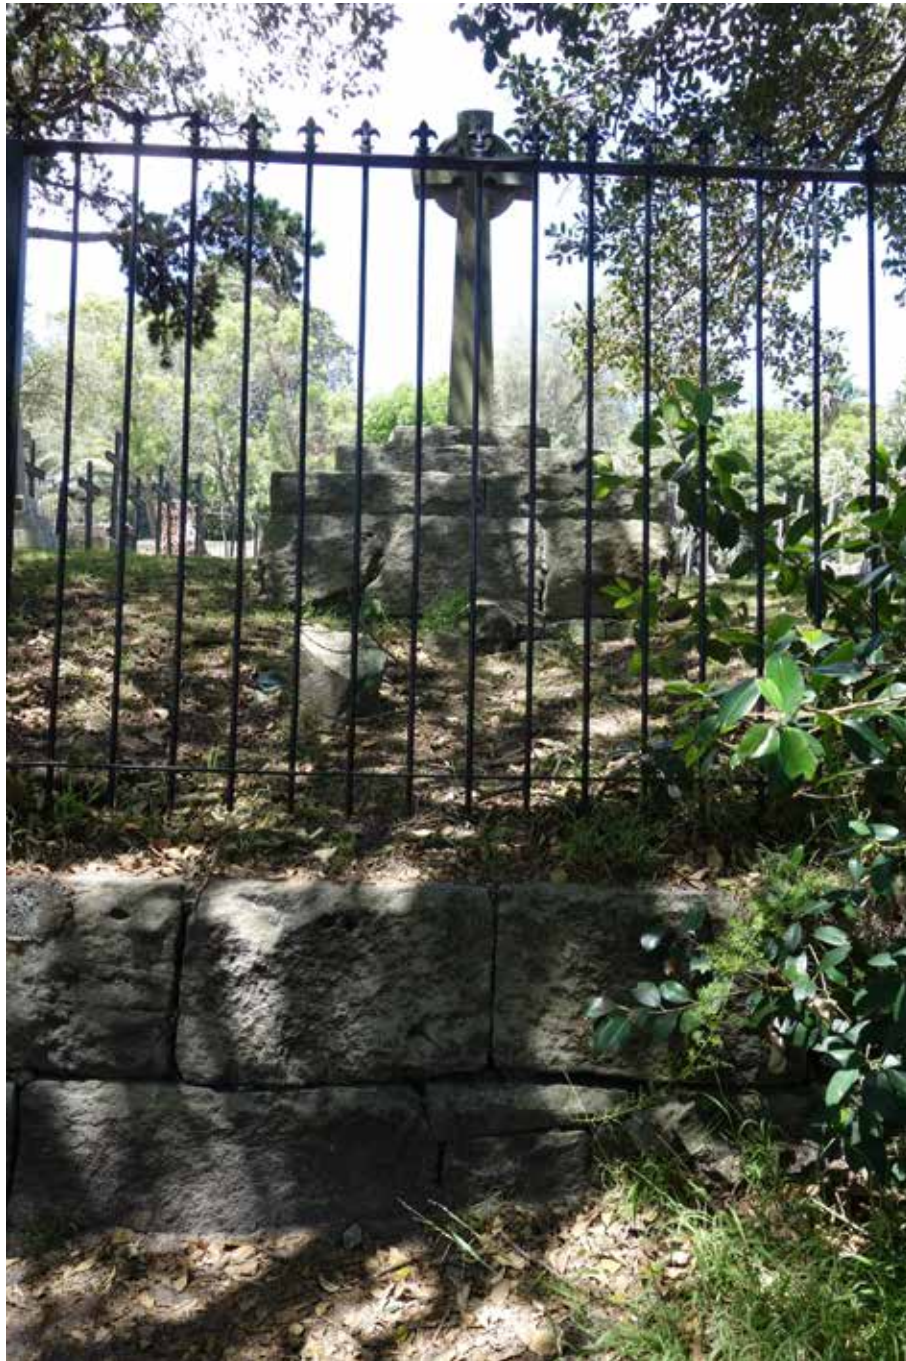
Figure 2.237: Cemetery from the Hermitage Foreshore Walk, with the Horbury Hunt designed Memorial Celtic cross for Mother Vercruysse in the foreground.

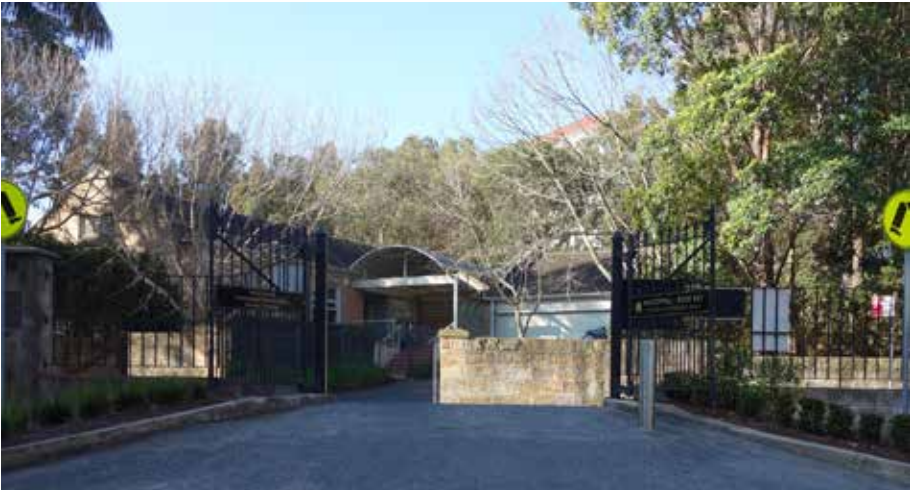
Figure 2.241: Kincoppal Gates on Vacluse Road.

During the installation of the gates, the mock-sandstone concrete block wall was altered and new balustrade fences either side of the gate were installed. The gates appear unaltered and are said to be the original Kincoppal House gates from c1860-70. The design relates to a standard cast-iron palisade fence, consistent with mid-1800s urban fence types, with a bottom and middle rail, a diagonal brace in the upper half and decorative spearheads.

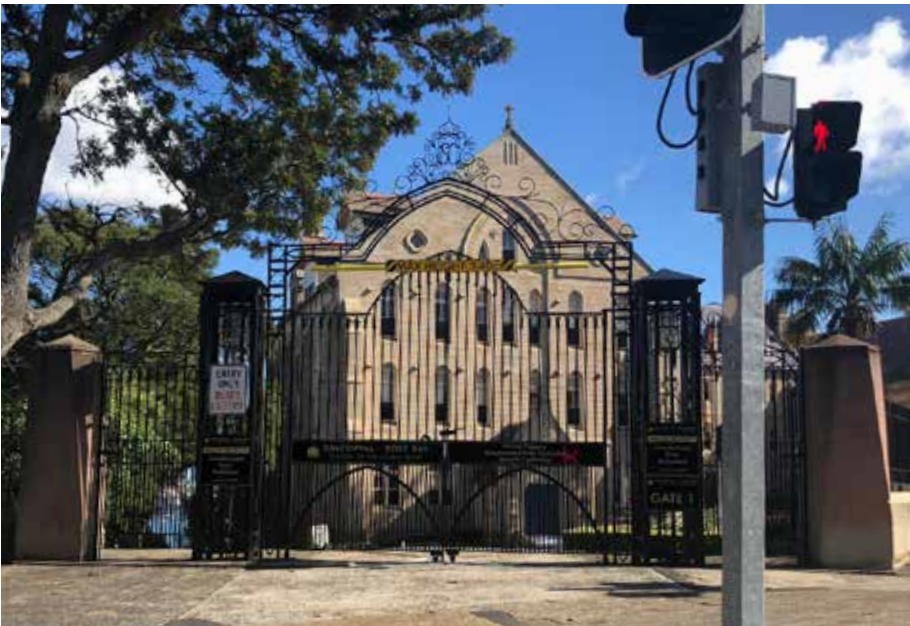
Figure 2.242: The Jubilee Gates on the corner of New South Head Road and Vacluse Road.

The Jubilee Memorial Gates or Jubilee Gates were opened on 25 May 1933. They were not quite complete by the school’s actual jubilee in 1932, but were officially opened by Mother Amelie Salmon, the Superior Vicar the following year. The iron entrance gates including the stone pillars were a gift from the members of the Rose Bay Association of Past Pupils for the occasion. It was noted in the 2002 Conservation Management Plan, that the decorative arched head on the gates had been removed around the time of writing the document, to allow delivery trucks to enter. In the physical investigation in 2002 it was indicated it had been stored under the stone overcroft behind the O’Neil Library.
